CO₂ Capture Project

Wellbore Integrity
Study

NETL Conference
5/7-10/2007

CO₂ Well Integrity Survey

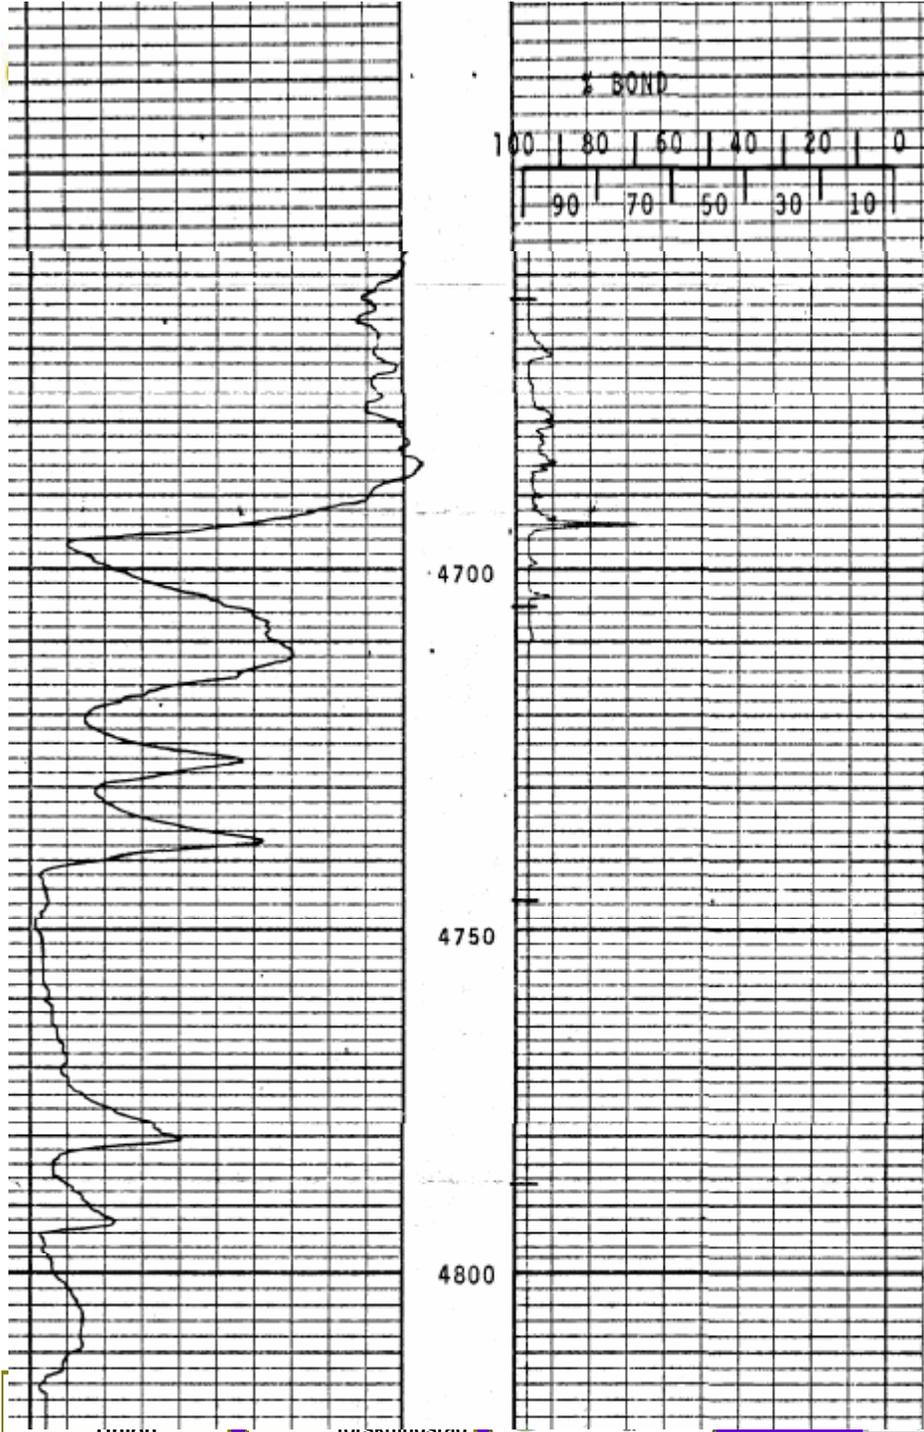
Generally good bond indicated by CBL

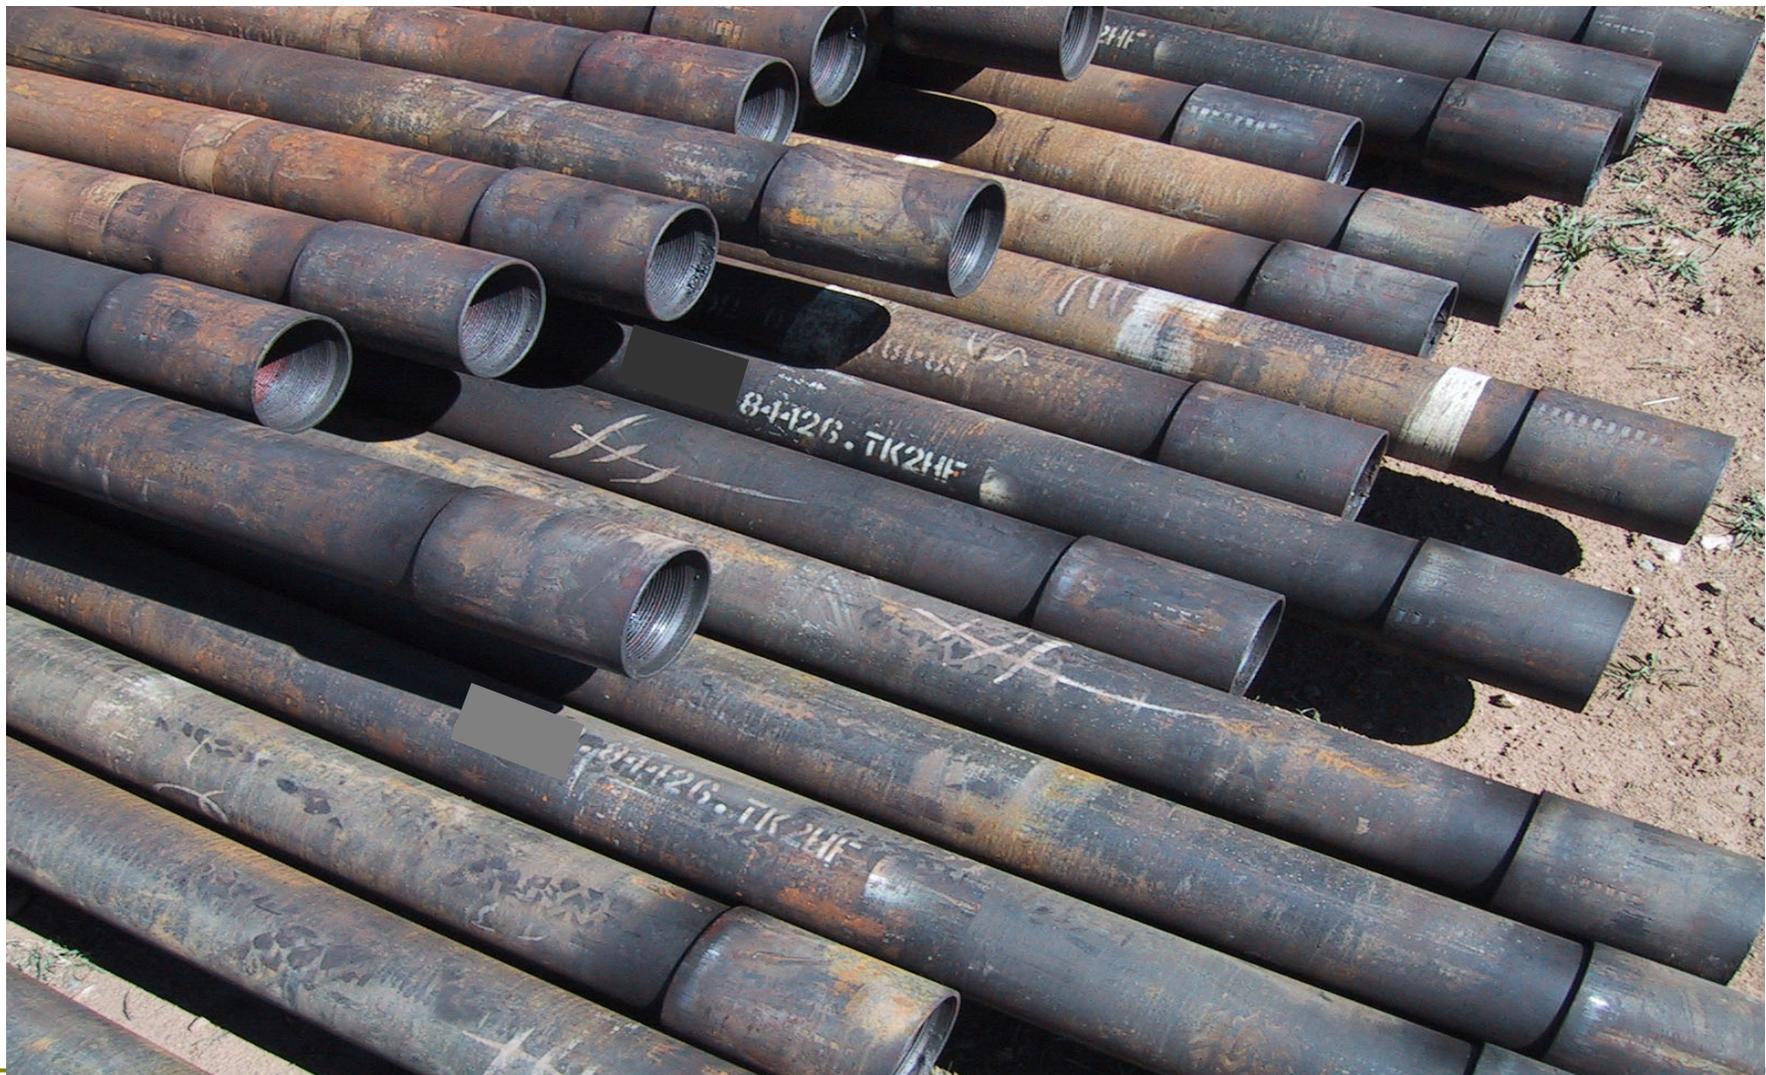
Tubing in good shape after 22 years - Foundry Stencil Visible

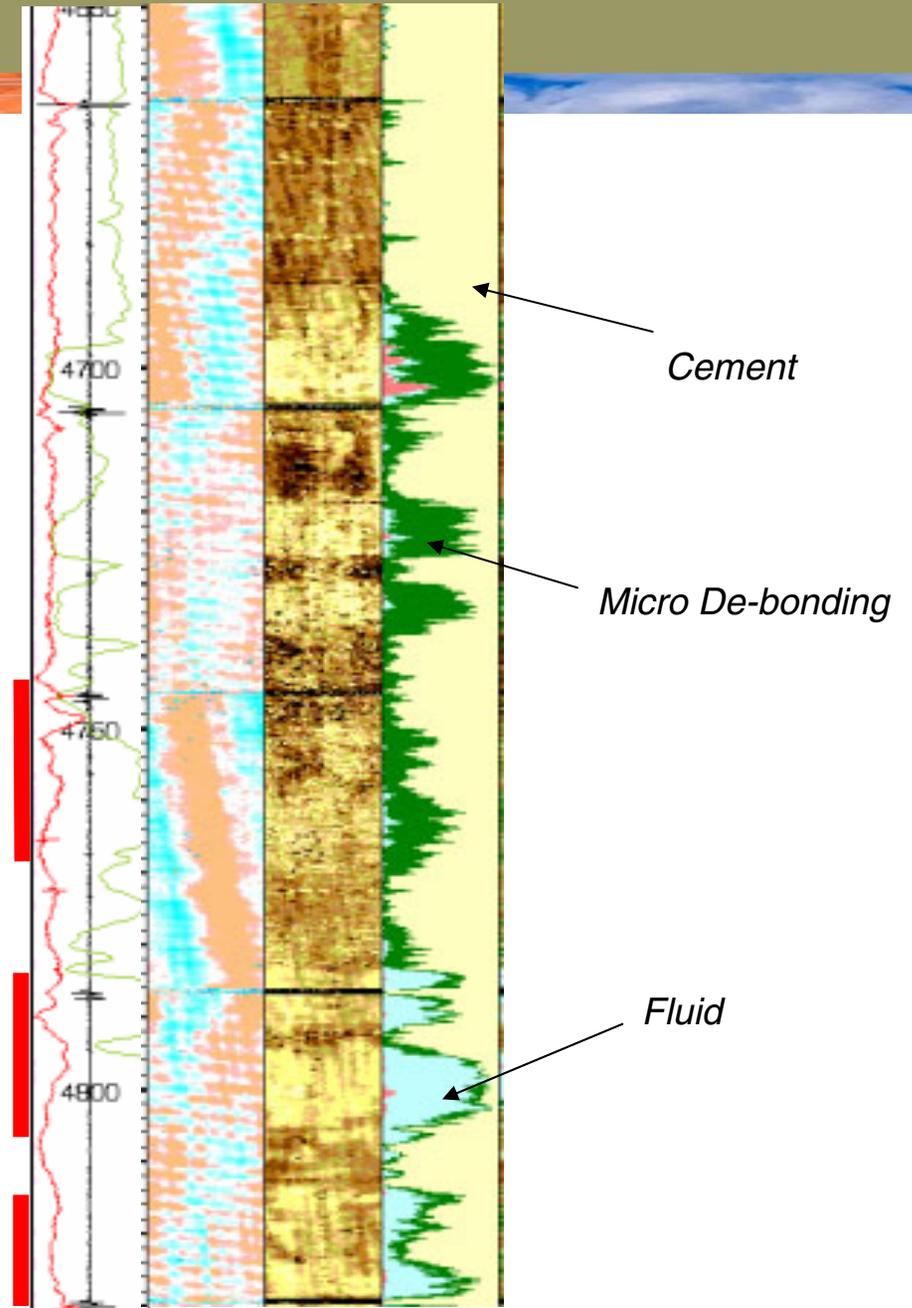
Cement analysis logs show generally good condition in caprock

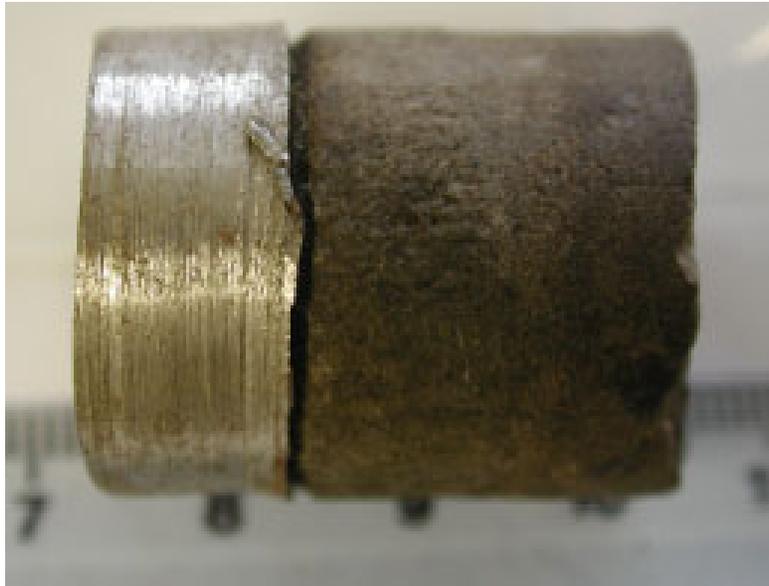
4650' (casing / cement)

XRD shows carbonation
Calcite 30%
Aragonite 3%

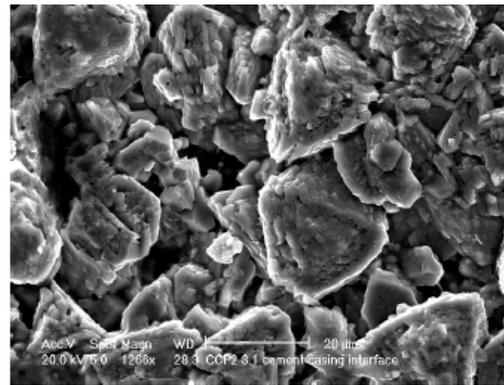
Figure 38: Close-up view of the calcium carbonate crystals in Fig. 37.

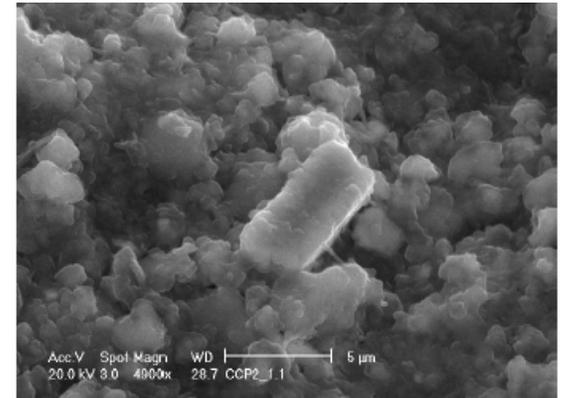
Figure 33: SEM image of tabular barite crystal in a matrix of cement-like composition. The barite may reflect drilling mud.

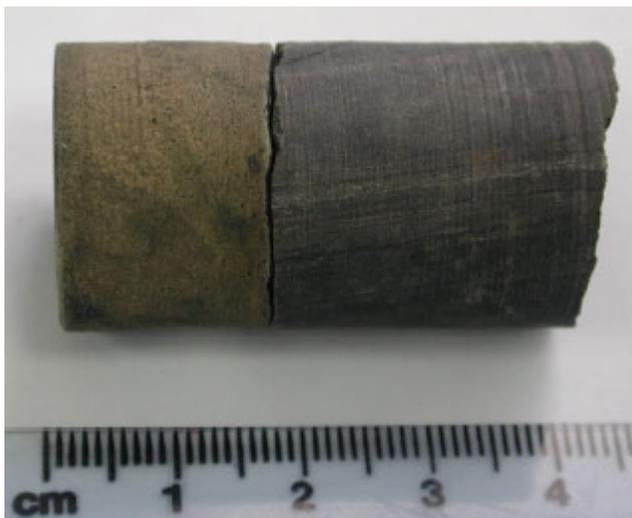
4682' (cement / shale)

**Calcite 30 – 50%
Aragonite 4 – 20%**

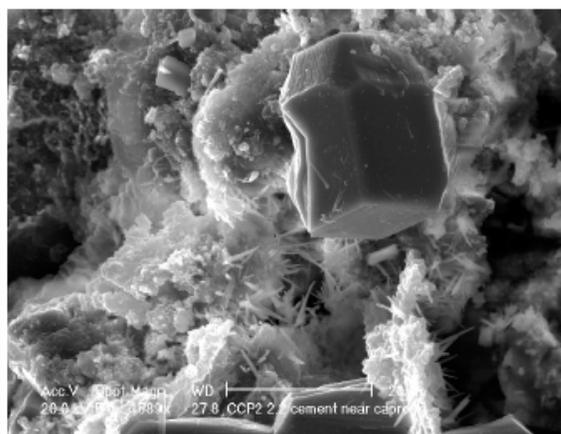
Figure 48: Close up of lower left region from Fig. 47. Large central crystal and the needles are calcium carbonate. The granu-

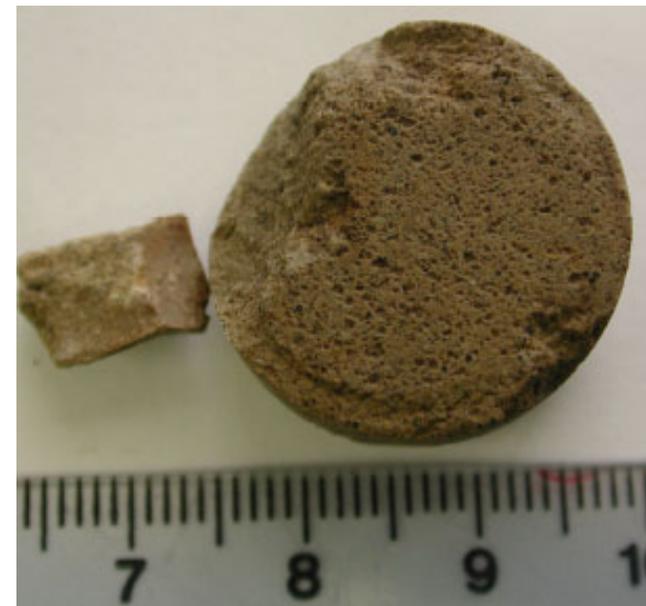
4701' (casing / cement)

XRD shows **Calcite** **21%**
much carbonation **Aragonite** **68%**
