DOE Contract DE-FE0012829

Pilot Test of a Nanoporous, Super-hydrophobic Membrane Contactor Process for Post-combustion CO₂ Capture

U.S. Department of Energy
National Energy Technology Laboratory
Carbon Management and Natural Gas & Oil Research Project Review Meeting
Virtual Meetings, August 12, 2021

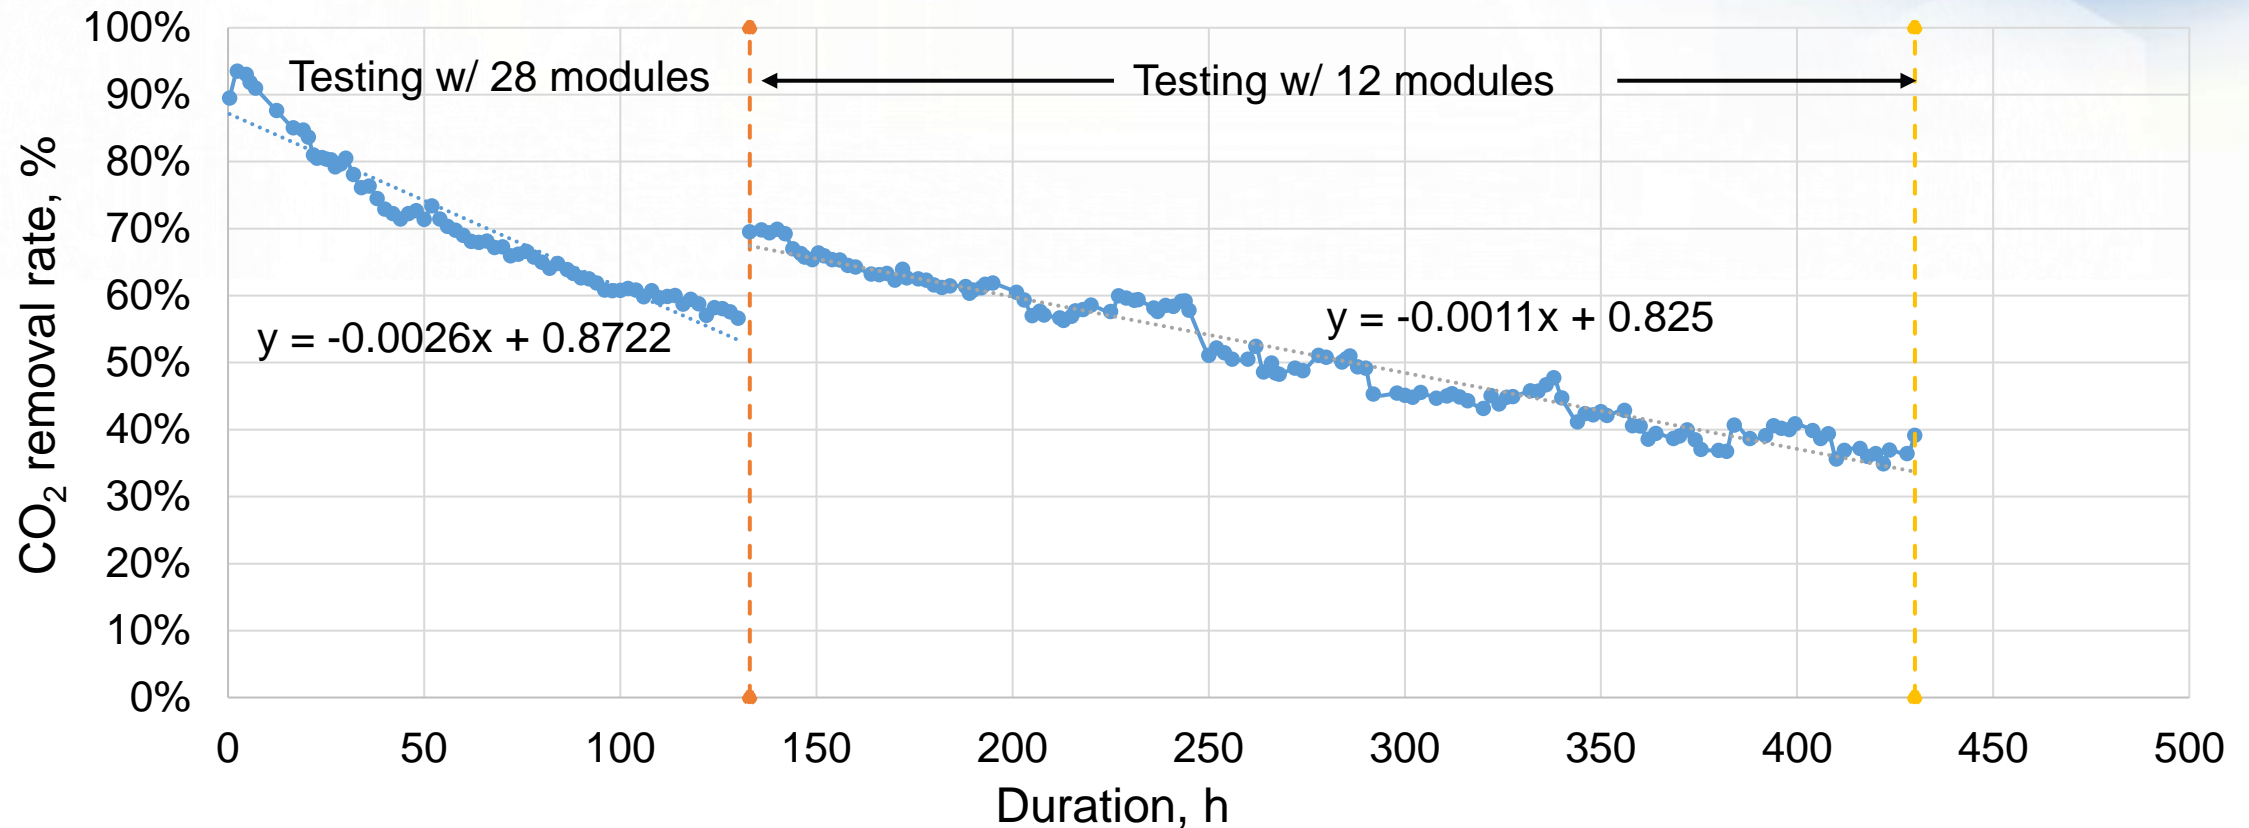
2018's testing with 28 membrane modules

- **Observation**: Performance declined with time
- **Analysis**: Quantitative analysis indicated three causes: 1) contaminants (powder and rust particles); 2) vapor condensation in fiber bores; and 3) capillary condensation of vapor in PEEK pores
- **Decision made at that point**: Resolve issue of contaminants (powder and rust particles) first

Additional flue gas filters and pre-membrane mesh pads installed to protect the membrane; orifice plates installed to monitor if there is a flow maldistribution issue

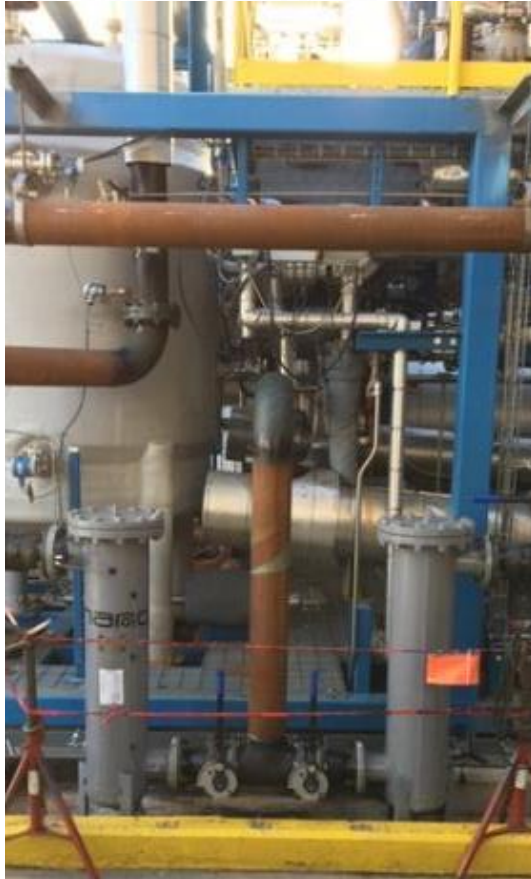
Installed new filters

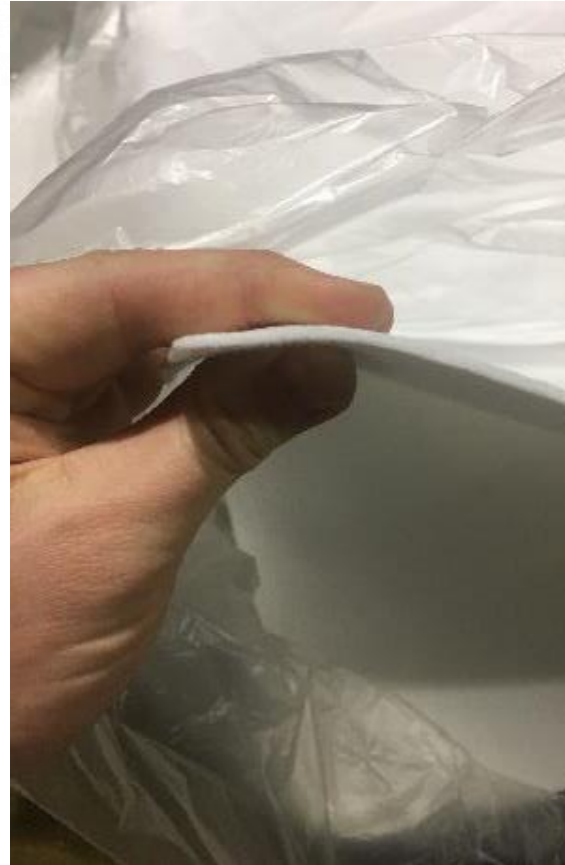
Pre-membrane mesh pad

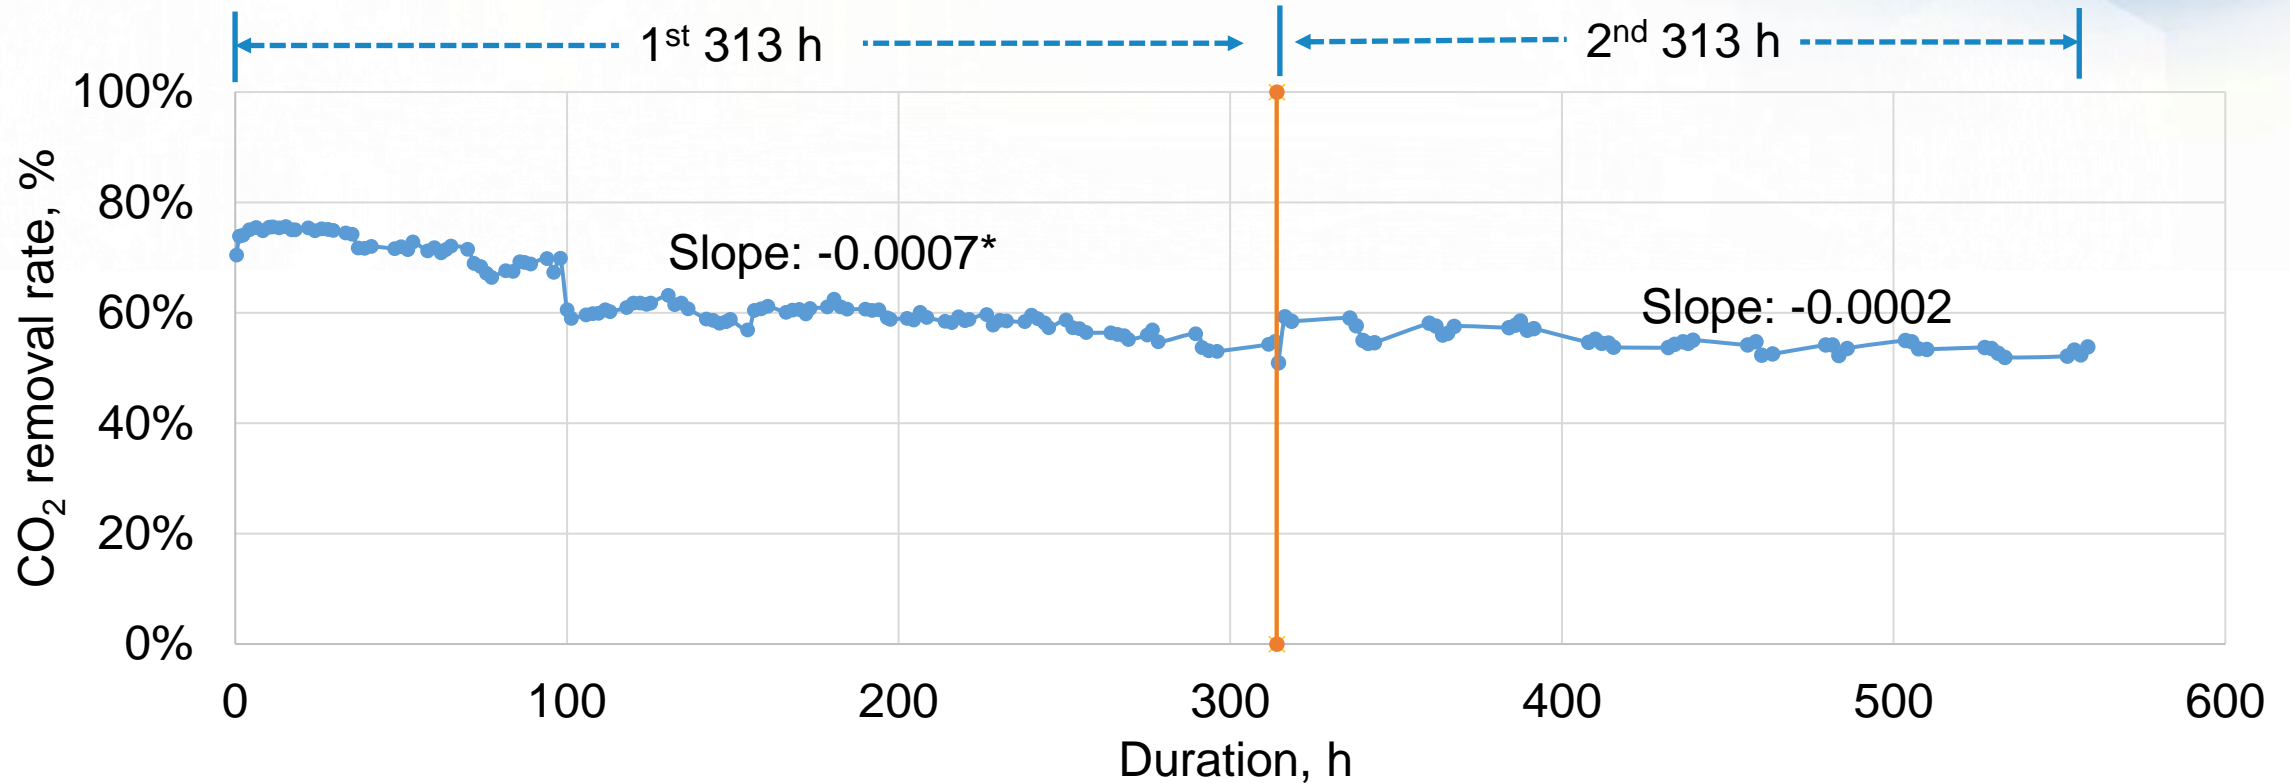
2019's testing with 8 modules (7 used and one new)

- **Observation:** stability improved, especially during the 2nd 313 h
- **Analysis:** 2% drop/100h during the 2nd 313h, might be because: 1) 7 used membranes (containing particles inside) were used, and 2) rusts from carbon steel piping; new membranes were expected to be stable
- **Decision made at that point:** move forward to fabricate 28 new membrane cartridges, replace carbon steel piping with stainless steel piping between filter and membrane header, and perform tests

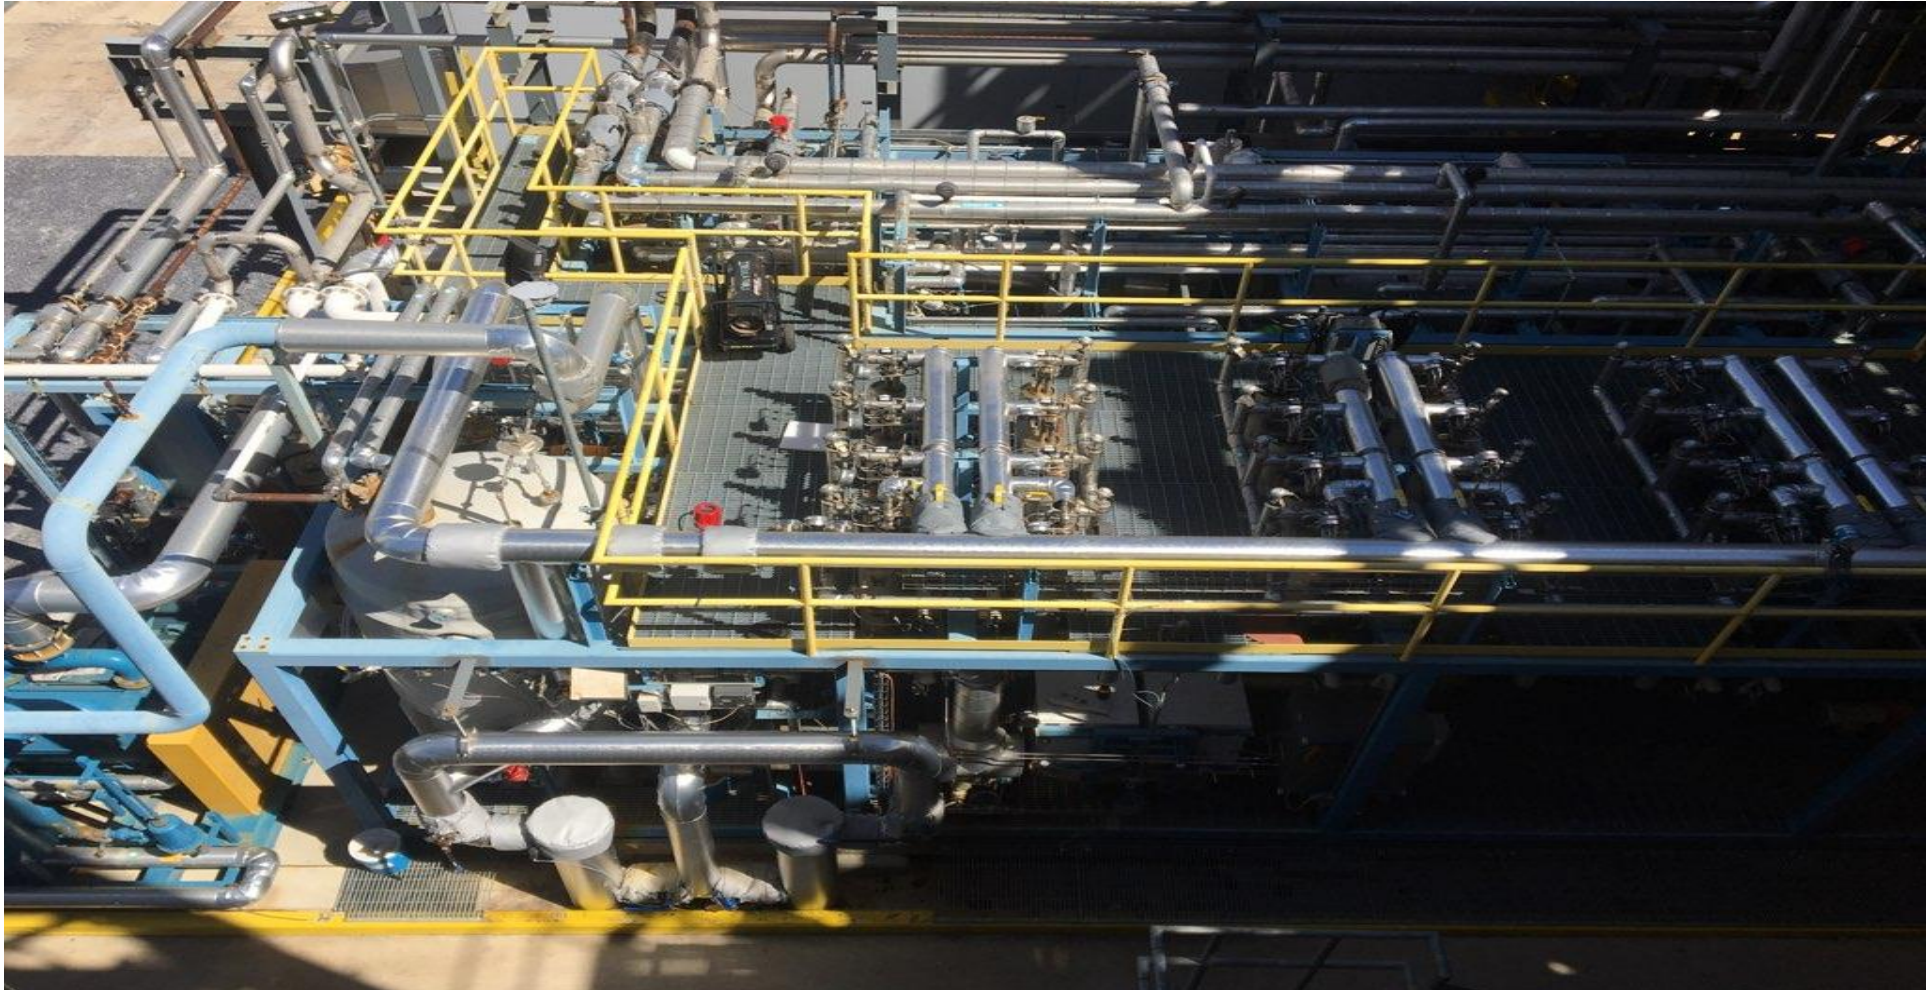
Modified skid with stainless steel piping (February 2020)

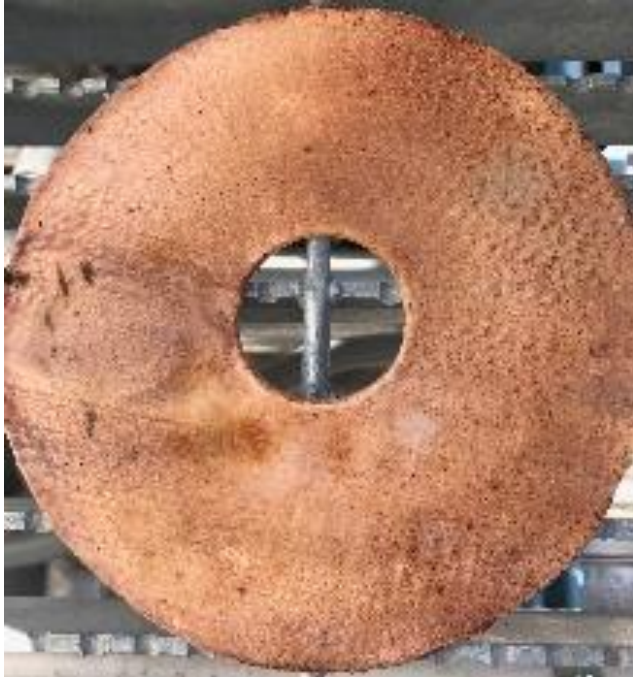
Inspection: Inlet mesh pads were clean after system improvements, no visible rust or particulates present on the mesh pads, indicating the issue of particles had been resolved

Used mesh pad top surface after March 2019 testing: rust particles observed because between filter and membrane header carbon steel piping was used at that time

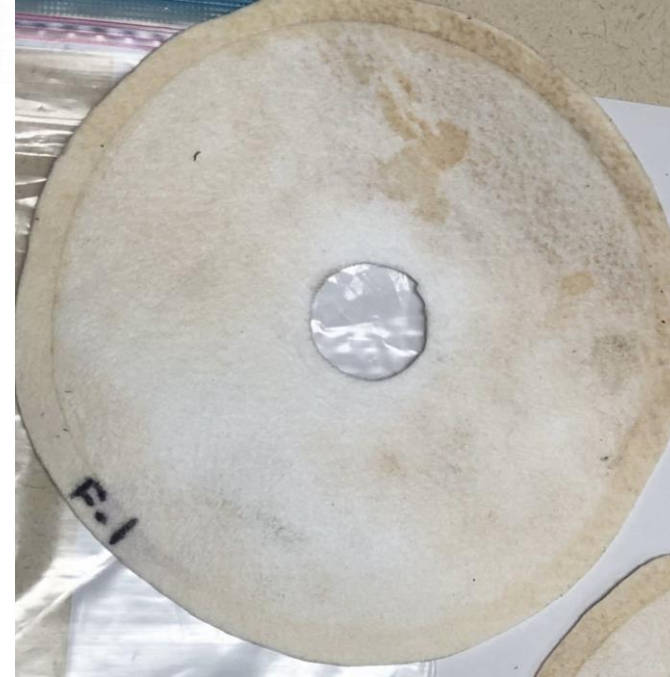
Used mesh pad top surface after 2021 testing: clean

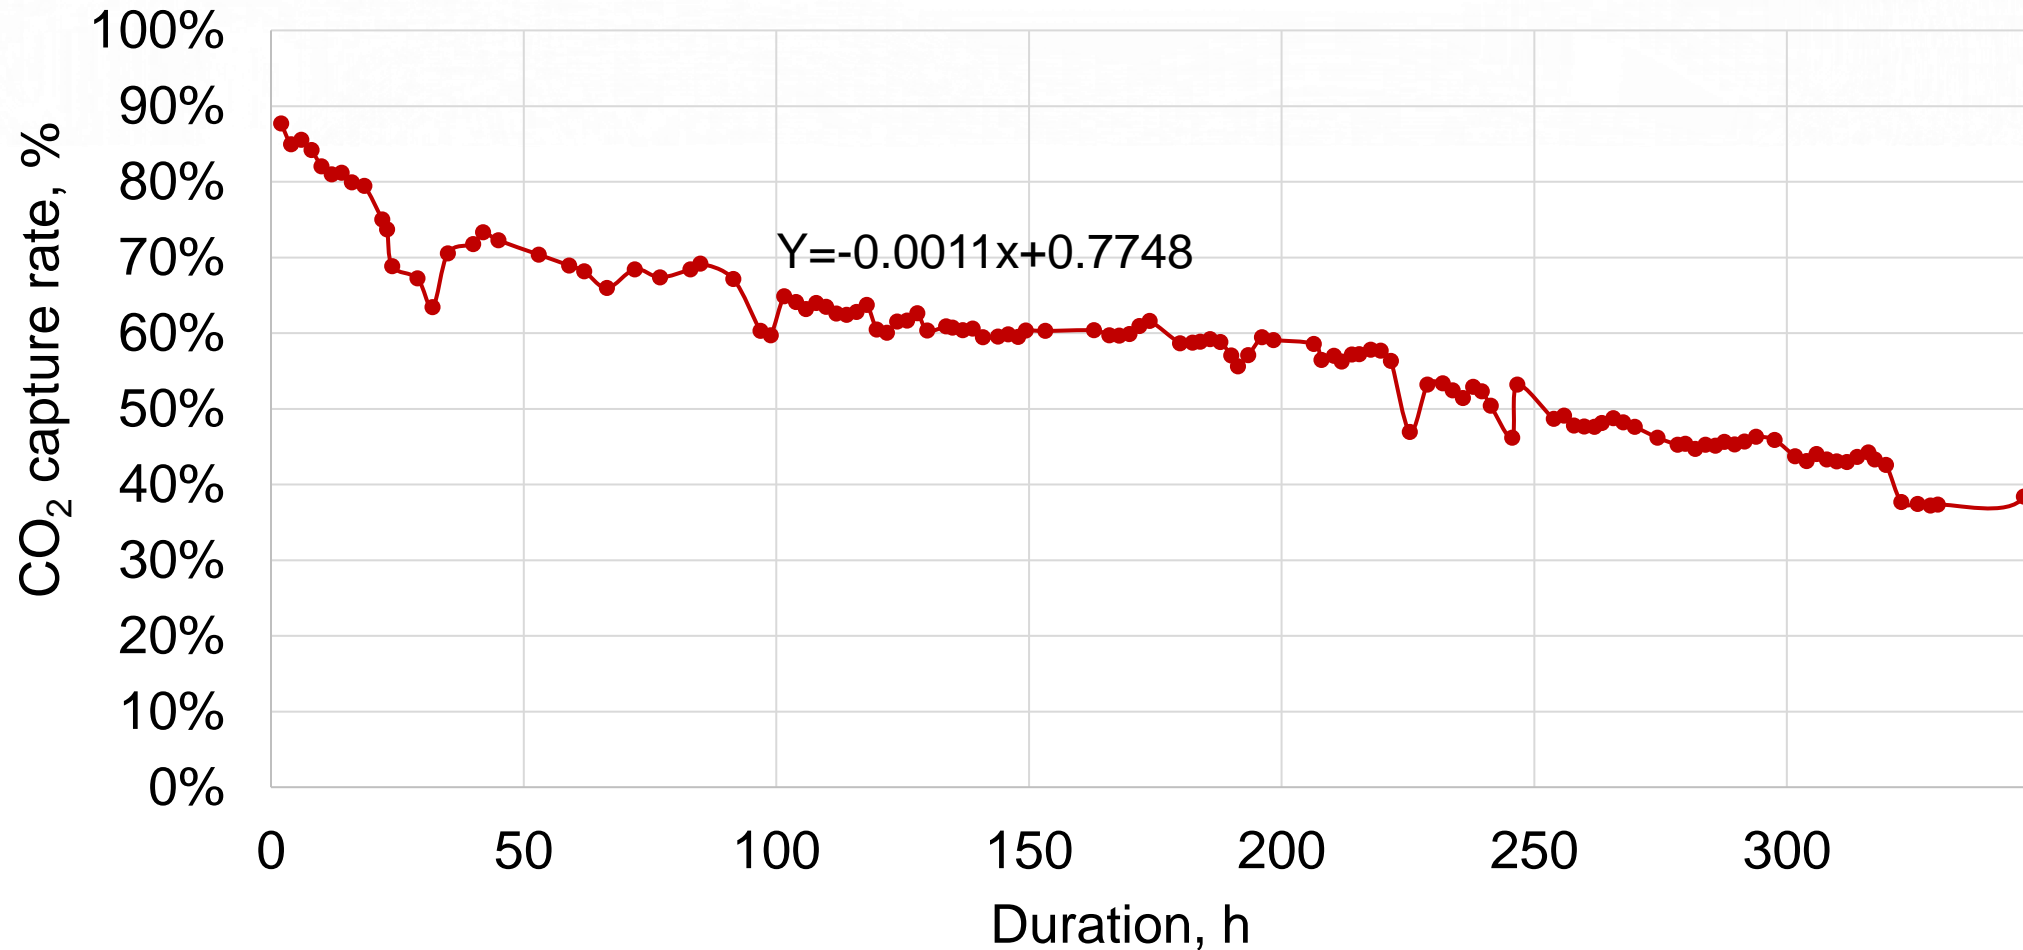
2021's testing: Decline in performance observed for the 1st 347 hours with 28 modules

Cause #	Explanation	Sub-cause #	Explanation	Mitigating Information/Action Required to Resolve	Resolved?
1	Contaminants in the flue gas	A	Solids observed on inlet tubesheets and in bores	Replaced piping with stainless steel, installed filter, mesh pads in 2020	Yes
		B	Within bore or pore, water vapor condenses, blocking CO ₂ passage	Reduced flue gas dewpoint with no effect on degradation. Liquid found in bore is consistent with amine, NOT flue gas	Yes, verified not to be the cause
2	Liquid was observed from the bore side drain with amine concentration close to solvent	A	Poor membrane potting into epoxy tubesheet provides a path	ALaS developed an infusion technique to eliminate leak path in 2016	Yes, verified not to be the cause
		B	Broken fibers during operations provide a path for amine to get into the top tubesheet and into the bores	Solvent permeation test, single gas permeation tests, and cyclohexane permeation tests on used modules	Ongoing

C	Defects of the membrane superhydrophobic layer coating during handling or operation	SEM and other characterizations, Solvent permeation test, single gas permeation tests, and cyclohexane permeation tests on used modules	Need action
		D	Membrane hydrophobicity change (especially surface contact angle) after long-term contact with liquid	ALaS: measure contact angle as a function of time in the presence of solvent	Need action
		E	Vapor phase permeation of the solvent through the membrane and then condensation in the pores and in the bore	GTI: V-L-E data for amine solution, amine and water permeances to calculate the amine concentration of the condensed liquid; ALaS: prepare PEEK with pores > 50 nm (current pores have average size of 13-16 nm).	Need action

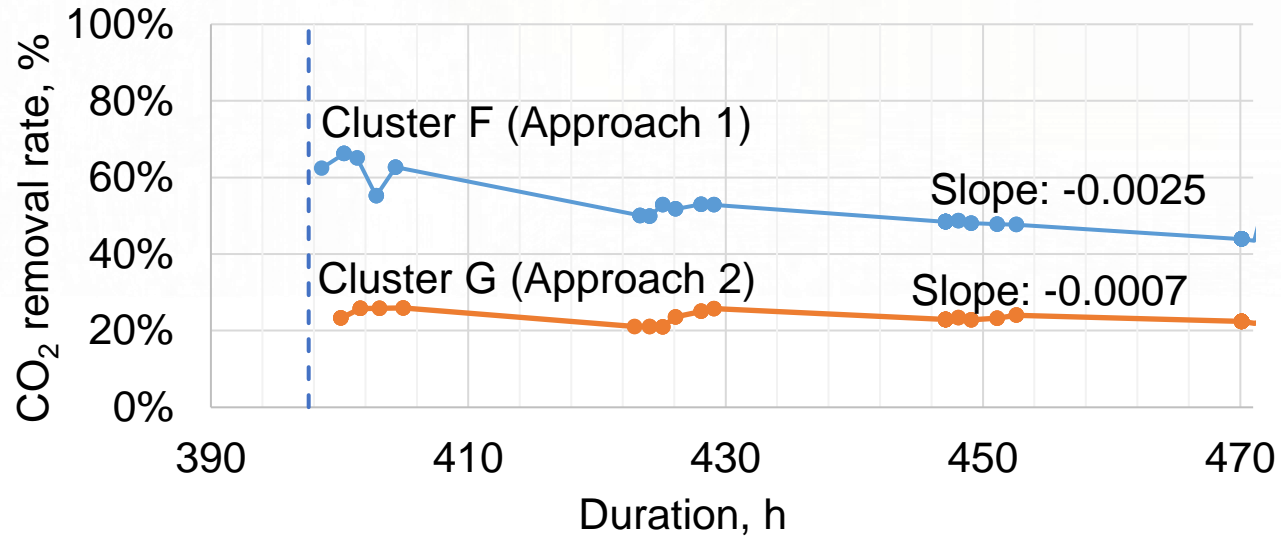
Performance can be recovered, but stability was not improved

- **Approach 1**: Water wash followed by air dry
 1. Drain liquid from membrane shell side
 2. Remove inlet mesh pad
 3. Connect demineralized water to gas inlet, allow water to flow down to gas outlet
 4. Connect instrument air to the gas inlet, purge fibers with air
 5. Replace gas inlet mesh pad, bring membrane back online
- **Approach 2**: Air dry
 1. Drain liquid from membrane shell side
 2. Remove inlet mesh pad
 3. Connect instrument air to the gas inlet, purge fibers with air
 4. Replace gas inlet mesh pad, bring membrane back online

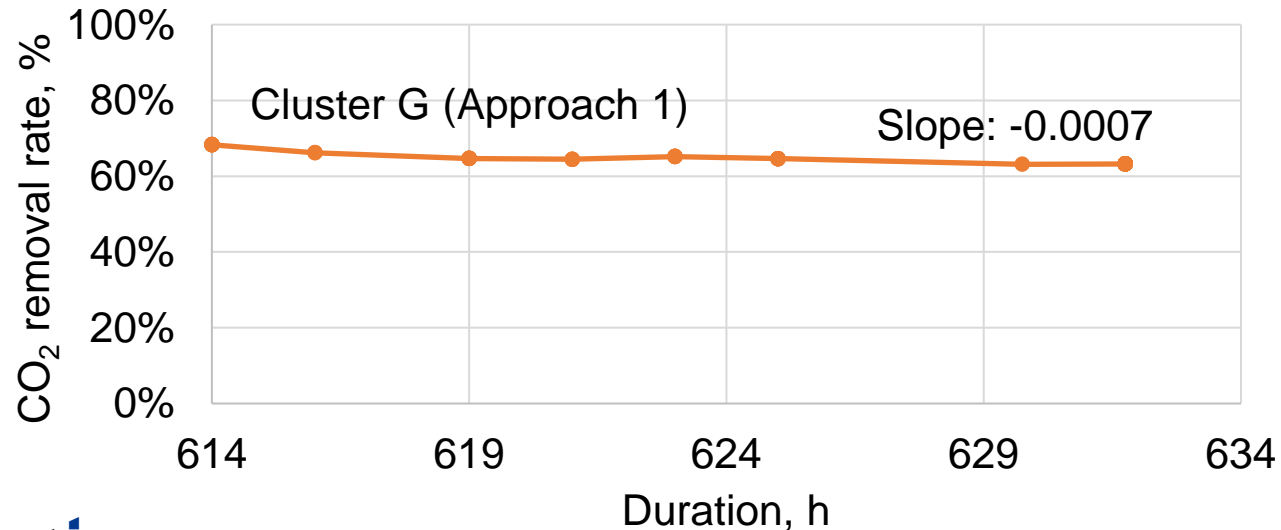
- Air purge alone was not sufficient in recovering performance
- Water wash + air purge can recover the performance but doesn't resolve continual decline issue

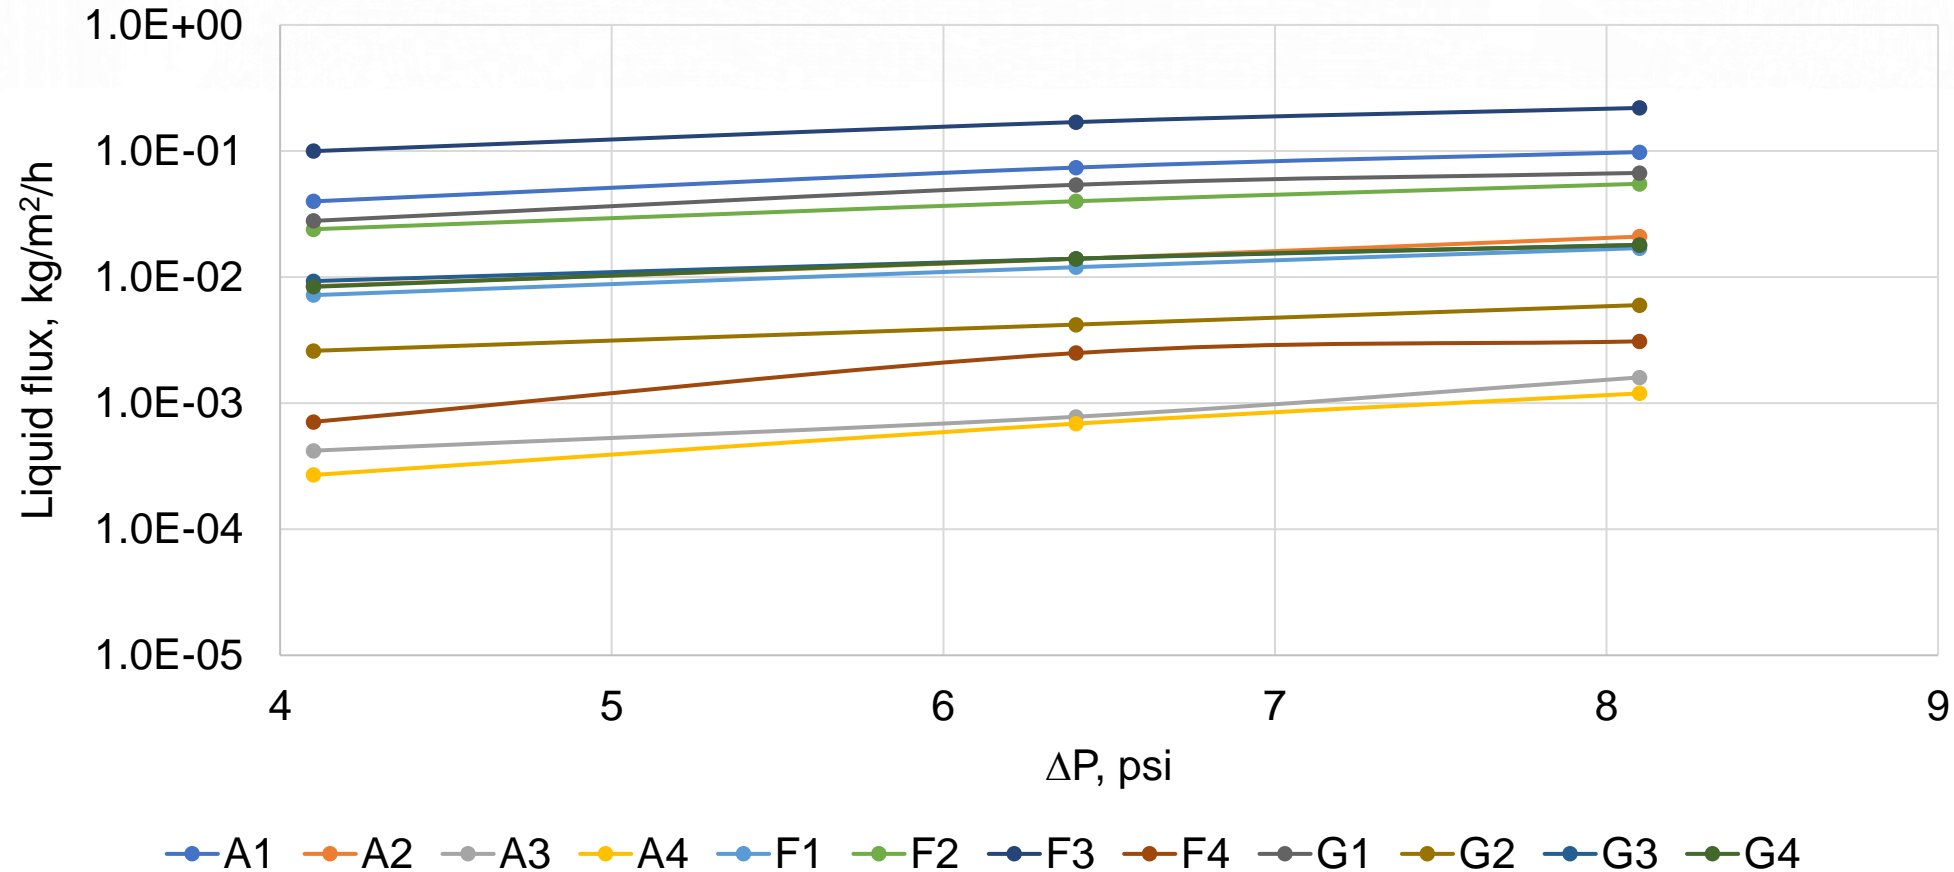
Testing underway to verify the causes of instability; solvent permeation tests suggest quality of the hydrophobic coating layer needs to be improved to be impermeable to solvent
