Appendix A

Bullfrog 5-12 Core Report

Appendix B

Natural Fracture Supporting Documentation

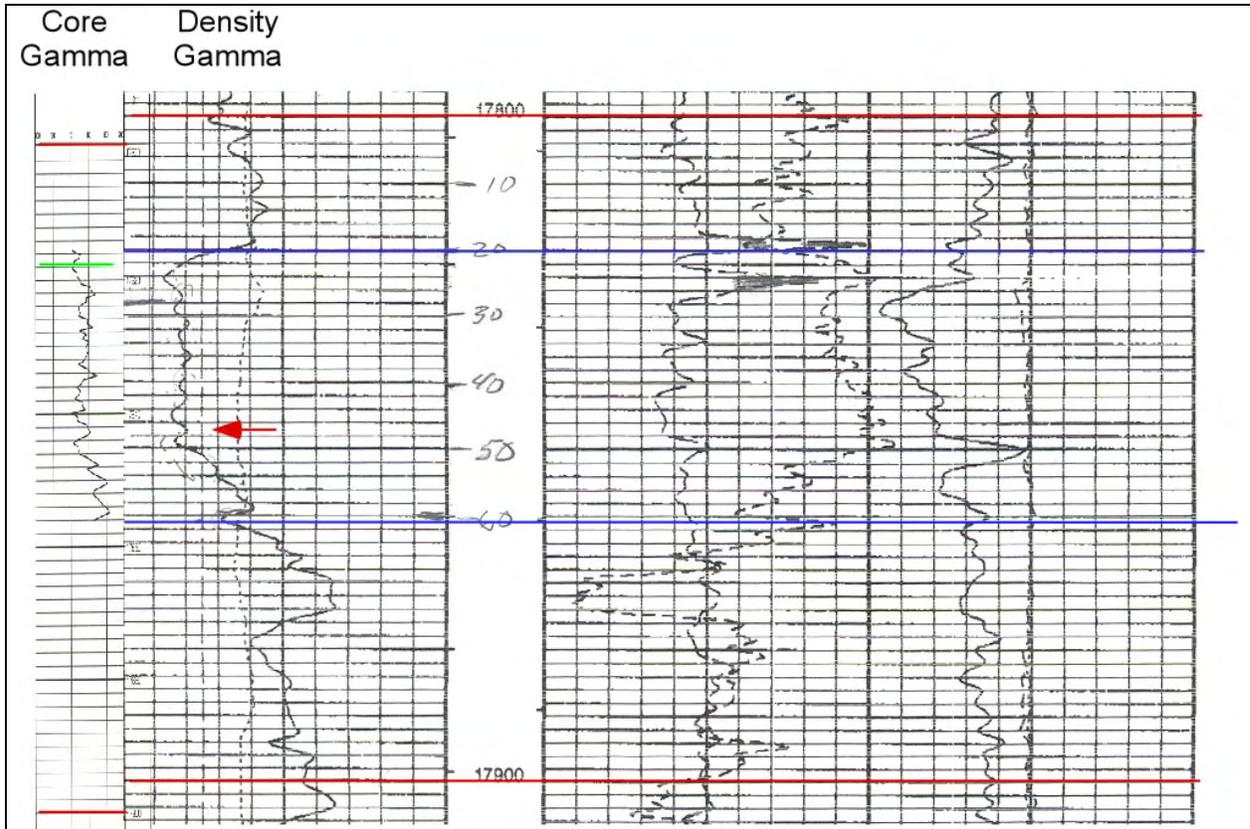
Fig. A-1 Core gamma log and porosity log comparison

Correlation of the adjusted core gamma ray log to the density porosity log indicates the core depth is approximately 4 ½ feet shallow to the log depth. The red lines are drawn at 17,800' and 17,900' respectively to demonstrate the shift after correlation. The core begins and ends in sand. The base of the clean sand provides a good tie point. Note the 12" shaly layer at 17,847' (red arrow). This conspicuous sand-shaly sand-sand-shale transition sequence marks the base of the clean sand and provides a unique core-lot tie point.

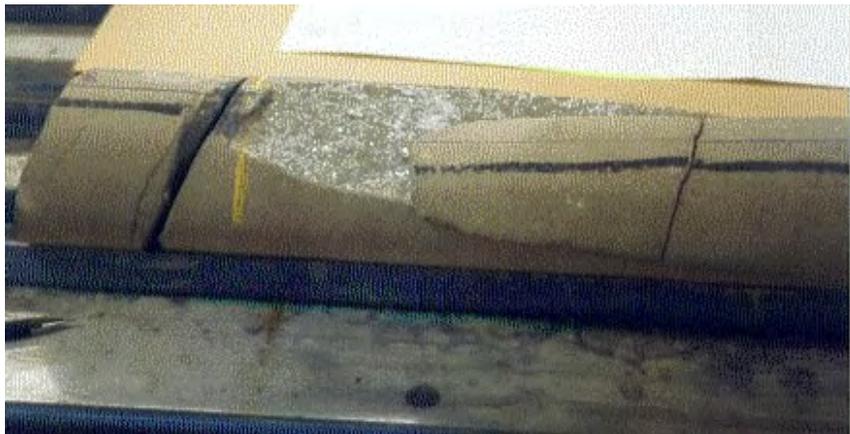
Fig. A-2. Fracture and associated concave down parabola

Concave downward parabola formed as the main cored fracture exits the core near 17,818' MD.
Euhedral calcite crystals visible as bright specs on fracture face.

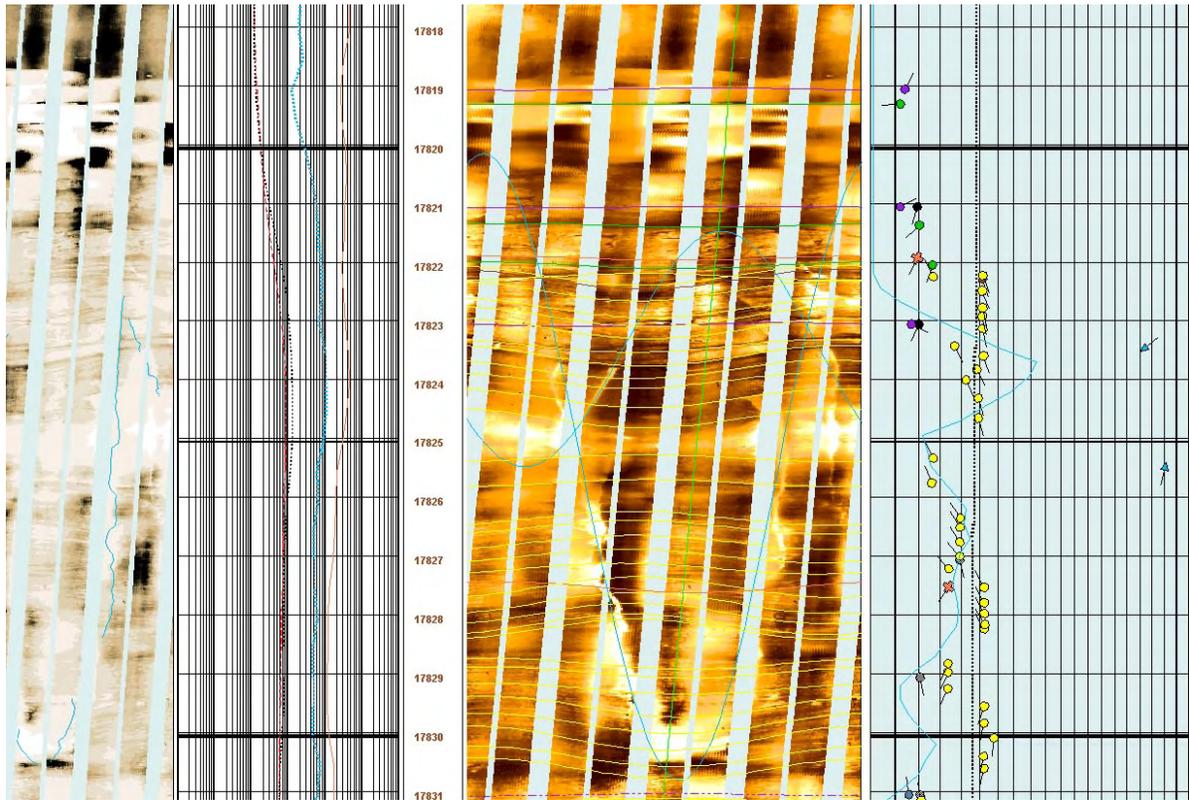
Fig. A-3. Prominent fracture in the FMI

Fig. A-3 at 17,830' MD shows the most prominent, spectacular fracture present in the FMI and its associated concave upward parabola. Assuming negligible differences in orientation between core and FMI and without reconciling the differences in diameter, this observation implies significant fractures of opposing dip paradoxically occupying the same volume in space.

Concave upward signature of the most prominent fracture feature imaged in the cored interval is visible in the lower center of this portion of the FMI. Bright line is high resistivity trace of fracture on the face of the wellbore. Such high resistivity is often interpreted to be cemented fractures however in this case the FMI is imaging the thick calcite coating on the fracture face and large portions of the fracture remain open. Note also the sigmoidal trace of the fracture and the variable width of the aperture.

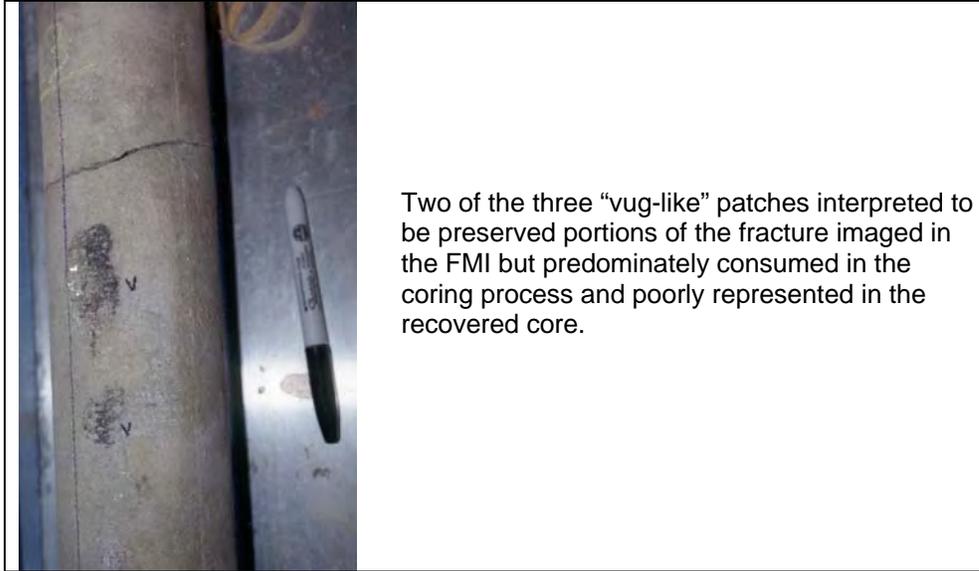
Fig. A-4. Vug-like patches of crystal on external face of core

There are 3 small patches of crystals (fig. A-4) on the external face of the core between 17,822.5' and 17,824' MD. These were initially interpreted as vugs; however, on closer examination they appear to be remnants of an undulatory fracture face. Their location and orientation on the core suggests they are remnants of the "core side" of the large imaged fracture.

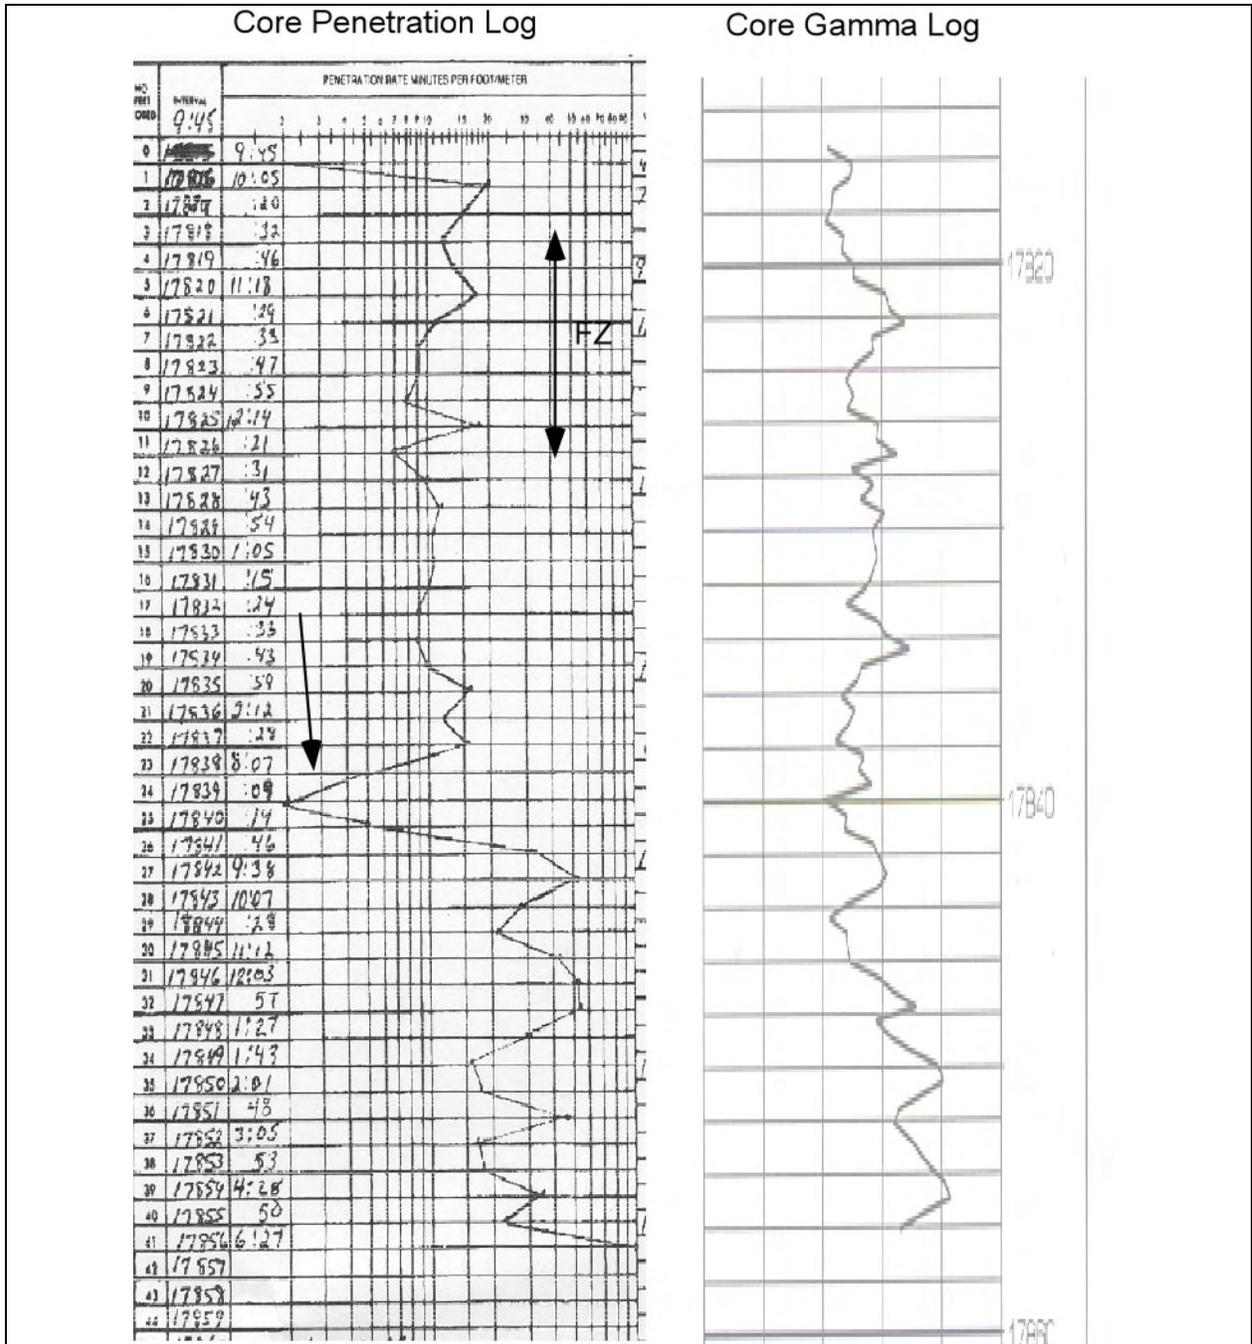
Fig. A-5. Core penetration and core gamma logs

This is further supported by the steadily increasing penetration rate (fig. A-5), and an increasing amount of gas influx that finally forced the well to be shut-in and mud weight raised. Interpreting the patches as fracture faces, and if they are approximately the same orientation as the prominent fracture imaged on the FMI, again places the MOL on an orientation of 205 degrees +/-.

Coring penetration log on left documents 2-foot drop of bit (arrow) during coring operation. There is no indication from the core, core gamma log on right or other logs to explain the event.

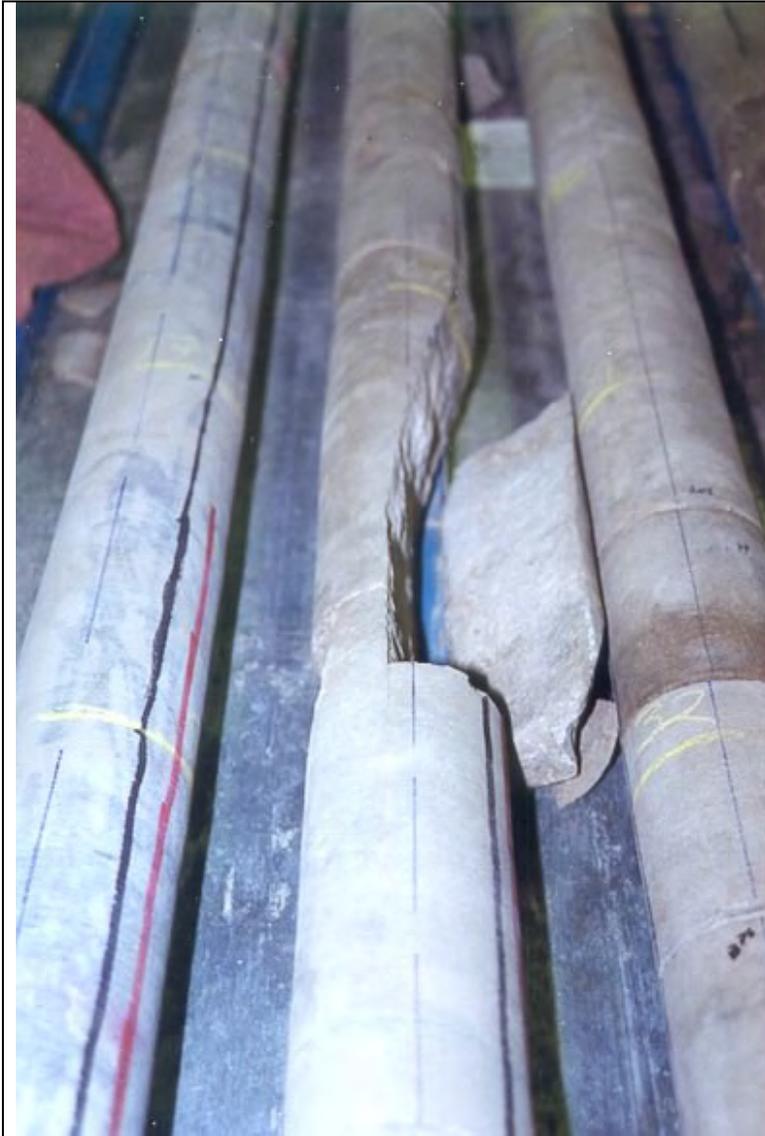
Fig. A-6. Coring induced petal fracture at 17,818' MD

Petal fractures (interpreted to be coring induced) occur throughout the core. Fig. A-6 is an example of the most prominent dis-articulated petal fracture. Others were noted and their strike orientations captured. Considerable variability was noted in their strikes. A rose diagram of this data is shown on Panel A-2, step 3. The predominant strike direction is approximately 50 degrees although there is considerable scatter.

Most of the induced petal fractures remained intact in the core. The petal fractures are interpreted to be indicators of present day stress direction and in aggregate lie in a northeast-southwest axis (see Panel A-2).

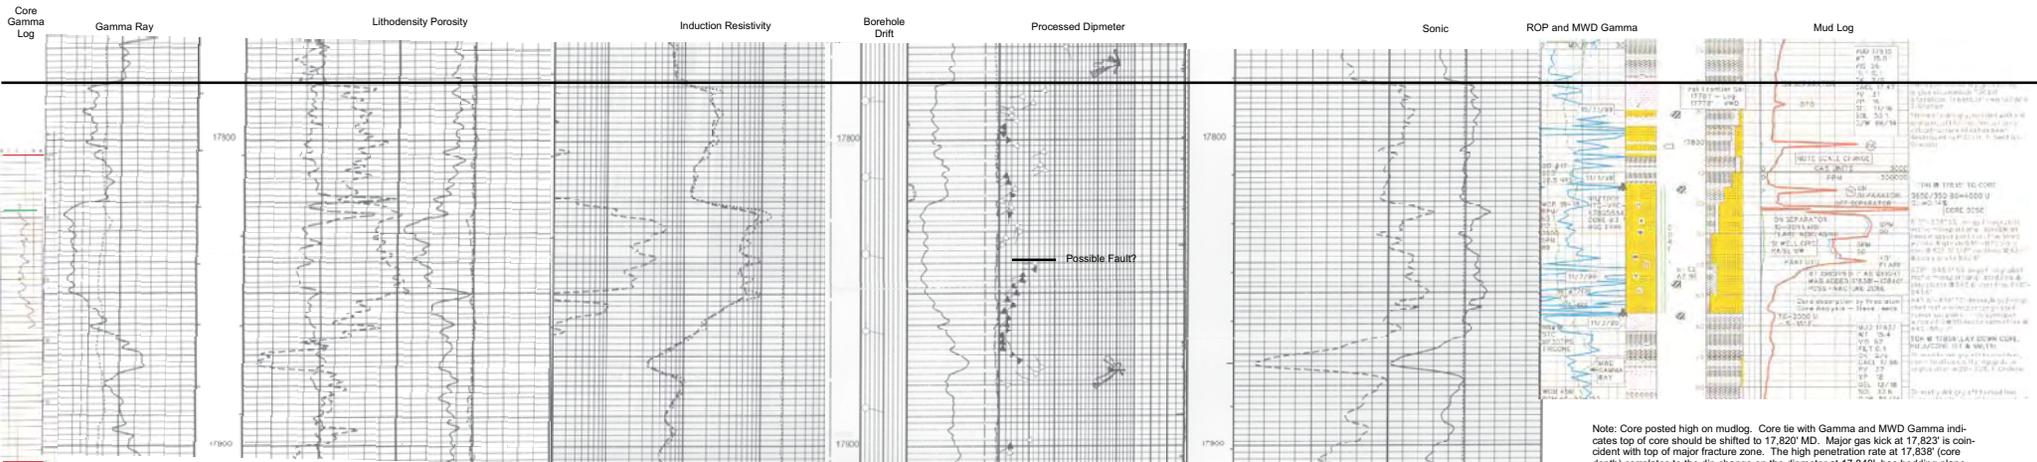
**Bullfrog Unit 5-12
Log Data Montage**

Note: Best correlation indicates core depth is 4.5-5' shallow to log depths

The wellbore is near vertical as shown by the drift column of the dipmeter. Structural dip is low above and below the Frontier sand. There is a possible fault of small displacement 17,838' (log depth). The downward decreasing dip suggests drag beneath a small reverse fault. This is coincident with a bit drop during coring, a small resistivity anomaly, and a small PEF departure. It is interpreted as an erosional surface on the FMI but the other data support an interpretation of a small fault or structural weak zone.

Note: Core posted high on mudlog. Core tie with Gamma and MWD Gamma indicates top of core should be shifted to 17,820' MD. Major gas kick at 17,823' is coincident with top of major fracture zone. The high penetration rate at 17,838' (core depth) correlates to the dip change on the dipmeter at 17,840', has bedding plane slip observed in the core and may be a small throw reverse fault.

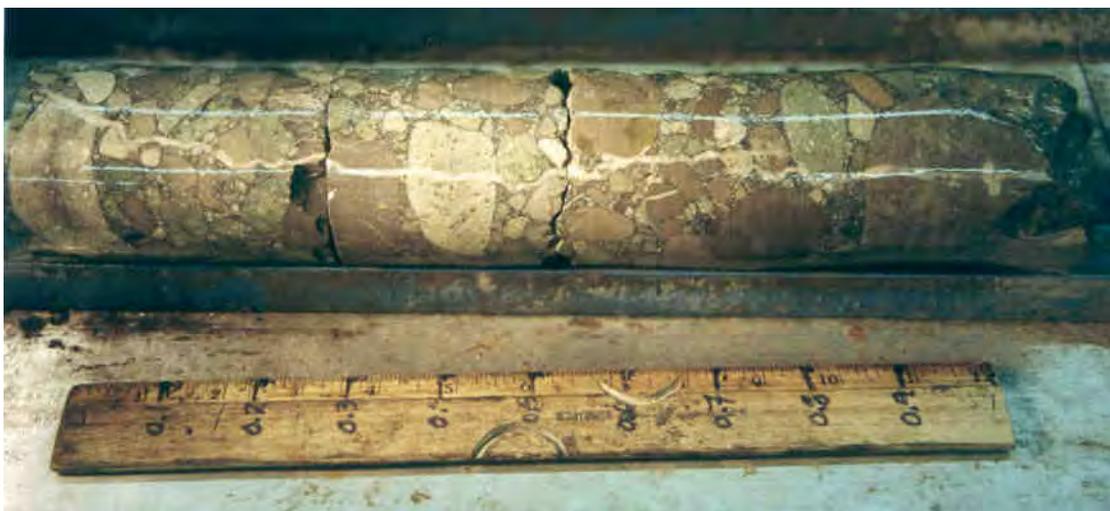
Fig. B-1. Aperture of the healed fracture

Two intervals of fracturing were observed. At 13,704-13,705' a calcite filled natural fracture of about 1mm aperture is observed breaking both through and around clasts (figs. 1 and 2). At 13710'-13712' a two-fracture swarm is observed (fig. B-1). The fractures were 2-3mm in aperture and are calcite filled. A drilling induced petal fracture forms 60-degree angle with the natural fracture (fig. B-2). The ends of the swarm are not observed. The swarm cross cuts the bed boundary at the base of the conglomerate (fig. B-3). Maximum height of the swarm was greater than presently visible (fig. B-4, fig. B-6)). A drilling induced fracture intersects a calcite filled fracture at an angle of nearly 60 degrees (fig. B-5) indicating a rotation of the principal horizontal stress since the formation of the calcite filled fracture.

Aperture of the healed fracture approximately 2 mm. Inter-penetration of the clasts can be observed on the left central part of the photo.

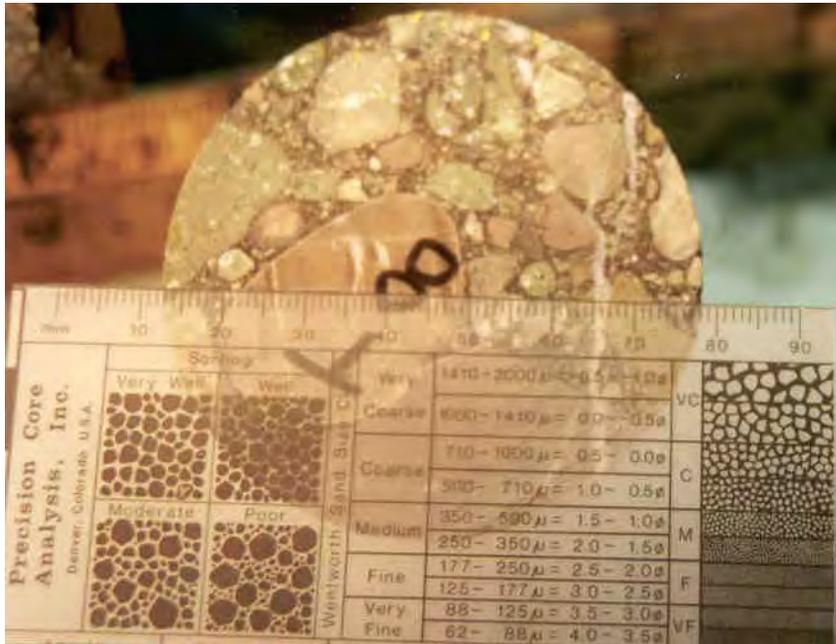
Fig. B-2. Butt photo of core

Aperture of the healed fracture was approximately 2 mm. Inter-penetration of the clasts can be observed on the left central part of the photo.

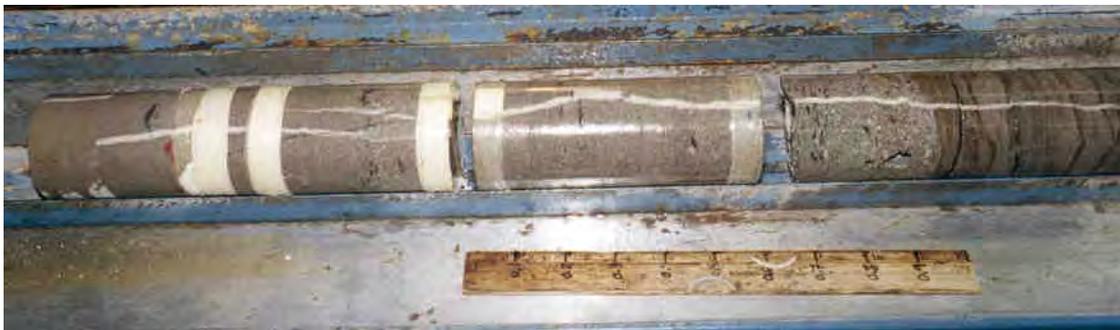
Fig. B-3. Large - fracture swarm encountered in the core at 13710'-13712'

A large 2-fracture swarm was encountered in the core at 13710'-13712'. The jagged white line along the upper third of the core marks the trace of the fracture. The overlap between the fractures is seen just above and to the left of the 1-foot scale. Pieces were sawn out of the core and missing. The missing gaps are interpreted based on a reasonable alignment of features in the core. Up is to the left.

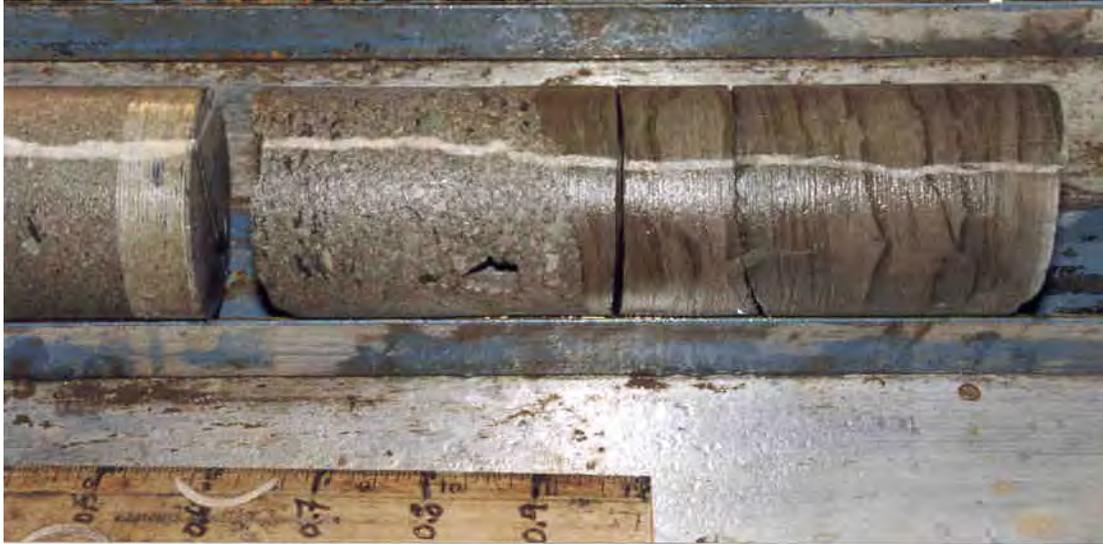
Fig. B-4. Fracture at 13, 712'

The fracture at 13, 712' cuts across lithologic boundary between pebble conglomerate and sandstone. The lower end of the fracture was not observed. Up is to the left.

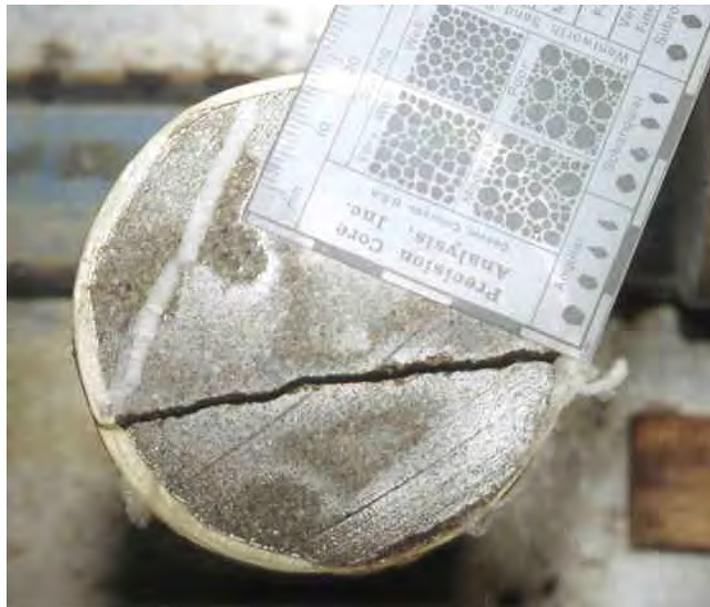
Fig. B-5. View looking up the core of healed, calcite filled natural fracture

The healed, calcite-filled natural fracture is the white line to the left center of the photo parallel to the scale edge of the grain size comparator. The jagged black line running left to right is the trace of a drilling induced petal fracture. The angle between the fractures was measured to be 60 degrees. The data supports a rotation of the stress field between the time of the natural fracture and the collection of the core. View is looking up the core.

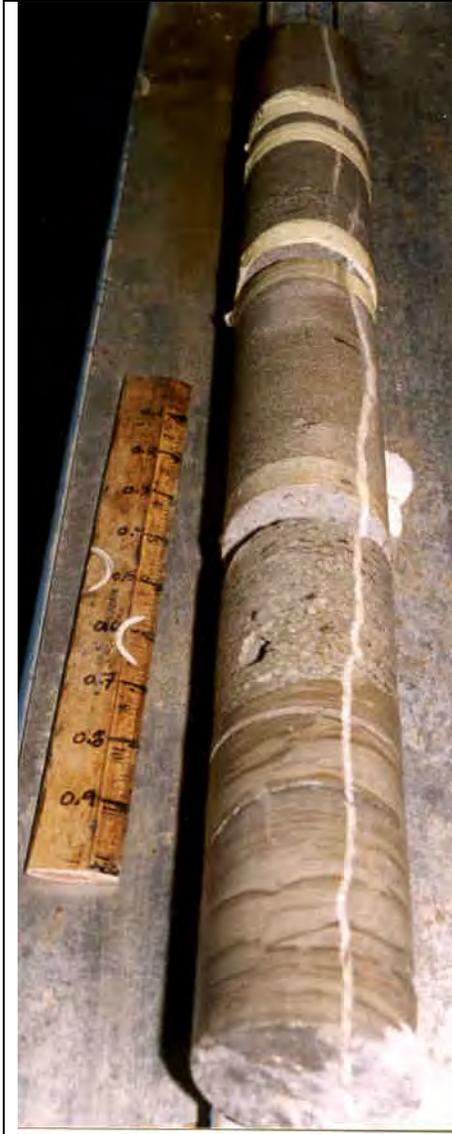
Fig. B-6. Oblique axial view of the core at 13710'-13712'

Oblique axial view of the core at 13710'-13712' showing the position of the fractures along the outer edge of the core, the jagged trace of the fracture and the overlapping nature of the fractures in the swarm. Neither the top nor the bottom terminations of the fracture swarm were preserved in the core so total height remains unknown. View is up the core from bottom to top.
