**TOXECON™ RETROFIT FOR MERCURY AND
MULTI-POLLUTANT CONTROL ON THREE
90-MW COAL-FIRED BOILERS**

Quarterly Technical Progress Report

Report No. 41766R19

**Steven T. Derenne
Wisconsin Electric Power Company
333 West Everett Street
Milwaukee, WI 53203**

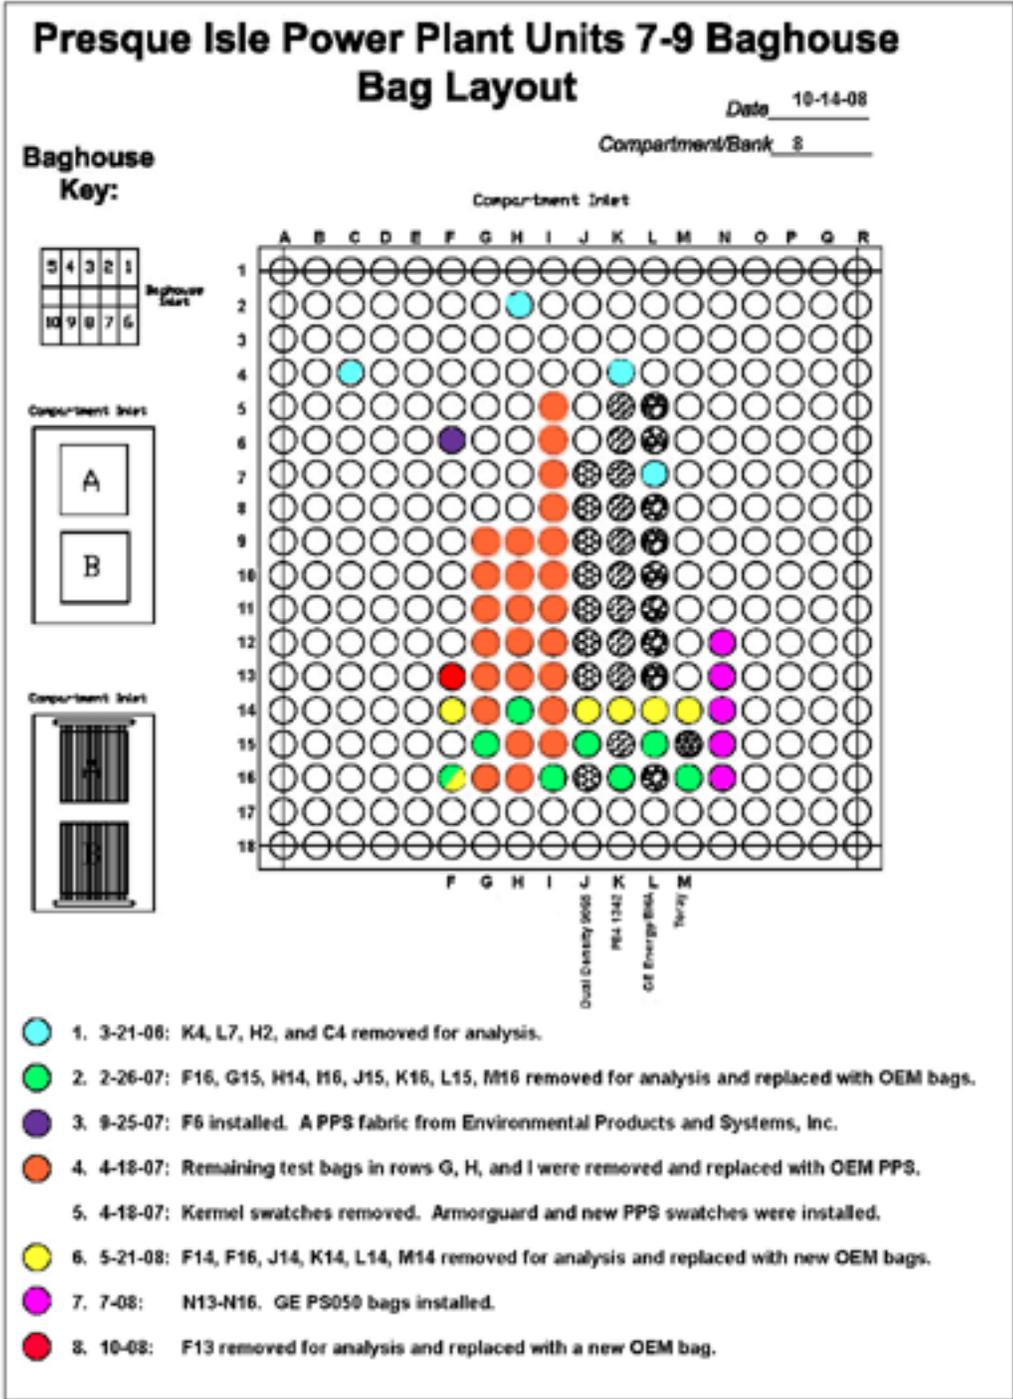
Figure 1. Test Bag Layout

A schematic of the compartment layout, bag numbering scheme and locations of the different bag types in bundle A of Compartment 8 is shown in Figure 1. This schematic also documents when new bags were installed to replace bags that were removed for various reasons, including:

- Heat damage from the overheating incident in February 2006
- Unacceptable emissions from the high-perm test bags, these bags were replaced in April 2007
- Replacement bags for bags removed for testing

A description of all the different types of test fabrics installed in Compartment 8 can be found in Table 5. All test bags are installed in bundle A, or the bundle closest to the inlet and outlet plenums. In the case of the Ahlstrom fabric, 4.75" x 9.5" swatches were installed in frames in a swatch holder, which was placed on the supporting steel above the bags and pulse pipes. Although full-scale bags are preferred for the tests, using swatches reduces the risk of premature failures with experimental bags. For comparison, PPS felt swatches were also installed.

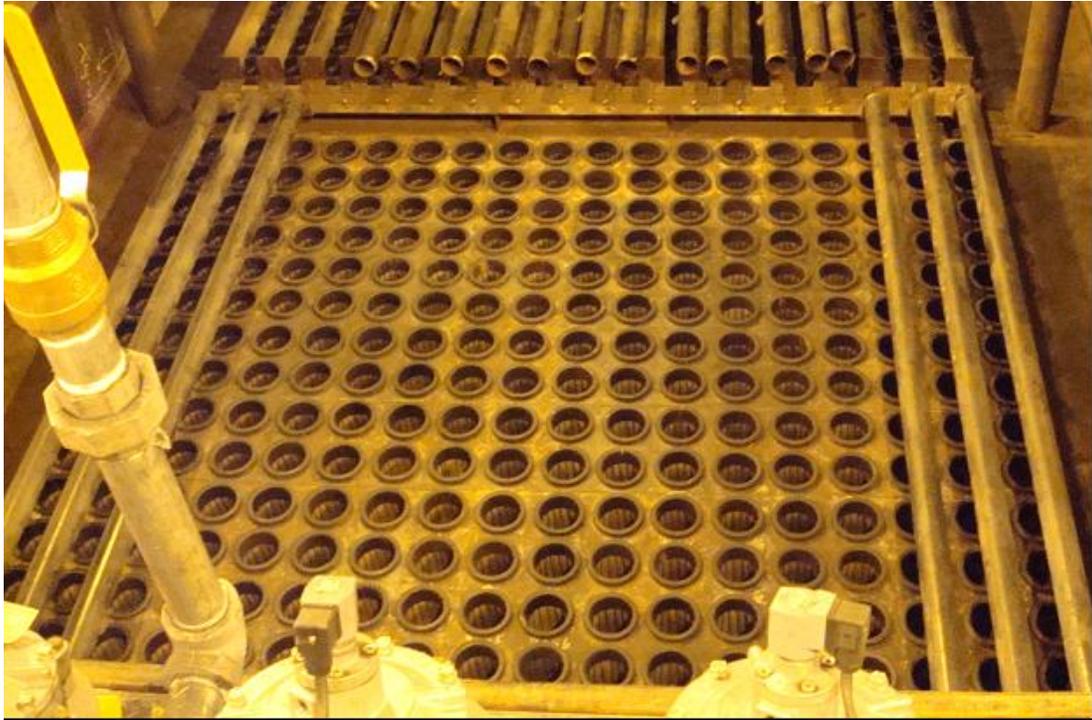
Figure 2. Picture of Compartment 8 Tube Sheet

- The tube sheet was clean, indicating that the bags were in good shape with a very low probability that any bags had failed (Figure 2).

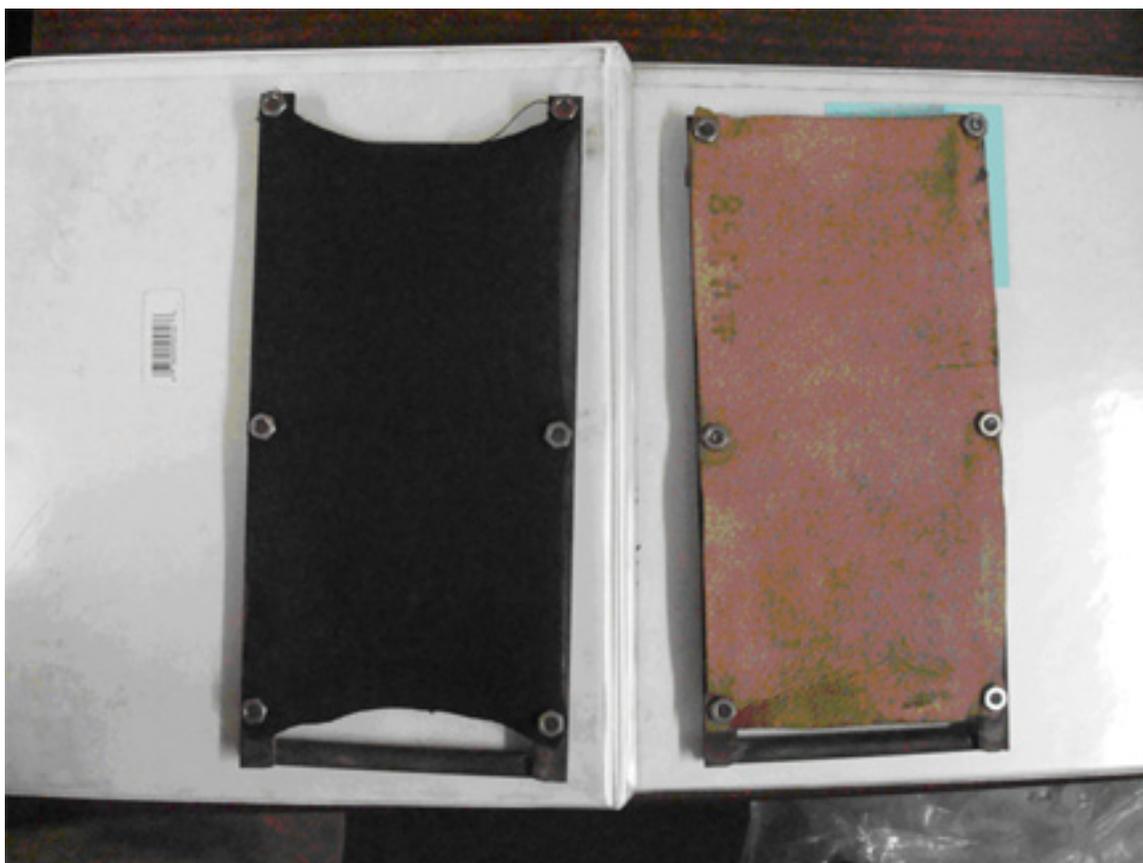
Figure 3. Picture of test and PPS swatches removed from Compartment 8

The final Ahlstrom test swatch and the standard PPS swatch were removed. The test fabric had shrunk, become discolored, and could easily be torn by hand. This kind of failure often indicates chemical attack from exposure to the flue gas. A photo of the test and PPS swatches can be seen in Figure 3.

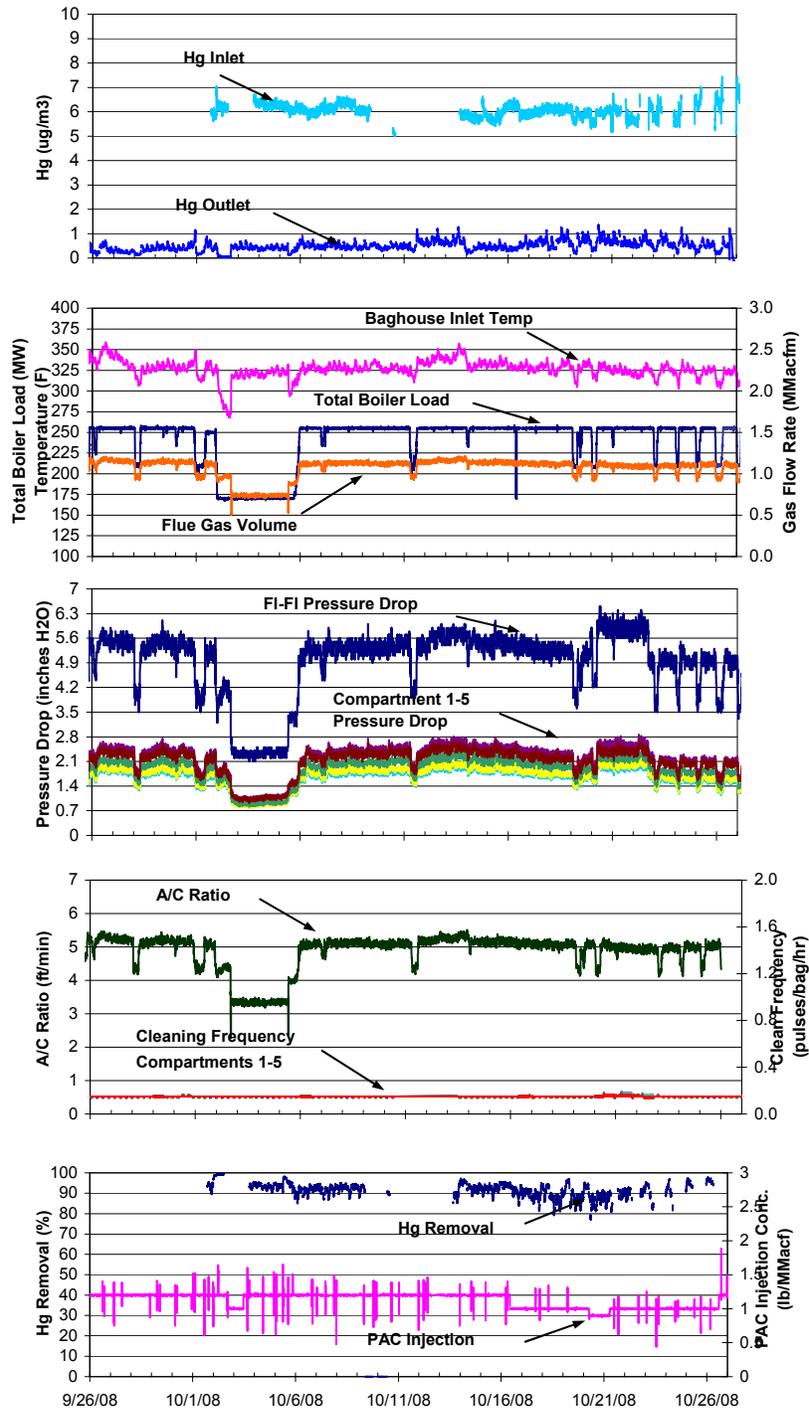
Figure 4. TOXECON™ Performance Data for October 2008.

DARCO[®] Hg-LH, a brominated carbon, has been used throughout 2008. Figure 4 shows TOXECON[™] data for October 2008. Mercury removal was over 90% for the majority of the month using 1.2 lb/MMacf PAC. Mercury removal dropped below 90% during part of the time when the injection rate was decreased to 1.0 lb/MMacf. The baghouse cleaning frequency was steady at 0.18 p/b/hr. The tube sheet pressure drop was around 2.0 inches of water with two units at full load.

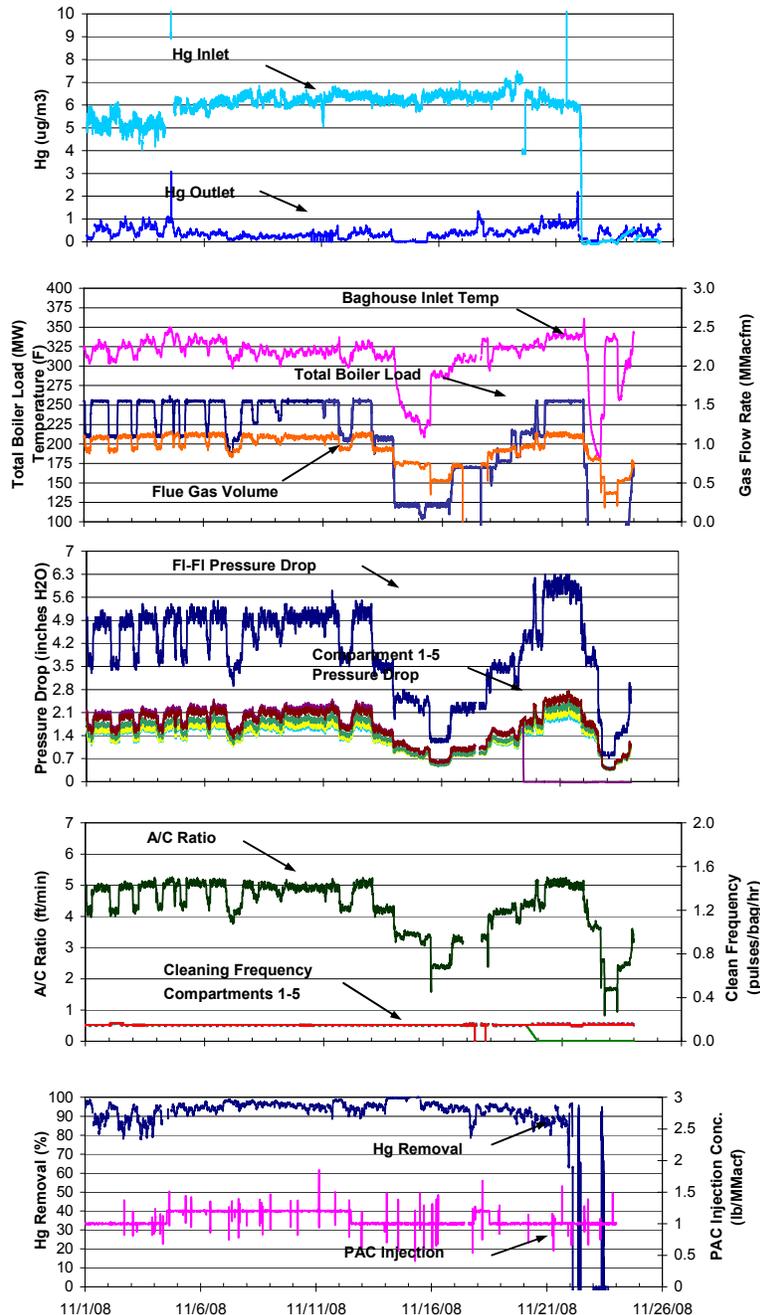
Figure 5. TOXECON™ Performance Data for November 2008.

Figure 5 shows TOXECON™ data for November 2008. Mercury removal was over 90% at a PAC injection rate of 1.0 - 1.2 lb/MMacf. The baghouse cleaning frequency was steady at 0.18 p/b/hr. The tube sheet pressure drop was around 2.0 inches of water when all units were at full load.

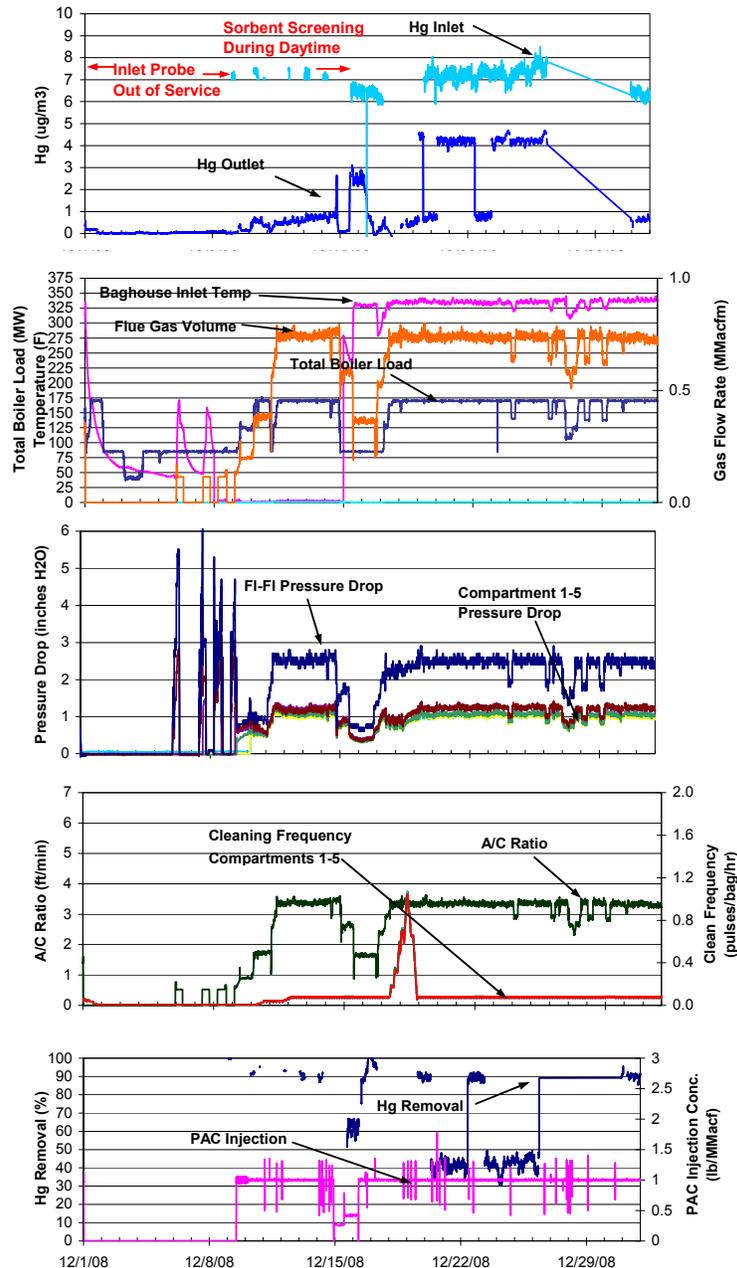
Figure 6. TOXECON™ Performance Data for December 2008.

Figure 6 shows TOXECON™ data for December 2008. The baghouse was off line the first week in December. Sorbent screening occurred during the second week in December so the inlet signal was intermittent. Problems with the outlet monitor during the last half of the month resulted in lost removal data for most of this time period. PAC injection rate was 1.0 lb/MMacf after the baghouse came back on line. The tube sheet pressure drop was around 1.0 inch of water with two units on at full load.

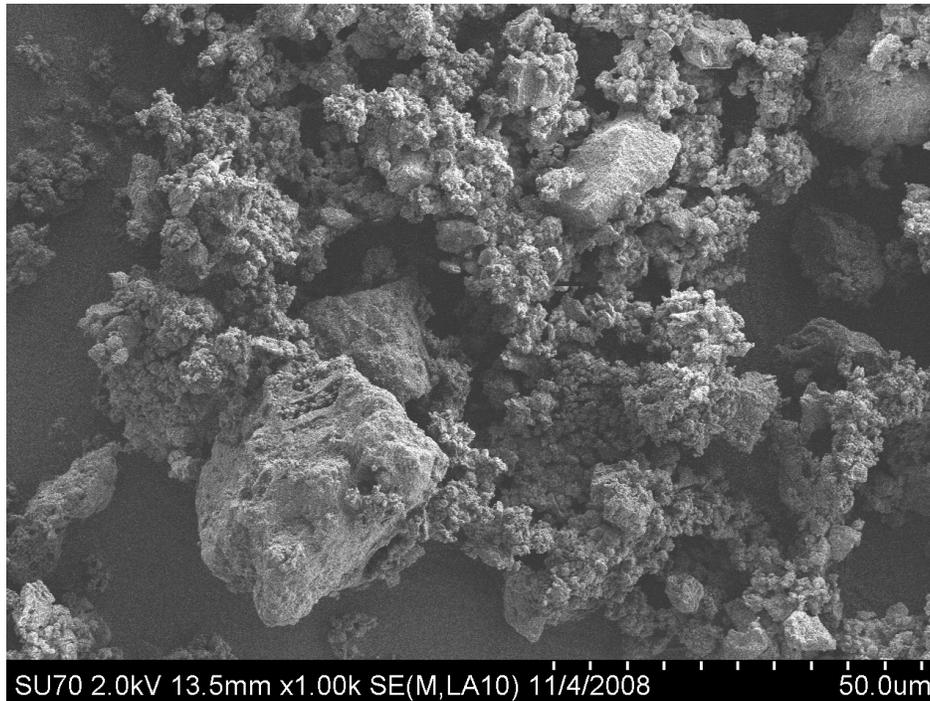
Figure 7. SEM Images of the PAC and Ash

The BET surface area of PAC-Ash was measured at UEE using the Quantachrome BET Surface Area System. The surface area of PAC-Ash was 123 m²/g. Because the PAC activated carbon had a surface area of 523 m²/g, the surface area of PAC-Ash correlated well with the carbon content in the ash of 25.46 wt% (Figure 7). The fly ash and activated carbon existed in the form of agglomerates. The density of the PAC-Ash was 0.60 g/ml.

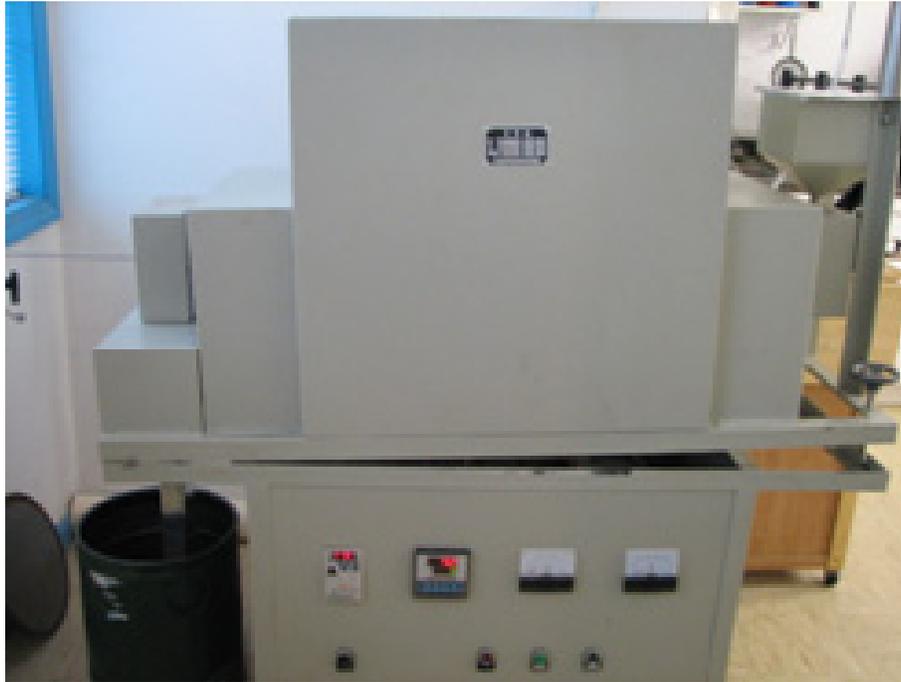
Figure 8. Large Batch Reactor

The fly ash powder is fed into the rotary reactor tube from the hopper. The maximum feeding rate of the rotary feeder is 3 kg/hour. The rotation and the slope of the reactor tube cause the

powder to gradually move downhill to the other end of the reactor tube. The residence time of the powder is controlled by the rotational speed and the degree of slope of the tube (Figure 8).

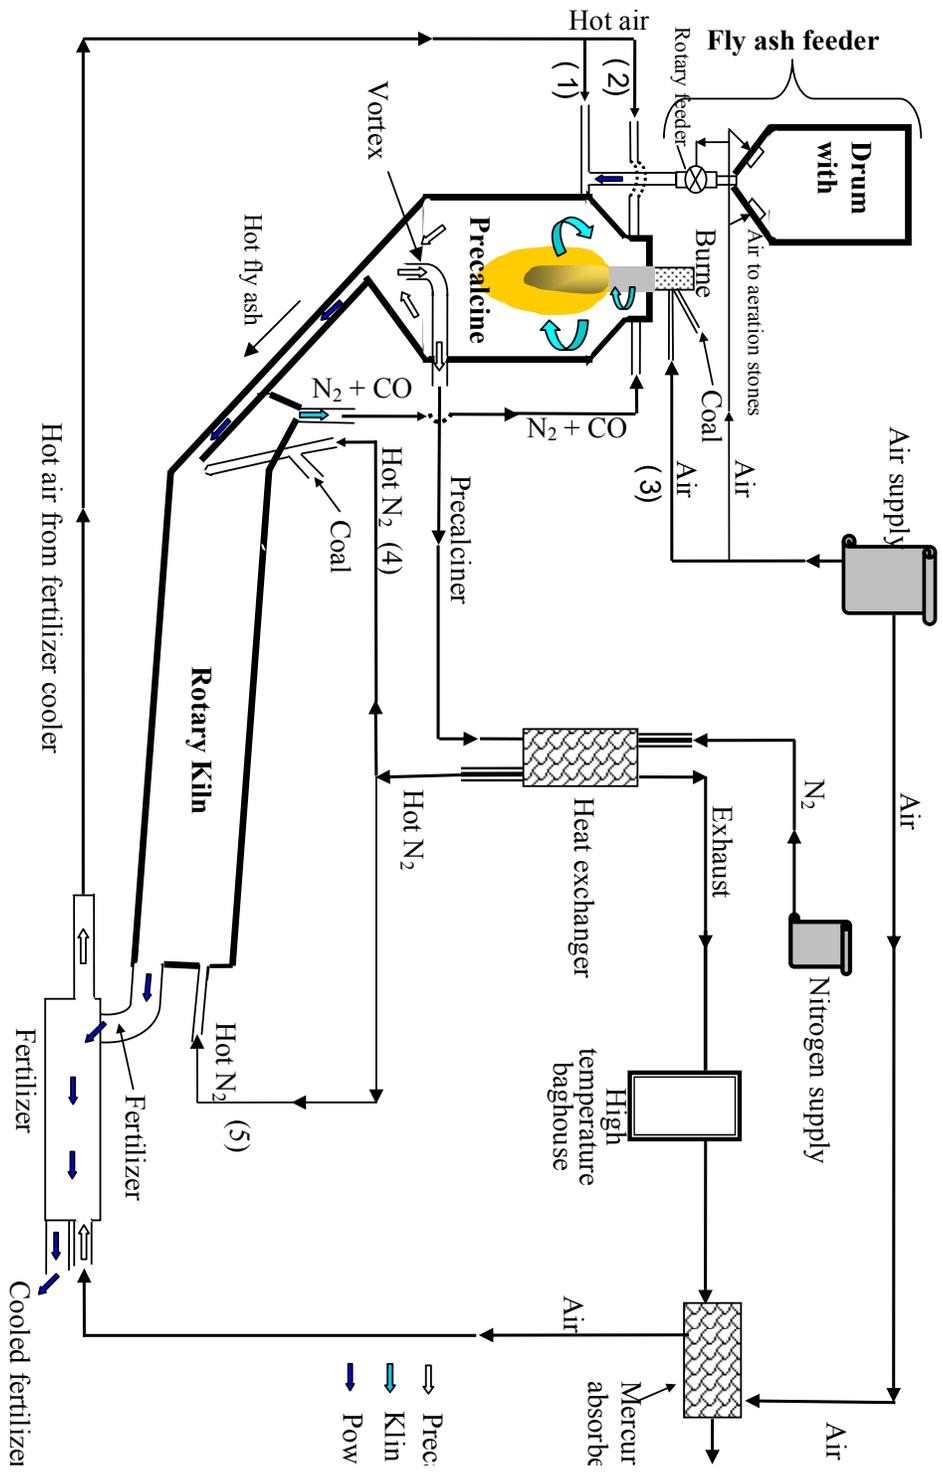
Figure 9. Fertilizer Production Diagram

vortex within the vessel. Both fly ash and gas spiral down toward the vessel bottom. Pulverized coal is blown in by air (3) through the burner, producing a large concentric flame in the vessel. The precalciner has the advantage of controlling the flame core temperature by adjusting the air/coal flow to the burner and the hot air flow (2). An increase in hot air volume leads to a high acceleration of the initial combustion of coal, resulting in a higher temperature in the precalciner. The fly ash is heated by contact with the hot gases from combustion of coal. The gases leave the vessel through a vortex-finder. The hot exhaust gases are sent to a nitrogen gas heat exchanger and then flow to the mercury capture equipment to capture the mercury and remove other air pollutants. The fly ash is thrown to the outside edge of the vessel by centrifugal action and leaves through a valve in the bottom of the cone to the inlet of the rotary kiln.

At the inlet of the rotary kiln, the hot fly ash encounters a high flow nitrogen gas stream (4) containing pulverized coal. The coal reacts with the oxygen gas entering with the hot fly ash from the precalciner. An excess amount of coal will be added so that all the molecular oxygen will be consumed and a sufficient amount of carbon will be left and available for the fertilizer production. Because the coal is present in excess, carbon monoxide, instead of carbon dioxide, will be the major product. The carbon monoxide will leave the kiln with nitrogen from the kiln inlet and be sent to the precalciner. The reaction of coal with oxygen is exothermic and provides additional energy for the carbonitridation reaction. The high flow nitrogen stream (4) spreads the fly ash and mixes the fly ash and coal uniformly. The fly ash then undergoes the fertilizer forming process when it moves slowly through the rotary kiln. To guarantee the availability of sufficient nitrogen gas, the other stream of hot nitrogen flow (5) is injected into the kiln through the other end of the kiln in a counter current flow mode with respect to the fly ash/carbon. The hot fertilizer product is discharged from the kiln to the fertilizer cooler. In the cooler, most of energy from the fertilizer is recovered to the air stream by a heat exchanger. The hot air from the cooler is sent to the precalciner. A data logger connected to platinum thermocouples located at different locations in the plant is used to record the temperature readings. In addition, all necessary safety measures for the plant will be taken carefully to ensure a safe working environment.

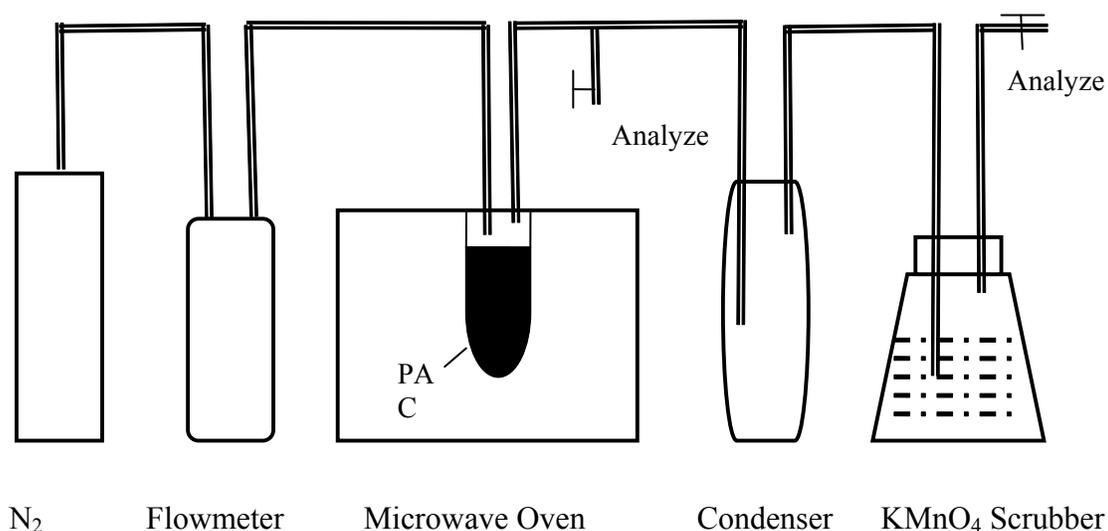
Figure 10. Schematic diagram for the mercury separation experiment.

Figure 10 shows a schematic of the setup for the experiment. Weigh $22\text{g}\pm 0.2\text{g}$ dried carbon sample (PAC) into a glass test tube, and place some glass fibers on top of the sample to prevent the carbon powder flying into the connecting tube. Then put the tube in the middle part of a microwave oven. Pure nitrogen is utilized to carry the vapor generated in the tube forward. The flow rate of nitrogen is measured with a Cole Parmer flow meter at $600\text{ml}/\text{min}$, which gives a continuous bubble stream in the KMnO_4 scrubbing solution. The carbon sample was irradiated with a 1 KW microwave oven at power 4 of maximum setting 10 for 2.5 min. The evaporates are carried by the nitrogen gas to a water cooled condenser and then the KMnO_4 scrubbing solution. Figure 11 is a picture of the microwave apparatus.

Mercury concentration in the gas flow after the microwave irradiation and the scrubbing can be determined with a gold film mercury vapor analyzer (JEROME 431-X, Arizona Instrument Corp.). The measuring range of the analyzer is 0.000 to $0.999\text{mg}/\text{m}^3$, with a resolution of $0.001\text{mg}/\text{m}^3$ and a sensitivity of $0.003\text{mg}/\text{m}^3$.

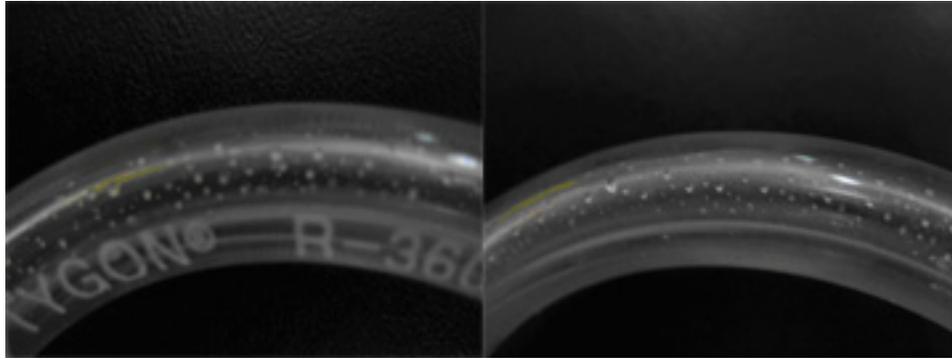
Figure 12. The crystals condensed on the connecting tube and (b) liquid droplets.

When the microwave experiments were started over with new Tygon tubing, some white crystals can be found in the connecting Tygon tube outside the microwave furnace after repeating the experiments for 8~10 times. The crystals are disseminated on the inside wall of the Tygon tube, as shown on Figure 12(a). These crystals can turn into liquid droplets after cool down under the atmospheric conditions (Figure 12(b)). By heating, the droplets turn back to crystals.

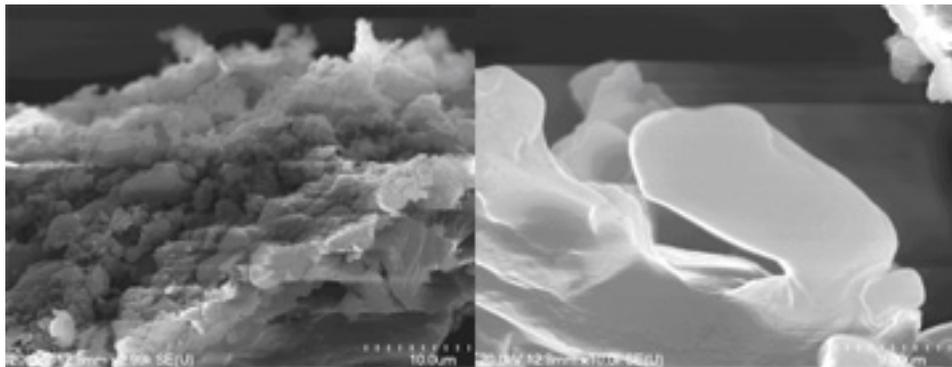
Figure 13. SEM image of the condensed white crystals.

The white crystals condensed on the inside wall of the Tygon tube were analyzed with SEM. Figure 13 shows the SEM images of the crystals. They are mostly in plate shape. The chemical compositions of the crystals were analyzed qualitatively with the electron probe. The EDS spectrum, as shown in Figure 14, reveals that the crystal has the characteristic peaks of mercury, sulfur and oxygen. Since the crystals can absorb moisture and turn into liquid droplets, it is reasonable to believe that the crystals are primarily mercury sulfate crystals with various amount of crystalline water. The standardless analysis of the spectrum gives an estimation of 7.89% mercury in the crystal (Figure 15).

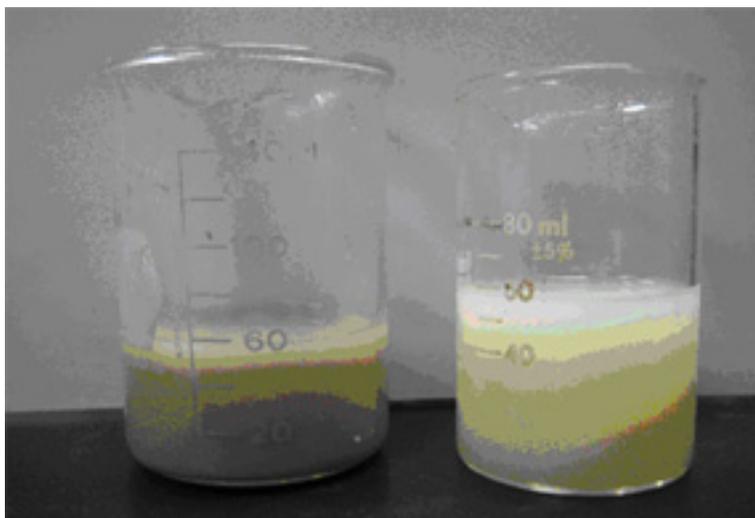
Figure 16. (a) The dark precipitates in the scrubbed solution with sodium sulfide addition on the left, and (b) the original solution with the addition of sodium sulfide on the right.

In a separate set of experiments, the gas was bubbled into the scrubbing solution without going through the condenser. The experiments were repeated 8 times. After that, we add 10 grams of $\text{Na}_2\text{S}\cdot 9\text{H}_2\text{O}$ to a beaker contains 100 ml of the original solution (Figure 16b) and 10 grams of $\text{Na}_2\text{S}\cdot 9\text{H}_2\text{O}$ to a beaker contains 100 ml of the evaporated gas scrubbed solution (Figure 16a). Dark precipitates were formed from the scrubbed solution. The precipitates were filtered and dried.

The precipitates are believed to be mercury sulfide (HgS). The reactions in the process are designed by the follows:

When the mercury in the gas passed through the scrubbing solution, it is oxidized into the soluble divalent mercury and is therefore dissolved in the solution. When sodium sulfide is added into the solution, the divalent mercury ions and the sulfide ions formed insoluble mercury sulfide and precipitates out.

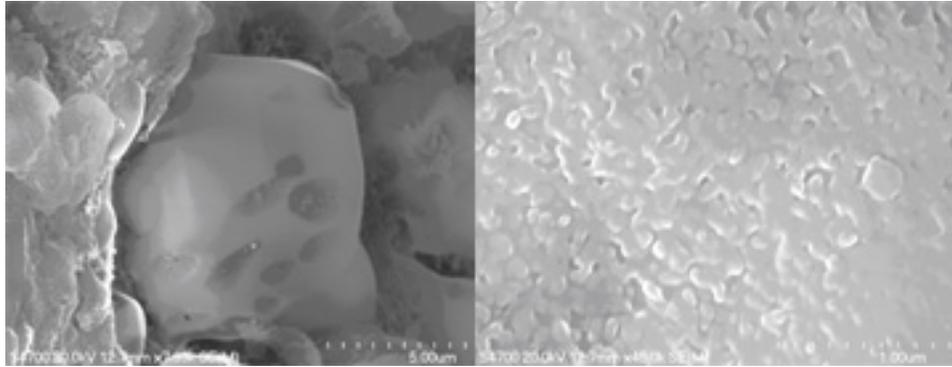
Figure 17. SEM images of the sulfide precipitates in the scrubbed solution.

To prove this is what happened, the precipitates were examined under the SEM as well. Figure 17 shows the SEM images of the sulfide precipitates. Figure 18 shows the EDS spectrum of the precipitates. Only the mercury and sulfur characteristic peaks are dominant. The oxygen peak is very weak. No other elements were found in the spectrum. The precipitates are, therefore, proved to be mercury sulfide. This demonstrates that mercury released from the sorbents in the microwave processing has been successfully scrubbed. A standardless analysis of the EDS spectrum gives an estimation of 23.07% Hg in the precipitates, as shown in Figure 19.

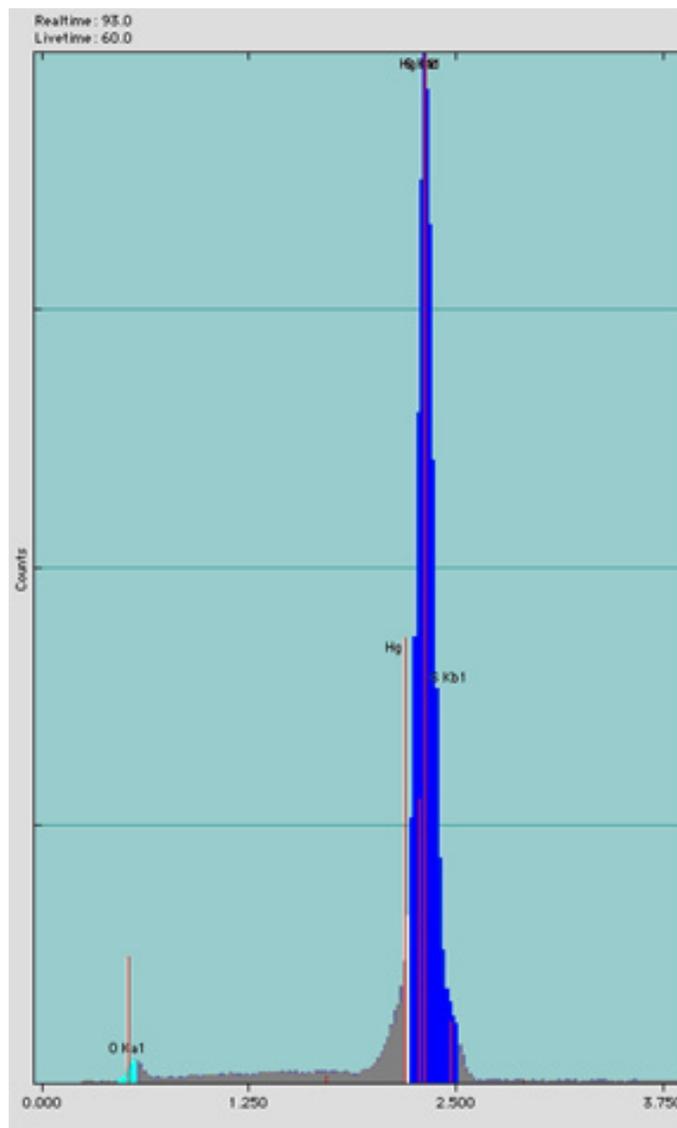
Figure 18. Spectrum of the sulfide precipitates in the scrubbed solution.

Quantitative Results for Spectrum1							
Analysis: Bulk Method: Standardless							
Acquired 13-Oct-2008, 20.0 KeV @20 eV/channel							
Element	Weight %	Std. Dev.	MDL	Atomic %	k-Ratio	Intensities	ROI (gross)
O	4.60	1.13	1.12	10.83	0.0236	925.1	1282.87
S	72.33	1.74	0.16	84.85	0.6266	62313.4	77697.20
Hg	23.07	1.06	1.84	4.33	0.2301	12262.8	
Total	100.00

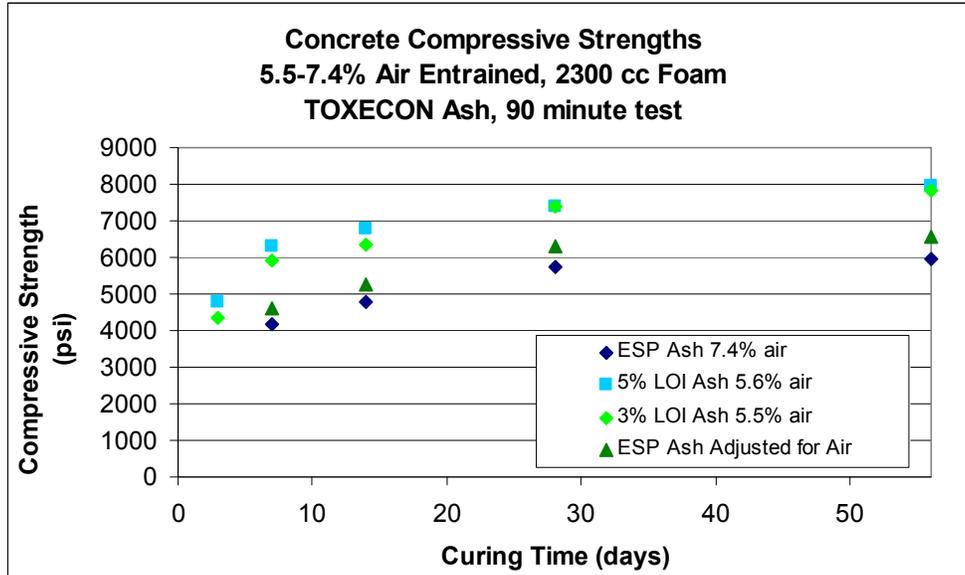
Figure 20. Concrete Compressive Strength Results

Figure 20 shows a comparison of compressive strength results using the Miracon foam using ash and PAC at varying LOI levels. The 3% and 5% LOI ash tests show an increased strength when compared to the control. All three tests had similar admixtures and the same amount of Miracon foam added. The air content was stable for 90 minutes, which is sufficient for most applications.

ADA-ES continued developing formulations for using PAC-containing fly ash in the preparation of structural and conductive concrete. Test results from several batches showed good air stability with the improved foam formulation and an increase in strength with higher LOI ash replacement.
