High Throughput, In-line Coating Metrology Development for **Solid Oxide Fuel Cell (SOFC) Manufacturing** DE-FE0031178 – 4/30/2019

2019 DOE Hydrogen and Fuel Cells Program Annual Merit Review and Peer Evaluation Meeting ¹Redox Power Systems, LLC. and ²National Renewable Energy Laboratory Yue Li¹, Derek Jacobsen², Brian Green², Johanna Hartmann¹, Stelu Deaconu¹ Peter Rupnowski², Michael Ulsh², Bryan Blackburn¹, and Sean R. Bishop¹ (PI)

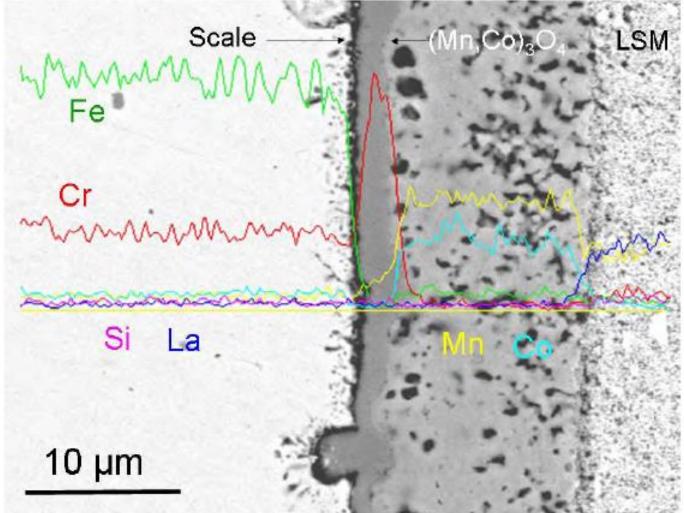
Coating and interconnect cross-section

Protective coating on interconnect:

- Prevent electrode Cr poisoning: Barrier to Cr transport
- Prevent interconnect oxidation: Barrier of oxygen migration

$(Mn,Co)O_4$ (MCO) is a commonly used barrier coating layer

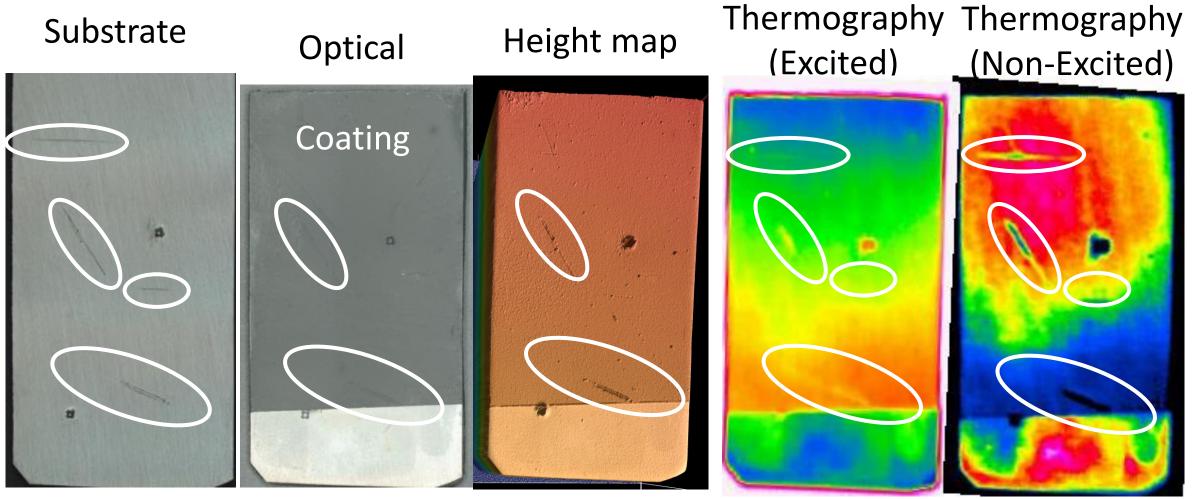
Metrology of sample with intentional scratches in substrate

- Thermography detects all 4 scratches
- Spatial variation in IR images even when there is no thermal excitation
- Thermal map "reversal" when a specimen is excited vs. non-excited

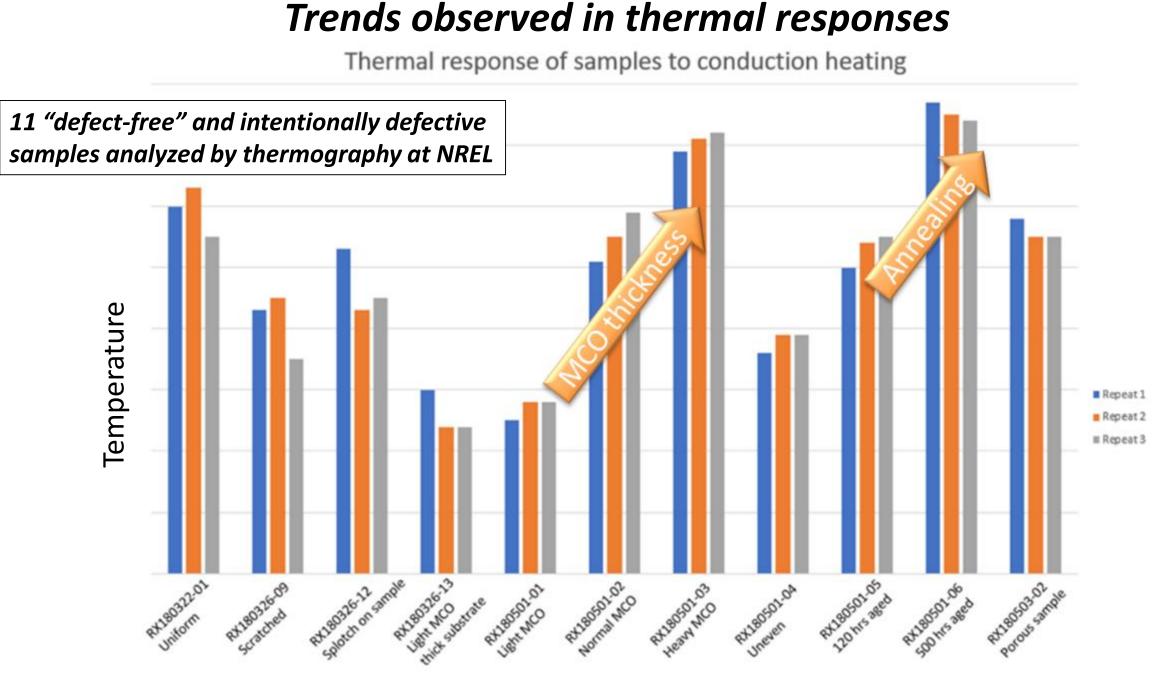
- Trends in thermal responses with extent of defects (e.g., thin vs. thick samples) observed
- Variations recorded in thermal response across individual samples observed, indicating some change in morphology and/or composition

- Trends in thermal responses with extent of defects (e.g., thin vs. thick samples) observed
- Variations recorded in thermal response across individual samples observed, indicating some change in morphology and/or composition
- Porosity variation observed via roughness change
- Intentionally thin coating shows unacceptable ASR • Intentionally highly porous coating exhibits low ASR, however, Cr

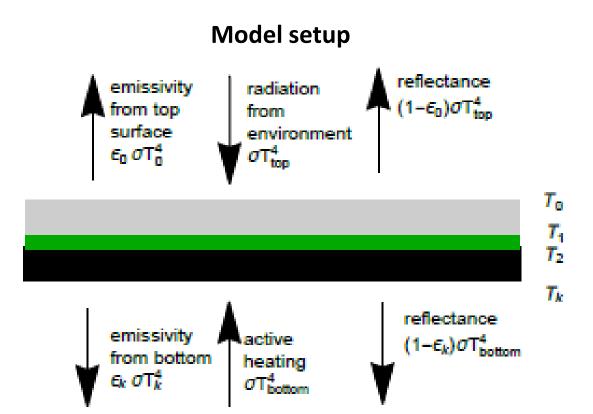
Modeling of thermography data

- Thermal response dominated by surface properties of film (e.g., emissivity and reflectance)
- Thermal map reversal due to thermal reflectance from higher environment temperature above sample
- Currently evaluating model assumptions and investigating new measurement techniques (e.g., transient stimulation)

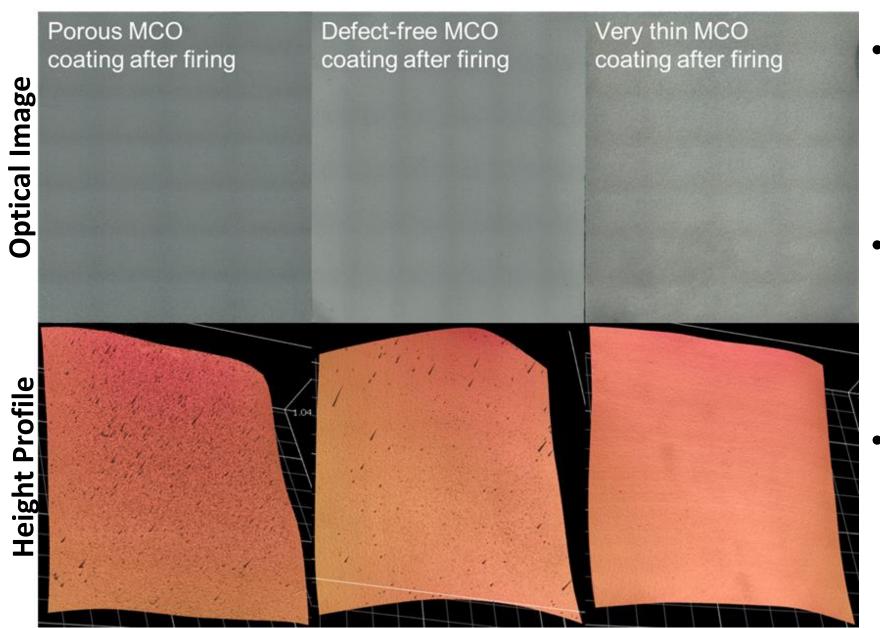
Optical imaging detects porosity and thin intentional defects

~8 cm x 10 cm MCO coated samples

- Less homogeneity detected in thin
- detected
- techniques able to detect defective samples

coatings as compared to "defect-free" coating

[•] High to low roughness trend (porous > "defectfree" > thin coatings)

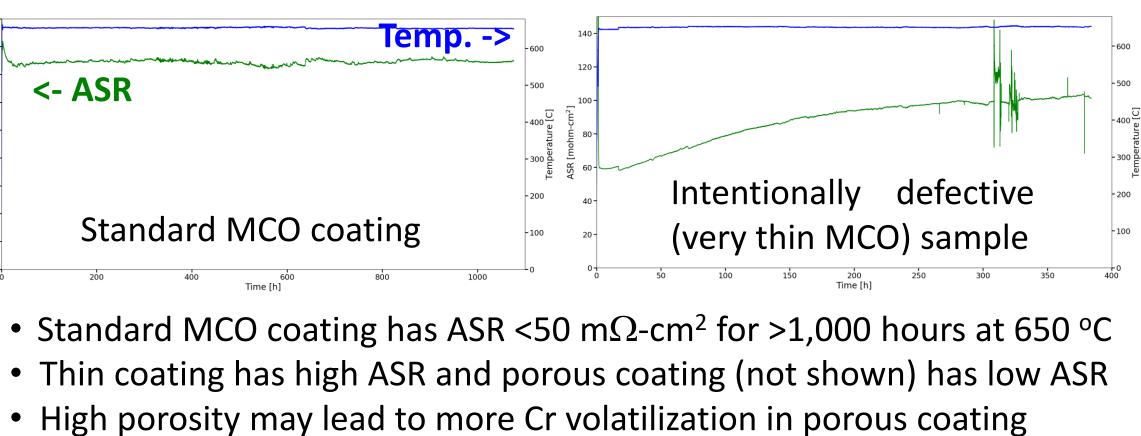
Area-specific-resistance (ASR) measurement of coating

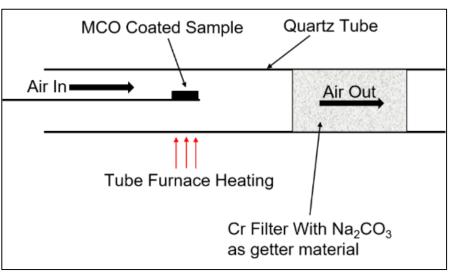
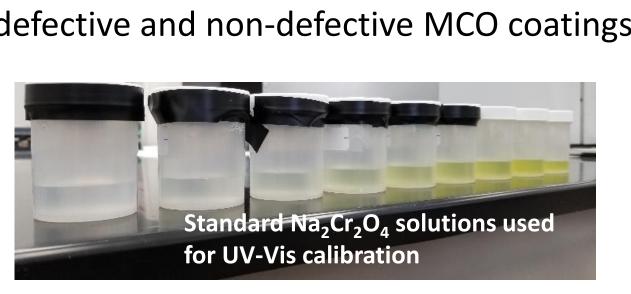
Cr volatility measurements

Detection of Cr volatility through defective and non-defective MCO coatings
