Summer UTSR Presentation

Thermal Barrier Coating Trials

Aged Material Evaluation

Blade Fracture Analysis

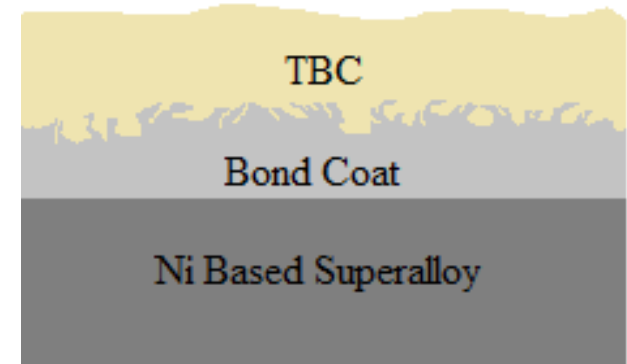
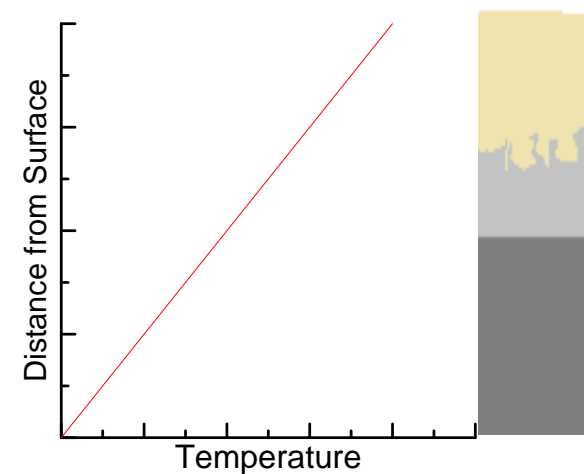
Thermal Barrier Coating (TBC):

- Used to protect metal of blades from high temperatures

Hot Engine Environment

Internally Circulating Cooling Air

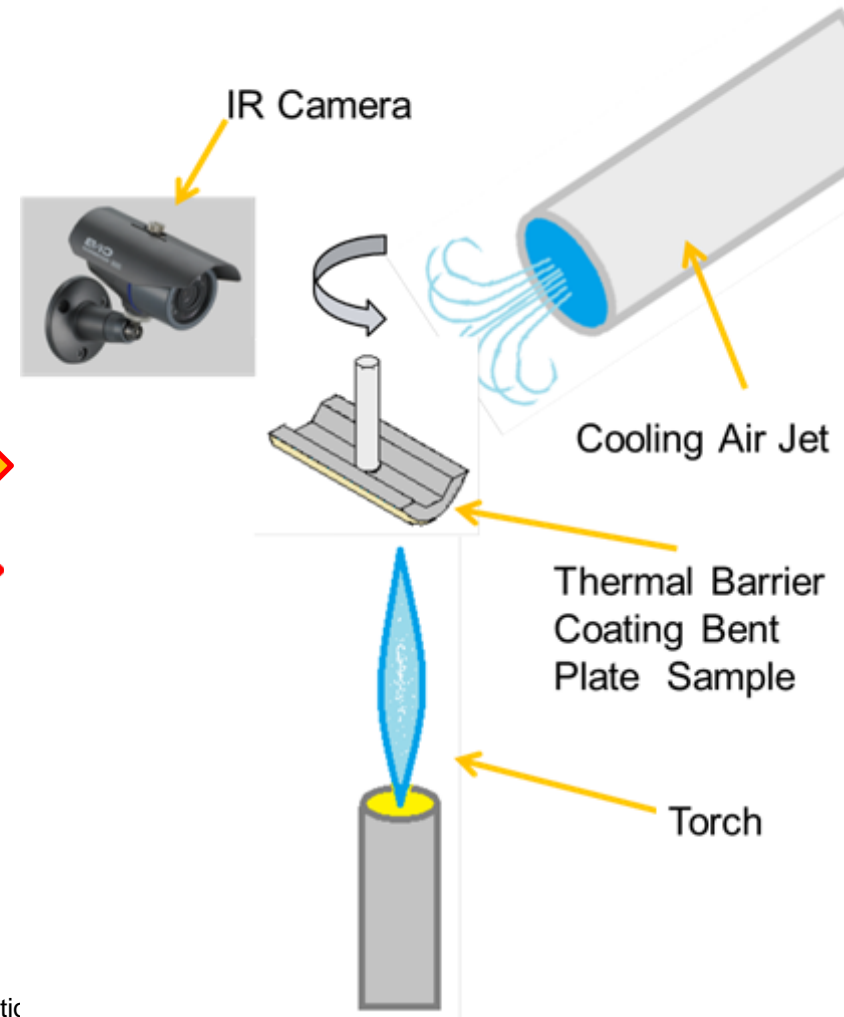
Testing Rig

- Testing new Bond Coat and Thermal Barrier Coating combinations
- Focus on adhesion and expansion characteristic

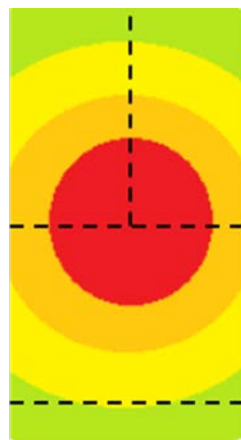
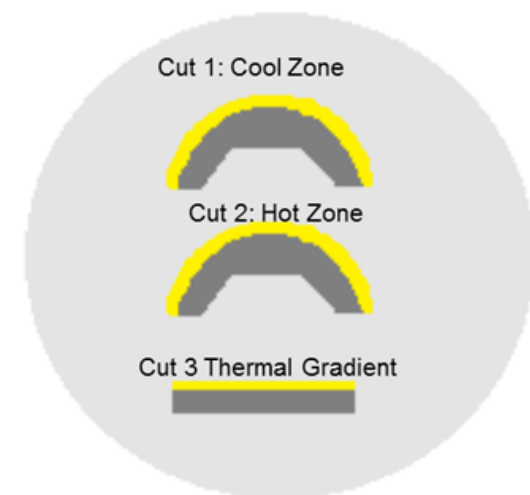
- Sample sectioning and polishing in preparation for inspection

Cut 2
Cut line
polish line

Cut 1
Cut line
polish line

Cut 3: Thermal
Gradient

Cut 2: Hot Zone

Cut 1: Cool Zone

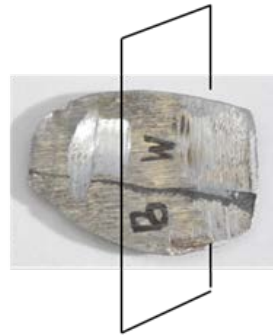
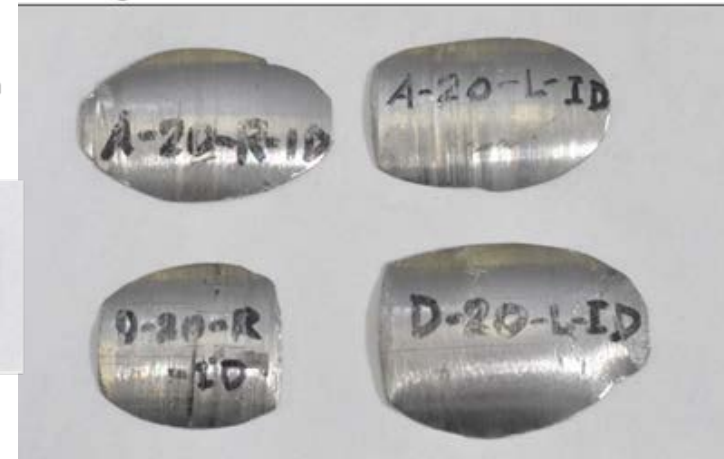
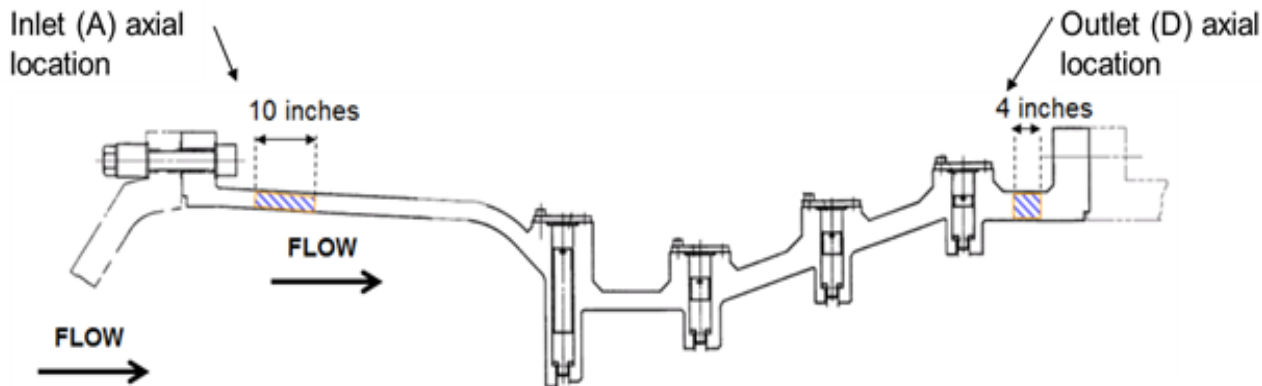
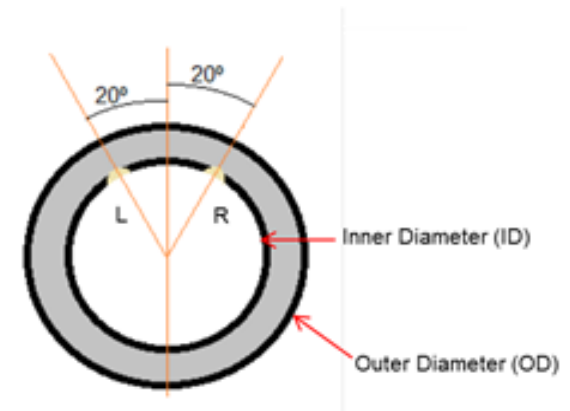
Cross section location

- Evaluate hazards of continued operation for a turbine casing with **~100,000** equivalent baseload hours

- Graphitization / Spheroidization
- Loss of strength

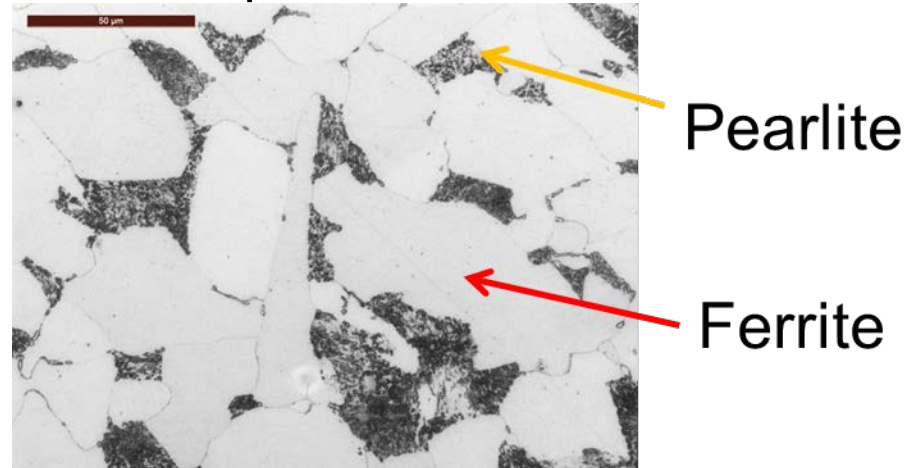
Low Temperature Inlet Section

- Sectioning and polishing
- Hardness testing and tensile strength estimations
- Etching, Metallography and analysis of microstructure
- Analysis of size and distribution of Graphite nodules

- No immediate danger in continued operation
- Indication of development of a possible hazard, yearly re-evaluation advised

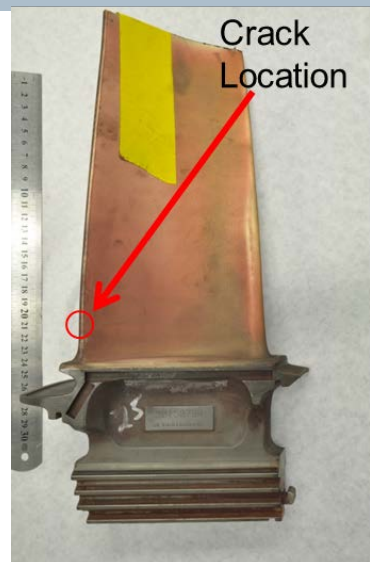
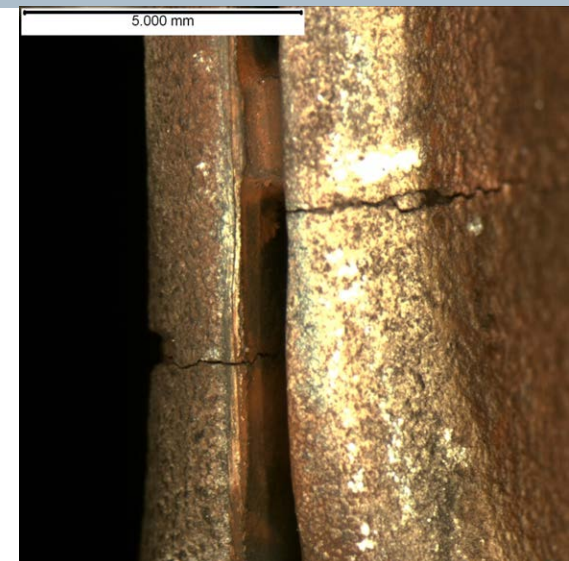
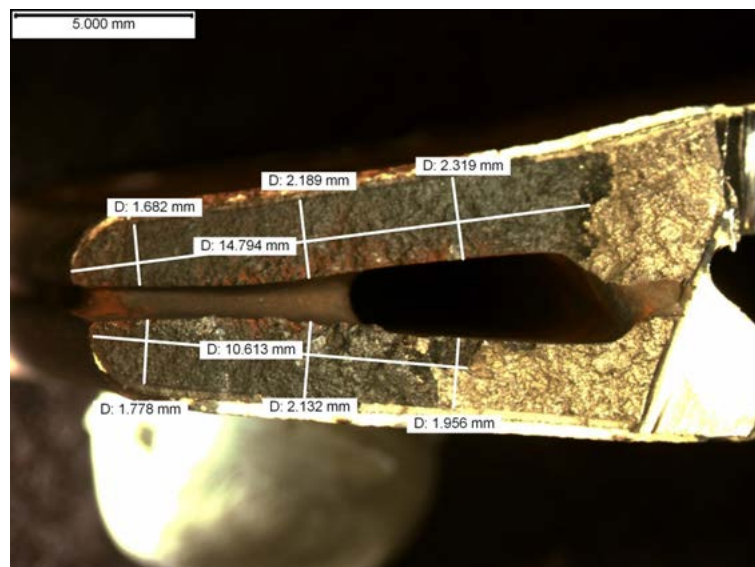
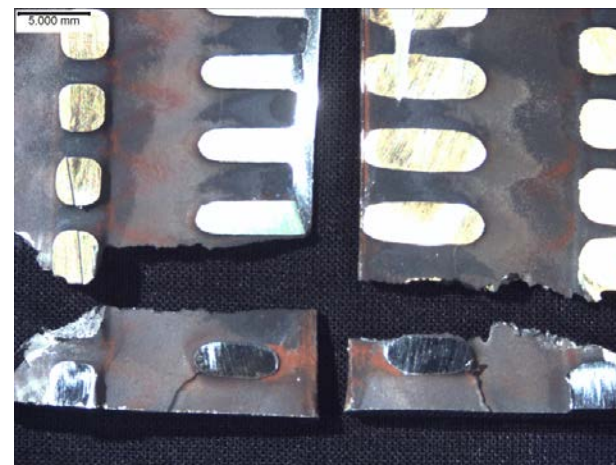
- Analyze and discover cause of cracking in two Row 2 blades

- Sectioning and polishing
- Optical Microscopy

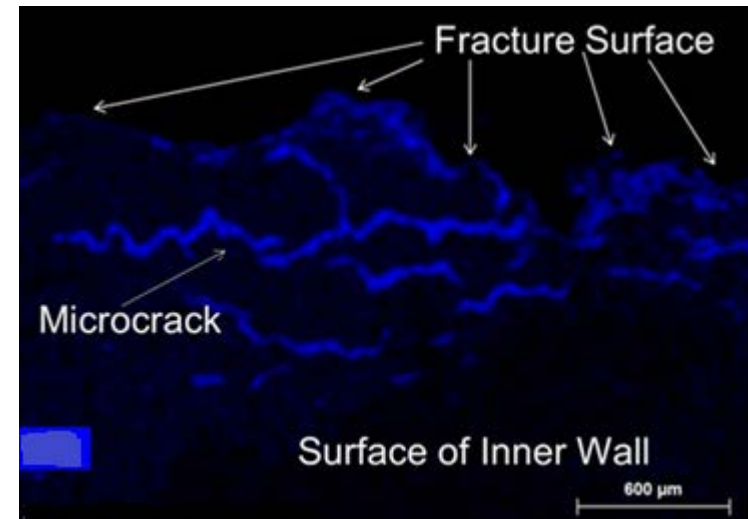
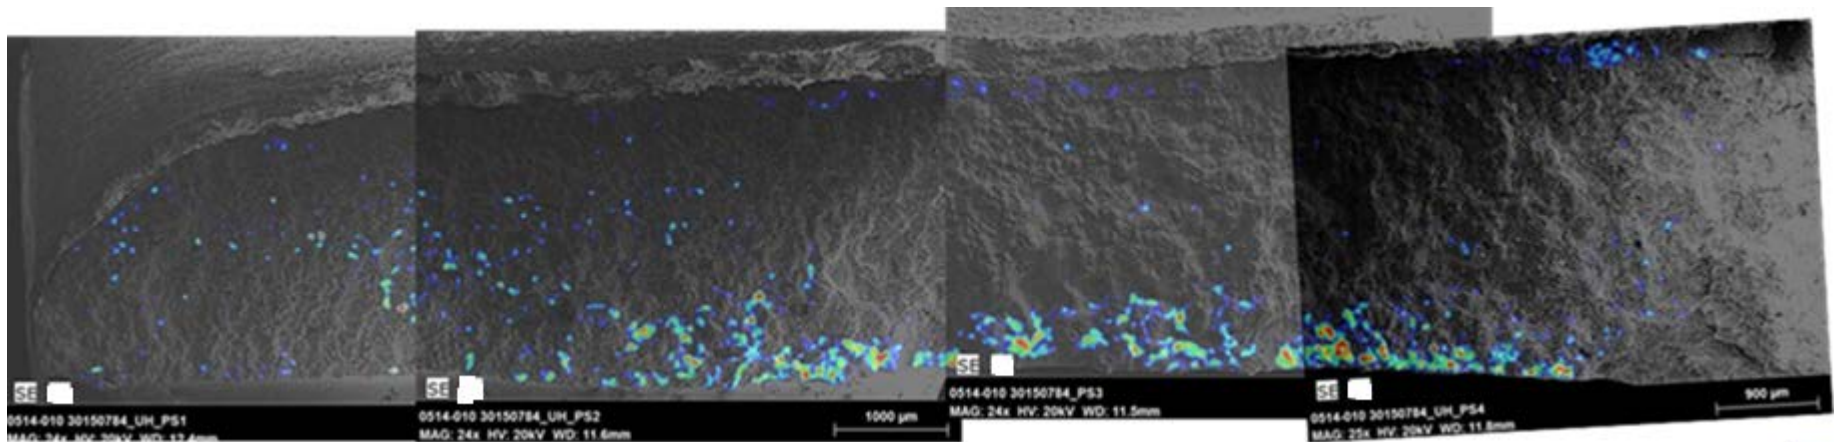
- Scanning Electron Microscope (SEM) Imaging
- Energy-dispersive X-ray Spectroscopy (EDS) elemental mapping.

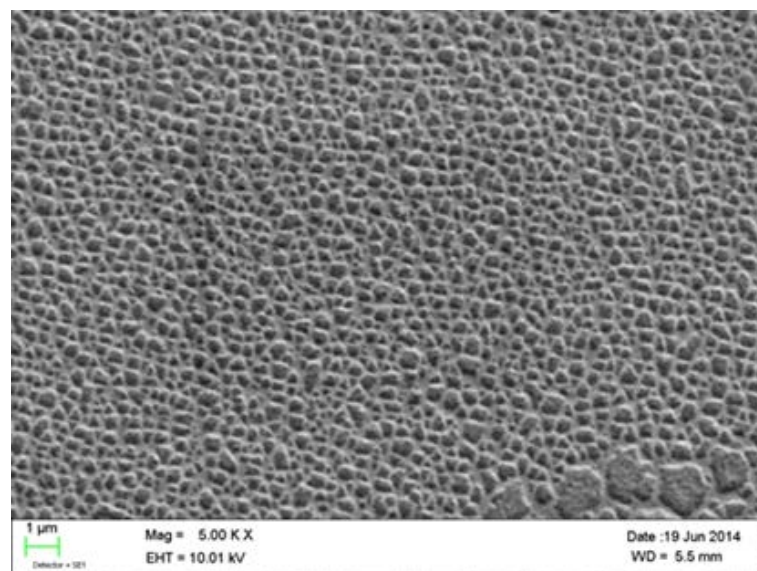
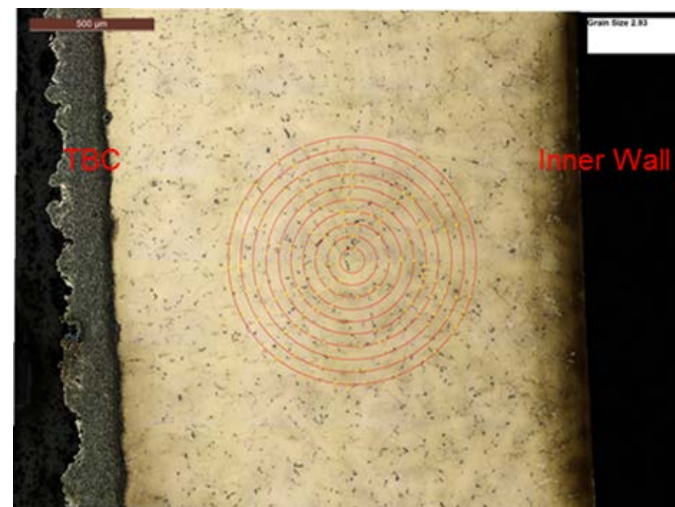
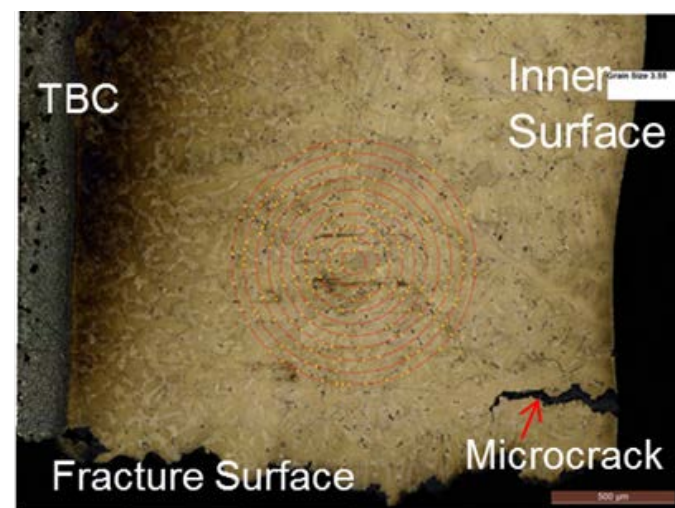
- Optical Microscopy and SEM Imaging
- Grain Size Analysis
- γ' Size analysis

- No materials flaw detected
- Failure due to overstress in the design
