## SOFC Quality Control and the Role of Manufacturing Defects on Stack Longevity

July 19th, 2016

Neil Fernandes

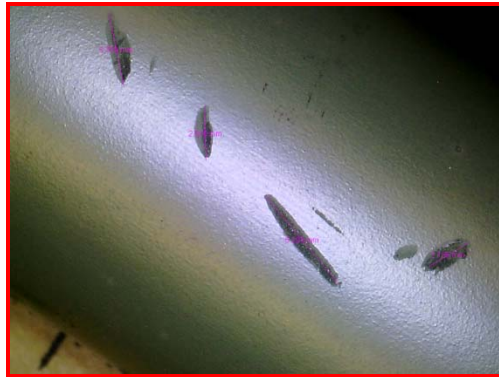
As discovered

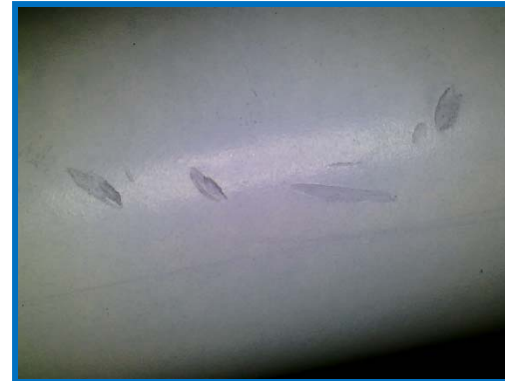
After SDC firing

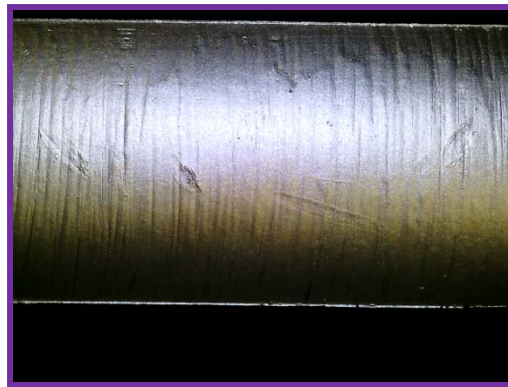
After Ag CC applied

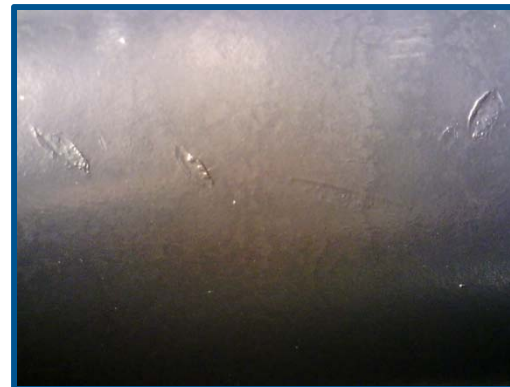
After Cathode coating and reduction

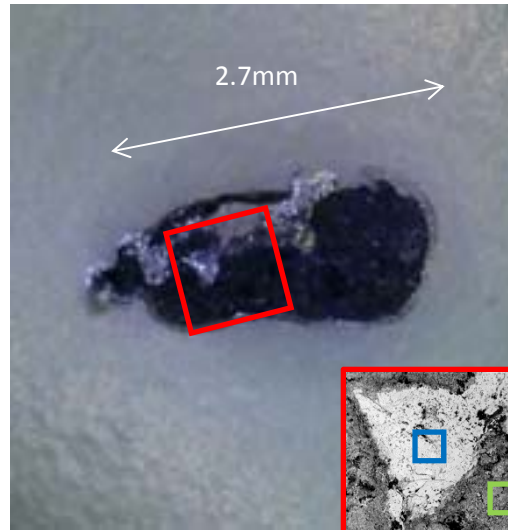
# Electrolyte Contaminant, NiO agglomerate

Element	At%
Ni	49.6
O	45.2
Cr	1.9
Zr	1.4
Y	0.5
Al	0.9
Fe	0.5

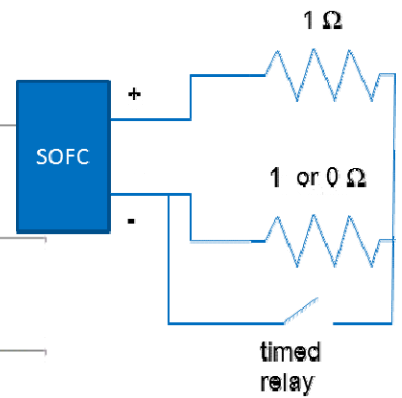
# Load cycling of "imperfect" stack ( CT-2)

— Cell1 Nose crazing   
 — Pinholes   
 — Cracks   
 — Scratch   
 — Control   
 — Leak

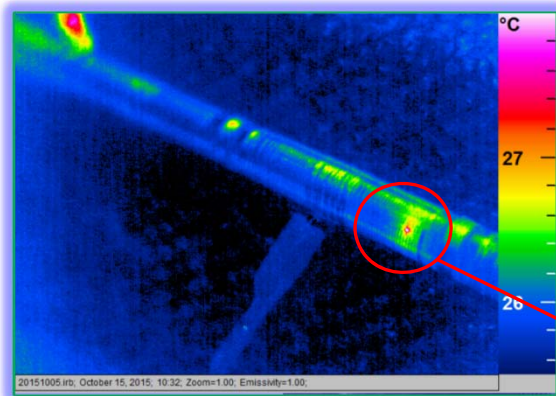
Heat signature of joule heating from an electric short can be easily picked up by a thermal camera (  $\sim 0.1W$  )

e.g. cell tested in field for 9000 hrs

Short in middle of cathode

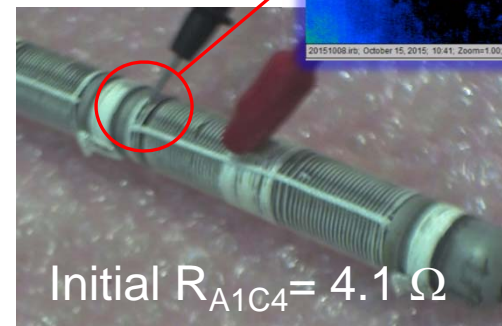
Short along edge of cathode

Initial  $R_{A1C4} = 4.1 \Omega$
