## Low Impact Testing of Oil Field Access Roads: Reducing the Environmental Footprint in Desert Ecosystems

07123.01.Final

### *Field Site Testing of Oil Field Access Roads*

**January 23, 2014**

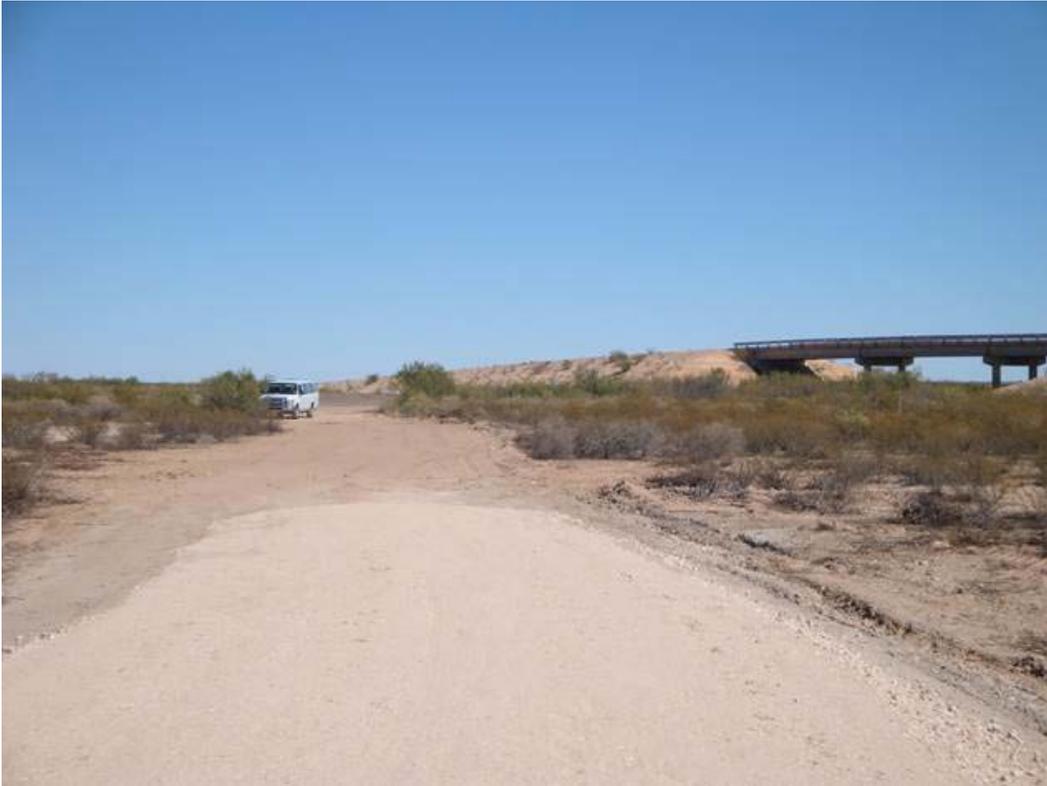
Figure 3. Photograph of dirt road to be used for spine section of test. Note overpass has not been removed from entry road.

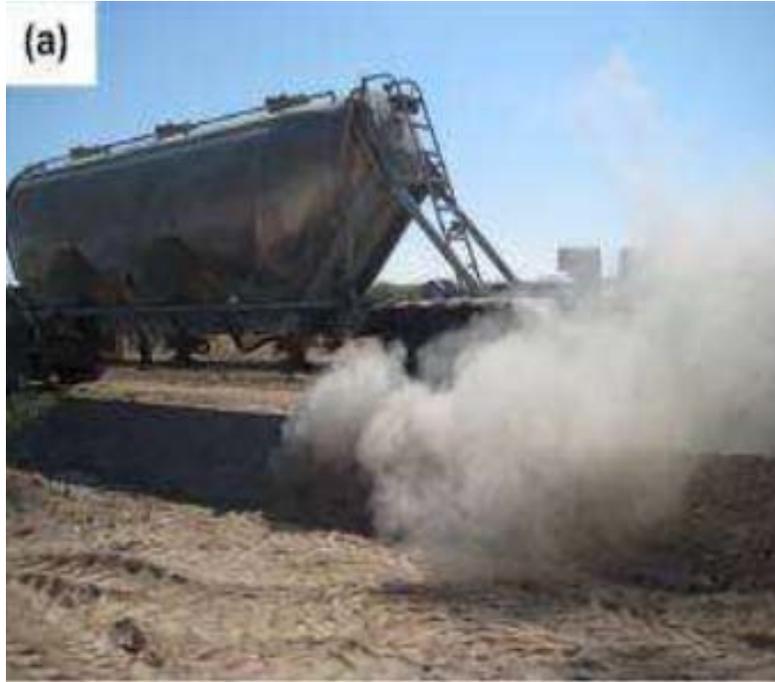
Figure 4. Bulk truck carrying mix for spine road. Dust from blowdown of material after unloading on site.

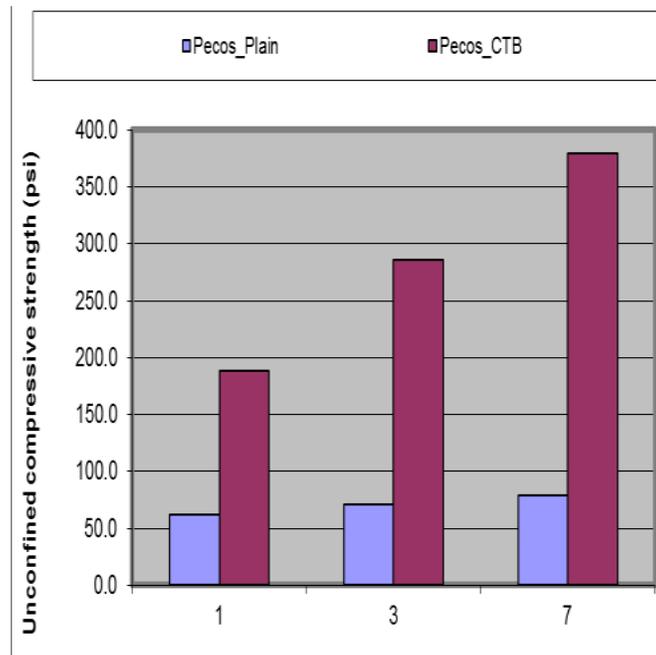
Figure 5. This plot represents a chart of the unconfined compressive strength of the Pecos road material as measured using the standard Tex-120-E Test Method “Soil-Cement Testing” protocol.

Construction, as described above, was successfully accomplished in one day, although strength gain in the material continued for several days. Figure 5 shows the strength gain of the material in place. A photograph of the completed road is shown in Figure 6. A composite sample of the PRM was taken by sampling the mixture during placement and sent for evaluation to a geotechnical testing laboratory, where it was mixed with the percentage of cement used and with an amount of water determined to yield a maximum density mold, then aged for seven days while being maintained in a moist environment. After completion of aging, the compressive strength and dielectric properties were obtained by standard tests.

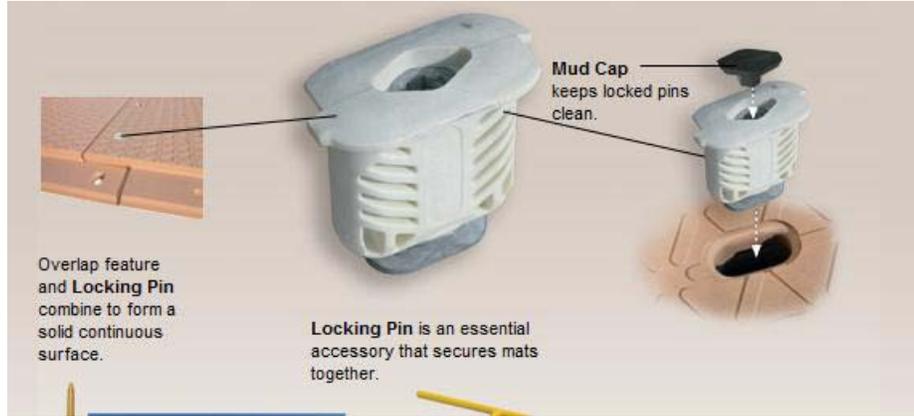
Figure 8. Locking pins and keylocks for Newpark Mats

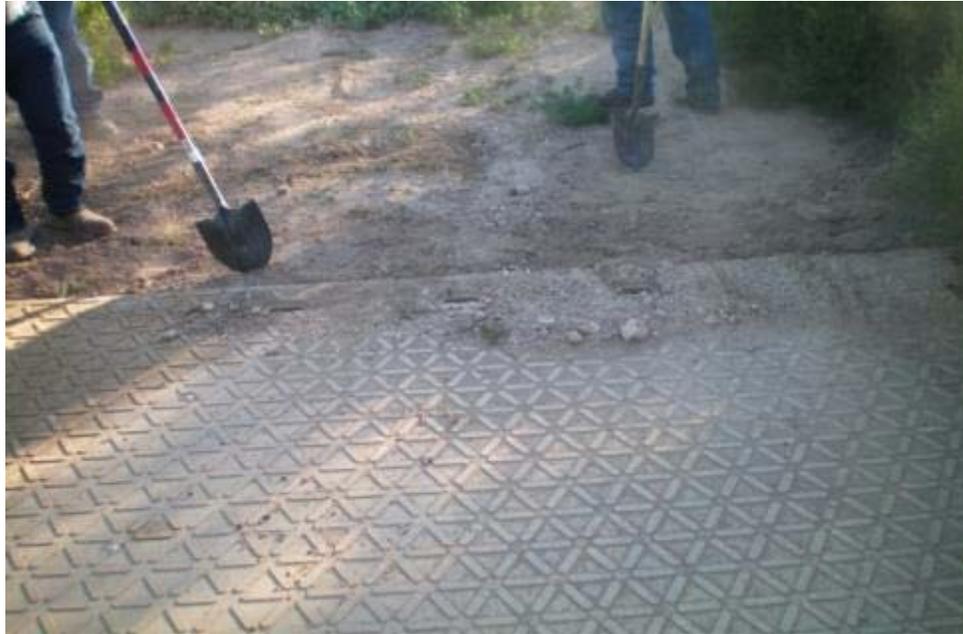
Figure 9. Cleanout of dirt and weeds at transition between Newport and Wyoming mats.

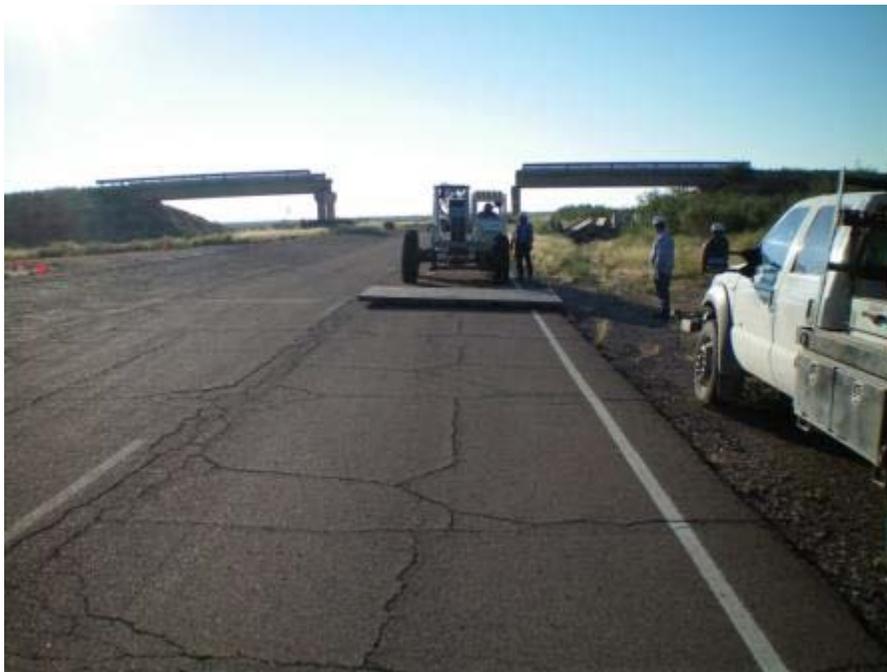
Figure 10. Movement of fixed Wyoming panels to road-site at bypass for overpass out of service.

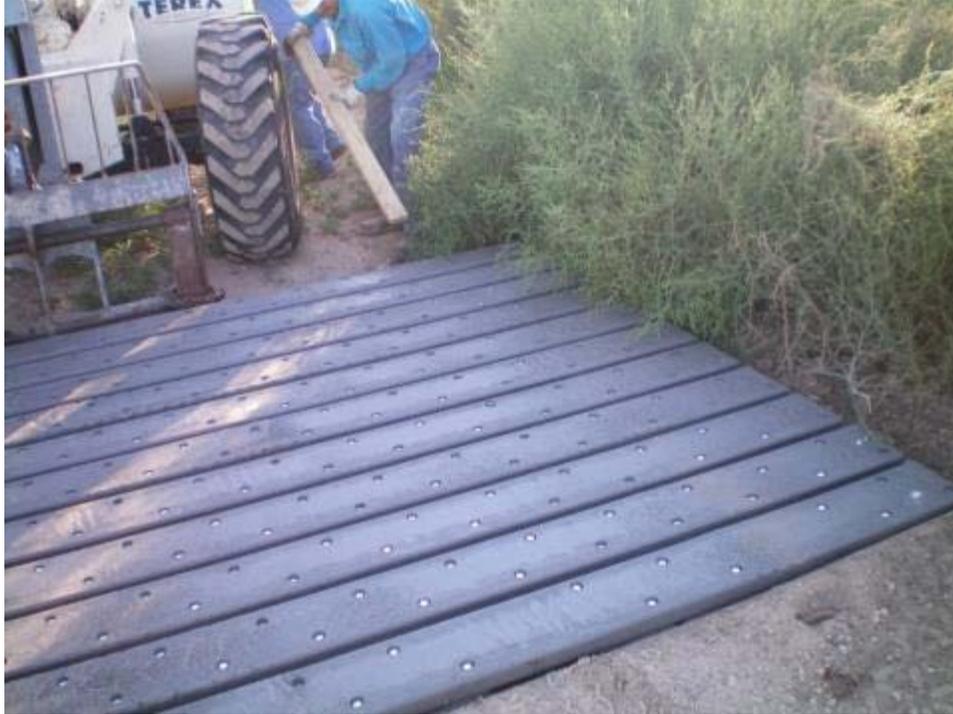
Figure 11. Wedging of Wyoming Panel to match Newport Mat. Newport mat set with an overlap on this side of panel to match the Wyoming panel setup.

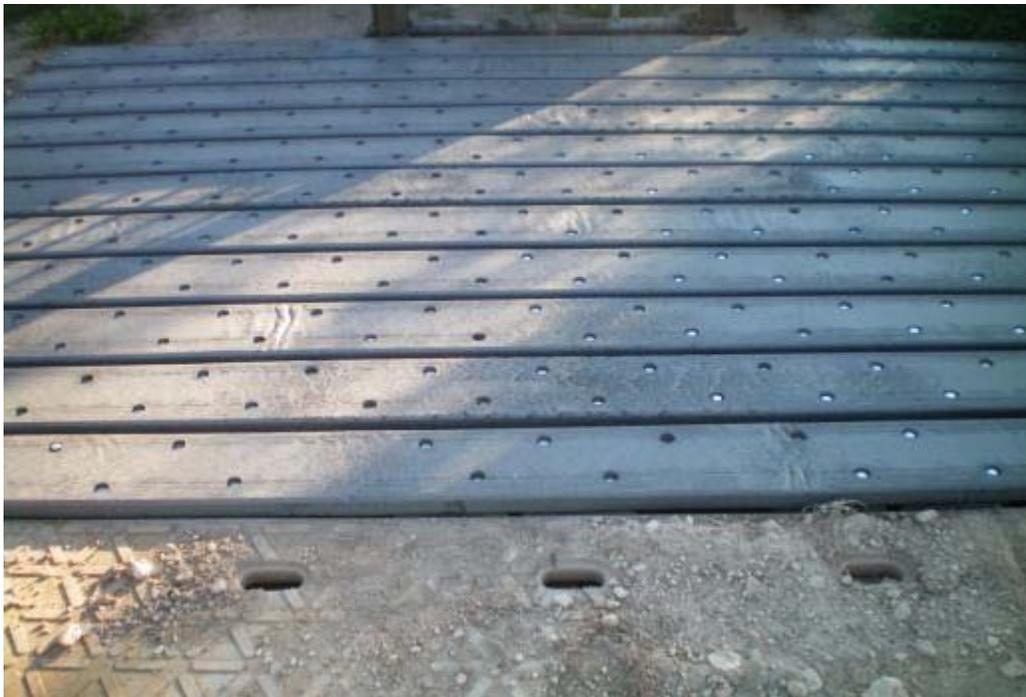
Figure 12. Transition between Newport and Wyoming panels in final layout of Pecos road section. Thickness of both type of panels similar and did not require major movement of soil to match panels.

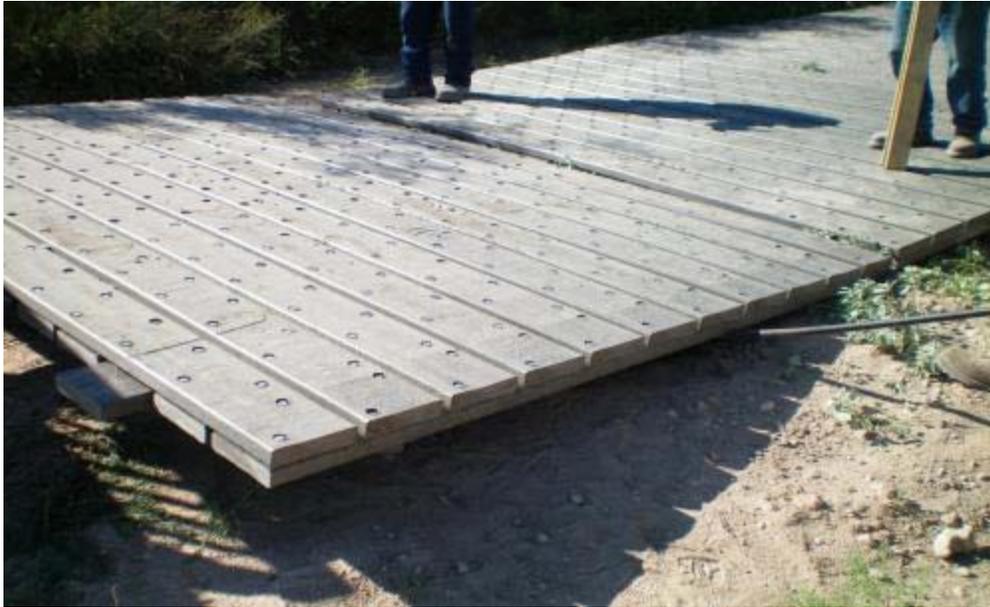
Figure 13. Dipping of front edge of Wyoming Flat panels to match new panel to previous installed panel before final layout of unit.

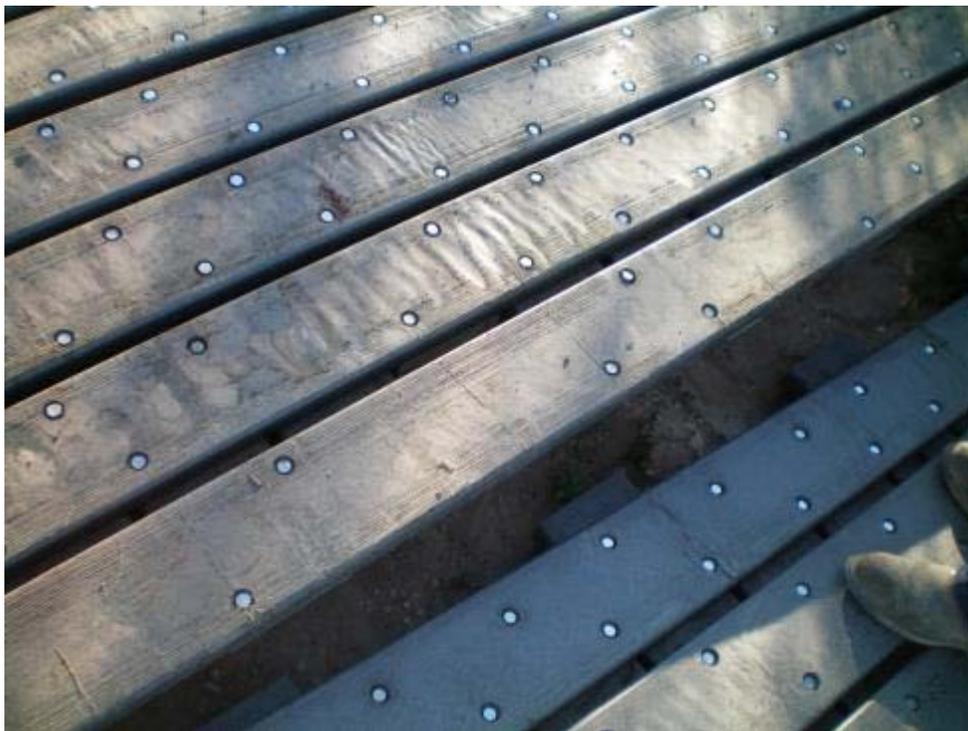
Figure 14. Adjustments required to match two panels to finalize installation of panels.

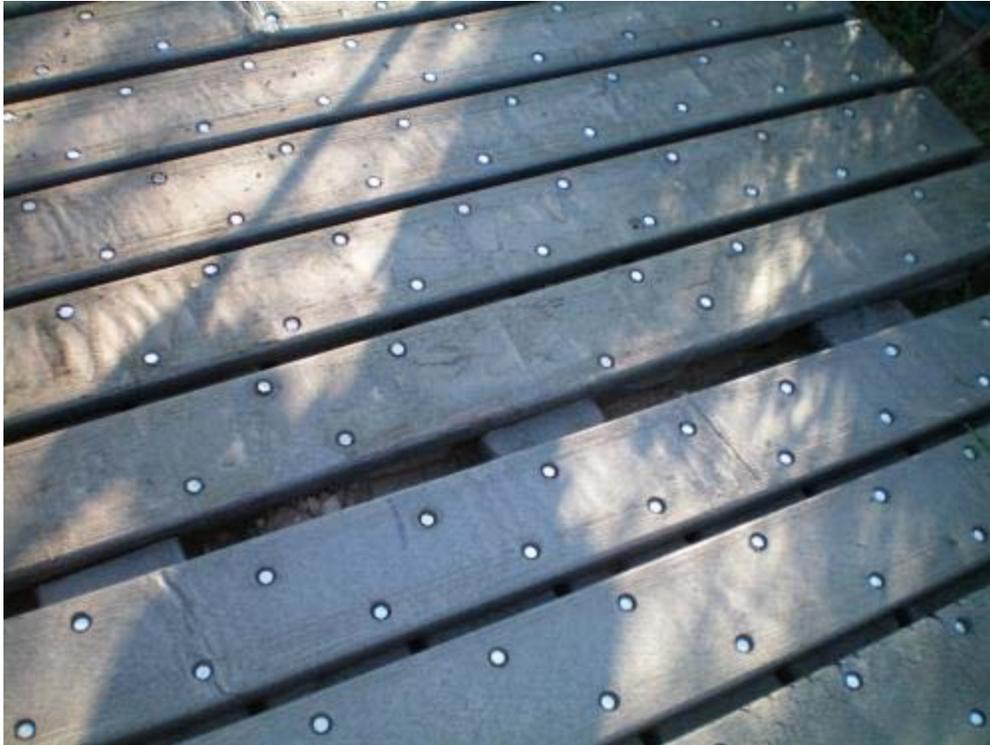
Figure 15. Top view of tongue and groove connections between two Wyoming Flat panels.

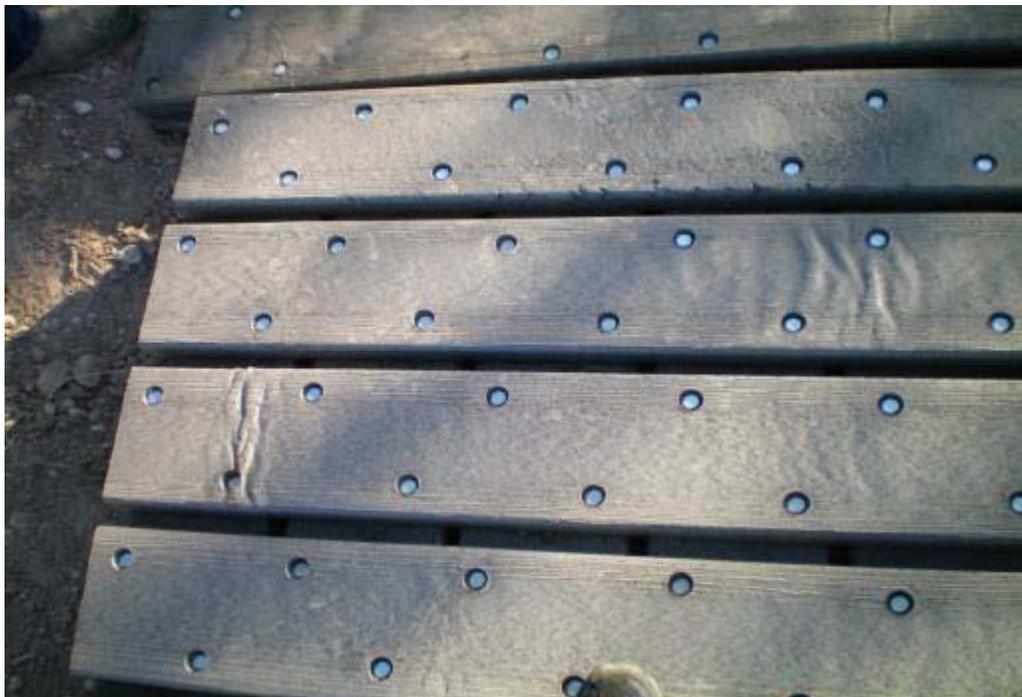
Figure 16. Wyoming Flat mats with cross hatch design. Note bolts used to connect upper and lower sections which are 90 degrees apart in direction.

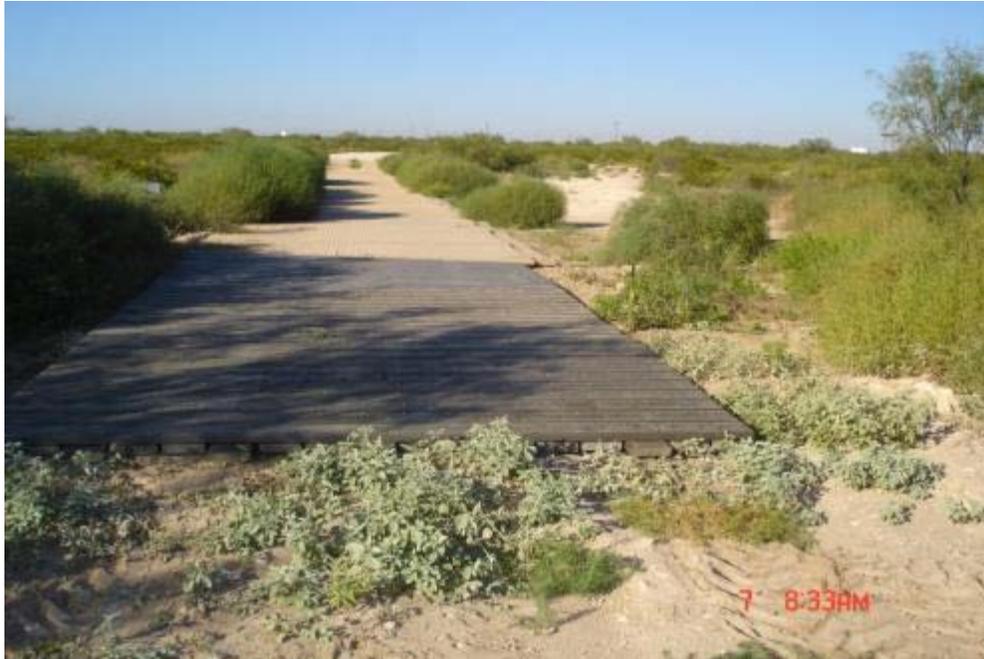
Figure 17. Back view of road sections note straight line of road. Special care is required to prevent a lateral slippage during installation that can cause problems later depending on length of road.

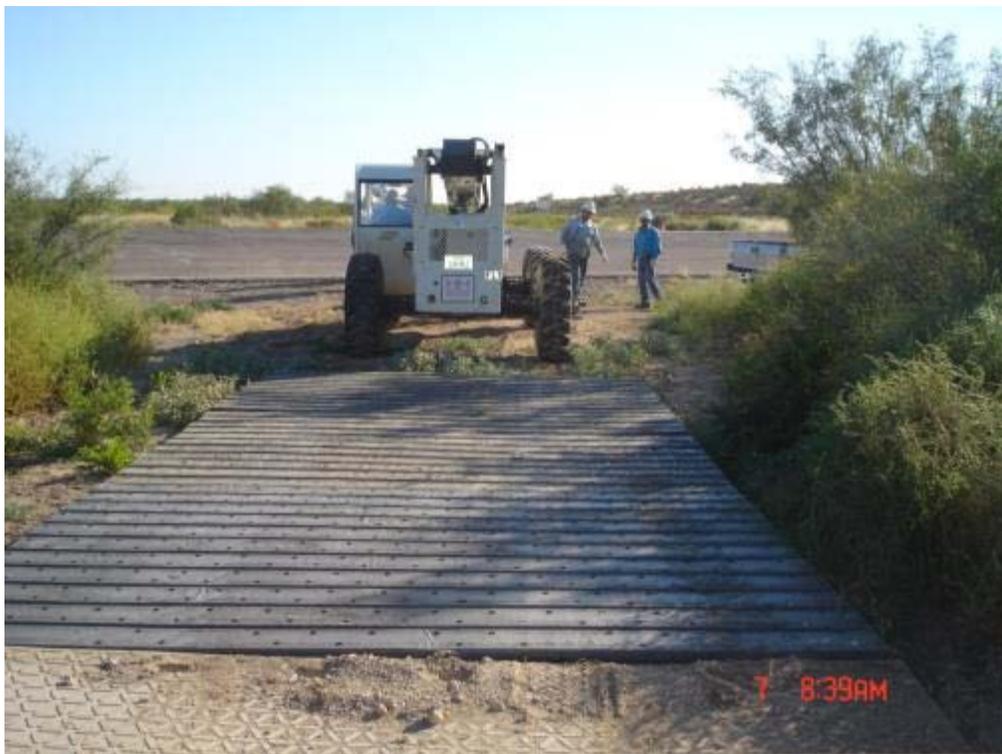
Figure 18. End of installation of Wyoming flat mats, crew ready to begin rollout installation.

Note the extension of board below the panel in Figure 14 which becomes more apparent in Figure 15 and 16 as a tongue and groove union between the panels. Figure 17 gives some indication of the complexity of the mat design. The panel is made of two courses 90 degrees apart bolted twice at each crossing point. At conclusion of installation of the fixed panels a semi-complete road section can be seen in Figure 17 and 18.

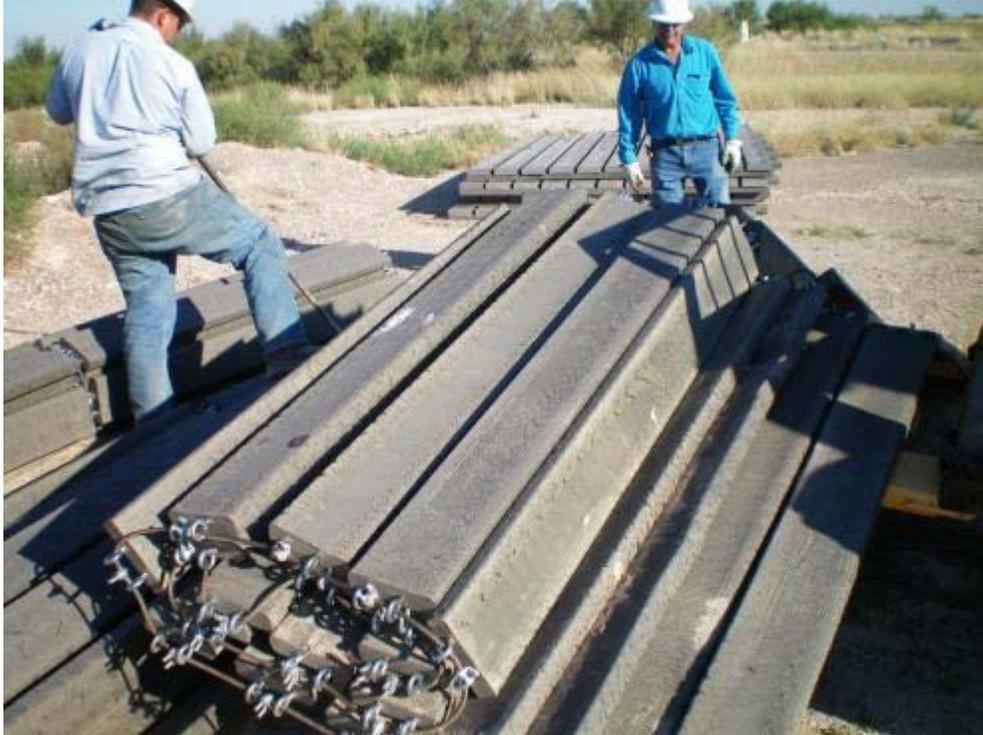
Figure 19. Stored Wyoming Roll-out mats after unloading from truck.

At this point the installation of the Wyoming Rollout panels was begun. The panels are shown in storage before installation in Figure 19. Note the cables and locking clamps on the edge of the panel. These sections had been folded over and rolled up for shipment to save space on the truck. Before installation the panels required the unfolding and rolling out of the section shown in Figure 20. After preparation of the panels they could be moved by forklift shown in Figure 21. Note the buckle along the cabled connection between the two sections. This was unstable during movement and did cause some problems during installation.

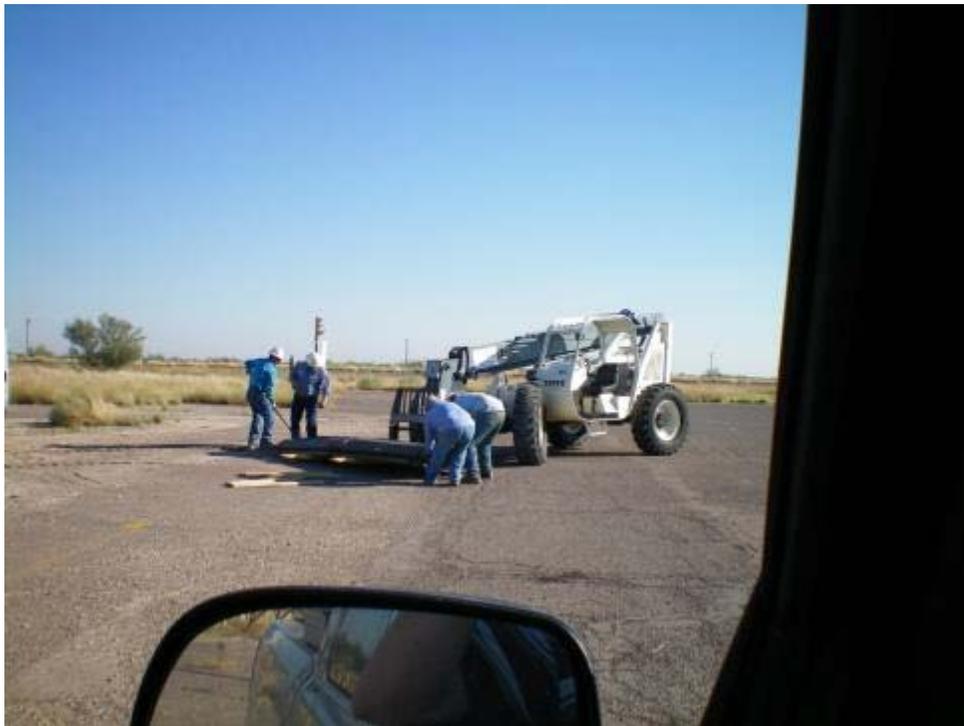
Figure 20. Wyoming Rollout panels must be rolled out and unfolded after shipment. All panels were packed this way to save space during shipment.

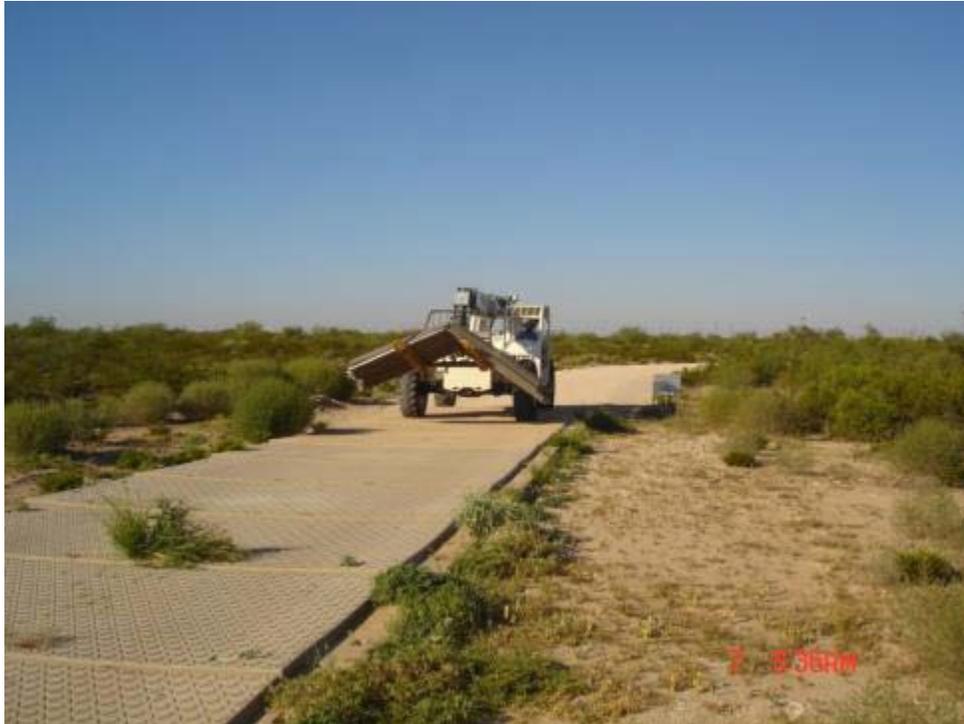
Figure 21. Movement of Wyoming Roll out panels can be difficult due the inability of the mats to lie flat on the forklift with the connection between panels.

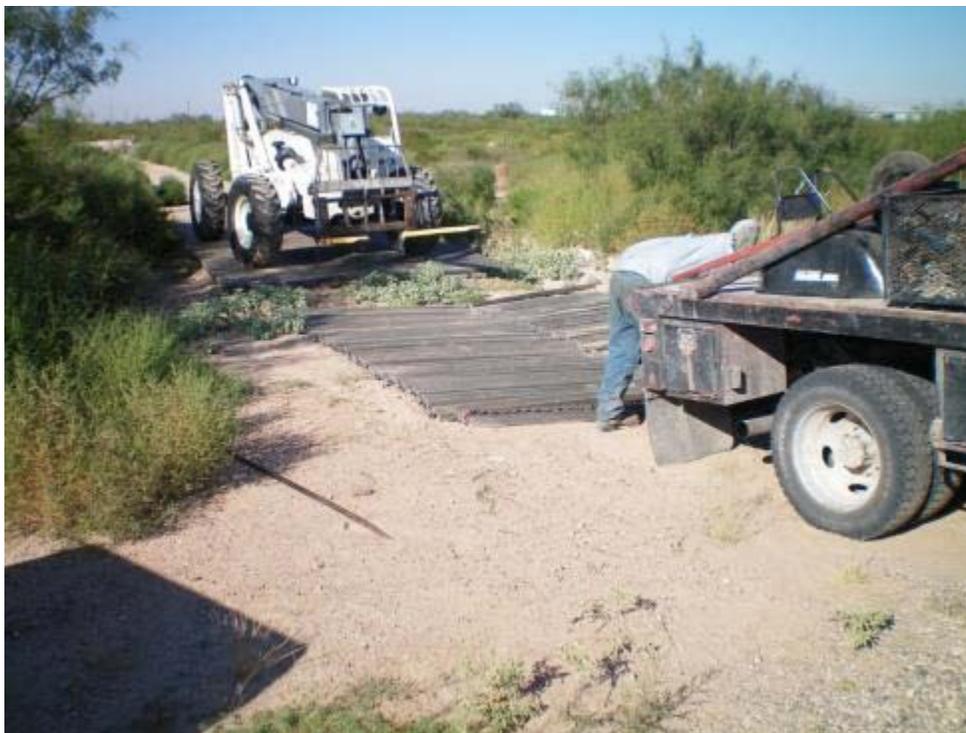
Figure 22. Laydown and drag out of first Wyoming rollout panel. Requires both the forklift and roustabout truck for placement.

Installing the road required both the forklift and a roustabout truck to stretch out the panel. This is shown in Figure 22. Without a fixed structure similar to the panels each unit requires special care during installation to obtain the best results. After stretch and layout the forklift drove on the panel to return to storage for another section. Note the break in an interior board of the rollout panel in Figure 23. A second fracture of the panel occurred at the end of the section as noted in Figure 24. In this case the track of the forklift can be seen over the failure as well as a washout or unlevel section at the point of the break.

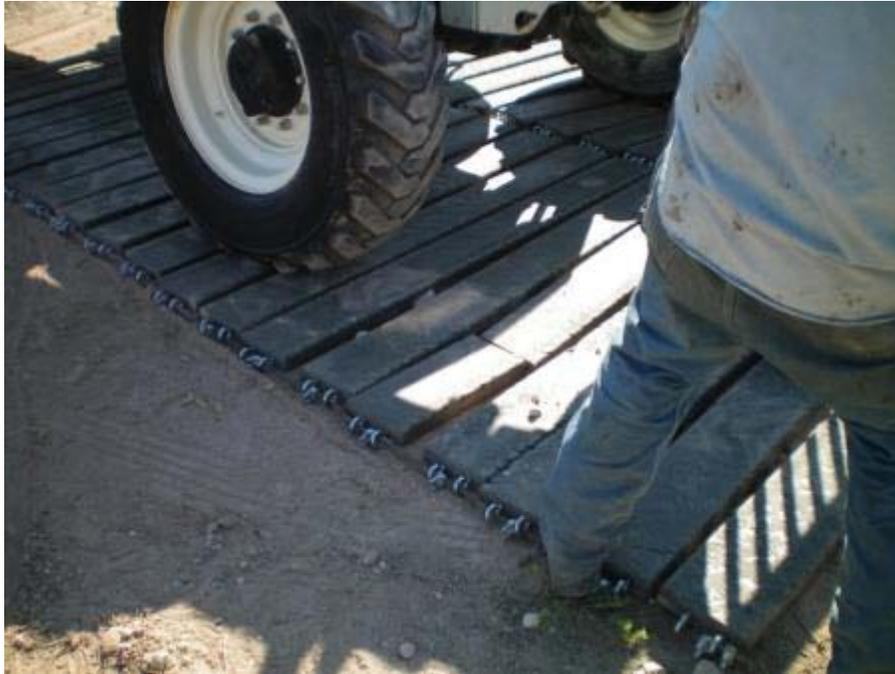
Figure 23. Note Break in interior board of Wyoming Rollout panel.

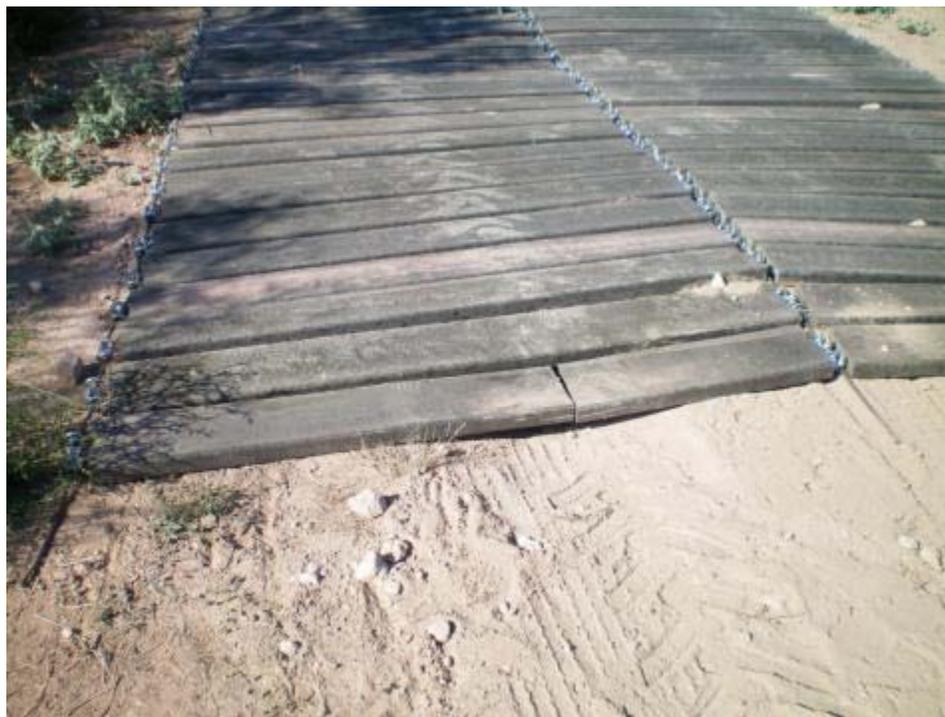
Figure 24. Note broken board section at end of panel. Cause of break can be seen by tire print on panel and the washout below the break in the board. The design of these mats gives strength in only one direction. To obtain maximum strength panels need bi-directional construction to prevent failure.

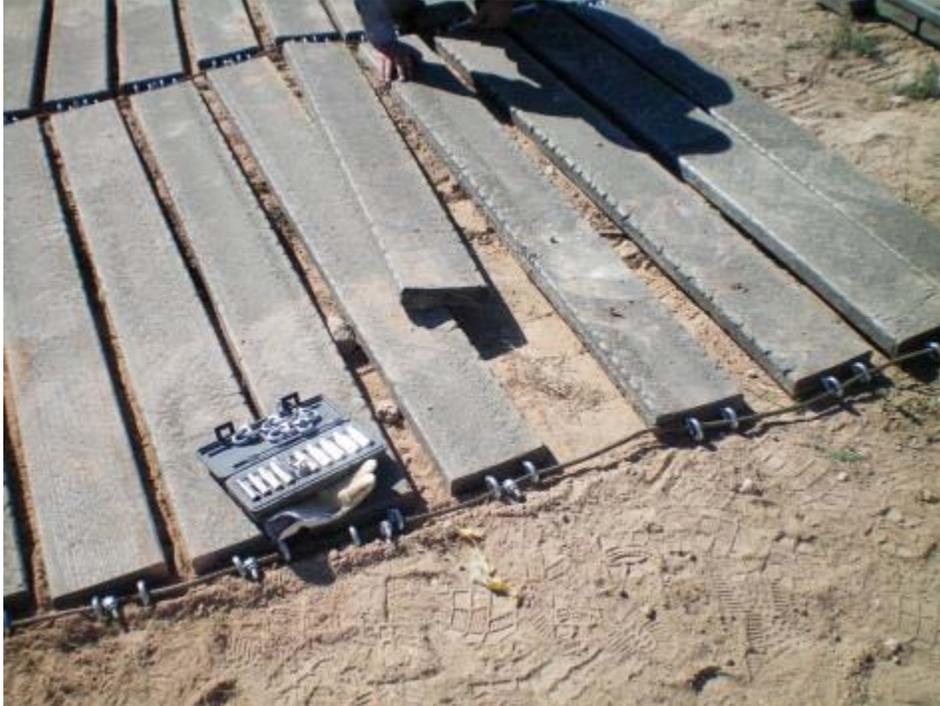
Figure 25. Removal of broken interior board of Wyoming rollout mat.

Although these breaks were serious a repair was possible as shown in Figure 25 and 26. The

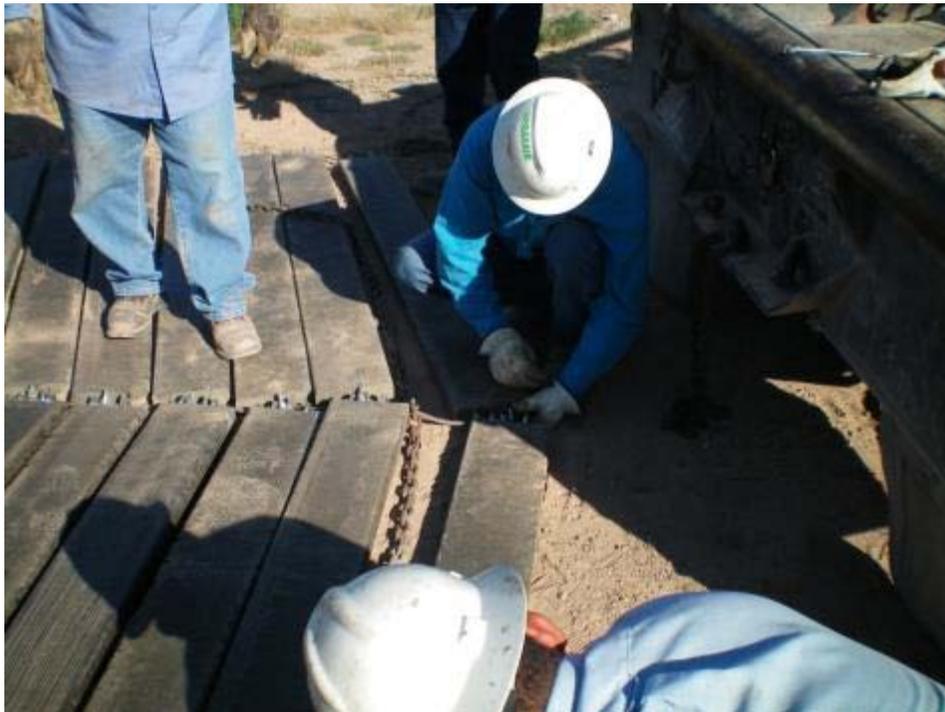
Figure 26. Removal and replacement of broken section of mat during installation. Required removal of locking clamps on each end of board to be removed.

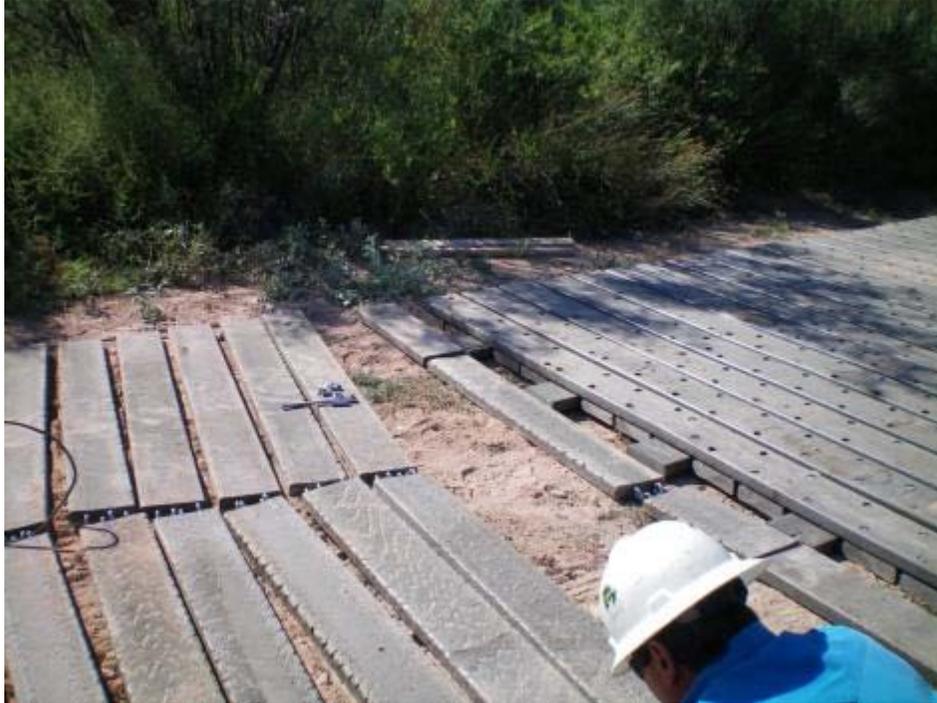
Figure 27. Placement of broken sections at union between fixed mat and rollout mat during installation. Note that vertical transition is attained using broken board sections as lift points on the mat.

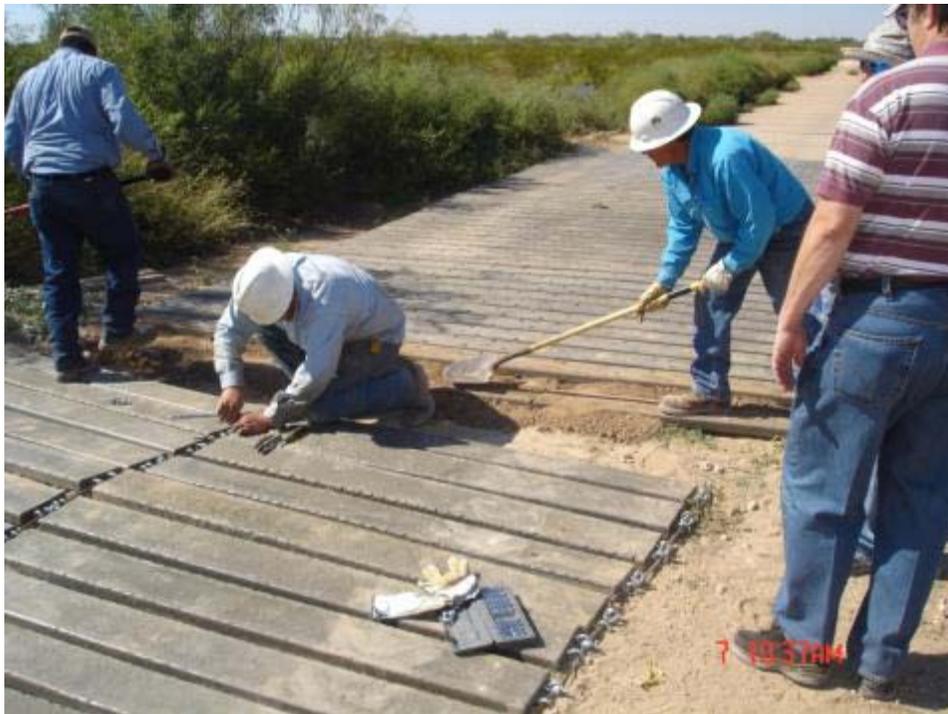
Figure 28. Backfill of transition point between fixed panel and rollout mat using broken sections as grade transition between units.

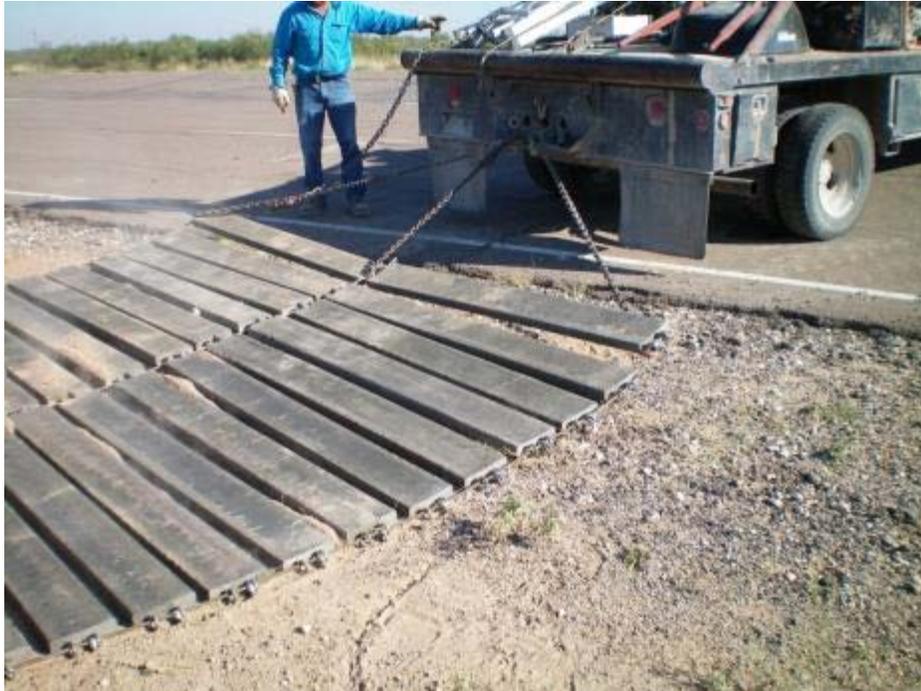
Figure 29. Use of the Roustabout truck and chains to shift direction of panel after laydown to match direction of crossroad.

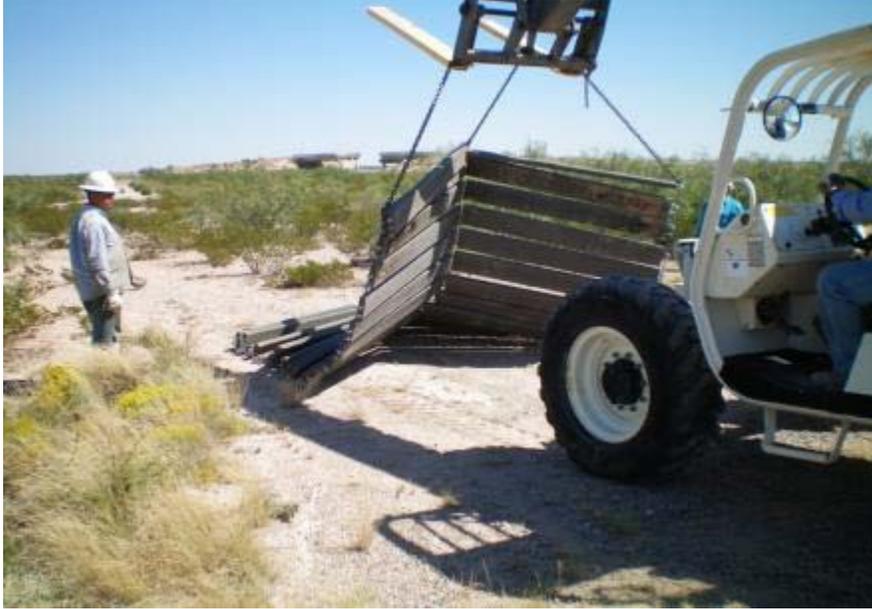
Figure 30. New Approach to installation of rollout panels. This required the chaining of the panels to the forklift to allow a vertical pickup with the panel hanging below the forks of the unit.

The final section of road to be built was at the street union on the outlet side of the test road. With the trouble installing the rollout section we approached this installation differently. In this section we used the extreme range of the field forklift to pick up the road mat for placement similar to laying out a blanket or towel on the ground. An example of this is shown in Figure 30 and 31. This was superior way to install the section and took only minutes for setup and installation. The addition of a steel bar or pipe on the forklift would have made it even faster to that found in this method.

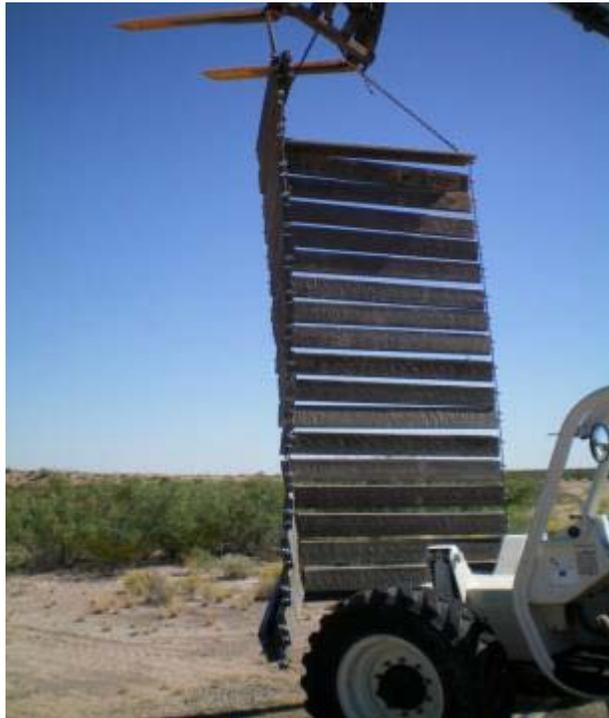
Figure 31. Extended View of rollout panel after pickup using new approach for installation. Panel is pivoted in middle but addition of steel stringer or section with chains would remove it and allow a straight hang of the panel before laydown.

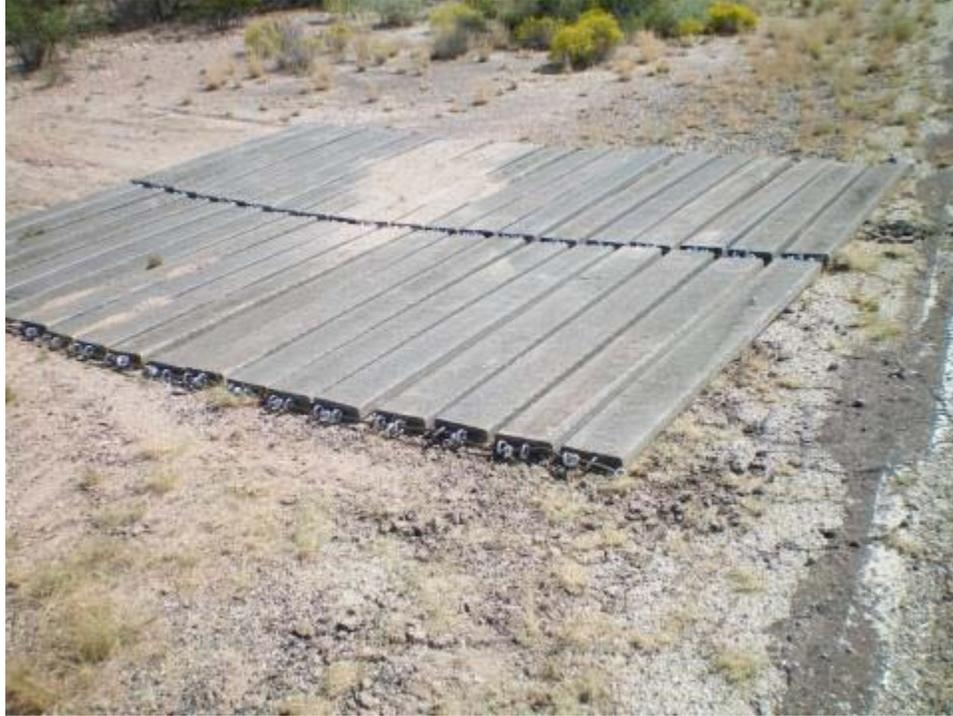
Figure 32. Wyoming Roll out panel as installed from roadway note flat installation before twist of panel to match street intersection.

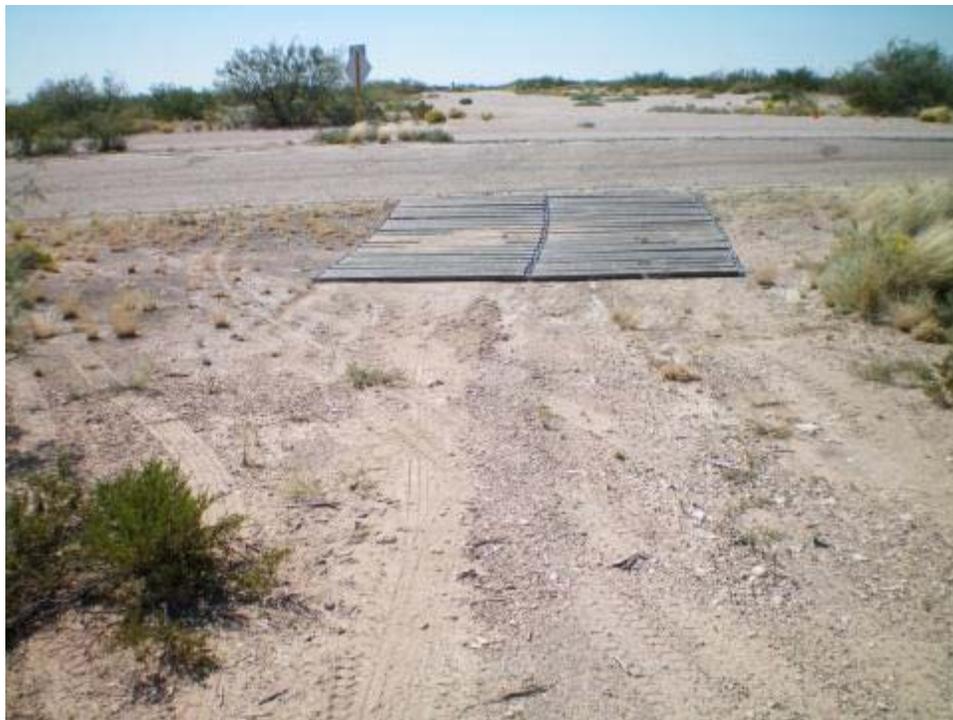
Figure 33. View of Rollout panels after placement. Note twist or nonlinear direction of panel as installed.

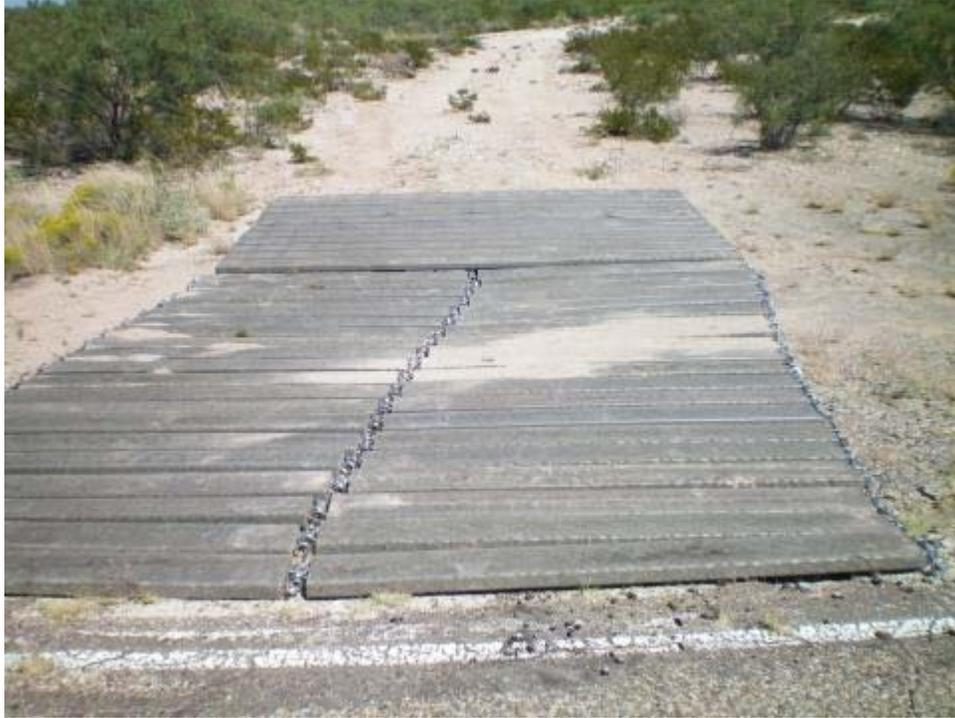
Figure 34. Final layout on Wyoming and rollout panels on exit from field road to paved street. Note nonlinearity of roadway with use of the rollout panels.

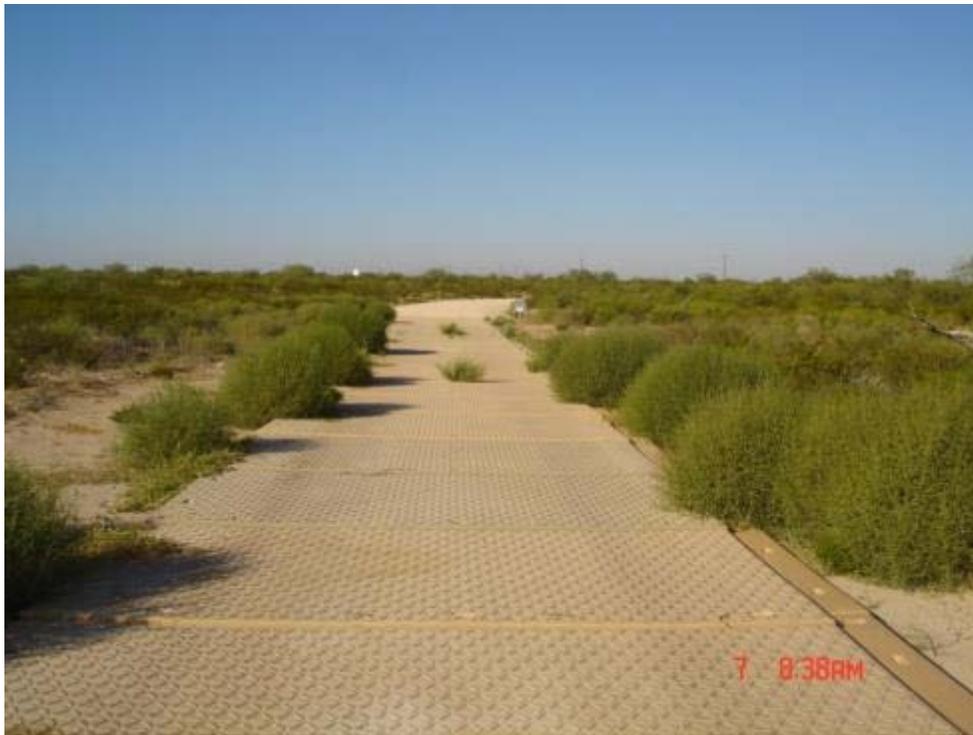
Figure 35. View back on Newpark panels installed earlier in project. Note the growth of tumbleweeds along edge of road and at unions between panels.

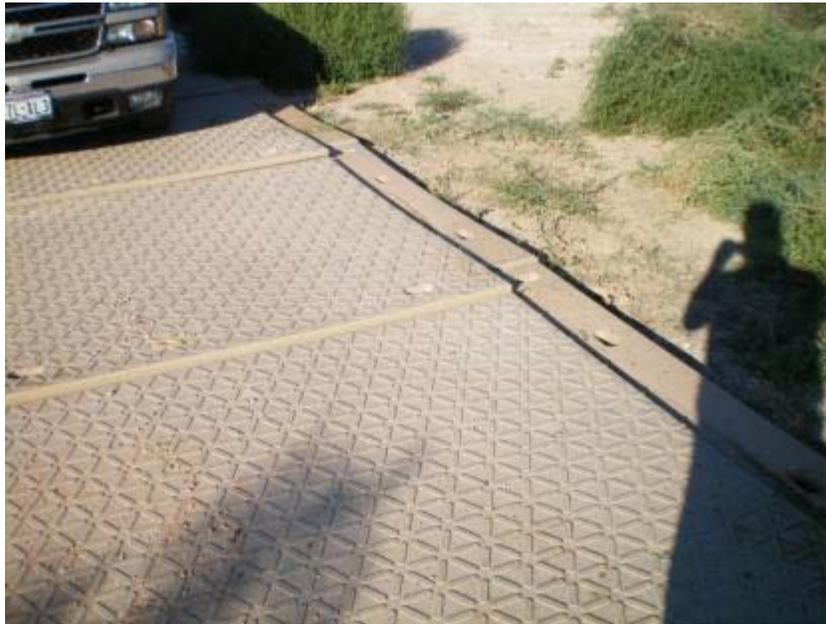
Figure 36. Note washboard buckling due to lack of connection between mats. Only two pins/locks were used per connection. The panel allows for a total of 5 per connection.

A major issue noted on visits to the site. Buckling was occurring on the outer edges of the Newpark mats. This was due to the connection method used to install the panels. This can be seen in Figure 36 and 37. The buckling although not a complete failure of the road would make it uncomfortable for drivers over long section of mat installed as a road. A second method of installation would be to fix the outer edges of the mats with keylocks to force the sections to remain at the same elevation and not buckle.
