## Low Impact Testing of Oil Field Access Roads: Reducing the Environmental Footprint in Desert Ecosystems

07123.01.Final

### *Field Site Testing of Oil Field Access Roads*

**January 23, 2014**

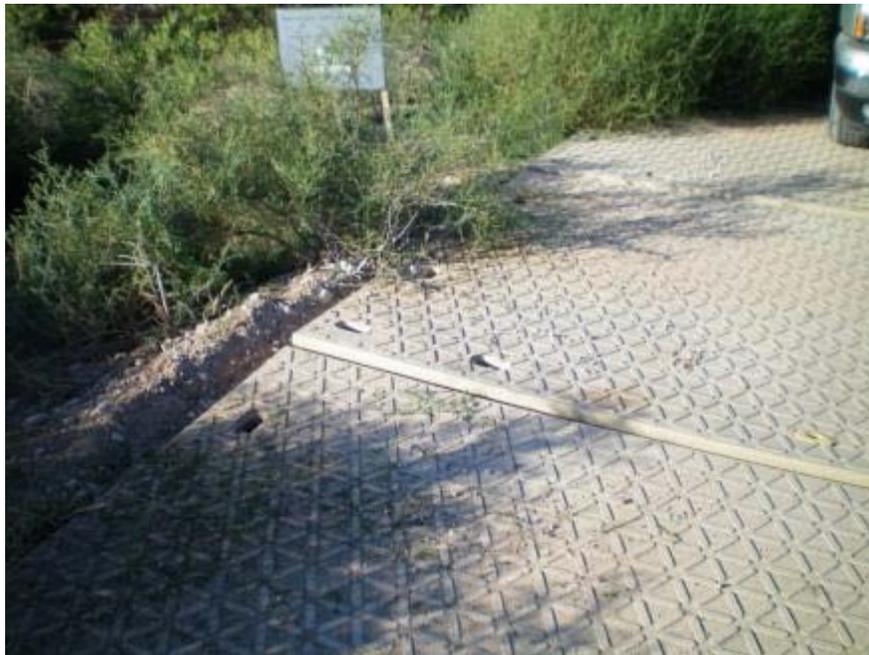
Figure 37. Outside edge of Newpark mats indicate buckling potentially caused by lack of keylock to connect panels.

A major issue noted on visits to the site. Buckling was occurring on the outer edges of the Newpark mats. This was due to the connection method used to install the panels. This can be seen in Figure 36 and 37. The buckling although not a complete failure of the road would make it uncomfortable for drivers over long section of mat installed as a road. A second method of installation would be to fix the outer edges of the mats with keylocks to force the sections to remain at the same elevation and not buckle.

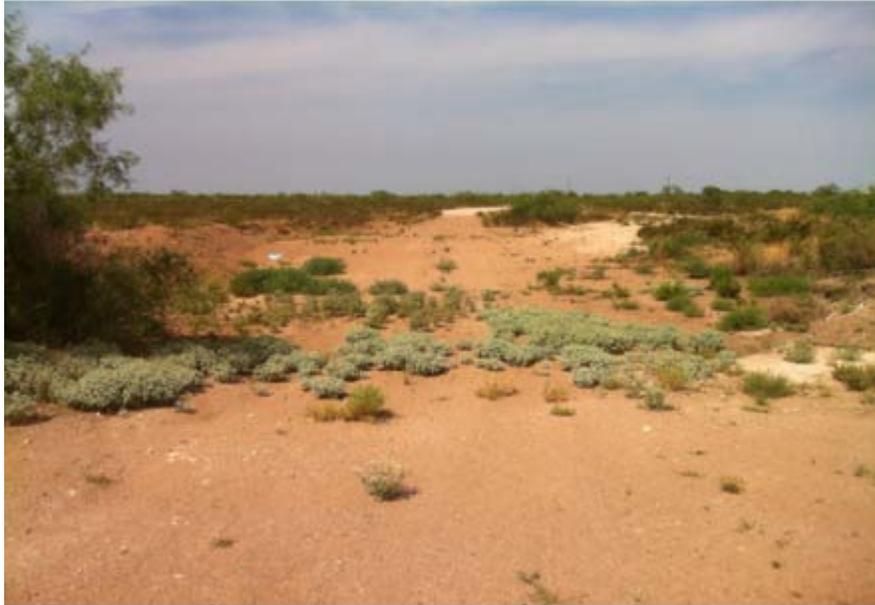
Figure 38. View of temporary road from track towards interior of facility. Note return of weeds and plant life to roadbed. Roadbed has been graded in last 4 months in preparations for a permanent road.

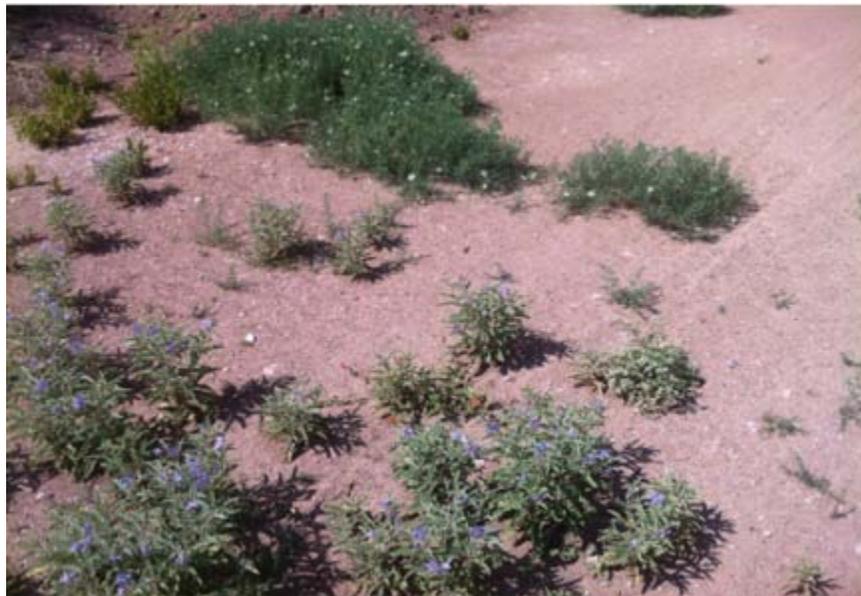
Figure 39. Weed growth at Track side of road. Same species was found at same location when we installed road mats.

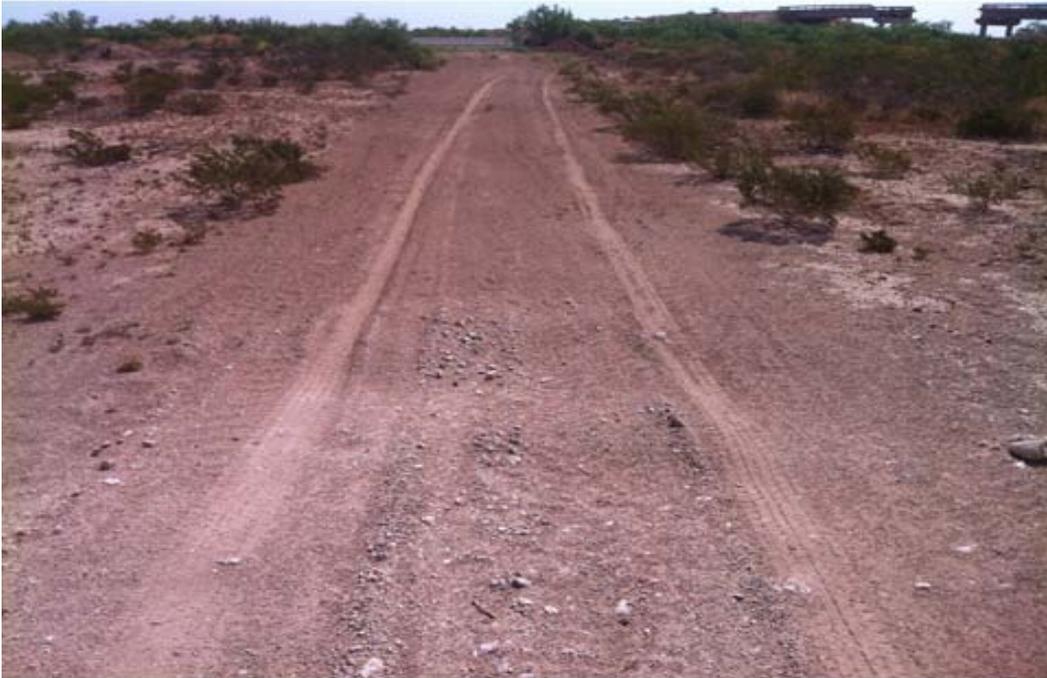
Figure 40. Reverse view of road from spline road section to Track. Note tilled soft dirt versus hard packed caliche. Material will allow for growth of plant life on old road.

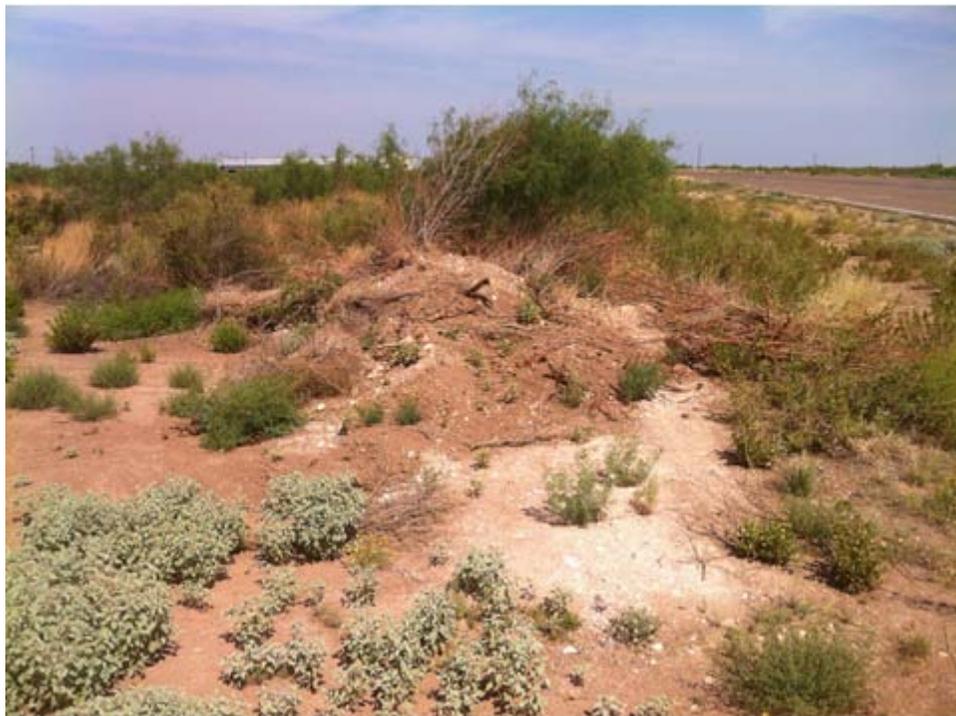
Figure 42. Spine road using well cutting after two years. Note no growth of plant life and limited weather wear on road section.

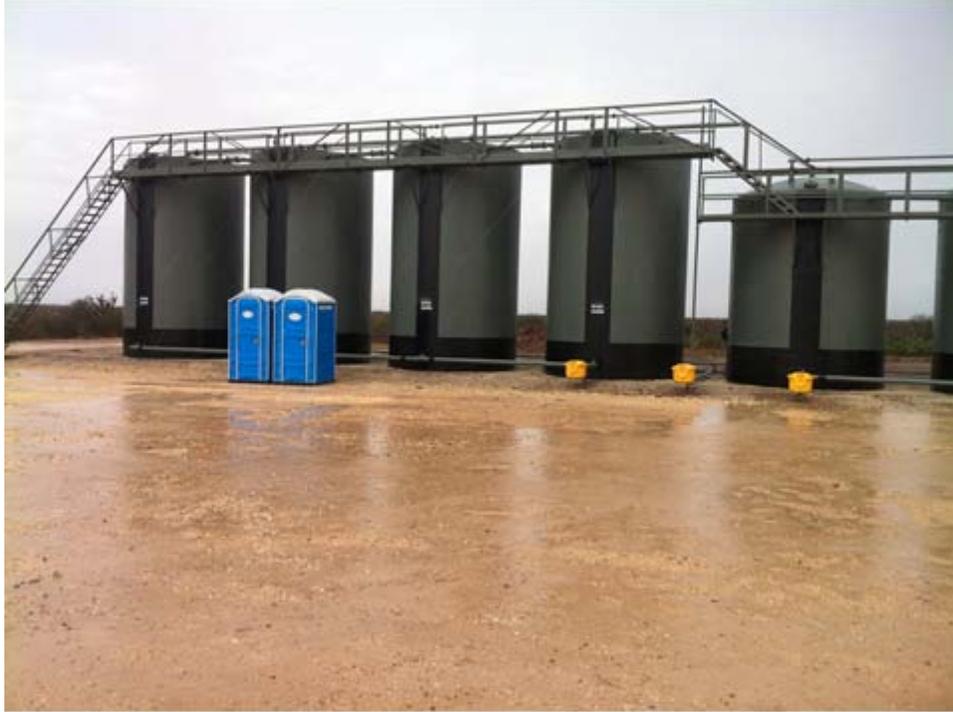
Figure 44. Test Site in Eagleford Shale area, note muddy location with soft clay content of caliche.

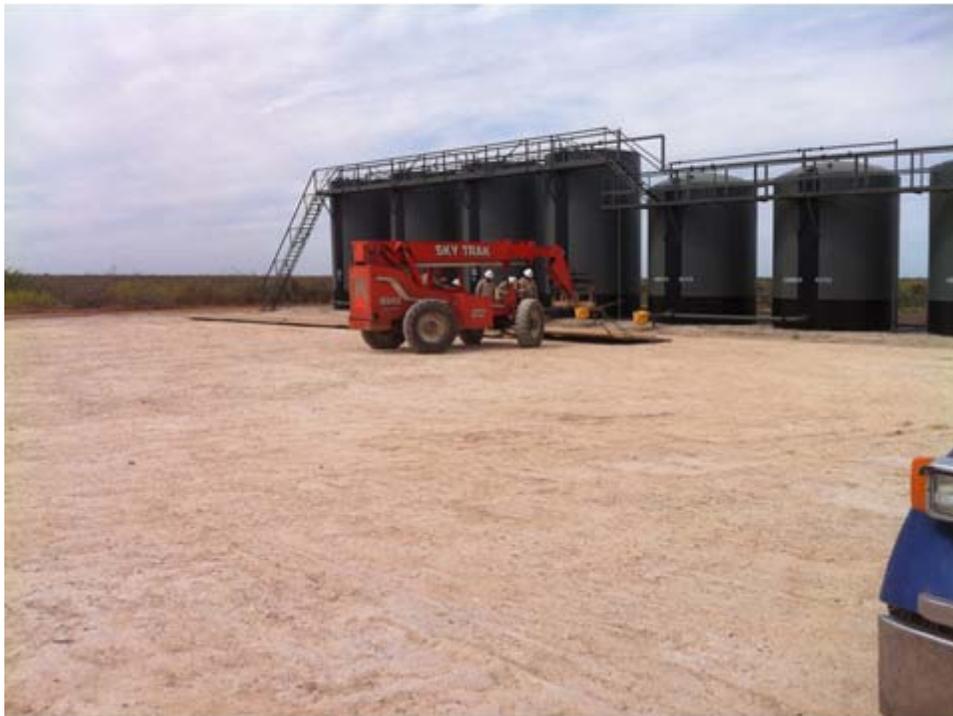
Figure 45. Initial setup and layout of road panels before containment built for tank battery.

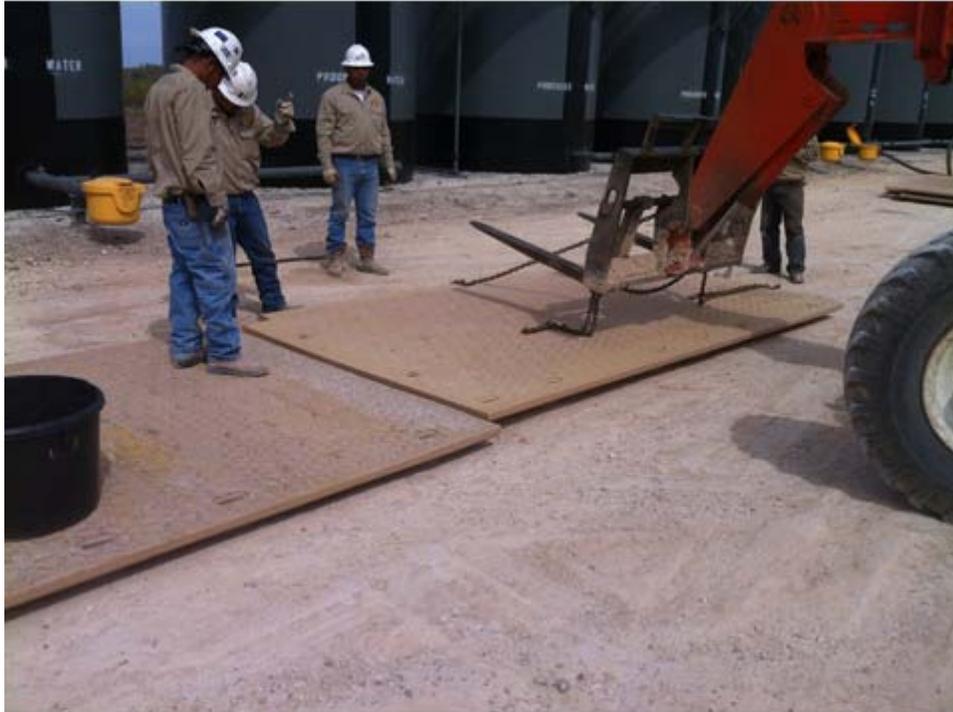
Figure 46. Use of forklift to spot and place mats along proposed road section.

The mats were installed in a similar fashion to that used in the Pecos trial. For this trial we were looking for an installation location that would have adequate traffic and loading to determine if either road material provided a workable solution. We selected a section of road to be installed in front of a production battery. The location prior to construction can be seen in Figure 44. In this test, we laid two panels side by side versus a continuous laydown of the panels used in Pecos. This laydown procedure can be seen in Figure 45. This gave better strength characteristics as well as prevented the buckling seen in the first trial. Figures 45 to 49 present the problems and issues seen while installing the mats at this site. As shown before for installation and setup of the mats, a roustabout crew and forklift operator were all that was necessary for this project.

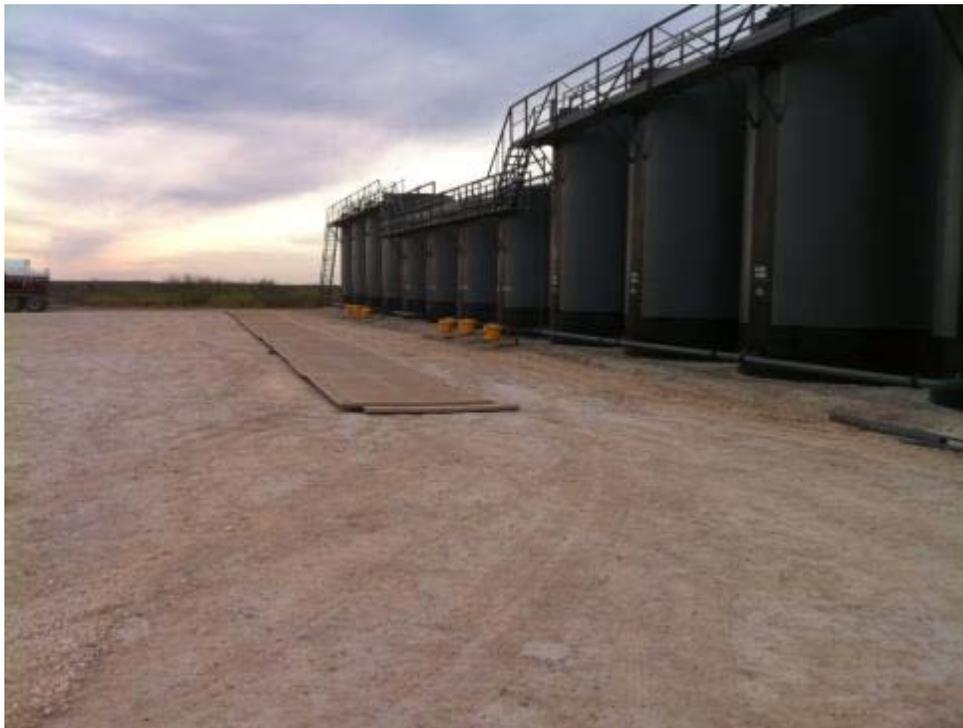
Figure 47. Completion of first row of roadbed. Note road not wide enough for large vehicle and overhang on left side of panel could be a problem.

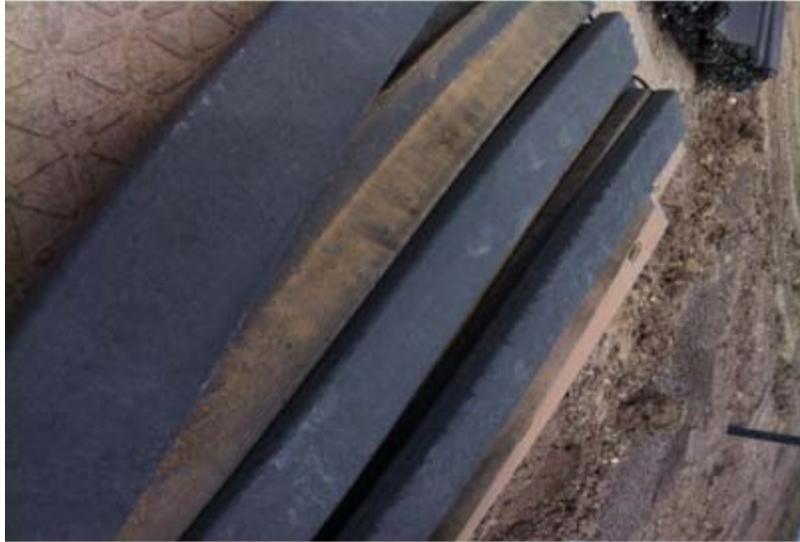
Figure 48. Due to the overlap of the Newpark mats some type of support needed for the overlap section of the mats. Each mat is made of two panels with an approximate offset of 8 inches in two directions of the panels. Without a specific trim piece for this section alternative methods are required to support the edge of the mats.

A problem did appear in this trial not seen earlier. With the ability of the trucks using the mats to enter or leave the road section by driving off the side of the mats cracks began to occur on the sections which overlapped the lower panel. Without support of this overhanging section the mats begin to fail and crack. This failure can be seen in Figure 60 and 61. A trim or finish piece is necessary to complete this cross-section and prevent failure. The drawback to this solution is cost. The number of trim or finish pieces to complete the road is equal to one half the number of panels used and can be a factor that is cost prohibitive. In our installation we modified the layout by using sections of the rollout panels Figure 48 as inserts under the overhang shown in Figure 49.

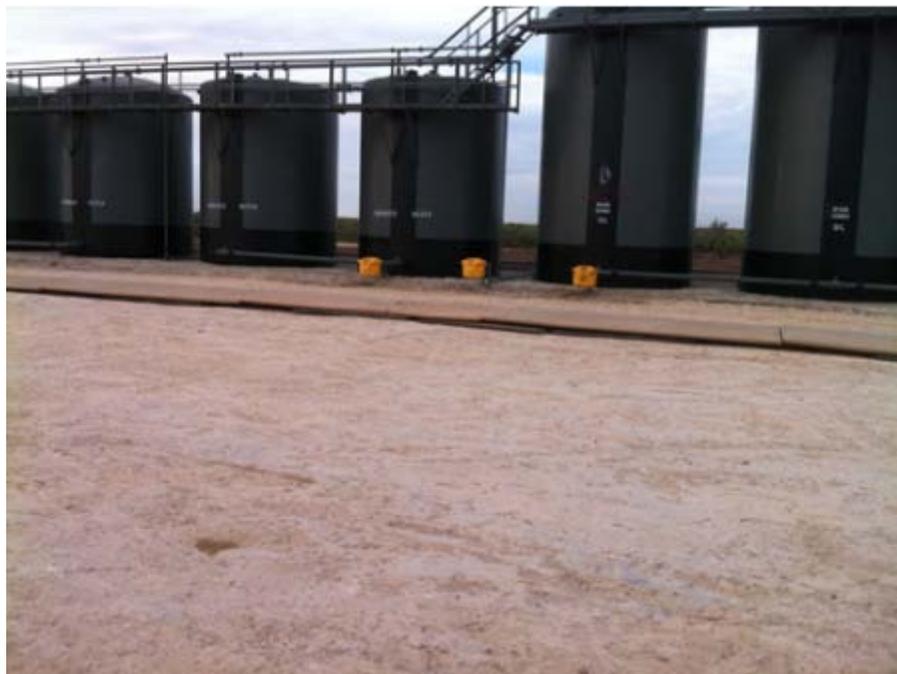
Figure 49. Note the installation of the board sections under the overhang section of the panels in this section.

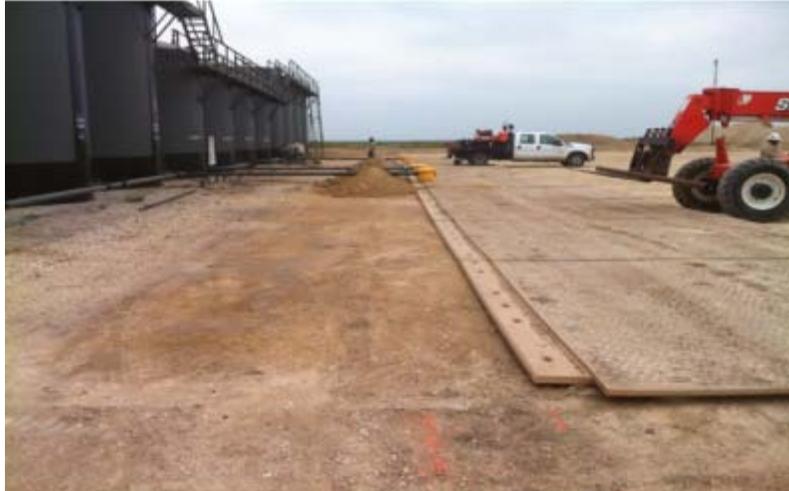
Figure 50. When ready to install the containment the road section needed to be moved for the installation. In this case two backhoes were used to drag the section approximately 8 feet to allow for containment.

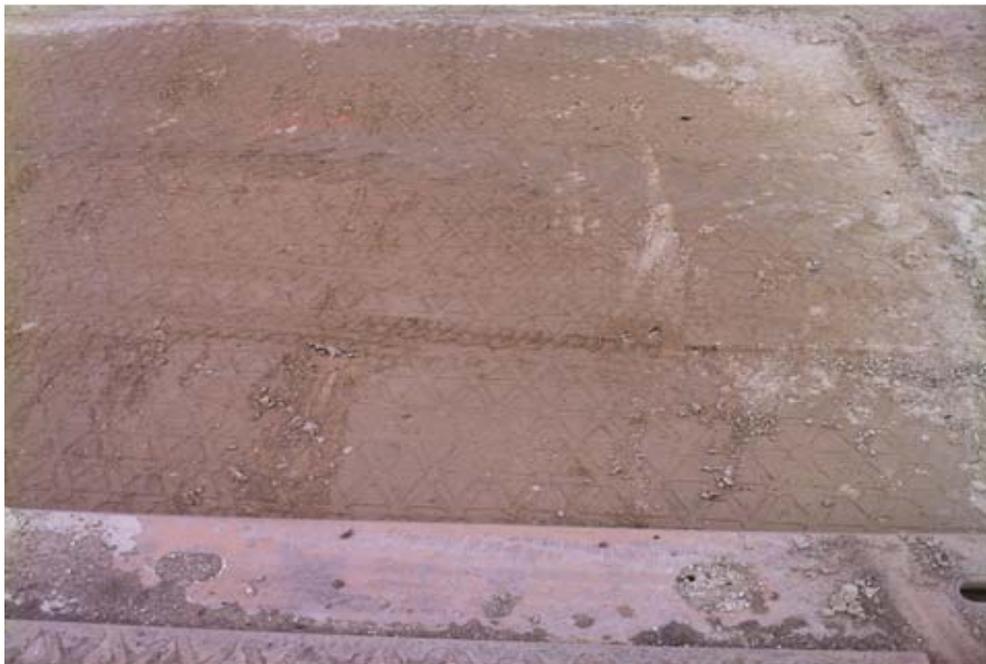
Figure 51. This indicates the amount of embedment of the mat into the caliche base on the location. The mat tends to imbed to some extent depending on the strength and integrity of the base material.

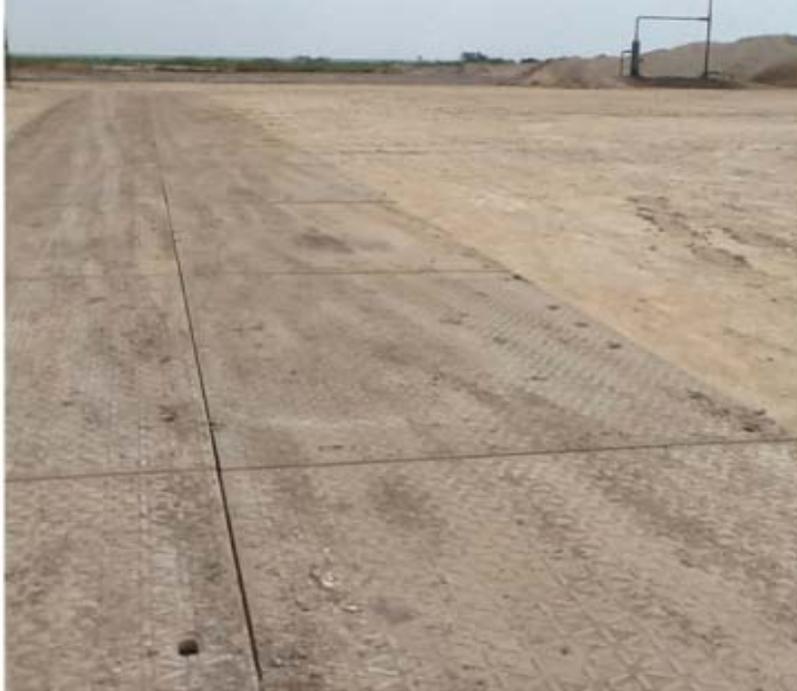
Figure 52. Final installation of road mats after construction of containment. Note the traffic patterns on the mats showing the drive up on to the road as well as the departure from road after loading.

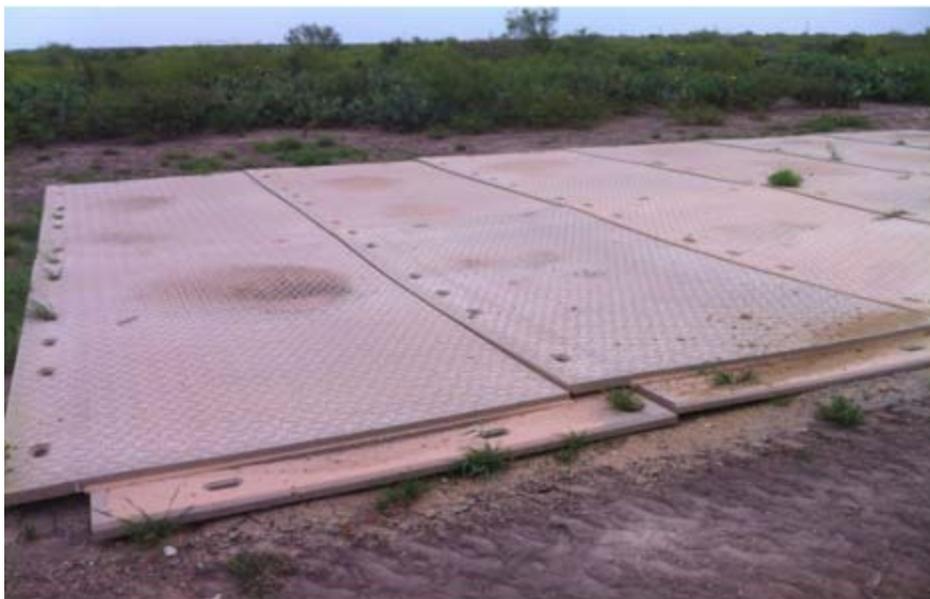
Figure 53. A second use of the Newpark mats was for a pad for field trials. The pad must be secure for equipment as well as preventing punctures of containment during tests. Note panels are not locked together due to a shortage of lock/pins.

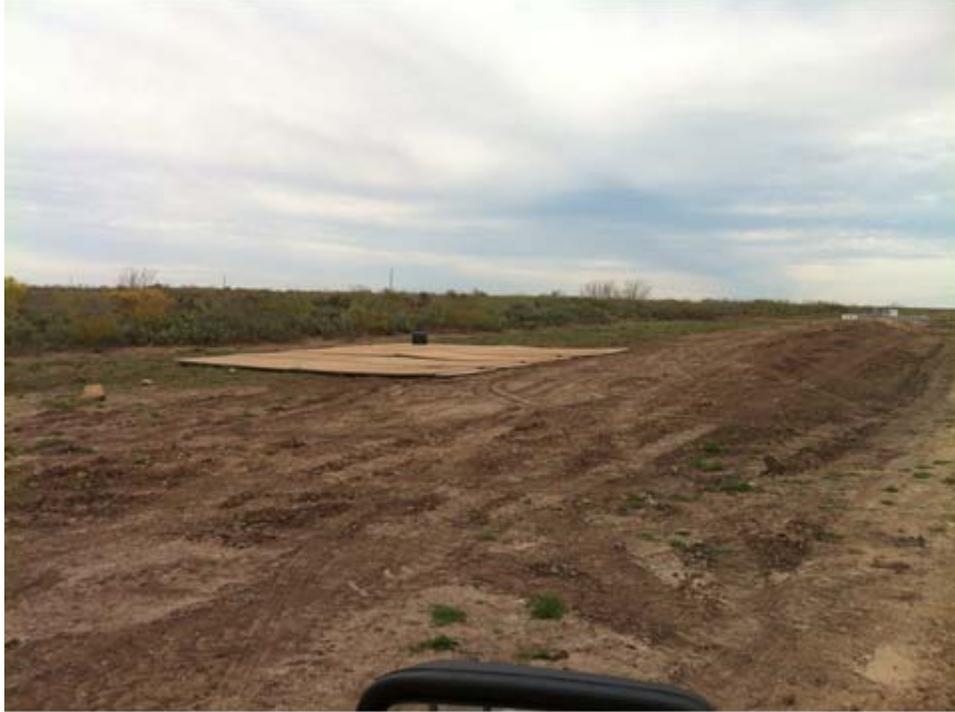
Figure 54. Final layout of pad behind production facility.

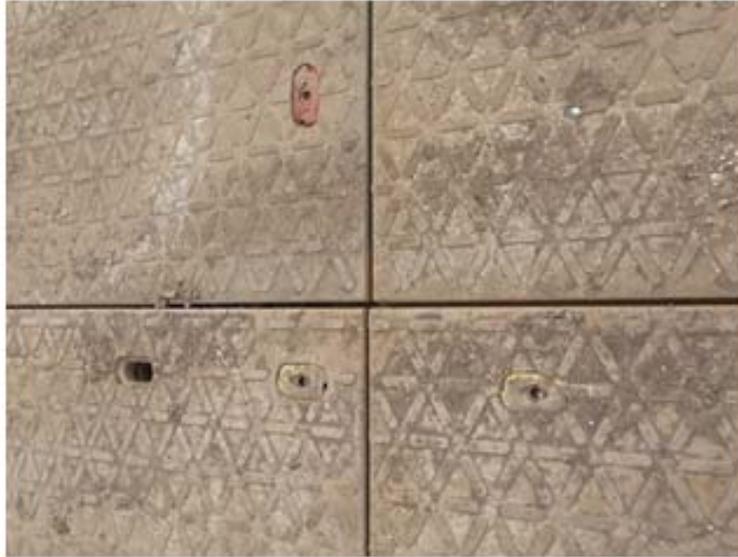
Figure 55. Panels after shipment of locks/pins arrive. Note that each corner has three pins as well as one in the middle of each panel to prevent buckling seen at the Pecos site.

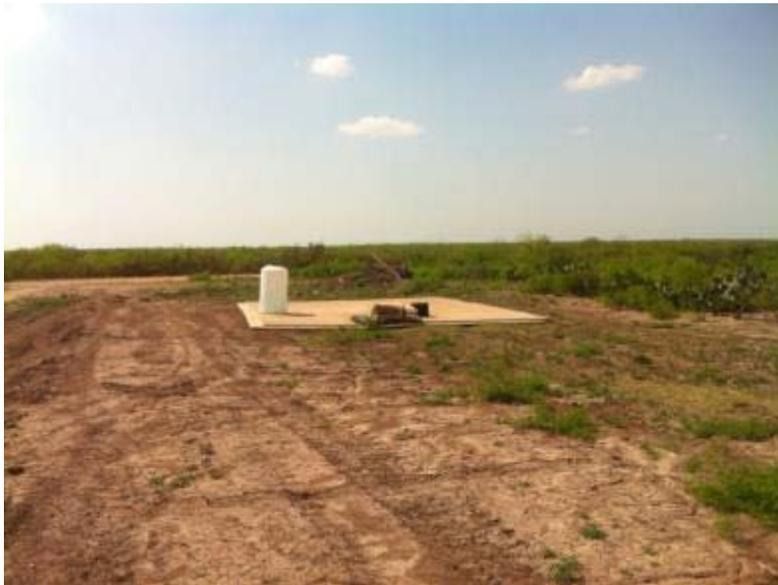
Figure 56. Final layout of pad before equipment move in and setup. Pad on unconsolidated soil not a prepared pad.

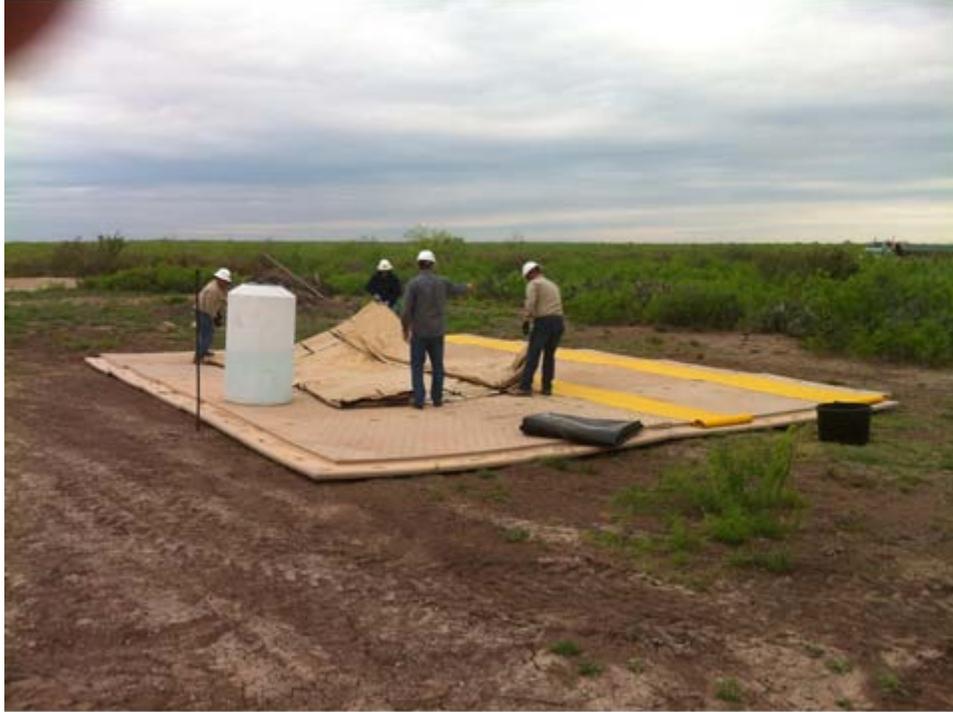
Figure 57. Layout of containment on pad to prevent leakage. All equipment of field trial will be on a pad made from some type of artificial material.

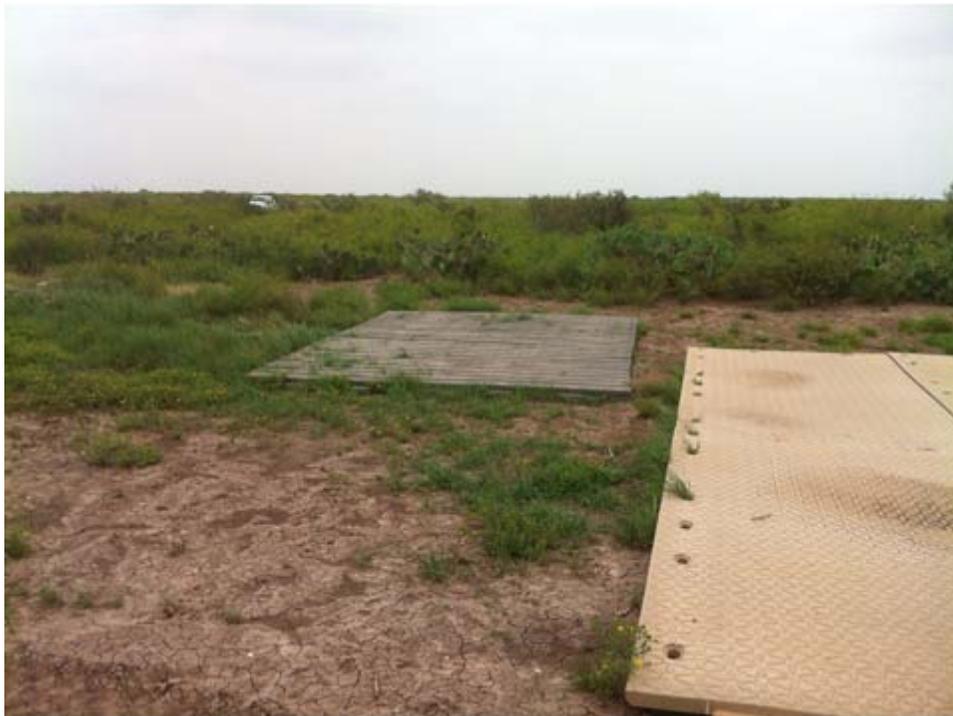
Figure 58. A secondary pad was made using the Wyoming mats for the generator. The size of the mat matched the size of the containment for the unit to be used.

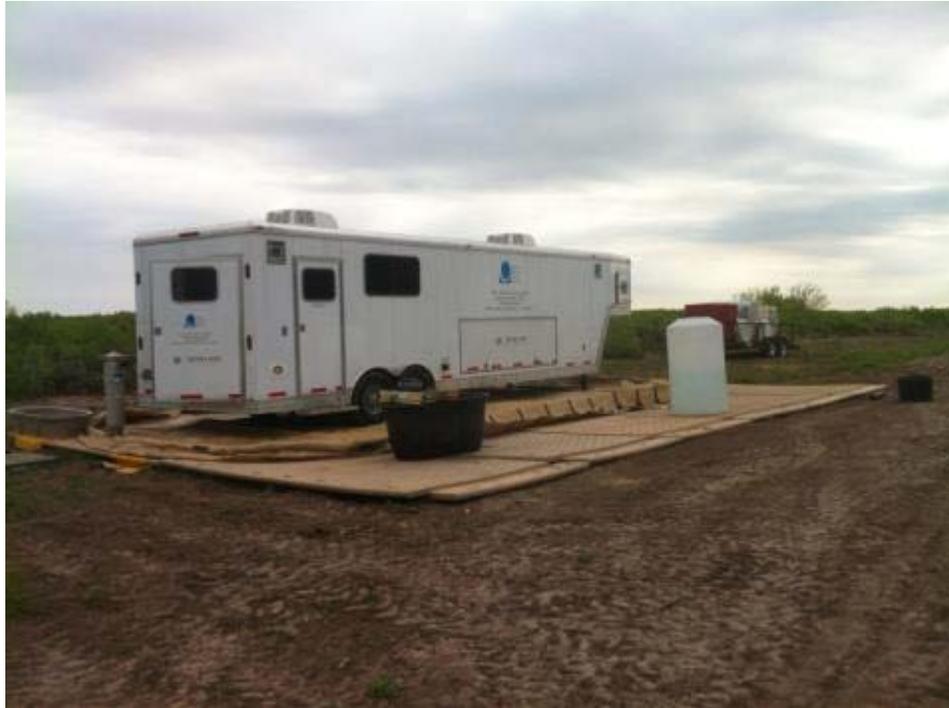
Figure 59. Final install of field trial equipment on pad using Newpark mats. Note we used a total of 10 mats for the pad.

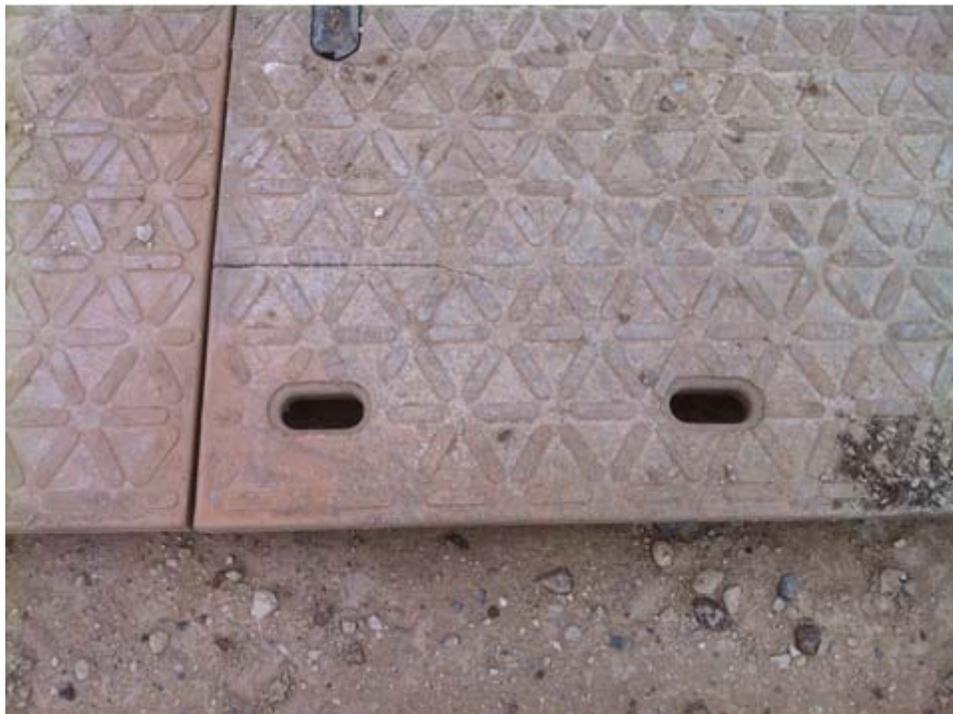
Figure 60. On several mats stress cracks occur at the union point between the upper and lower section of each mat.
