# **Development of NDE Technology for Environmental Barrier Coatings and Residual Life Estimation**

**W. A. Ellingson, C. Deemer, J. G. Sun, S. Erdman<sup>+</sup>, D. Mulier<sup>+</sup>,  
and B. Wheeler<sup>+</sup>**

Presented to  
**Turbine Power Systems Conference and  
Condition Monitoring Workshop,  
Galveston, TX  
February 25-27, 2002**

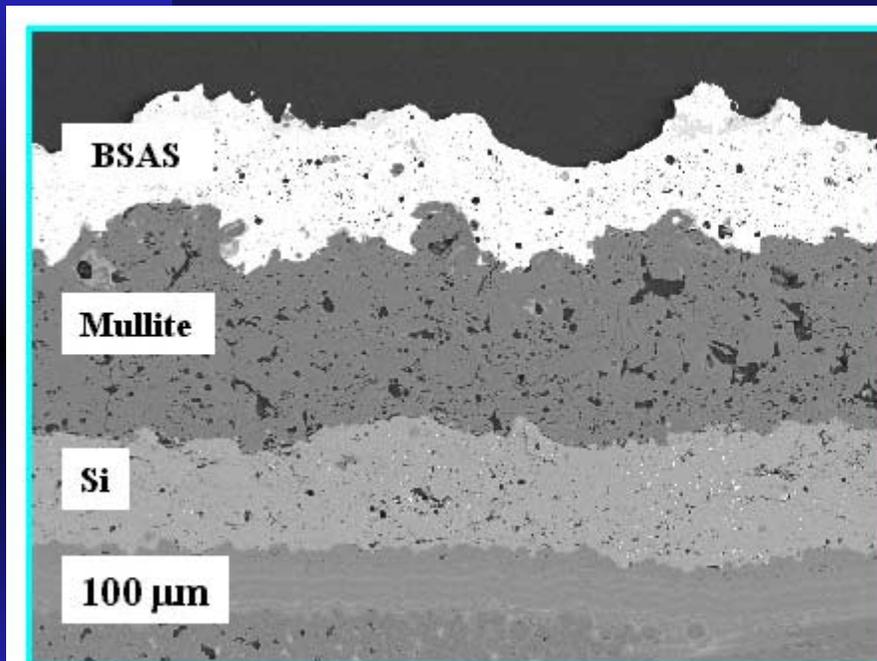
Plasma sprayed coatings consist of two layers on a Si bond coat and CVD SiC seal coat

“Dual layer” Mullite/BSAS

Currently on Inner Liner at Texaco

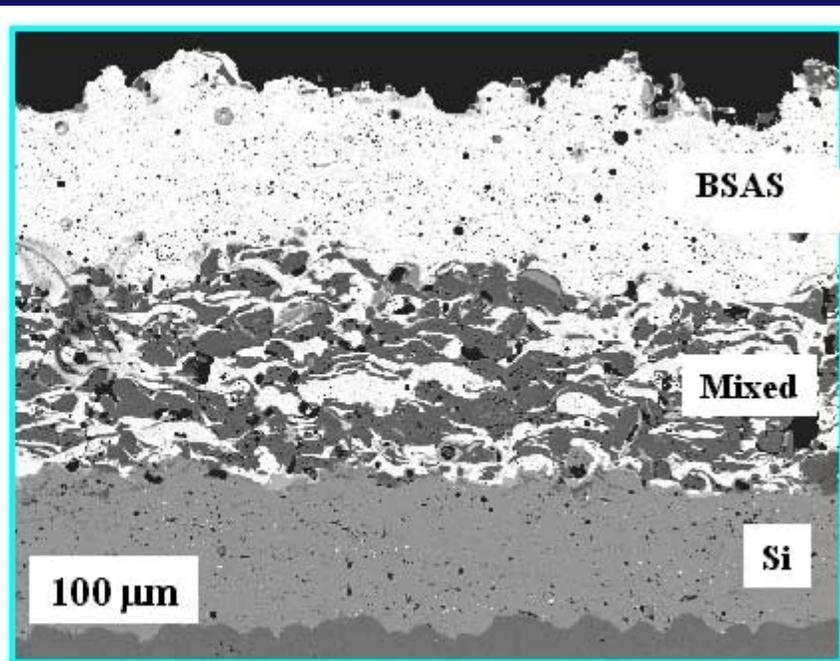
“Mixed layer” (Mullite+BSAS)/BSAS

Currently on Outer Liner at Texaco  
and on both liners at Malden Mills

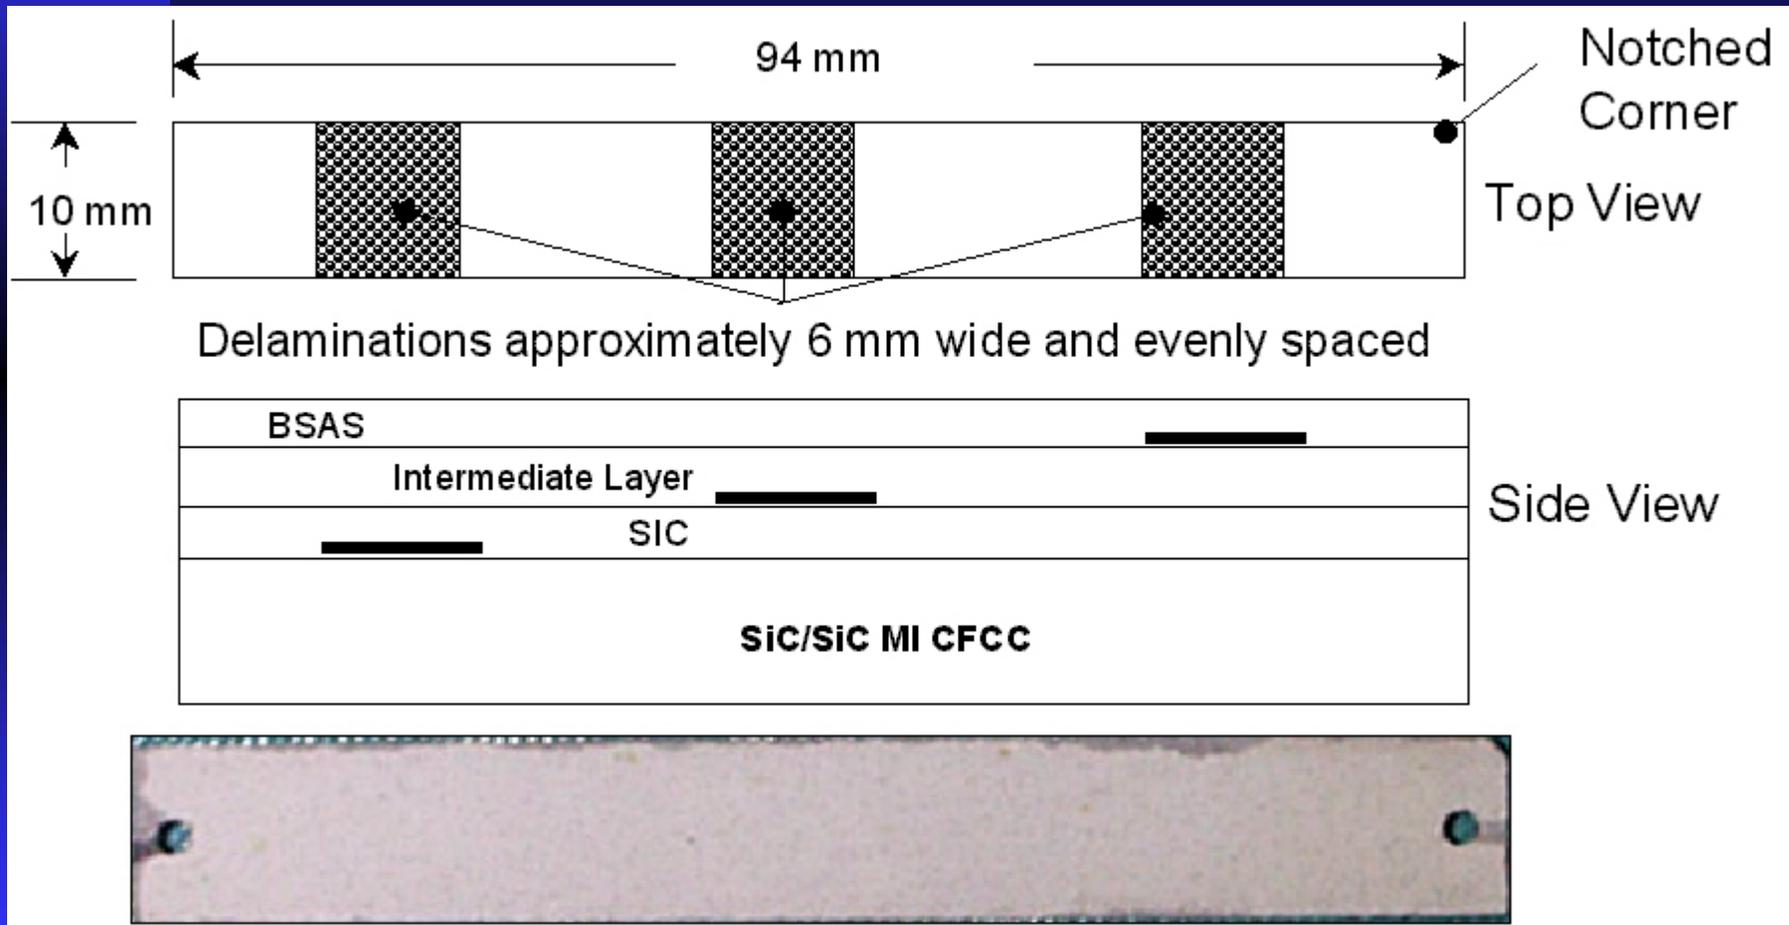
# EBC SEEDED DEFECT COUPONS FOR NDE -DELAMINATIONS-

Test Samples Provided by UTRC

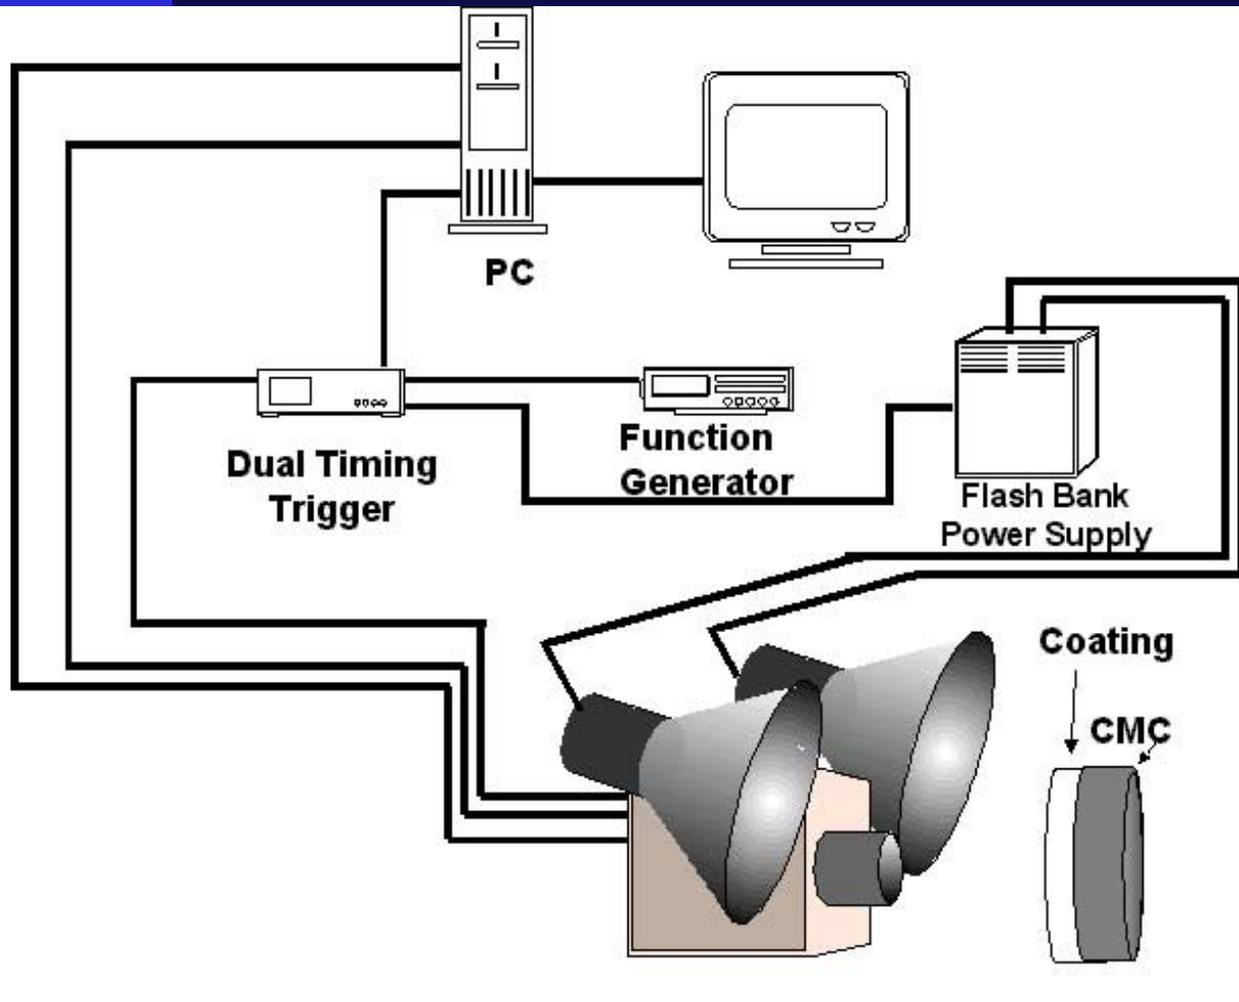
# THERMAL IMAGING NDE EXPERIMENTAL APPARATUS

## Detector

- 256x256, InSb, 200 mm
- 12-bit dynamic range
- Full window frame rate to 120 Hz
- 64x64 window frame rate to 1900 Hz.
- Typical flash pulse width approx. 6.0 ms

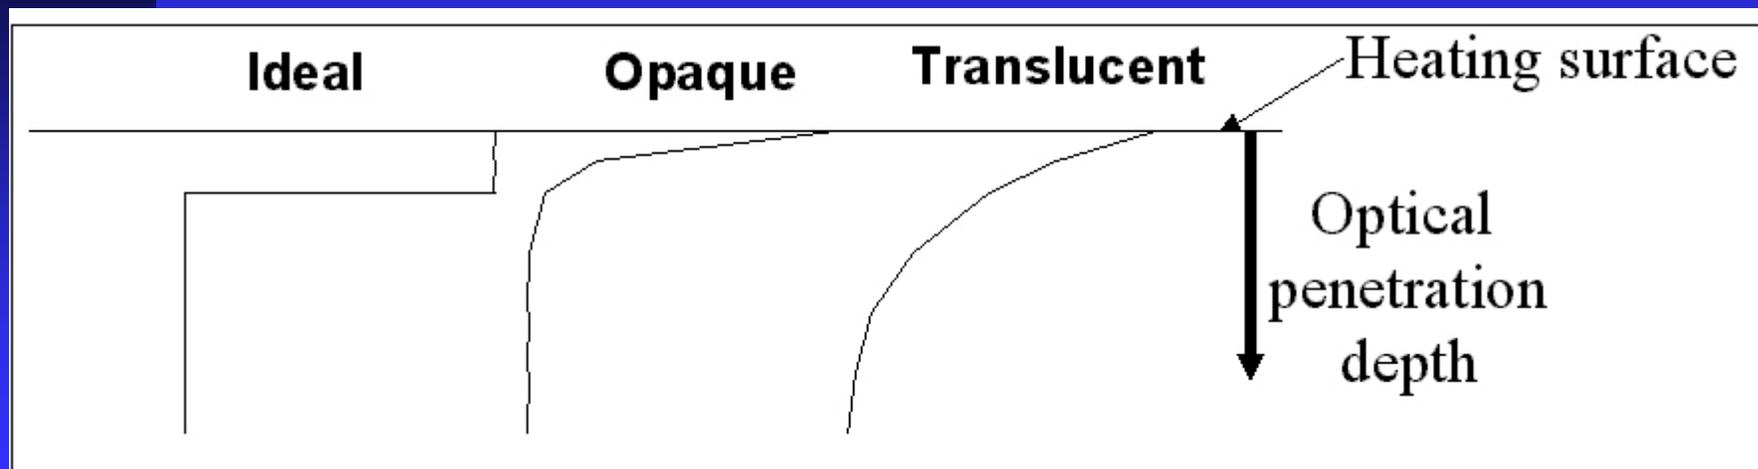
# EFFECT OF OPTICAL PROPERTIES

- Parker's theory of the surface temperature decay assumes material is heated with a step heating pulse whose penetration depth is negligible
- This assumption is appropriate for optically opaque materials
- Absorption depth cannot be considered negligible for translucent materials and introduces volumetric heating

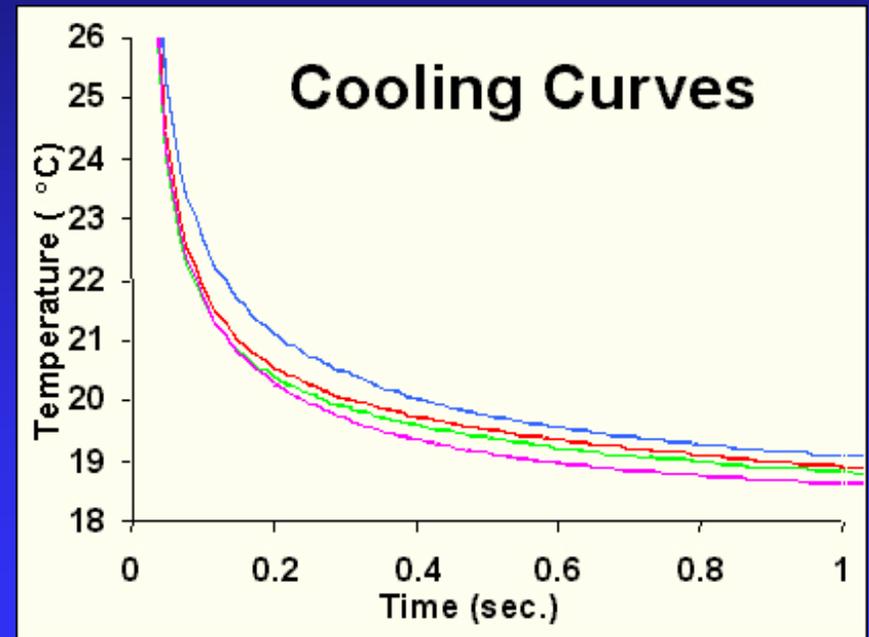
Diffusivity Map

If volumetric heating was significant, seeded delamination would be indistinguishable from non-flawed regions Argonne National Laboratory

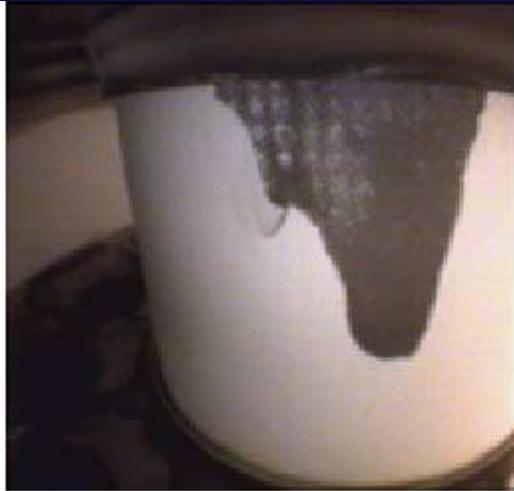
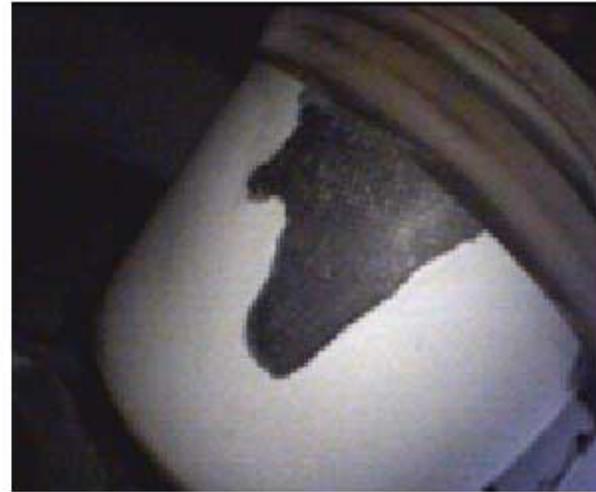
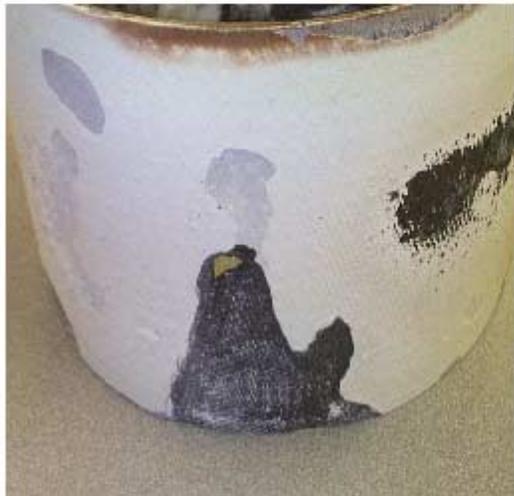
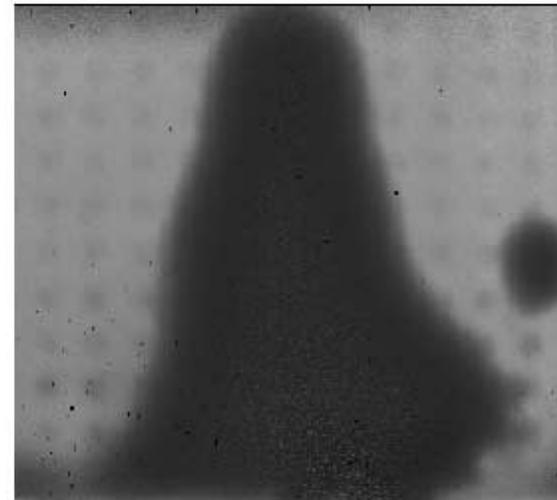
# SPALLATION OF EBC COATED LINER

4533  
hours

7317  
hours

14,000  
hours

Thermal  
Diffusivity  
Map

Boroscope Images Courtesy of Solar Turbines

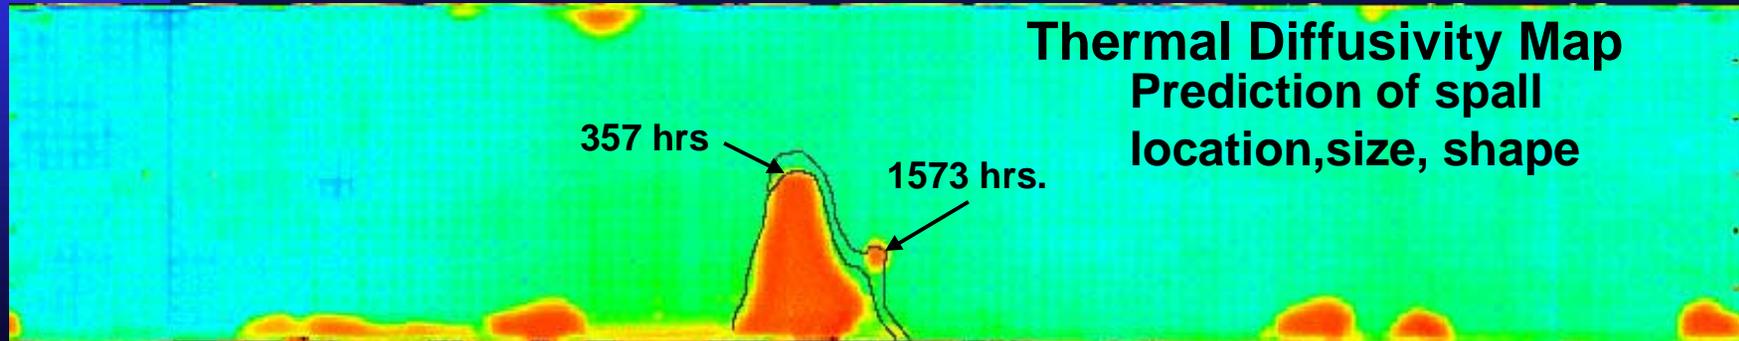
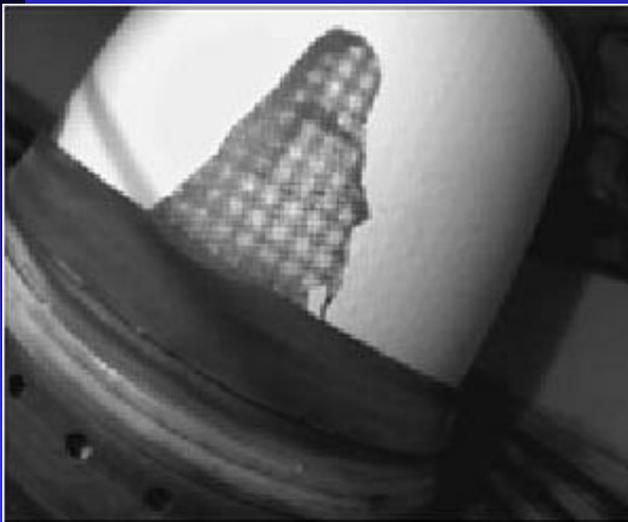
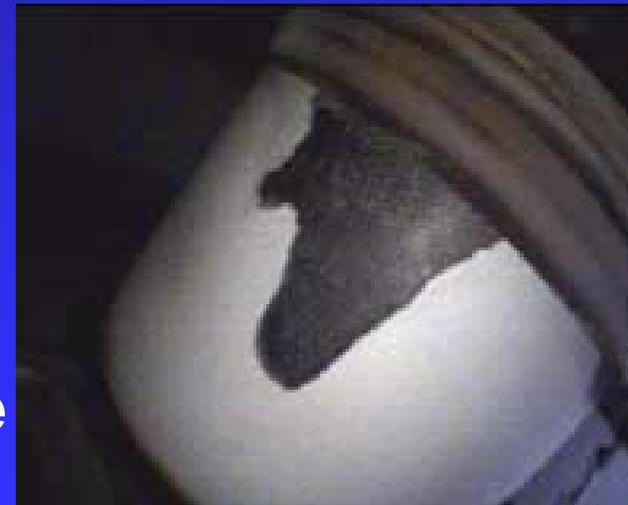
# NDE PREDICTED SPALL

357 hrs.

Boroscope  
Images

1573 hrs.

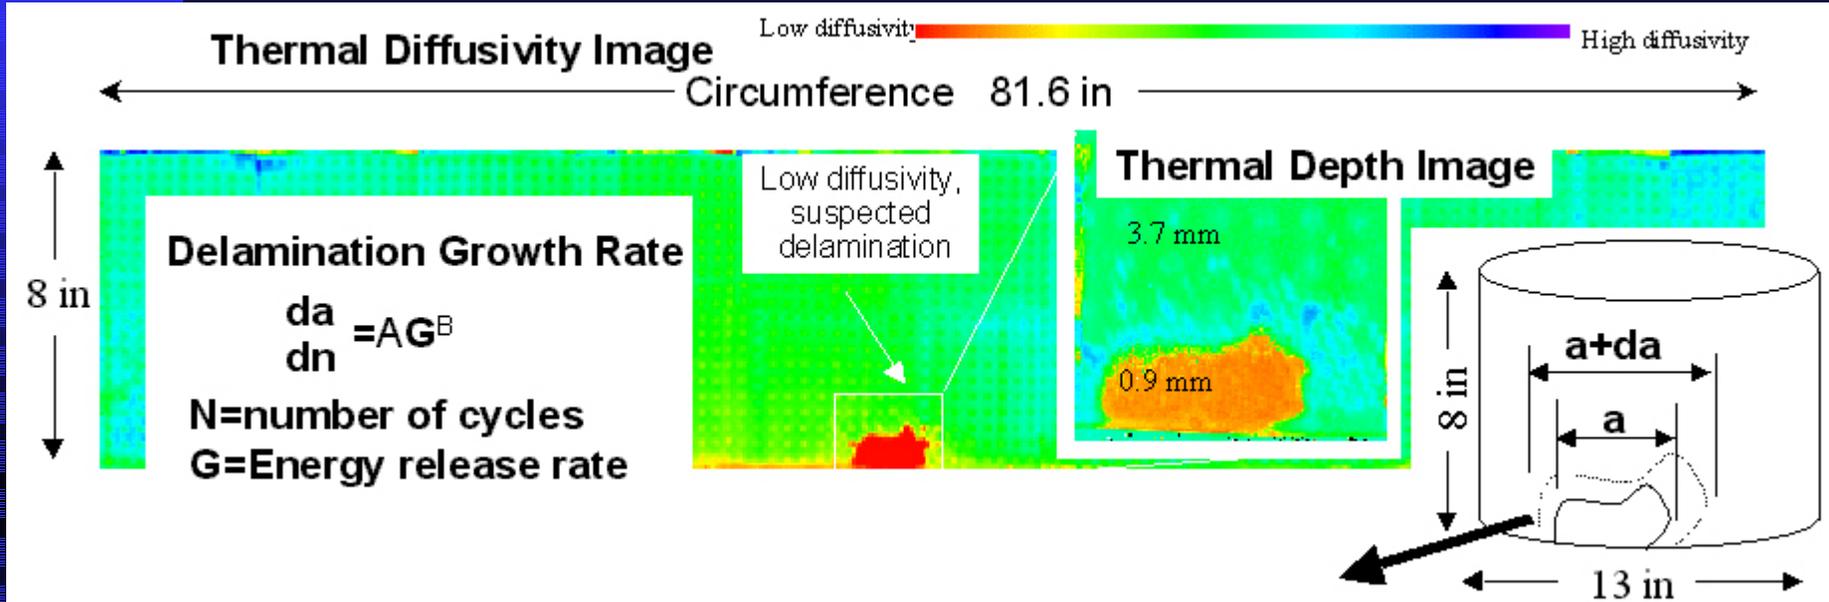
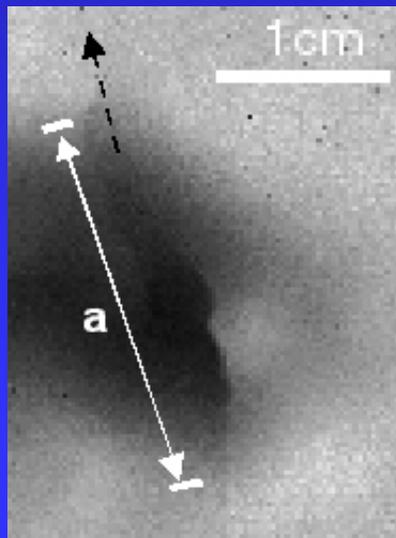
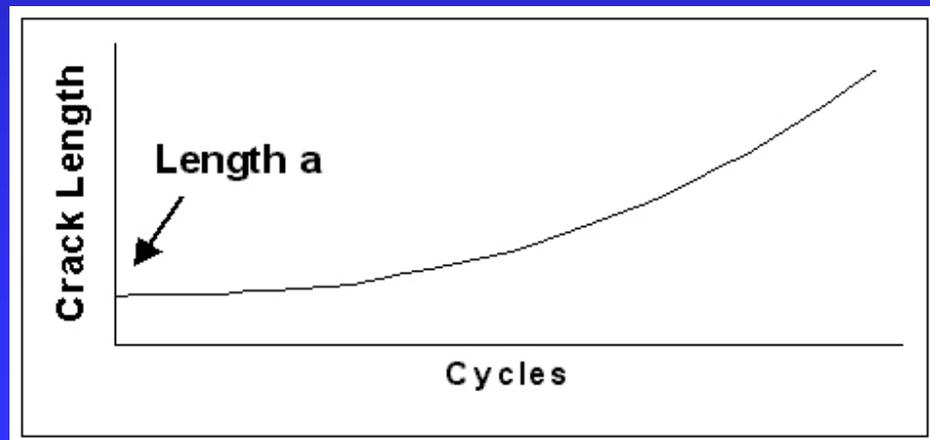
# Large Flaw Characterization

Predicted Crack Growth Rate

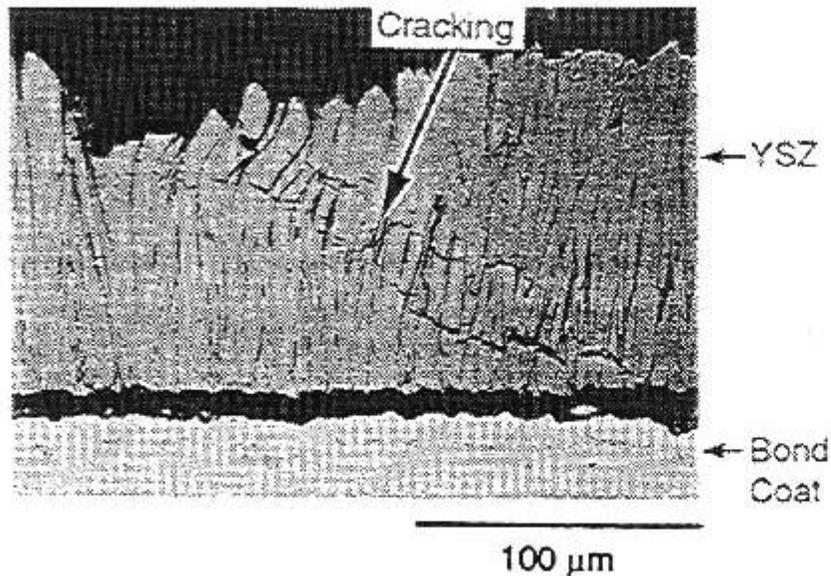
Micrograph of TBC Showing  
Cracking Due to Particle  
Impact Damage

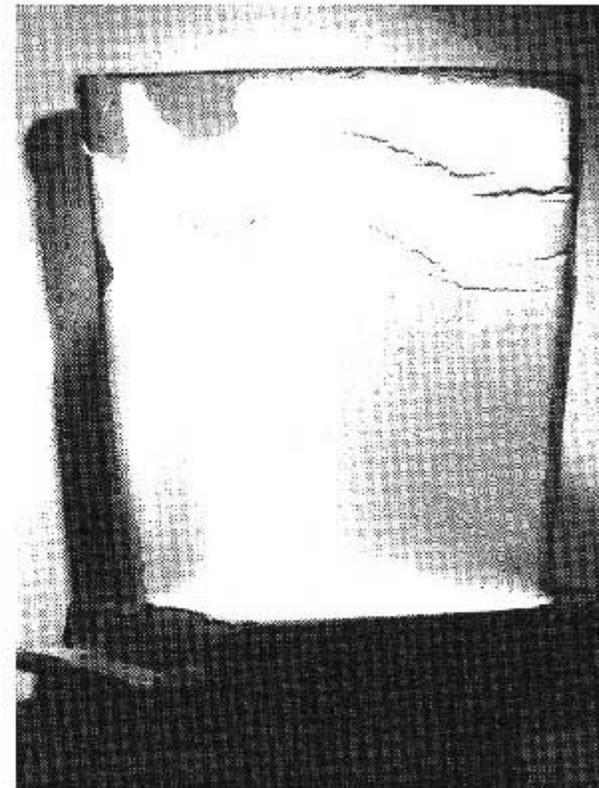
EB-PVD Yttria Stabilized Zirconia Coated  
Blade Showing Coating Distress and  
Cracking Near Trailing Edge

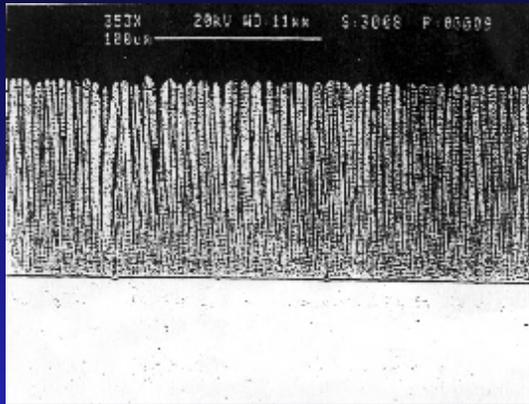
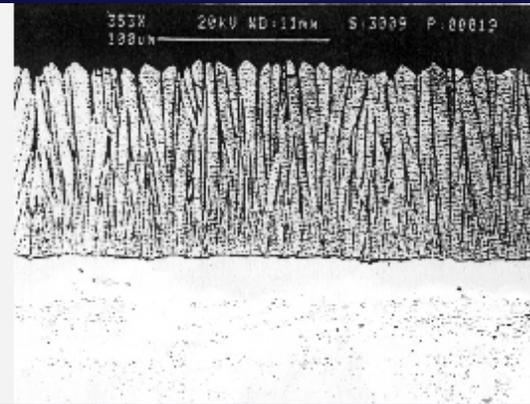
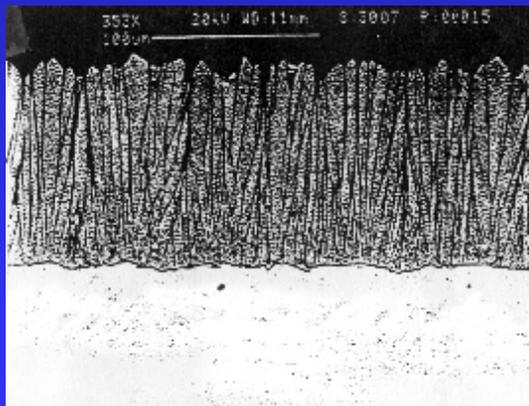
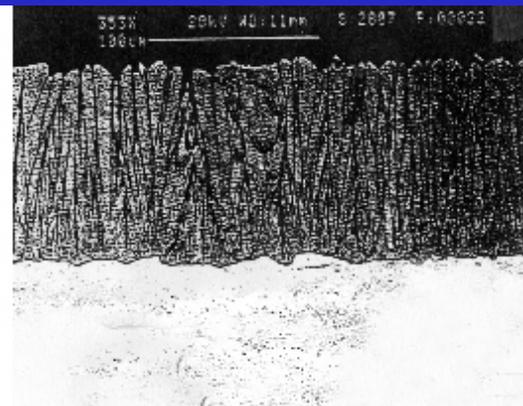
# EFFECT OF BOND COAT SURFACE TEXTURE ON EB-PVD MICROSTRUCTURE

Polished

220 Grit

80 Grit

54 Grit

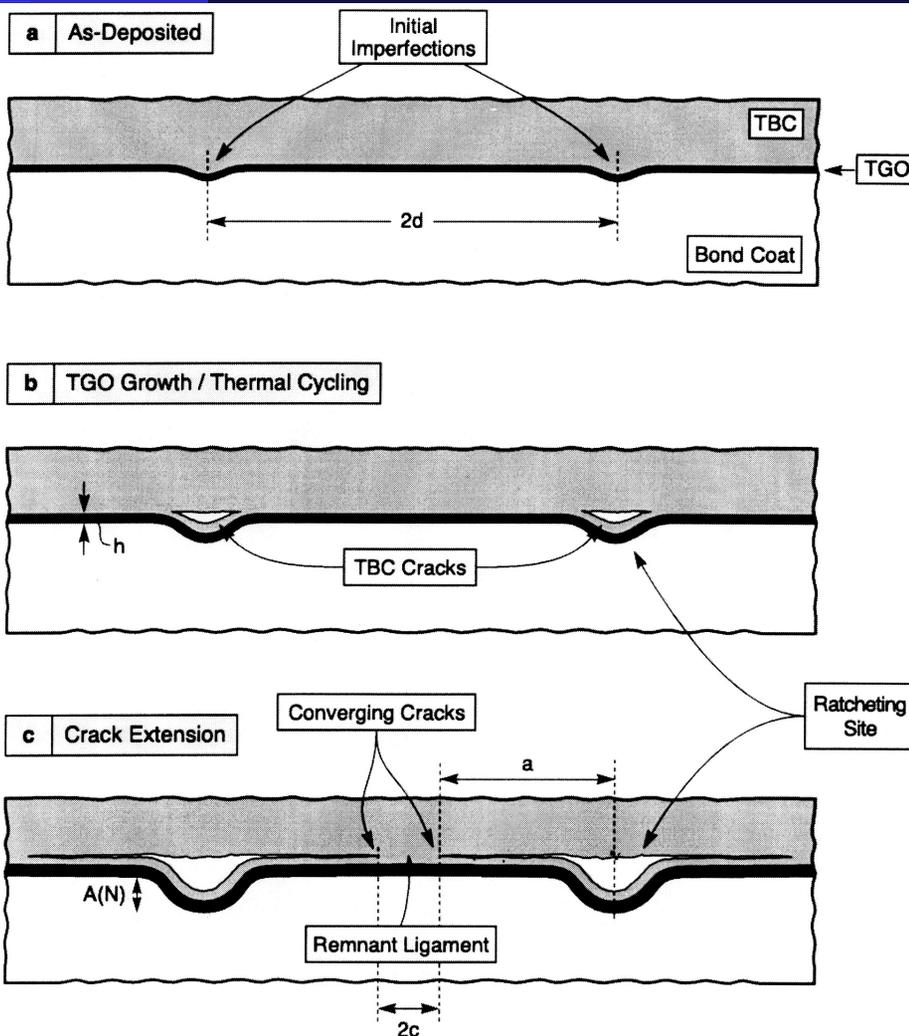
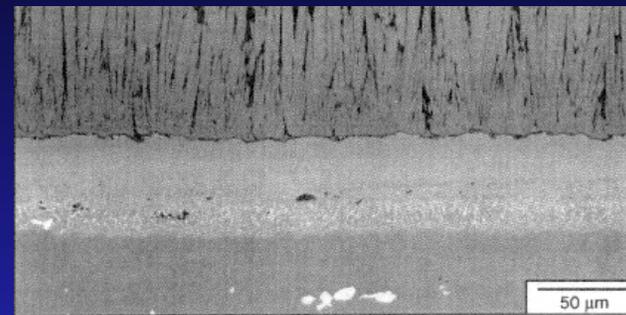
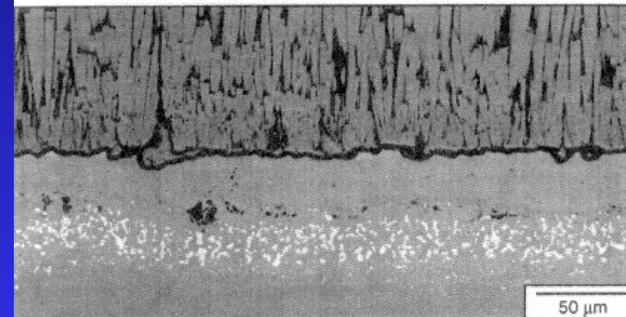
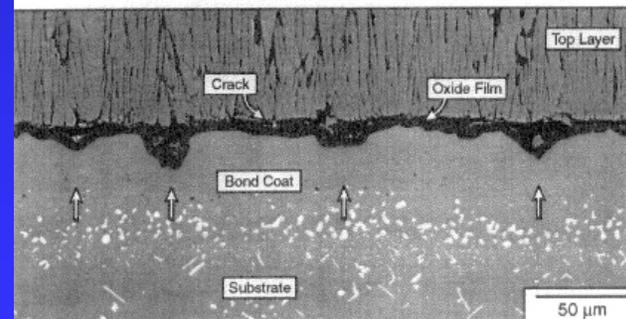
# MECHANICS OF SPALLATION OF TBC -ONE THEORY

As Received

80 Cycles

180 Cycles

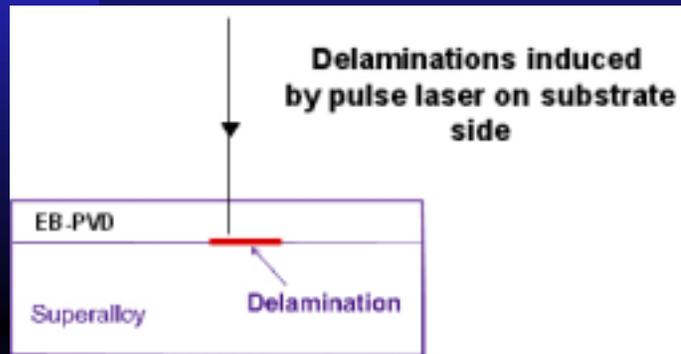
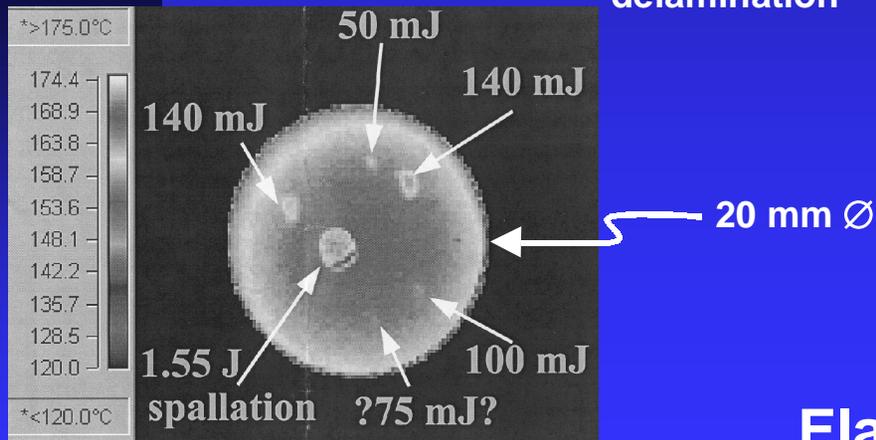
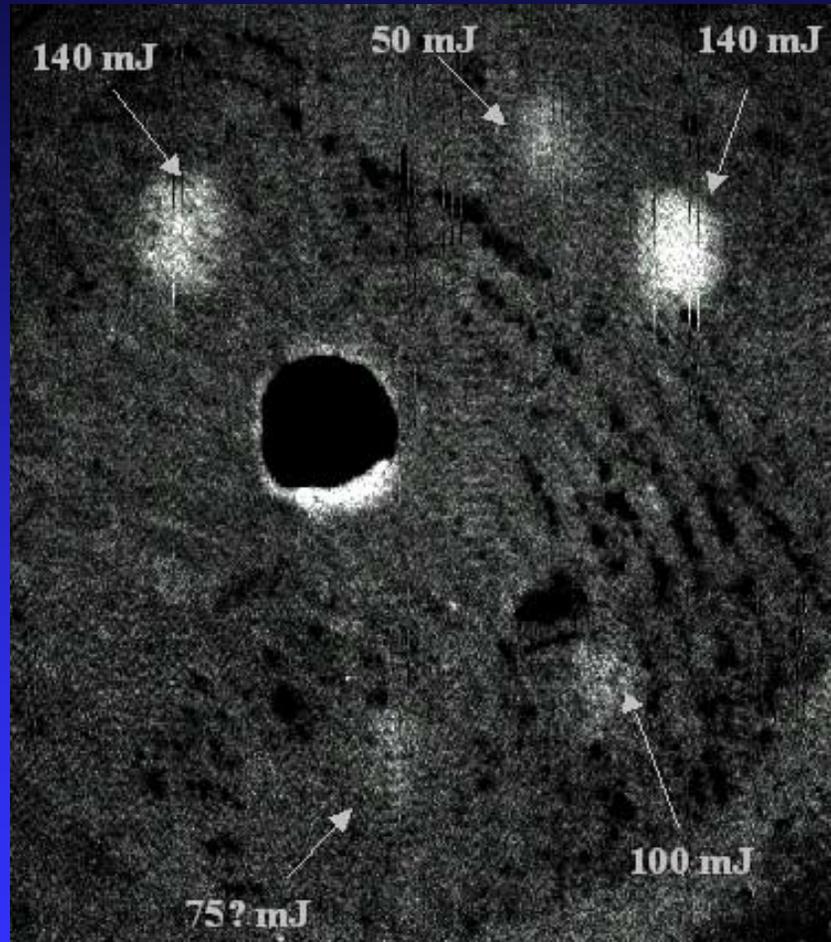
# Elastic Optical Scatter Detection of Induced Delaminations

EB-PVD - No bond coat

← Laser Pulse for delamination

Thermal Image Reveals Regions of Interface Delaminations Produced By Laser Pulse. Courtesy of JRC-Petten

Elastic Optical Scatter Image Data  
 $\lambda=0.6328 \mu\text{m}$ , Scan Step =  $10\mu\text{m}$

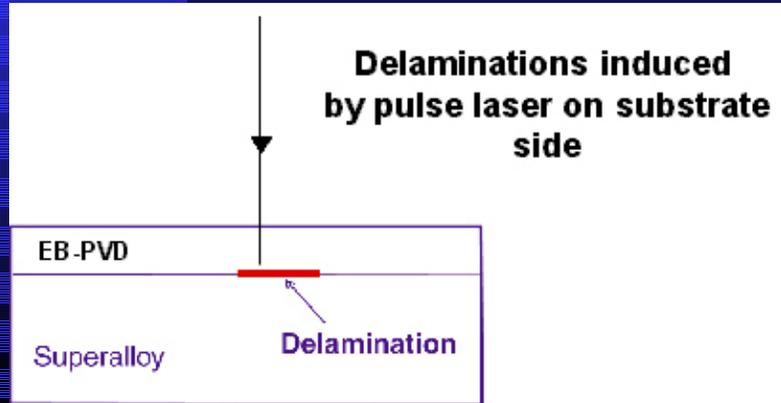
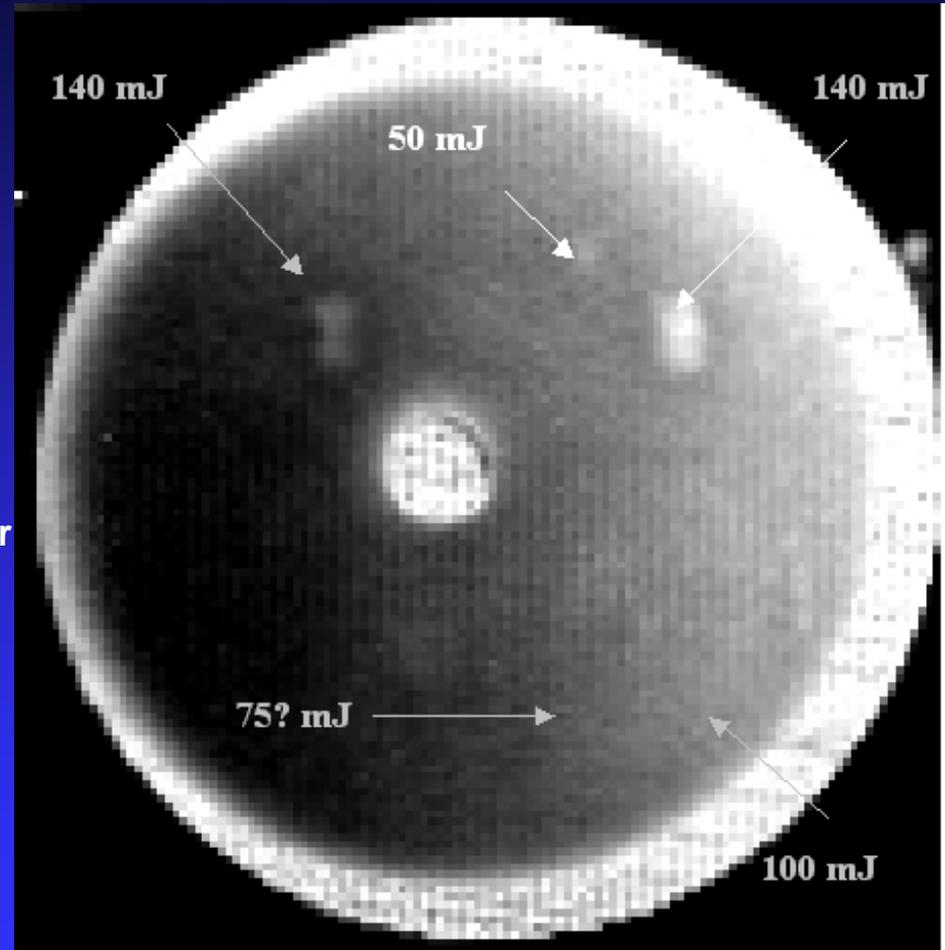
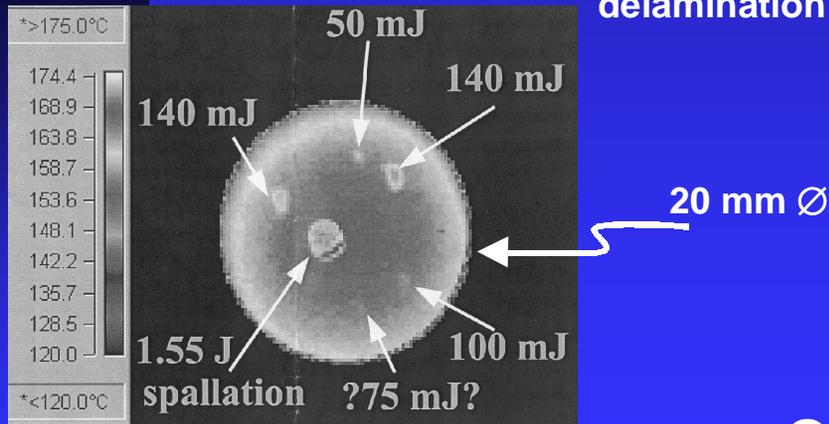
# ONE-SIDED THERMAL FLASH NDE DETECTION OF INDUCED DELAMINATIONS

EB-PVD - No bond coat

← Laser Pulse for delamination

## One-Sided flash Time-Dependent Surface Temperature Image

Thermal Image Reveals Regions of  
Interface Delaminations Produced  
By Laser Pulse. Courtesy of JRC-Petten

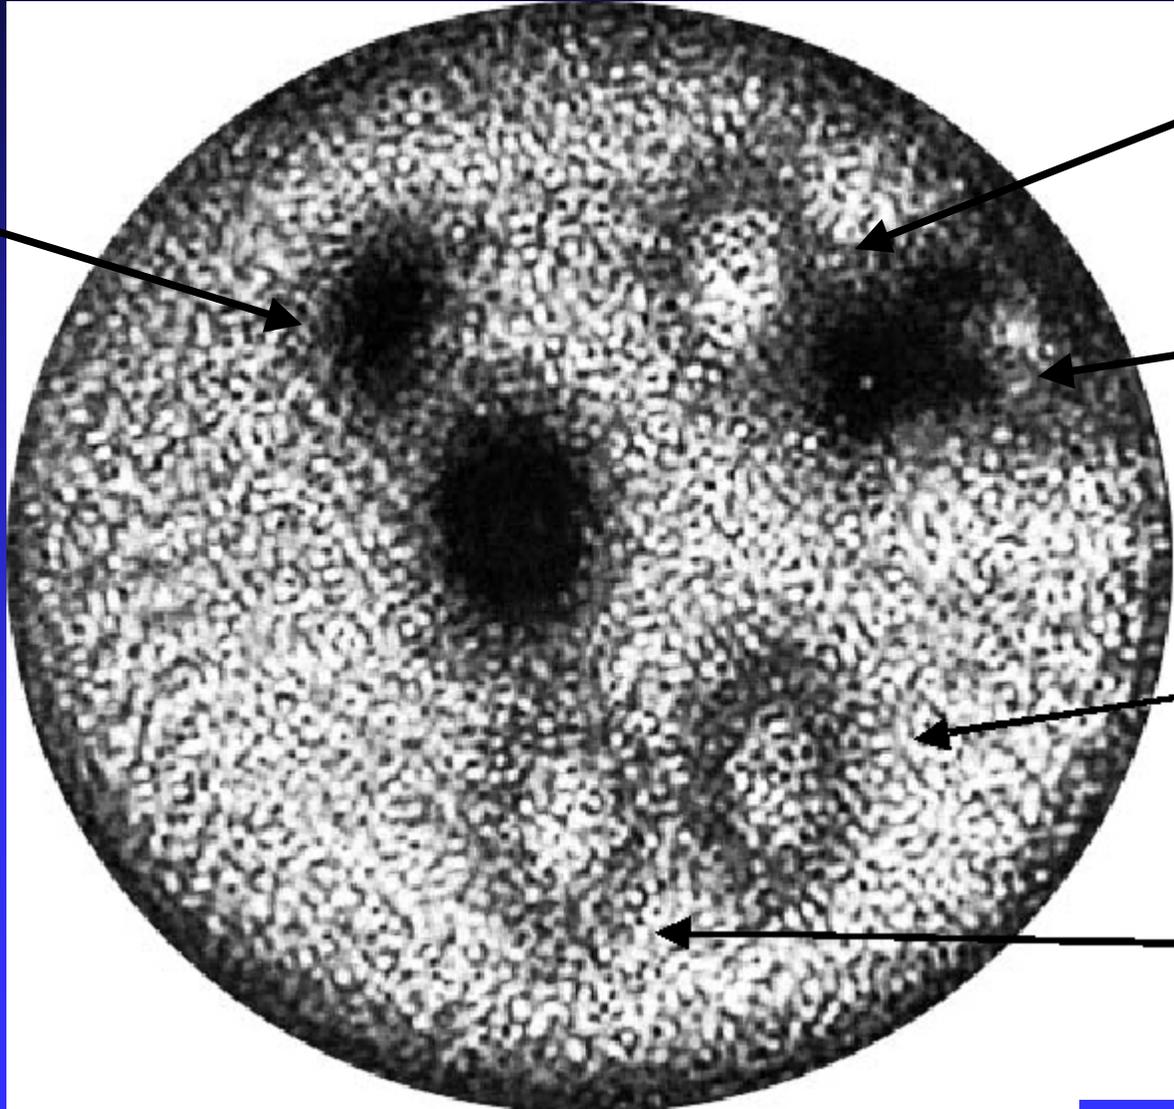
# Scanning Laser Ultrasound C-scan of EB-PVD Defect Sample

140 mJ

50 mJ

100 mJ

75 mJ

Data Obtained  
at Lasson  
Technologies

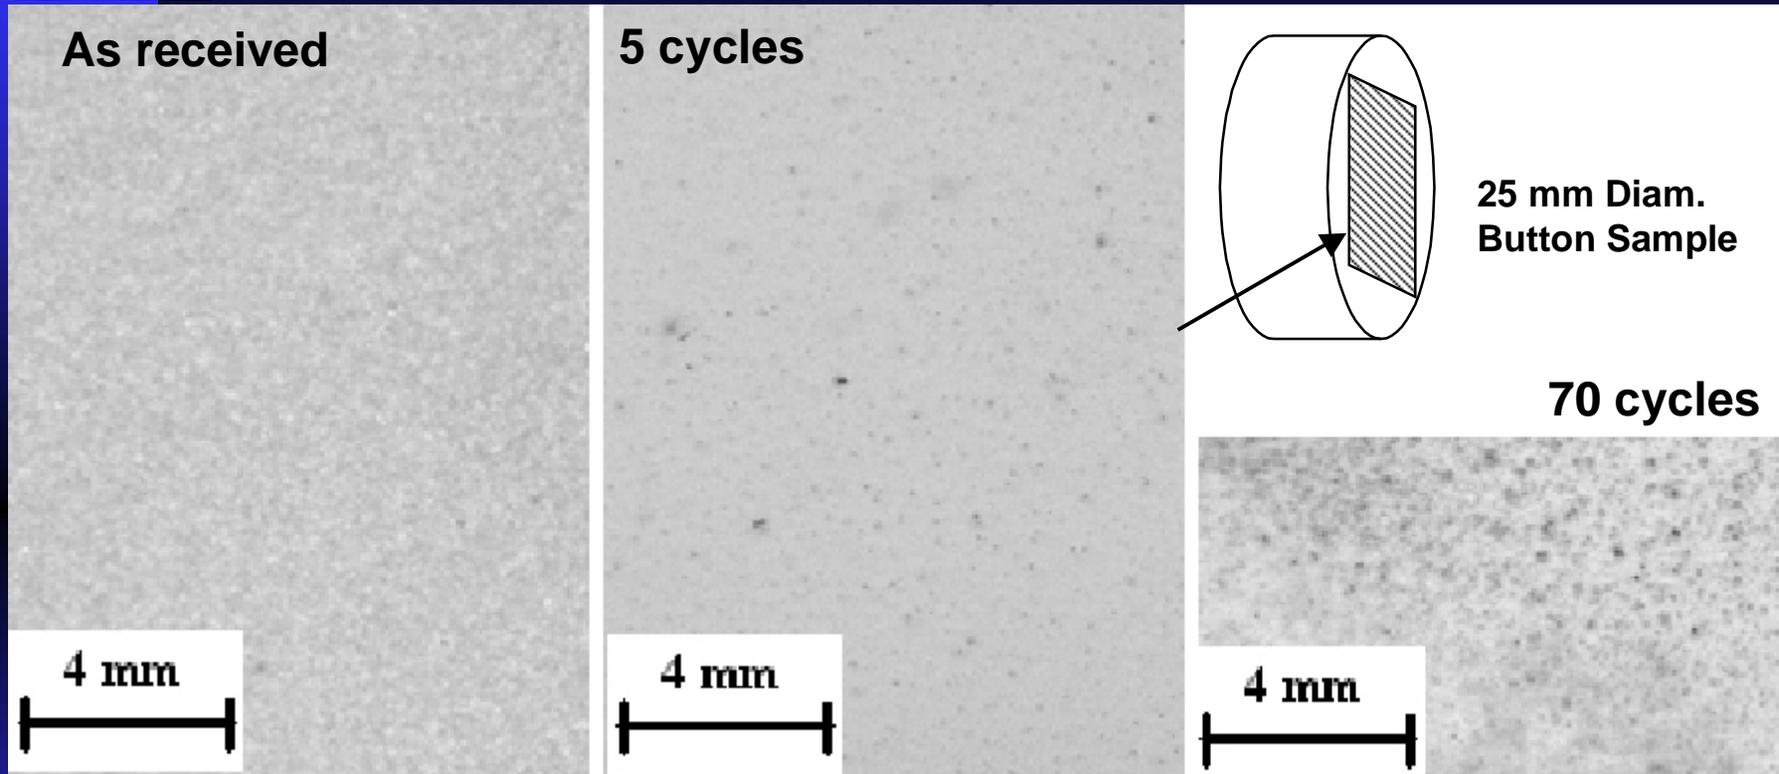
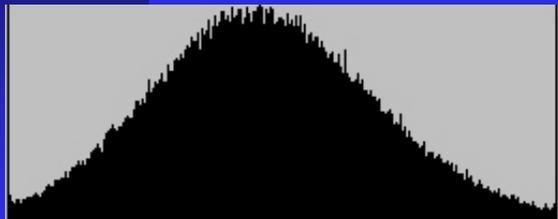
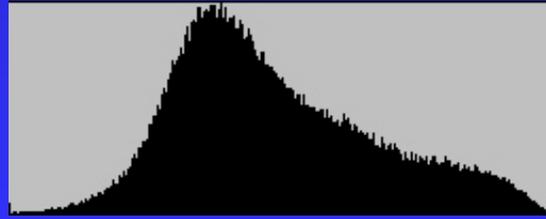
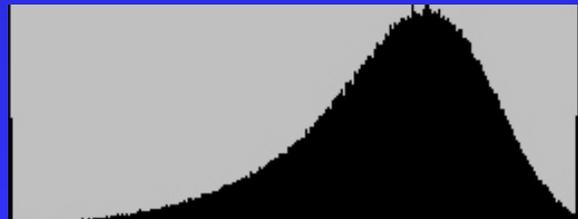
# LASER SCATTER NDE DATA FROM THERMALLY CYCLED EB-PVD TBC

Pixel Count

Grey Scale

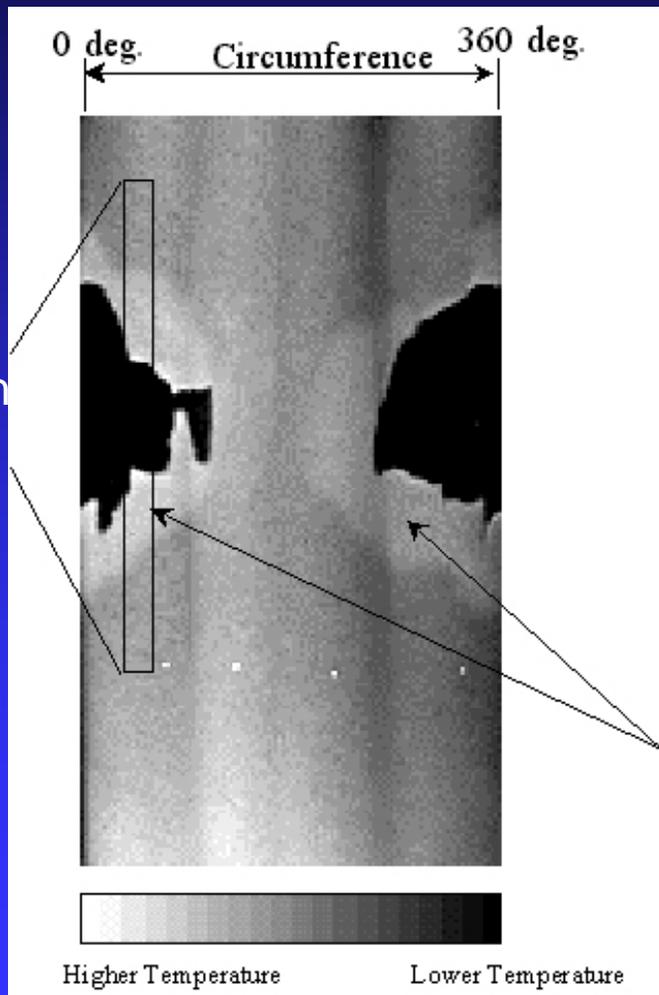
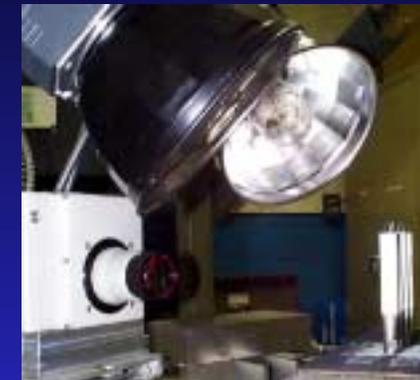
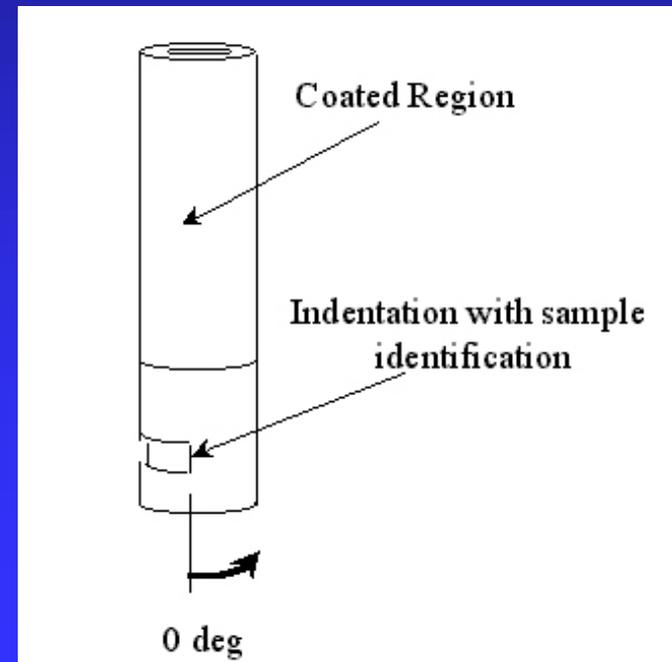
# TBC-AIR PLASMA SPRAY ONE-SIDED THERMAL DELAMINATION DETECTION

## Thermal Image

## Experimental Setup

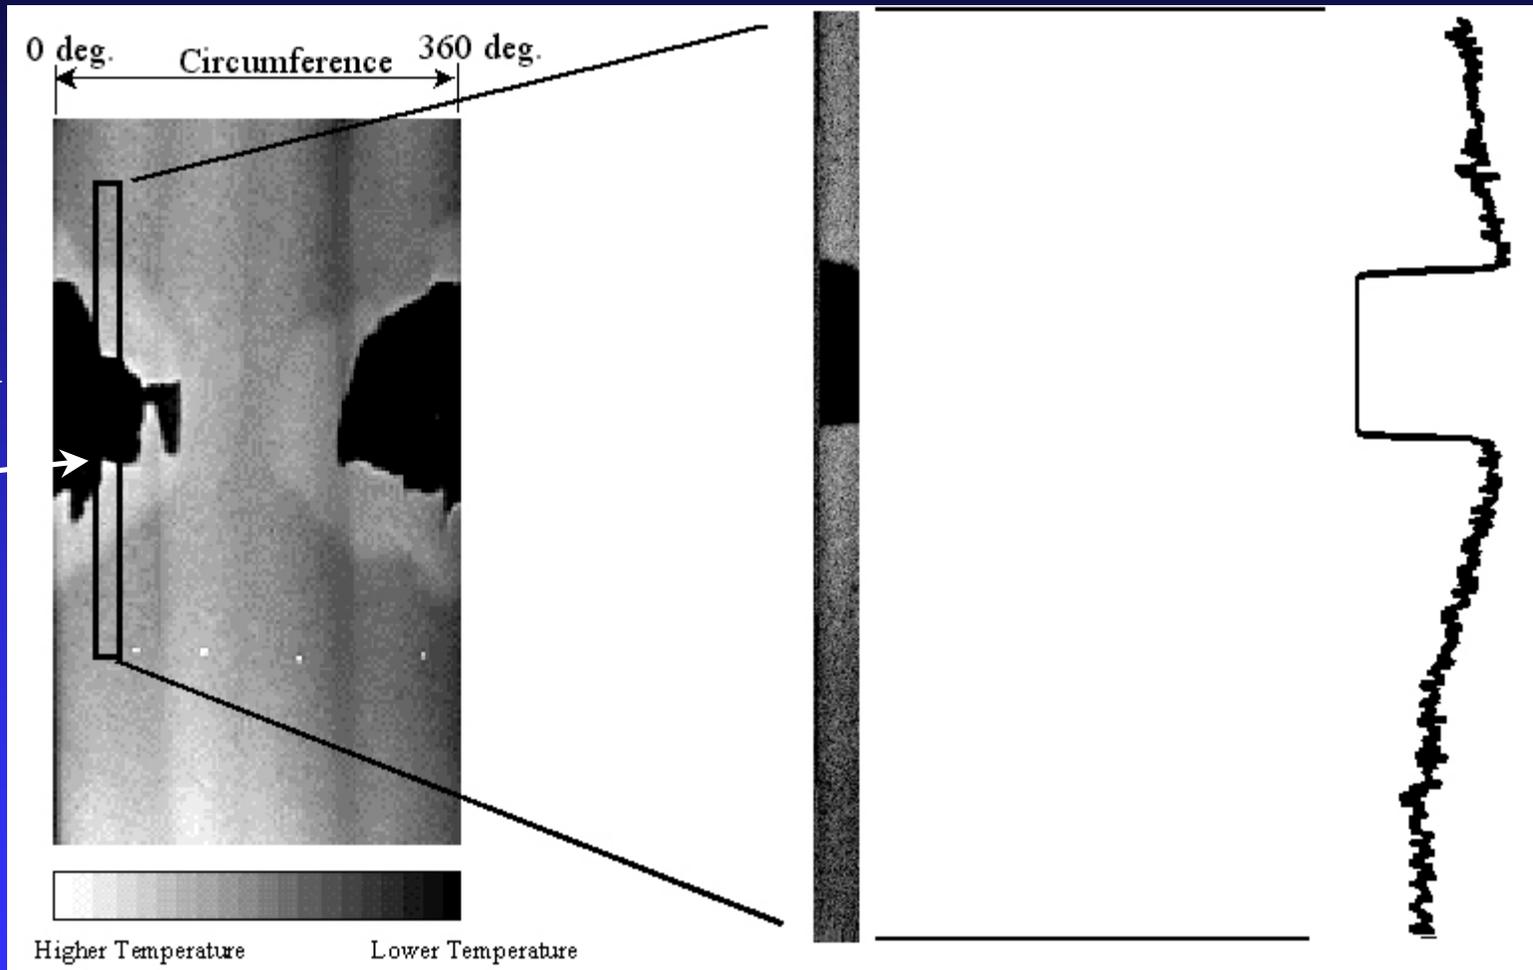
# EFFECT OF DELAMINATION ON ELASTIC SCATTER DATA

Laser Scanned Region

Front-Flash Image

Laser Scatter Image

Line plot of  
Laser Scan Data
