# **Pipeline & Hazardous Materials Safety Administration**

## **Pipeline Inspection Technologies Demonstration Report**

## **Pipeline Safety Research & Development Program**

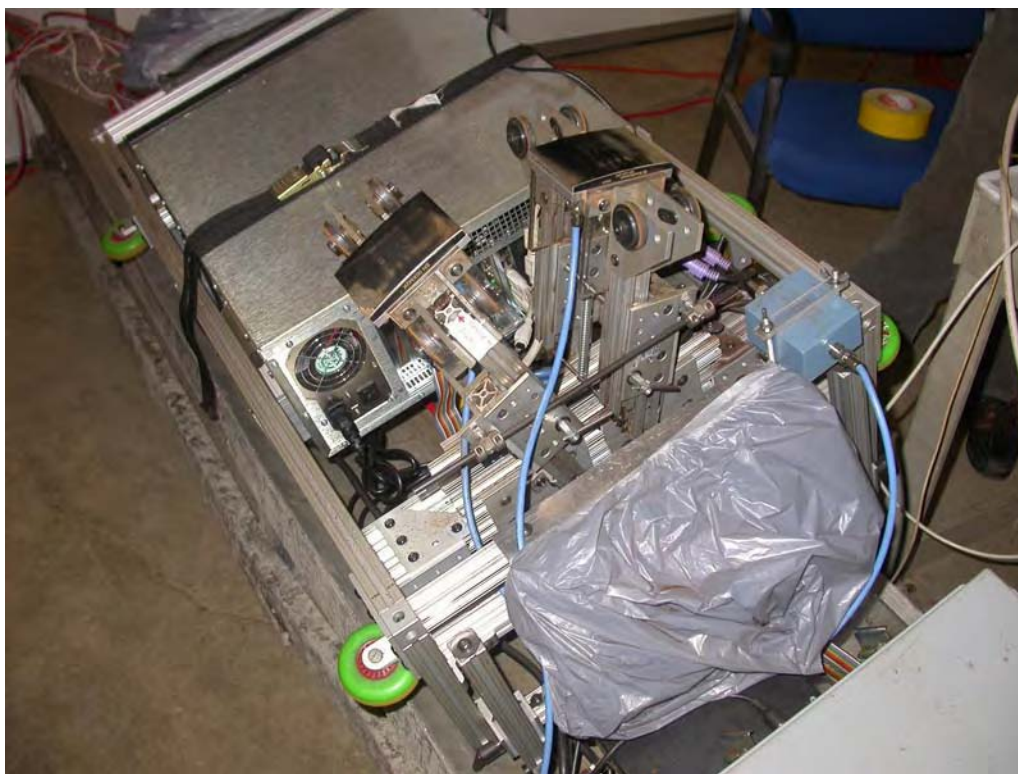
**Figure 1. ORNL Shear Horizontal EMAT**

*ORNL Shear Horizontal Electromagnetic Acoustic Transducer (EMAT)* – Oak Ridge National Laboratory (ORNL) has developed an EMAT system that uses shear horizontal waves to detect flaws on natural gas pipelines. A wavelet-based analysis of ultrasonic sensor signals is used for detecting physical flaws (e.g., SCC, circumferential and axial flaws, and corrosion) in the walls of gas pipelines. Using an in-line non-contact EMAT transmitter-receiver pair, flaws can be detected on the walls of the pipe that the current magnetic flux leakage (MFL) technology has problems detecting. One EMAT is used as a transmitter, exciting an ultrasonic impulse into the pipe wall while the second EMAT located a few inches away from the first is used as a receiving transducer. ORNL's technology is depicted in Figure 1.

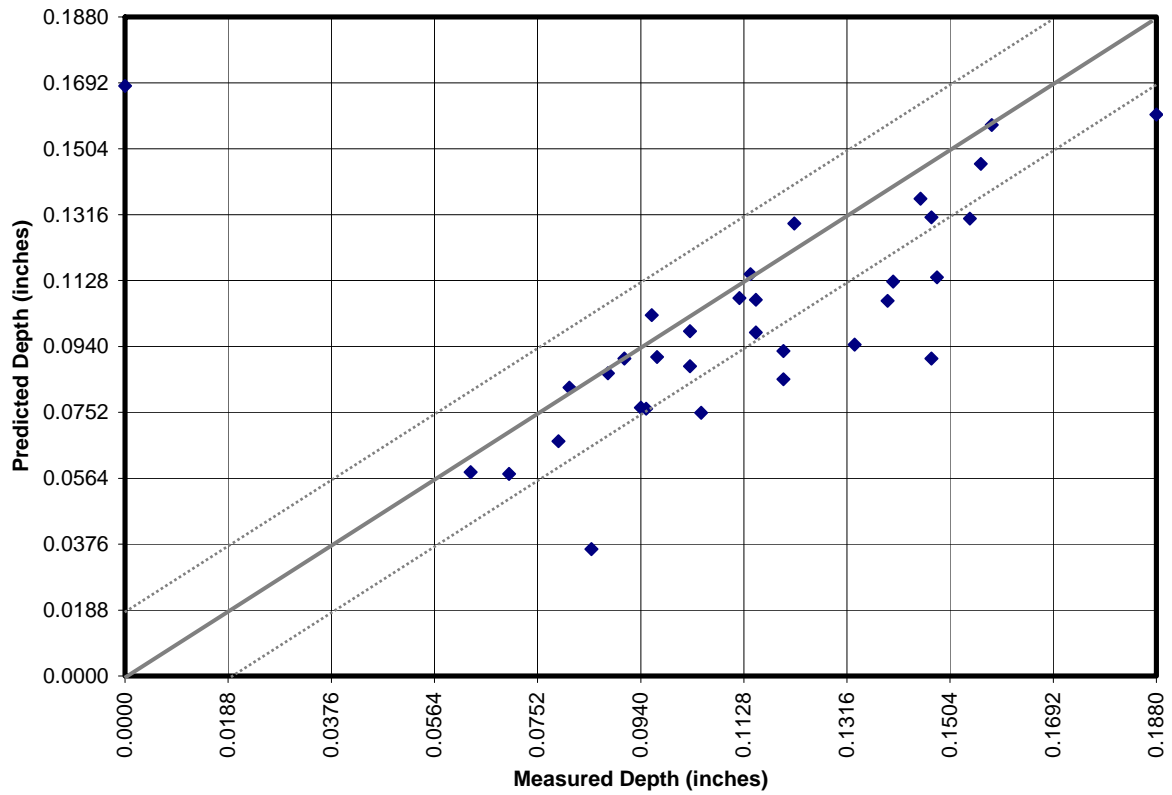
The SwRI *RFEC* technology detection rate was 100%, detecting all defect sites on Pipe Sample 1, Pipe Sample 2, and Pipe Sample 3. On average, SwRI located anomalies slightly past the actual start of the defect location with a standard deviation of 1.71 inches. The SwRI *RFEC* technology detected one false positive signal on Test Line 1 of Pipe Sample 2. The false positive signal was identified as a repeatable signal without typical flaw signal characteristics with a depth of nearly 90% of the wall thickness and approximately 1 5/8 -inch in length. SwRI's sizing accuracy is depicted in Figures 10 through 12 in which the predicted and measured anomaly depths, lengths, and widths are presented.

**Figure 10. Measured Depth vs. Predicted Depth for the SwRI *RFEC***

**Figure 11. Measured Length vs. Predicted Length for the SwRI *RFEC***

**Figure 12. Measured Width vs. Predicted Width for the SwRI *RFEC***

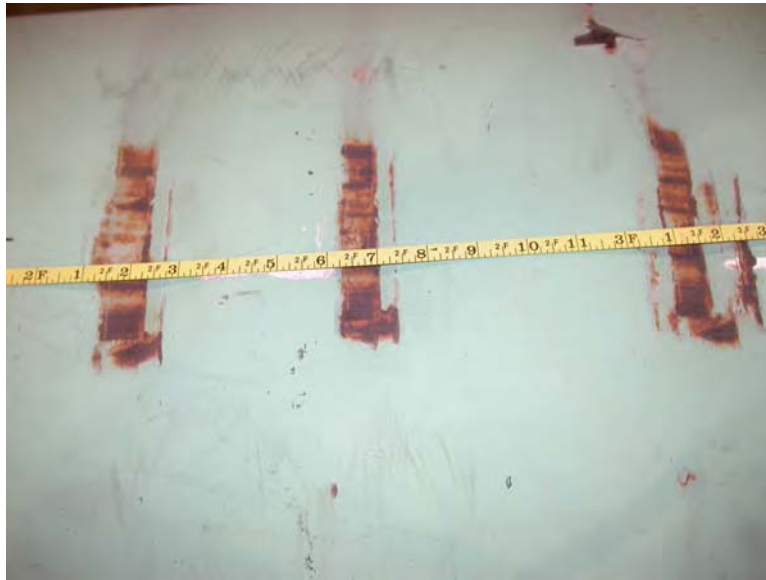
**Figure 19. Example Mechanical Damage Defect from Pipe Sample 1**

Only one technology, the PNNL *Ultrasonic Strain Measurement* technology, was tested for assessment of mechanical damage. Two 24-inch diameter pipes were inspected by PNNL for mechanical damage. The first pipe (Pipe Sample 1) consisted of two pipes welded together with mechanical damage defects along three rows separated by 120° and measured approximately 28-feet in length. The test line on Pipe Sample 1 consisted of mechanical damage created using a 50-ton track hoe. An example mechanical damage defect from Pipe Sample 1 is shown in Figure 19. The second pipe (Pipe Sample 2) measured approximately 40 feet in length with plain (or smooth) dent defects along one test line. An example mechanical damage defect from Pipe Sample 2 is shown in Figure 20.

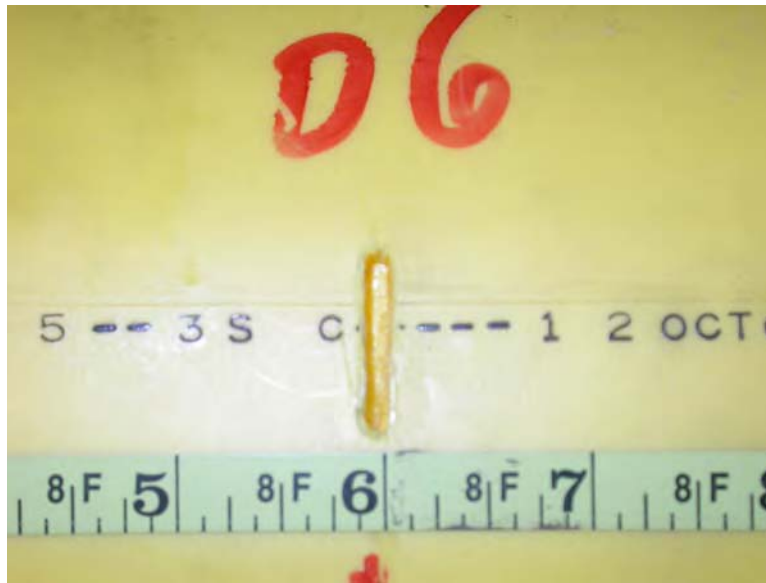
**Figure 22. Example Plastic Pipe Defect**

calibration defect. An example defect is shown in Figure 22. This defect was calculated to have a volume of 0.04 cubic inches which equals a significance of 1.43. As shown in Table 11, the technology ran one test line on a 6-inch diameter polyethylene pipe sample.
