# **CIRCUMFERENTIAL MFL IN-LINE INSPECTION FOR CRACKS IN PIPELINES**

## **FINAL REPORT**

J. B. Nestleroth  
Battelle  
505 King Avenue  
Columbus, Ohio 43201

June 2003

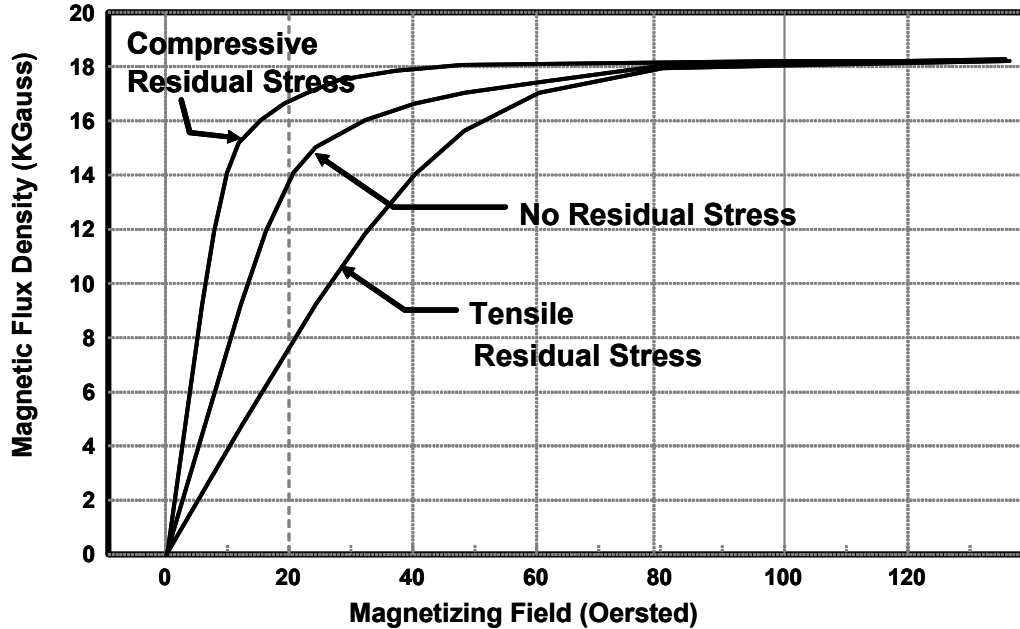
Figure 1. The effect of stresses on the magnetization curves which govern magnetism and flux leakage.

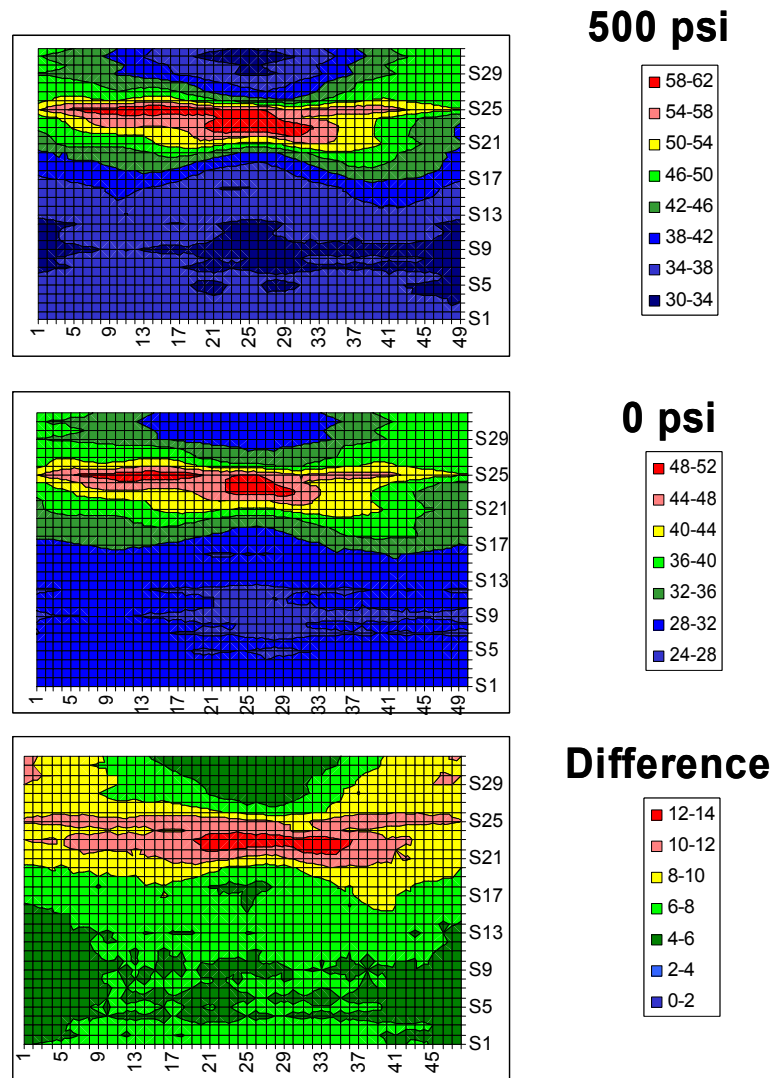
Figure 9. Circumferential MFL signals under pressure.

Figure 9 shows that at high pressure the signal levels increase approximately 12 to 14 gauss or 20 percent. These results show that signals from stress-corrosion cracks can be augmented by internal pressure, provided that this pressure locally increases the stress in the pipe wall. The fact that significant stress effects would only be detected at pressures that begin to threaten integrity suggests an alternative concept for pipeline inspection.

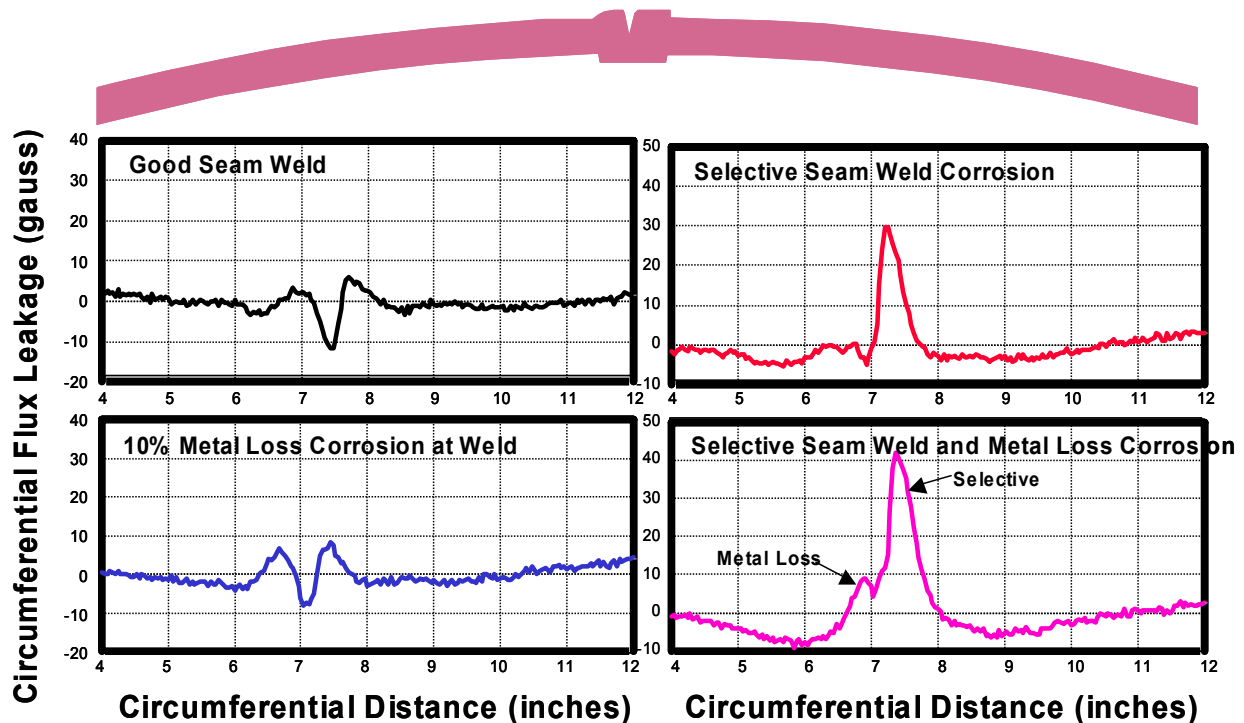
Figure 10. Circumferential MFL signals from selective seam corrosion.

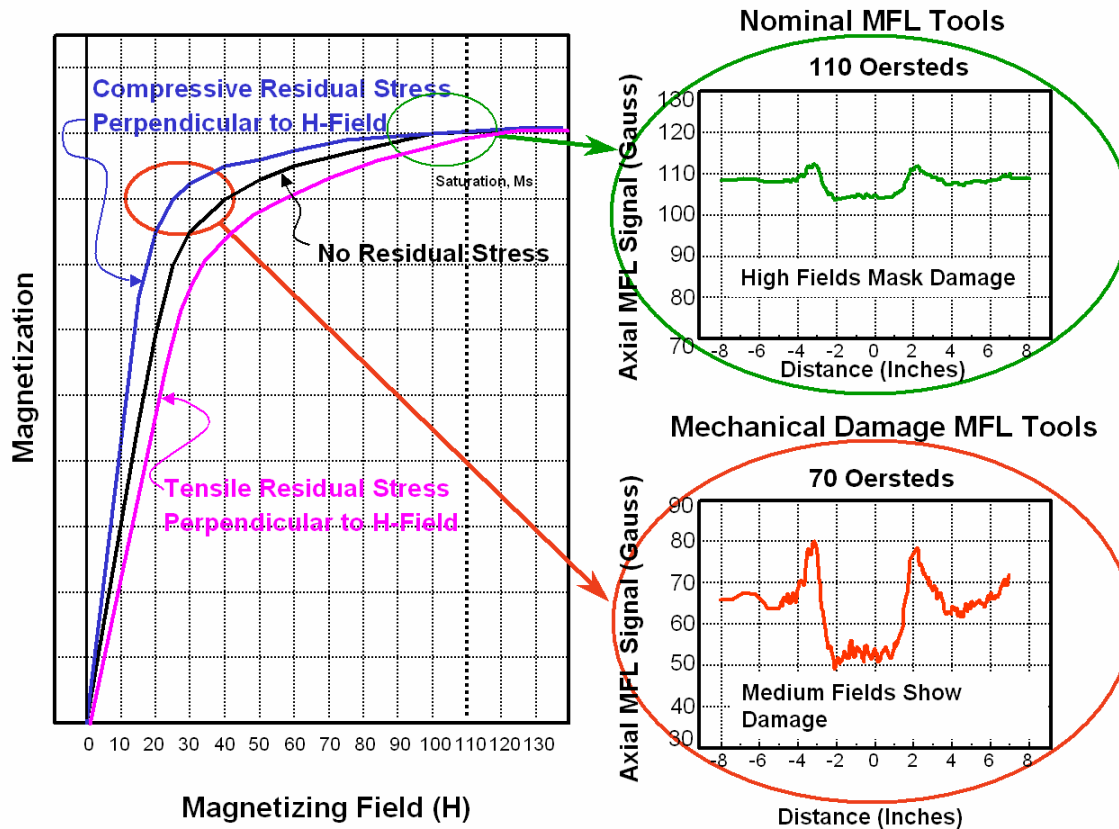
Figure 11. The effect of compressive residual stresses.

The effect of compressive residual stresses is illustrated in Figure 11. At the left of Figure 11, the curves show that the magnetization is nearly independent of field levels. A zone of compressive stress was created by compressing the surface of a pipe with a force sufficient to cause a few percent plastic deformations. Inspection using a magnetization level of 110 Oersted, a level at the low range of commercial MFL tools, produced a leakage of less than 10 gauss. Using a lower magnetization field to 70 Oersted causes a larger signal of 30 Oersted. This illustrates that lower magnetic field are more sensitive to stress effects.

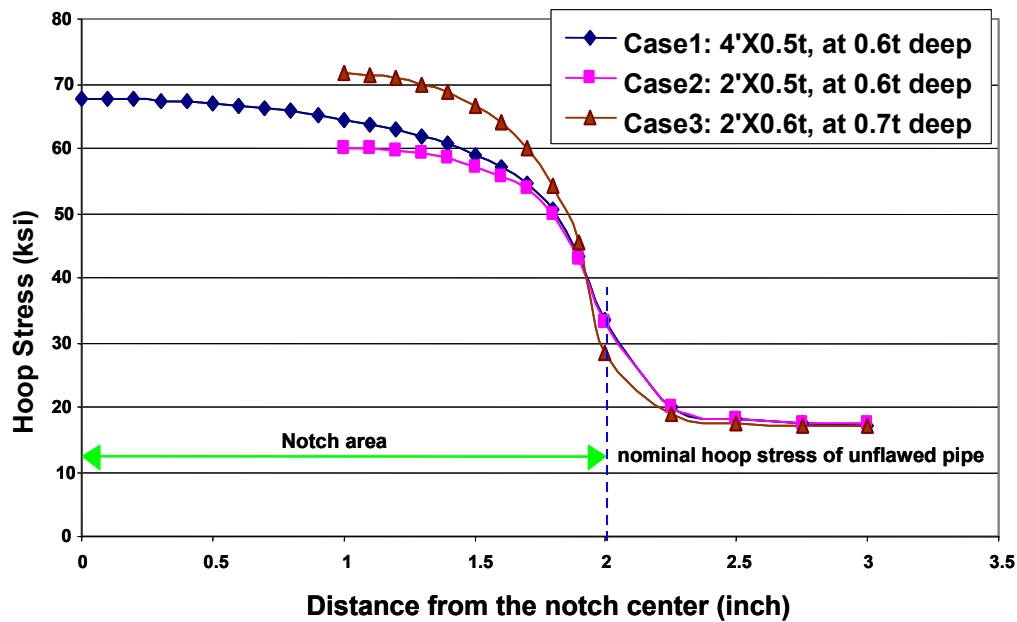
**Figure 14. Stress at and near the notch tip.**

Note: At 500 psi internal test pressure, the stress under the notch exceeds the 65 ksi SMYS of the pipe material

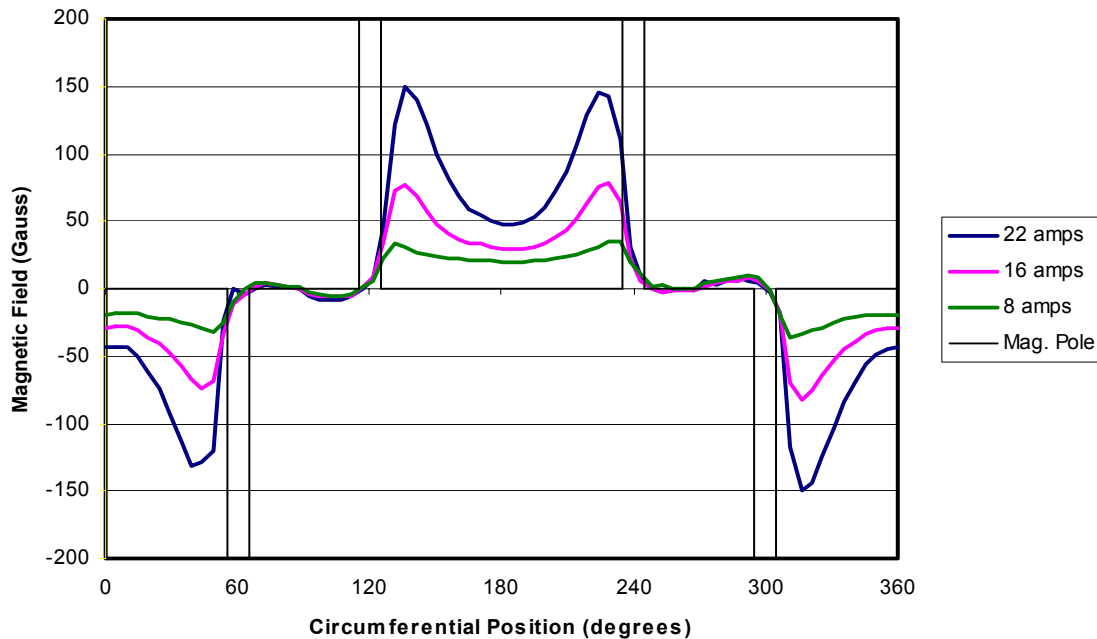
**Figure 16. The circumferential component of the magnetic field around the circumference of the pipe for the electromagnet test bed vehicle circumferential magnetizer.**

A fully configured magnetizer was pulled into a 0.300-inch wall thickness pipe and magnetic field measurements recorded around the circumference of the pipe using a three axis gaussmeter. Figure 16 shows the test results, where the highest circumferential field occurs between opposite poles and a designated null is present between like poles. However, the field in the pipe between the poles is quite variable. The maximum field level is attained at 10 to 15 degrees from the magnetizing pole and is substantially lower midway between the poles. For the applied magnetizing current of 22 amps, the peak field was 150 Oersted, which would eliminate stress effects, but the field between the poles was 50 Oersted, in the middle of the stress effects zone. At this field level, stress effects would still be seen.

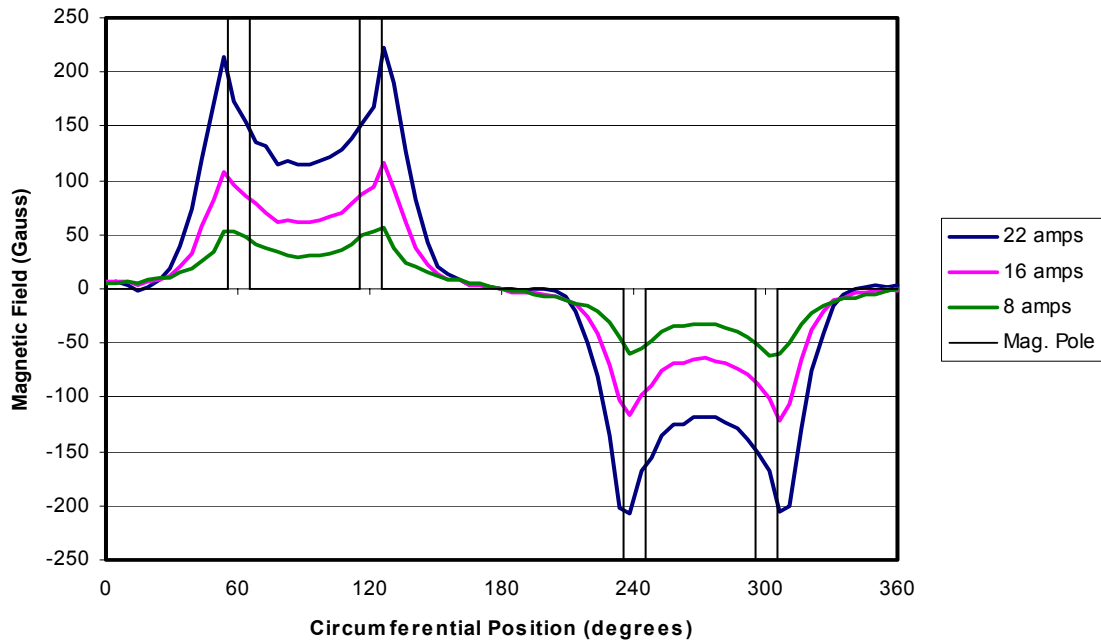
Figure 17. The radial component of the magnetic field around the circumference of the pipe for the electromagnet test bed vehicle circumferential magnetizer.

Figure 17 shows the radial component of the magnetic field around the circumference of the pipe. This figure shows a large portion of the flux leaks out of the pipe into the air. The opposing high radial field between the like poles indicates a lower than expected permeability and saturation in the circumferential direction.

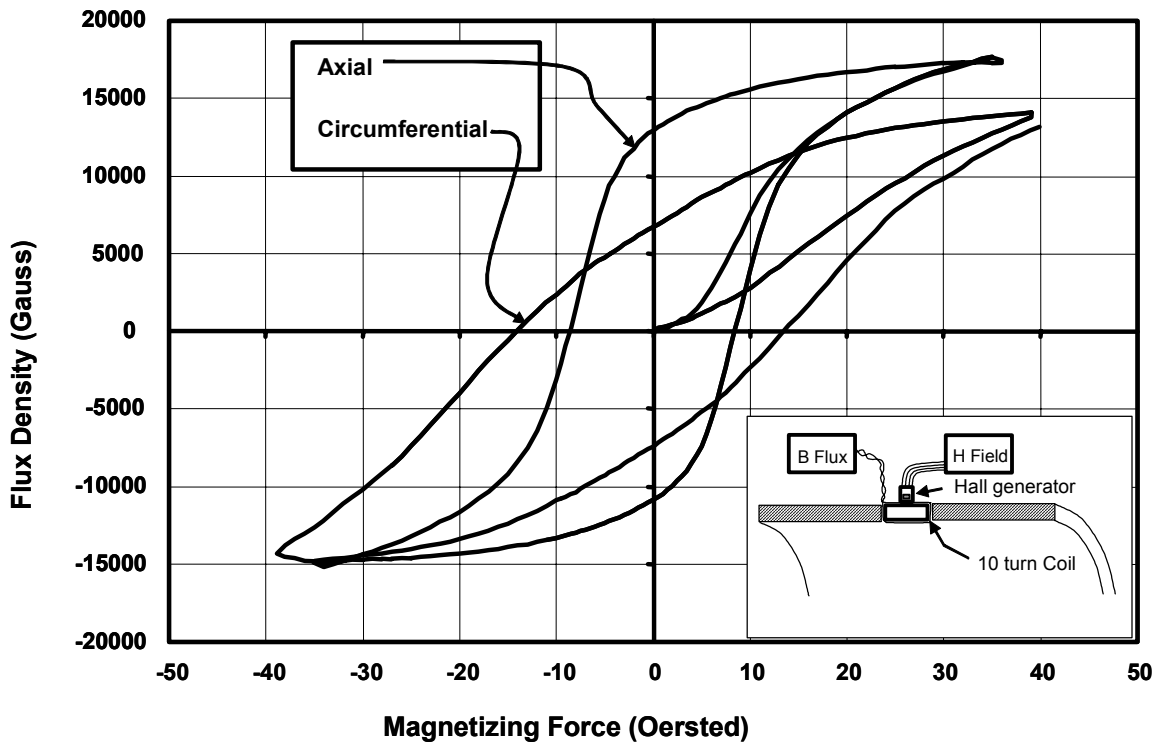
Figure 18. In-situ magnetic measurements demonstrating difficulty in saturating the pipe material in the circumferential direction.

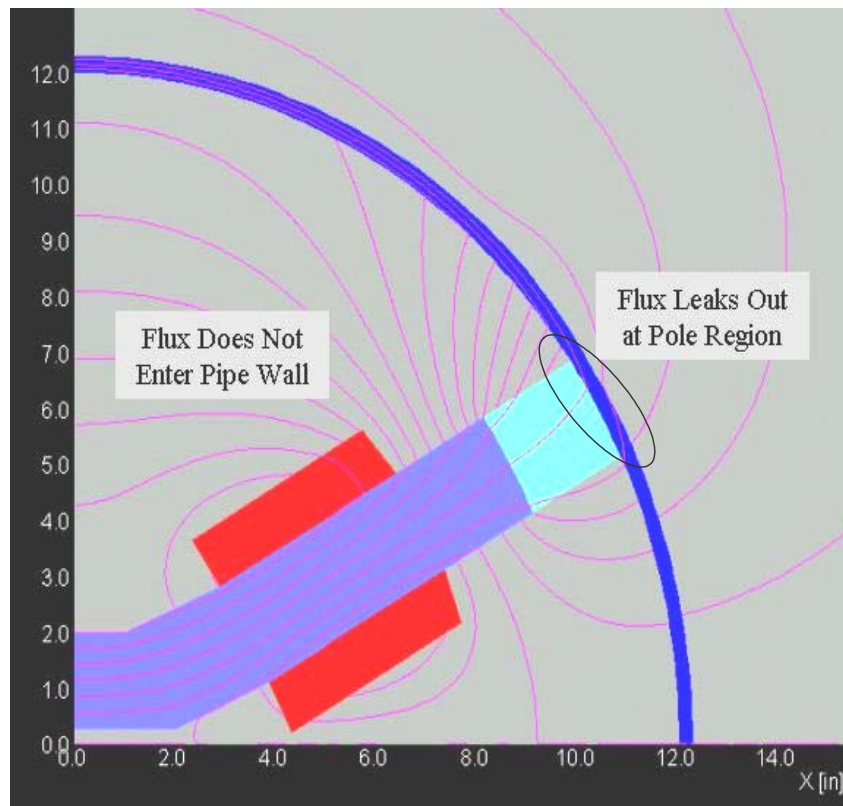
**Figure 19. Quarter magnetic finite element model electromagnet circumferential magnetizer.**

Magnetic finite element modeling was used to visualize the flux leakage in the pipe and surrounding medium. Taking advantage of symmetries, a quarter of the circumferential magnetizer was modeled. The modeling results shown in Figure 19 shows that the pipe material near the magnetizer pole is saturated (permeability  $\sim 15$ ), but the material midway between the poles is not (permeability  $\sim 75$ ). Lower magnetization levels mean the tool is more sensitive to stress and material property variations.

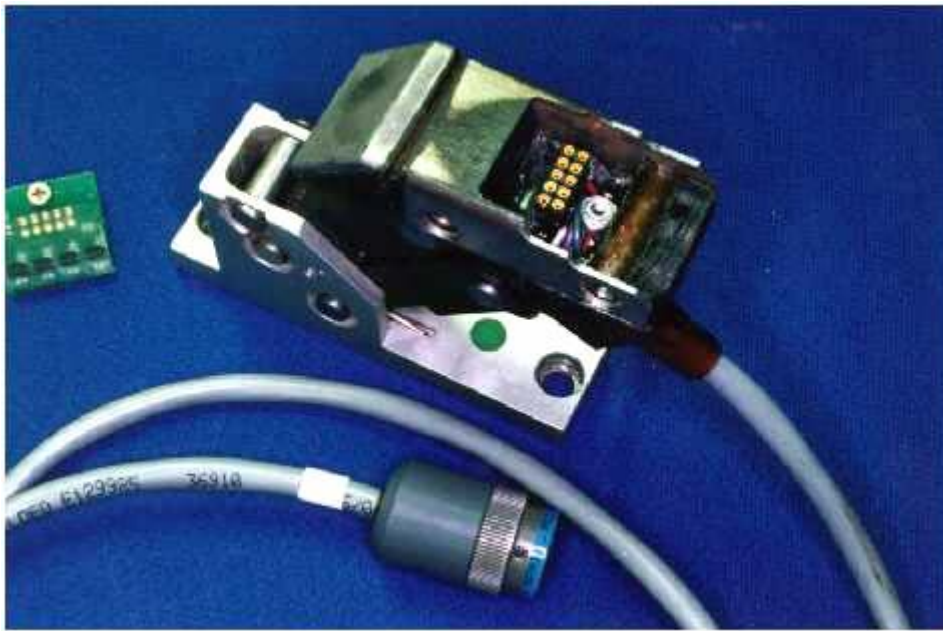
**Figure 21. A sensor head with replaceable sensor circuit.**

Hall effect sensors are semiconductor devices that convert flux leakage signals into electrical signals. The sensors on the test bed vehicle were replaced by SS495 Series, solid-state, ratiometric, linear sensors manufactured by Honeywell Micro Switch. These sensors have the necessary characteristics to measure the fields generated by mechanical damage defects. The sensors operate on supply voltages ranging from 4.5 volts to 10.5 volts. Outputs are ratiometric, and are set by the supply voltage. The sensors measure a minimum of +/- 600 Gauss, and they include an amplifier integrated into the circuit. Sensor arrays made up of multiple sensors are constructed using printed wiring boards. These sensor arrays are potted in a sensor housing and mounted in the sensor. Figure 21 is a photograph showing a sensor head with replaceable sensor circuit. More than one Hall effect sensor is contained in each sensor head assembly. Figure 22 shows a sensor head configured with four Hall effect sensors spaced evenly over the 1-inch wide sensor head.

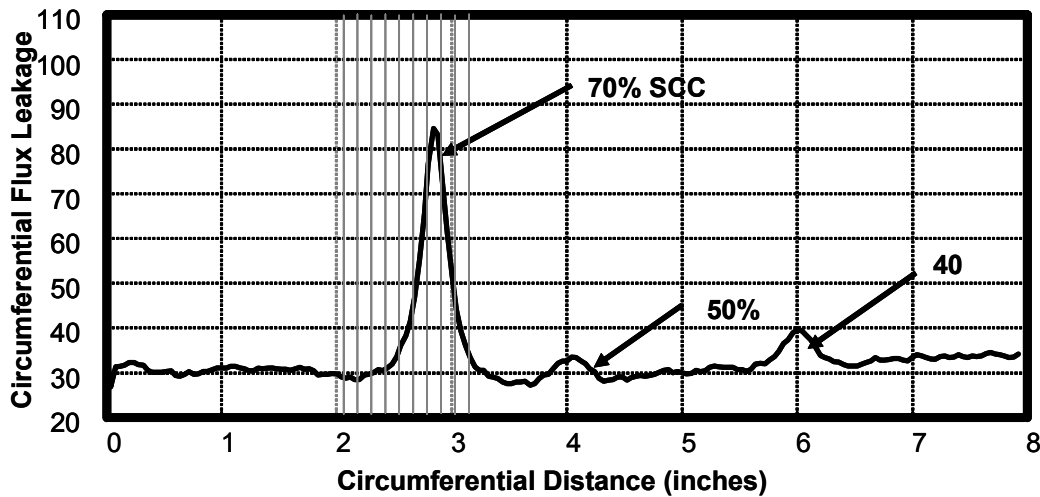
**Figure 23. Sensor spacing determination based on crack signals acquired in the laboratory at 0.050-inch circumferential intervals.**

The sensor spacing has to be based on the flux leakage response of the defect. The sensor must reasonably capture the peak response of the defect. Figure 23 shows a flux leakage signal from a crack that measured single probe scanned in the circumferential direction across a series of cracks of different depths. The output of the sensor was sampled in 0.050-inch intervals. The eight vertical lines that span the 70% deep crack show that eight sensors per inch does not quite adequately measure the peak. Detailed analysis showed that the peak was 84 gauss. The left sensor measured a peak of 78 gauss (a 7% error) and the right sensor measure 74 gauss (a 12% error). The other cracks showed that the width of the signal does not change significantly; however, the sharpness is reduced.

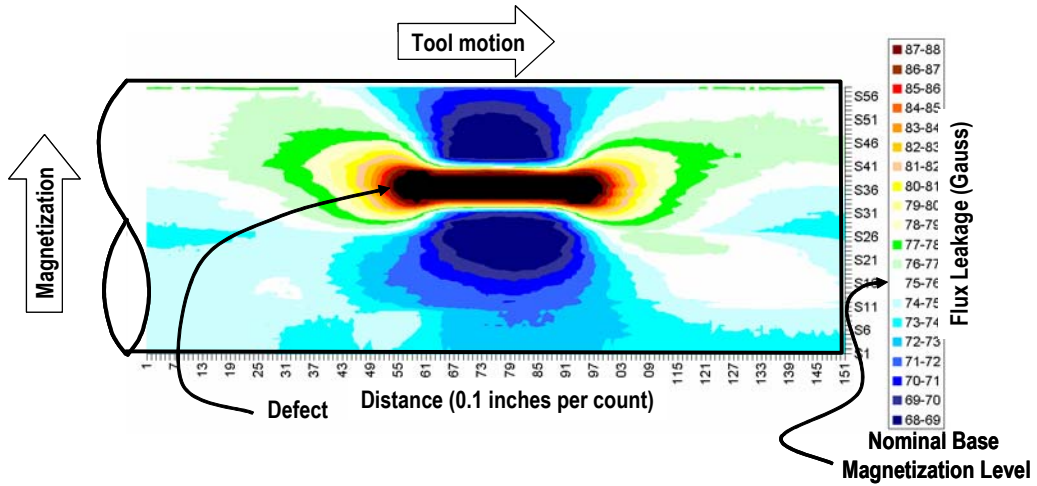
Figure 26. Data display convention.

A data display convention was established for visualizing the flux leakage from defects. The convention, illustrated in Figure 26, is used in many of the figures in this report and is one of many used by commercial pipeline inspection companies. In this representation, the inspection tool moves from left to right. The sample interval on the horizontal axis is 0.1 inch. On the vertical axis, the sensor spacing is 0.0625 inches (a sixteenth of an inch). Color is used to indicate flux leakage intensity. White is assigned to be the nominal background magnetization level. Increasing flux leakage levels progress through green, yellow, orange, red and black. Flux levels below the magnetization level are represented by shades of blue.

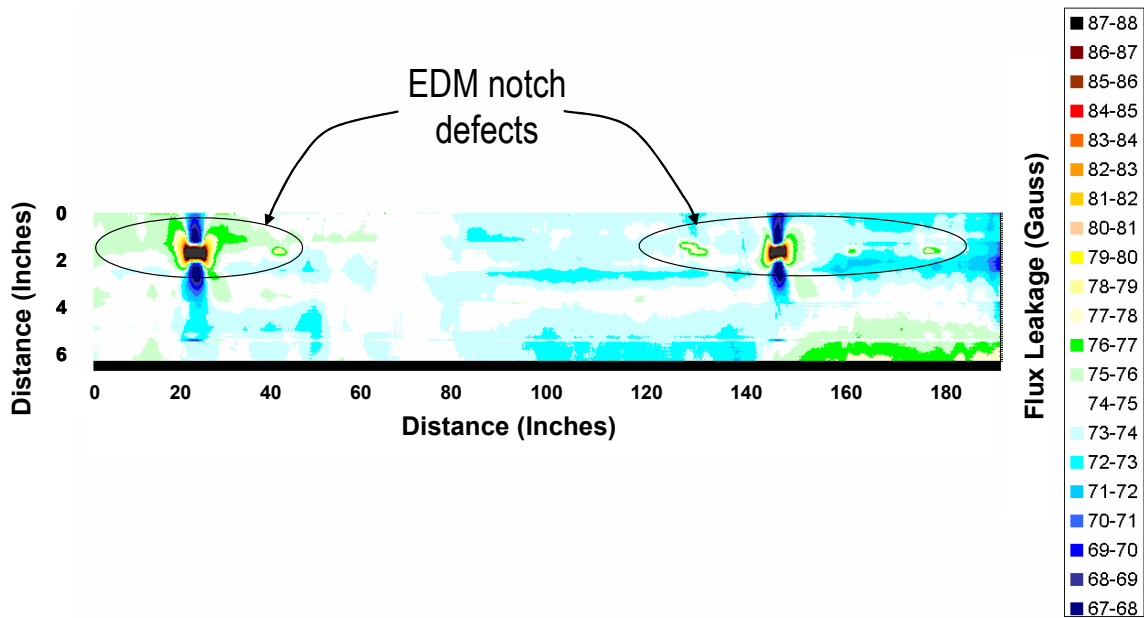
Figure 27. Flux leakage for the full pipe sample with EDM notches.

The detection of notches in the parent material and weld zones demonstrates the sensitivity of the circumferential MFL system as configured. Figure 27 shows a typical result from the pipe sample with EDM notches. Two large notches and four smaller notches were detected. There is also a large zone between the two circled regions that have no defects. This area can be used to establish a noise level for the detection of smaller defects. Figure 28 focuses on the right portion of Figure 27. The 2-inch long, 50 percent deep EDM defect was clearly detectable. To the right of this defect is a 2-inch long, 10 percent deep EDM notch that produces a signal that is three gauss above the magnetization level. In the left portion of this image were signals from two parallel notches that were 4 inches long and 10 percent that were overlapped for 2 inches. The image shows two signals at separate circumferential locations, but these signals merge at the overlap.

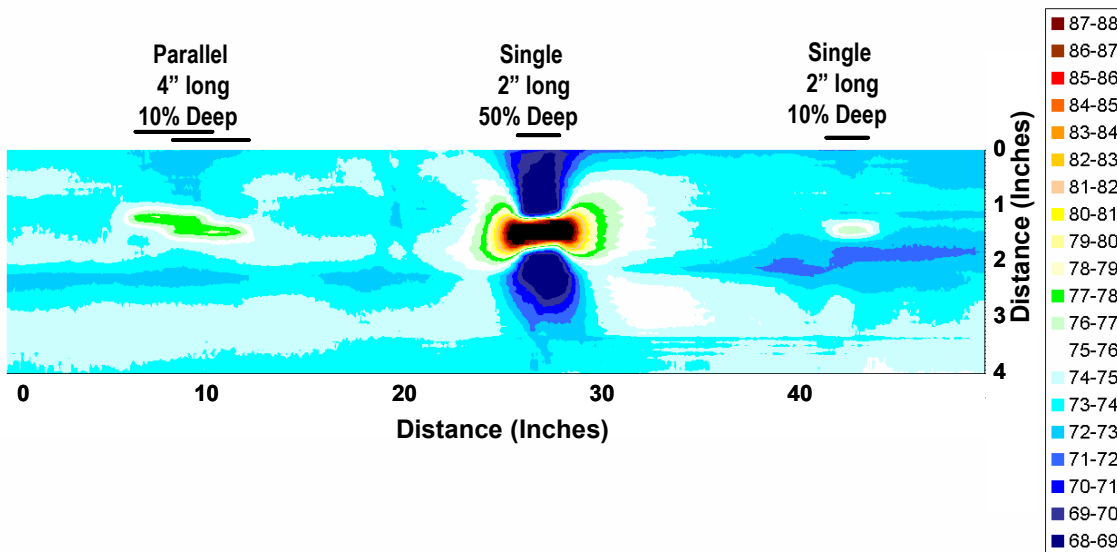
Figure 28. Flux leakage from three EDM notches demonstrating the detectability of these defects.

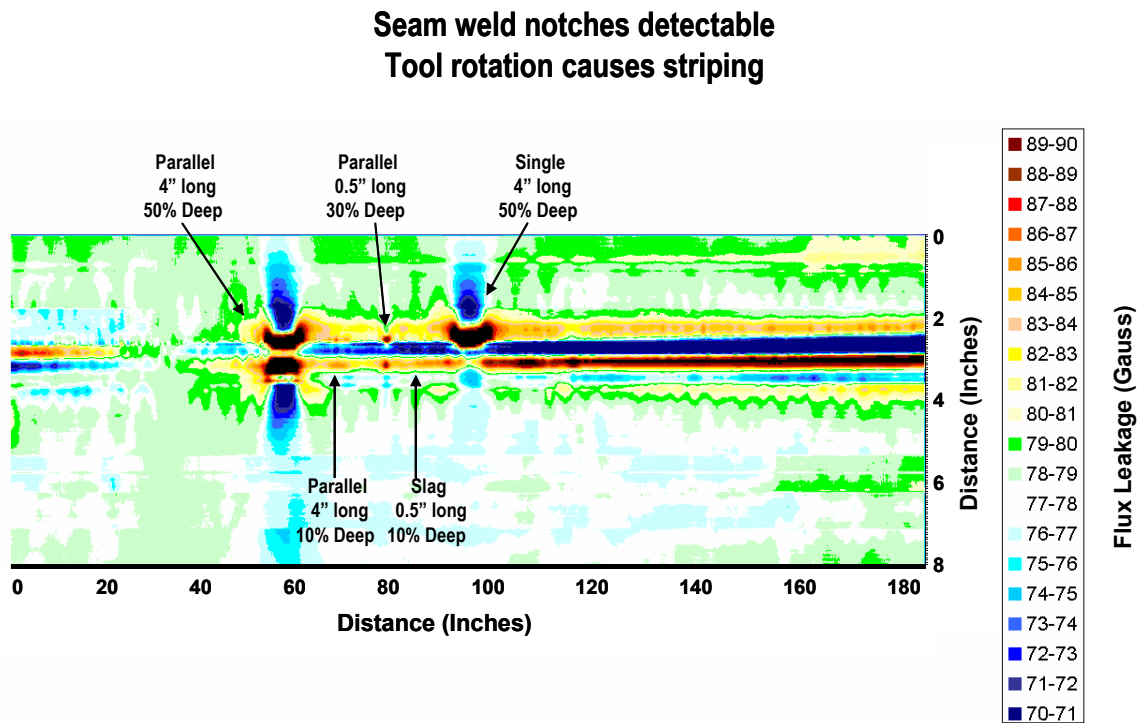
**Figure 29. Flux leakage from a weld zone with EDM notches.**

EDM notches were detected in the weld zone. However, the detection process is complicated by signals from the weld itself. Defects in the weld must produce a signal that is distinguishable from the ever present weld signal. To extract the defect signal, a typical weld signal can be generated by averaging recorded data from several axial measurement positions. The number of averages depends on situation, but can be as small as four axial readings, which corresponds to a length of about 10 mm (0.4 inch) in many circumferential MFL tools. More commonly, over 100 axial readings are used, which corresponds to 250 mm (10 inches), or measurements from the entire pipe seam of a joint of pipe are used. To detect defects, the average weld signal is subtracted from the measured signals. The difference shows both the natural variations in the welding process and potential defects. Since seam welds are made with automatic processes, the natural variations are small in amplitude and long in axial extent as compared to cracks and corrosion in this zone. Figure 29 shows a typical result from the weld zone with four EDM notches and one slag inclusion. The three larger defects can be seen. However, the 10 percent defect EDM notch was not distinguishable within the weld signal. One complicating factors is inspection tools often rotate as the travel down a pipeline. The generation of an average and subsequent subtraction is valid over a short range. Figure 29 shows that the weld commensuration procedure works only over a short range. The blue and red stripes before and after the defect zone are caused by tool rotation.

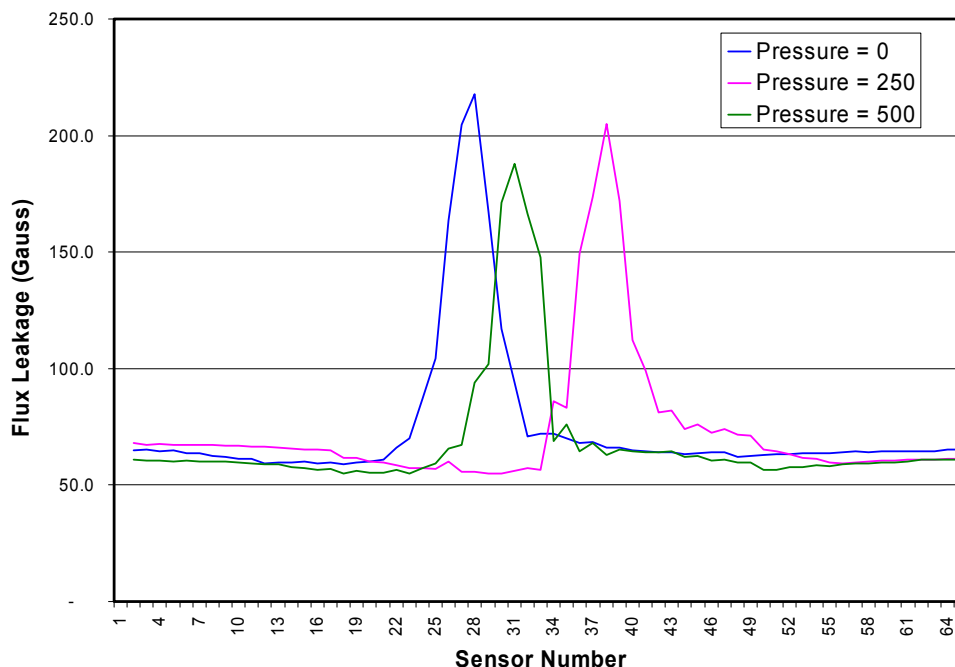
**Figure 30. Flux leakage signals from a fifty percent deep EDM notch at pressures ranging from atmospheric to approaching yield.**

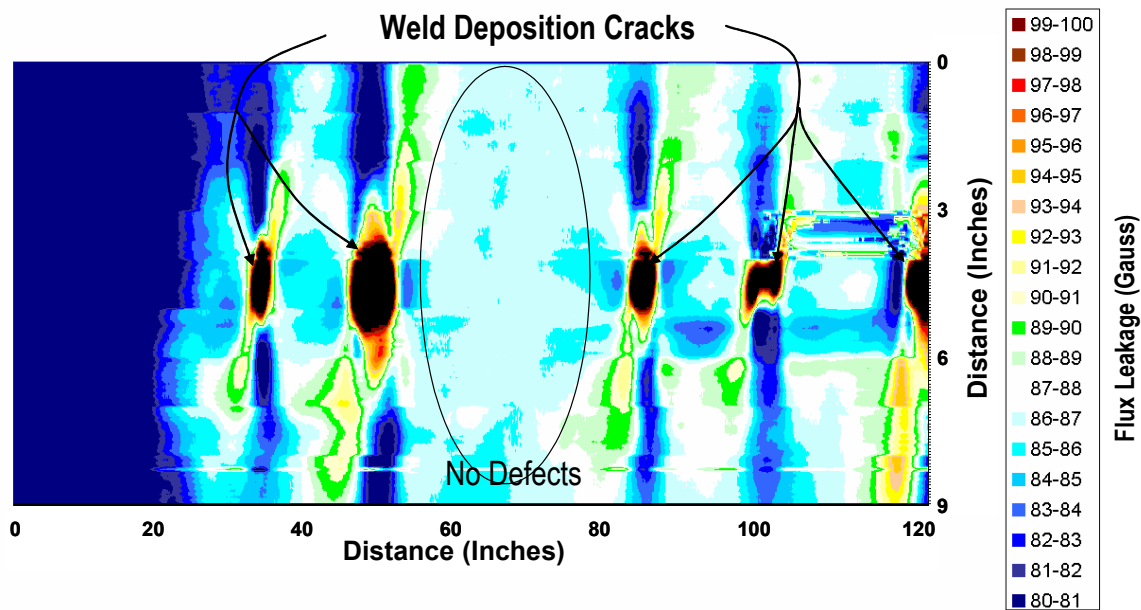
**Figure 31. Flux leakage from weld deposition cracks.**

Weld deposition cracks were available in the pipe sample and flux leakage signals were recorded from these defects. Figure 31 shows the results from one row of cracks. The signals are much more volumetric than the notch signals and appear to have very similar amplitudes. Table 1 shows the depth of the cracks. The depths of these cracks were measured using two ultrasonic methods, time of flight diffraction (TOFD) and phased array imaging. Neither technique could accurately size the depth for the second crack. These results show that weld deposition cracks are not good substitutes for natural cracks for magnetic inspection systems.

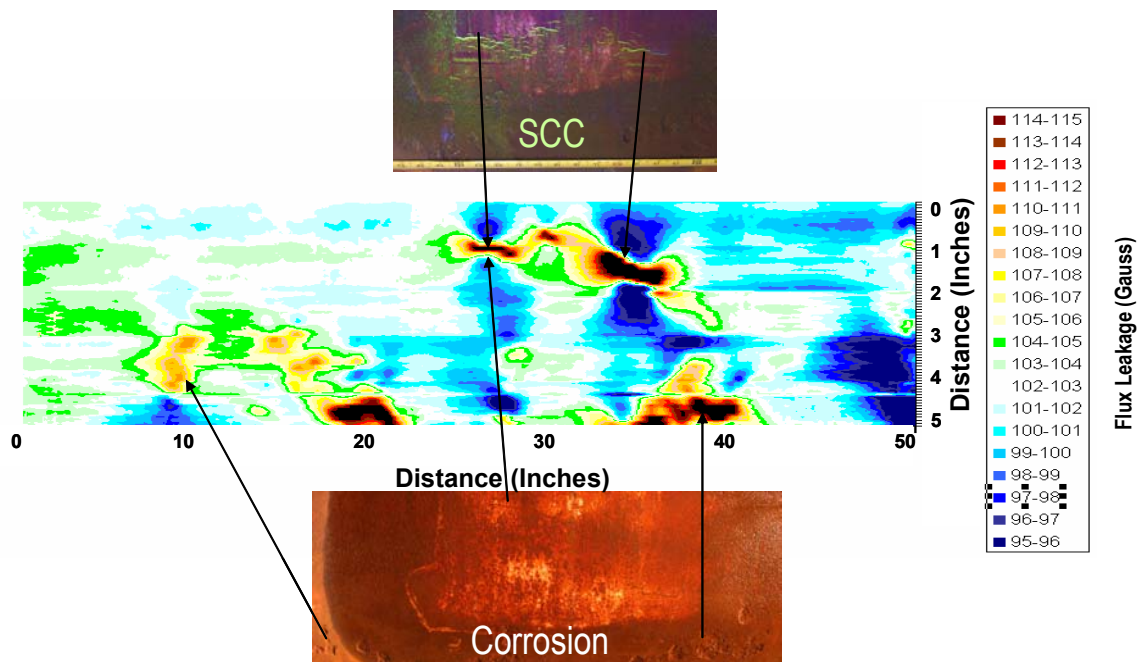
**Figure 32.** A flux leakage image, magnetic particle enhanced photograph of a stress corrosion crack colony and a photograph indicating corrosion pits.

Prior results showed that some natural cracks could be detected with circumferential MFL. These were laboratory results under static conditions. A pipe sample with natural SCC was examined using the circumferential inspection system. Figure 32 shows the flux leakage from the pipe sample, a magnetic particle enhanced image of the crack zone and photograph indicating corrosion pits. Figure 33 shows the details of the crack zone. It should be noted that not all cracks were detected and the depth of these cracks was not known. The pipe sample had numerous corrosion pits and multiple cracks that look like corrosion in the flux leakage image.
