Delivery Reliability for Natural Gas -- Inspection Technologies

Phase I Topical Report

DE-FC26-04NT42266

Prepared by:
Gas Technology Institute
1700 S. Mount Prospect Road
Des Plaines, Illinois 60018

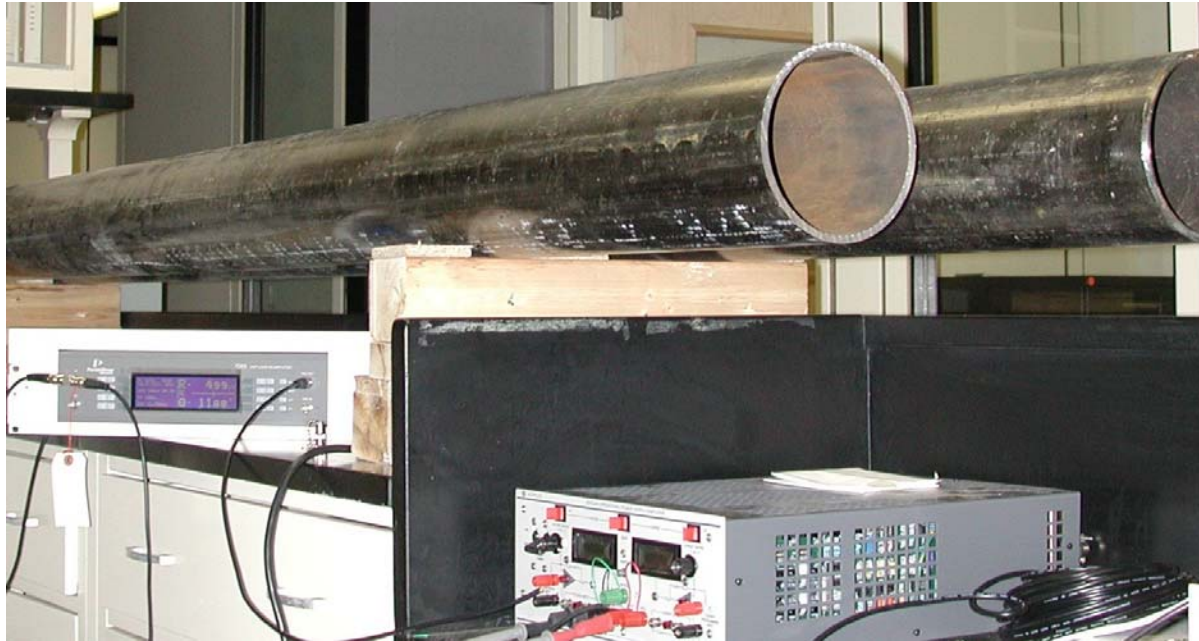
Figure 3: RFEC laboratory setup.

Figure 3 shows the laboratory setup for performing RFEC research tasks. We machined defects sets into two 10' sections of 6" diameter pipe. One pipe is seamless, the other is seam welded. The seamless pipe is set up with a Kepco BOP, bipolar operational power supply, on the right, which drives the exciter coil and a PerkinElmer lock-in amplifier, on the left, which filters and amplifies the signal received by the sensing coil.

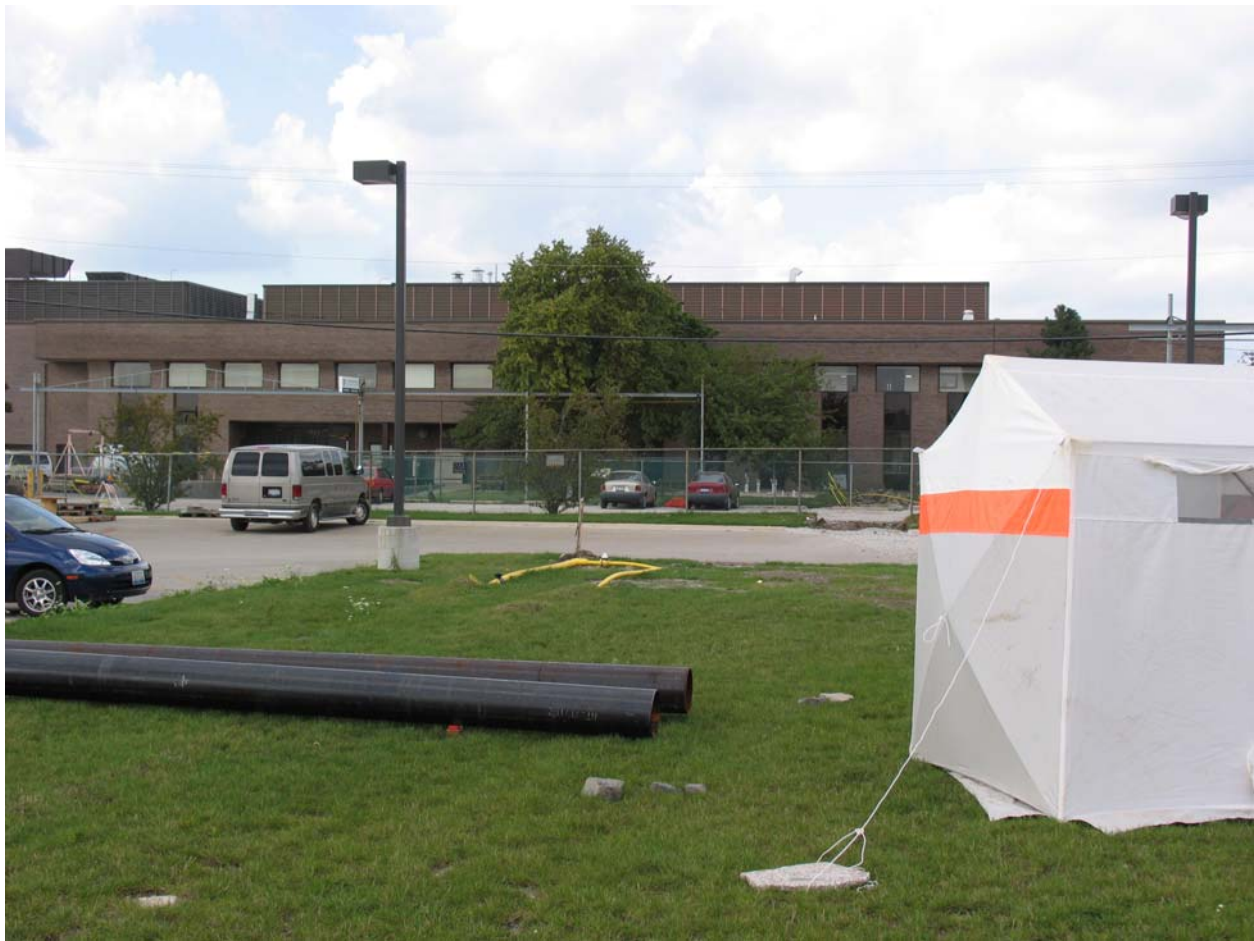
Figure 4: RFEC testing on 12" pipe samples.

Early in the project, we performed RFEC testing on 12" seamless and seam-welded pipes. Figure 4 shows the pipes and equipment tent. This testing was initially started in preparation for the DOE-NETL technology demonstration held at Battelle Laboratories in Ohio. The RFEC vehicle is shown in Figure 5.

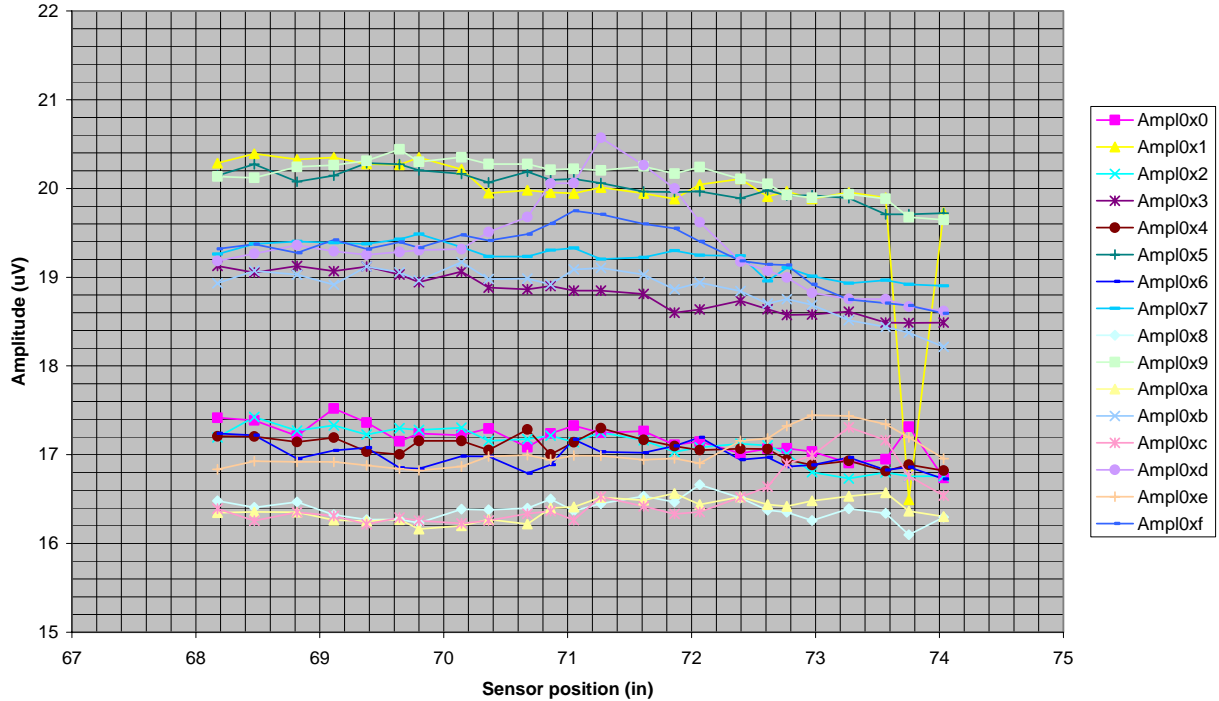
Figure 6: Amplitudes vs. Sensor Position Inside 12" Pipe

The graph in Figure 6 shows the amplitudes of the signals seen in all 16 channels while scanning a 6" section of the 12" test pipe. The 80% WT defect is nominally at 72" from the end of the pipe. The sensors labeled *Ampl0xd*, *Ampl0xf*, *Ampl0xc*, and *Ampl0xe* all indicate an increase in amplitude near the defect location. The horizontal axis indicates the position of sensors *Ampl0xd* and *Ampl0xf* along the pipe. *Ampl0xd* and *Ampl0xf* do not indicate exactly 72" because of systematic and correctable imprecision in their position. This is not due inherently to the technique but rather to position calibration constants. Due to mechanical constraints, the sensors *Ampl0xc*, and *Ampl0xe* are about 2" farther into the pipe¹, which is why they indicate a defect location about 2" farther than the other two sensors. The fact that multiple sensors

The graphs in Figures 6 and 7 are simple excel plots. One advance made in this segment

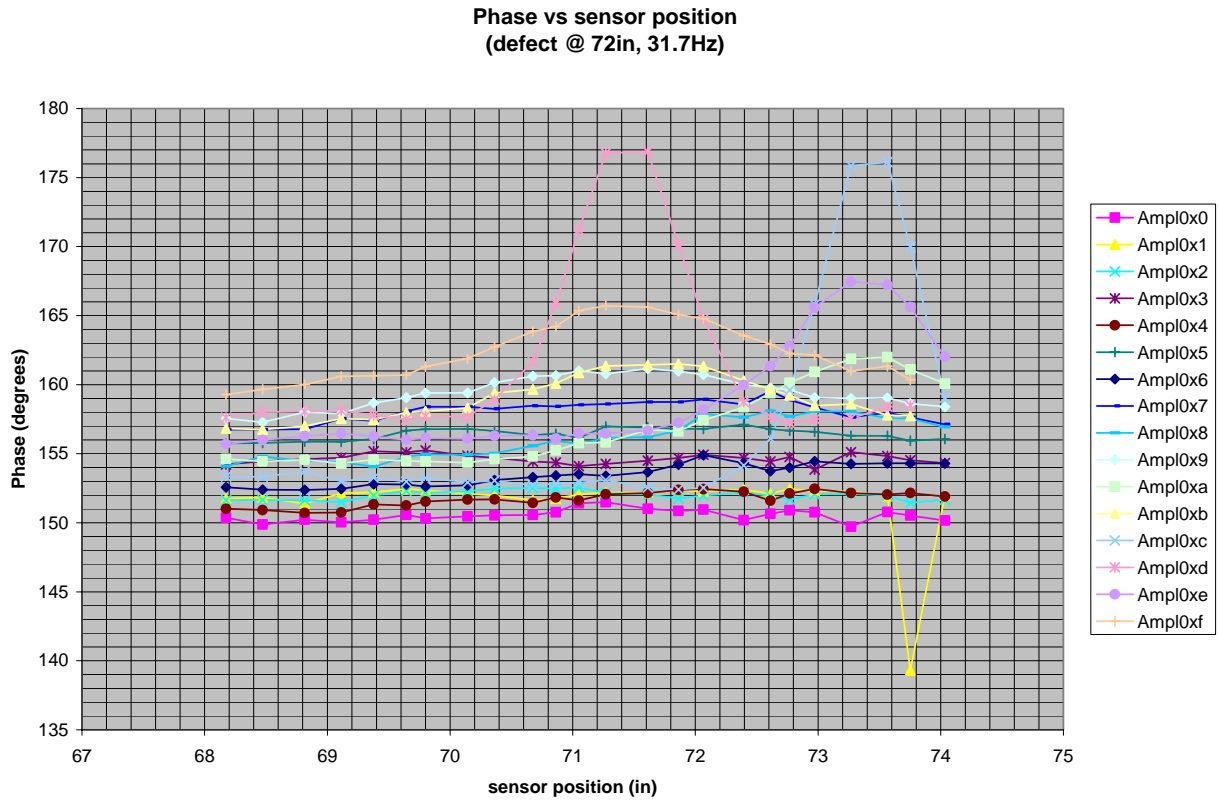
Figure 7: Phases vs. Sensor Position Inside Pipe

Figure 7 shows the phases of the signals seen in all 16 channels while scanning a 6" section of the 12" test pipe. The 80% WT defect is nominally at 72" from the end of the pipe. The sensors labeled *Ampl0xb*, *Ampl0xd*, *Ampl0xf*, and *Ampl0xa*, *Ampl0xc*, *Ampl0xe* all show an increase in phase near the point of the defect. The horizontal axis indicates the position of sensors *Ampl0xb*, *Ampl0xd*, *Ampl0xf*. The defect signals on channels *Ampl0xb*, *Ampl0xd*, *Ampl0xf* do not occur exactly at 72" because of systematic and correctable imprecision in their position. This is not due inherently to the technique but rather to position calibration constants. Due to mechanical constraints, the sensors *Ampl0xa*, *Ampl0xc*, *Ampl0xe* are about 2" farther into the pipe, which is why they indicate a defect location about 2" farther than the other two sensors. The fact that multiple sensors indicate the defect allows for locating it circumferentially as well as axially.

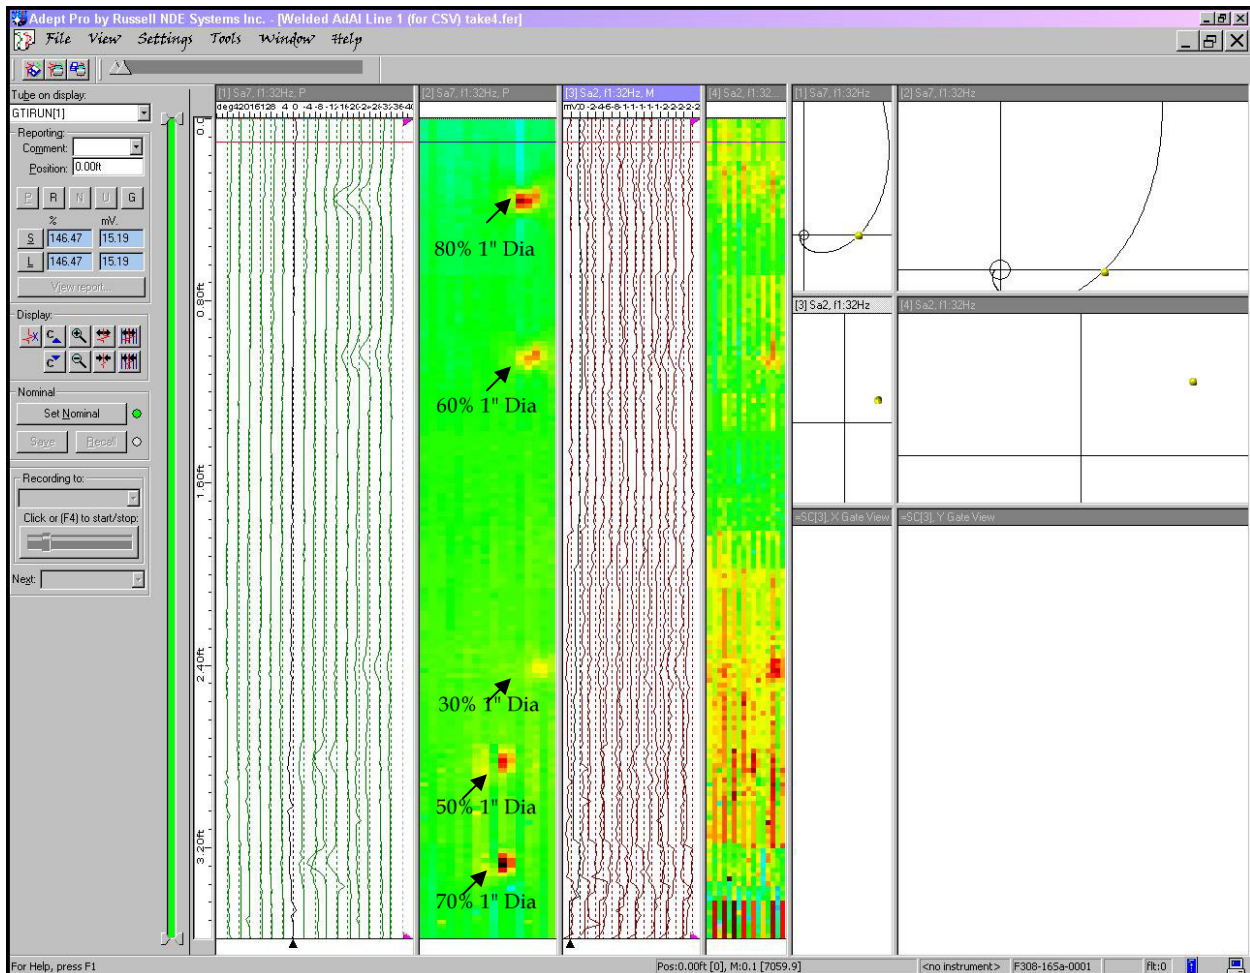
Figure 9: Adept Pro software showing defect locations in pipe along defect line 1.

Figure 9 is data analysis done on the first defect line of a 12" seam welded pipe with the second drive coil. Five of six defects were identified. The defect that was not detected was a 1" diameter circular defect of only 5% of the wall thickness.

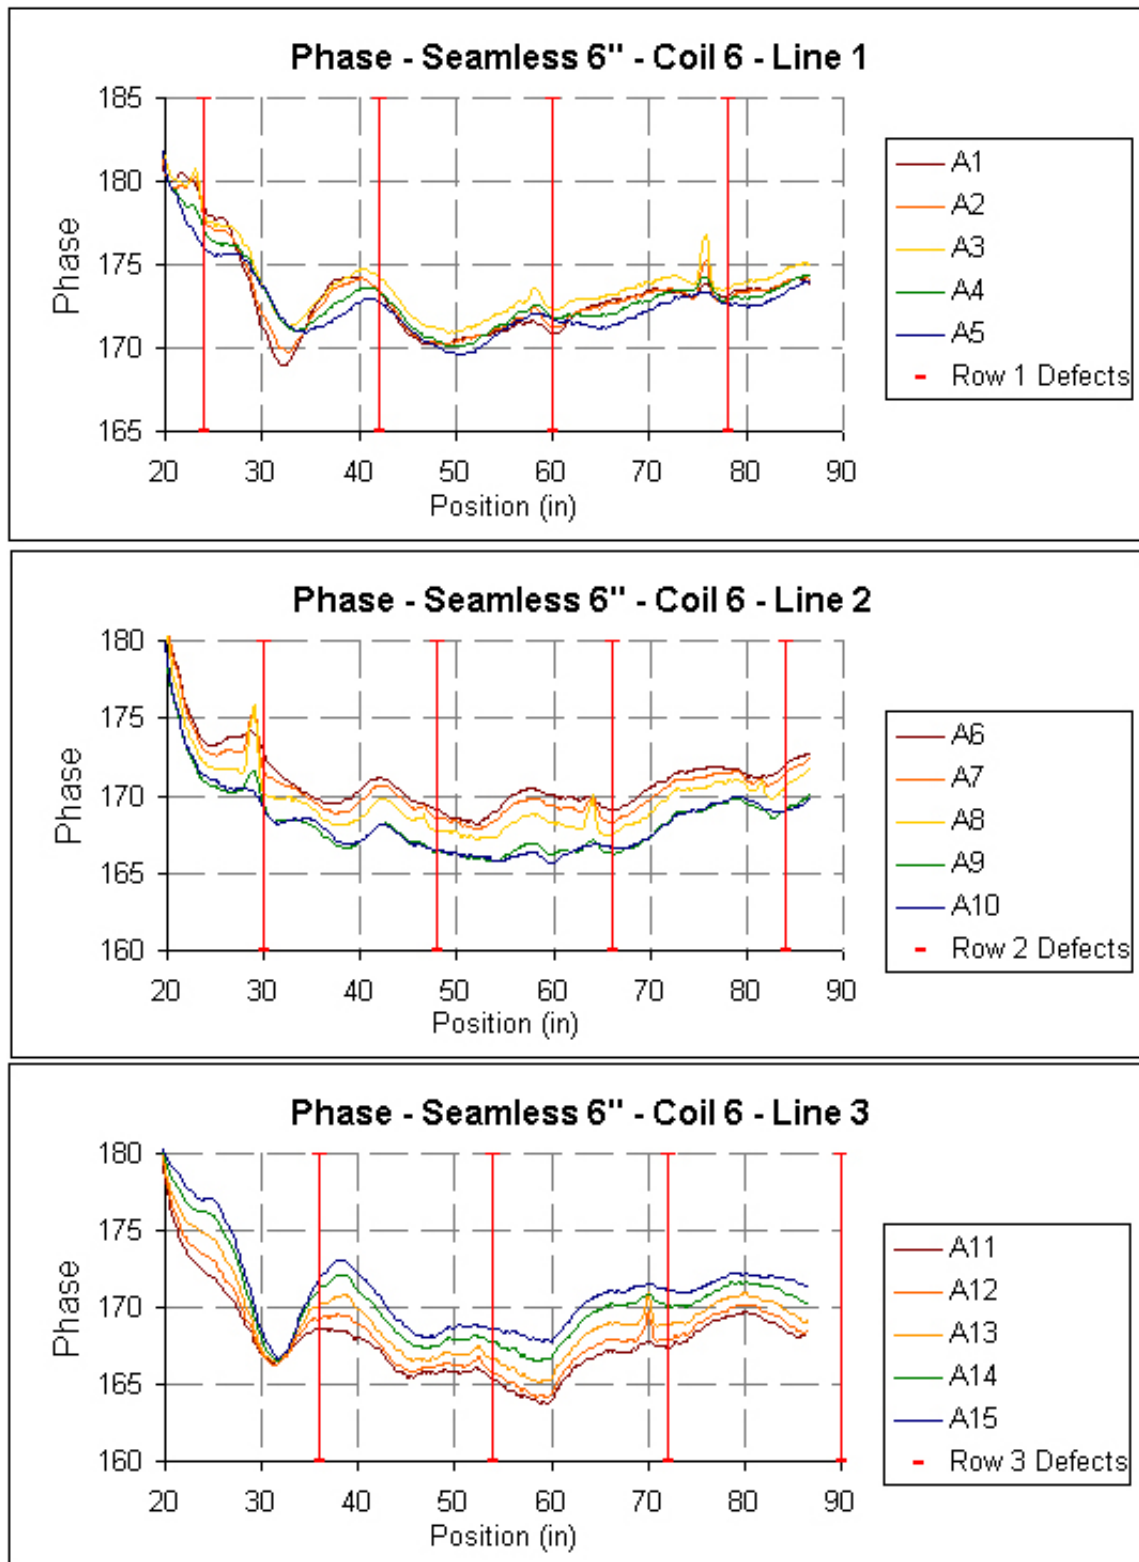
Figure 15: Results of scanning the 6" seamless pipe with Coil 6.

The figure above shows scanning results of exciter coil 6 in the 6" seamless pipe. The results are similar to Coil 5 results shown in Figure 13. Coil 6 detected all the defects Coil 5 and in addition, detected the 20%, 1/2" defect at 54" in line 3. In other scans with Coil 6, we have seen detection of all defects with the exception of the 5%, 1/2" defect.

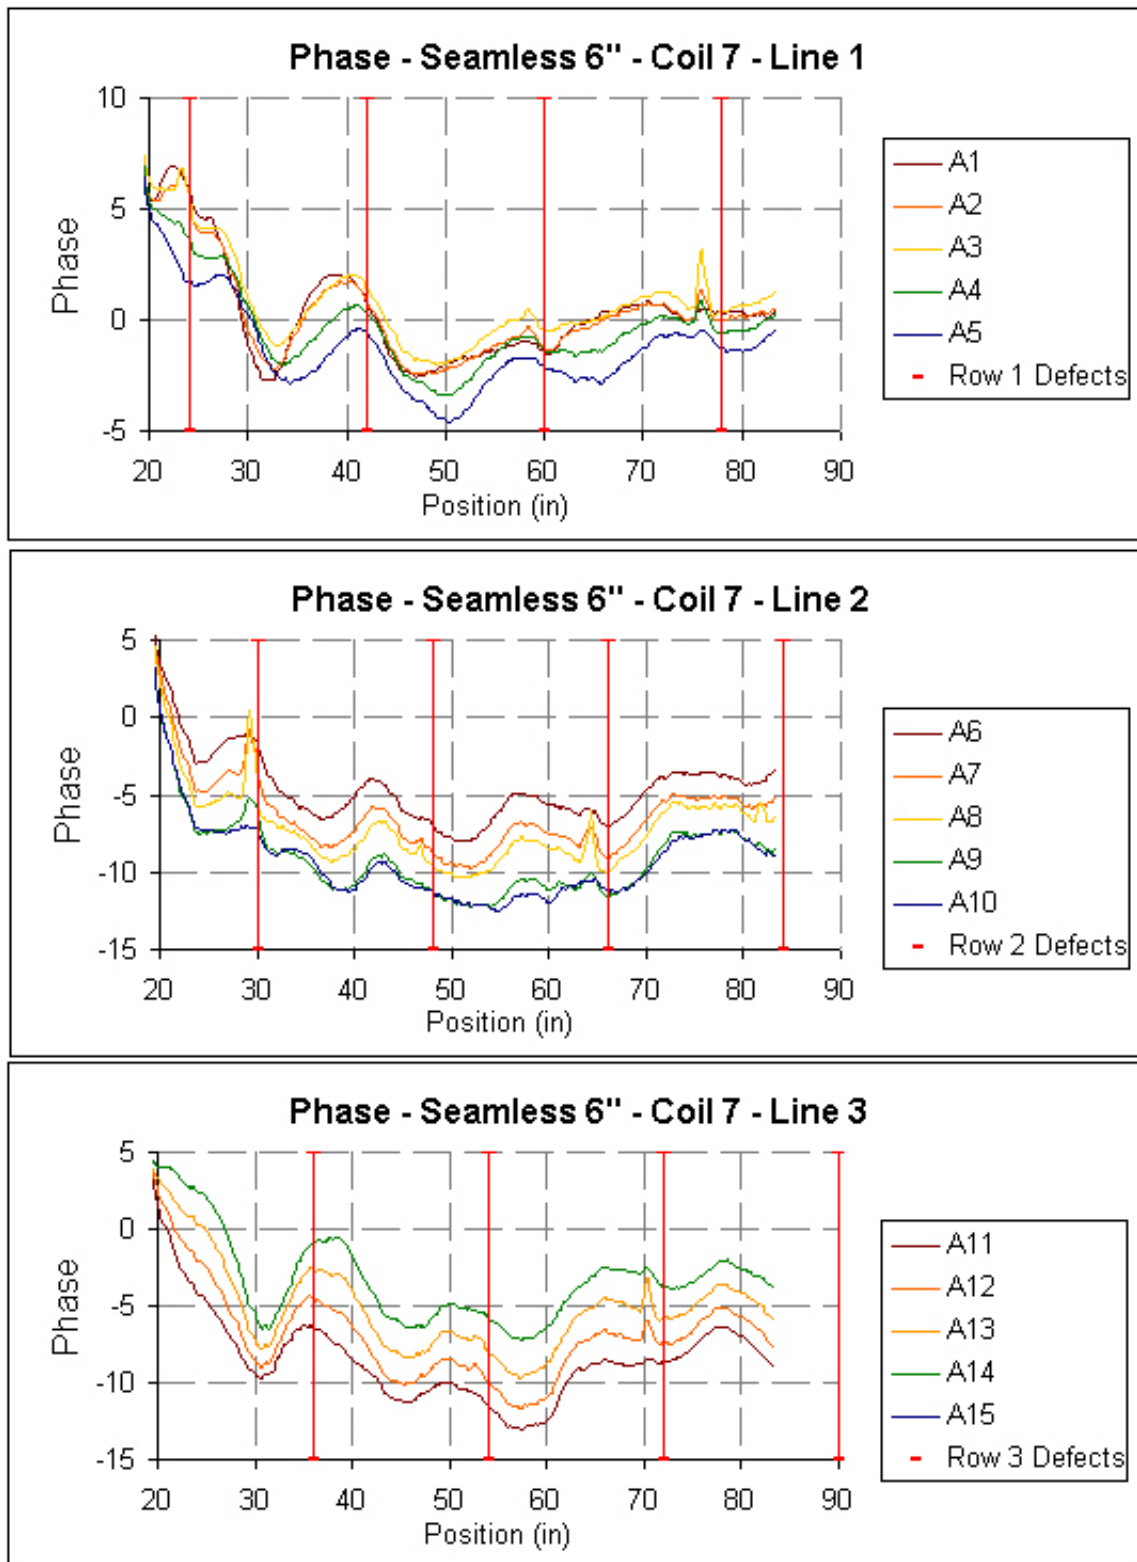
Figure 17: Results of scanning the 6" seamless pipe with Coil 7.

Figure 17 shows results obtained from scanning the 6" seamless pipe with Coil 7 as the exciter coil. To date, Coil 7 has been the only exciter coil to detect all 13 defects, including the 5% wt. Throughout the testing process, the data obtained from scanning the seamless pipe tends to follow the same trends. At the same time, there are also trends in the magnitude and phase data from the welded pipe scans. The patterns in the welded pipe differ from the patterns seen in the seamless pipe. We suspect the gradual rising and falling of the data is attributed to residual magnetic fields in each of the pipes. In order to better understand the data and to have a set of data to use as the base, we set up a baseline test. We laid both pipes parallel to each other and ran subsequent tests using the same vehicle and lab equipment. The first baseline test results are displayed in Figure 17. We performed the first scan on the seamless pipe. Upon completion of that scan, we transferred the RFEC vehicle to the welded pipe and performed a new scan on the welded pipe. These results are shown in Figure 18 below.

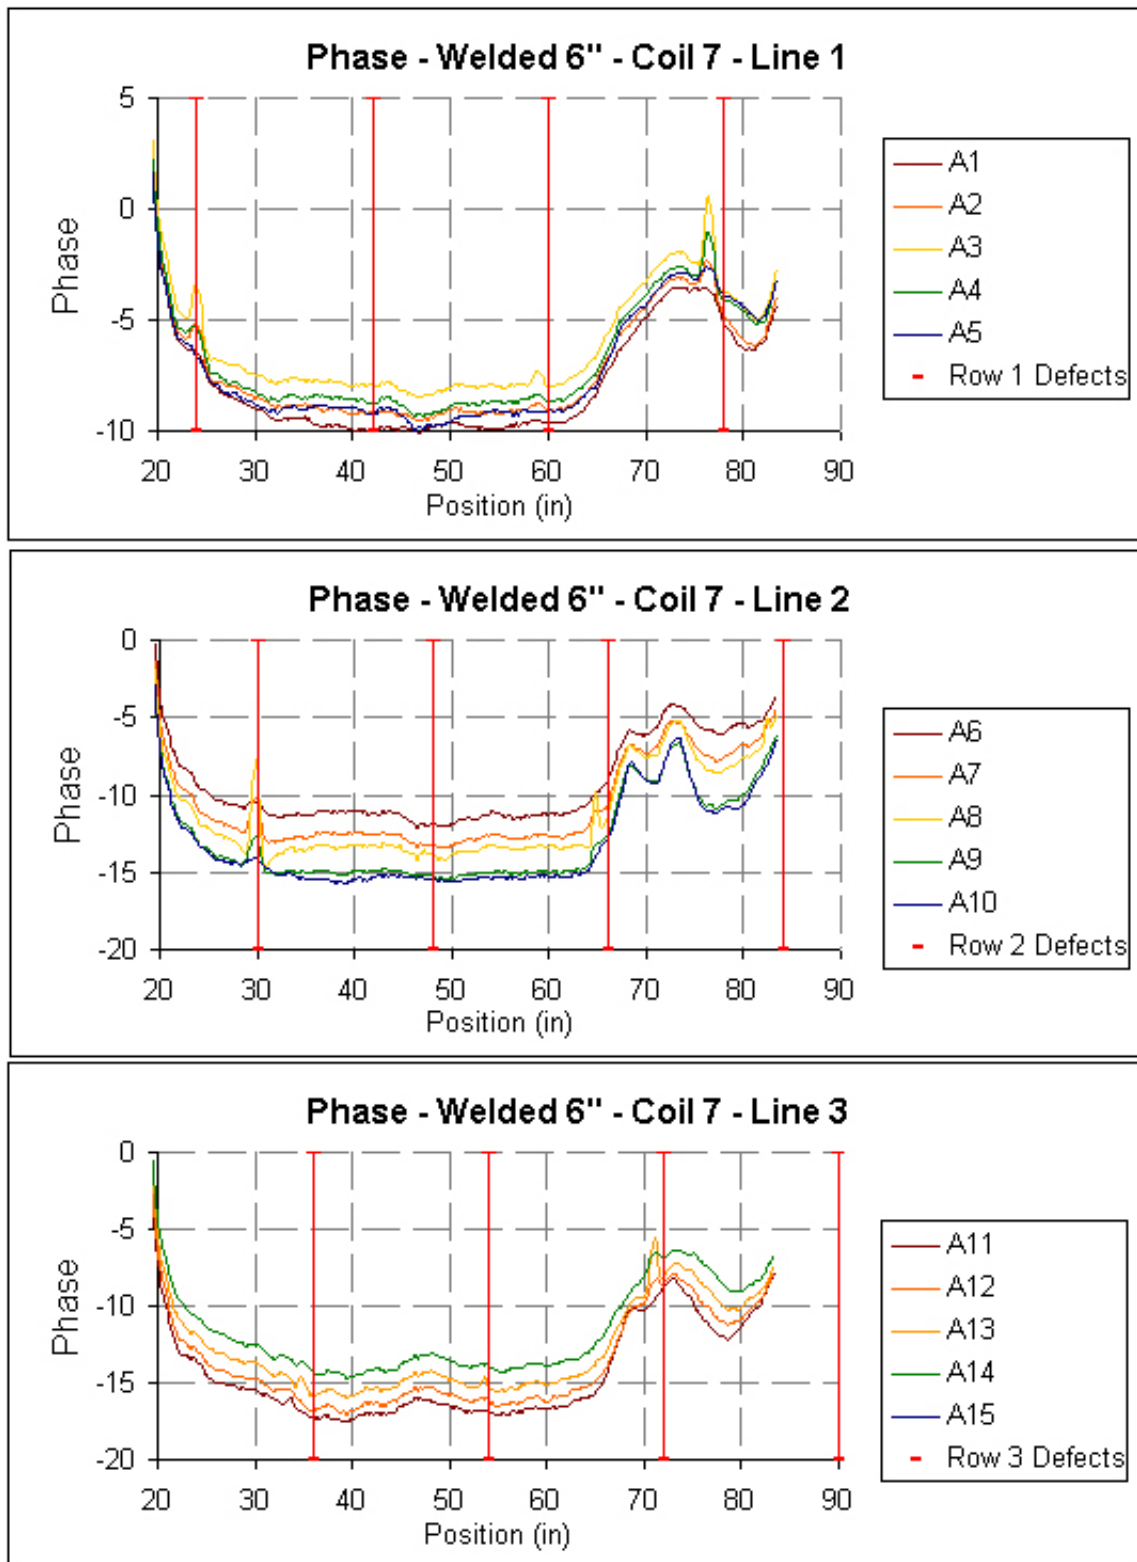
Figure 18: Results of scanning the 6" welded pipe with Coil 7.

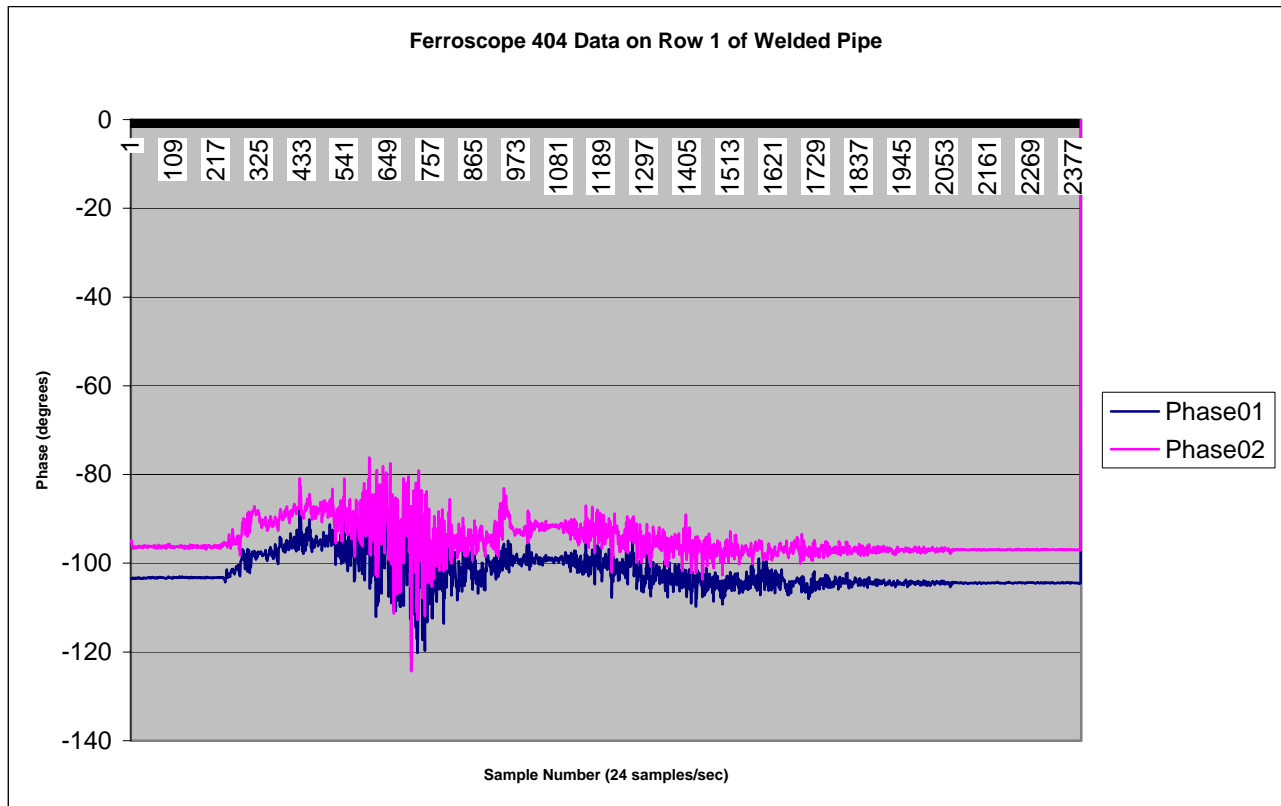
The results of the first test shown in Figure 19 below are for two coils pulled at a rate of about 1.5 inches/second. The complete defect line was scanned in 100 seconds compared to the lock-in amplifier which took about 90 minutes. The length of the lock-in scan is due mostly to the multiplexer which sequences through the 16 pickup coils and the associated settling time between channels.

For the first 250 measurements and the last 300 measurements the coils were stationary and show that the electronic noise is acceptable, causing a jitter of about .3 degrees in the phase data. However the noise level increased dramatically after the system began moving.

Figure 19: Data from defect line1 using the Russell board.

This was the first test conducted with the Russell boards where data was collected while the coils were moving. We believed that the noise was due to mechanical vibrations of the pickup coils interacting with the residual magnetic fields in the pipe itself. Tests with the system designed to be more rigid and pulled smoother verified this conclusion.

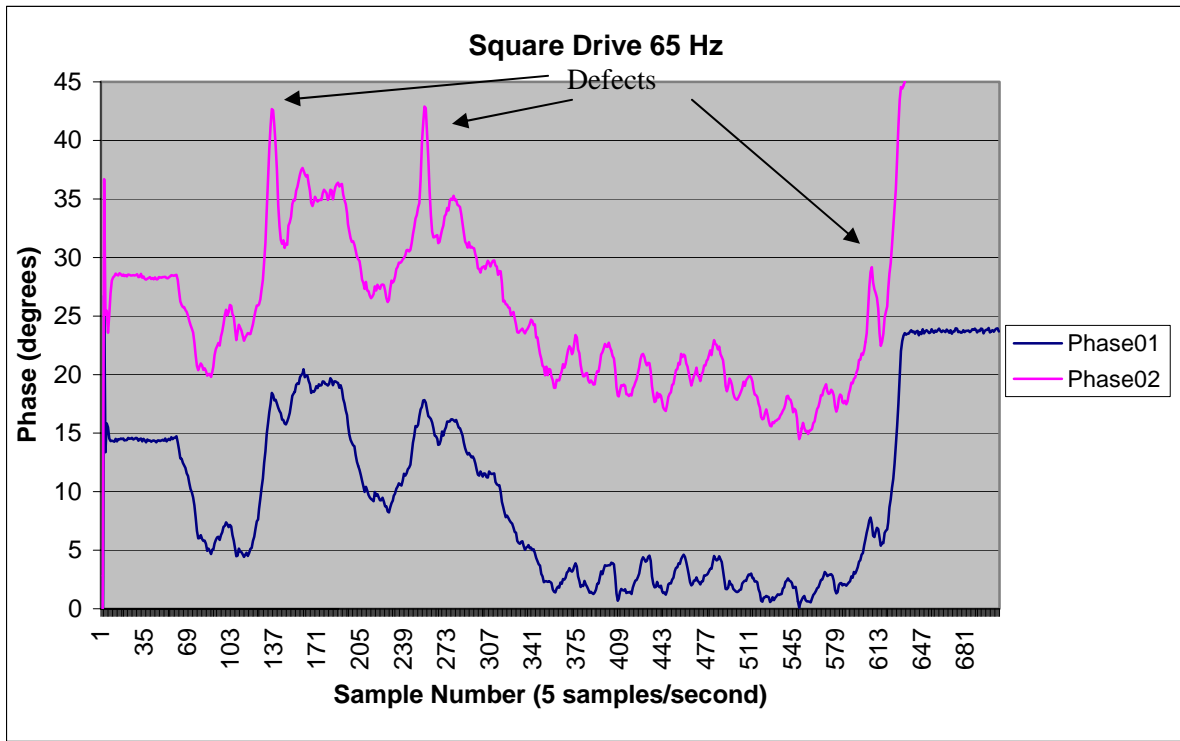
Figure 23: Phase data taken while driving the exciter coil with a 65Hz square wave.

Results of the 25Hz scan, shown in Figure 22, show 4 of 5 defects. Noise levels look reasonable. Starting at 45Hz and up to 75Hz, there was quite a disturbance in the noise. It seems to be periodic and we suspect it may be interference from 60Hz signals created by standard electronic devices (lights, computers, etc.) We only detected 3 of 5 defects during the 65Hz scan, shown in Figure 23, but it is interesting to note that the amplitude of the defect signals is considerably larger, about 3x. The amplitudes of the defect signals in the 85Hz in Figure 24 are 4-5x larger than the signals in the 25Hz test. The periodic type noise is reduced in the 85Hz test and 4 of 5 defects were detected.

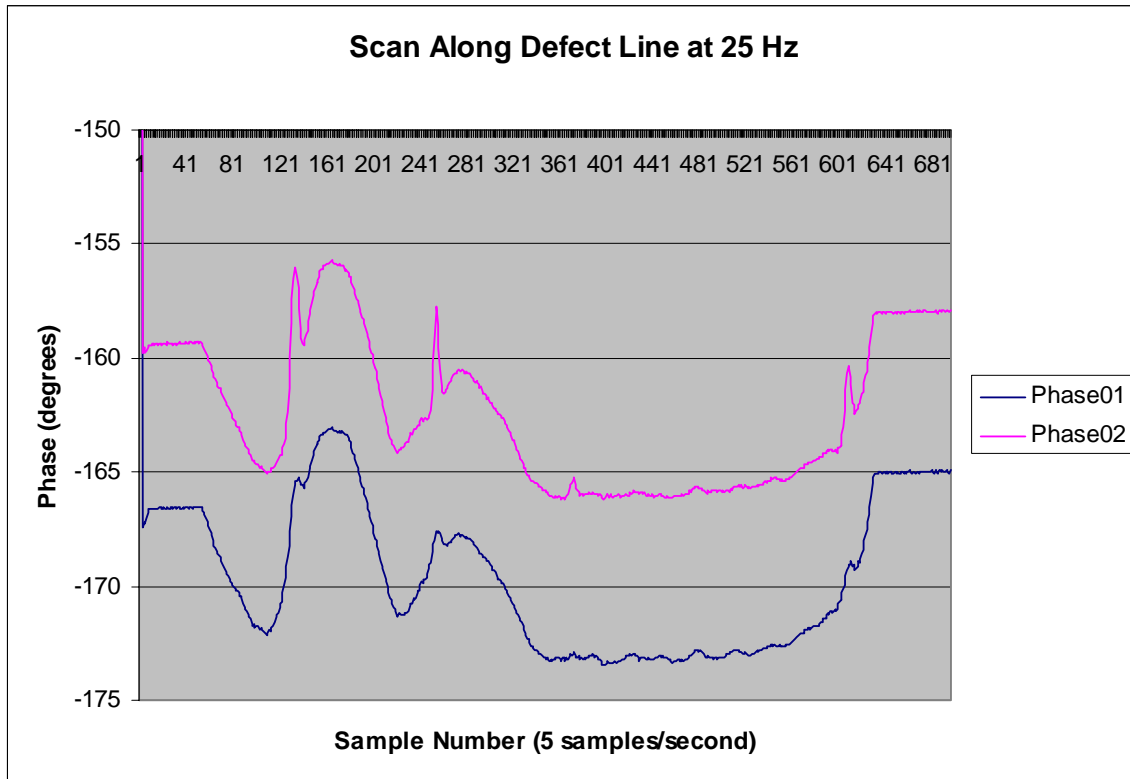
We have observed that changes in permeability, the magnetic property of the pipe, affect the amplitude and phase response of the RFEC. To date we rely on the small lengths of the artificial flaws to distinguish between flaws and permeability changes. In Figure 25 below the sharp spikes from coil 2 (Phase02) at 121, 250, 370, and 601 are artificial flaws while the gradual peaks at 161 and 281 are permeability changes caused by pipe magnetization. We realize that real corrosion can be much longer and that it may be more difficult to distinguish between them.

Figure 25: Defect scan at 25Hz

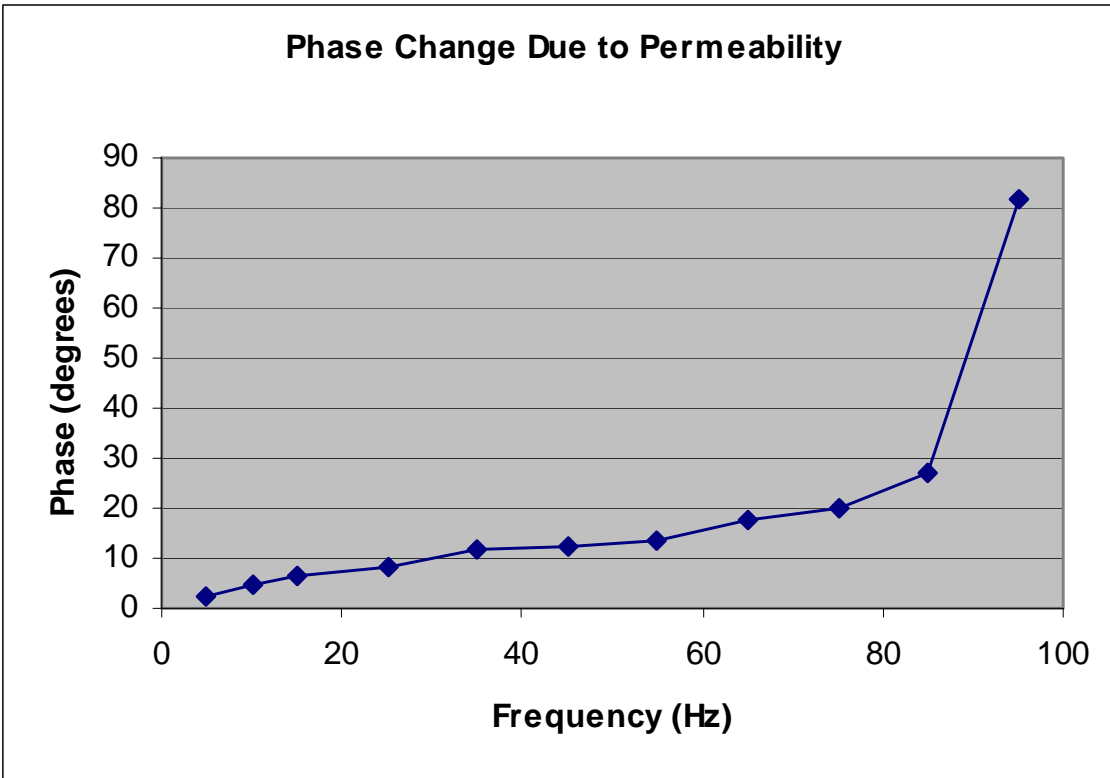
The difference in phase between two locations with different permeability was plotted against frequency and found to also be linear with a sharp increase at 95 Hz. This plot is shown in Figure 27. The similarity of the responses indicates that it may be difficult to distinguish between permeability and gradual thickness changes using phase alone. We expect better results analyzing data in the complex plane. The behavior at higher frequencies is still puzzling and we plan on investigating it in more detail.

Figure 27: Phase change due to permeability
