# Flight Testing of an Advanced Airborne Natural Gas Leak Detection System

TYPE OF REPORT: **Final**

**DOE AWARD NUMBER:** DE-FC26-03NT41877

**ITT INDUSTRIES SPACE SYSTEMS, LLC  
1447 ST. PAUL STREET  
ROCHESTER, NY 14653**

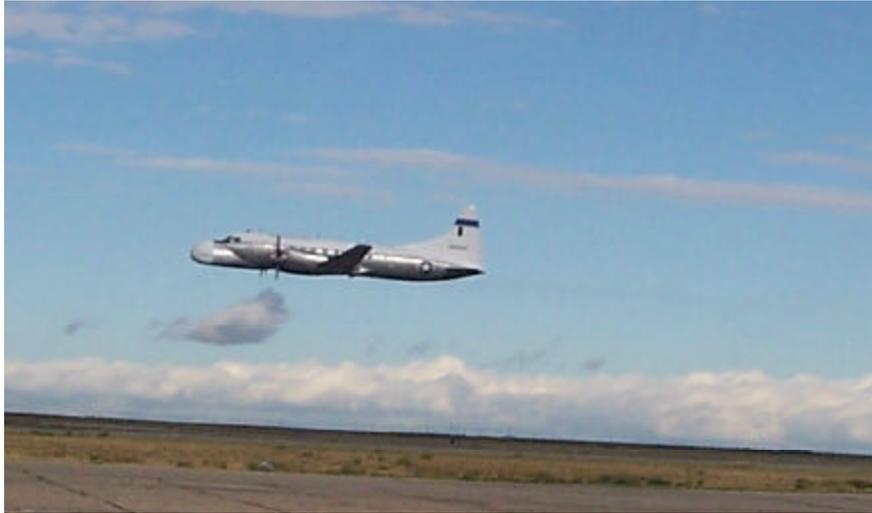
*Figure 6. Space Systems’ ANGEL System test aircraft – General Dynamics Convair 580 (NC-131H) turboprop landing at the Natrona County International Airport, Casper, Wyoming*

The airborne portion of the ANGEL System consisted of a test aircraft and an integrated sensor payload. The test aircraft used was a modified Air Force owned Convair 580 (NC-131H) Turboprop known as the Total In-Flight Simulator (TIFS), operated by General Dynamics. This aircraft was used for both Early Flight Testing and for the Field Test at RMOTC. The TIFS aircraft shown in Figure 6 is illustrated in Figure 7. Although the ANGEL System was later integrated into a much smaller (and more economical) Cessna Grand Caravan following early flight tests, the TIFS aircraft was chosen for early flight tests in order to accelerate the development schedule and allow the ITT team to participate in the DOE sponsored RMOTC field test in Wyoming. The TIFS aircraft is a very large and very powerful test aircraft with ample room for the sensor and multiple operators, easy access to the sensor once installed, ample

electrical power, payload carrying capacity, and a history of carrying FAA approved experimental payloads. The skilled General Dynamics test pilots, flight crew, and ground crews mitigated the risk of conducting early flight tests on an accelerated schedule. Early integration and testing in the TIFS aircraft greatly simplified the later integration of the sensor into the much smaller Cessna aircraft.

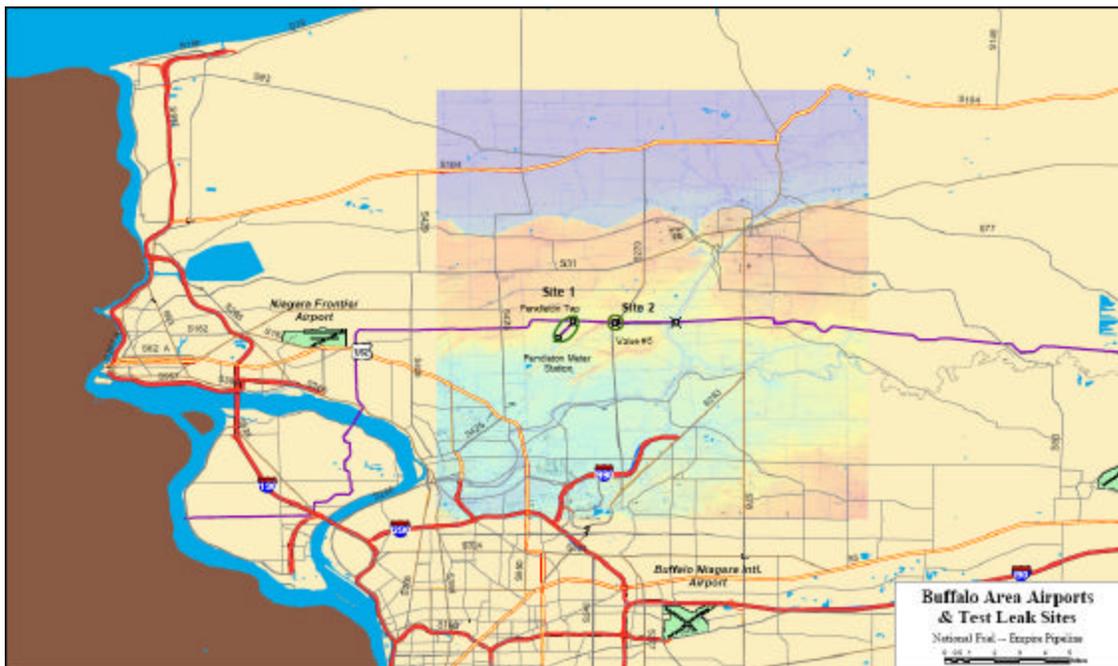
*Figure 11. Map showing the location of the Niagara Frontier Airport and 2 sites selected for possible simulated leaks along the Empire Pipeline (shown in purple).*

Over the summer of 2004 the Space Systems team worked with National Fuel gas Pipeline Company in upstate New York with the goal of creating a series of simulated leaks along actual pipeline Rights-of-Way in Upstate New York. Early planning efforts included a physical survey of the Empire Pipeline and an assortment of other National Fuel lines and facilities between Rochester and Buffalo. Two sites along the pipeline were selected as ideal for the creation of moderate to large natural gas leaks (Figure 11). The sites chosen were on property owned by National Fuel, close to the airport and away from public roads. Ultimately only the sites closest to the airport were used to create simulated leaks.

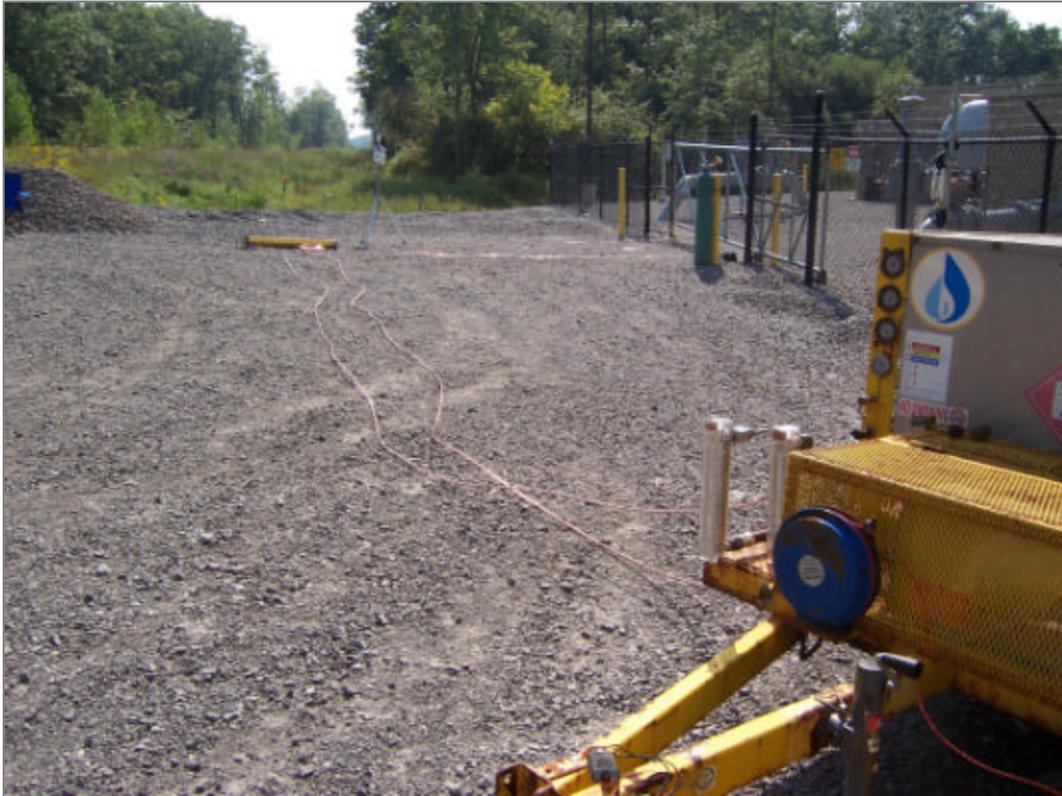
*Figure 12. Image of a simulated natural gas leak site along a pipeline right-of-way near Buffalo, New York.*

During early flight testing, National Fuel supplied gas for the simulated leaks using a set of portable high pressure natural gas storage tanks mounted on a trailer. Gas from these tanks was run through a 2-stage regulator to control the release rate and flowed through a 30 foot length of copper tubing to the actual release site. A flow meter was used to accurately set the regulator to a given release rate before each ITT Industries ANGEL System overflight. At the actual simulated leak site the copper tube was run to the bottom of an 18 inch deep post hole filled with coarse gravel. A heavy weight was placed on the copper tube at the leak site to prevent movement of the copper tube during large releases. Calibrated natural gas leaks from near 0 to 5,000 standard cubic feet per hour (scfh) were possible with this setup (Figure 12).

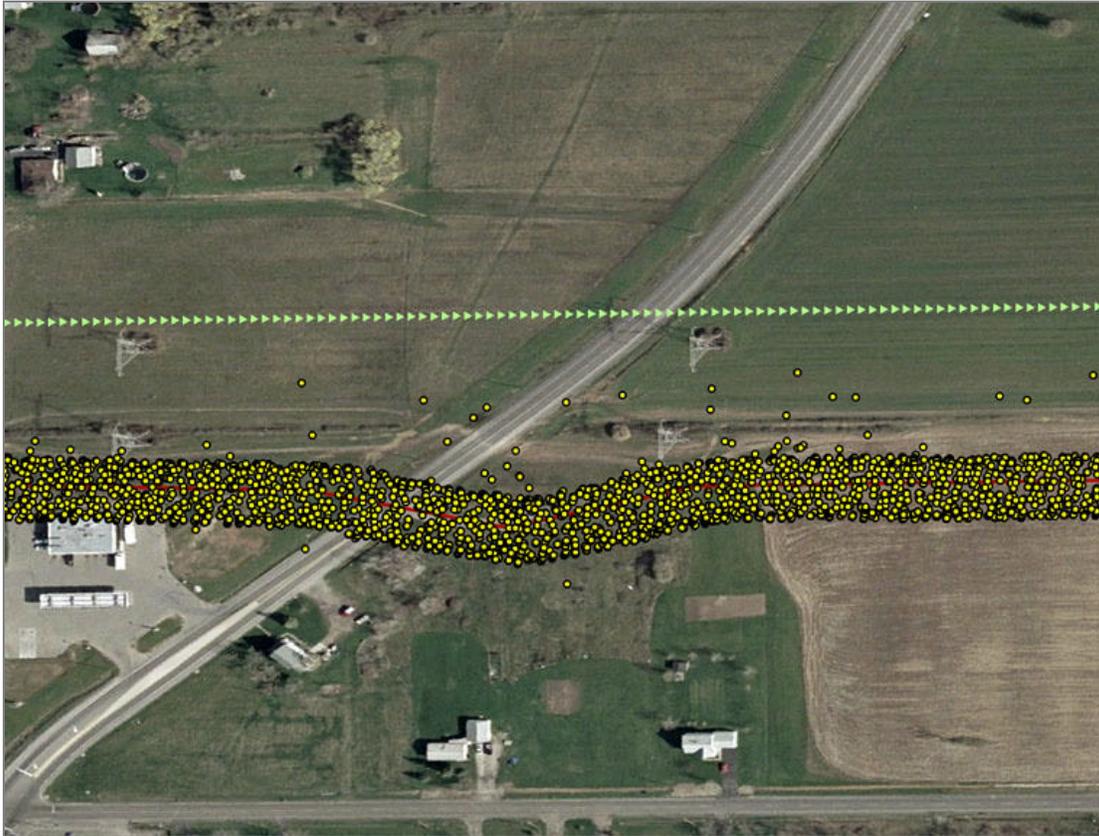
*Figure 13. A geo-referenced color image of the pipeline right-of-way is used as a base GIS raster imagery layer. The GIS vector layer of the pipeline supplied by National Fuel is indicated in red, the track of the ANGEL system aircraft as it flew the line is marked in green. Yellow dots indicate the position of individual laser spots along the inspection swath of the DIAL system.*

One major advantage of selecting the Empire Pipeline system for flight testing was the availability of recently acquired GIS information for these lines. GIS information supplied by National Fuel combined with GPS locations of selected simulated leak sites were used to create Mission Planning files to guide the pilot and point the sensor. GIS information from National Fuel was draped over publicly available 1-meter geo-referenced imagery of the area (Figure 13) to roughly verify the accuracy of the GIS data and ultimately to provide context to the data collected.

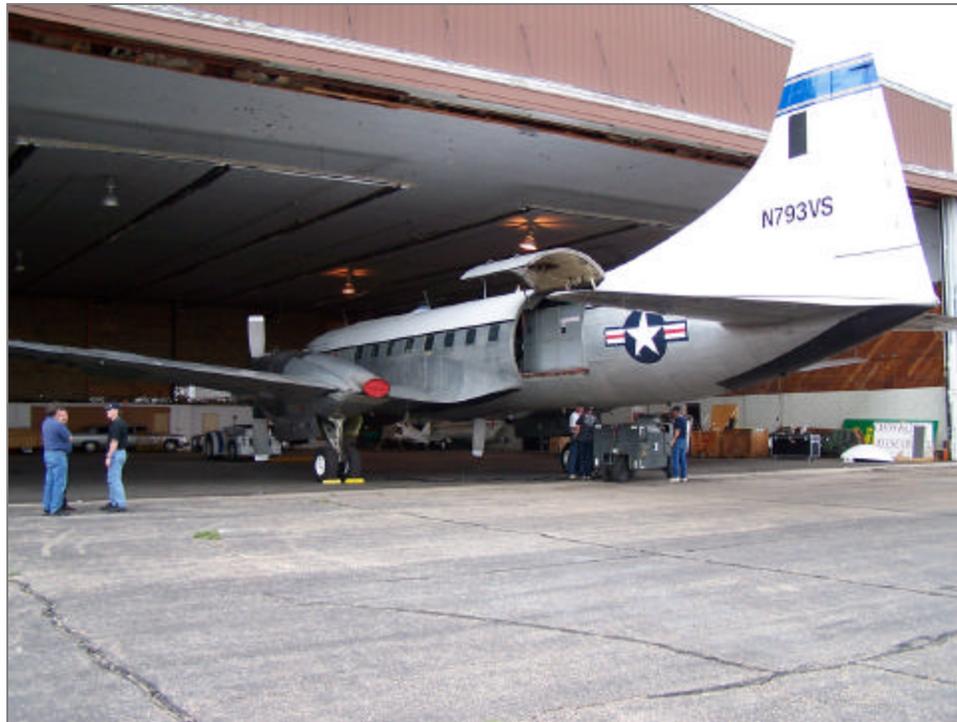
*Figure 19. ITT Industries ANGEL system test aircraft in Casper, Wyoming*

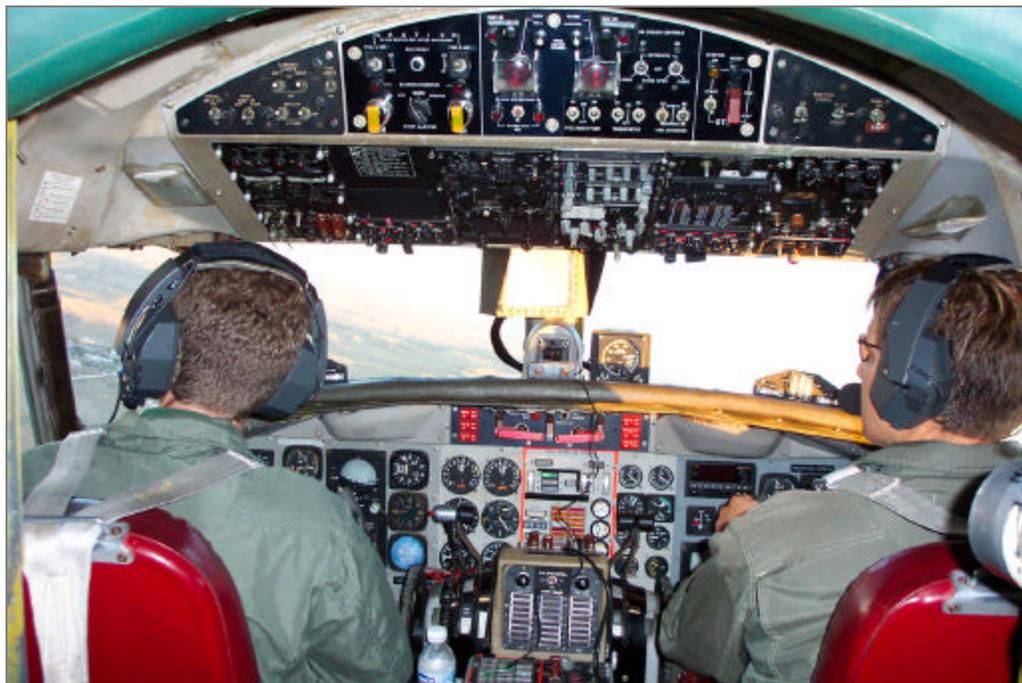
*Figure 21. Pilots view of the RMOTC test area from 1,000 feet*

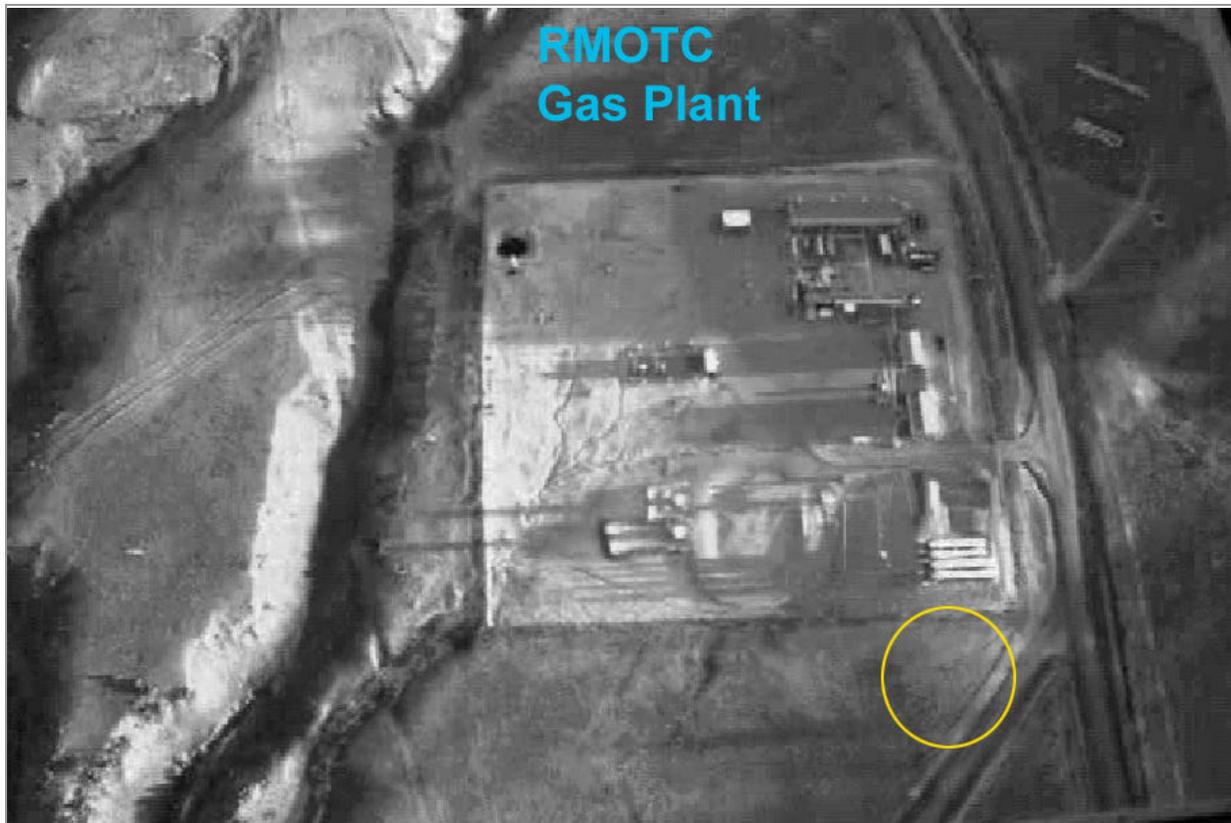
The ANGEL aircraft has been fitted with a monochrome video camera that is used for flight path verification. This camera collects looking forward at 15 degrees from nadir and provides MPEG2 motion video imagery with approximately 1.4 ft raw GSD resolution. A sample frame is shown below from one of the PM passes. The video camera currently in use was designed only to provide engineering flight test information. It will soon be replaced with a much higher resolution color and false color IR digital camera designed to collect a continuous strip of geo-referenced imagery as the sensor is flown along the pipeline right-of-way. The image below was acquired during a PM run as the ANGEL aircraft was inspecting the pipe from North to South. The yellow circle indicates the approximate area North of the RMOTC Gas Plant in which elevated levels of methane were detected.

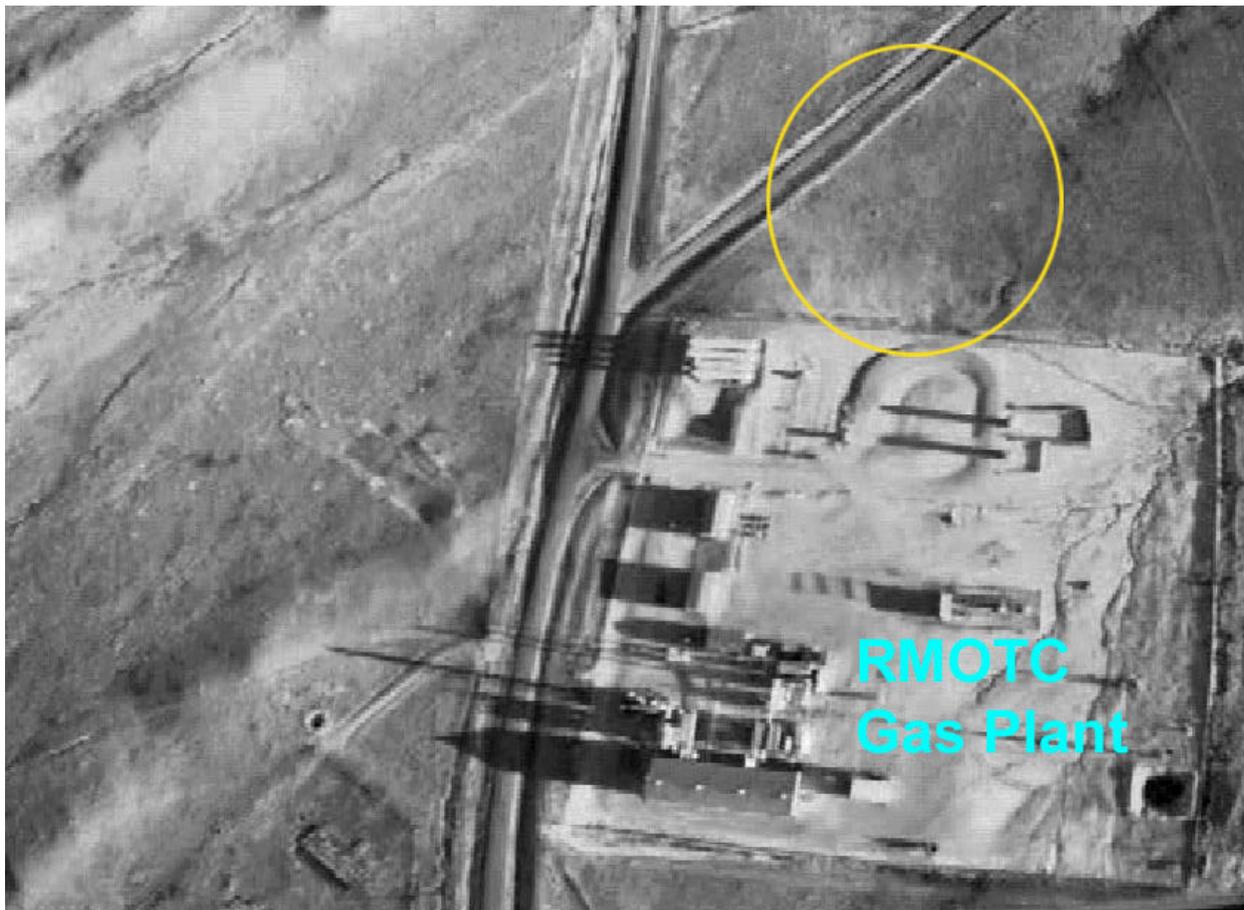
In image of the RMOTC Gas Plant shown below was captured during an early AM S to N pass. The yellow circle North of the Gas Plant indicates the approximate position of elevated methane levels detected throughout the day on Friday 9/17/2004.

The ANGEL aircraft has been fitted with a monochrome video camera that is used for flight path verification. This camera collects looking forward at 15 degrees from nadir and provides MPEG2 motion video imagery with approximately 1.4 ft raw GSD resolution. The video camera currently in use was designed only to provide engineering flight test information and will soon be replaced with a much higher resolution color and false color IR digital camera designed to collect a continuous strip of geo-referenced imagery as the sensor is flown along the pipeline right-of-way.
