FIELD TESTING OF REMOTE SENSOR GAS LEAK DETECTION SYSTEMS

Final Report for the Period of September 11 – 17, 2004

U.S. Department of Energy
Rocky Mountain Oilfield Testing Center
907 North Poplar, Suite 150
Casper, Wyoming 82601

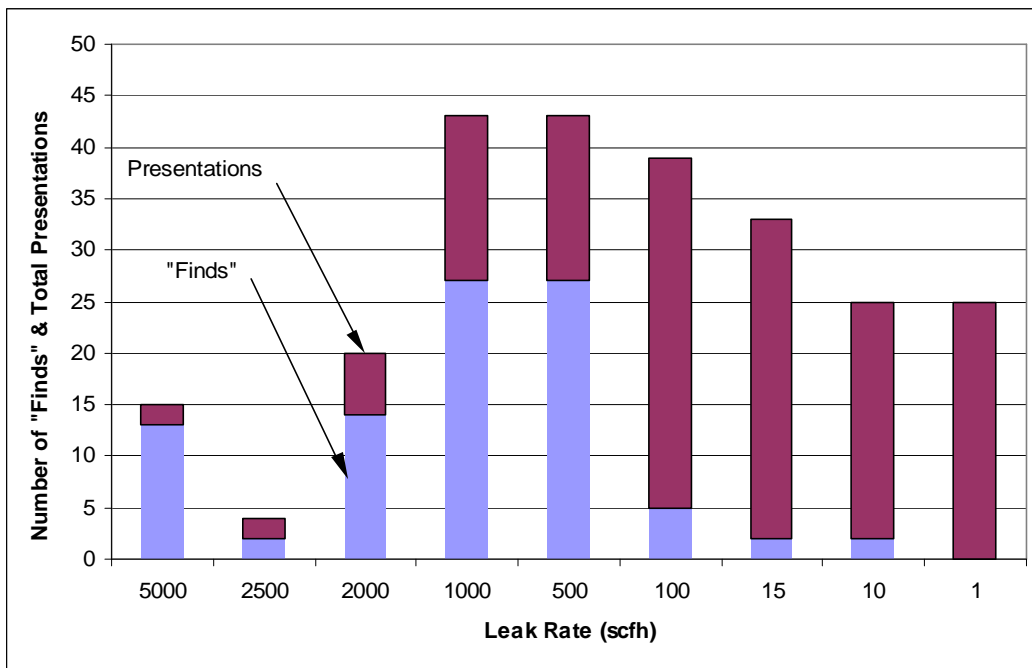
Figure 4.1 Instrumentation Sensitivity to Leak Rates – Bar Chart

There was a major difference in overall performance of the leak detection equipment to detect leaks between 100 scfh and 500 scfh.

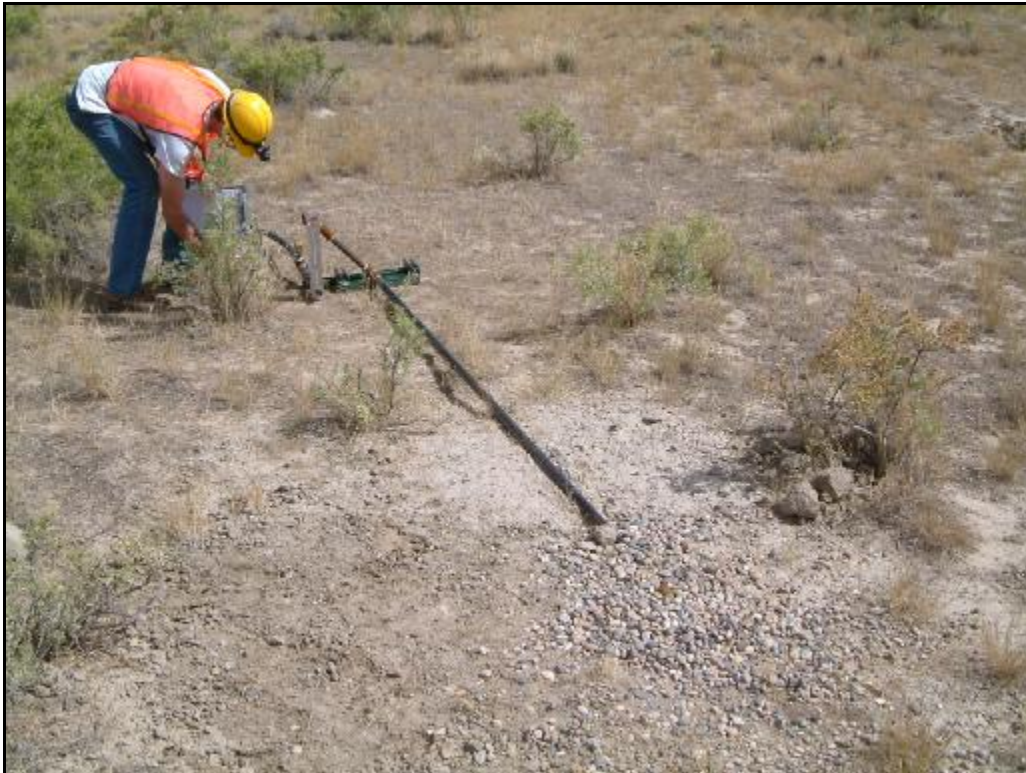
Site 4 – Underground leak emitting through gravel.

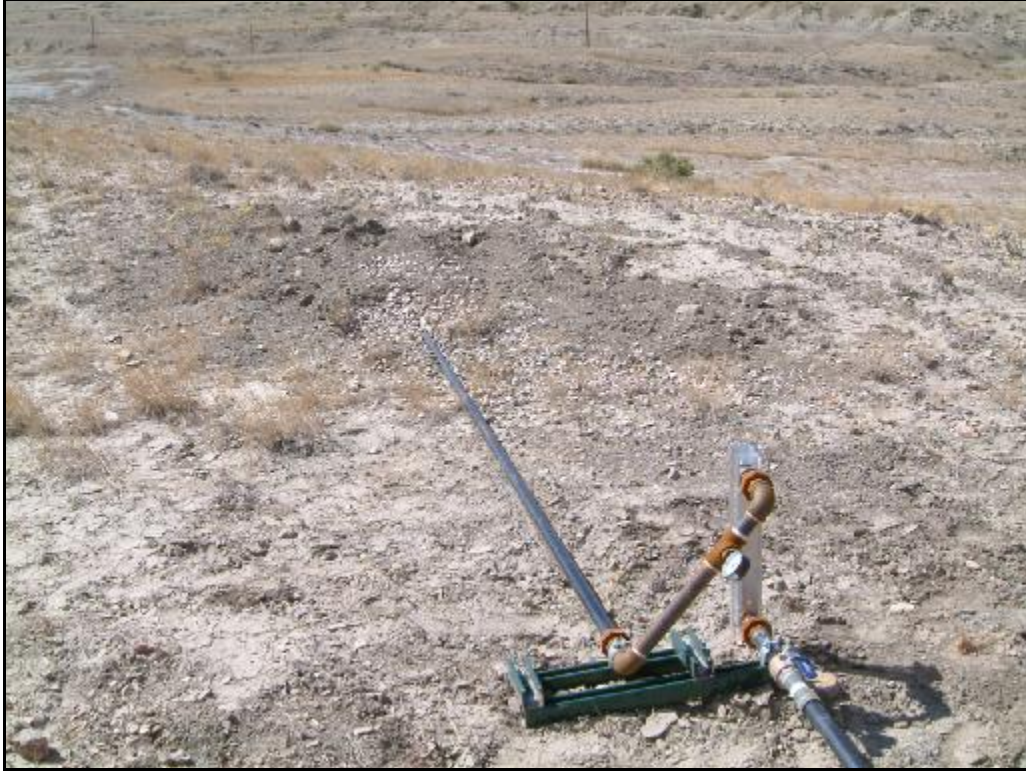
Site 6 – View at the top of the hill. Underground leak at gravel located approximately 10 feet from the rotometer.

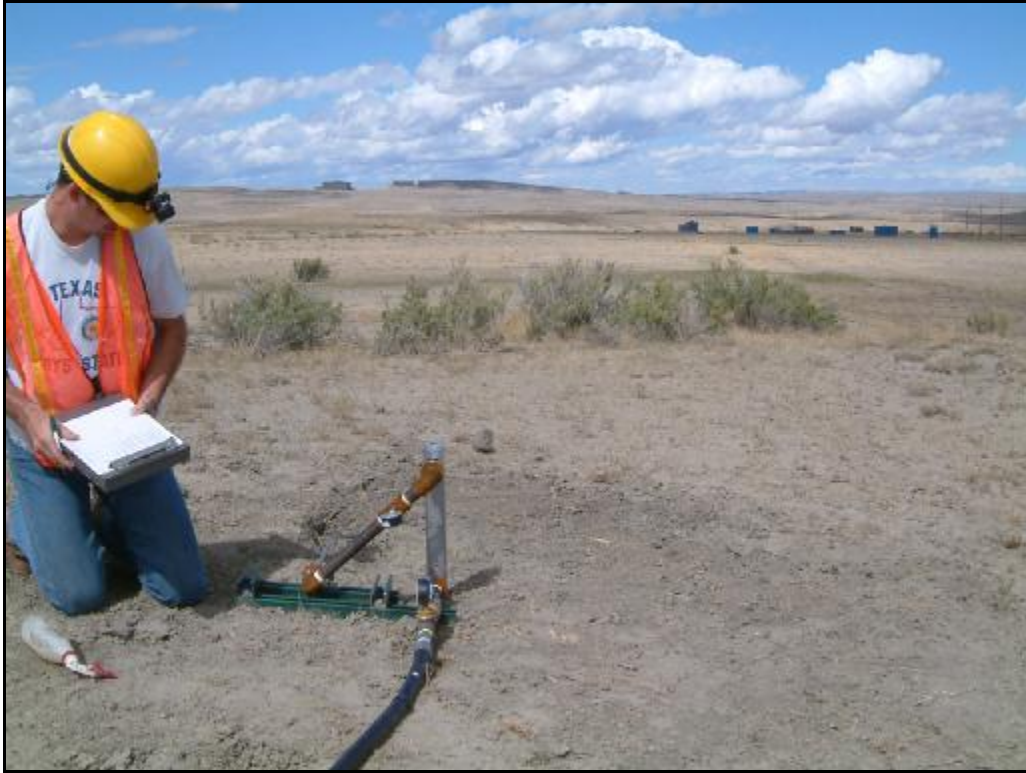
Site P2 – View of leak site and vegetation. The gas leak emits underground near the middle of the greasewood bushes.

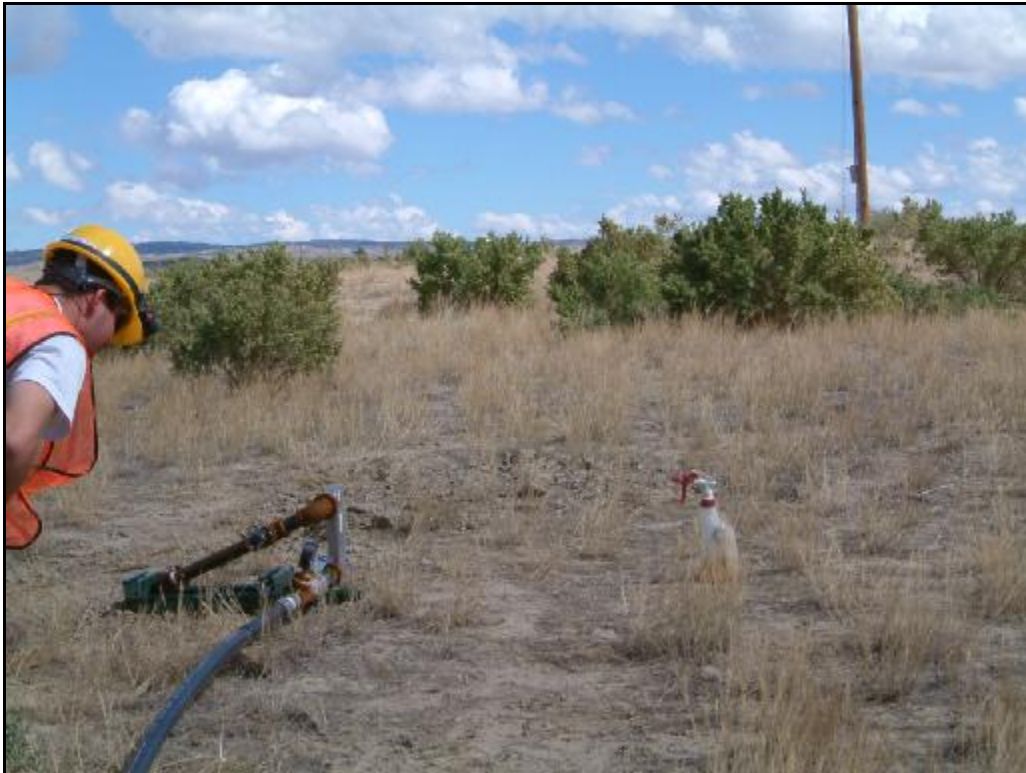
Site P3 – View of leak site and vegetation. The gas leak emits near the middle of the greasewood bushes.

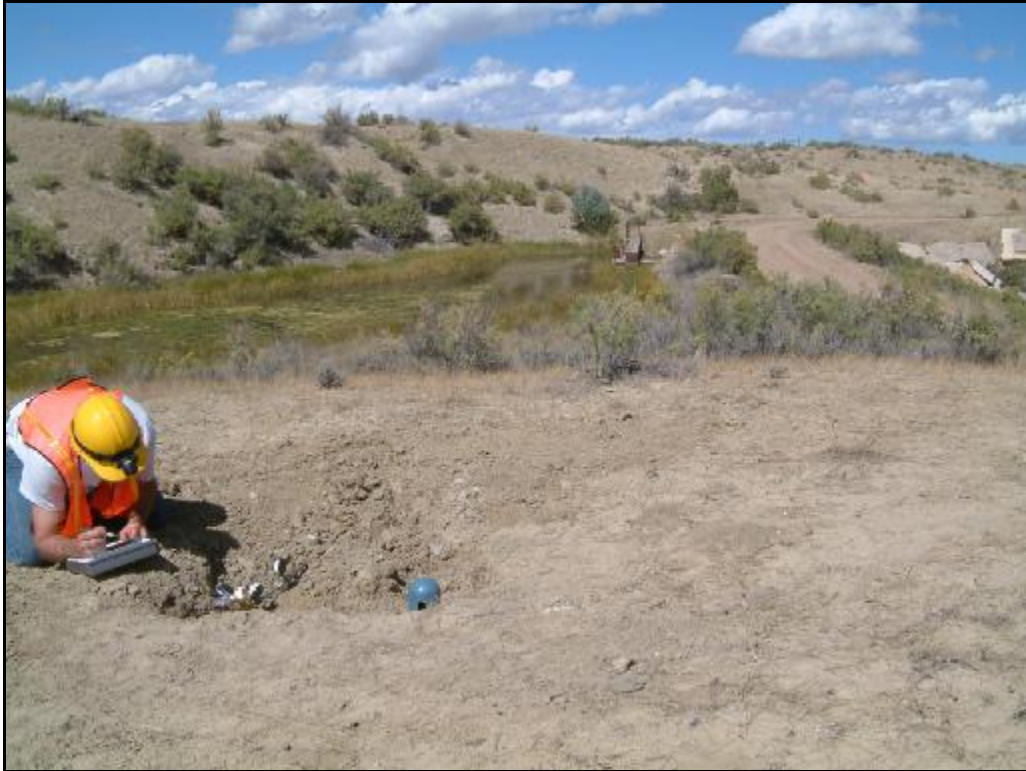
Site P5 – View of site and vegetation. The leak emits beneath the greasewood bushes in the middle of the picture.

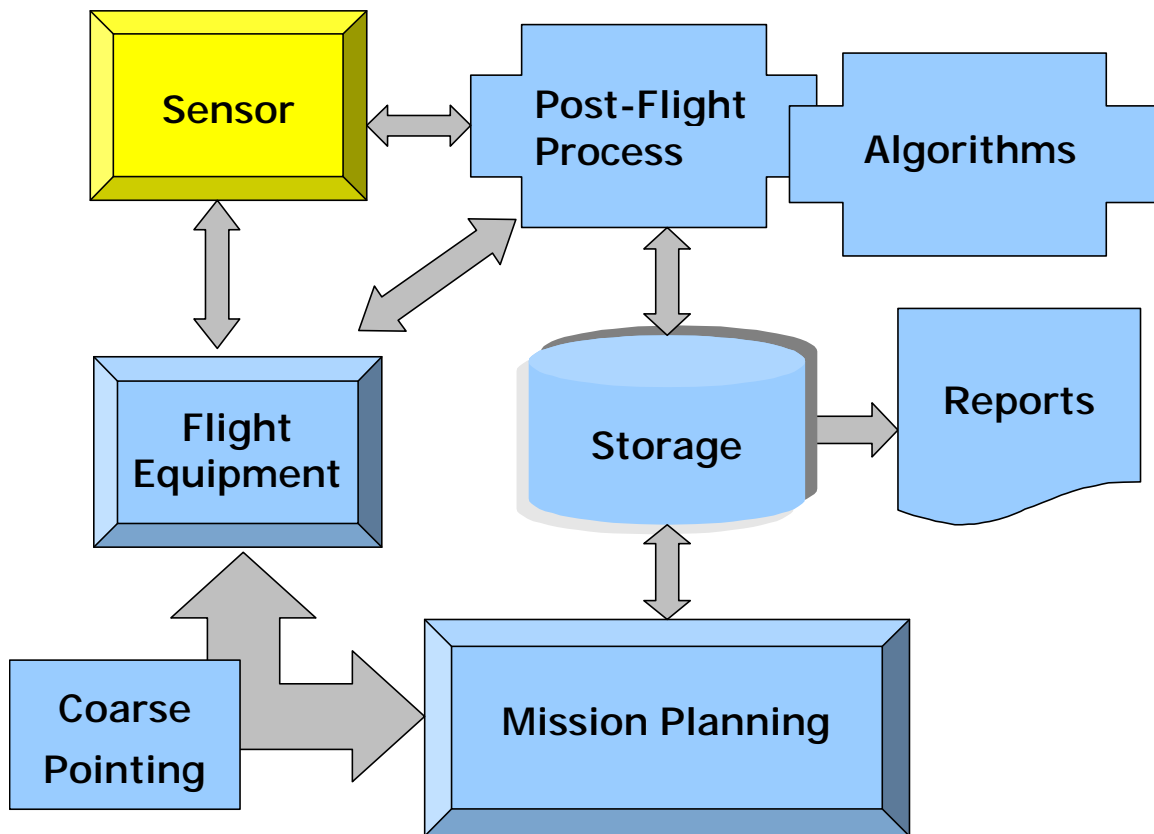
Figure 2.0.1 Data Collection and Reduction Scheme

Figure 2.0.1 is a block diagram of the data collection and reduction scheme as used for the tests at RMOTC.

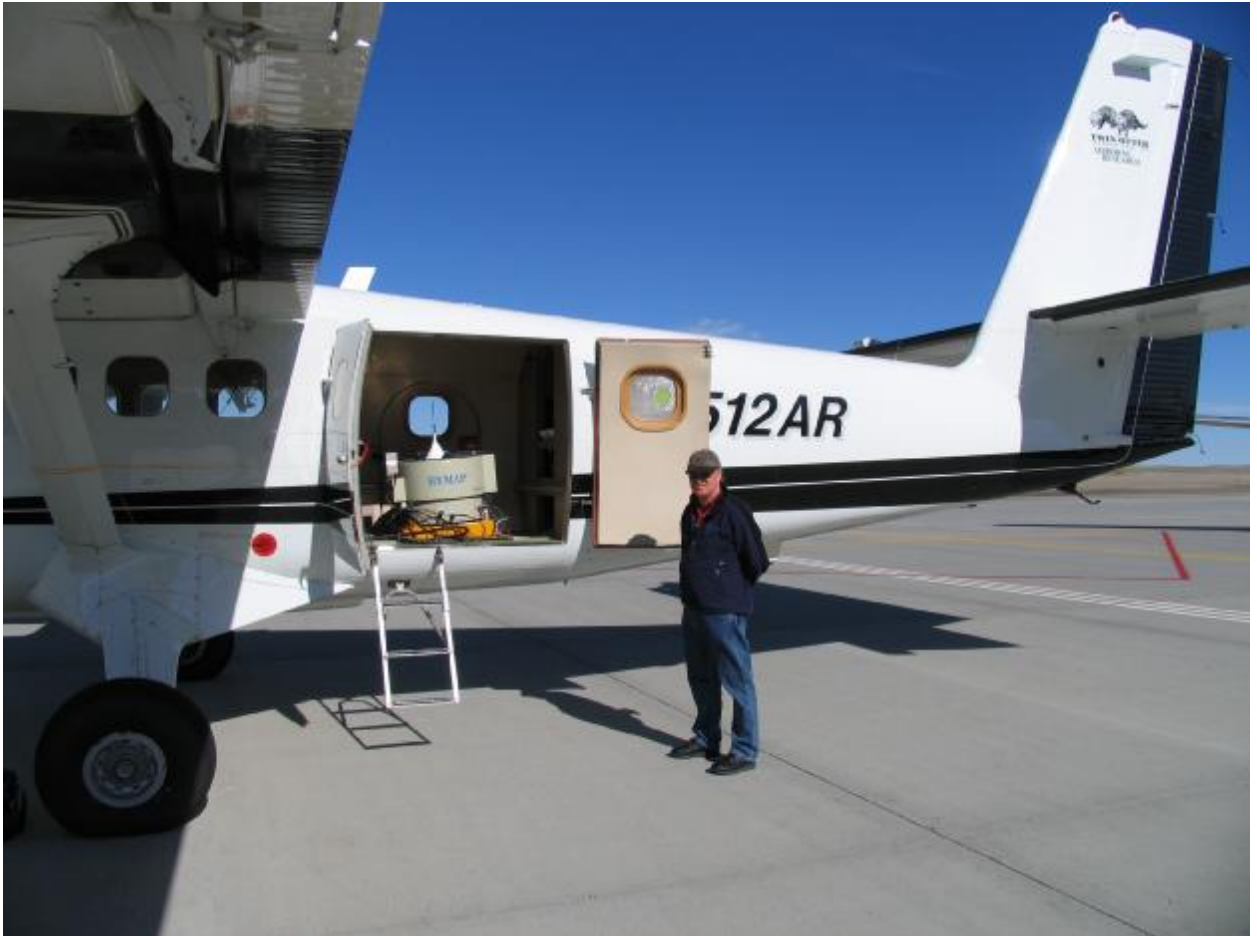
Figure 1 The HyMap sensor is white sitting on the stabilizing platform that is yellow inside the Twin Otter manned aircraft. Mike Hornibrook who is the HyVista operator is shown standing outside side the hatch doors.

The hyperspectral imaging spectrometer is mounted in a Twin Otter aircraft, which has a view hole cut in the bottom of the plane. The sensor is mounted on a stabilizing platform, which contains an inertial measuring unit (IMU). The stabilizing platform maintains the sensor axis angle with respect to the earth below in spite of the motions of the aircraft. The stabilizing platform and sensor combination are mounted over the hole in the bottom of the aircraft. The sensor and the stabilizing platform are controlled by a computer which is rack mounted in the plane near the sensor stabilizing platform combination. The photo in Figure 1 below shows the sensor as white labeled HyMap and the stabilizing platform, which is yellow inside the Twin Otter. The HyVista sensor operator, Mike Hornibrook, is standing at the open hatch doors.
