## **DEVELOPMENT OF INTERNAL (TRENCHLESS) REPAIR TECHNOLOGY FOR GAS TRANSMISSION PIPELINES\***

W. A. Bruce, D. D. Harwig,  
I. D. Harris and J. R. Gordon  
**Edison Welding Institute**  
Columbus, Ohio

\* For presentation at Natural Gas Technologies II, GTI Conference & Exhibition, February 8-11, 2004, Phoenix, Arizona.

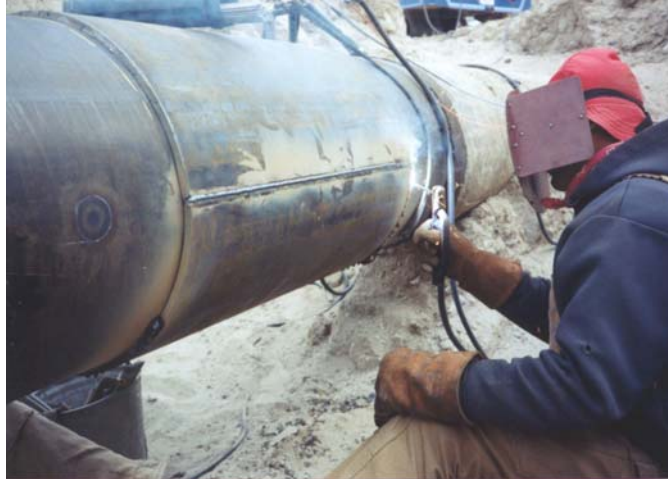
**Figure 1 - Installation of a Welded Full-Encirclement Steel Repair Sleeve**

The most common cause for repair of gas transmission pipelines is external, corrosion-caused loss of wall thickness. To prevent an area of corrosion damage from causing a pipeline to rupture, the area containing the corrosion damage must be reinforced. Other pipeline defects that commonly require repair include internal corrosion, original construction flaws, service-induced cracking, and mechanical damage. Defects oriented in the longitudinal direction that have a tendency to fail from hoop stress (due to pressure loading) must be reinforced in the circumferential direction, while defects oriented in the circumferential direction that have a tendency to fail from axial stresses (e.g., pipeline settlement) must be reinforced in the longitudinal direction. The most commonly used method for repair of gas transmission pipelines is the installation of welded full-encirclement steel repair sleeves (Figure 1). These sleeves resist hoop stress and, if the ends are welded to the pipeline, can resist axial stresses.

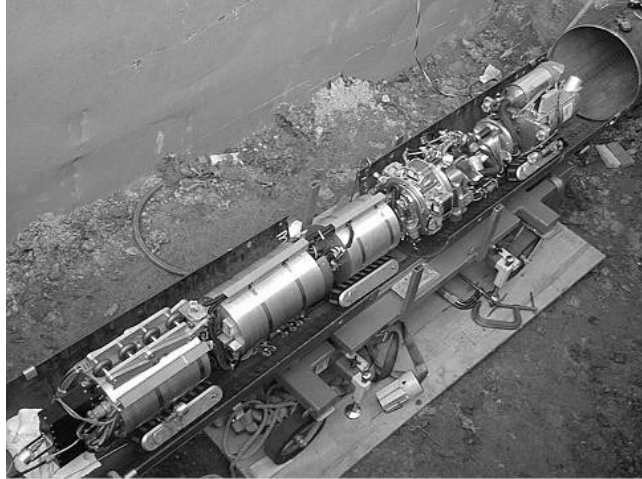
Pacific Gas and Electric Company (PG&E) has developed the Internal Pipeline NDE System (IPNS) for internal inspection of gas pipelines (Figure 2). This system incorporates a variety of inspection technologies to characterize girth and long seam flaws, corrosion, and dents and gouges. A grinder is incorporated for preparation of areas of interest. The system has been in field use since 1996 and has a maximum range of 2,500 ft. The robot is self-propelled using tracks and is able to traverse 90-degree bends in 22- to 24-in.-diameter pipe. An umbilical is used to supply power and to control the device. Preliminary development work was performed for a companion system to perform machining and welding of defective welds. While not a welding system, IPNS demonstrates the practicality of performing work inside gas pipelines at extended distances from the entry point.

**Figure 2 – Pacific Gas & Electric Internal Pipeline NDE System**

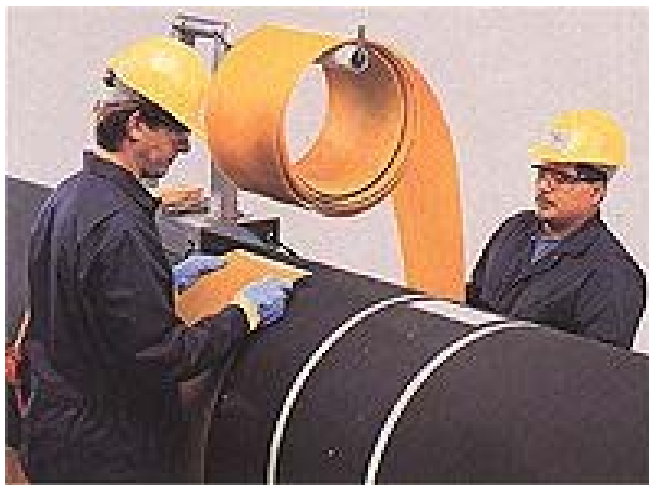
Fiber-reinforced composite repairs are becoming widely used as an alternative to the installation of welded full-encirclement steel sleeves for repair of gas transmission pipelines. These repairs typically consist of glass fibers in a polymer matrix material bonded to the pipe using an adhesive (Figure 3). Adhesive filler is applied to the defect prior to installation to allow load transfer to the composite material. The primary advantage of these repair products over welded full-encirclement steel repair sleeves is that the need for welding is precluded.

**Figure 3 - Installation of a Fiber-Reinforced Composite Repair Device**

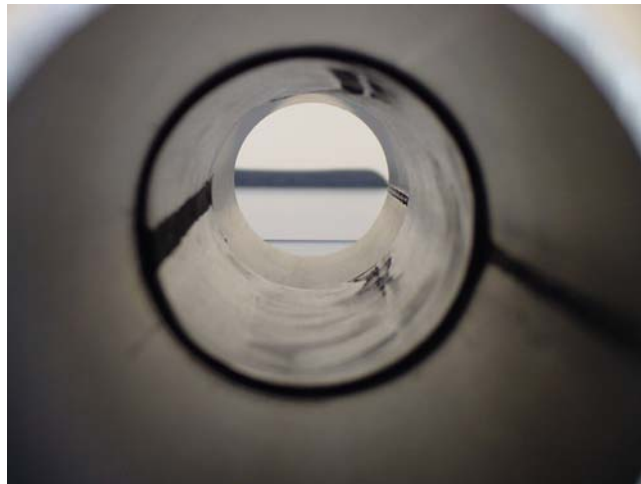
A supply of 4.5-in.-diameter  $\times$  0.156-in. wall thickness API 5L Grade B pipe material was procured and cut into four sections approximately 4-ft long. After the inside surface was degreased, lengths of lining were installed into two of the pipe sections. The installation process consisted of inserting a silicon rubber bag inside the liner and locating the liner inside the pipe. The silicon bag was then inflated to press the liner against the pipe wall. For these experiments, the entire pipe sections were then heated in an oven to approximately 400°F to fuse the liner to the pipe wall. Possible choices for liner installation in the field include infrared (IR) heaters on an expansion pig or a silicon bag inflated using hot air. An installed liner is shown in Figure 6.

**Figure 6 - Liner Inserted into Center of 4.5-in.-Diameter Pipe**

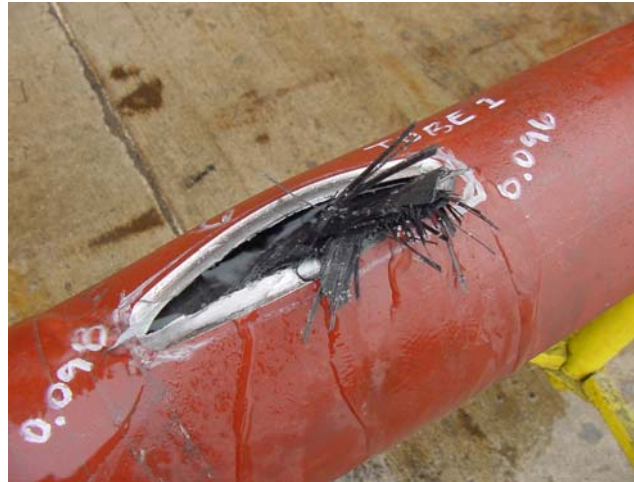
All four pipe sections failed in the areas of simulated corrosion damage. Both pipes with long shallow damage representative of general corrosion resulted in ruptures (Figure 7). The two pipes with short, deep damage representative of a deep isolated corrosion pit developed leaks. The failure pressures for the pipes with the liners were only marginally greater than the pipes without liners (i.e., 3472 vs. 3431 psi for the pipe samples containing long shallow damage and 4031 vs. 3750 psi for the pipe samples containing short, deep damage). This indicates that the liners were generally ineffective at restoring the pressure-containing capabilities of the pipes.

**Figure 7 - Pipe Section with Liner Following Hydrostatic Pressure Test**

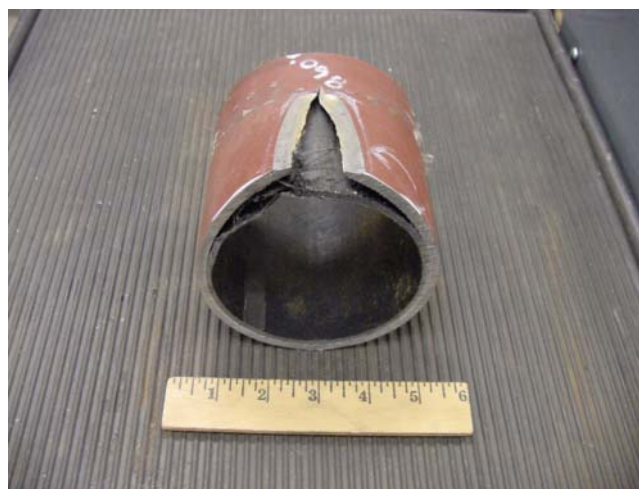
A postmortem analysis was conducted on the four hydrostatic burst tests in pipe sections with simulated corrosion. To avoid damage to the liner, water jet cutting was used to section the pipe sample containing the round-bottom longitudinal slot with the liner installed (Figure 8). The results indicated that the liner did rupture, and that disbonding was not an issue.

**Figure 8 - Water-Jet Cut Section through Pipe Section with Liner**

Further analysis indicated that the difference in modulus of elasticity between the steel and liner materials prevents the liner from carrying its share of the load. The modulus of elasticity for steel is approximately  $30 \times 10^6$  psi. Tensile testing was carried out to determine the modulus of elasticity for the glass/polypropylene liner material that was used. The mean value for the modulus of elasticity for the liner material was measured to be approximately  $2.2 \times 10^6$  psi. Because the liner material had a significantly lower modulus of elasticity than the steel pipe, as pressure in the lined pipe increases, the stiffness of the steel prevented the composite liner material from experiencing enough strain to share any significant portion of the load. Therefore, the mechanical properties of this liner material were inadequate for internal pipe repair.

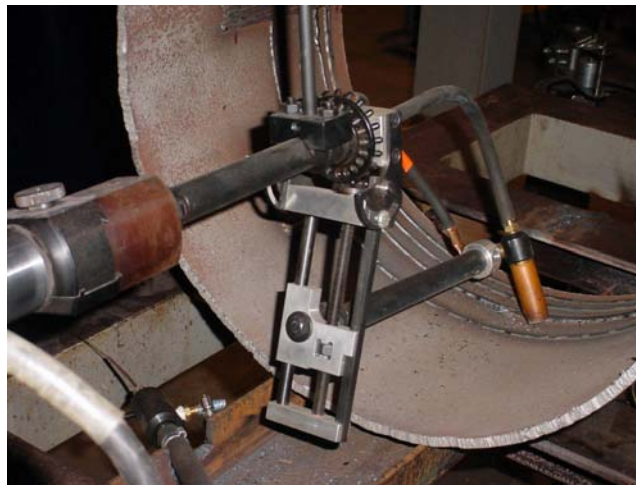
The Bortech system was selected initially because it is affordable, uses simple motors for motion, and has simple controls for operating constant voltage (CV) power supplies (Figure 9). It was necessary to purchase and install a counterbalance to offset the weight of the opposing torch.

**Figure 9 - Bortech Internal Bore Cladding System**

Preliminary weld trials with the Bortech system using an 0.035-in.-diameter ER70S-6 filler metal (i.e., electrode) produced marginal results. Only stringer beads could be deposited using short-circuit transfer in the spiral-clad mode. With stringer beads, the deposition rate was low since only narrow beads could be deposited. The bead shape suffered the most in the overhead position when starting downhill. The Bortech system does not allow torch weaving, which is required to improve weld bead profile thus allowing higher deposition rates and improved fusion. In principle, the Bortech system could be made suitable for an internal repair system. Anti-backlash servo-motors and gears, and programmable controls would be required, as well as an additional motor drive to permit control of the torch and work angle.

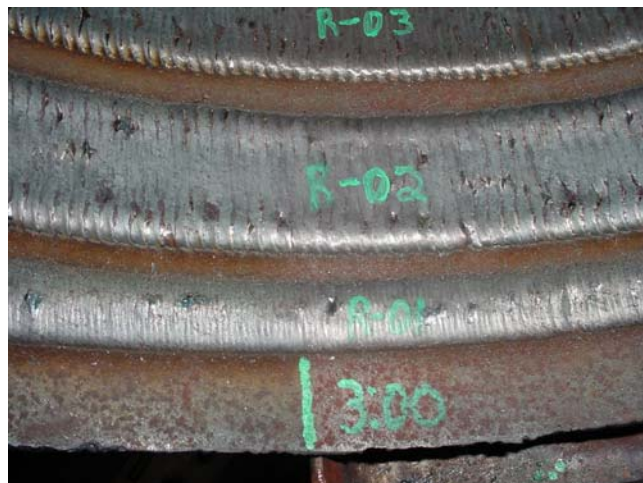
Using the robot welding system, orbital welding parameters using weaving were developed for several bead widths (Figure 11). The pipe is near room temperature when welding is initiated. In general, most weld starts appeared more convex because of this. The weld bead profile slowly changes as steady-state temperatures are achieved in the pipe wall. The development of welding parameters was based on optimizing the bead shape in the steady-state condition. In practice, a programmable weld controller could be used to increase the welding heat input at the weld start. This would provide better weld bead start quality. As steady-state temperatures are achieved, the start parameters could be transitioned to steady-state parameters to provide uniform bead shape.

**Figure 11 - Typical Bead Shapes in Steady-State Condition**

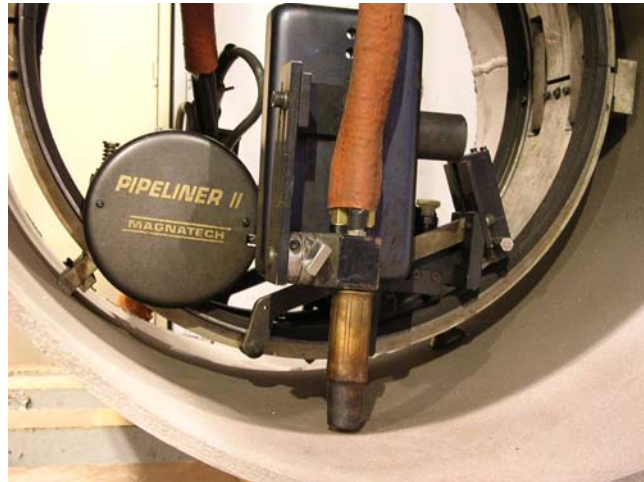
Several years ago, PG&E purchased a welding tractor from Magnatech for internal weld deposition repair procedure development (Figure 12). Since the robot welding system is not portable, the Magnatech system was sent to EWI so it could be used for further parameter development and demonstrations. The Magnatech welding tractor has orbital motion with controls for torch oscillation. The system is limited to a finite number of revolutions that can be made before cables need to be unwound. The controls are analog and do not have high accuracy; however, they are sufficient for preliminary parameter development and demonstration welding.

**Figure 12 - Magnatech ID Welding Tractor Capable of Spiral and Ring Motion with Oscillation**

The Magnatech tractor was interfaced to a Panasonic AE 350 power supply, which provides pulse waveforms and can be operated in a short-circuit mode where artificial intelligence is used to minimize spatter. The current pulsing and short circuiting helps lower heat input and improve deposition rate in out-of-position welds. Pre-programmed current waveforms are provided by algorithms for steel electrodes and many other materials.
