Sealing Large-Diameter Cast-Iron Pipe Joints Under Live Conditions

**Final Report
March 25, 2002 – September 24, 2005**

**By:
Kiran M. Kothari
(Gas Technology Institute)
and
Gerard T. Pittard
(Maurer Technology Inc.)**

DE-FC22-02NT41316

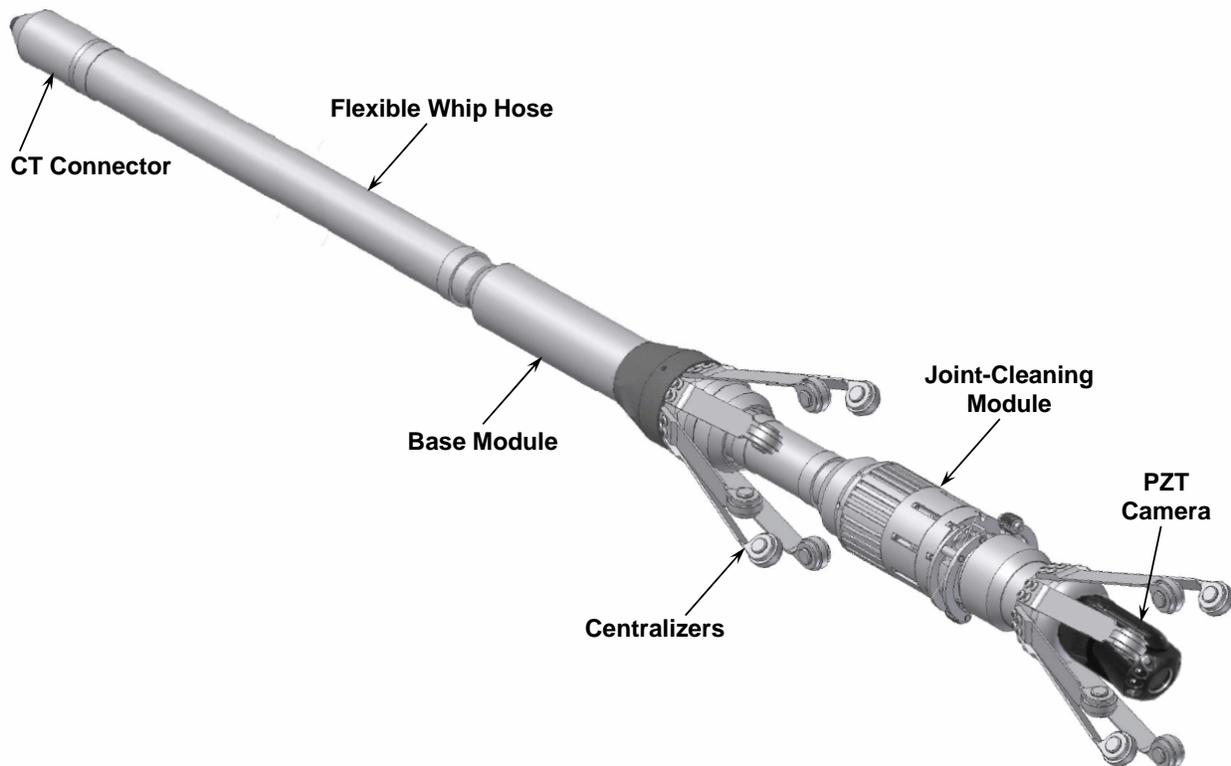
Figure 1. Pipe Wall Inspection/Preparation Robot Train

Two in-pipe robot trains are required. The first train (Figure 1) has a front-mounted PZT (pan/zoom/tilt) camera that is used to visually locate each bell-and-spigot joint (Figure 2). Directly behind this camera is a rotating brushing module whose function is to remove debris from the pipe wall immediately next to the cast-iron bell-and-spigot joint. The third module is a base module that houses all power and microprocessor control of the other modules. The base module is common to both trains.

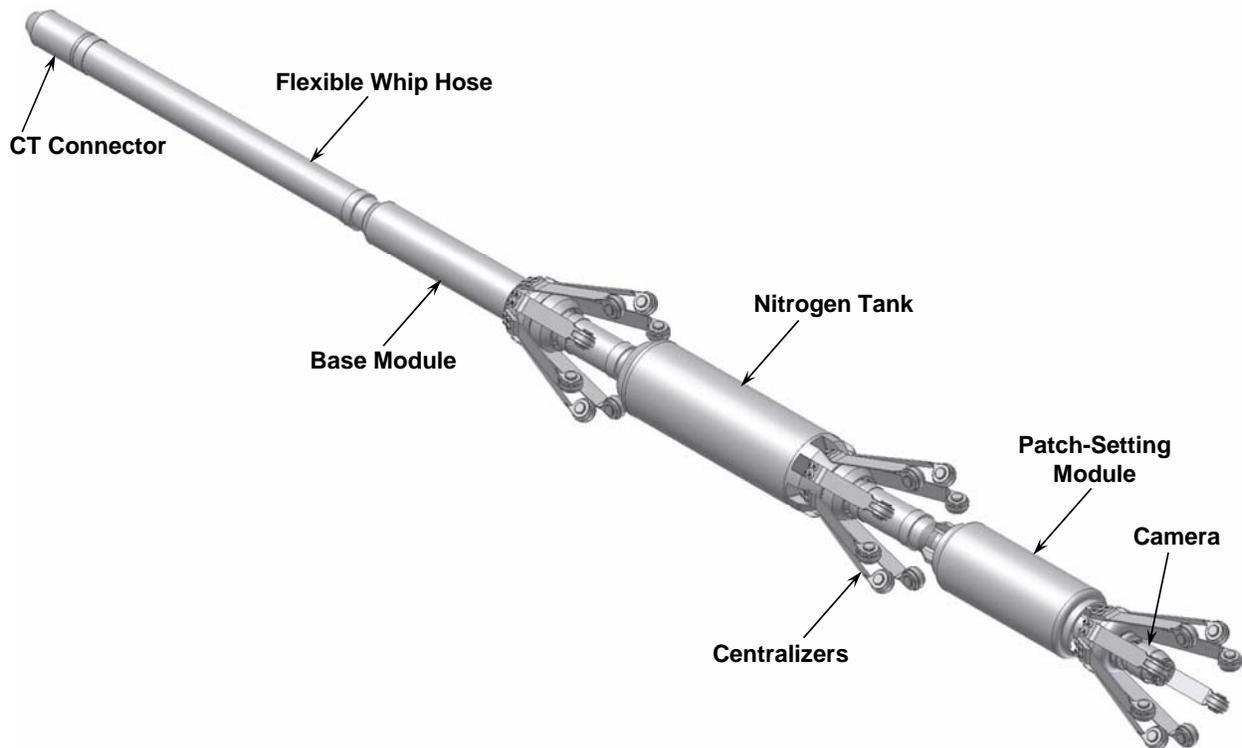
Figure 3. Patch-Setting Robot Train

The PZT camera and brush modules are then removed from the train and replaced with the patch-setting and nitrogen canister modules (Figure 3). A stainless-steel patch sleeve is prepared and then slid over the carrier along with its polymer sleeve and polyester felt, which is saturated with epoxy.

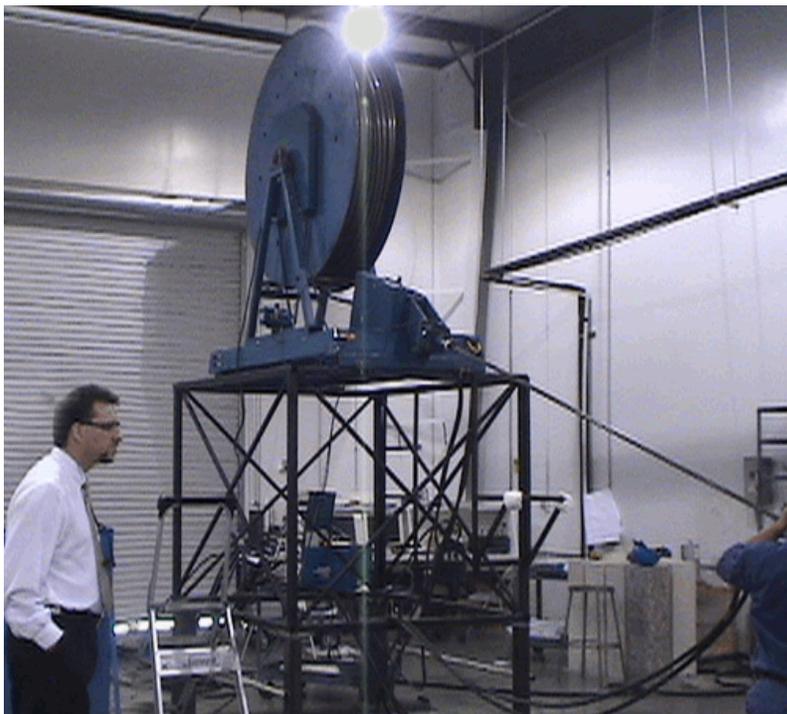
Figure 4. Coiled-Tubing Locomotion Unit

The CT surface unit (Figure 4) is then used to deliver the patch-setting train to the most distant bell-and-spigot joint. This location is confirmed both with the quadrature encoder footage counter and visually by camera. Once the camera is located exactly at the bell-and-spigot-joint gap, the fine-resolution odometer on the camera is set to zero. The CT unit is then used in conjunction with the camera's odometer to move the patch-setting train forward by a known, fixed distance which assures the patch is properly aligned with the bell-and-spigot joint. A control command is then issued from the surface unit to the base unit to release nitrogen from the stainless-steel pressure vessel behind the patch-setting module into the expandable rubber bladder. This causes the bladder to inflate and locks the stainless-steel sleeve into position via its interlocking, ratcheting barbs. The epoxy cures and reaches full strength within 12 hours. During the interim, a gas-tight seal is assured by the polymer sleeve which has been energized against the joint by the hoop stress of the stainless-steel sleeve.

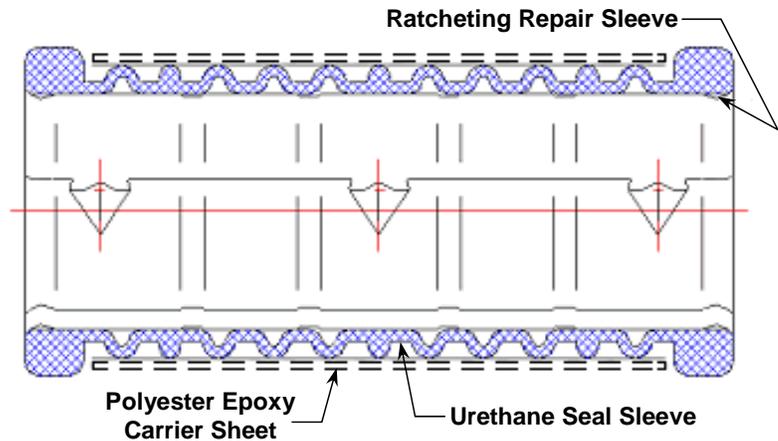
Figure 5. Ratcheting Repair Sleeve

Figure 5 illustrates critical design features of the new repair sleeve. A 28-gage, corrugated stainless-steel sleeve (316 SS) is used as the innermost member. Its function is to provide a mechanical means for energizing the urethane seal sleeve against the cast-iron wall to form the first leak seal and to allow the epoxy-saturated polyester carrier to cure to form a

second (redundant) leak seal. The sleeve gage (28) is a reduction from the 24 gage normally used. Its use will enable the sleeve to be coiled in a smaller diameter without yielding. Analysis indicated that the design can be rolled into a diameter of about 55% of the pipe ID versus 75% of the pipe ID for 24-gage sleeves. Corrugations, consisting of folds spaced on 1-inch centers, improve structural stiffness of the device so it does not deform during setting.

The most obvious trait of the urethane seal sleeve is its grooves (ribs). This new design compensates for axial shortening that would otherwise occur if a non-ribbed sleeve were allowed to radially expand significantly. The end elements feature increased thickness and act as an O-ring once the seal is expanded. Their thickness, coupled with low durometer, should provide an effective pressure seal across a range of cast-iron surface conditions as well as easily compensate for variation in pipe ID. AutoCAD machine drawings of the molds to produce these sleeves in both 8- and 12-inch sizes were prepared.

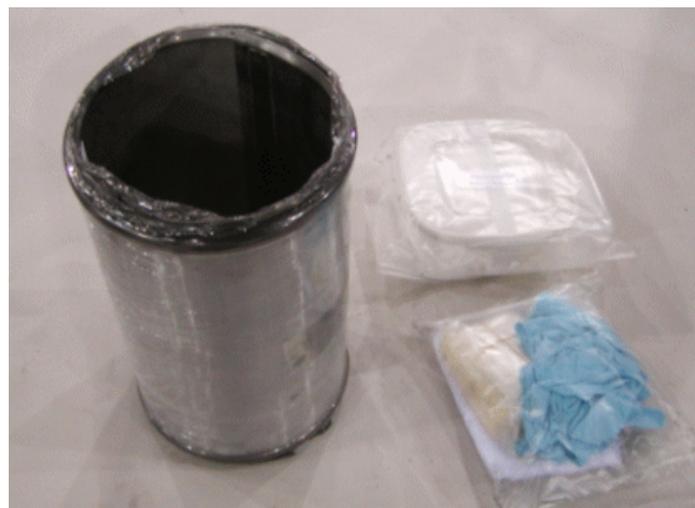
Figure 6. Repair Sleeve Components

Work progressed to fabrication and full testing of the second-generation 12-inch repair sleeves featuring ratchets and polyurethane seal sleeves. Components of the sleeve design are shown in Figure 6. The sleeve is 12 in. long x 7.5 in. OD in its collapsed (unset) state. Figure 7 shows a sleeve with epoxy applied ready for insertion into the gas main via the inflation module.

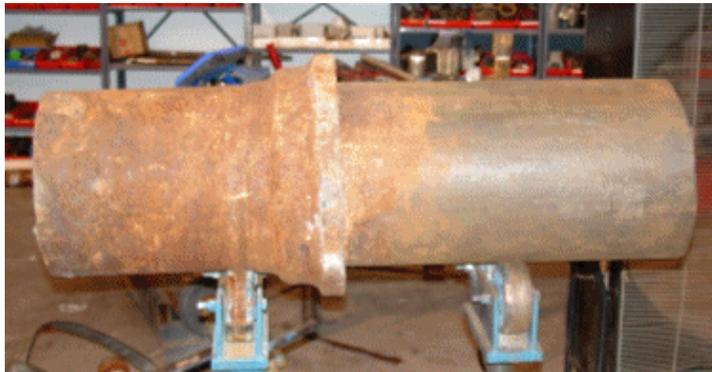
Figure 8. 12-Inch Cast Iron Pipe Sample

Mock-up tests were conducted in the shop to set new 12-inch sleeves inside sample cast-iron joints (Figure 8). The first step was to use the cleaning module to clean debris and scale from inside the joint in preparation for running the sleeve (Figure 9).

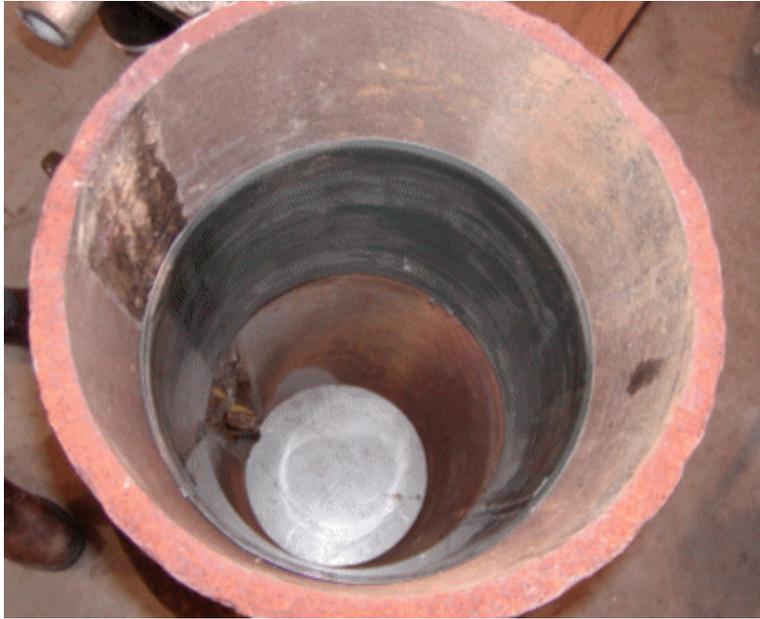
Figure 10. Successfully Installed Repair Sleeve

Next, a patching sleeve was successfully set at a maximum inflation pressure of 30 psig (Figure 10).

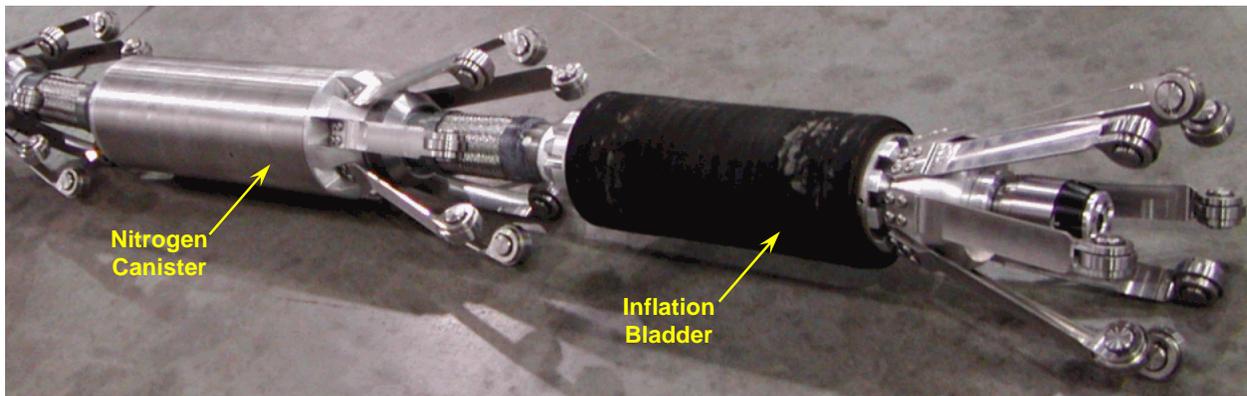
Figure 11. Patch-Setting Module

Various patch-setting inflation modules were designed, built and used to install the different generations of ratcheting repair sleeves. The final sleeves are set by inflating the bladder to 30 psig and maintaining pressure for 5 minutes before deflation. This provides sufficient time for the urethane sleeve to be compressed against the pipe and the ratchets to engage and lock.

Setting tests were successful, so efforts were directed to design of the control electronics to operate the solenoid-controlled valve attached to a pressurized canister of nitrogen. Figure 11, Figure 12 and Figure 13 illustrate key aspects of the equipment. Unlike other robotic elements, natural gas is bypassed to prevent interruption of customer service through the central pipe and not in the annular space between the outside of the robotic element and the cast-iron main.

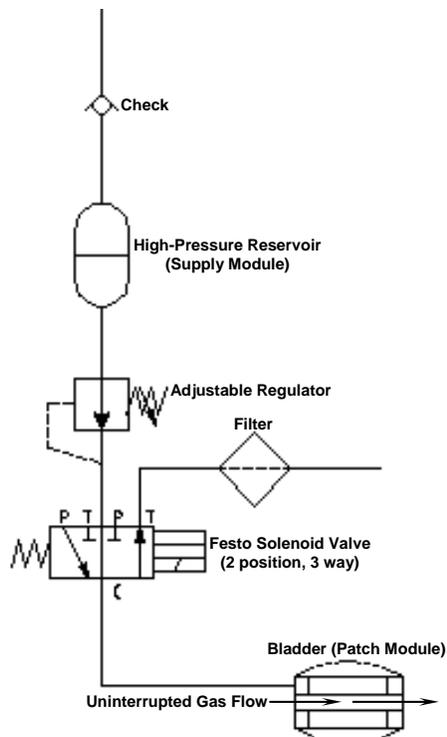
Figure 14. Pneumatic Inflation Circuit

The patch-setting control system consists of a solenoid valve which allows N₂ pressure to be admitted into the inflation bladder under computer control; a pressure chamber for storing the nitrogen charge and pressure relief valves which allow adjustment of the charge pressure to compensate for differences in the gas main operating pressure. Figure 14 depicts the pneumatic inflation circuit.

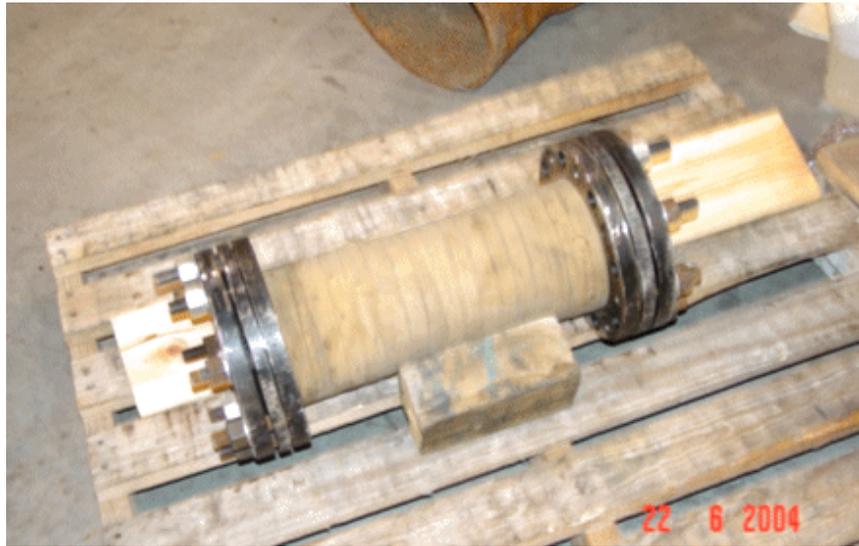
Figure 15. Inflation Bladder

While setting new patches with the original inflation bladder, it became apparent that the bladder material (Figure 15) was not adequate. The bladder was observed to fail after a limited number of inflation cycles along the line where the end of the inner sleeve contacts the gum rubber. Options for modifying the bladder include using another compound having a higher tensile strength, or further increasing the thickness of the gum rubber. Figure 16 shows a failed gum-rubber sleeve. Alternatives for modifying the gum-rubber sleeve were investigated.

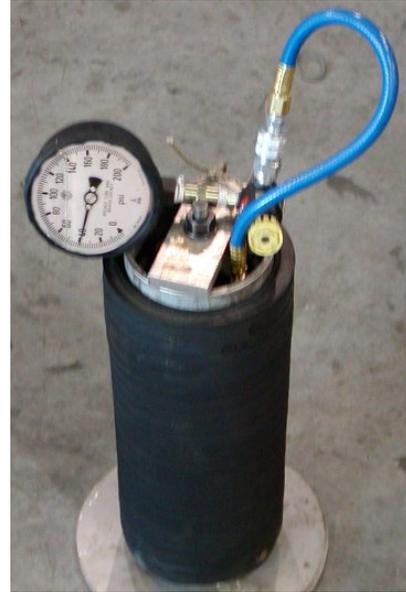
Figure 17. New Inflation Bladder

During the twelfth quarter, the team acquired and tested a commercial inflation bladder (Figure 17) from the company that manufactures the patch assemblies. Initial OD of this system is 6½ inches and total length is 16 inches without any centralization hardware added. The bladder is constructed from heavy fiber-reinforced elastomer bonded to an aluminum tube. The bladder requires gas at 40 psi to fully inflate.

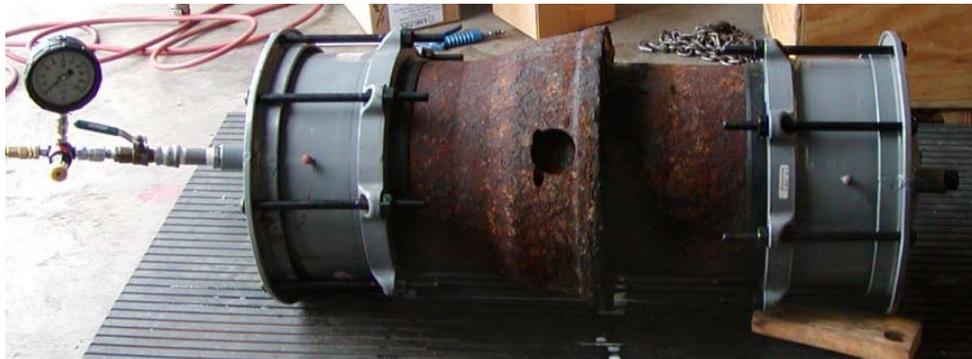
Figure 18. Cast-Iron Joint Tested for Leaks

1. The ends of a sample cast-iron joint were capped (Figure 18) and the internal pressure raised to 2 psi to check for leaks around the joint. Two small leaks were observed using soap spray in the jute area of the joint. These were marked.

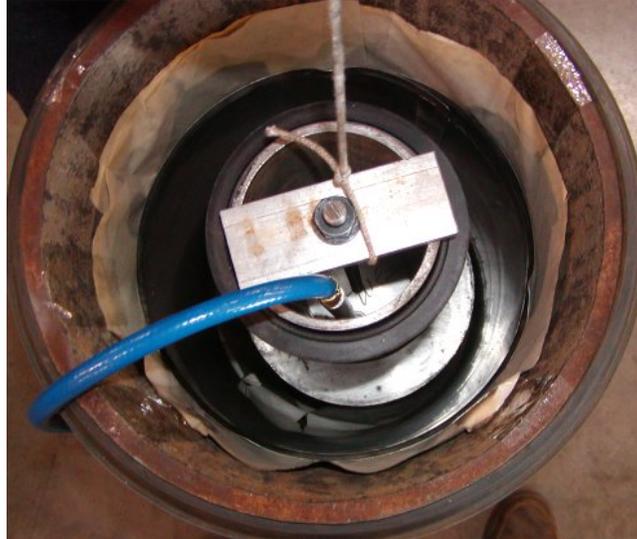
Figure 19. Bladder/Patch Assembly Hung in Joint

2. Caps were removed from the test joint and the pipe ID was cleaned across the joint area prior to patching.
3. A new patch and patch-setting bladder assembly were prepared. The patch was placed at the center of the length of the bladder, and was held in place by slightly inflating the bladder to grip the patch.
4. The patch/bladder assembly was inserted into the joint via a special fixture that allowed the patch to hang in the center of the joint (Figure 19).

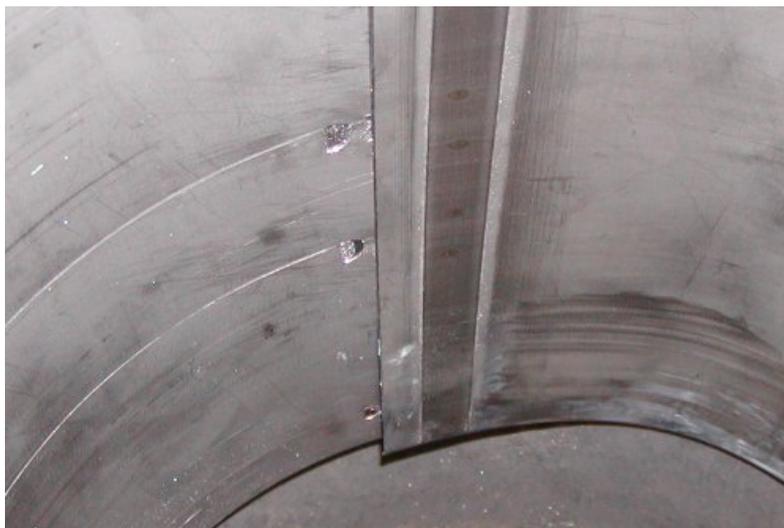
Figure 20. Partial Ratchet Engagement After Patch Setting

After these tests were completed, a careful inspection of the set patch revealed that the two outermost rows of ratchets did not engage as deeply as the two inner rows (Figure 20). It appeared that the inflation bladder needed to be about 2 inches longer on each end to fully engage the patch sleeve ratchets as currently configured.

Even though the patch set successfully and all leaks were sealed, it was desired to modify the patch or bladder design to allow deeper ratcheting toward the outer edges of the patch. Since use of a standard bladder design is preferred, changes to bladder design were avoided. Another solution was conceived and pursued. The patch manufacturer was asked to stamp two additional rows of ratchets into the sleeve midway between the existing rows. Several prototype sleeves with this modification (that is, a total of six rows of ratchets) were ordered and tested.

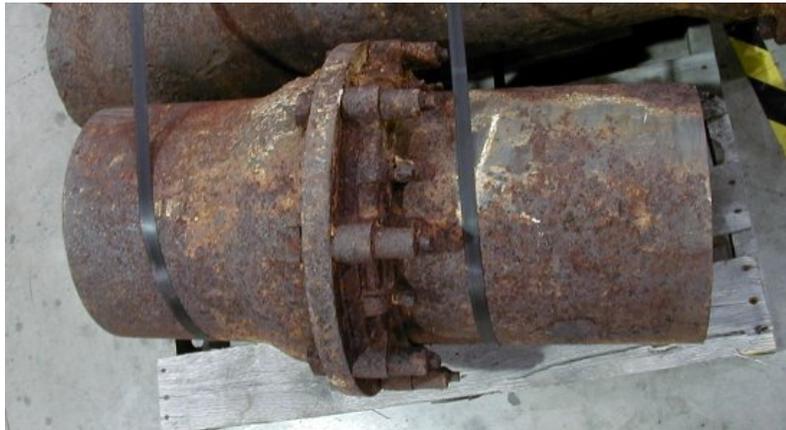
Figure 21. Sample Cast-Iron Joint for Full-Function Tests of Patching Module

Prior to the full-scale demonstration described under Task 8, the latest generation of sleeves was tested at MTI's shop using the completed inflator, supply, and base robot modules. A sample bell-and-spigot joint (Figure 21) was selected and placed at the end of the test main. The purpose of this test was to verify the improved ratchet engagement of the sleeve as well as to function-test the robots as an assembled unit. This test verified performance of the control circuitry of the base module for full inflation and deflation time requirements, the supply module for charge pressure and volume, and the inflation module for centralization.

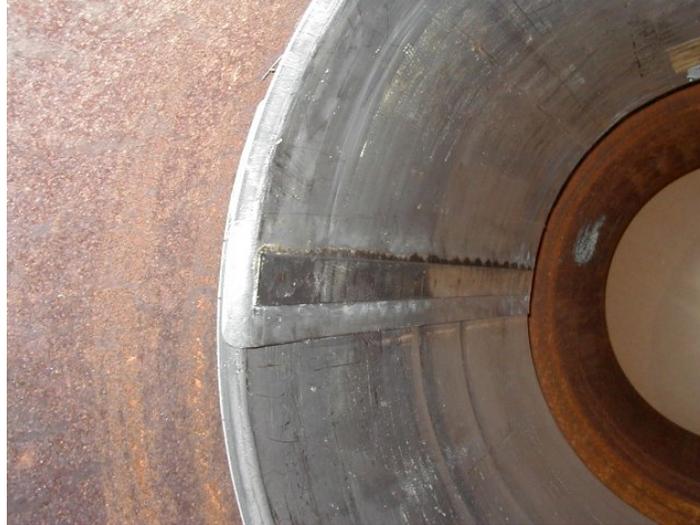
Figure 22. Final Patch Design Set in Test Joint

The joint was cleaned with the brush module attached to the end of the coiled tubing. A patch was prepared and installed on the patch module. The patch was run into the main and set by the robot train. Test results were very encouraging. The full inflation time was reduced to less than 2 minutes. A second inflation cycle to full setting pressure verified the nitrogen tank was charged to the proper pressure (350 psi) and had sufficient volume to cycle the inflator twice for each patch set. Deflation times were also acceptable (less than 2 minutes). Observation of assembly centralization showed that the centralizer arms needed to be increased in thickness to provide a larger spring constant and more accurately centralize the module. Inspection of the patch after the tests (Figure 22) confirmed that the additional ratchets in the final sleeve design provide a more uniform ratchet engagement along the length of the patch seam.

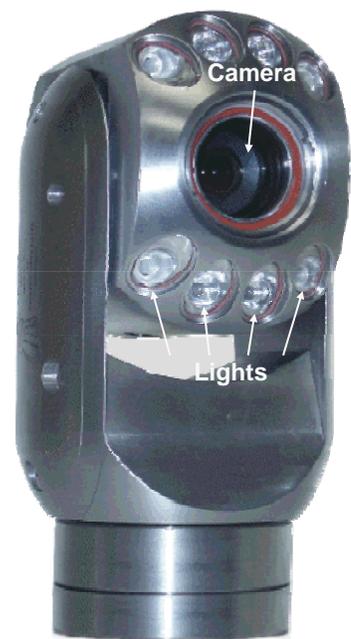
Figure 23. PZT Camera

Analysis of commercial PZT cameras was completed in the second quarter and a preferred design selected. The inspection camera (Figure 23) measures 4 inches OD x 10.5 inches overall length. It features 270° of tilt, 340° of pan and a 72:1 zoom ratio. Its eight high-intensity argon lights were found to provide excellent illumination in tests conducted inside sealed 12- and 24-inch pipes. Specifications are summarized in Figure 24.

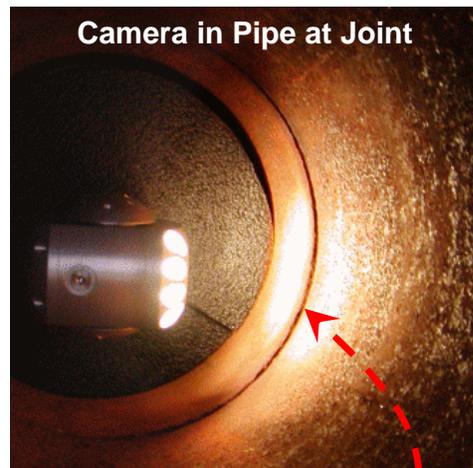
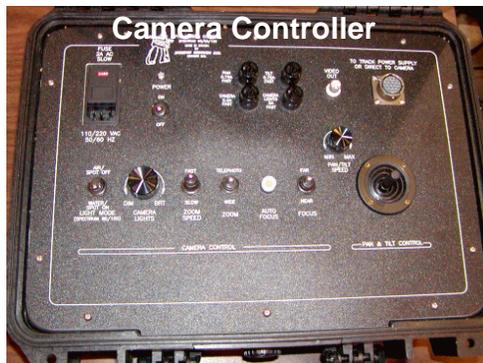
Figure 24. PZT Camera Specifications

- Pick-up Element: 1/4" CCD
- Lens: 72:1 Zoom (18X Optical, 4X Digital)
- Resolution: >460 TV Lines
- Illumination: 3 lux
- Horizontal FOV: 48° wide, 2.7° tele (in air)
- Lights: 8 x 6 W argon lights, variable intensity
- Pan Range: 340° mechanical, 360° visible
- Tilt Range: >270°
- Power Requirements: 110/220 VAC
- Pan/Tilt Control: proportional

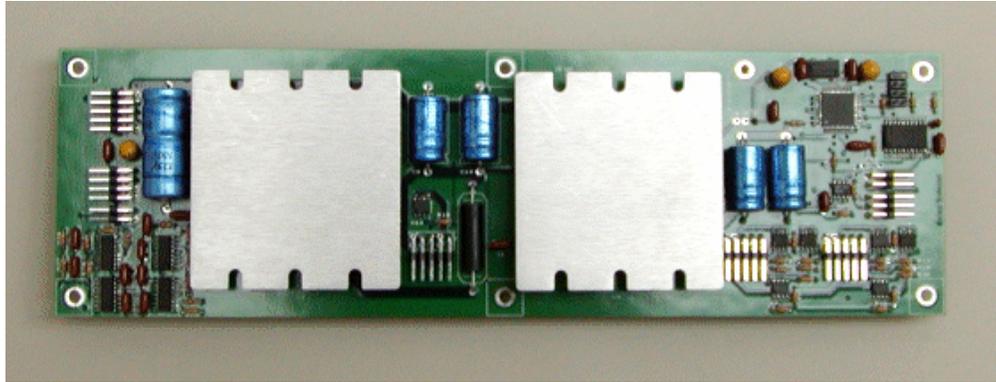
Figure 25. Downhole Camera Control Circuit Board

The physical printed circuit board produced (Figure 25) is a four-layer board made of FR4 material, measures 3 inches wide x 10 inches long, and is housed inside the robotics base module. Worthy of note are the large heat sinks for the DC-to-DC power converters used to take the single DC voltage supplied from the surface and generate +24V, +12V and +5 VDC regulated power for the various camera functions.

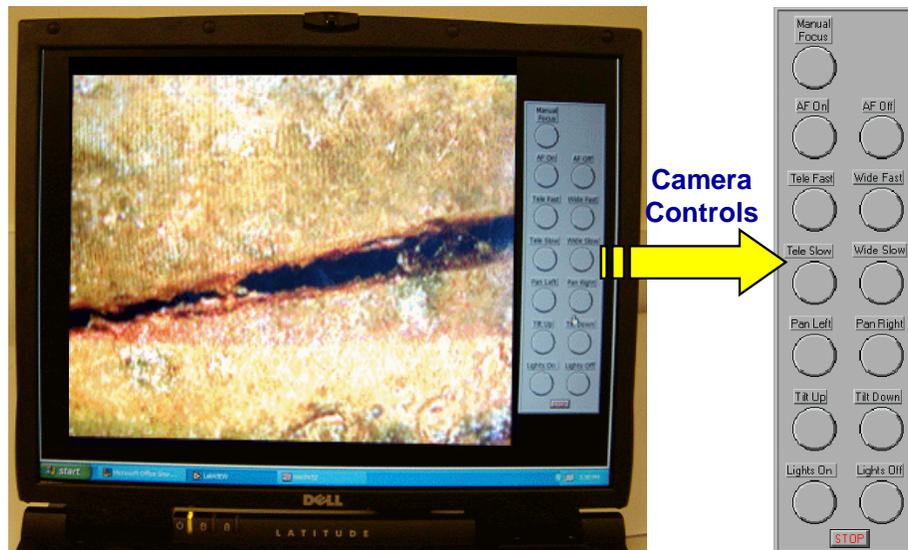
Figure 26. Camera Display and Control Software

Camera control software and the display were finalized. Figure 26 shows the camera display/control functions as presented on a laptop computer.

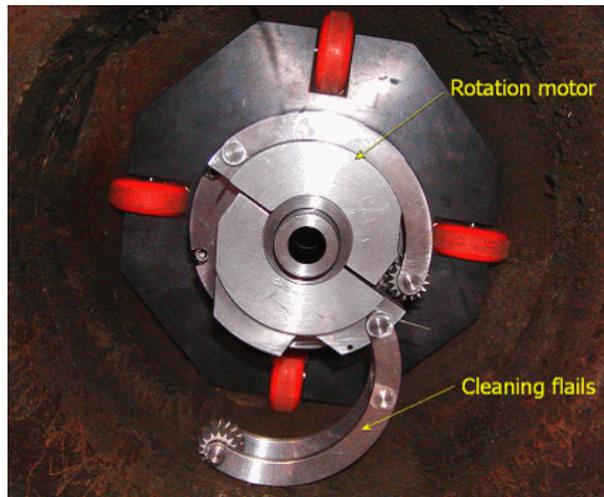
Figure 27. Pipe Wall Cleaning Assembly

The arm assembly was designed to be packaged as a complete robotic element. This included both design and fabrication of the drive motor, motor controller electronics, cleaning head housing and collapsible arm (Figure 27). The completed robot assembly was tested by cleaning several 12-inch cast-iron bell-and-spigot joints (Figure 28). Tests showed the design to be very effective. The most efficient cleaning occurs at rotary speeds of 300 rpm with forward and backward translation across the joint at speeds of 4 inches per minute. This corresponds to a total of approximately 5 minutes per joint.

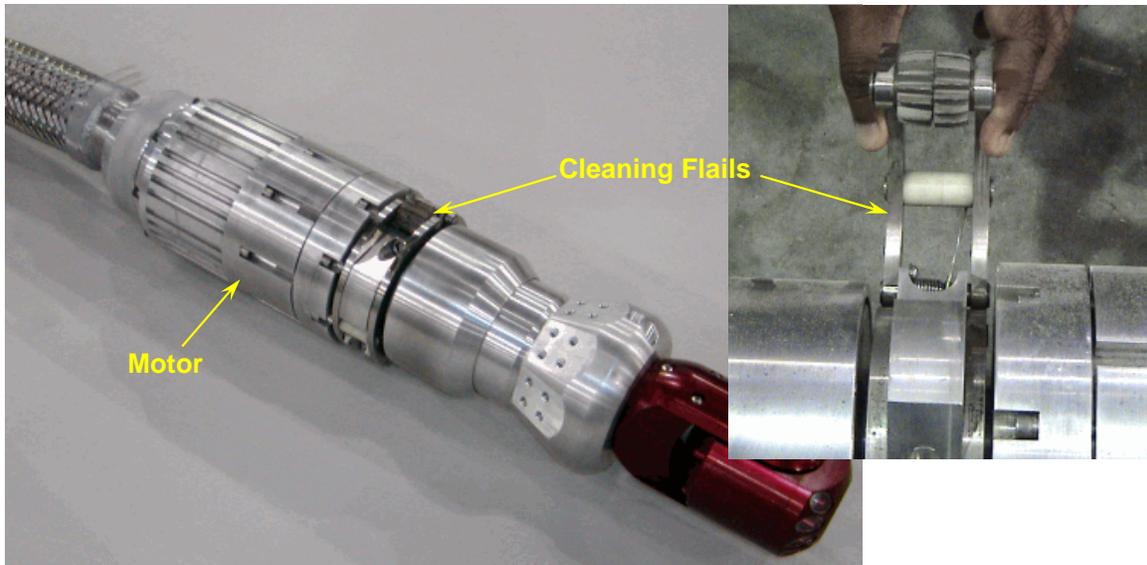
Figure 29. Final Design of Cleaning Module

For the final design of the cleaning assembly (Figure 29), the module shown above was shortened and the steel housings were replaced with aluminum to reduce weight. The initial test module used fixed centralizers, while the final system incorporates collapsible centralizers. (Note that the centralizers are removed in Figure 29.) Power is supplied to the motors from an on-board power supply located in the base module.

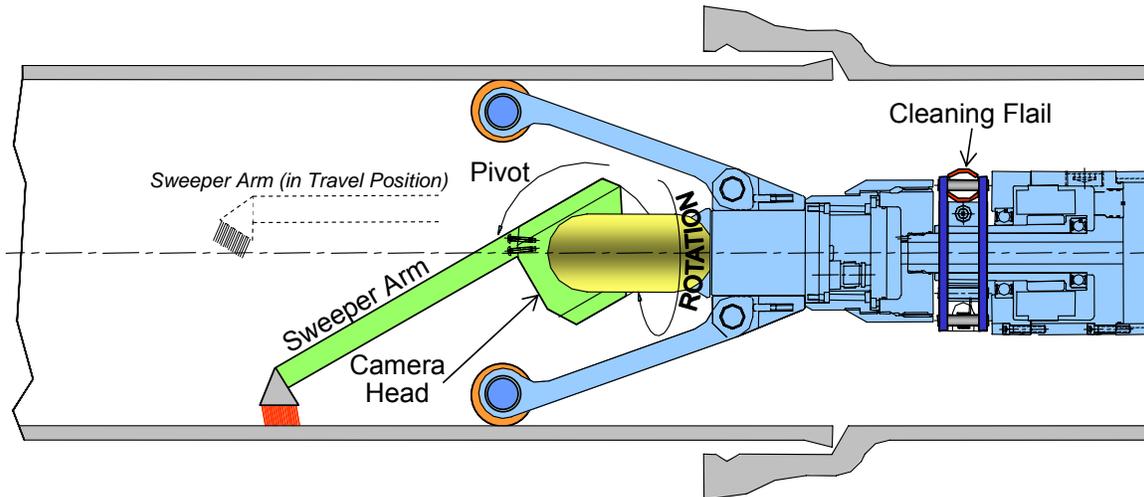
Figure 30. Camera-Mounted Sweeper Arm

Both ferromagnetic and non-magnetic debris will need to be collected and/or removed from the joint area. It will likely be sufficient to sweep (or plow) the debris forward so that the area surrounding the pipe joint is clean prior to running a patch. The most straightforward approach is to attach a sweeper arm to the camera assembly (Figure 30). This provides the capability to position the brush anywhere on the circumference of the pipe.

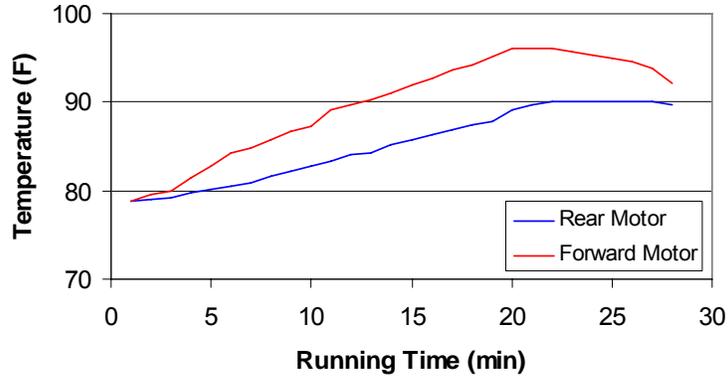
Figure 31. Cleaning Module Motor Heat Tests

The motors that power the cleaning flails were tested for any problems with heat build-up during extended (continuous) operation downhole. The system was run in a simulated cleaning operation inside a section of cast-iron main. Temperatures of both motors were monitored during a 30-minute test. Results (Figure 31) showed that heat build-up reached a maximum value after about 20 minutes and will not be hot enough to damage any downhole components during extended system operation.

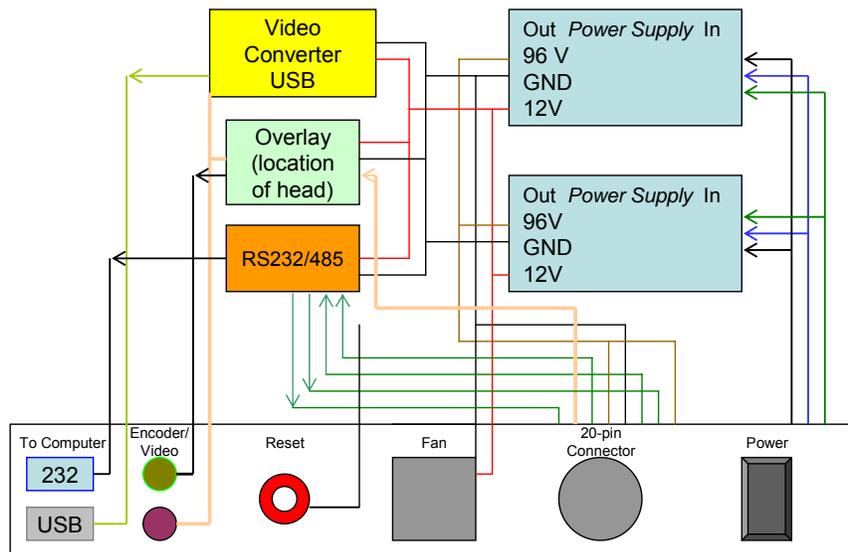
Figure 32. Schematic of Surface Control Module

Near the end of the effort, the final control module was fabricated and installed in field-ready packaging. The controller assembly (Figure 32 and Figure 33) was designed with two power supplies. These are configured in parallel and will provide more than sufficient current to power the camera and other downhole motor assemblies. The module was tested with the CT surface equipment in the laboratory (including running power and signals through 1000 ft of CT on the spool) to confirm correct function and that power supplies will not overheat in normal system operation. System requirements for electrical current and operating temperatures were well within the safe range for these components.

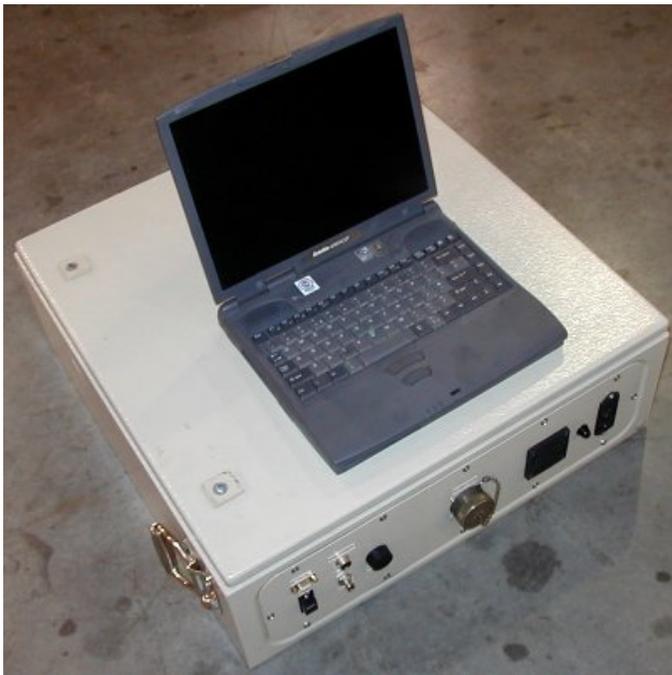
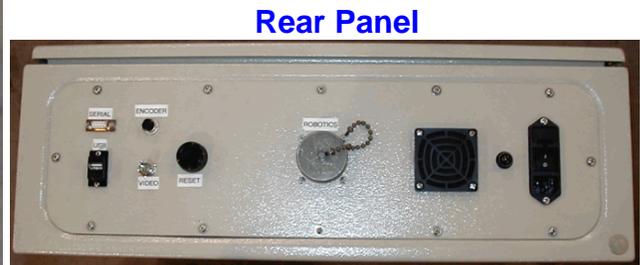
Figure 34. Control Module and Computer

The control module was completed (Figure 34) and fully tested in the shop tests conducted late in the project. Control software is based on LabVIEW and was programmed and tested for controlling (1) the camera, (2) brushing operation and (3) patch inflation system. LabVIEW RS232 commands are converted to RS485 to transmit the command over the 1100 ft conductor bundle to the base module. The composite video signal from the module has distance encoder information overlaid onto it in the control module. It is then converted to digital video for capture and display on the laptop computer.

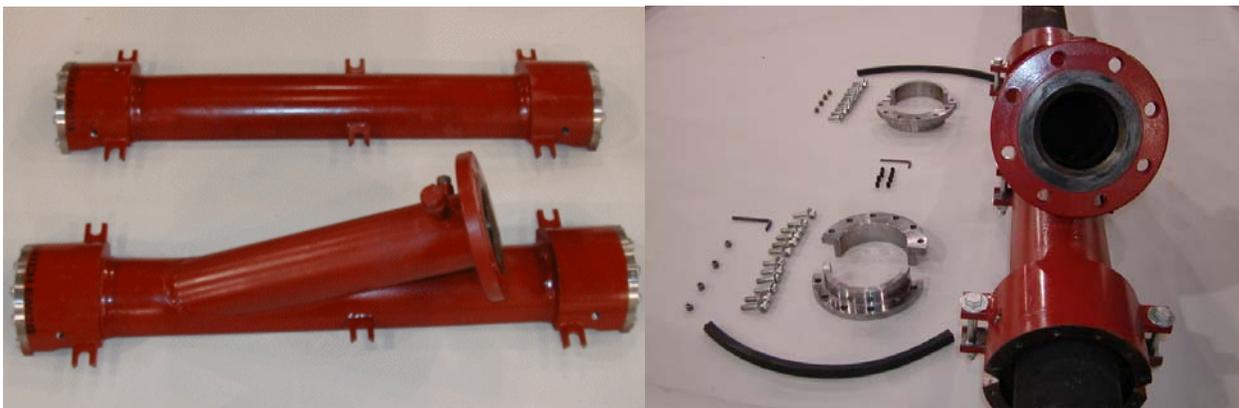
Figure 35. Cast-Iron Entry Fitting (4-inch Prototype)

Early in the project, the access fitting was produced in a 4-inch prototype size to validate the design prior to embarking on the fabrication and testing of a 12-inch version (which is considerably more expensive). Sealing tests at pressures up to 100 psig were successfully conducted along with preliminary hole-cutting tests. Figure 35 illustrates its key components.

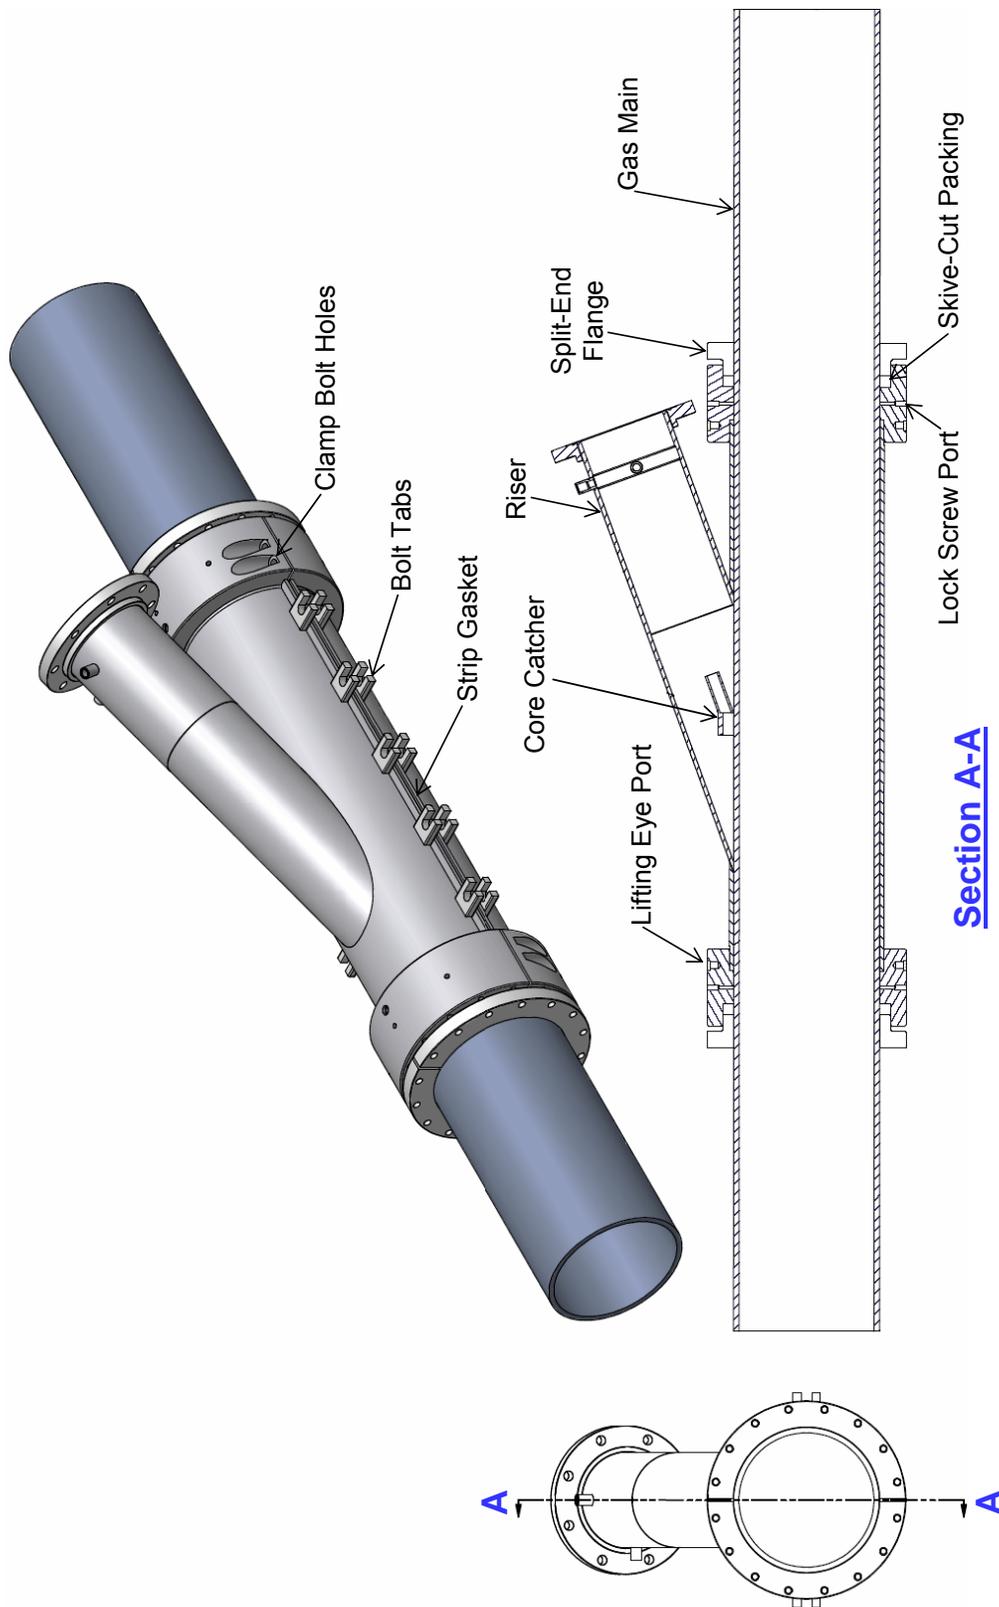
Figure 36. Bolt-On Fitting for Live Access into 12-in. Cast-Iron Mains

Unlike the smaller bolt-on fitting, no welding is required for larger gas mains, due to low operating gas pressures (<2 psi).

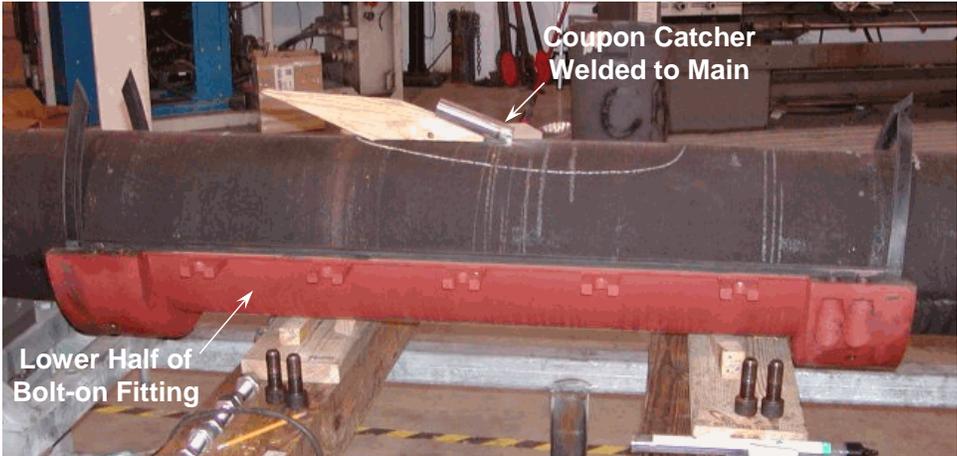
Figure 37. Initial Assembly of Large-Diameter Bolt-On Fitting

As stated, initial assembly of the fitting includes correct positioning and attachment of the coupon catcher onto the main (Figure 37). After correct alignment, the coupon catcher is welded onto the main and the upper half of the fitting is lowered into position (Figure 38).

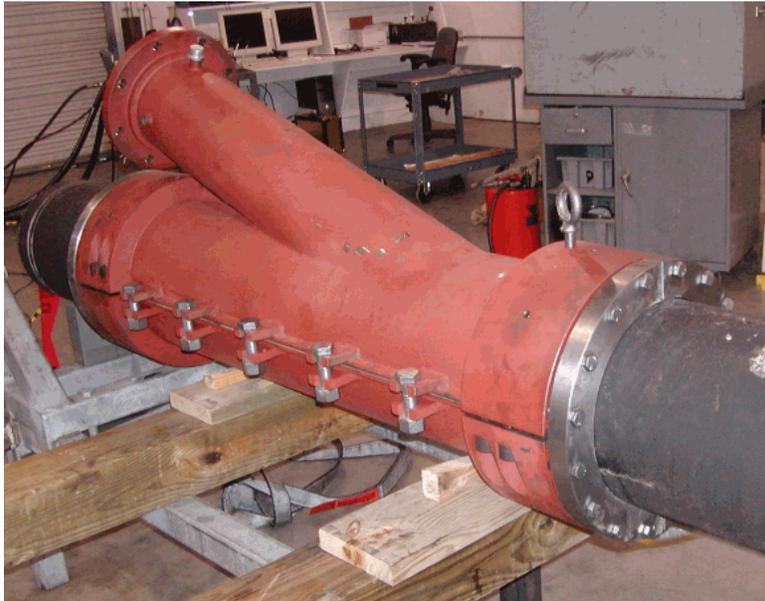
Figure 39. Large-Diameter Bolt-On Fitting Installed

The fitting is shown after being completely made up to the pipe in Figure 39. The assembly was pressure tested successfully to 5 psi.

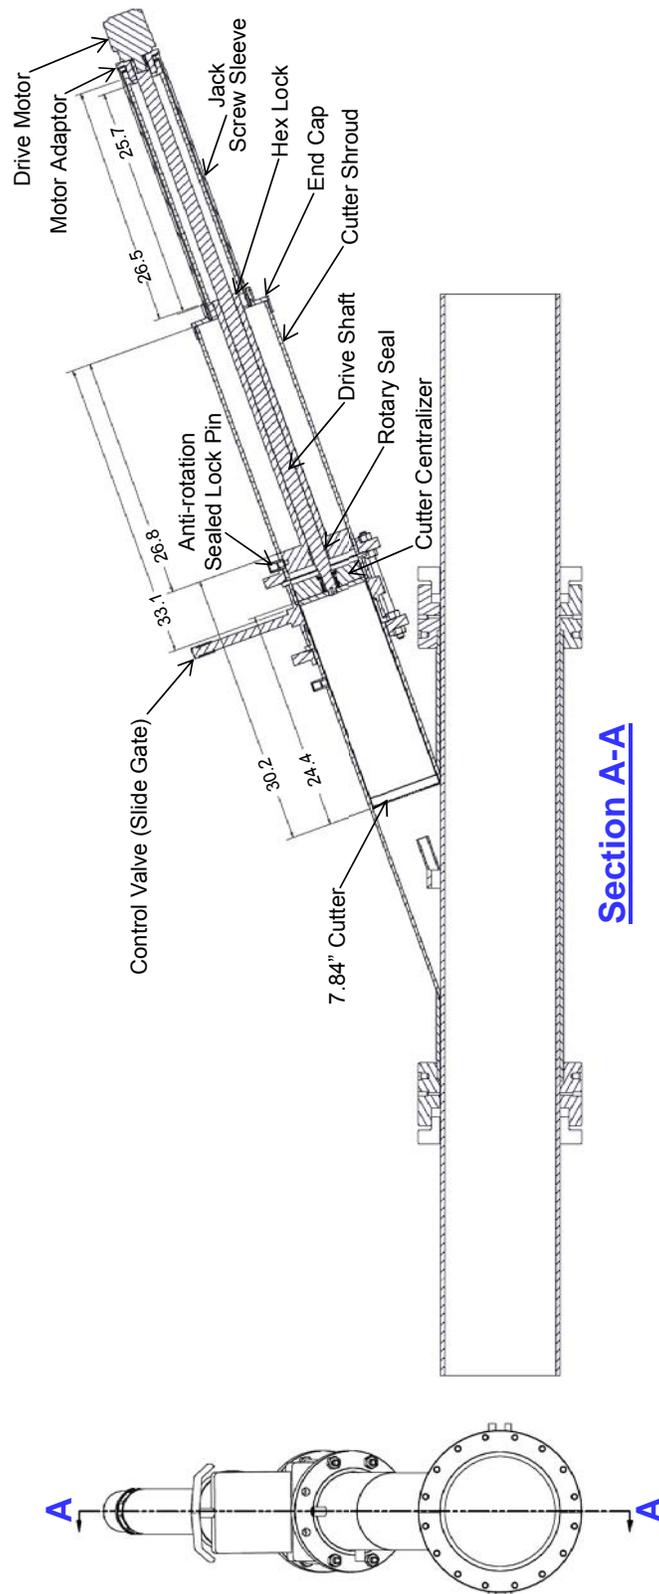
Figure 40. Drilling Assembly for Cutting Access Hole in 12-in. Cast-Iron Mains

is advanced. Once it is engaged and the entry hole is cut, the spear retains the coupon within the cutter as the drilling assembly is retracted into the cutter shroud.

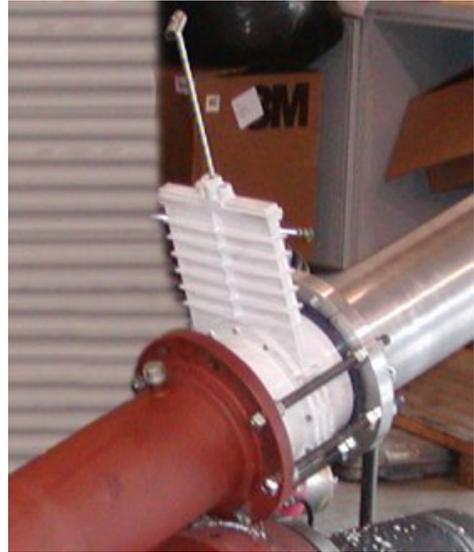
Figure 41. PVC Control Valve

The lightweight PVC gate valve obtained was about 8 inches flange to flange and weighs 22 lb. Conventional steel ball valves for this size are about 18 inches flange to flange and weigh about 400 lb. These valves are not available commercially in lightweight materials. The PVC valve, although adequate for shop testing, is not suitable for field applications because it provides almost no structural support for the cantilevered drilling assembly mounted to its outer flange. To address this need, an aluminum slide gate valve (Figure 42) was designed by the team, detailed, and manufactured. It was not ready for use at the time of the shop tests, but will be used in future shop and field tests.

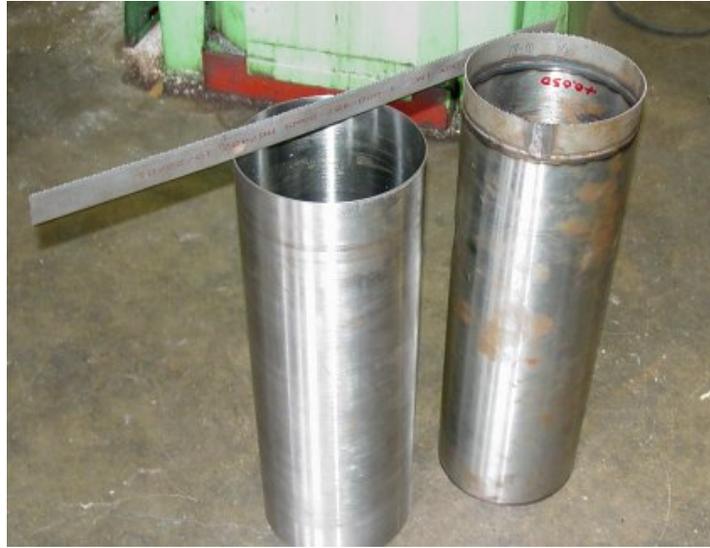
Figure 43. Hole Saw for Cutting Access Hole in Gas Main

To support use of the 12-inch entry fitting, a saw cutting system was designed to cut an angled hole into the pressurized cast iron gas main. Since the angle of entry is near 20° , the body of the saw must be very deep to receive the elliptical coupon as it is cut. A hole saw for cutting an 8-inch angled hole was designed, manufactured and tested (Figure 43). In the left side of the figure, a saw blade is shown on top of a saw body prior to attachment. The hole saw is powered by a hydraulic motor which is powered by a 50 horsepower, diesel-driven hydraulic power supply. This same power supply also operates the CT unit.

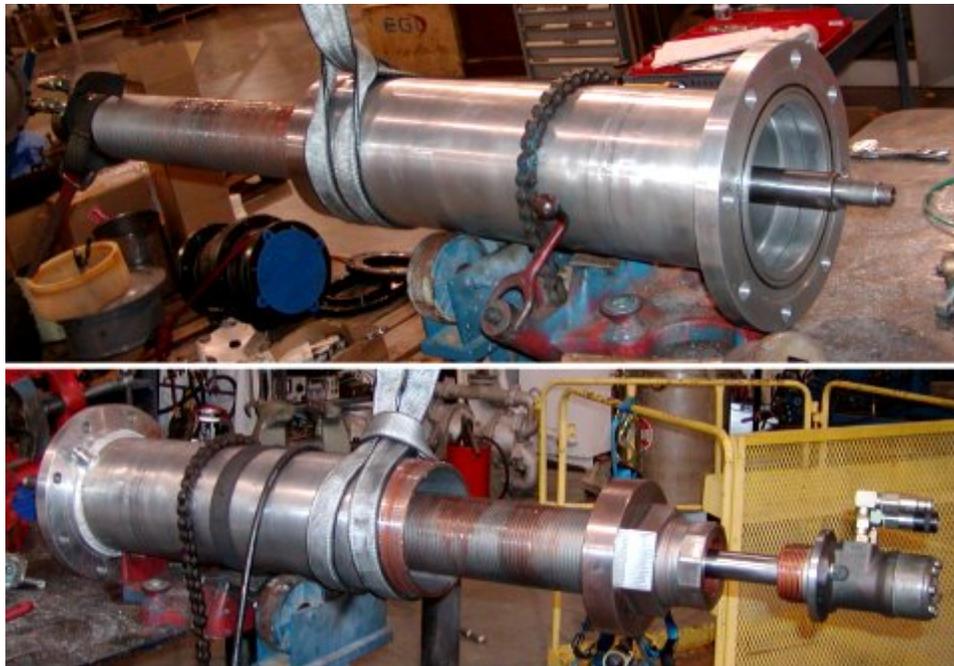
Figure 44. Drilling Assembly for Large-Diameter Pipe

The drilling assembly (Figure 44 and Figure 45) was fabricated and tested multiple times in the shop for fit and function.

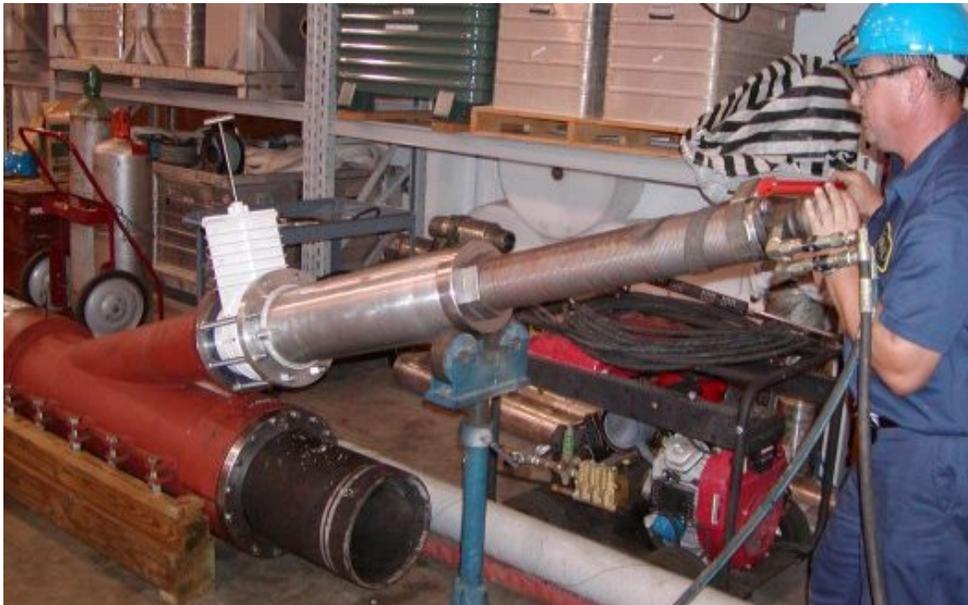
Figure 46. Testing Drilling Assembly

The drilling assembly was tested successfully several times in MTI's shop (Figure 46). In all cases the coupon was engaged and retrieved successfully (Figure 47 and Figure 48). These results showed that the large-diameter drilling assembly was ready for full-scale patch-setting tests in the shop. These were conducted late in the project and are described under Task 8.
