Sealing Large-Diameter Cast-Iron Pipe Joints Under Live Conditions

**Final Report
March 25, 2002 – September 24, 2005**

**By:
Kiran M. Kothari
(Gas Technology Institute)
and
Gerard T. Pittard
(Maurer Technology Inc.)**

DE-FC22-02NT41316

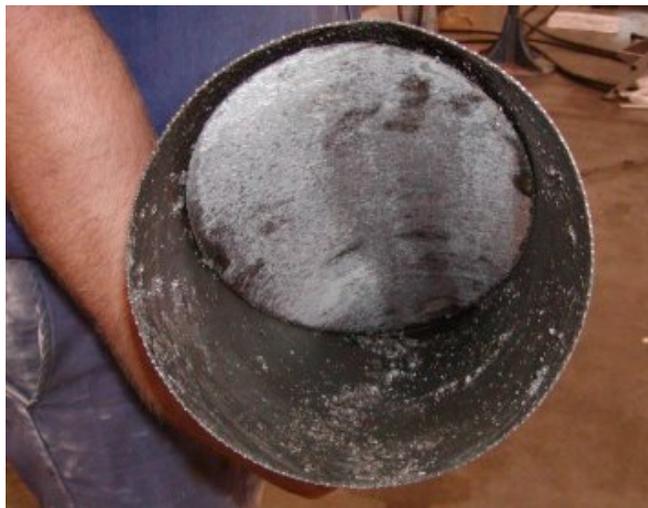
Figure 47. Hole Saw with Captured Coupon

The drilling assembly was tested successfully several times in MTI's shop (Figure 46). In all cases the coupon was engaged and retrieved successfully (Figure 47 and Figure 48). These results showed that the large-diameter drilling assembly was ready for full-scale patch-setting tests in the shop. These were conducted late in the project and are described under Task 8.

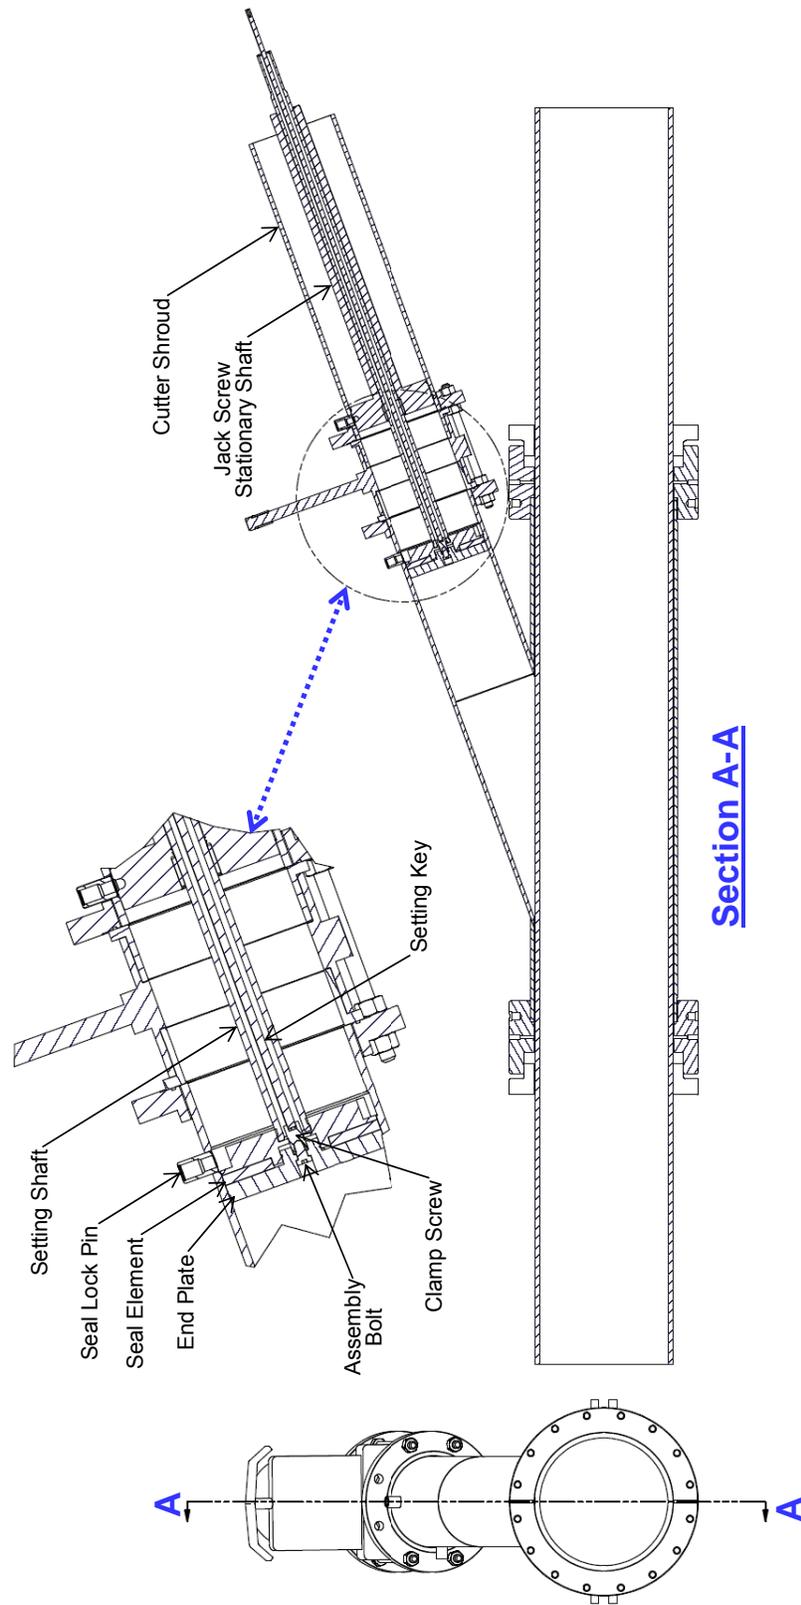
Figure 49. Plug-Setting Assembly for Resealing 12-in. Cast-Iron Mains

The expandable plug consists of an end plate, body, clamp screw and assembly screw. An elastomer element is placed between the end plate and body for sealing to the riser ID when compressed. The element is relaxed while lowered into the riser. The plug assembly is attached to a setting shaft which is placed inside the jack-screw stationary shaft. Once in place a sealed lock pin is threaded through a side port provided on the riser. The lock pin serves as an anti-rotation stop for the expandable plug body. A hex key is placed through the setting shaft and engages the clamp screw. Rotating the clamp screw with the hex key causes the end plate and the plug body to move together and compress the elastomer element. The element expands until it contacts the wall. The setting shaft and setting key are removed from the plug by retracting through the control valve and cutter shroud. After the shroud and control valve are removed, a second lock pin may be installed through a second port provided on the riser of the bolt-on fitting and a blind flange mounted to the riser flange.

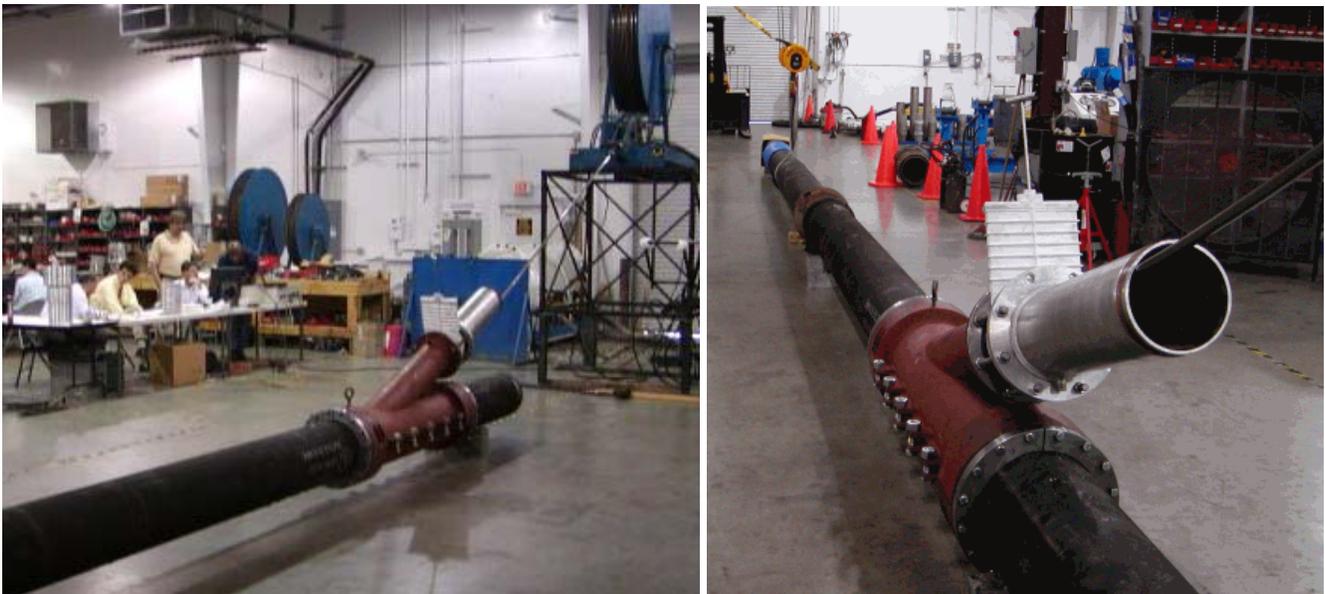
Figure 50. Shop Tests – Entry Fitting, CT Unit and Pipeline

Based on the satisfactory results of full function testing of each subsystem, a test main was prepared for a full-scale system demonstration at the MTI shop facility (Figure 50) on 26 August 2005. Team members from GTI, MTI and Noble participated, along with a representative from Public Service Electric and Gas Company. To properly align the CT unit with respect to the pipeline, a special frame was constructed to raise the unit, thereby simulating typical cover depths (3 to 4 ft).

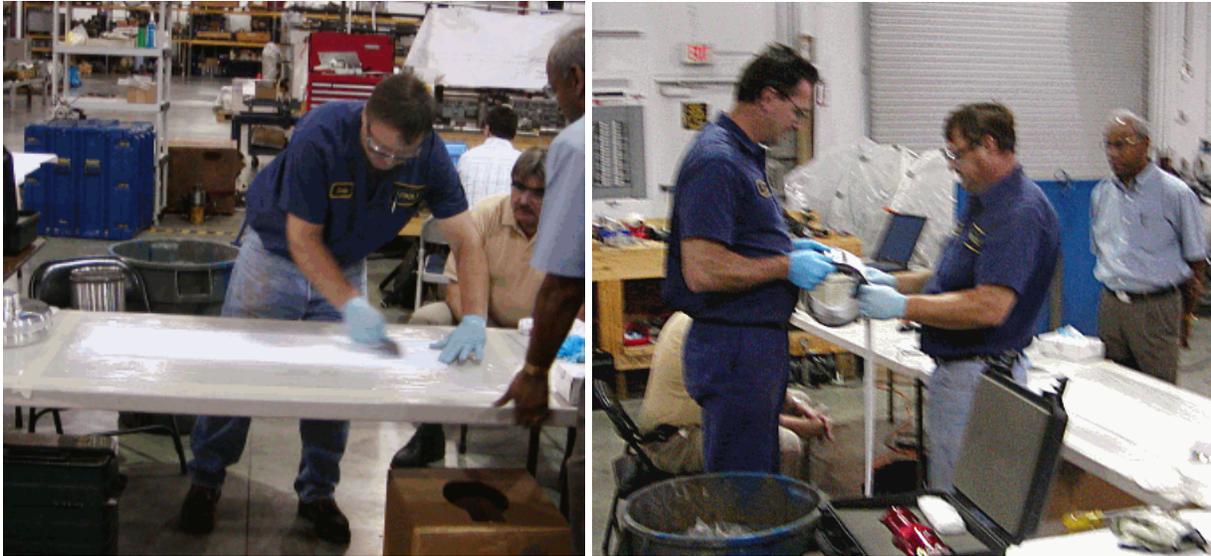
Figure 54. Preparing Patch for Setting in Pipe

After cleaning operations were complete, the cast-iron joint was returned to its position between the ductile iron joints for patching operations. This was done to demonstrate the procedure of using the camera and the footage counter to accurately locate the patch within the joint. A new patch was prepared (Figure 54) and loaded onto the patching module bladder (Figure 55). The joint position was located and setting operations were activated as designed from the control console.

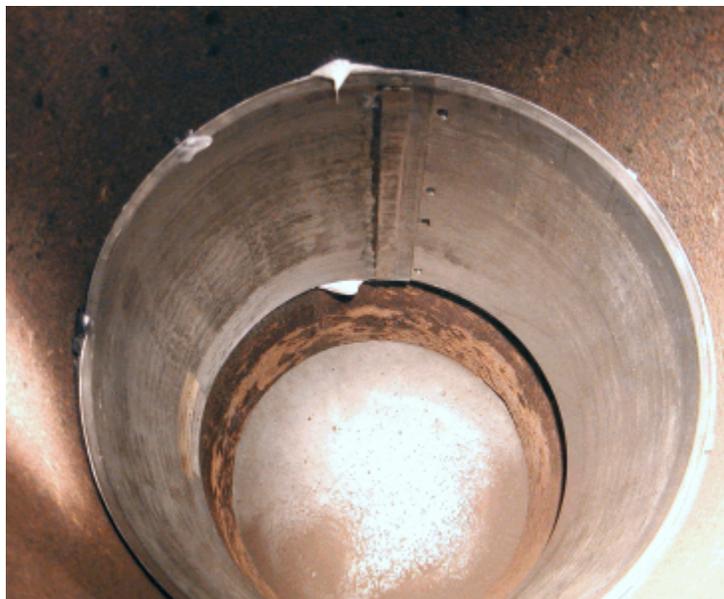
Figure 56. Successfully Patched Joint

After patch setting operations were complete, the patching module was withdrawn through the patch sleeve without problems. The cast-iron joint was then removed from the test main and visually inspected (Figure 56). (The joint is set upright in this photo.)

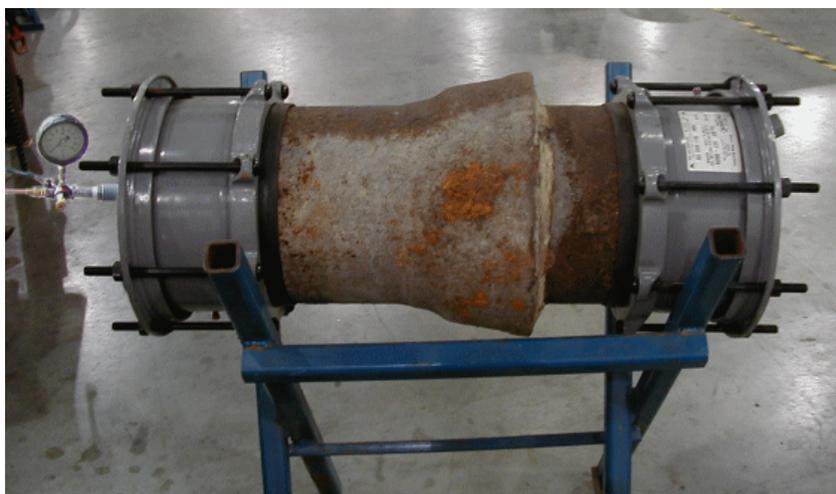
Figure 57. Patched CI Joint Tested for Leaks

After inspection, the patched joint was sealed with end caps which allow internal pressurization for verifying patch sealing effectiveness (Figure 57). The joint was pressurized to 10 psi. The joint was sprayed with a solution of soap and water to locate leaks; none were detected. Internal pressure remained steady at 10 psi after 1 hour of monitoring.

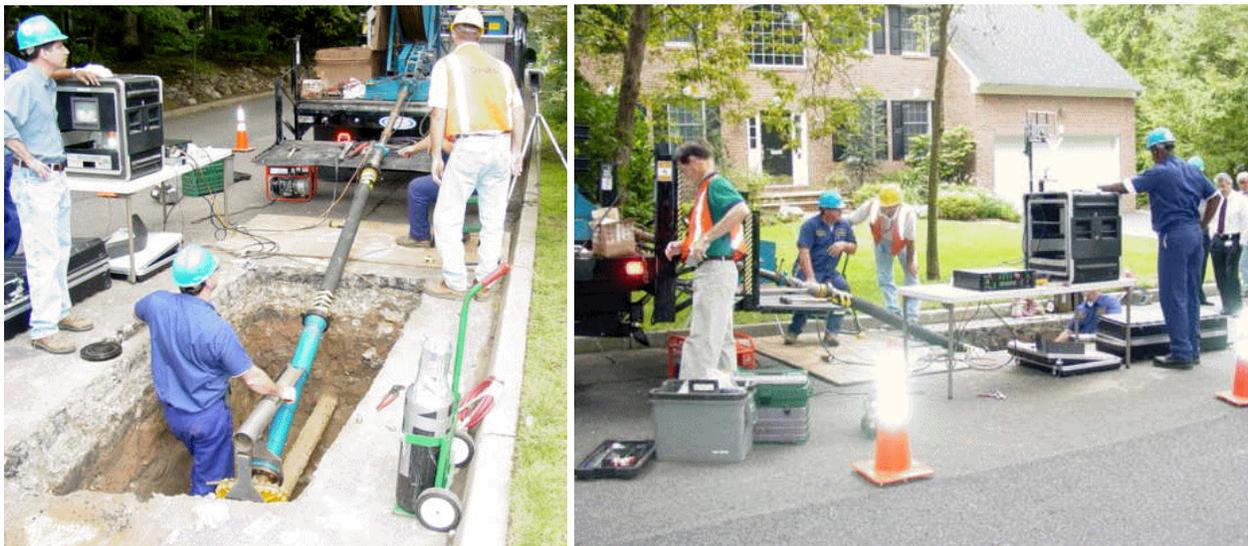
Figure 58. Field Test Site for Small-Diameter System

On August 24–26, 2004, MTI and GTI conducted field tests of the small robotic joint-repair system in a gas main provided by Public Service Electric & Gas Company (Figure 58). The location was in a residential neighborhood in the town of Oradell, New Jersey.

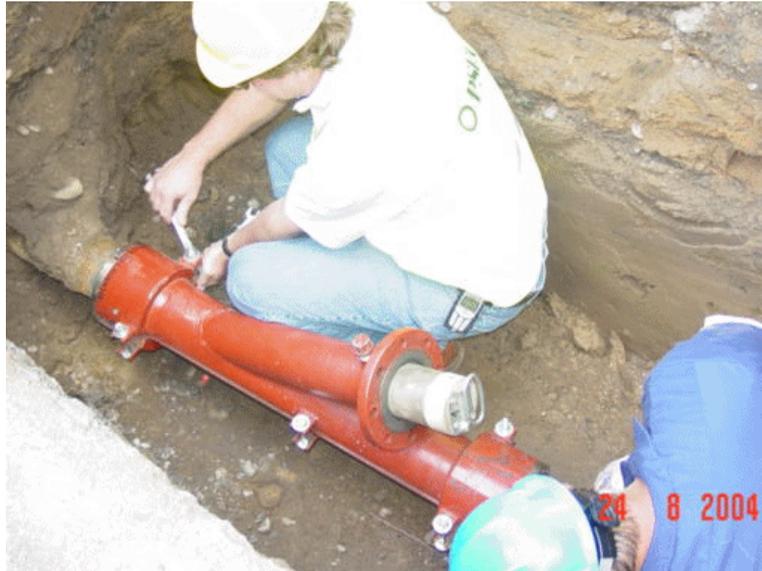
Figure 59. Attaching 4-in. Entry Fitting to Pipe Prior to Welding

uncovered and prepared for the tests, the coupon retention fitting was welded to the pipe. Next, the 20° angled entry fitting was secured (Figure 59) and then seam-welded to the main.

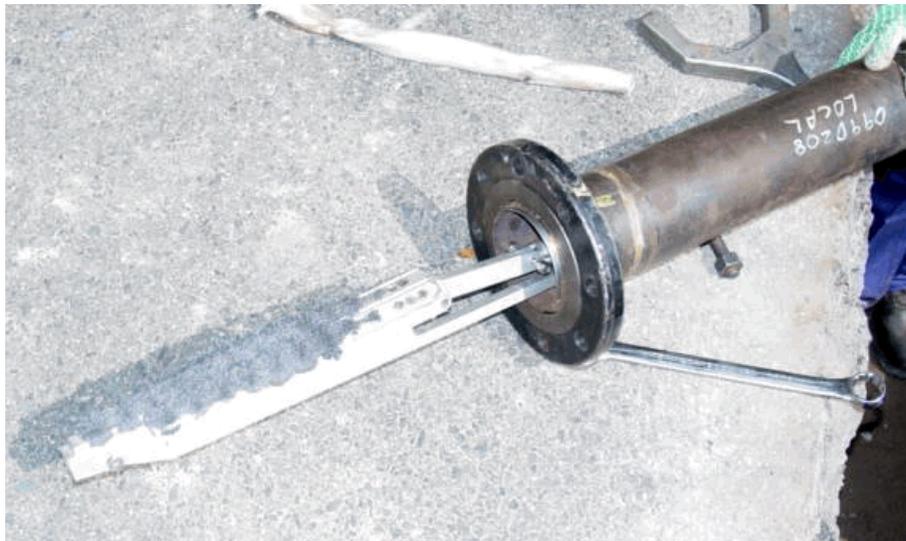
Figure 60. Magnet Assembly for Removing Filings

The coupon was successfully retrieved. Next, a magnetic cleaning assembly (Figure 60) was run into the pipe for three passes to remove the vast majority of metal filings created by the sawing process.

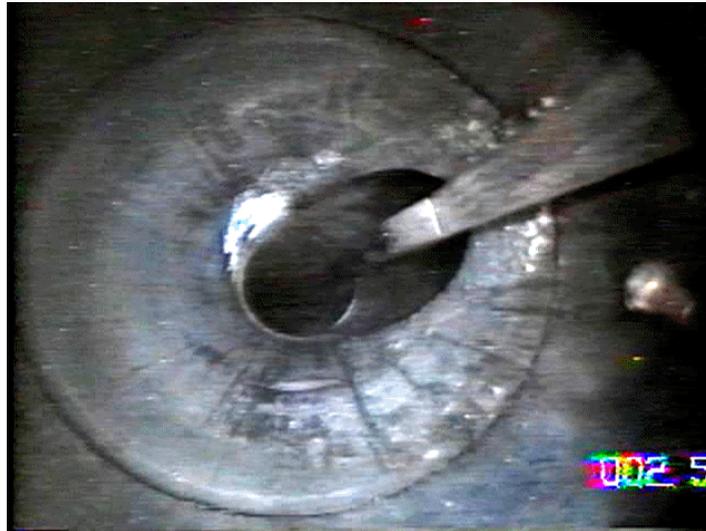
Figure 61. 4-in. Robot Moving through Entry Fitting

The first robot train assembly consisted of: (1) a CCD camera to inspect the main, (2) a brush module for cleaning the bell-and-spigot joints selected for repair, and (3) a base module which supplies electrical power, communication and control signals between the surface

hardware and the in-pipe robot elements. After the assembly was passed through the entry fitting (Figure 61), the first run down the pipe was to inspect the environment and log the location of potential target joints and other features.

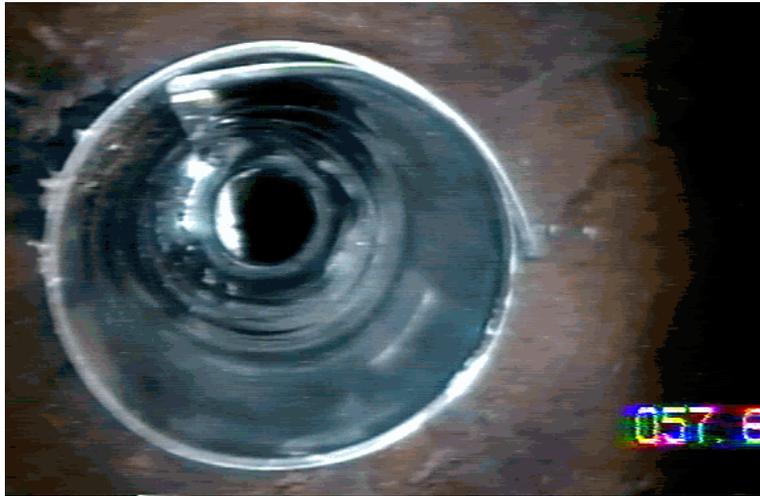
Figure 63. Partially Engaged Patch at 57.6 ft

- One sleeve (at 58.6 ft) failed in the first attempt to set it, was carried with the assembly back to the entry point, and was then rerun and set successfully (although the ratchets did not engage completely (Figure 63)).

Potential causes for the failure of two patches to set are: (1) pipe ID may have been smaller than the first row of ratchets at these two bell-and-spigot locations, (2) debris levels may have been too high or (3) the bell and spigots were angularly misaligned. No problems were observed with the repair sleeve setting train either in the field or after its return to Houston. Consequently, the team believes that the patch-setting failures were due to geometric issues.

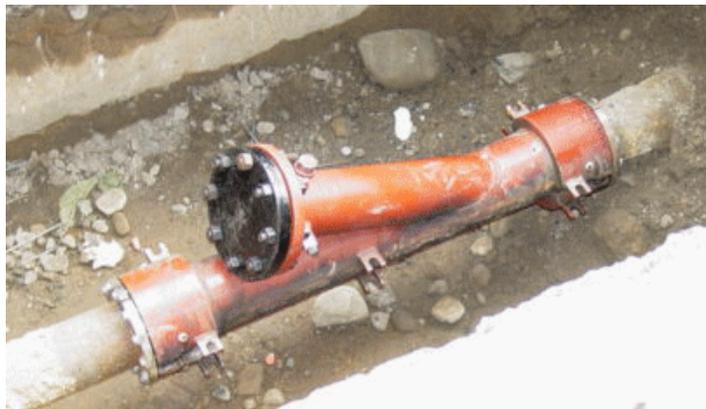
Figure 64. 4-in. Entry Fitting Ready for Burial

After all in-pipe operations were complete, the equipment was removed from the pipe and disassembled. A seal plug was then inserted into the 20° riser section of the entry fitting. Once the seal plug is set, the gate valve was then removed from the main. A blind flange was then attached to the 20° riser to create a second (redundant) gas seal and allow future re-entry into the pipe is so desired. The sealed entry fitting ready for burial is shown in Figure 64.

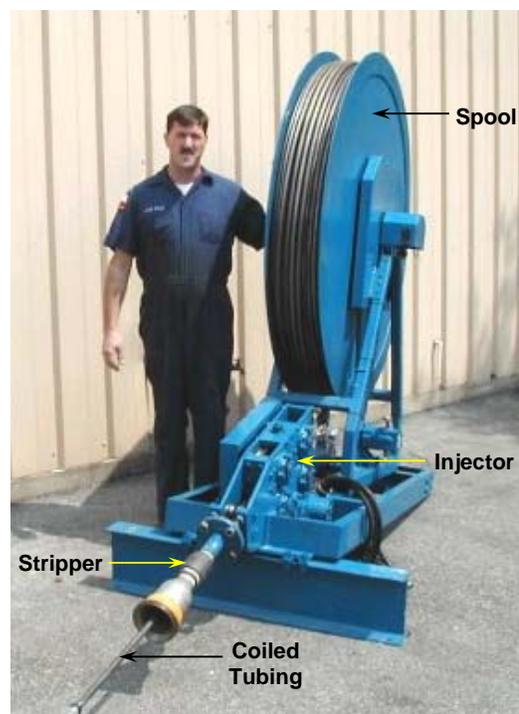
Figure B-1. CT Delivery System

GTI and MTI have successfully used CT systems for a variety of utility pipe inspection and repair operations (Porter and Pittard, 1999). In this project, the CT and its surface unit (Figure B-1) will provide primary locomotion of the cast-iron joint sealing robot trains.
