# **Development of Permanent Mechanical Repair Sleeve for Plastic Pipe**

## **Final Report**

GTI Project No. 15446

Gas Technology Institute  
1700 So. Mount Prospect Rd.  
Des Plaines, IL 60018

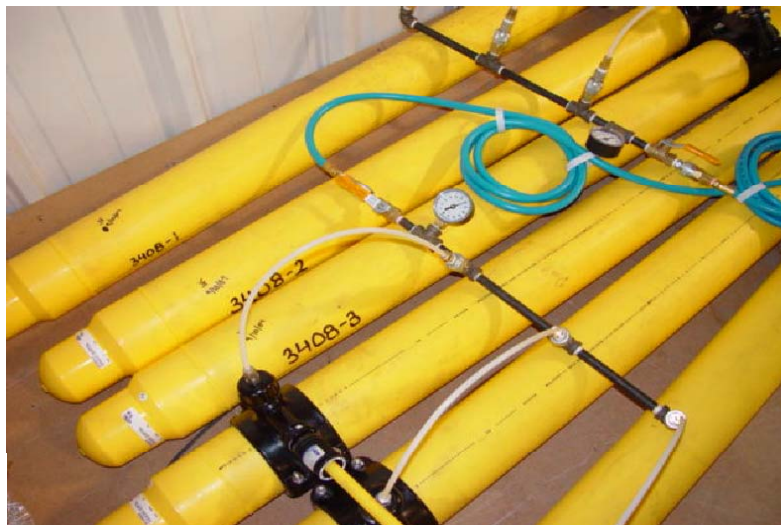
*Figure 6. SCG Test Setup*

then placed inside the 4-inch pipe assemblies. Plastic tubing (1/4 inch) was inserted through each of the tees and connected to the whip extensions of each of the 2-inch pipe samples with compression fittings. 4-inch SDR 11 end caps were heat fused onto the 4-inch pipe and the entire assembly was connected to individual pressure gauges and connected to a pressure manifold. The test set-up is shown in Figures 4-6.

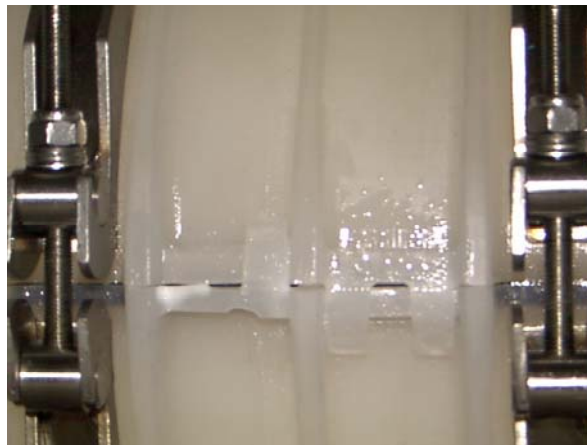
The results of the testing demonstrated that these prototype fittings could not hold water. Due to anomalies in the machined parts and the seals, there were several leak paths that were observed at pressures above 20 psig at the interface of the two fitting halves. Small scale changes were made to the seal and the prototypes were re-tested at higher pressures – 60 psig. Six Belleville washers were placed in series on the stud and compressed by a ¼-28 nut to produce a minimum pre-load on the bolt of  $\approx$  800 lbs. Even with the greater pre-load, both prototype fittings leaked and a slight separation was noted, see Figure 10.

*Figure 10. Sustained pressure testing to verify leak tightness of proposed seal design at 60 psig internal pressure*

From Figure 10, in addition to the leaks, it was observed that the fitting began to separate between the clamps with the greatest separation occurring on the outer most edge of the rib centered between the two clamps.

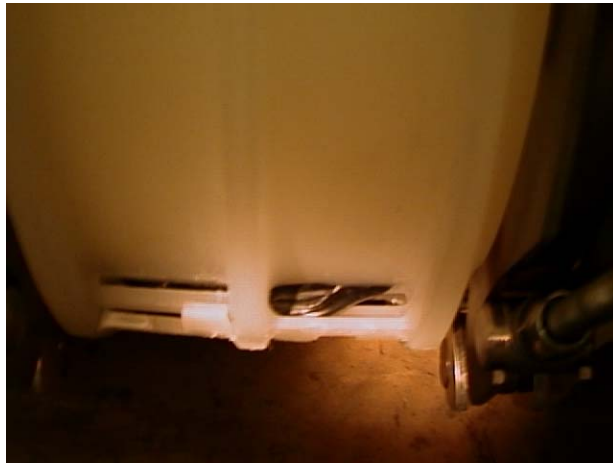
Having resolved the leaks at the seal interface, the next area of concern was the “bulging” and separation of the fitting halves that was observed at increased pressures. It was theorized that the outward bulging of the fitting shell was potentially due to the internal pressure, which causes this separation. In order to test this hypothesis, the pressure was increased to 90 psig to obtain a greater understanding of this phenomenon. Over the course of several hours at 90 psig, the gap at the center separation increased significantly. Ultimately, after several hours under pressure, the seal extruded itself out of the fitting, as shown in Figure 12.

*Figure 12. Sustained pressure testing to verify leak tightness of proposed seal design at 90 psig internal pressure*

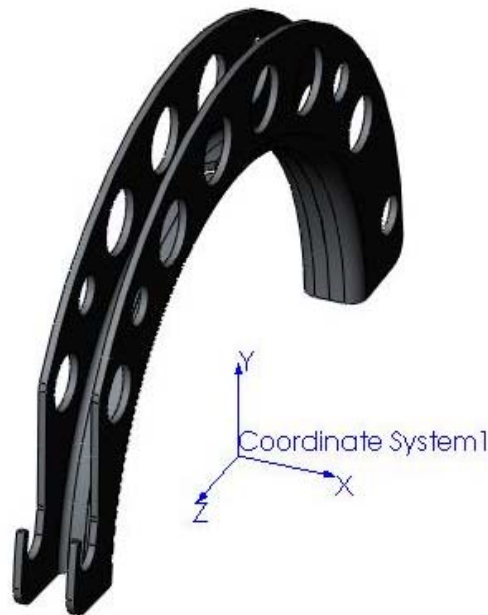
Based on the positive results of the FEA modeling, the clamping structure design was fixed and prototype clamping assemblies were fabricated. The entire clamp structure was constructed from 316 CRES (Stainless Steel). Each collar clamp half was made in two pieces by piercing and blanking the outline of the collar channel and then forming the perpendicular surface. For the prototype, the blanks were laser cut in their flat form to represent a part that would be produced on a pierce and blank die. Two simple tools, one for the small collar clamp and one for the large collar clamp, were built that could be loaded in a hydraulic press brake for forming the perpendicular radial surface. Two blanks were loaded in the forming tool where one cycle of the tool produced a left and a right version of the part. Laser cutting the blank allowed for easily changing and optimizing the shape of the blank to produce a formed part needing only minimal cleanup before the welding process. The formed left and right parts were then placed into a welding fixture where a stitched seam weld was placed on the inside of the channel making the two pieces into one half of the collar clamp as shown in Figure 19.

*Figure 19. Small collar clamp*

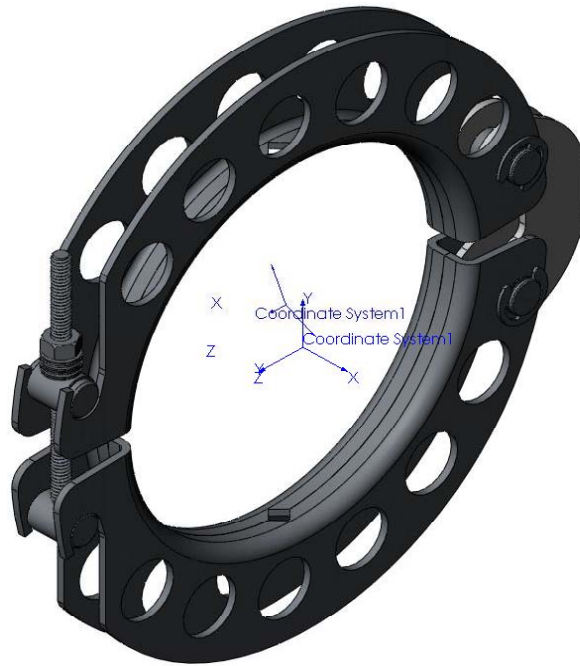
Link plates for the clamp hinge were also laser cut for the prototypes, which were pierced and blanked from a die in production. The threaded swing pin and threaded stud were welded together to form the tee bolt for the small collar clamp. Two small collar clamp halves were assembled together with the link plates, link pins and E-rings. The tee bolt was crimped in to the saddle on one of the collar halves to capture the bolt and allow it to pivot. A Nylock nut was added to complete the small collar clamp assembly as shown in Figure 20.

*Figure 20. Assembled small collar clamp*

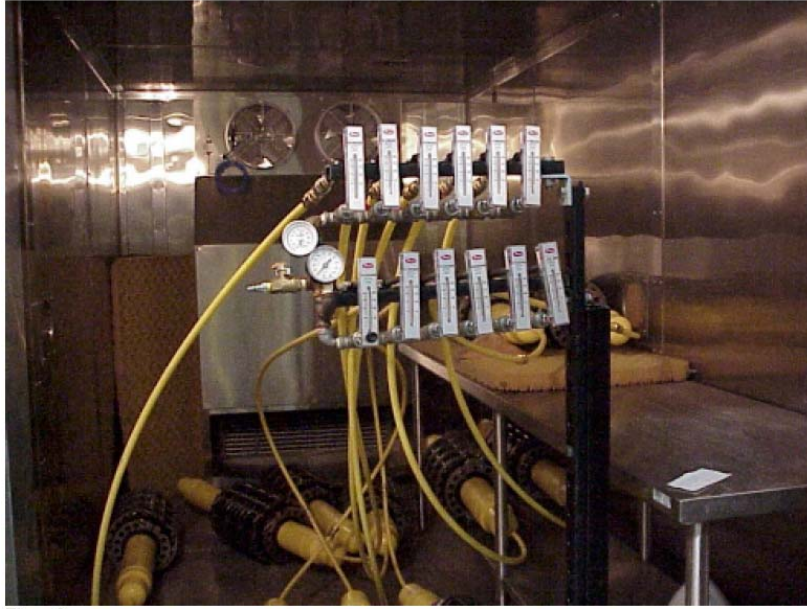
Owing to the paucity of information that was collected during the previous round of testing, the test apparatus was slightly modified in order to gain further insight into the exact temperatures at which the test specimens begin to leak. A new manifold was built with discrete flow gauges inline for each fitting. The gauges were arranged to be visible through the observation window from out side of the chamber. A video camera was placed outside the chamber and focused on the manifold gauges to monitor the test over the ten days it would take to complete the five cycles. Figure 27 illustrates the modified test apparatus.

*Figure 27. Modified Thermal Cycling Test Apparatus*

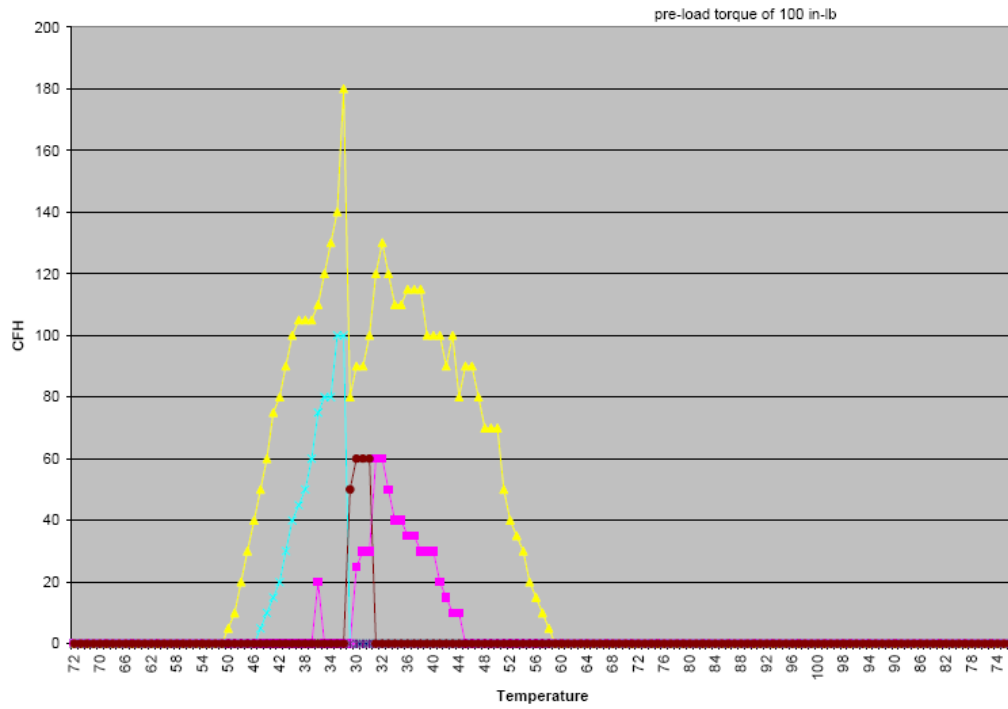
After the first cycle, there were no leaks on any of the newly installed six specimens with the increased pre-load and stiffer washers. The results of the testing were significantly better than the previous round of testing. Based on the positive results, a decision was made to install the stiffer washers on the previously tested pipe/fitting specimens (from the first round of testing) with an increased pre-load. Therefore, a total of 12 test specimens were placed in the chamber. The testing was suspended for less than an hour to allow the fittings from the previous round of testing to be put back on test. Figures 28-31 presents the leak rate as a function of temperature for each cycle.

Figure 28. 2<sup>nd</sup> Test – Cycle 2
