DOE Award No.: DE-FC26-01NT41330

Phase IIIB Topical Report Report #41330R27

Characterizing Natural Gas Hydrates in the Deep Water Gulf of Mexico: Applications for Safe Exploration and Production Activities

Principal Investigator:
Jimmy Bent
Chevron Energy Technology Company
1500 Louisiana Street
Houston, Texas 77005

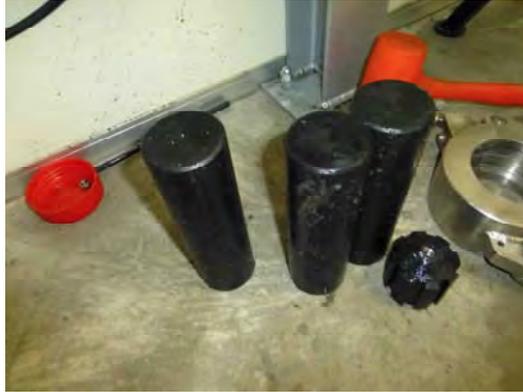
Figure 2.2. Black spacers (center of photograph) used in Nankai Trough pressure cores to uniformly position the free core end, thereby facilitating liner grabbing.

- Establish the core location in the storage chamber (were spacers used?)
 - Geotek spacers (Fig. 2.2) used during initial storage of the Nankai Trough cores tested at the AIST facility, Sapporo, Japan were very effective and provided an almost constant free-edge location of the core for all tested cores.

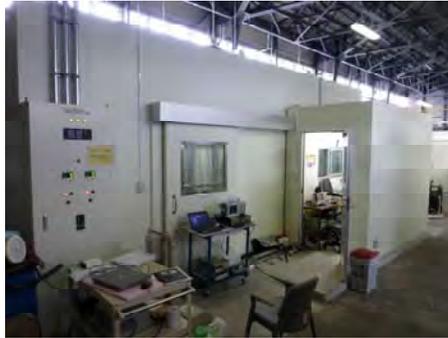
Figure 2.4. Front view of the refrigerated van used at AIST, Sapporo, Japan showing environmental conditions monitoring panel (left), sliding door (center), and the attached electronics area (right).

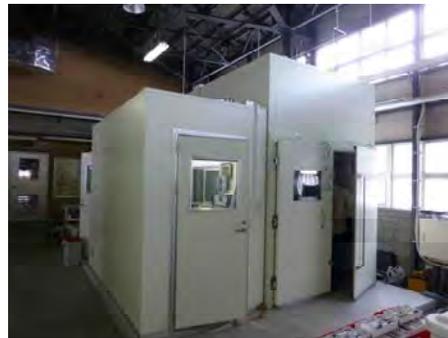
Figure 2.5. Side view of the refrigerated van used at AIST, Sapporo, Japan showing the door to the electronics room (left) and the double doors leading into the refrigerated work area (right).

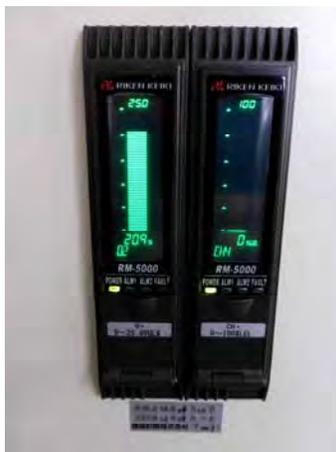
Figure 2.6. Part of the environmental conditions monitoring panel showing O₂ (left) and CH₄ (right) levels in the refrigerated work area.

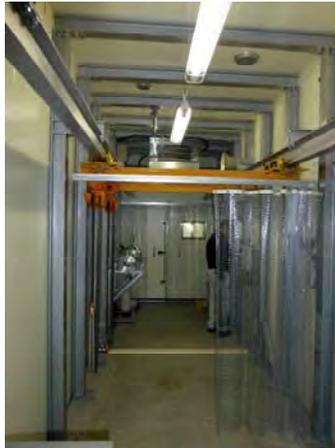
Figure 2.7. Refrigerated work area at AIST, Sapporo, Japan showing moveable plastic curtains used for reducing temperature fluctuations when outer doors are opened.

- Configuration
 - One of the short walls should have double doors with hanging clear-plastic strips (Fig. 2.7) to allow core-storage chambers to be brought in.

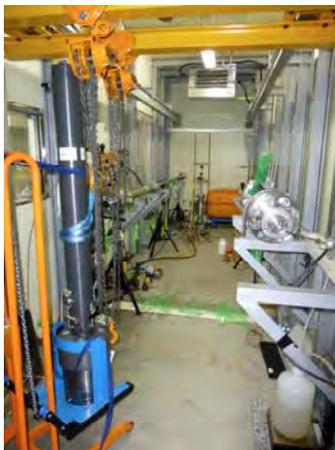
Figure 2.8. Refrigerated work area at AIST, Sapporo, Japan showing (left to right): window looking into the electronics area, custom cart for transporting pressure cores, yellow double overhead hoist system, manipulator string, Direct Shear Cell (far end of van), orange seawater tank, AIST IPTC, and wall-bracket supports.

- Configure remaining space in a horse-shoe arrangement with open central area for walking and moving gear, manipulator string along one long wall, PCCT devices along the opposite long wall, cold saltwater reservoir along the remaining short wall (Figs. 2.8-2.9).

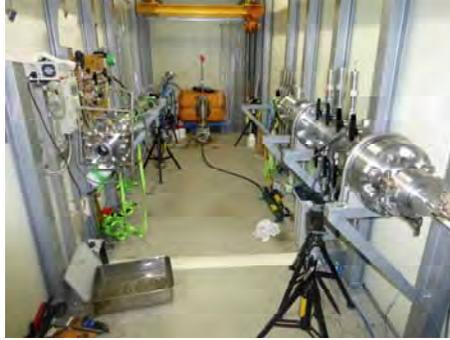
Figure 2.9. Layout in the refrigerated work space at AIST, Sapporo, Japan showing (left to right): intrinsically-safe phone used to communicate with the electronics area, manipulator string (note the wall support brackets), Direct Shear Cell (far end of van), orange seawater tank, yellow double overhead hoist system, US IPTC, and AIST IPTC.

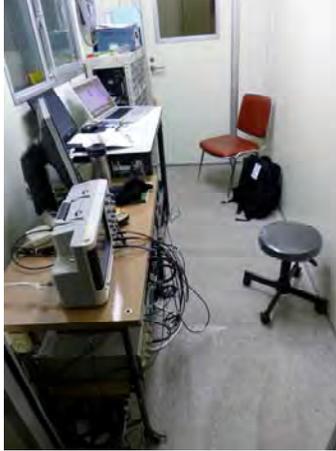
Figure 2.10. Electronics area at AIST, Sapporo, Japan. Note the window and telephone (upper left corner) allowing visual and voice communication with the refrigerated work area.

- Option 2: Electronics *outside* the operational cold room (Fig. 2.10)
 - Electronics room should be a minimum 2 x 6 m (6.5 x 20 ft) space to accommodate all PCCT systems, but preferably the electronics space would run the complete length of the cold room, with glass between the electronics and the cold room.

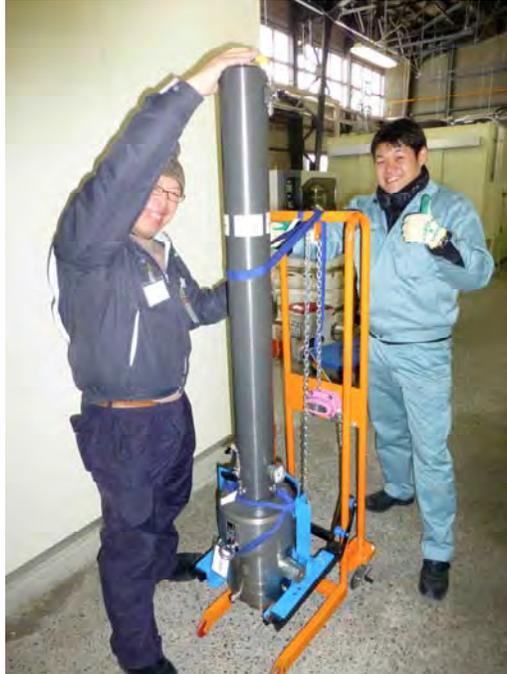
Figure 2.11. Transporting a pressure core using a custom-rolling cart.

- Device Manipulation Requirements
 - Ramp access between permanent storage room and testing facility.
 - Fitted carts for pressure vessel transport. These may need to be customized for each site depending on core storage device (Fig. 2.11).

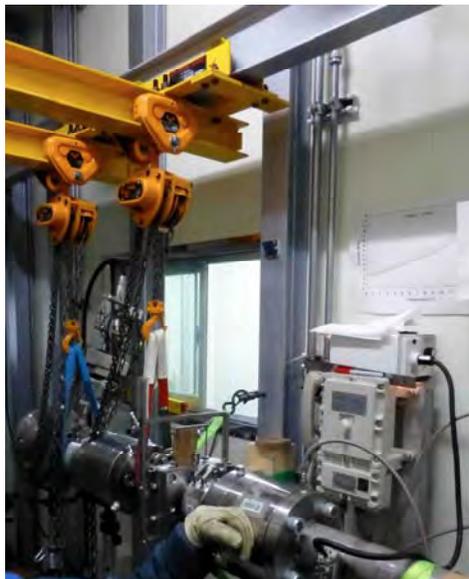
Figure 2.12. Yellow double overhead hoist system (upper left) being used to support a PCCT device in the cold room at AIST, Sapporo, Japan. The window separating the cold room from the electronics room (center) and the intrinsically safe telephone used to communicate with the electronics room (right) are also shown in the photograph.

- Independent overhead cranes with a 2.5 m (8 ft.) chain fall significantly improve device manipulation and alignment (Figs. 2.12-2.13).

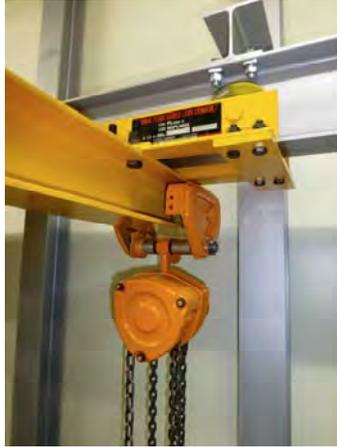
Figure 2.13. Close up view of the overhead hoist system used in the cold room.

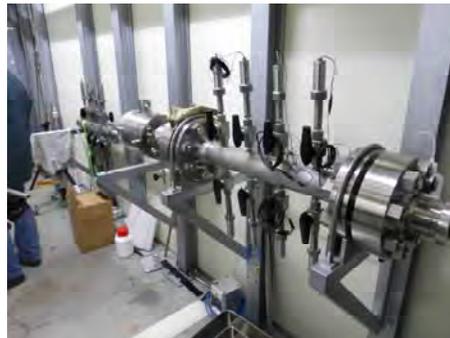
Figure 2.14. Wall brackets support the US IPTC (left) and the AIST IPTC (right).

- Wall-mounted brackets (Fig. 2.14) and rubber shims/step blocks worked very well for supporting the manipulator string. 1 m (39.5 in) centers, on the bracket spacing was acceptable. 1 m (39.5 in) height to the bracket top was acceptable.

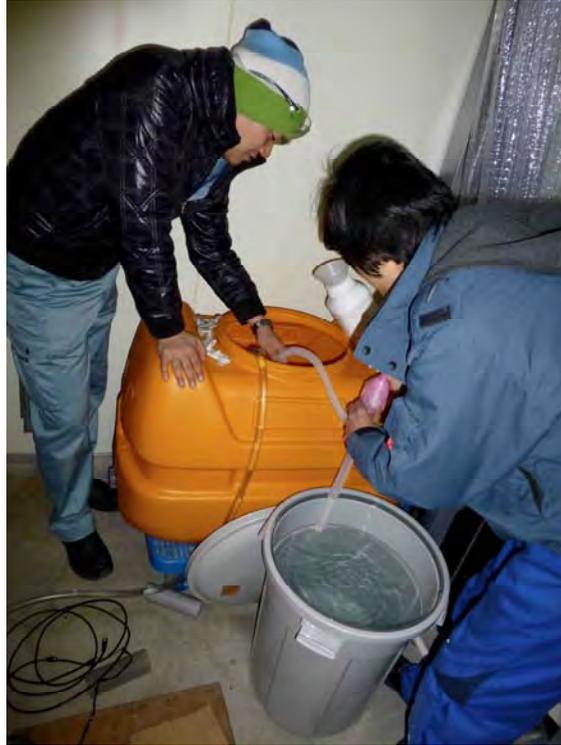
Figure 2.15. Siphoning water into the orange seawater container in the cold room.

- Fluid Handling Requirements
 - 200 L plastic container (or two 100 L containers) (Fig. 2.15) is needed as a saltwater reservoir held at cold-room temperatures for filling devices and storage vessels.

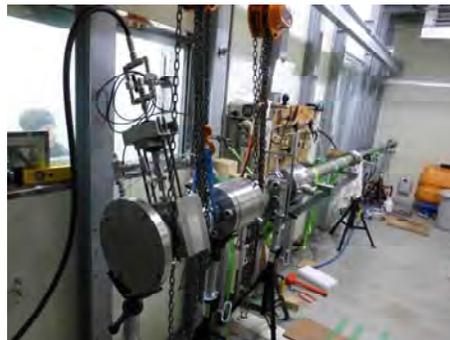
Figure 2.18. Manipulator string in the cold room at AIST, Sapporo, Japan with the Direct Shear Cell attached on the near end and the stepper motor that controls core movement located at the far end. William Waite (USGS) views the operation from the electronics room through a window (upper left).

- Manipulator (1 GaTech, 2 GaTech/USGS) (Figs. 2.18-2.19)
 - Controller (1)
 - Position verification (2: tape measure operator; spreadsheet operator)
 - During operation, a position verifier can monitor whether the motor is moving and verify motor revolution count during precision operations.

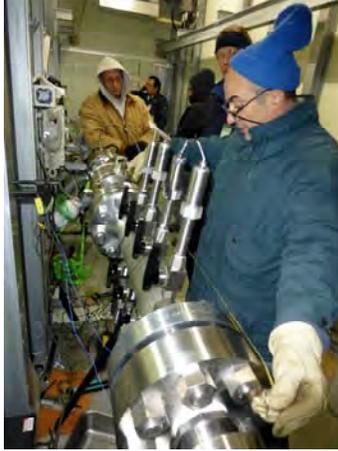
Figure 2.19. Measuring the manipulator string prior to moving a pressure core into the AIST IPTC (foreground).

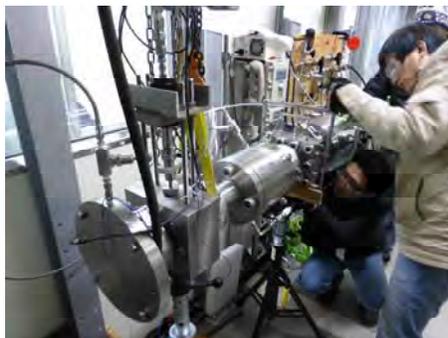
Figure 2.20. Cutting a core section prior to transferring it into the Direct Shear Cell (DSC) (left).

- Cutter (1 GaTech, 2 GaTech/USGS/Other) (Fig. 2.20)
 - Controller (1): Needs to be someone with a feel for the correct behavior of the cutter blade, proper tension and loading, proper activator-arm and core-grabber tightening.
 - Saw (3): Cutting worked well with a rotation between the person moving the saw, the person applying a load to the blade and someone resting/marketing the progress. One of these three can be the controller.

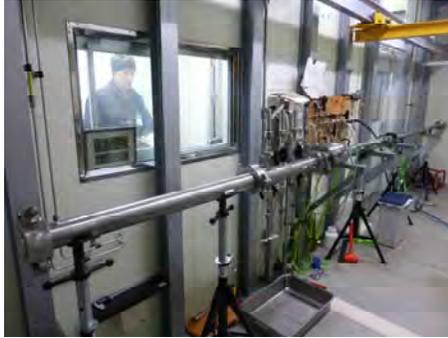
Figure 2.21. Complete manipulator string containing an extension chamber, the US IPTC, and manipulator (left to right) viewed by personnel in the electronics room.

- IPTC (4 USGS, 1 GaTech) (Figs. 2.21-2.22)
 - Device operator (2: mechanical controller; electrical controller)
 - Movers/plumbing/repairs (2)
 - Manipulator operator (1)
 - During operation, the movers and manipulator operator will also act as second hands/brains for the mechanical and electrical controllers.

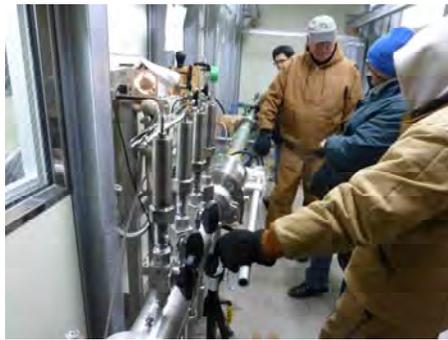
Figure 2.22. Opening a ball valve, prior to transferring a pressure core section into the US IPTC (foreground).

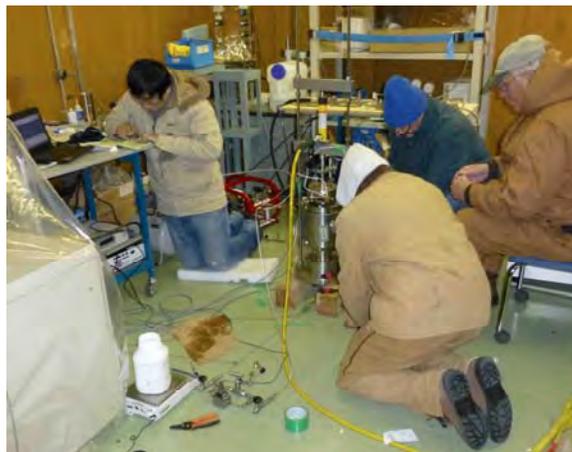
Figure 2.23. Working with the Effective Stress Cell.

- Effective Stress (2 GaTech + 2 movers/plumbers) (Fig. 2.23)
 - Manipulating the device requires 2 movers and 1 device controller.
 - Operating the device requires 2 operators for pressure management.

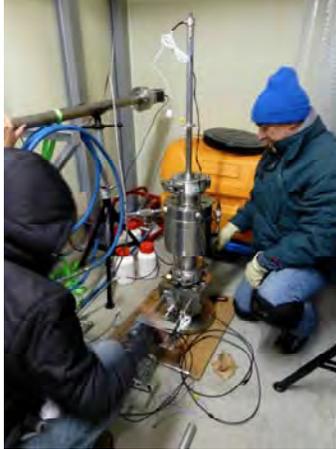
Figure 2.24. Operating the Direct Shear Cell in the main cold room.

- Direct Shear (2 GaTech + 2 movers/plumbers) (Fig. 2.24)
 - Manipulating the device requires 2 movers and 1 device controller.
 - Operating the device requires 2 operators for pressure management.

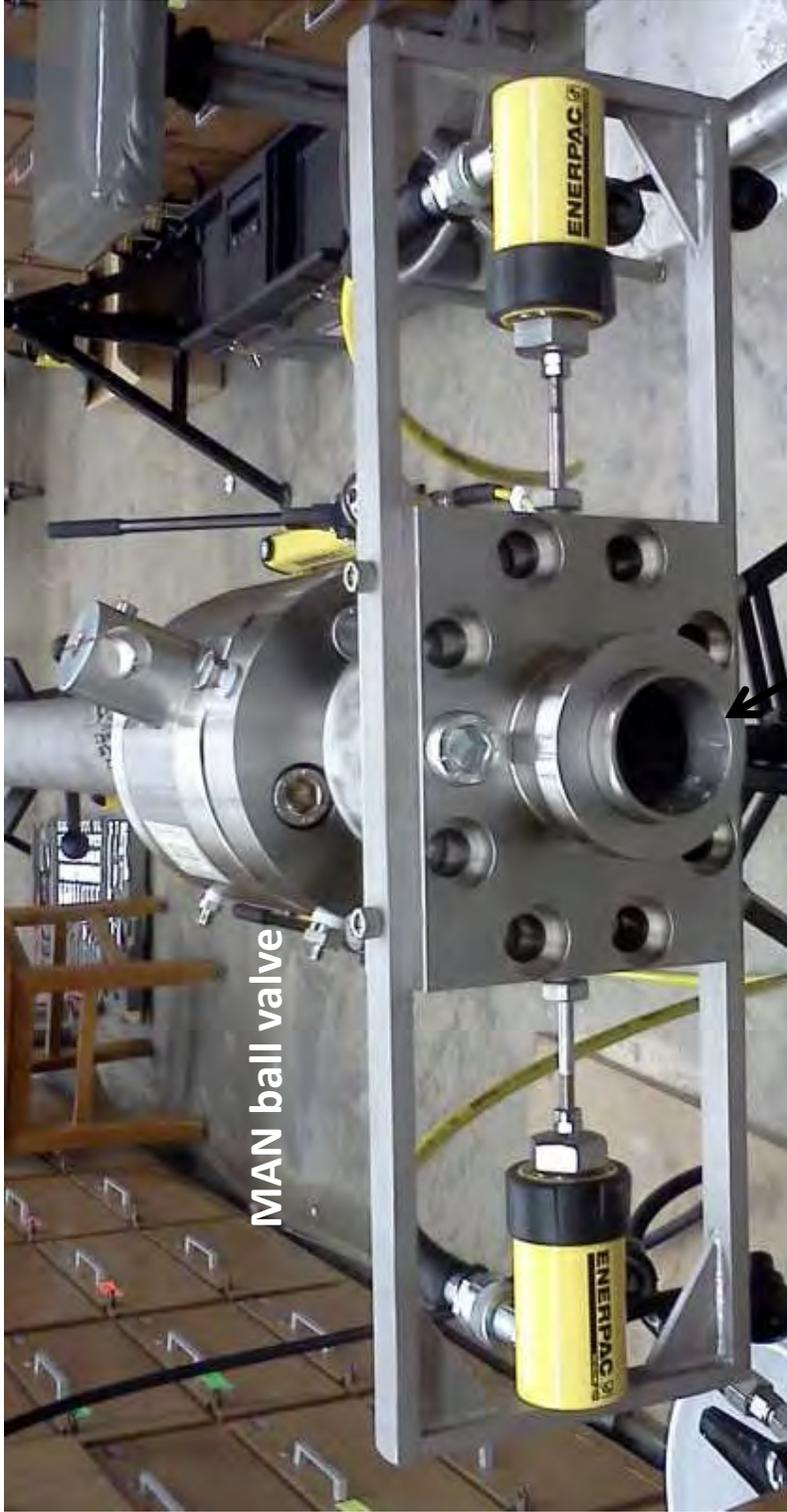
MAN ball valve

Coupler

Assembly to MAN <ol style="list-style-type: none">1. Couple with MAN from one side and any PCCT on the other side. With the help of couplers, it is possible to couple to MAN the same way it is done with each chamber (in the figure is shown only 2 screws of the 10 needed to operate).2. Fill the chamber with water and pressurize. Check for leaks3. Once the pressures on the MAN and GUI matches, the ball valve can be opened	AS-GUI 4

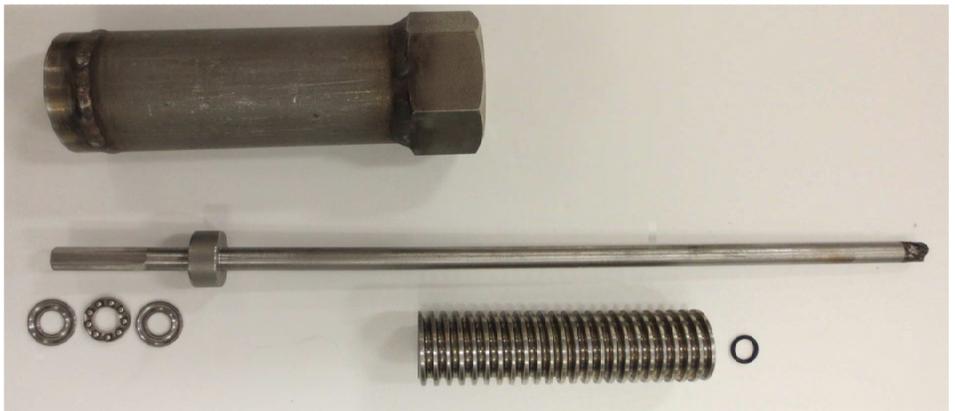
**SELF-DRILLING
THERMOCOUPLE**

Slide #
<p>Early steps Connect electronics and tubing</p>	
<p>Depressurization</p> <ol style="list-style-type: none"> 1. Fill water in the chamber through the fitting on the cap until the port on the flange drains water 2. Perforate holes on the liner by using the drilling system while transferring the core 3. Insert self-drilling thermocouples by rotating the rod and hand driver 4. Place a thermocouple in the thermo-drilling rod cavity until it touches the tip 5. Open the needle valve to dissociate gas. 6. Monitor chamber pressure, chamber temperature, and the weight of gas storage. 	<p>OP-DSC 1</p>
<p>Caution</p> <ul style="list-style-type: none"> • Be sure that the minimum engagement length of thread connections during operations (25 mm for the hand-driver and 2.5 mm for the locking nail) • Do not apply high pressure to acrylic storages: the maximum pressure is 35 kPa (5 psi) for the gas storage, and 210 kPa (30 psi) for the water storage.

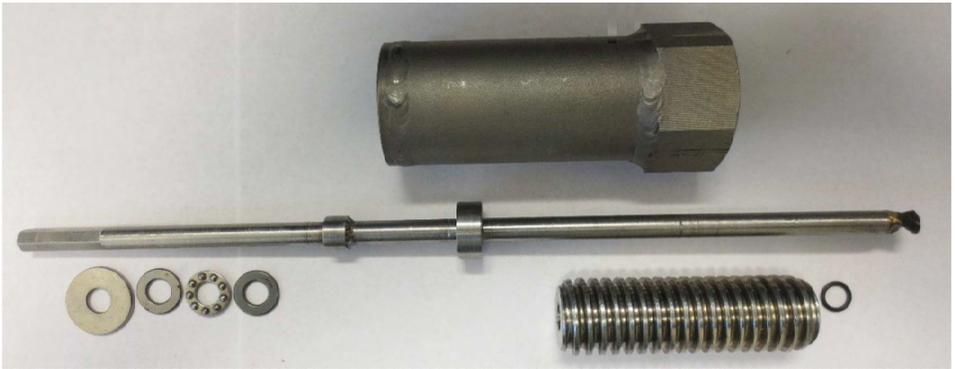
DRILLING SYSTEM

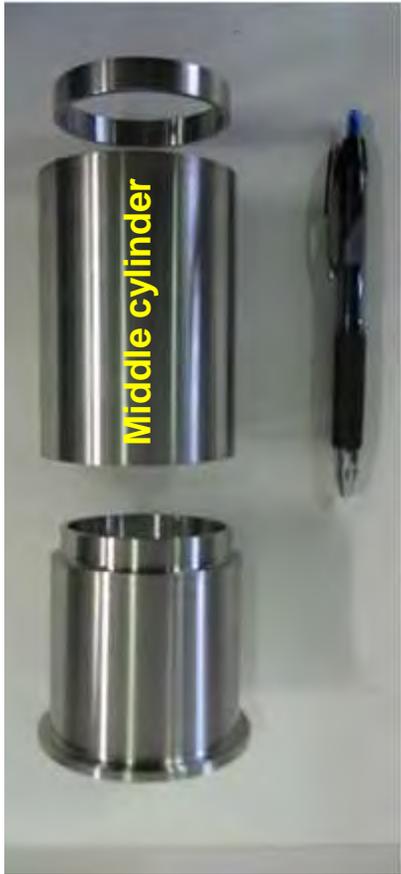
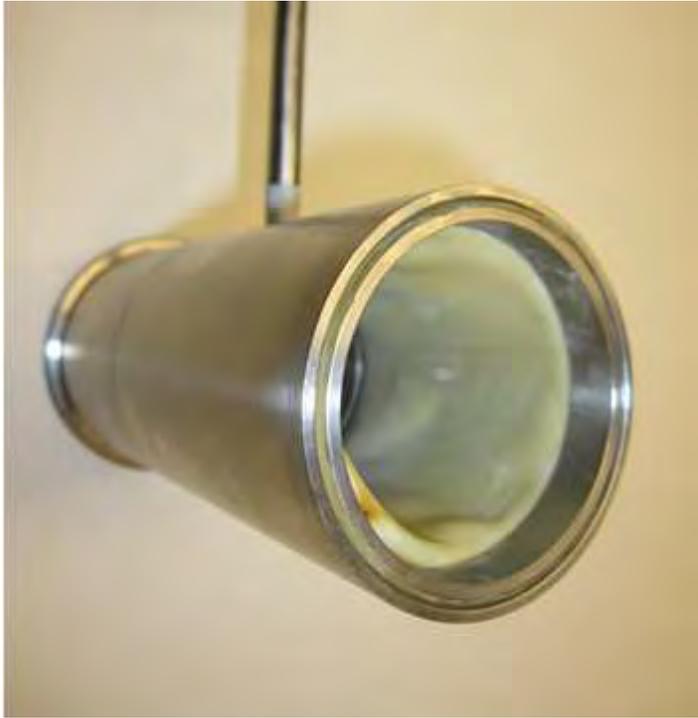
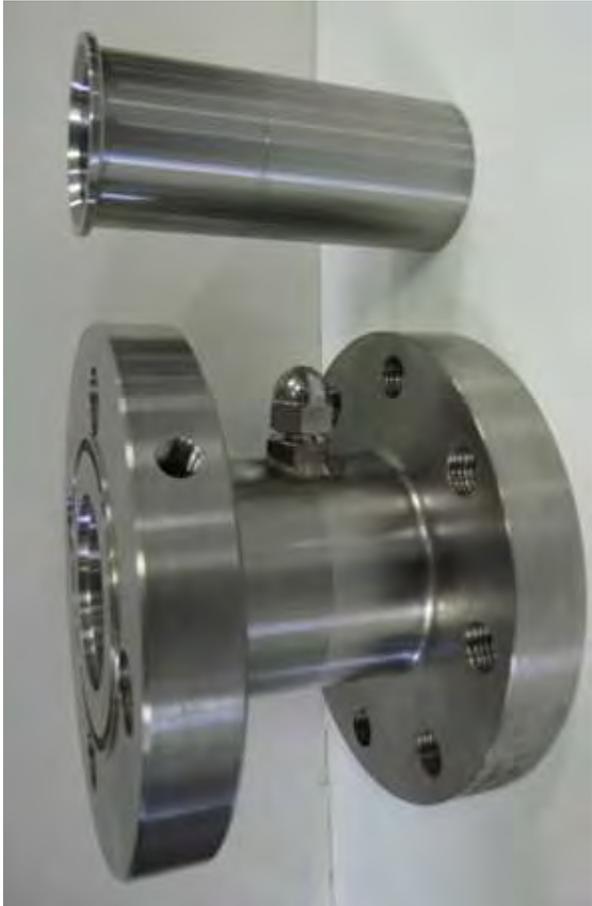
Slide #
<p>Assembly of the membrane cell</p> <ol style="list-style-type: none"> 1. The membrane cell consists of 3 stainless steel cylinders and a 2"-diameter rubber membrane. 2. The membrane should cover the inside of the middle cylinder (which has a 1/6" NPT hole) and be flipped over at the two ends to cover the outside of the middle cylinder. 3. The other two cylinders are inserted into the middle cylinder and tightly squeeze the membrane. 4. Cut off the part of the membrane that outside the cylinder. 5. Place the membrane cell into the main chamber (#4 in Slide AS-ESC 2). Use a 1/16"-NPT tubing to go through the side weldolet on the main chamber and connect with the membrane cell. 6. The 1/16"-NPT tubing is sealed by an o-ring and a back-up ring between the weldolet and a weldolet nut. <p>Note:</p> <ol style="list-style-type: none"> 1. The tested maximum differential pressure for the membrane within the cell is ~1MPa. 2. To replace the membrane: (1) unscrew the weldolet nut; (2) unscrew the 1/16"-NPT tubing; (3) take the membrane cell out of the main chamber; (4) take apart the 3 cylinders and replace the membrane. 	AS-ESC 3

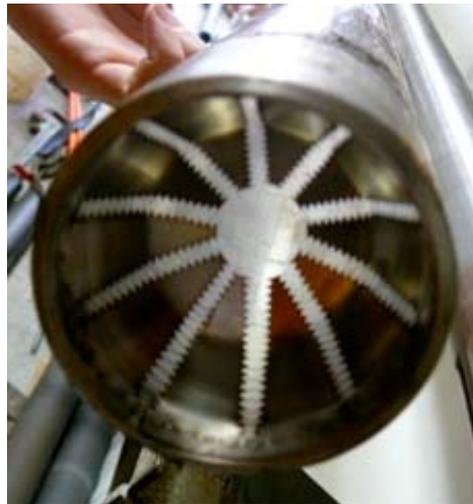
Figure 4, Basket Catcher

The basket catcher is very similar to a mining type core catcher. It has a series of spring steel sheet metal fingers pointing up that fold open to allow the core to enter but collapse inward when the core pushes them down. This prevents the core from sliding back out. This is the catcher that has been traditionally been used in coring systems with the ability to transfer to PCATS under pressure.

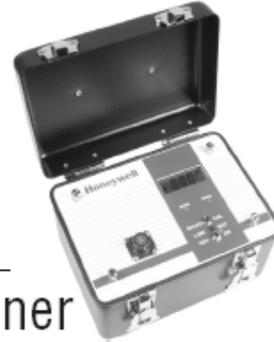
Portable LCD Display/Signal Conditioner

The Model NK portable instrument features a full 4 1/2 digit LCD display and is designed for use in remote field operations as a portable calibrator or readout device. Shunt calibration offers the operator quick field setup with a minimum of warm-up. A peak/hold feature is optional.

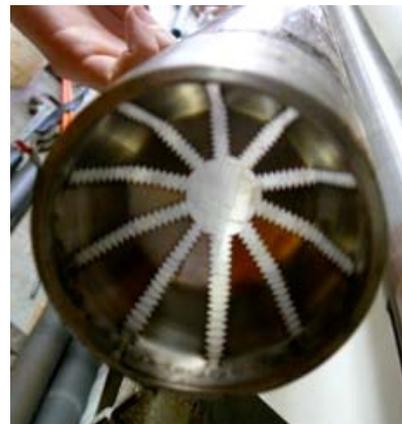
Figure 10. Hybrid PCS Basket Core Catcher

Core catchers allow relatively free entry of the core into the core liner in the inner tube but prevent it from exiting when the core barrel is lifted off bottom. There are three core catcher options for the Hybrid PCS. The basket core catcher is shown in the photo. The thin sheet metal blades spring open to allow the core to enter but spring closed to prevent the core from sliding out. There is also a conventional slip type catcher and a full closing flapper catcher for very soft formations. The basket catcher can be used alone or in conjunction with one of the other two.

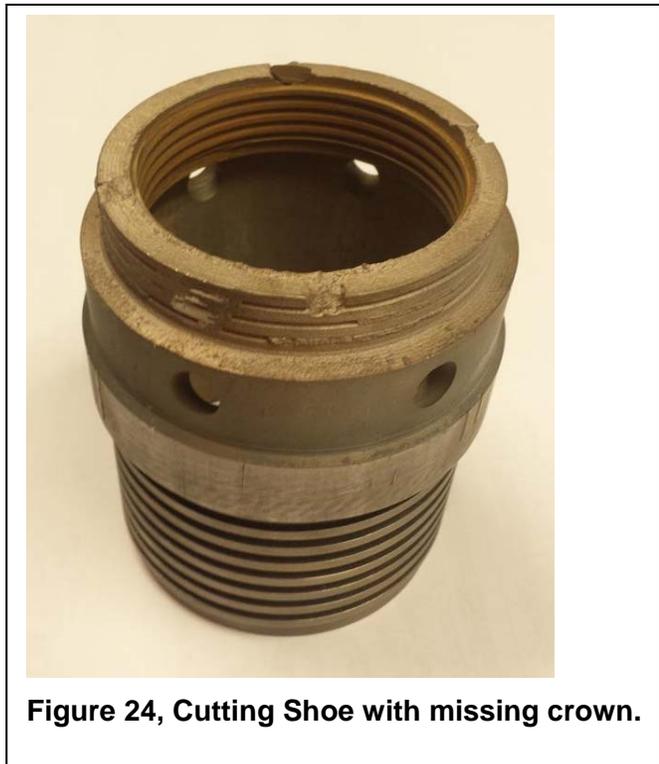
Figure 24, Cutting Shoe with missing crown.

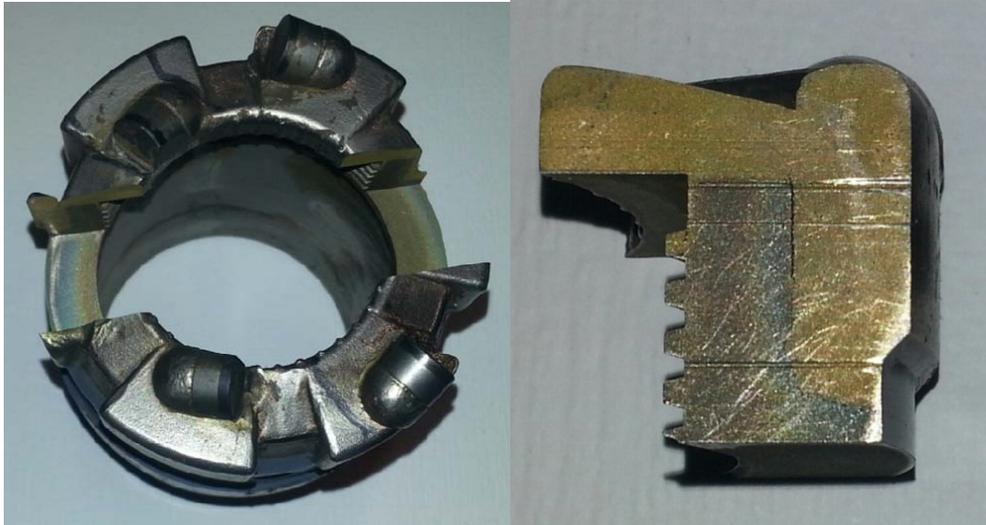
a metallurgical section of a new cutting shoe in the bond area prepared to confirm and verify the metallurgist's hypothesis. A apparent void area can be seen in the section in the area between the crown and shank showing an imperfect bond but this is not serious enough by itself to explain the complete disintegration of the matrix crown.

Figure 25, Cutting shoe crown with section removed for analysis.

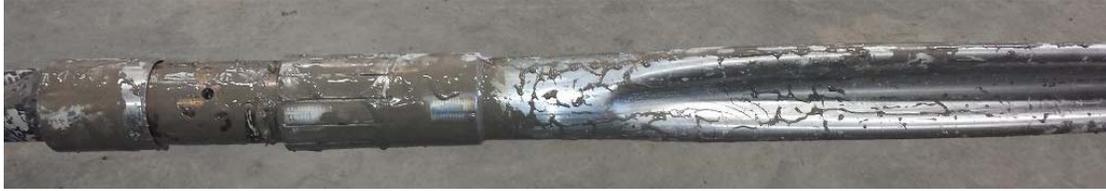
Figure 27, Collapsed inner tube from face bit Dimensional Test #1.

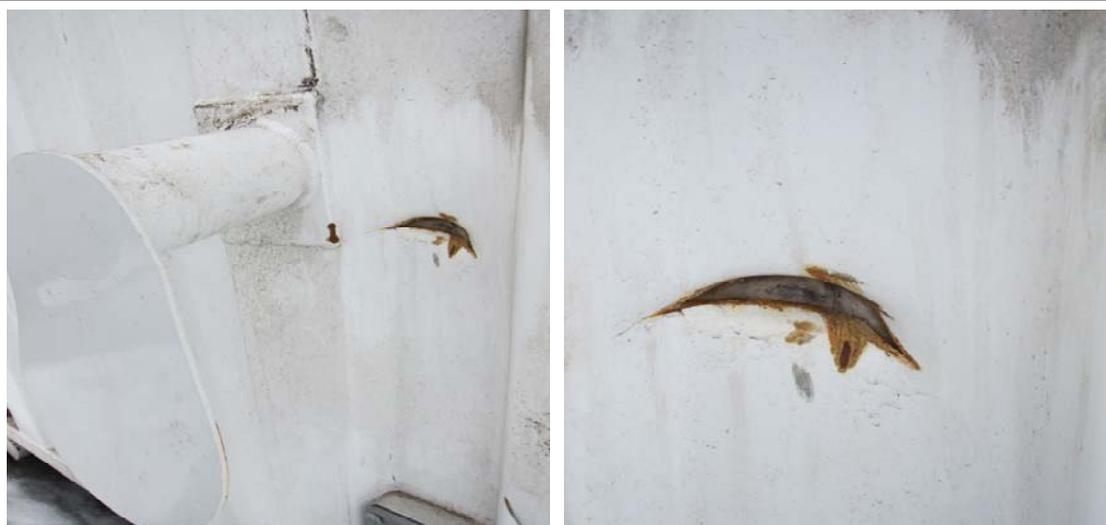
The Service Van was apparently stabbed with a forklift either during placement or while being moved or loaded following the field test. AAI inspected the damage and believed the damage to be superficial and not structural.

Figure 28, Damage to Service Van from apparent fork lift stab.

Aumann & Associates obtained approval from Chevron and repaired the damage. The following photos show the damaged area after the repairs were made.

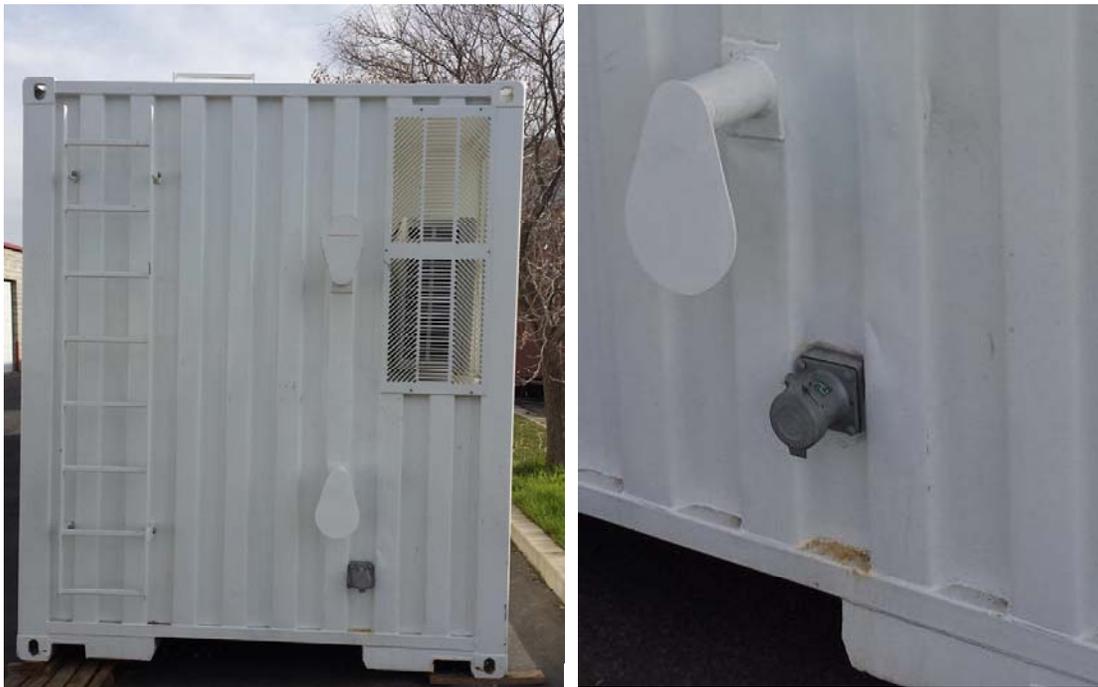
Figure 29, Repaired Service Van

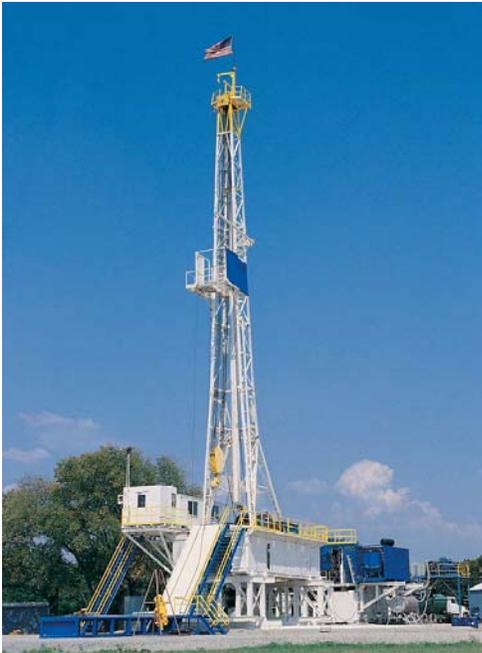
The Catoosa rig was custom built for research drilling and testing. It has a substructure that can rotate around a circular track allowing multiple wells to be drilled from the rig. Each well in turn had a conductor set below the water and surface sediments, and can be sidetracked in many directions. Geological control is very good as there are many penetrations in the strata.

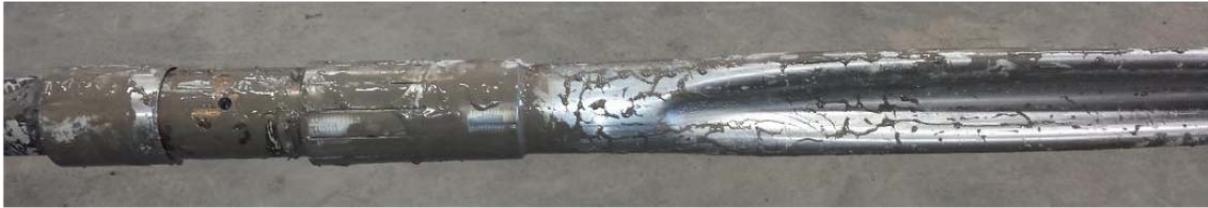
11:00AM – Ran the wireline pulling tool which latched, released and wire-lined to surface with no problem. Upon inspection, it was discovered that the ball valve was not totally closed (about 90% turned). Ball valve appeared to be blocked by the rabbit in the core liner, some mud caked on the core rabbit. Note that no screens were used in the mud system. Closer inspection revealed that both the plastic liner and inner aluminum barrel had collapsed (see photo). It was decided to POOH to inspect the BHA.

Collapsed inner tube from face bit Dimensional Test #1.

2:00-7:00PM – Conducted two near-surface pressure tests to identify possible flow restrictions: (1) the first with no liner or steel inner tube – no pressure anomalies were observed. (2) Second test included both a liner and steel inner tube – again no pressure anomalies were observed. No clear reason was discovered for the cause of the differential pressure in the tool that collapsed the plastic liner and inner steel barrel. AAI reviewed the design and decided the Face Bit Upper Assembly did have a restricted flow path in the area of the outer bearing and recommended drilling holes in the extension tubes in the upper assembly to reduce pressure. However, this still did not explain the excessively high pressure spike observed in the first test. A collective decision was made to switch around the testing program and move ahead with the planned test of the Cutting Shoe version and move the Face Bit tool test to the following week. This would provide time to examine the AAI proposal over the weekend and make the modifications if warranted and continue to study the problem.

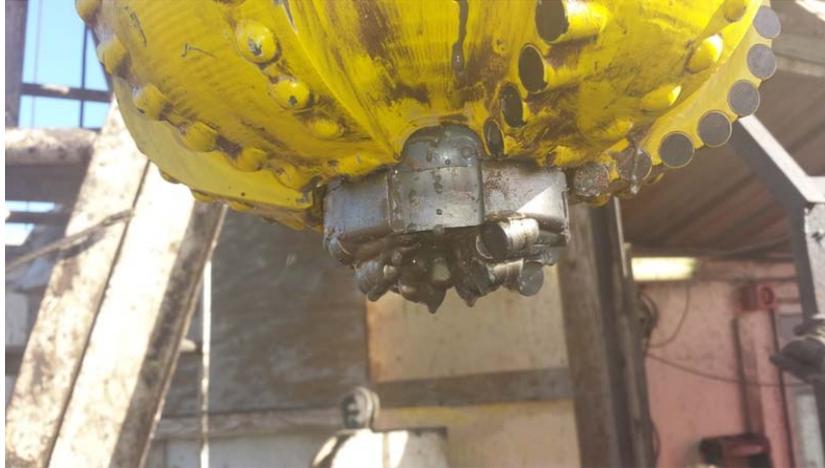
Face bit center bit extended ahead of the main bit by about 3/4".

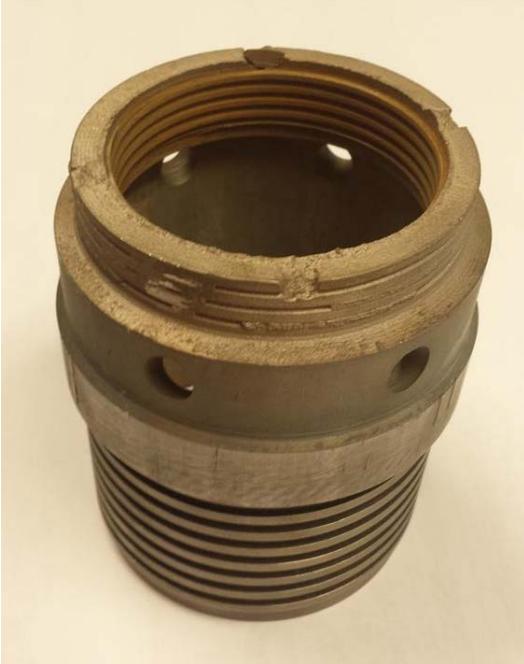
Note: A weird chatter pattern was visible on the ID of the Cutting Shoe Bit that was not there previous to the failed core run. It has been speculated that this may be due to the matrix and PDC cutters grinding on the bit ID as it was disintegrating after the cutting shoe head separated from the cutting shoe shank. (See photos.)

Cutting Shoe with missing crown

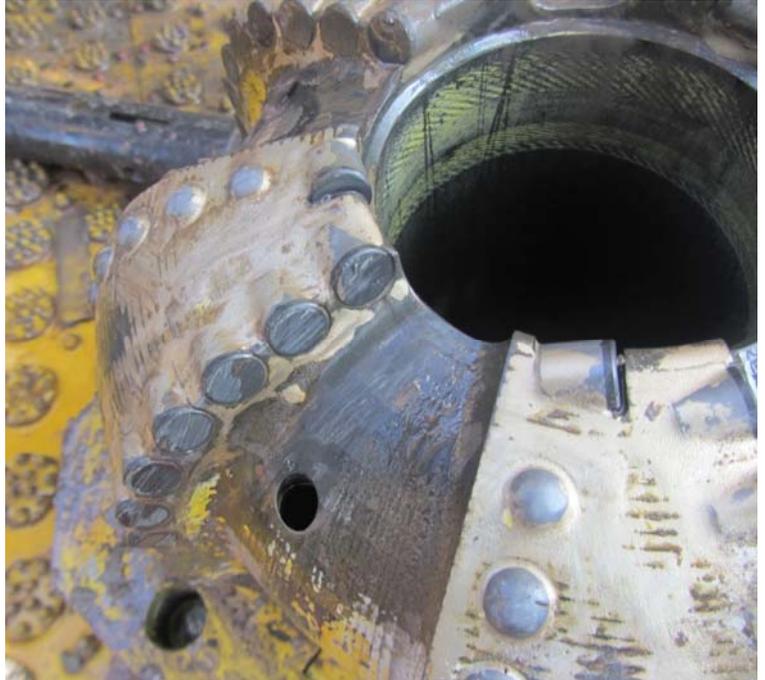
Chatter pattern in ID of Cutting Shoe Main Bit.

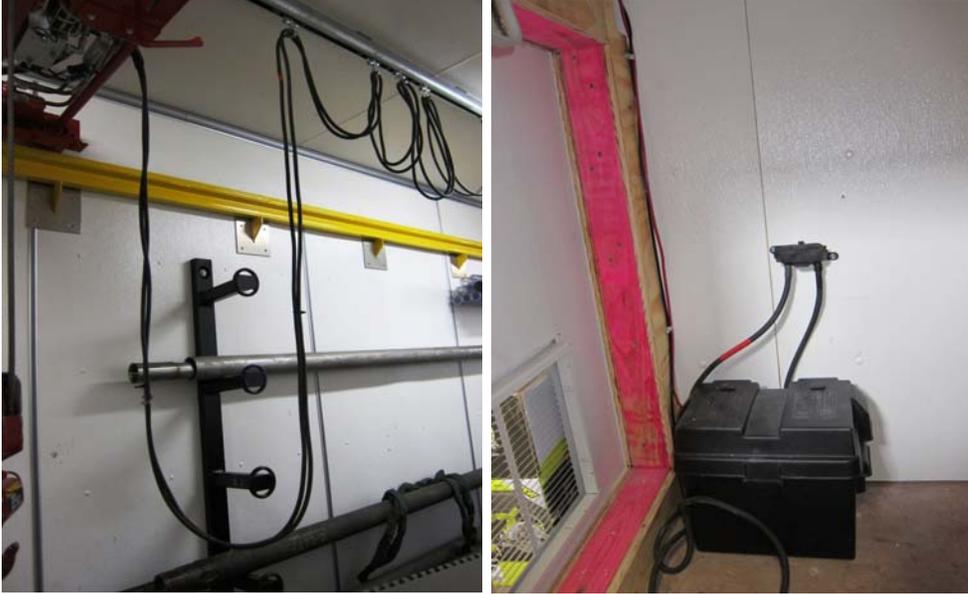
Possibly unsafe overhead crane power supply hookup.

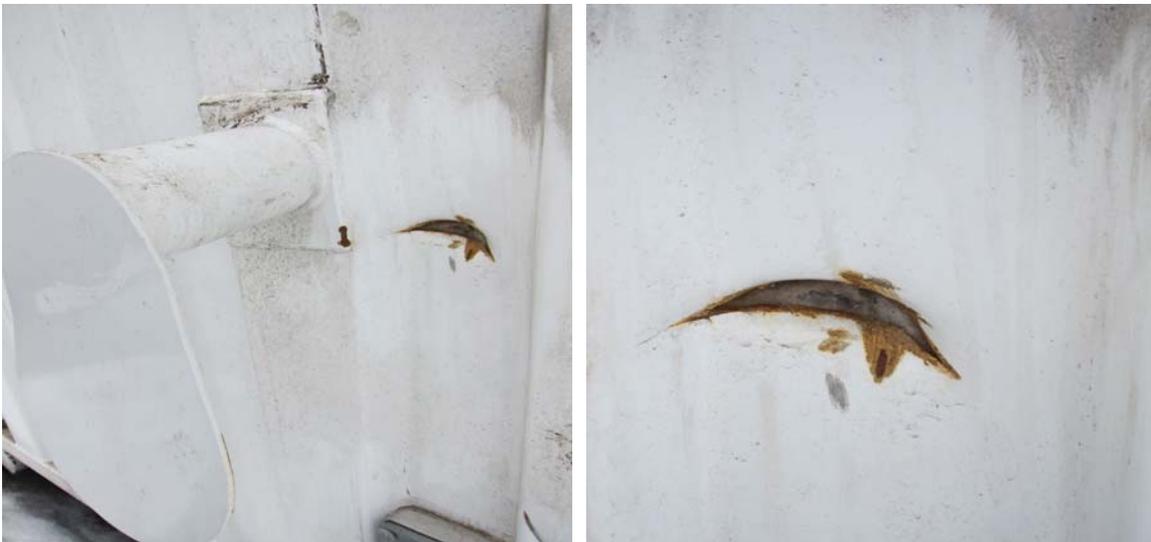
- The Service Van was damaged during the CTF tests. It appears to have been stabbed with a forklift truck on the rear of the unit. There is a puncture in the skin and several dents with paint missing. The damage was repaired.

Damage from apparent forklift stab during the CTF field test.

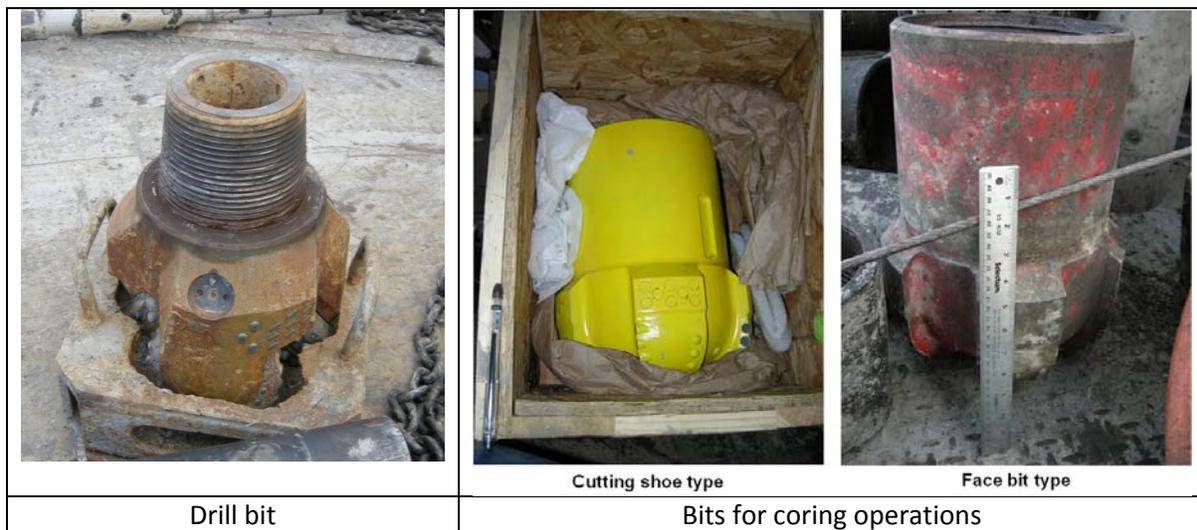
Two types of coring tool cutting structures were used, the cutting shoe and face bit type. The figure below illustrates the bits. The maximum diameter of these bits was 10-5/8 inches.

In the cutting shoe type, the core is cut by an inner bit called a cutting shoe while the main bit opens the hole. The face bit type is more like a conventional coring system where the main bit both cuts the core and drills the hole and there is no inner bit. The figure below illustrates the general scheme of the tools in working operations.

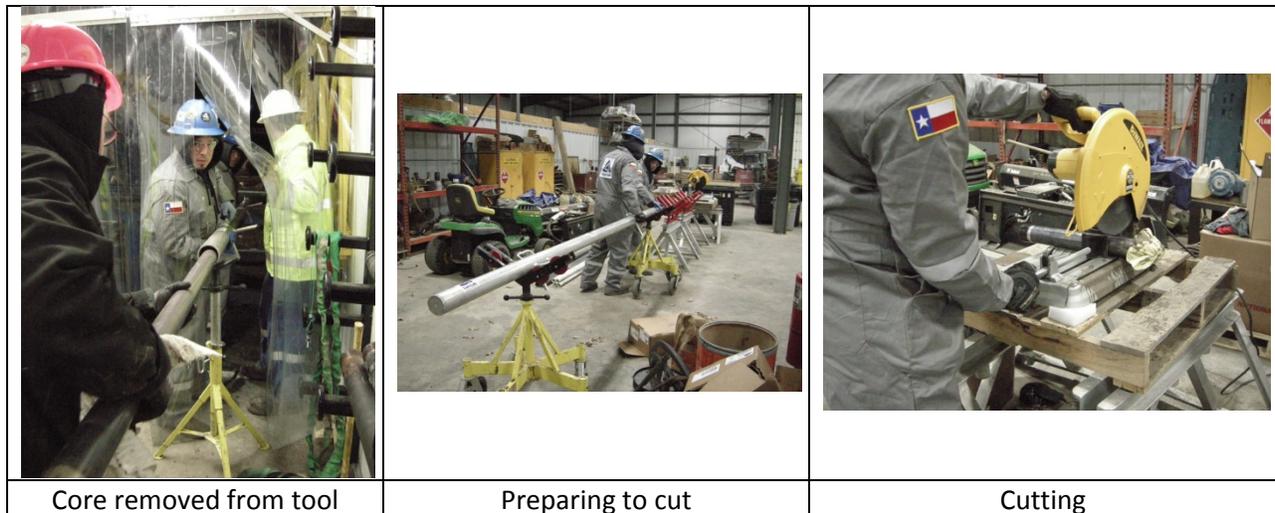
At the surface, the liner is removed from the tool and transferred to the transfer pipe. Then the liner is transported to the workshop where by the help of stands, it is placed ready to cutting procedures. The figure below illustrates this typical procedure.

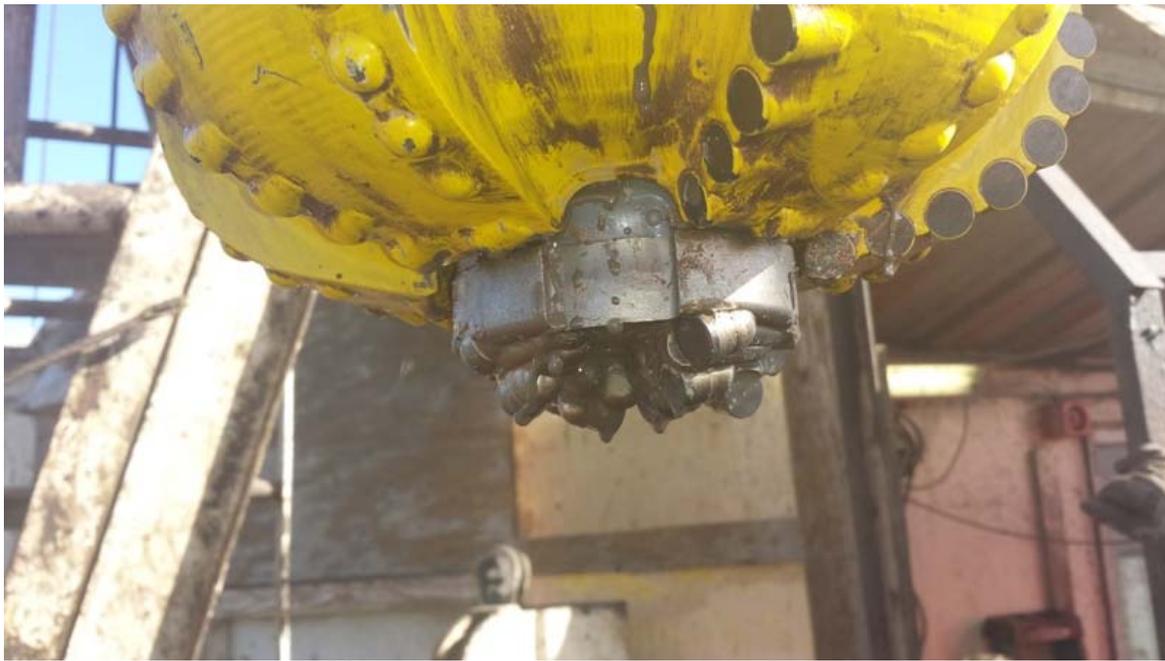
Figure 1. Face bit center bit extension.

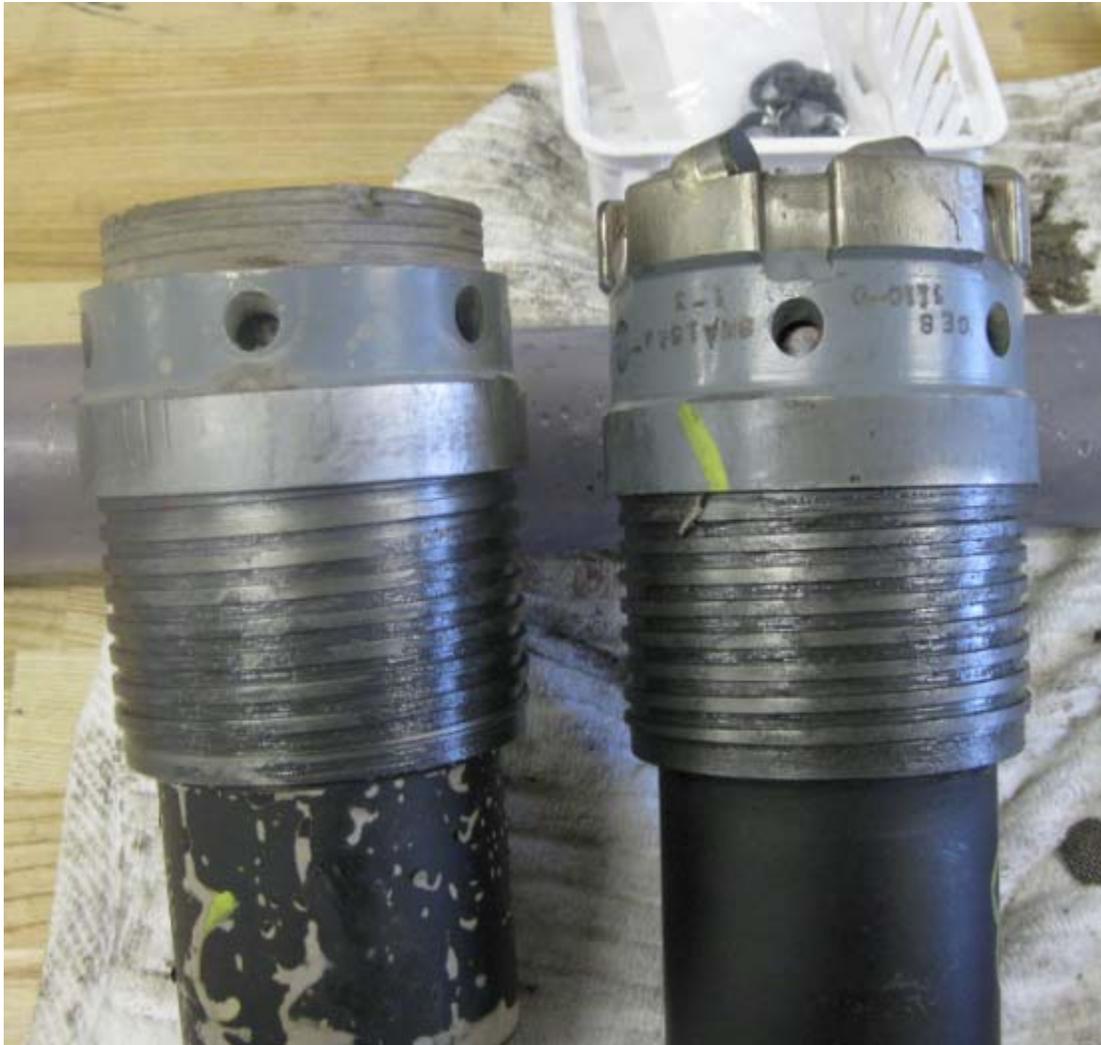
Figure 3. Disintegrated cutting shoe crown.

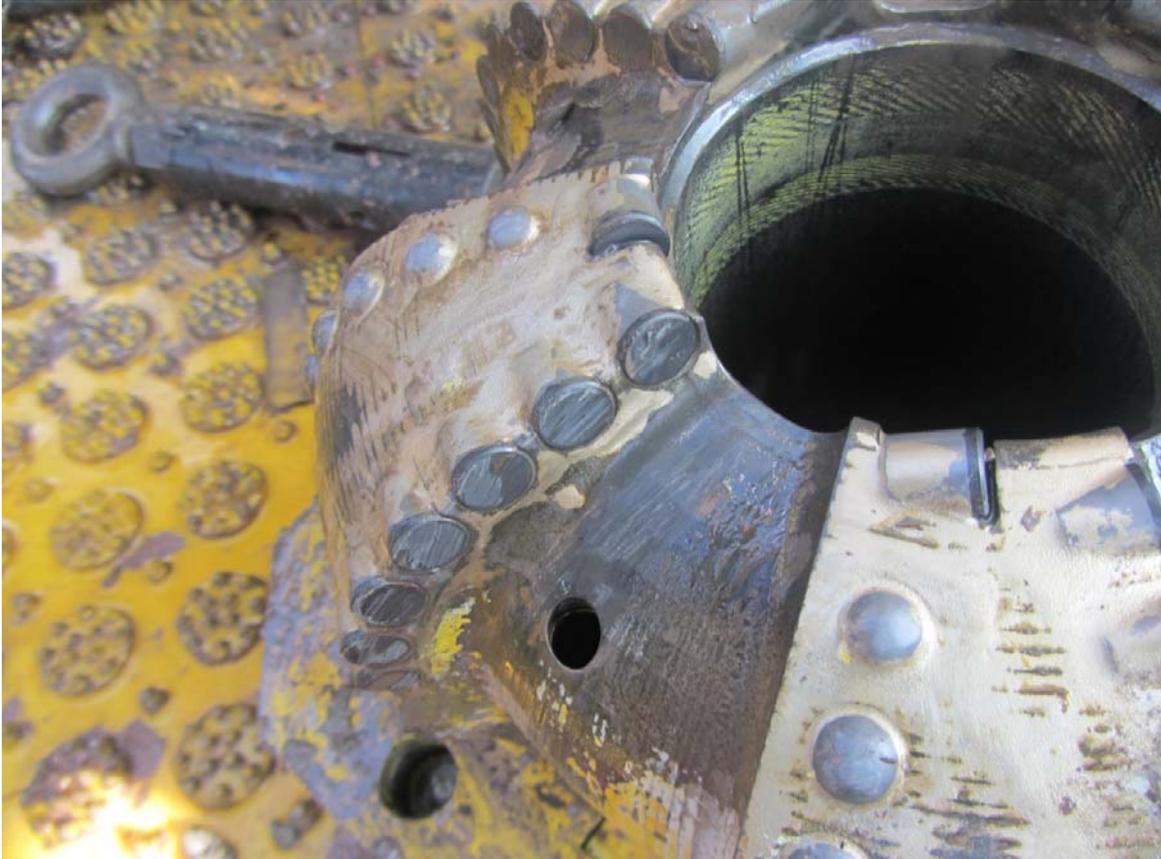
Figure 4. Chatter pattern observed on main bit.

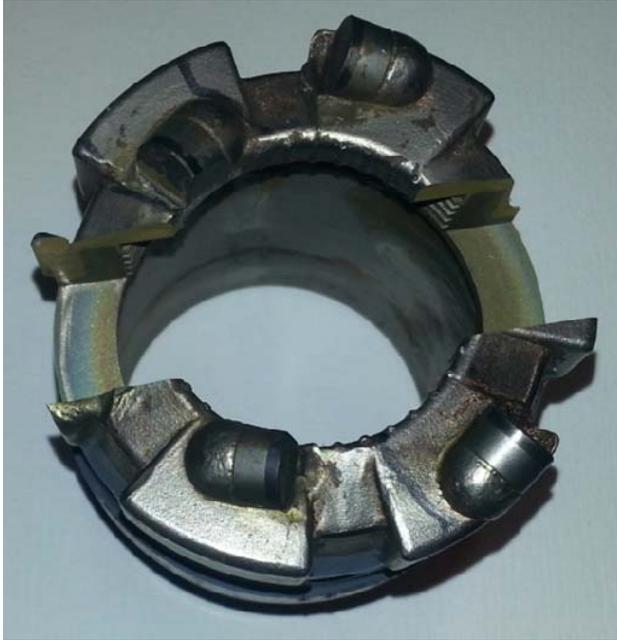
Figure 5. Sectioned new cutting shoe crown.

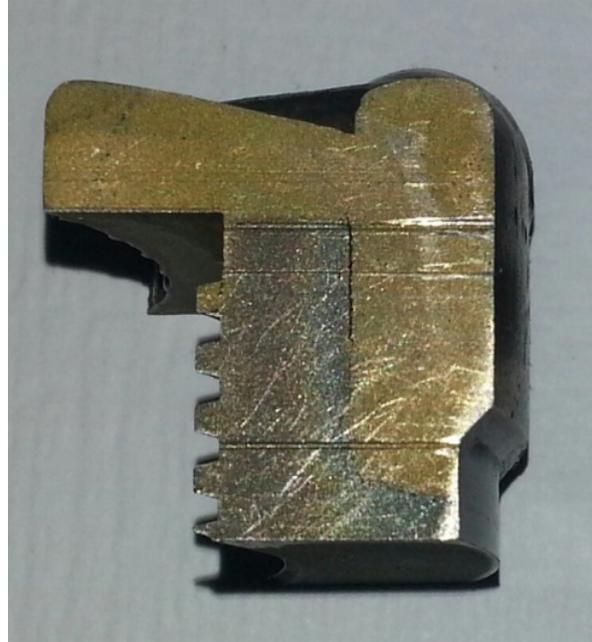
Figure 6. Cutting shoe crown section.

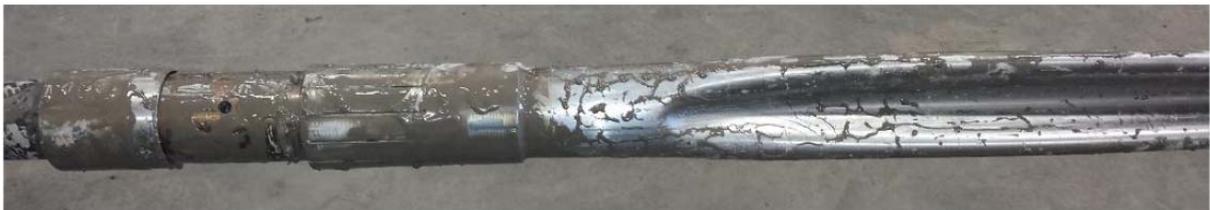
Figure 8. Collapsed inner tube from face bit Dimensional Test #1.
