DOE Award No.: DE-FC26-01NT41330

Phase IIIB Topical Report Report #41330R27

Characterizing Natural Gas Hydrates in the Deep Water Gulf of Mexico: Applications for Safe Exploration and Production Activities

Principal Investigator:
Jimmy Bent
Chevron Energy Technology Company
1500 Louisiana Street
Houston, Texas 77005

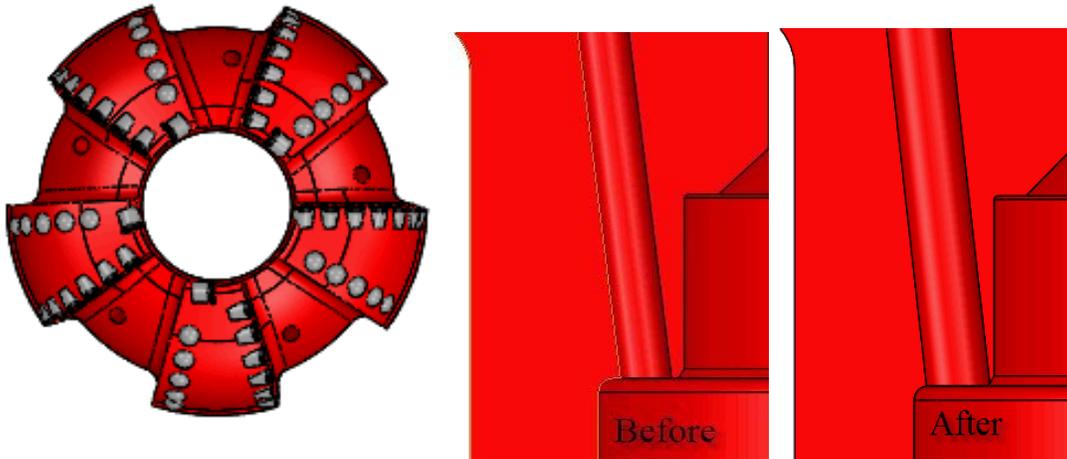
Figure 9. Cutting shoe main bit modification

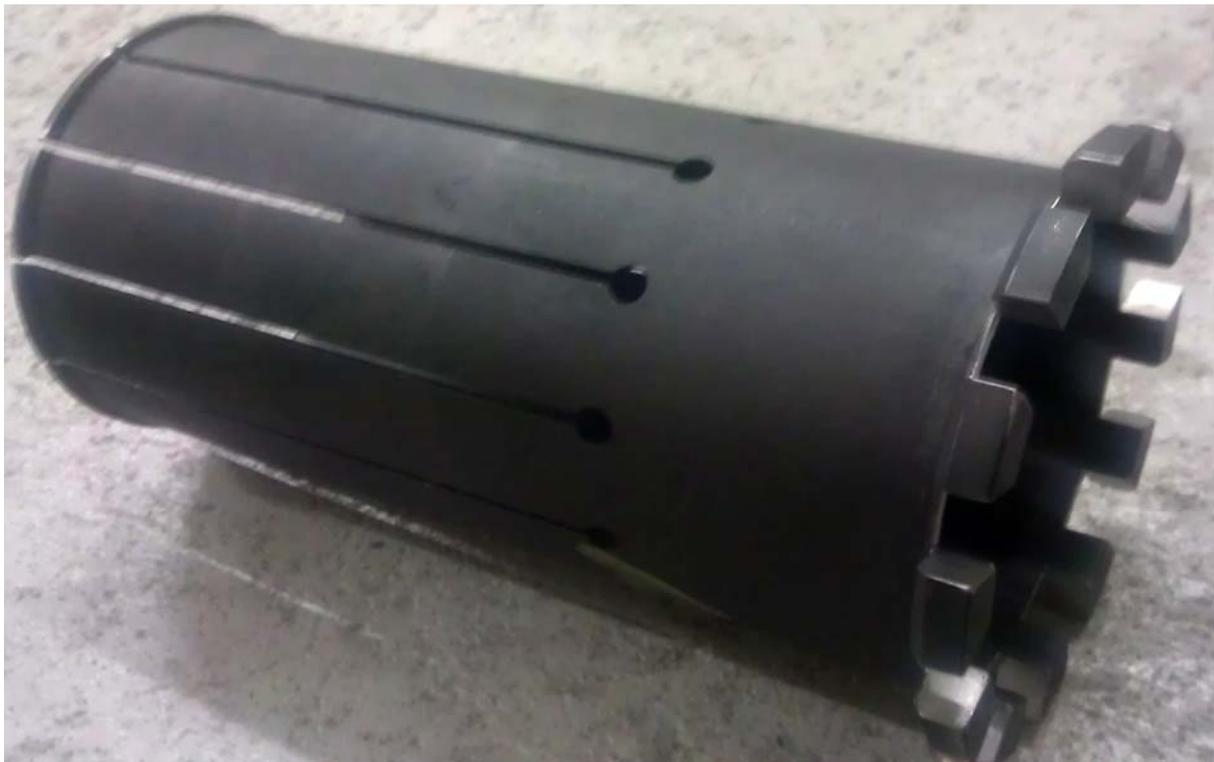
Figure 12. Flow slots added to the Ball Valve Release Collet.

- Ball valve closure tests were conducted at AAI using thick grease to simulate a viscous drilling mud (reference Appendix III. Ball Valve Closure Test Chart). The grease appears to be more viscous than typical drilling mud. Ball closure was timed with and without grease pumped into the chambers. Assemblies with parts that were modified with flow slots were also tested in the same way. Closure times were measured by counting video frames. The tests showed significant improvement with the added flow slots (reference Appendix Va and Vb. Full Function Pressure Test Chart).
- Full Function Pressure Tests (reference Appendix IV. Post Field Test Full-Function Test Summary) have been conducted since the CTF field test. A Full Function Pressure Test is a pressure test carried out horizontally in the AAI service shop.

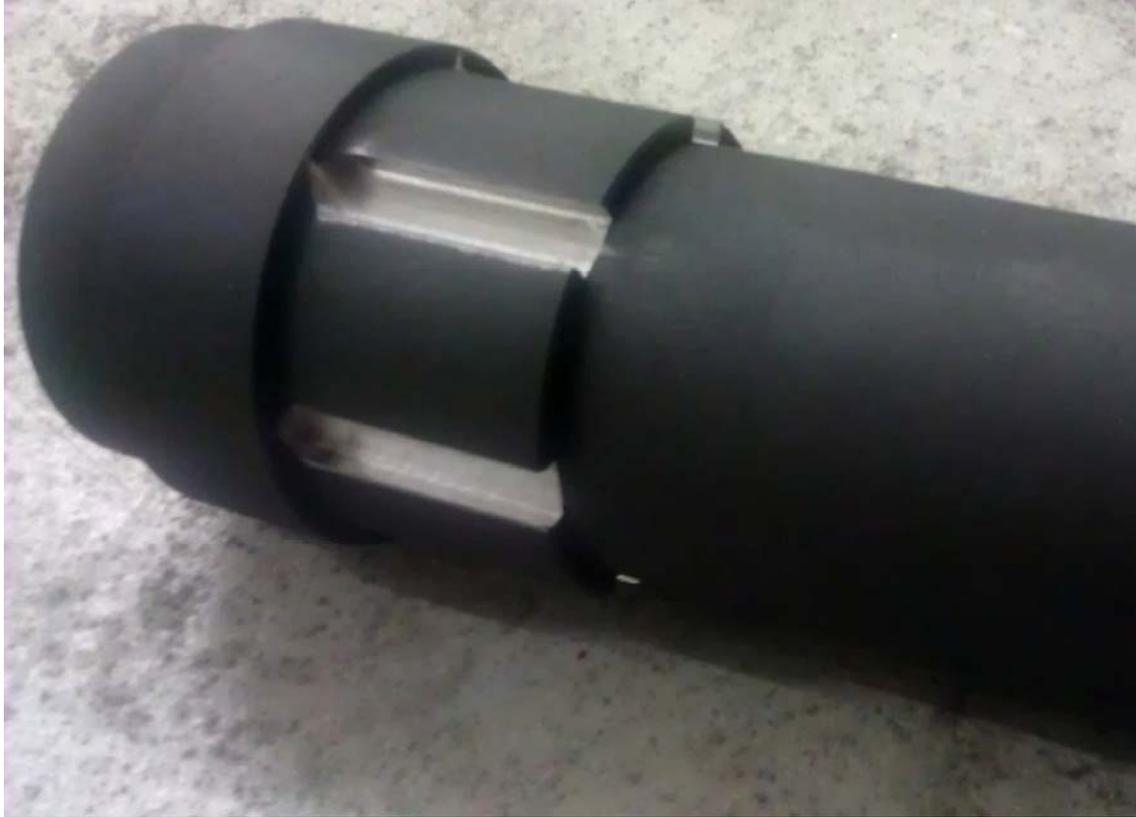
Figure 13. Flow grooves added to the Ball Follower.

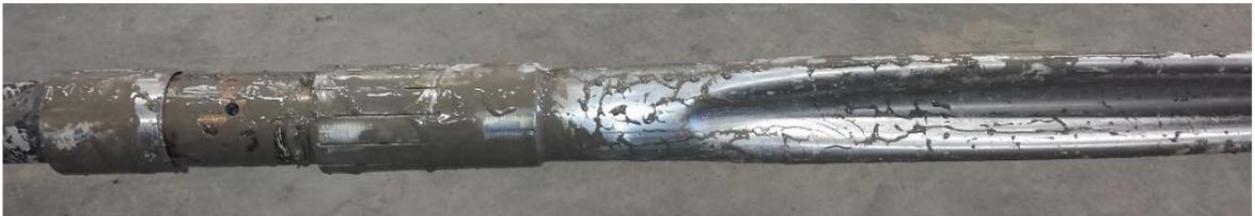
During Run 2: Face Bit Dimensional Test #1 at the CTF, when the mud pump was engaged to initiate circulation, a pressure spike of 860 psi was observed. Circulation was established for 30 min. The PCTB was then recovered and upon inspection, it was discovered that the core liner and inner tube had collapsed, preventing the ball valve from closing.

Figure 16. Collapsed inner tube from face bit Dimensional Test #1.

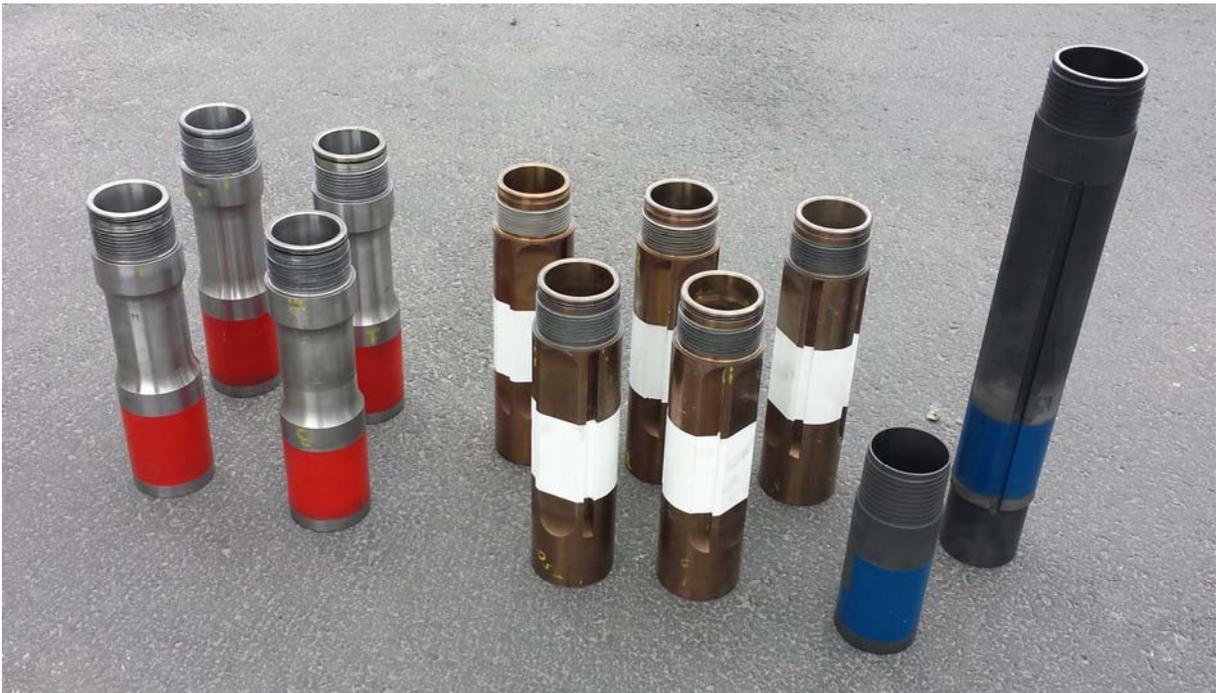
The various PCTB subassemblies were color coded prior to delivery.

Figure 17. Color coded subs for easier identification.

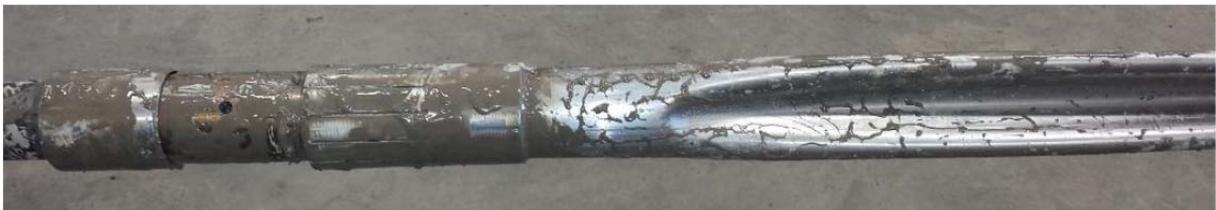
After redressing the H-PCS, it was lowered on wireline to the BHA at 741 ft for Dimension Test #1. The H-PCS landed and latched in the BHA and then released properly. When the mud pump was engaged to initiate circulation, a pressure spike of 860 psi was observed. Circulation was established for 30 min. Note that the Dimensional Tests were intended to be circulation and function tests in the casing with no coring attempted. The H-PCS was then recovered on wireline

Figure 2. Collapsed inner tube from face bit Dimensional Test #1.

without incident. Upon inspection of the H-PCS, it was discovered that the liner and inner tube had collapsed, preventing the ball valve from closing.

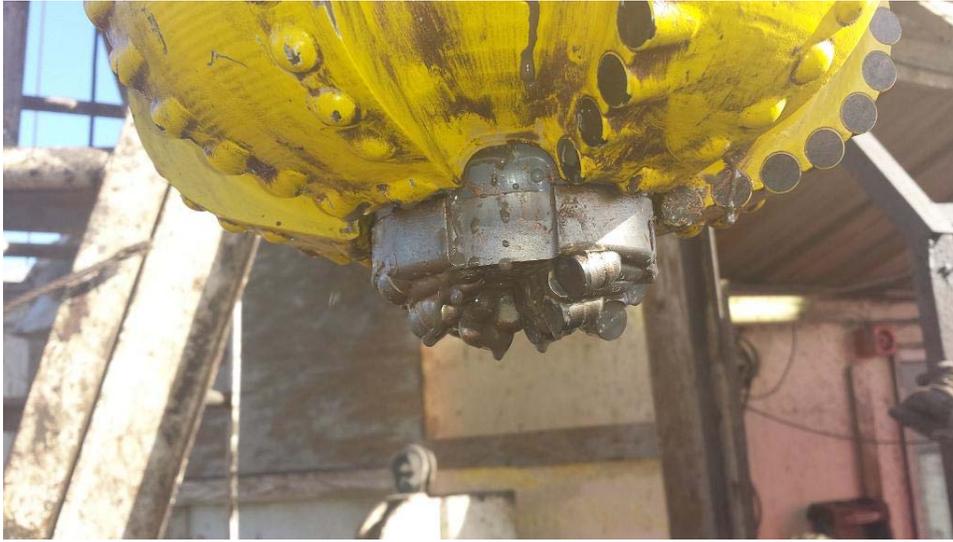
Upon inserting the cutting shoe center bit C-5 in the BHA, it was observed that the center bit protruded 1" beyond the face of the main bit. It was expected that the center bit would only protrude about 7/16" ahead of the main bit. There was some concern that the extra exposure might be a weak point or cause a problem.

Figure 2. Center bit cutting shoe extension

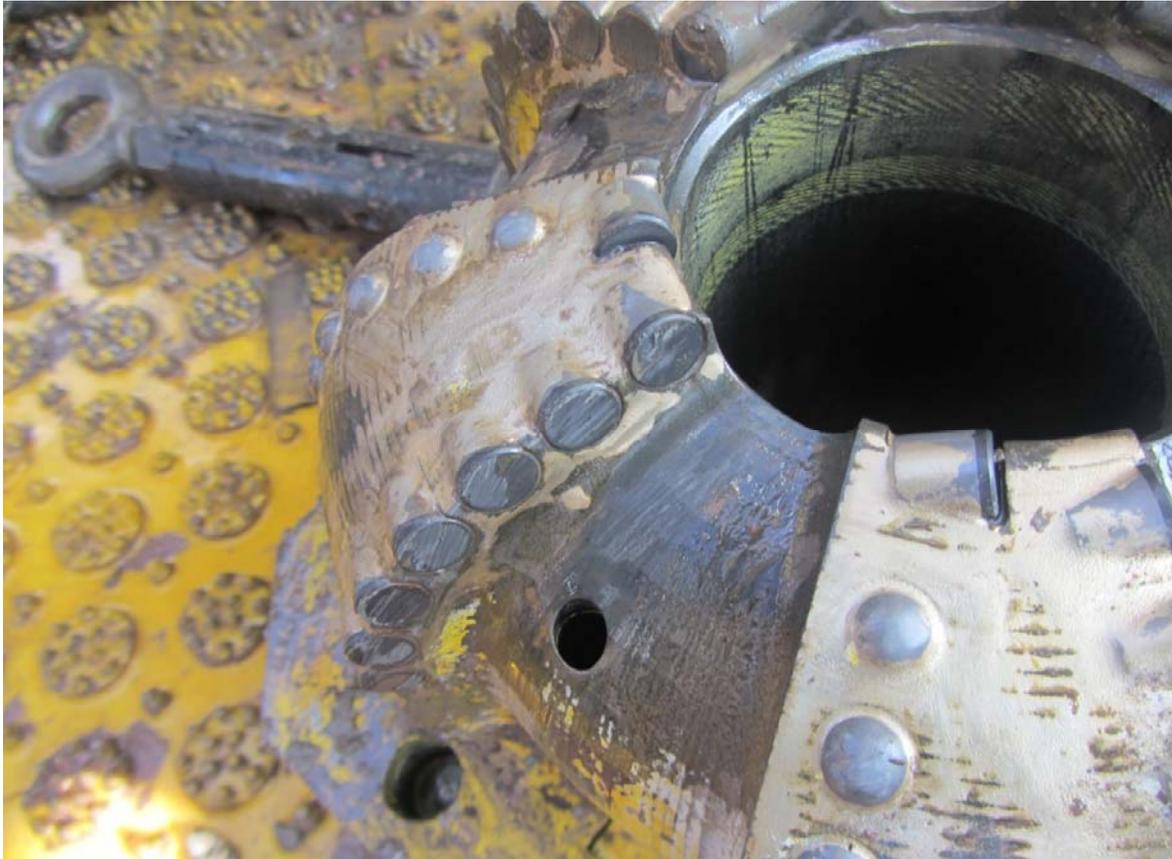
The BHA was then pulled out of the hole for reconfiguration into the face bit configuration. The cutting shoe main bit was found to have a chatter pattern on the ID which may have been created by the disintegrating cutting shoe head.

Figure 3. Chatter pattern observed on main bit

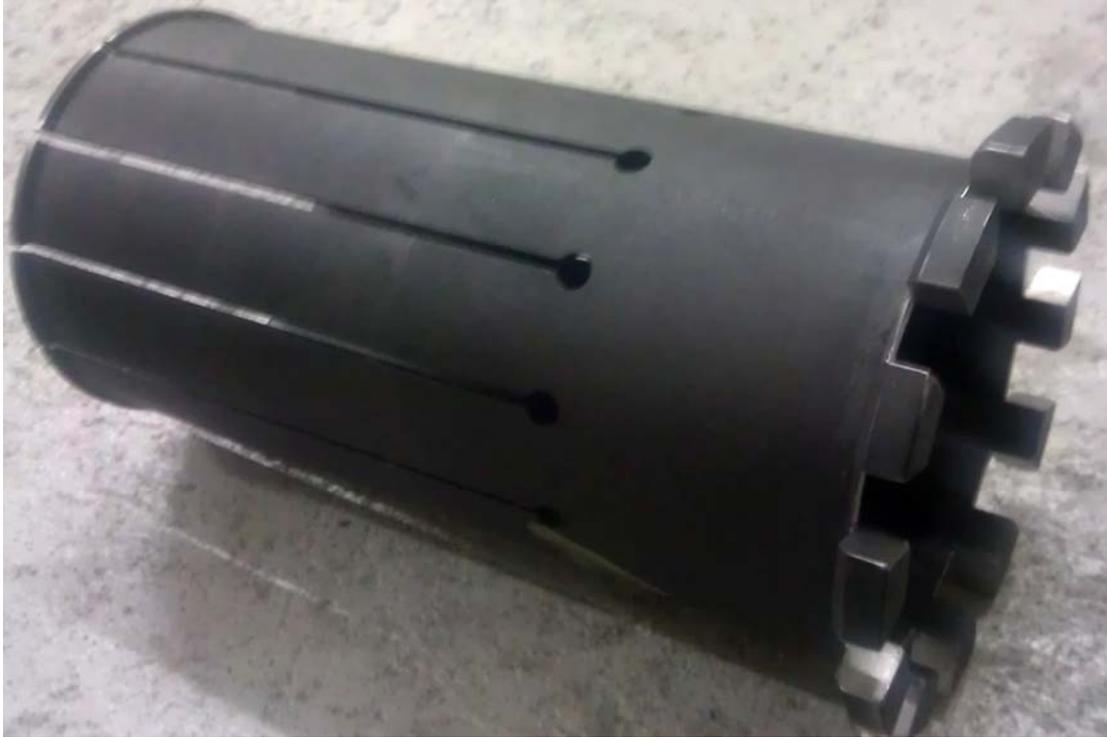
1. Two chambers in the autoclave could become pressure traps if operations are done with viscous drilling mud instead of seawater. These pressure traps can result in very slow ball rotation as verified in lab tests using grease as the trapped fluid. The slow rotation would make it easier to jam the ball in a partially open position and could also allow the N₂ supplied to escape before the ball closed. Parts were modified to provide fluid escape paths to speed up ball rotation even when used with viscous drilling fluids. The modified parts were tested and confirmed the improved ball valve operation.

Figure 4. Flow slots added to Collet

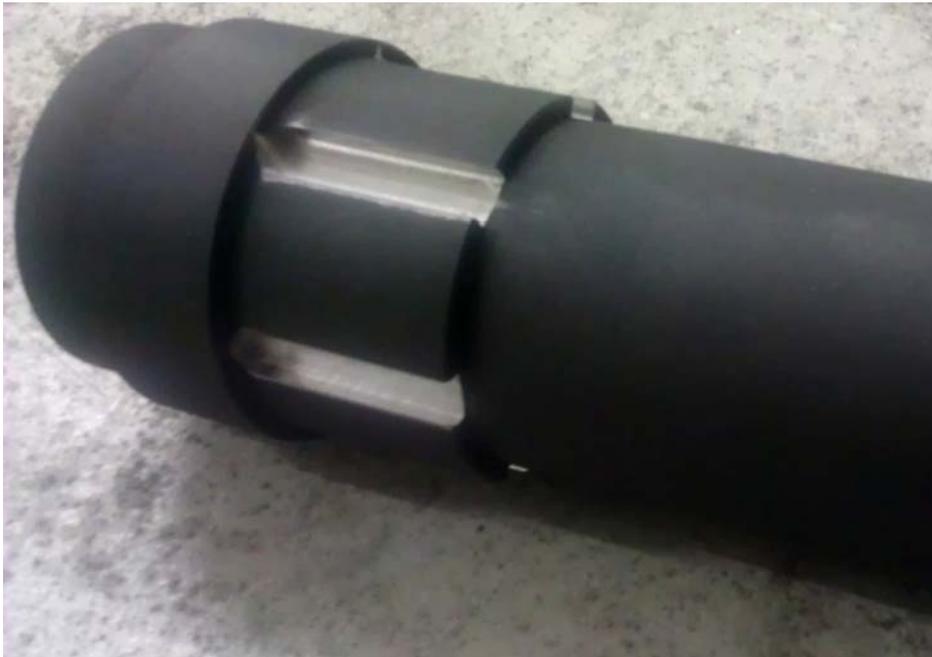
Figure 5. Flow grooves added to Ball Valve Follower
