# Update on Coal Ash Corrosion-Resistant Materials Testing Program

Dennis K. McDonald

Babcock & Wilcox, 20 S. Van Buren Ave., P.O. Box 351, Barberton, Ohio 44203-0351  
 Email: [dkmcdonald@babcock.com](mailto:dkmcdonald@babcock.com); Telephone (330) 860-6175; Fax (330) 860-2348

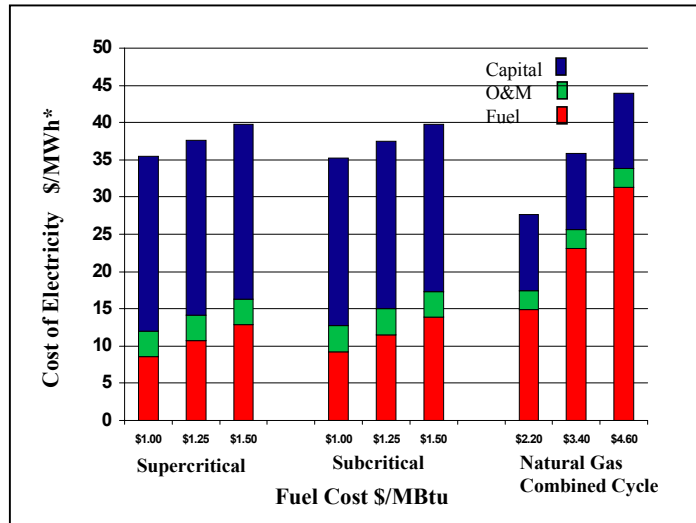
**Figure 1: Comparison of Cost of Electricity**

Materials development is important to the power industry, and to the use of coal. Figure 1 compares the cost of electricity for subcritical and supercritical coal-fired plants with a natural gas combined cycle (NGCC) plant based on an 85% capacity factor. This shows that at \$1.20/MBtu for fuel, coal is competitive with NGCC when gas is at \$3.40/MBtu or higher. An 85% capacity factor is realistic for a coal-fired plant, but NGCC plants are currently only achieving about 60%. This gives coal an advantage if compared on the basis of cost per kW generated per year. When subcritical and supercritical plants are compared,

(Assumptions: 85% capacity factor, Tax life 20 years, Book life 30 year, All heat rates HHV, Levelized Capital Charge - EPRI Tag)

supercritical is only slightly more costly than subcritical because the higher capital cost is nearly offset by the fuel savings resulting from the higher efficiency. Consequently, subcritical coal-fired plants would dominate the market were it not for environmental concerns, especially CO<sub>2</sub>.

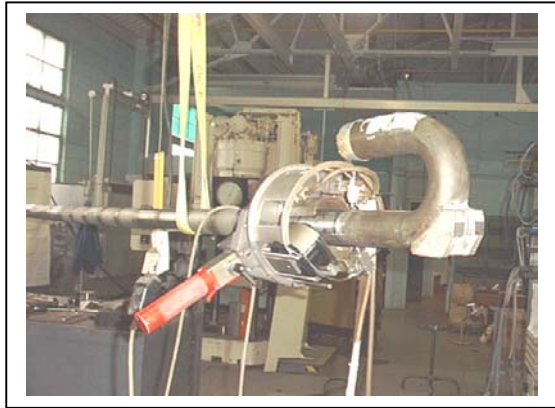
**Figure 6: Tungsten-arc Orbital Welder**

The Sections were fabricated at McDermott Technologies Inc., B&W's research facility in Alliance, Ohio. All but one of the 6 in. long specimens are 2.5 in. diameter by 0.400 wall. They were joined using alloy 625 filler metal by rotating the tube in a tungsten-arc orbital welder; every one of the 116 welds was x-ray clear.

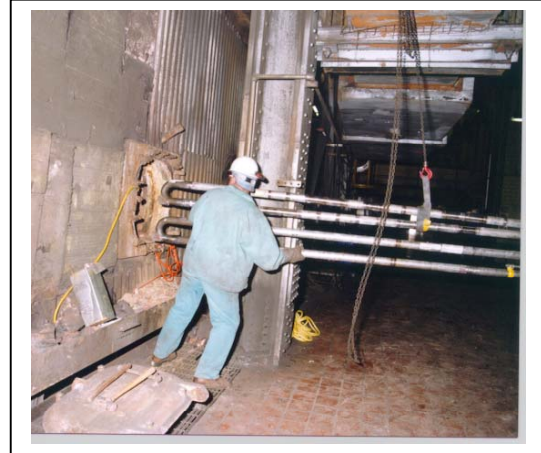
**Figure 7: Installation into Niles Boiler**

Installation was completed in May of 1999, followed by shakedown and controls tuning. During this period the steam temperature was controlled first to 1000F and then to 1050F before being raised to the current temperature of 1075F which produces a predicted surface metal temperatures in the top row between 1300F and 1350F.

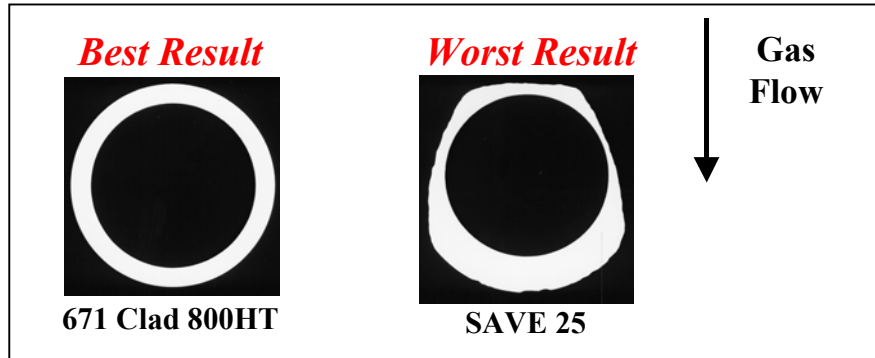
**Figure 9: Best and Worst Specimens from First Section**

Evaluation of the first Section is underway at McDermott Technologies Inc. Figure 9 shows the best and worst specimens from the top (hottest) row. After 22 months of operation, the SAVE25 specimen actually developed a pinhole leak just prior to removal.

The as-received condition of the specimens from the first Section has been documented; ring segments have been cut, de-scaled and measured. Metallographic rings have been mounted and ground and the chemistry has been determined for all specimens. These rings are now being polished, etched and documented and additional specimens through welds will be taken. The chemical analysis of each specimen will be compared to the original material specifications, the dimensional data will be evaluated relative to as-received measurements and time-temperature data, and SEM evaluation of the deposit and scale will be completed. These results will be recorded in a Topical Report scheduled for completion in June 2002.
