# Computational Modeling and Assessment of Nanocoatings for USC Boilers

DOE Sponsored Program: DE-FC26-07NT43096

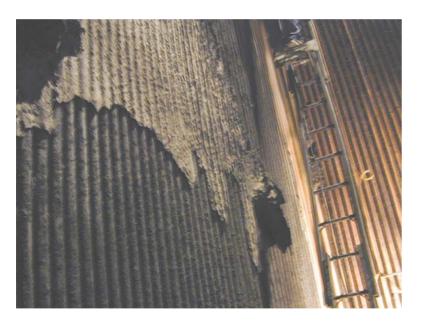
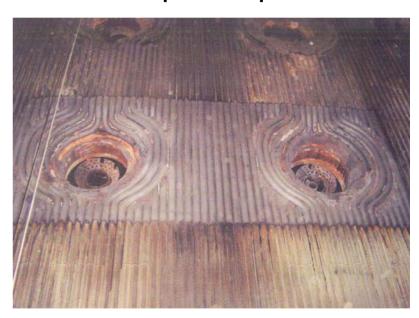
Equivalent Availability Loss from Boiler Tube Failures in US is 2.5-3.0%

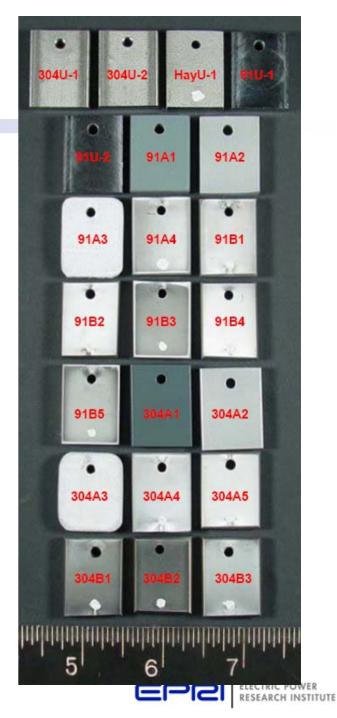
- In addition to the 4 newly developed test nanocoatings, two vendors supplied nanocoatings for corrosion testing:
  - N-TECH Inc.
  - NanoSteel

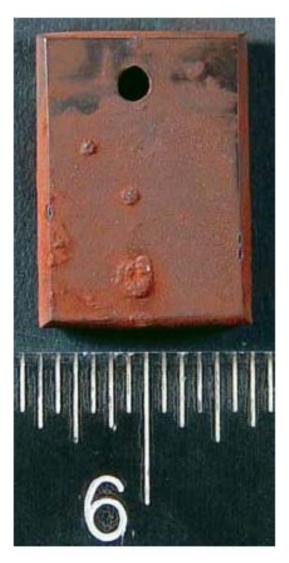
### Task 4 - Corrosion Testing -- Following 500hrs of testing

- A few nanocoatings still in good shape after 500hrs exposure.
- Many samples exhibited some level of blistering.
  - Suggests coating processing issues.
- Metallography just starting
- Will require recoating (process improvement warranted) and additional corrosion testing.
