The ODS Alloy High Temperature Heat Exchanger and Associated Work

**Fred Starr : Project Leader and Senior Principal Scientist
British Gas 1966-96**

**The ODS Heat Exchanger Programme and
how it came about**

The Closed Cycle Gas Turbine Demonstrator

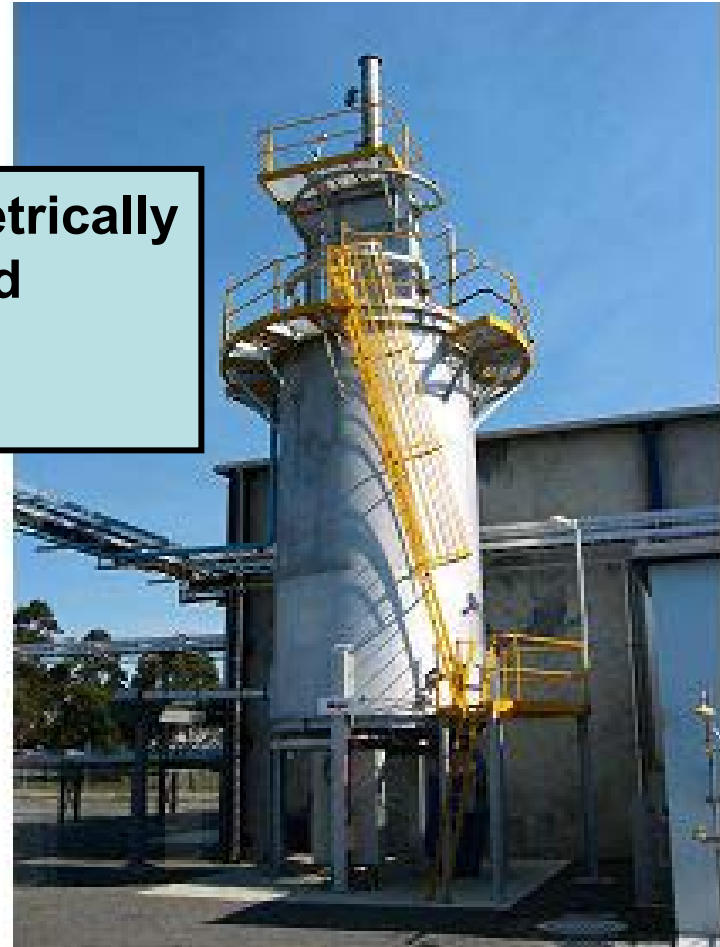
**Tubes symmetrically
arranged
round
burner**

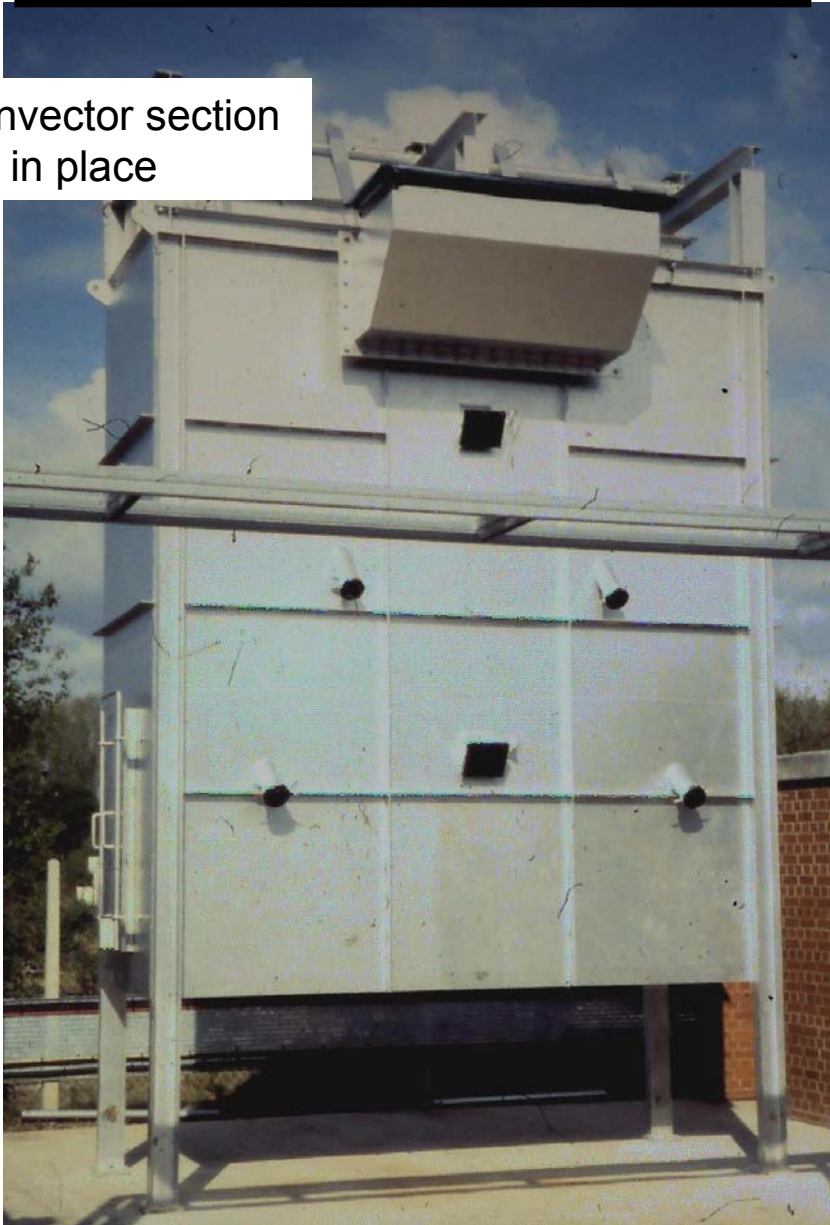
Heater Box Before Piping Up

Convactor section
not in place

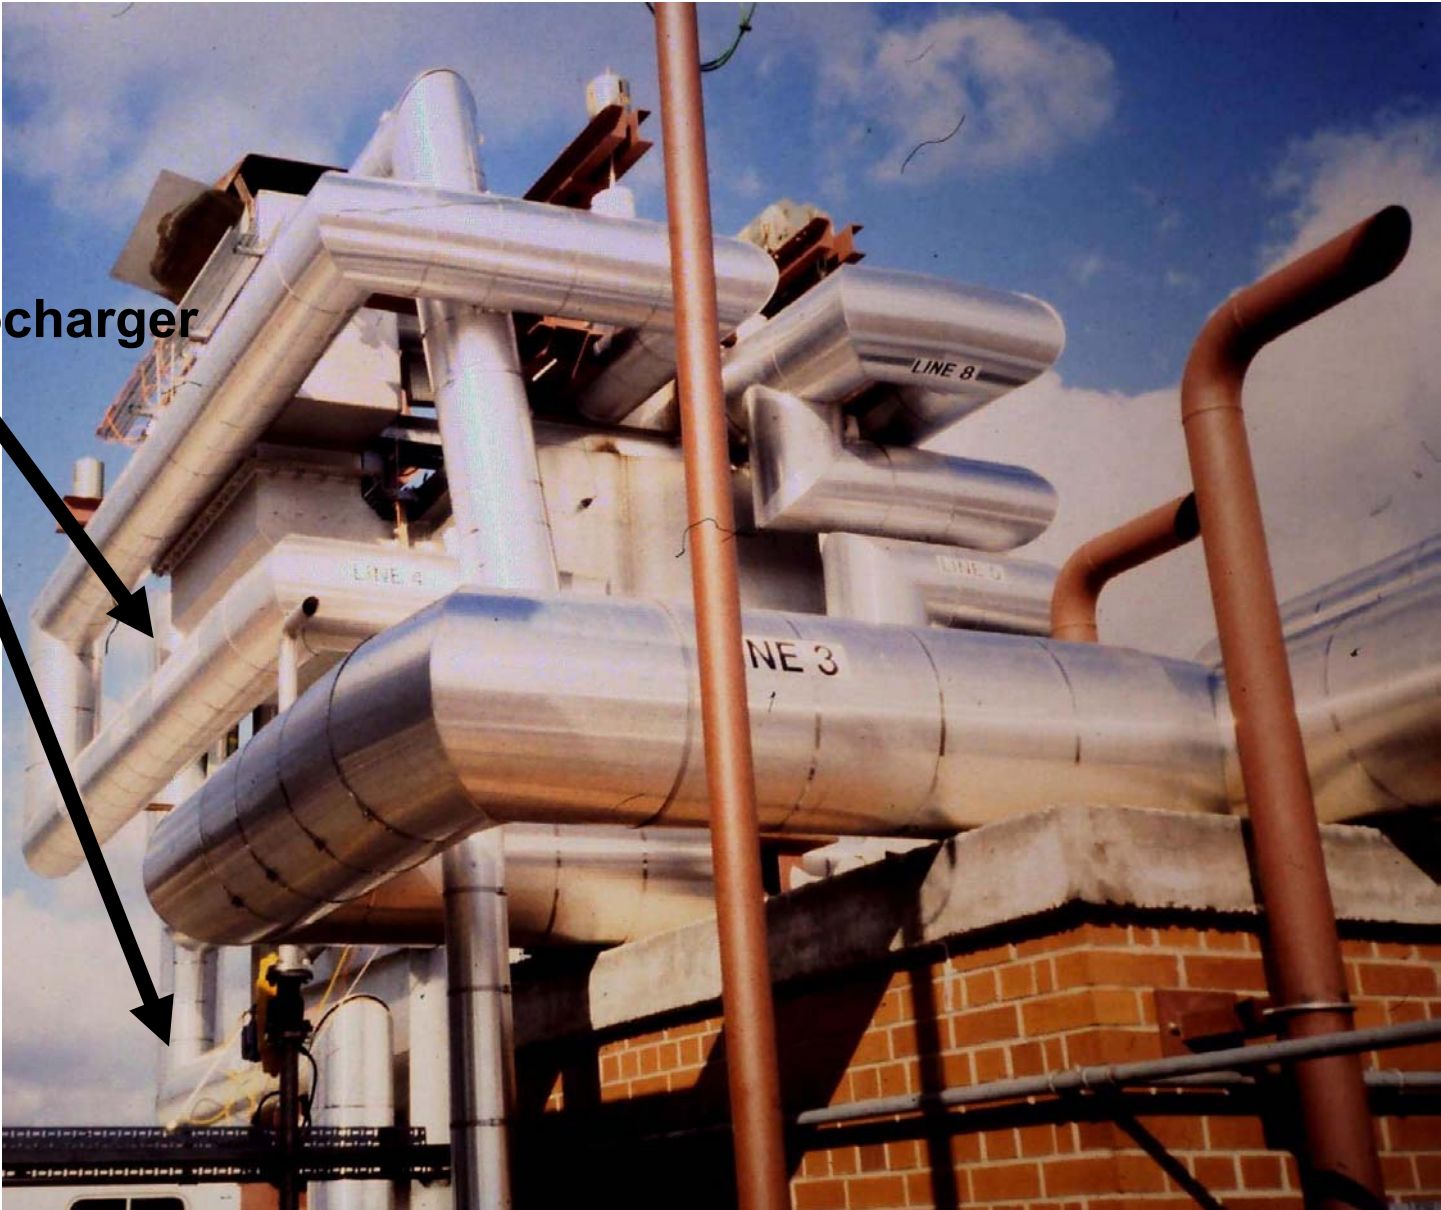
**800°C Flow
from Convactor
to
ODS Heater**

Piping system was extremely complex because of ;

Bypass systems to reduce inlet temperature to turbocharger

Cocurrent flow design of heater

Pipe to Turbocharger

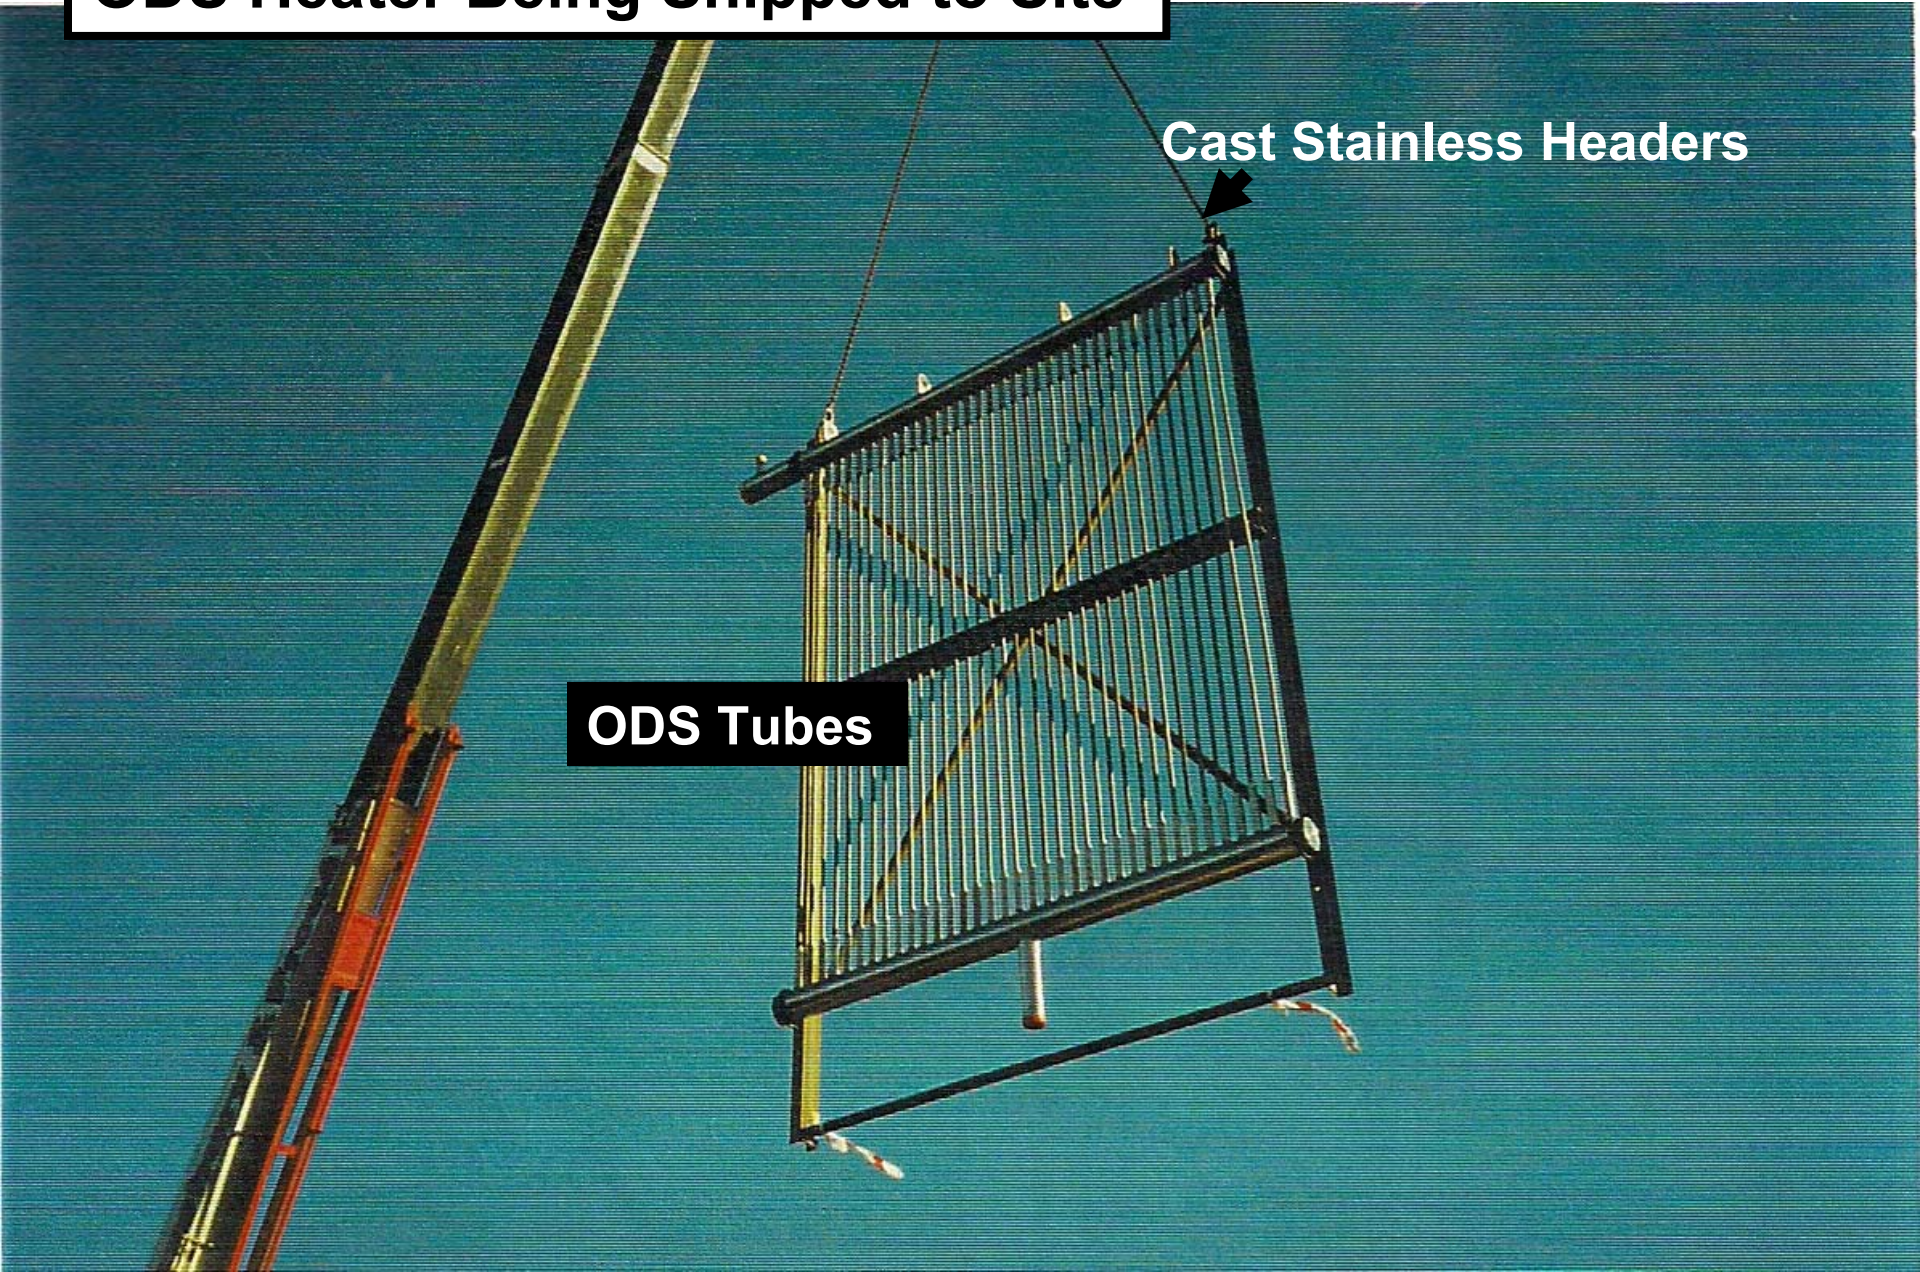
ODS Heater Being Shipped to Site

Cast Stainless Headers

ODS Tubes

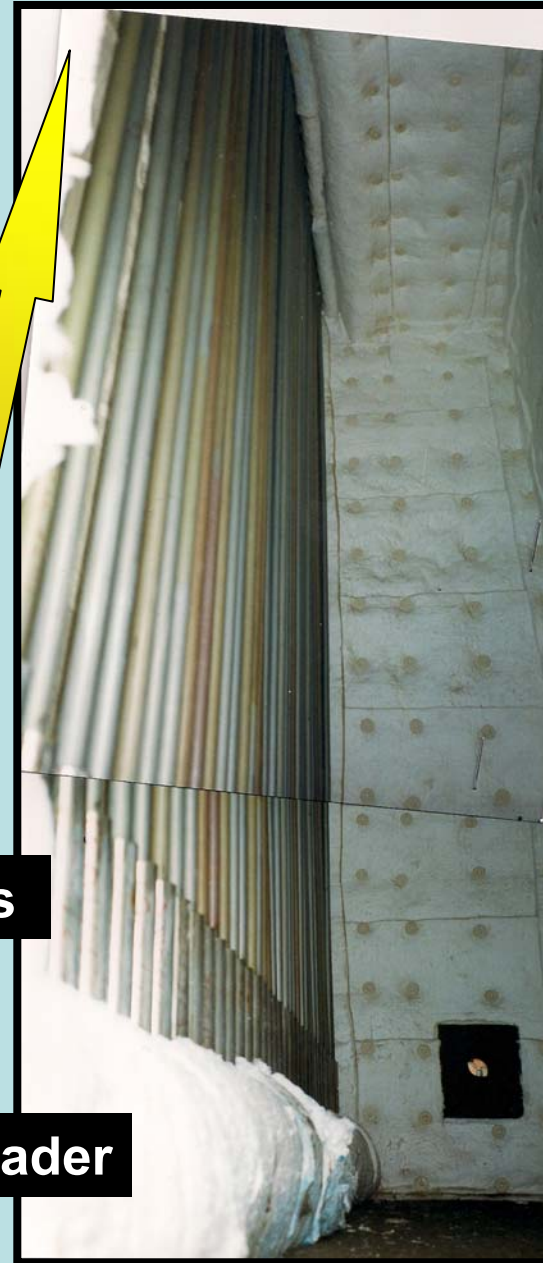
Inside of Furnace Box

*Direction
of
Flow*

Transition Joints

Insulated Bottom Header

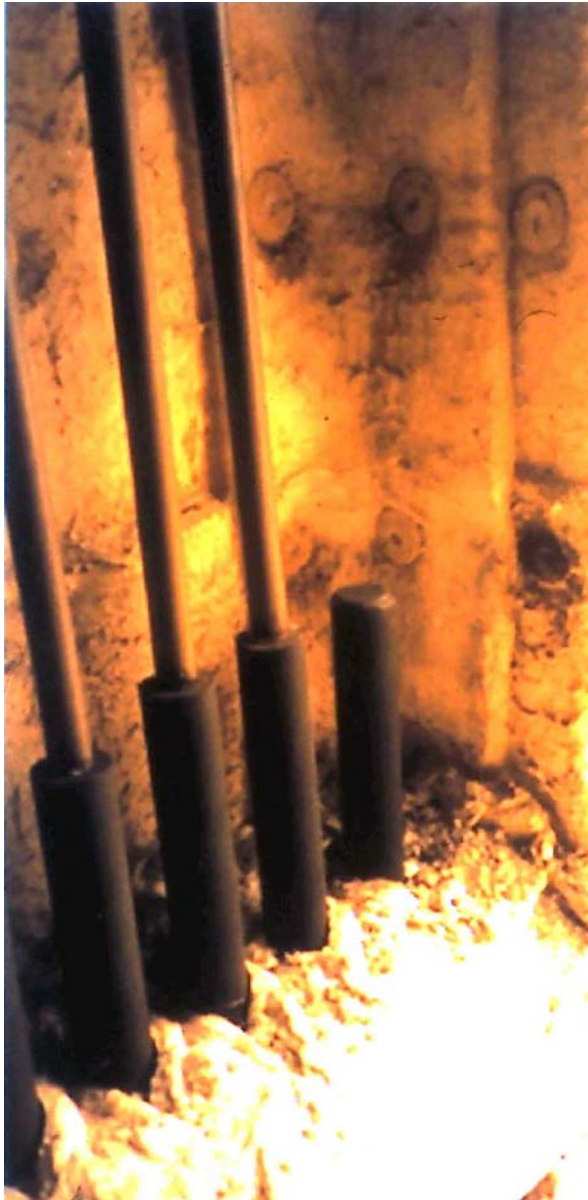
End Tube had to be Capped off Because of Tube Failure

Failure occurred very rapidly
in end ODS tubes:

- **Poor temperature and heat distribution**
- **Tubes did not have bends to compensate for thermal expansion**
- **Very limited short term tensile and creep ductility**

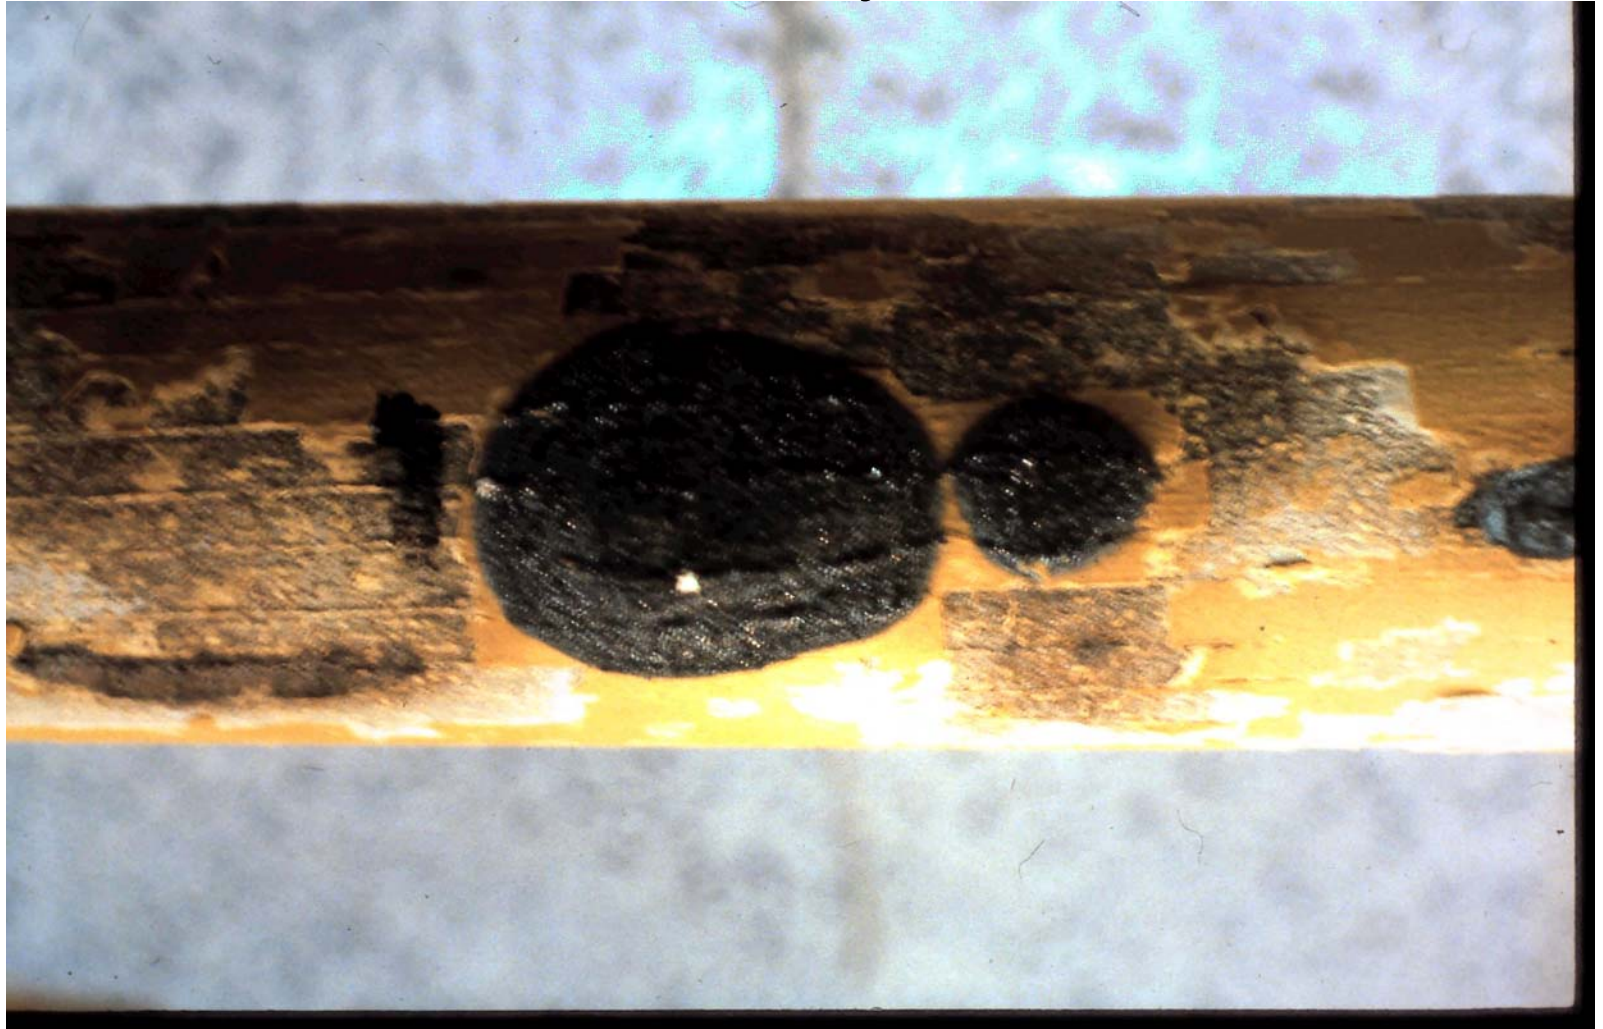
Another View of Breakaway

**Breakaway on MA956
after
2500 hours at 1200°C**

Time to Breakaway is determined by:

- Temperature
- Free aluminium content
- Tube thickness
- Spallation
- Local Geometry

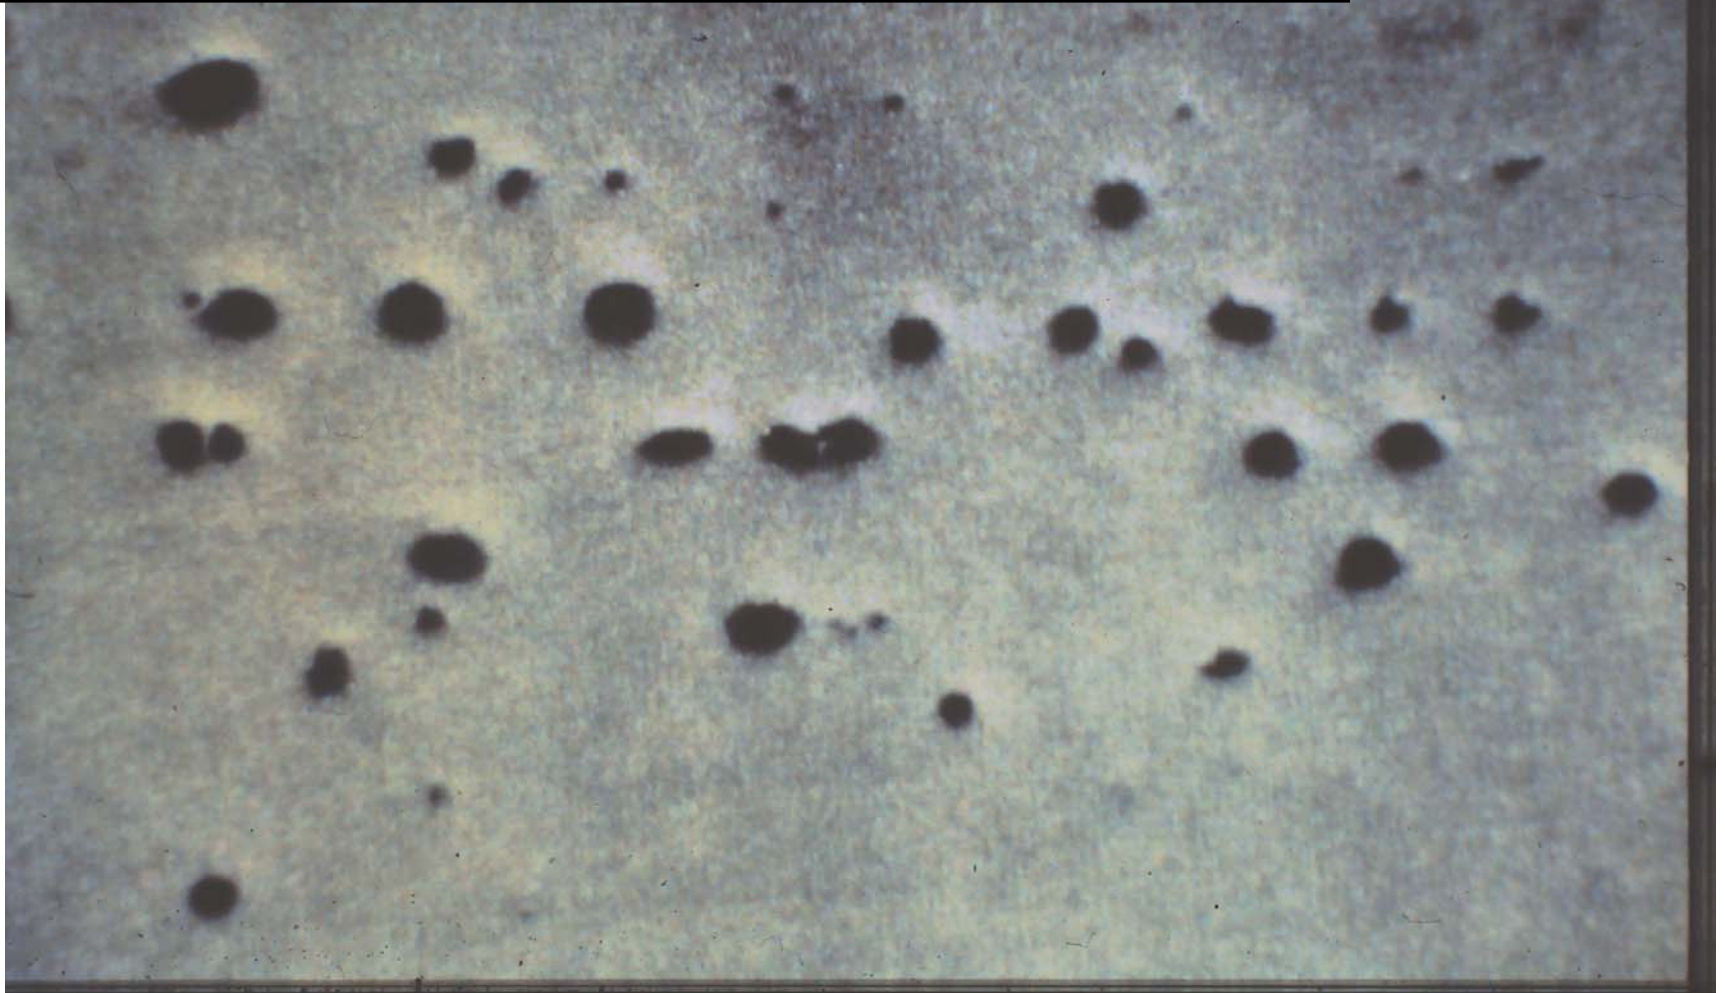
Extensive nitridation
in diffusion zone

ODM 751

Cracking is probably caused by oxide jacking
and thermal expansion mismatch

**Extensive porosity formation
associated with Ni diffusion into ODM 751**
