## ***ODS Alloys in Coal-Fired Heat Exchangers – Prototypes and Testing***

**2010 ODS Alloy Workshop  
San Diego, California  
November 17–18, 2010**

**John P. Hurley  
Senior Research Advisor  
Energy & Environmental Research Center  
University of North Dakota**

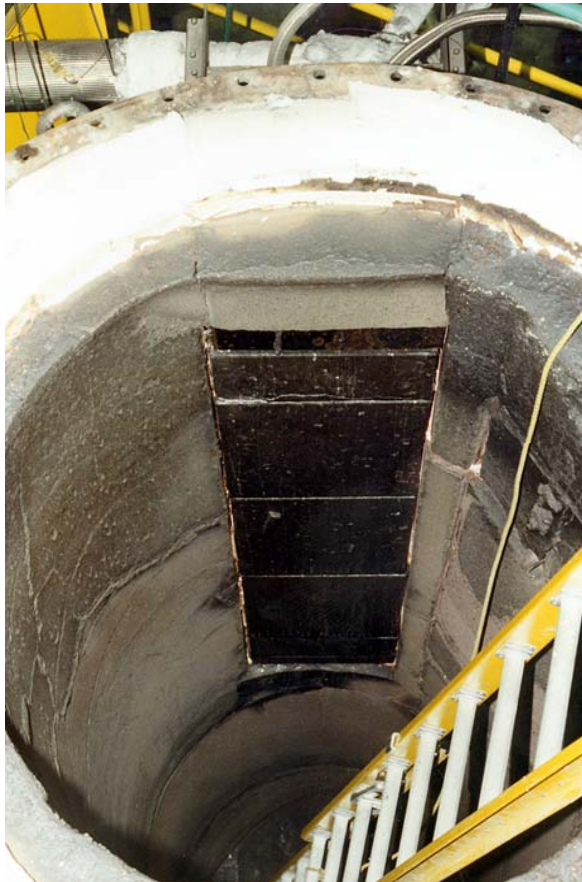
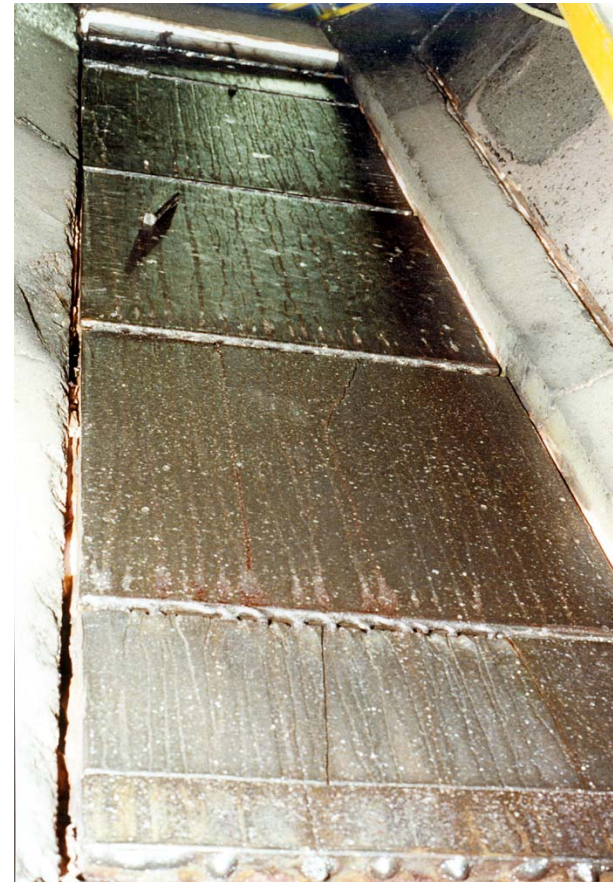
# Large RAH Panel Inside the Slagging Furnace

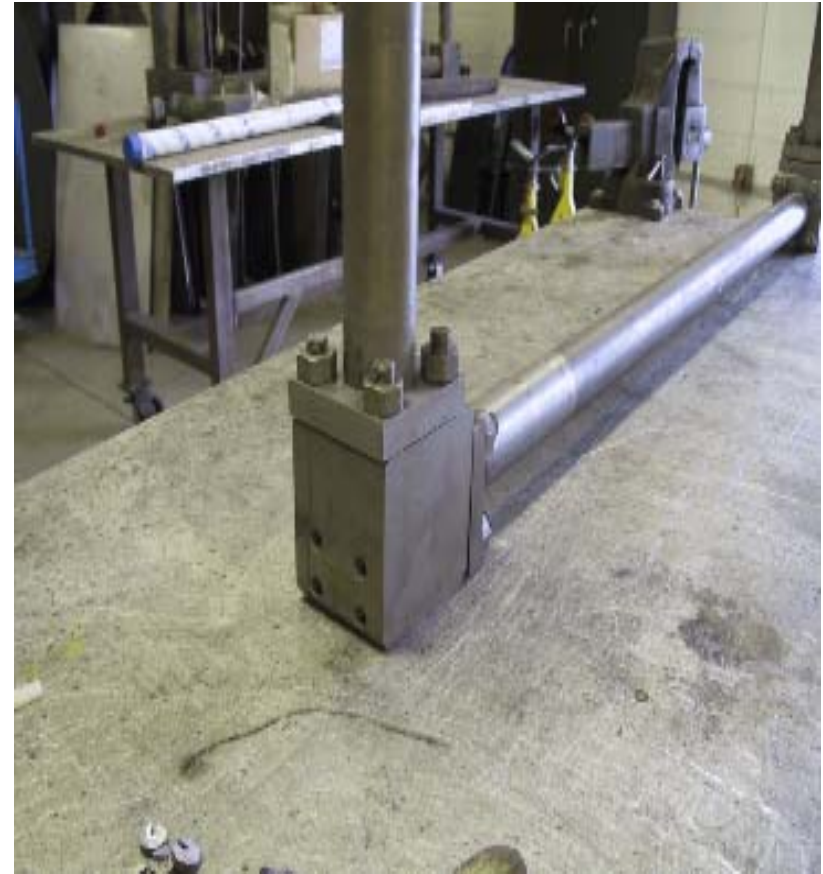
# Bolted MA956 HTHX Tube

- Bolts machined from MA956.
- Mica/Inconel gaskets.
- 500 hours of service with five cycles has caused no leaks.

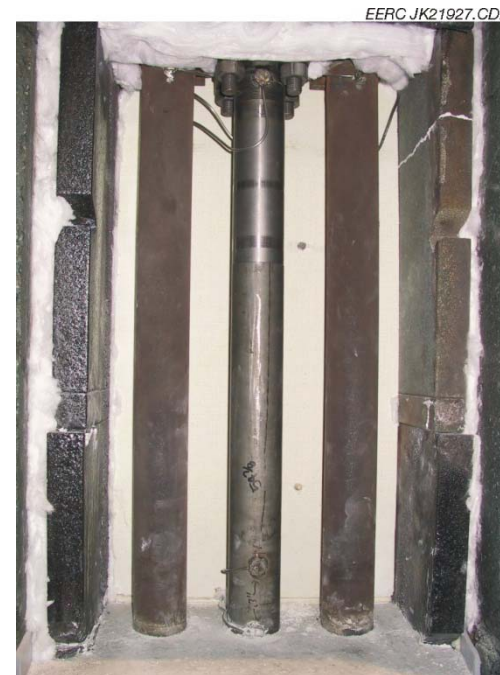
# MA956 Tube Installed in the HTHX

## Concerns with Bare-Tube Testing

- Uneven heat flux may cause warping.
- Insufficient heat-transfer rates to the pressurized air may cause excessive surface temperatures.
- Slag deposits may corrode.
- Slag deposits may insulate.

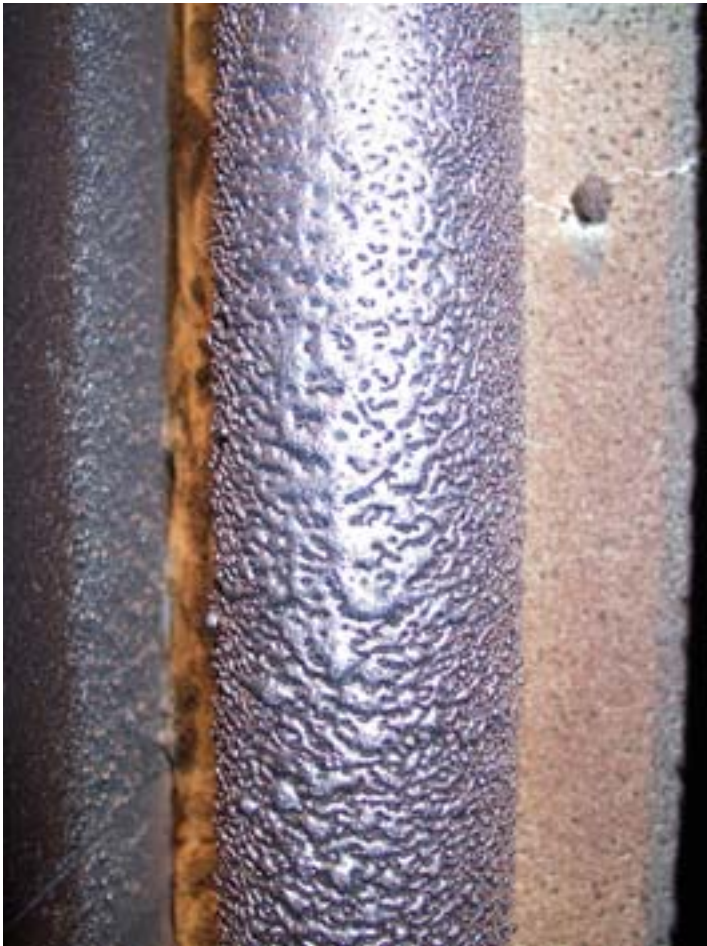
# HTHX Tubes After August 2001 Test

- Slag layer self-cleaning.
- 3 mm thick maximum.
- Reduces heat flow by 15% as compared to 50% for sintered ash.

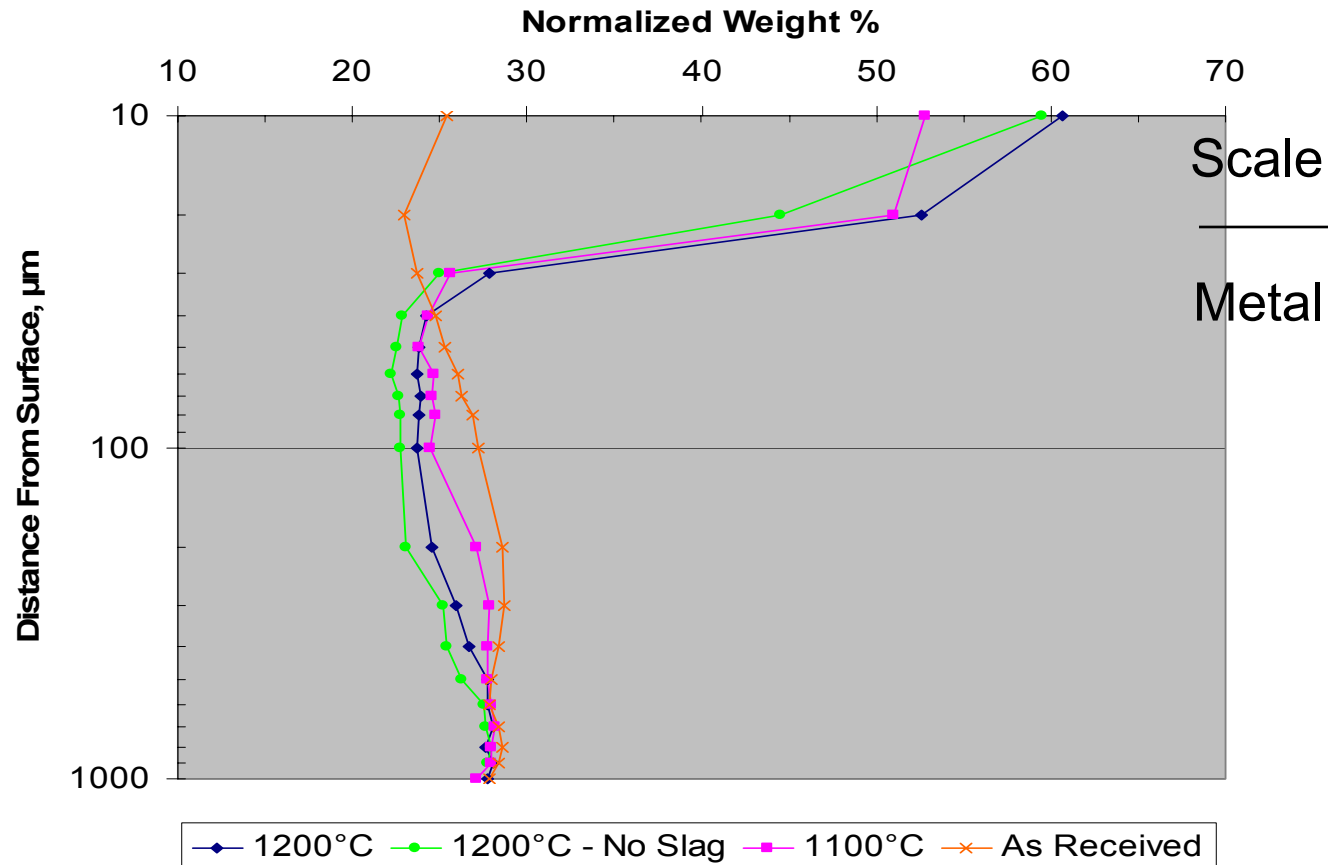
# MA754 Chromium Content Flowing Illinois No. 6 Slag – 100 hours

- Chromium depletion excessive for MA754 at 1100°C or above.
- Slag layer lost on cooling, shortening life.
- Slag reduces chromium loss during a single cycle.

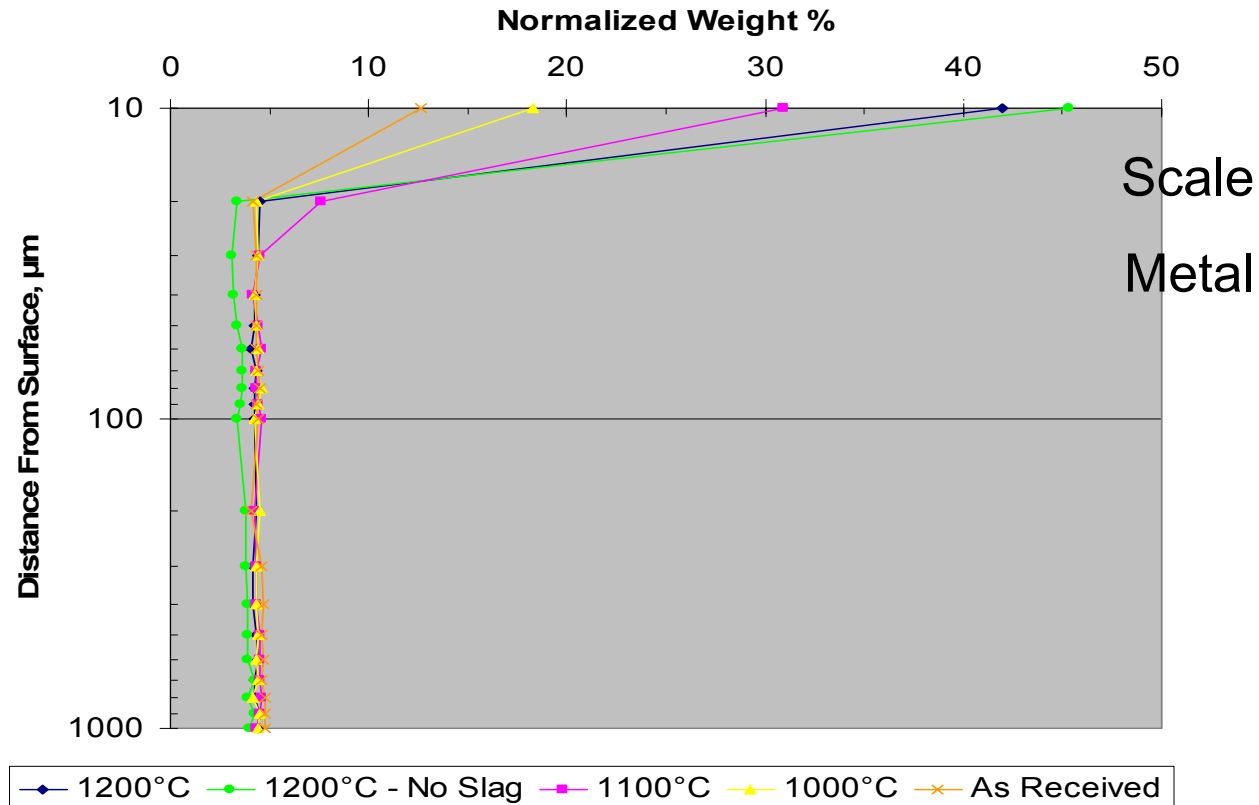
# MA956 Aluminum Content Flowing Illinois No. 6 Slag – 100 hours

- Oxygen penetration and aluminum depletion minimal at up to 1200°C under flowing slag.
- Slag layer retained on temperature cycling.
- Slag may reduce aluminum depletion.

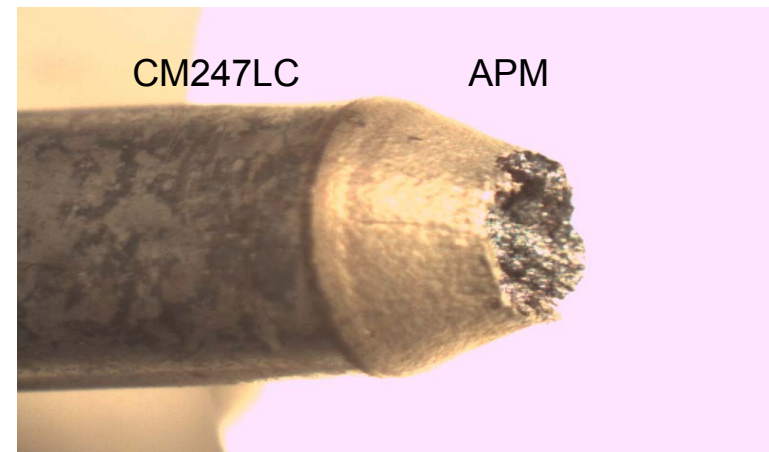
# Joining APM to CM247LC Thin-Layer Sandwiches

- 1-mm- and 4-mm-thick layers of APM (not dispersion-strengthened) were sandwiched between rods of CM247LC.
- All high-temperature ruptures occurred in the APM.
- APM strengthened by metal diffusion from the CM247LC.
- Thick layers (4 mm) were not strengthened all the way through, but thin layers (1 mm) were.
- Diffusion increased lifetime of thin layer by 20 times or more.
- Different joining alloys had different effects on interdiffusion.
