# Condition Based Monitoring of Gas Turbine Combustion Components Program Review

**DoE Funding Opportunity No. DE-PS26-08NT00440-1B**

**DoE Award Cooperative Agreement No. DE-NT0006833**

**March 2012**

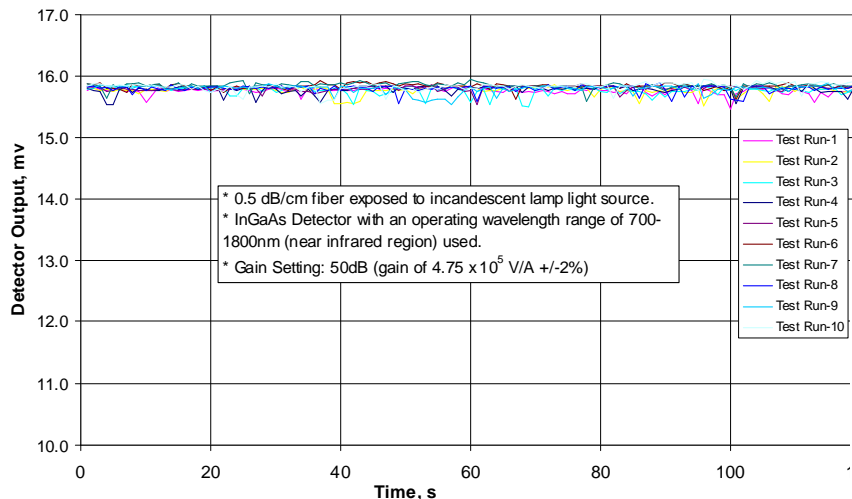
Measurement Stability and Repeatability Tests

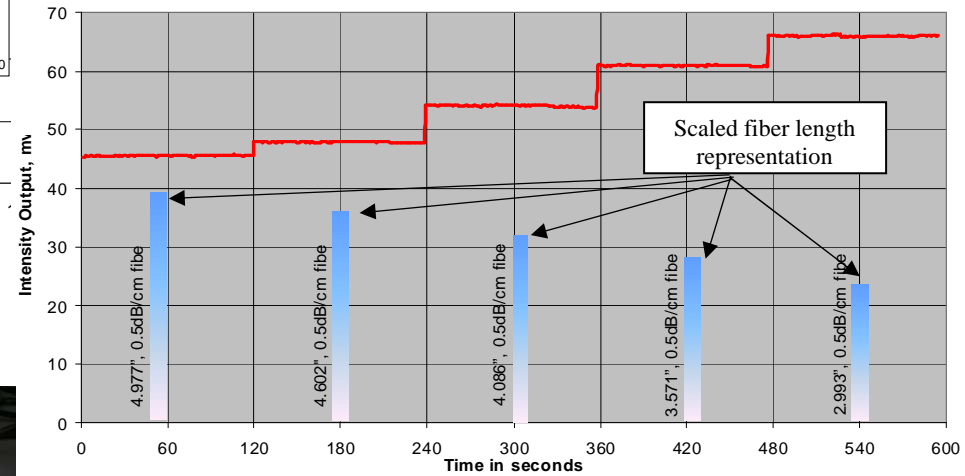
Detector Output versus Sensing Element Length Test

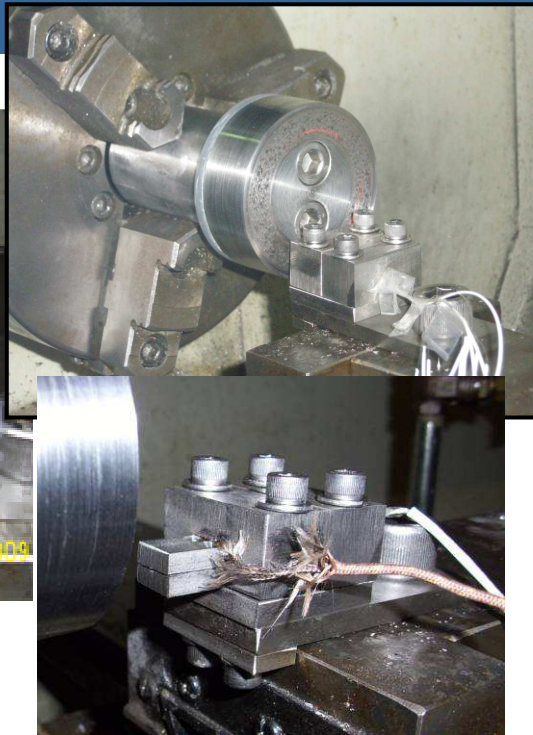
Sensing fibers assembled in this groove using high temperature cement glue

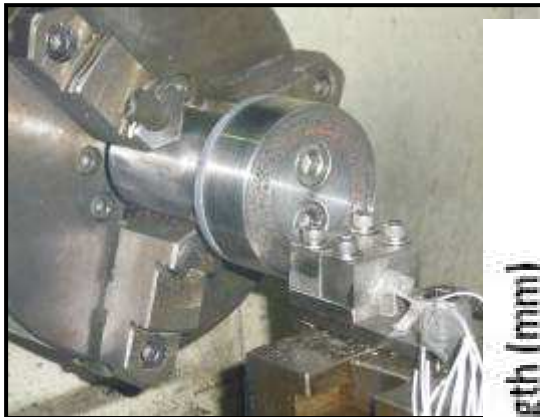
Metal-to-Metal Wear Simulation Test: created wide uncertainty band in measurement

Wearing the fiber created cracks that reflected light and made the measurement very noisy

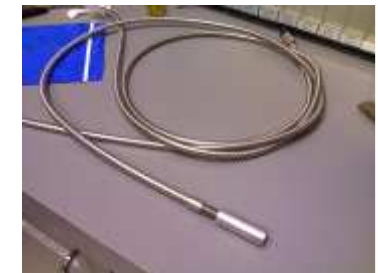
Philtec Gap Measurement Technology Integrated with a Siemens Wear Probe Concept

- Performs better in aggressive wear environment
- Closer to practical demonstration than the K Sciences concept

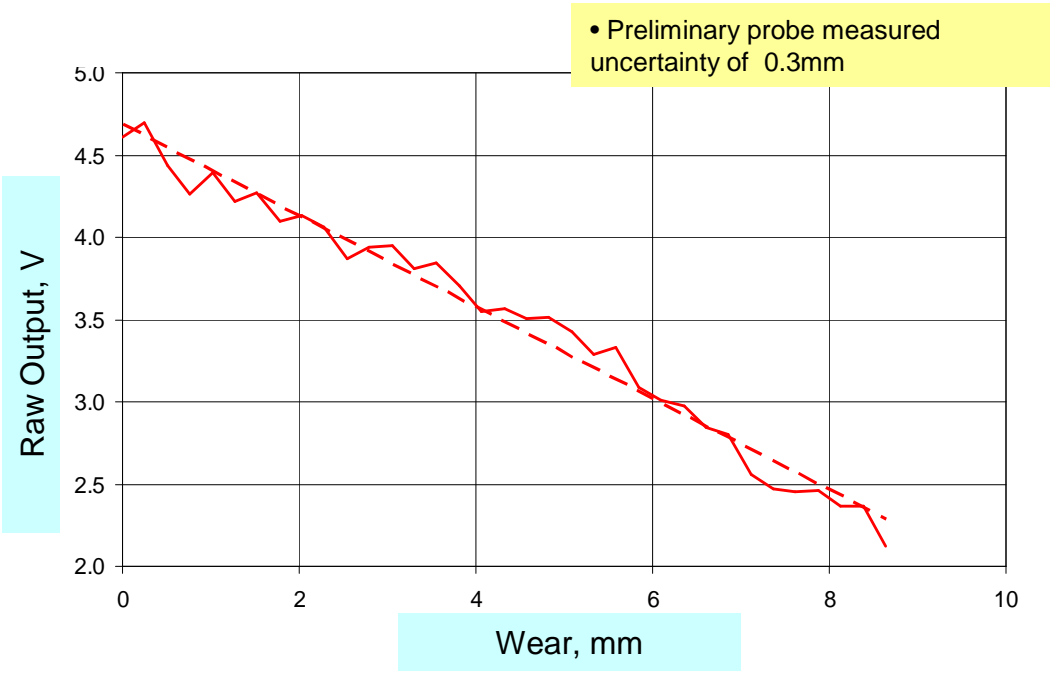
(b) Sensor output correlation to probe tip wear progression

Alternate sensor design improved wear monitoring capability over the Baseline (K Sciences) design in a dynamic wear simulation environment

Uncertainty achieved = +/-0.3mm.

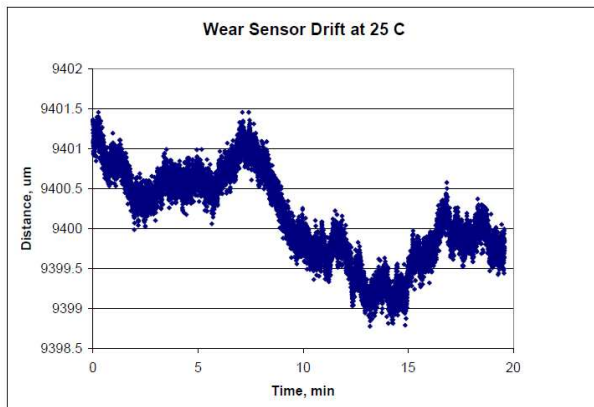
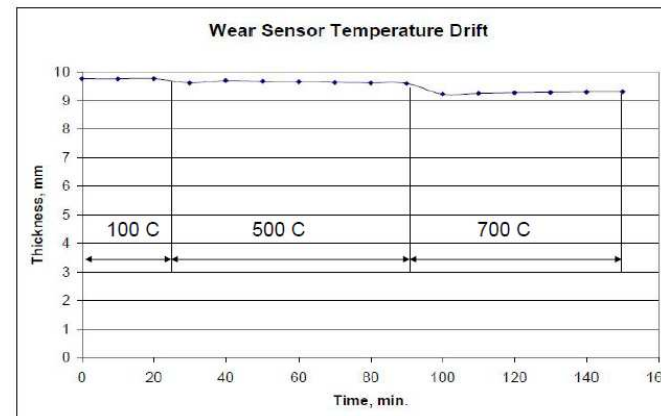
At room temperature the sensor output drifted less than 2 um during 48 hours.

Optical properties of the quartz media and reflective surfaces are temperature dependent; so calibration at operating temperatures is needed.

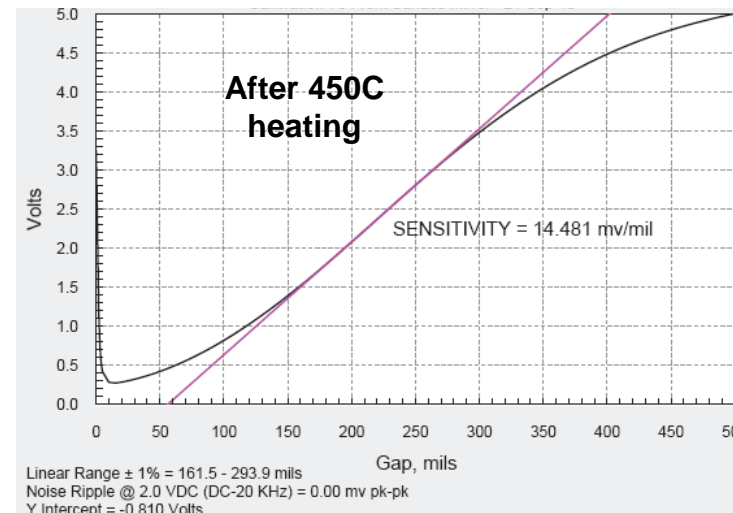
Sensor response after heated to 450°C for more than 12 hours

The calibration curve before and after heating remained the same and the response during heating was as expected.

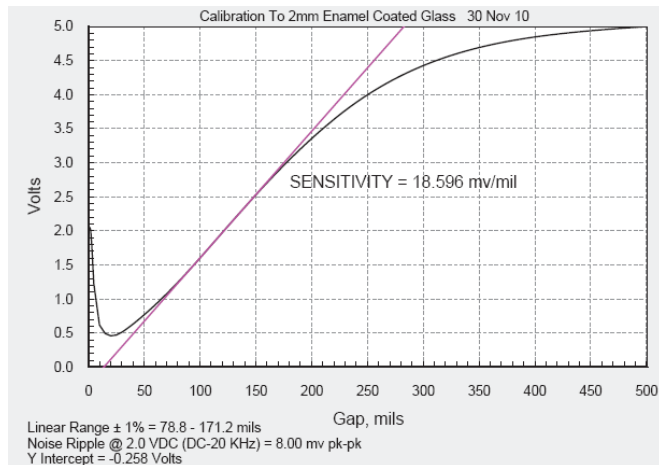
Sensor calibration curve before the high temperature test. The linear range spanned 78 to 171 mils (2mm to 4.3 mm)

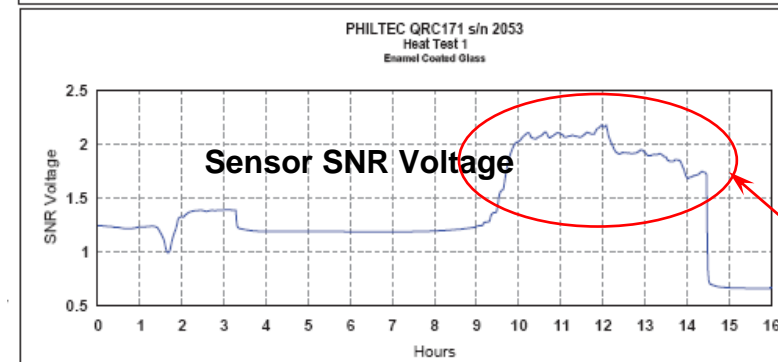
Sensor response shifted due to background radiation that is now compensated

Some drift observed at 800C and up due to thermal radiation noises and other setup issues. Work in progress to resolve the issues.

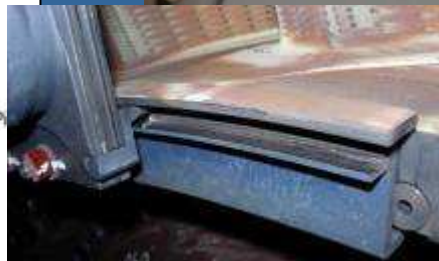
Probe can be mounted on the floating seal with the probe tip flesh against the wearing surface.

- Threaded probe tip, 0.375" diameter
- Flex hose cable, 0.25" diameter
