Wellbore Seal Repair Using Nanocomposite Materials

Project Number DE-FE0009562

U.S. Department of Energy
National Energy Technology Laboratory
Carbon Storage R&D Project Review Meeting
Developing the Technologies and
Infrastructure for CCS
August 20-22, 2013

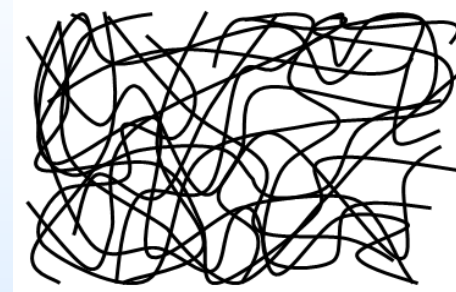
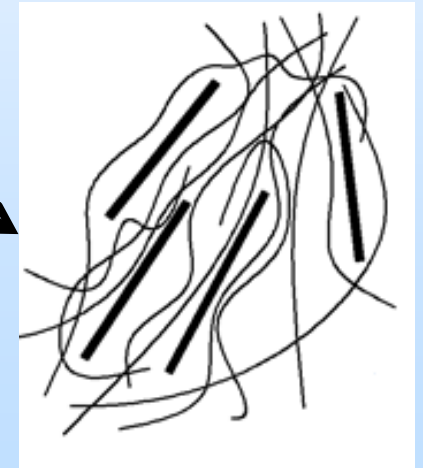
Epoxy-Montmorillonite nanocomposite

Clay nanoplatelets

Epoxy resin molecules

$d_{001} = 18.5 \text{ \AA}$

Conventional Composite

Intercalated Nanocomposite

Exfoliated Nanocomposite

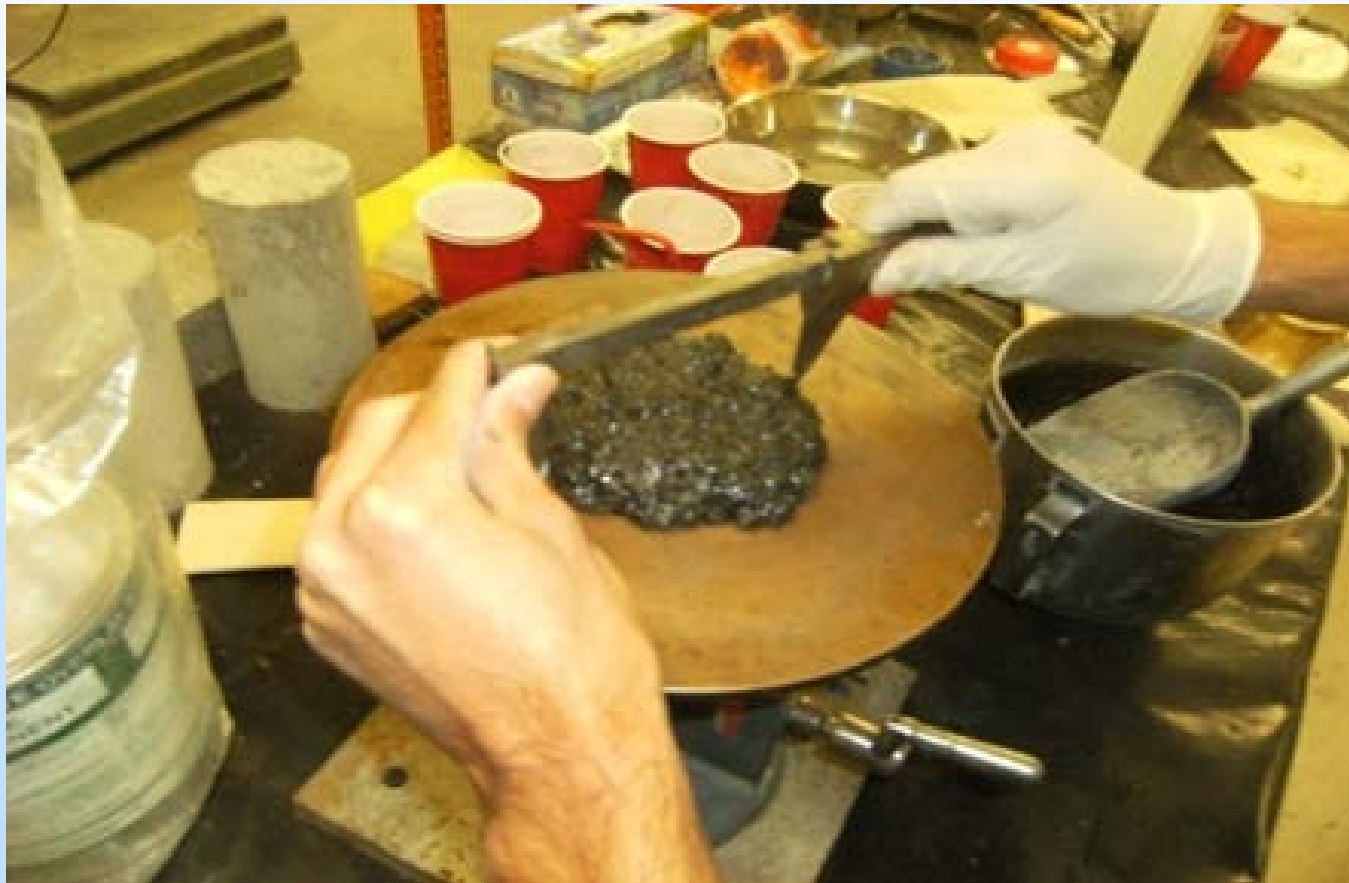
Flowability

related to ability to inject nanocomposite into flaws.

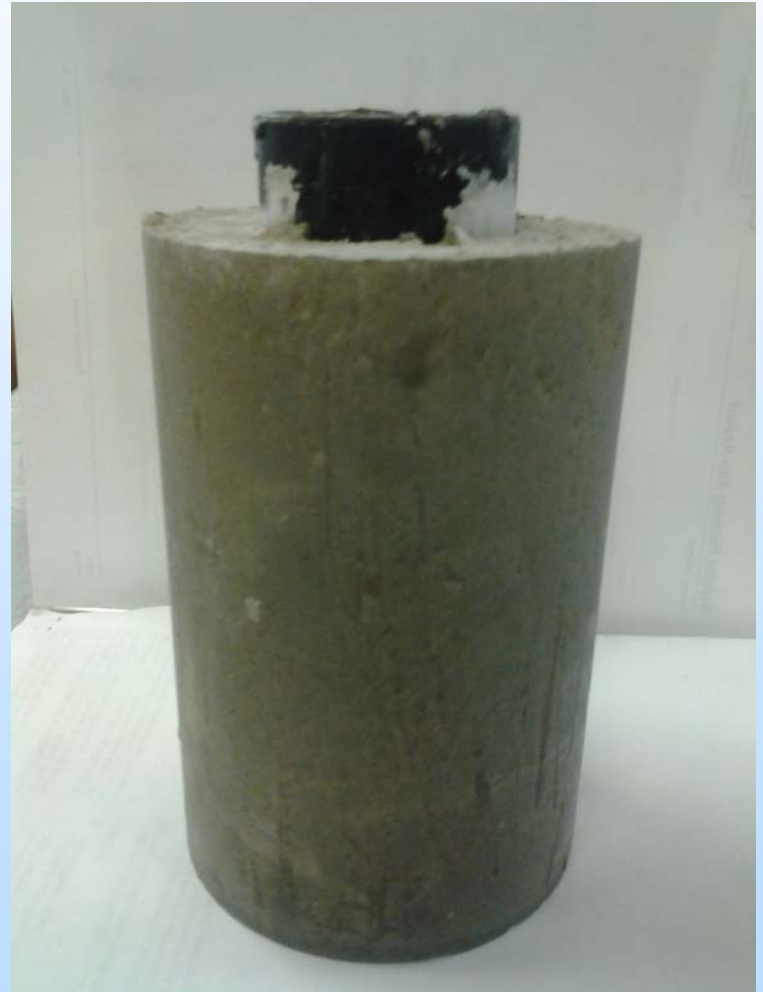
Annular seal system specimen preparation

- Microannulus (flaw) created at casing-cement interface.

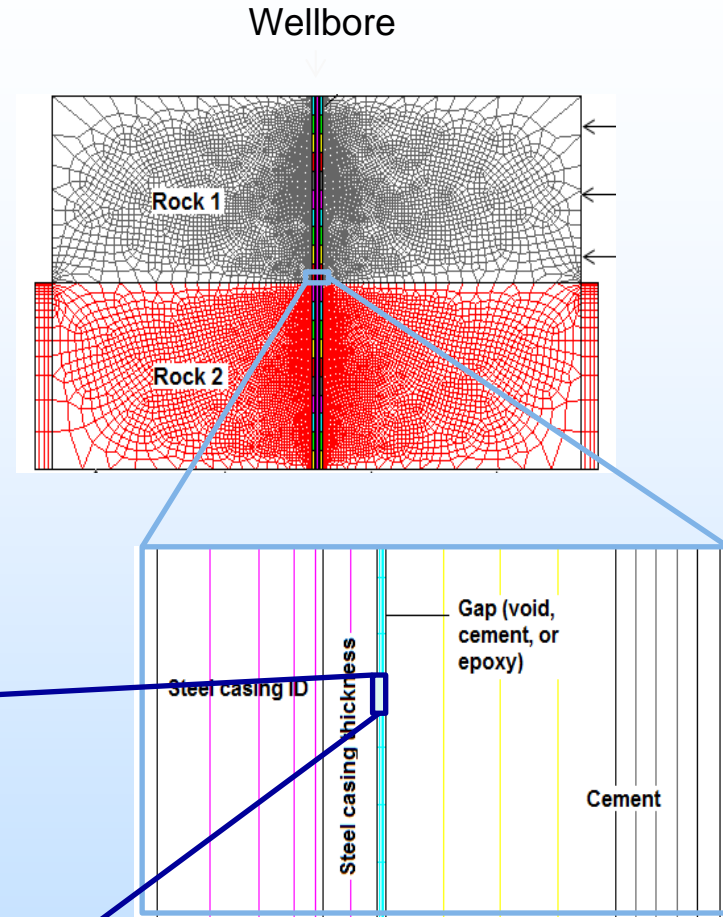
- Simulate wellbore condition, including interfaces and surrounding flaws
- Next step: Predict response of nanocomposites

Epoxy-CNTs nanocomposite

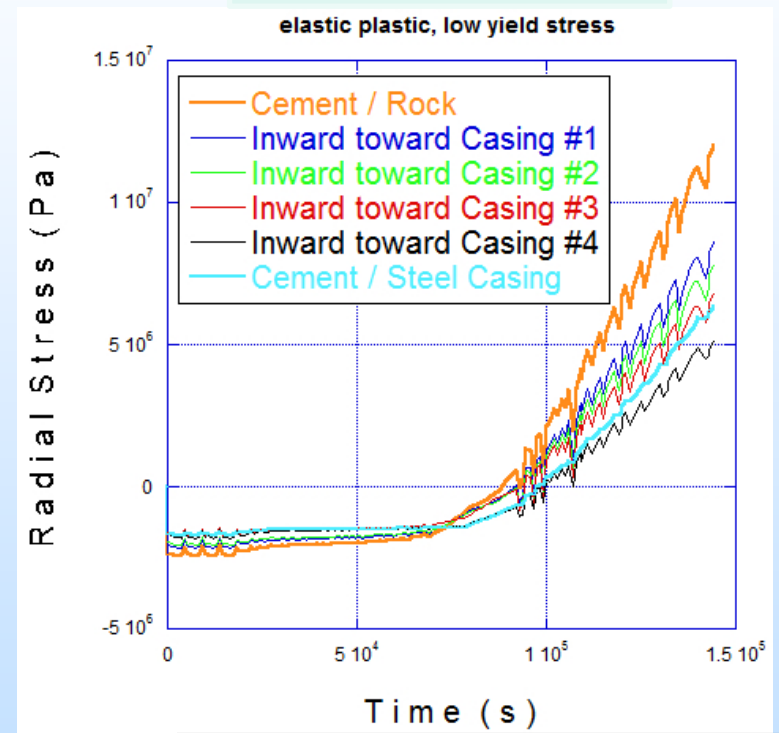
*3D Geomechanical Modeling
of Wellbore Interfaces*

Results show importance of material properties on wellbore conditions

High yield stress

Low yield stress

Cement/rock interface
(orange curve)

Cement/casing interface
(light blue curve)

Stress at cement/casing interface is greater when yield stress of cement is low
