Materials for Advanced Ultra-Supercritical Steam Service - Turbines

Phil Maziasz, Amit Shyam

Materials Science and Technology Division
Oak Ridge National Laboratory

2014 NETL Crosscutting Research Review Meeting, 19-23 May, 2014, Pittsburgh, PA

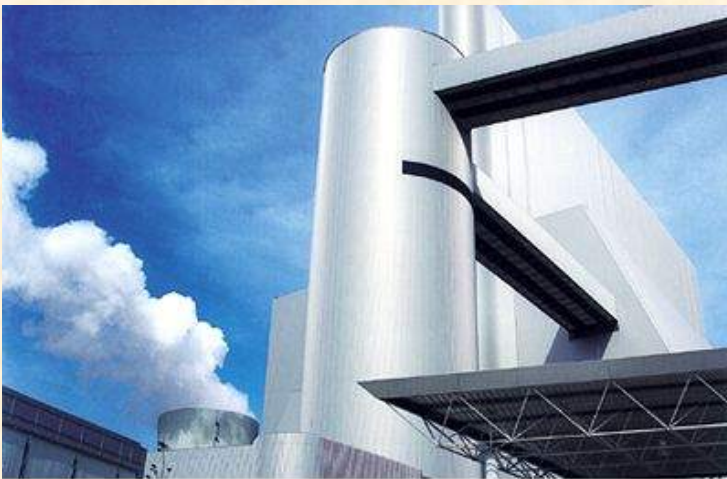
2 x 800 MW Lignite-Fired Power Plant Schwarze Pumpe, Germany

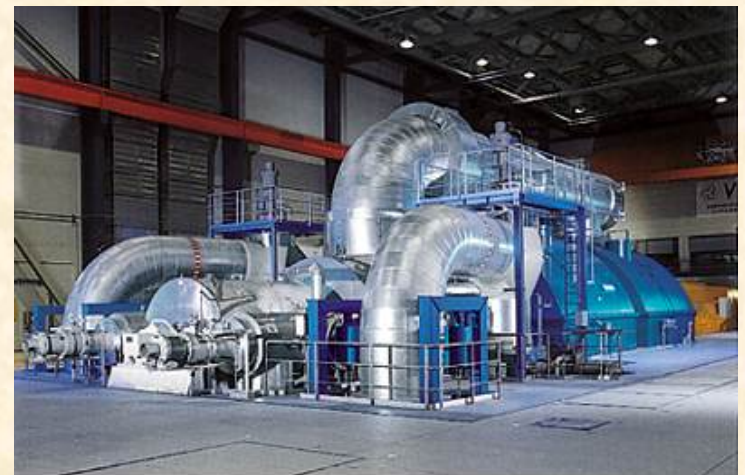
HMN-Series (High-, Intermediate- and Low-Pressure) Steam Turbine for Combined-Cycle and Steam Power Plants

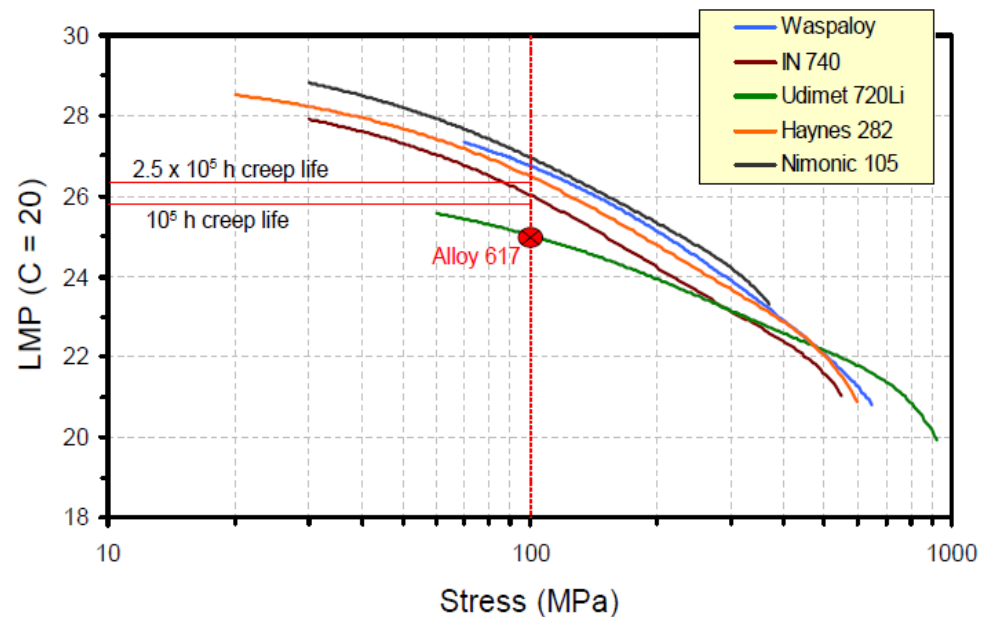
A-USC Turbine Designs Need Ni-based Superalloys (rotors, blading, casing)

Wrought Ni-based superalloys (NI 105 and HR 282) have creep-strength needed for rotors and blading to last 250,000h

Alstom HP Turbine Concept

Consortium Phase 1 Result

Cast Ni-based superalloys were needed for turbine casing

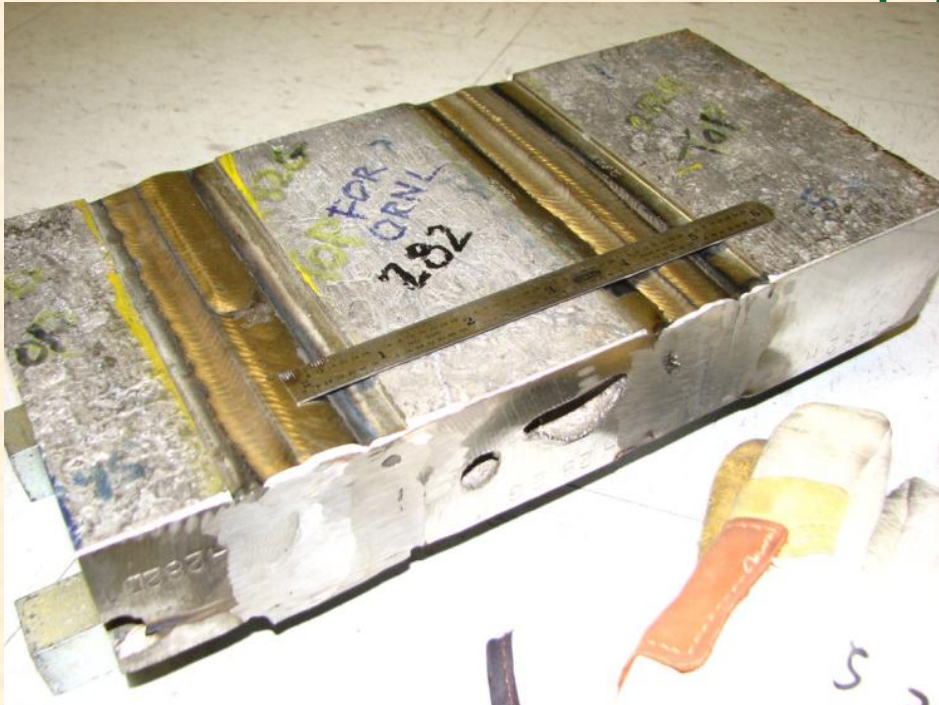
Testing of Narrow-gap GTAWs of Cast HR 282 supplied by GE

- 18 cross-weld specimens have been machined
- Stress-rupture creep testing is underway

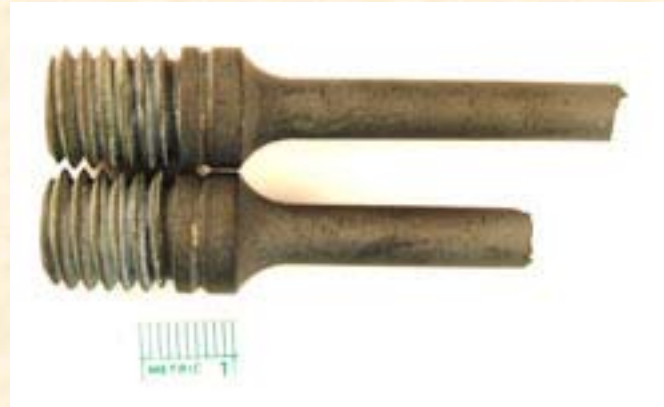
As-welded

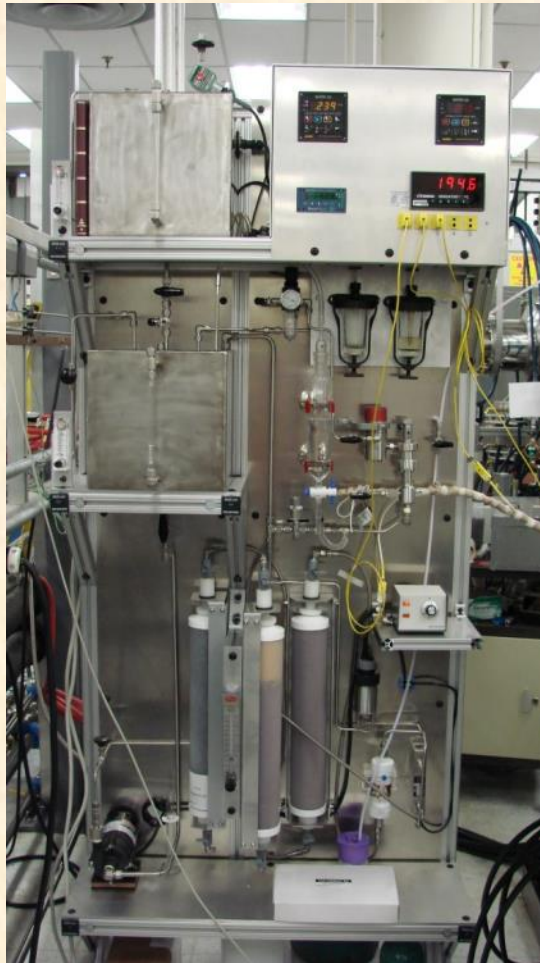
Steam Fatigue Testing Setup

Steam Generator

(water chemistry is controlled)

Steam inlet

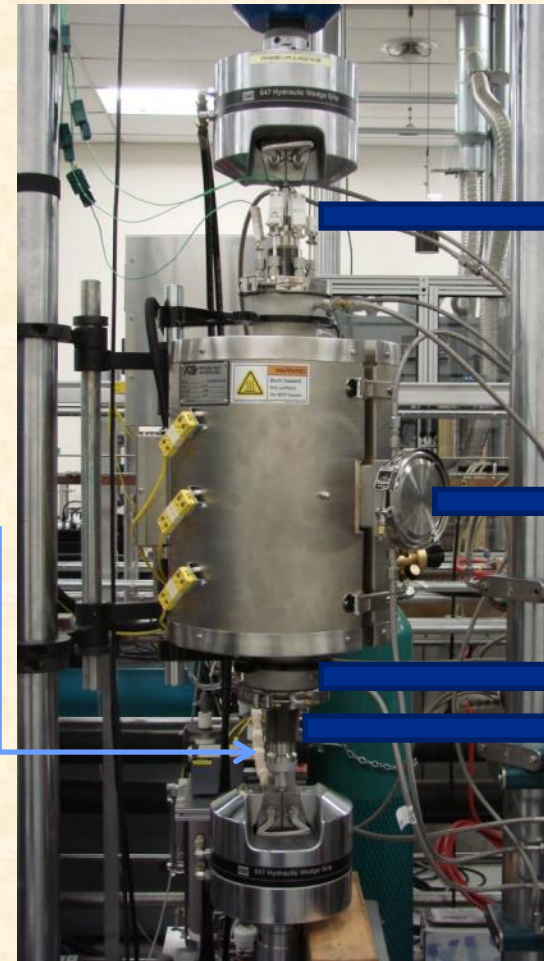
Thermocouples
and steam outlet

Extensometer port
in furnace (closed)

Inconel retort

Water cooled
Bellows (on both sides)

Assembled Load Train at 800°C

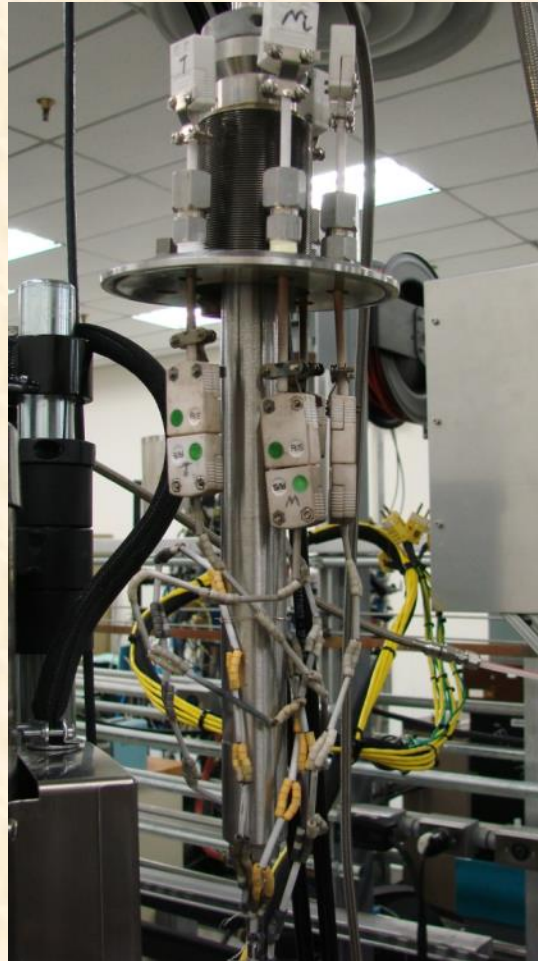
Top part of load train assembly

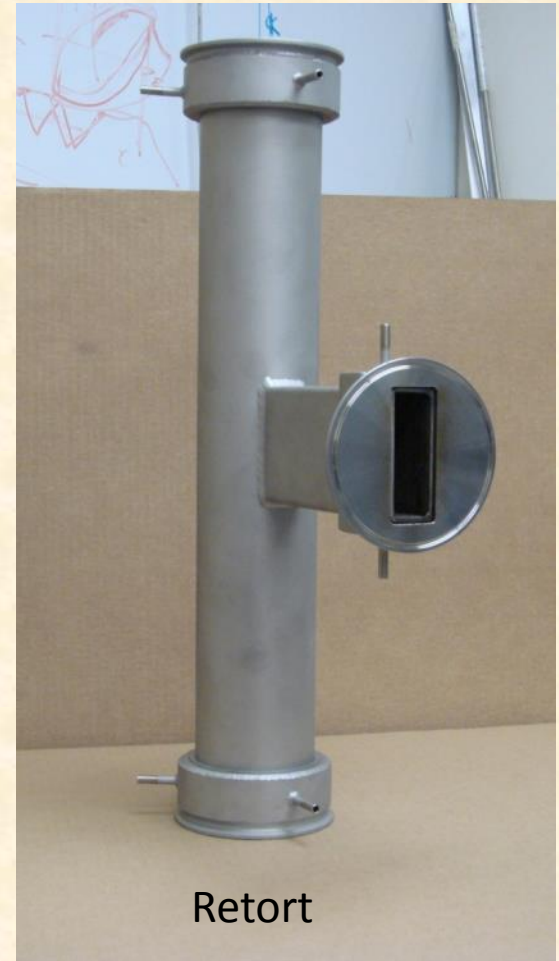
Retort

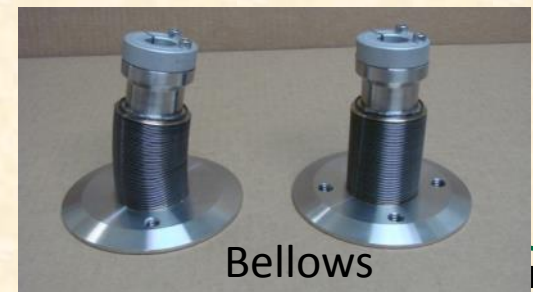
Bellows

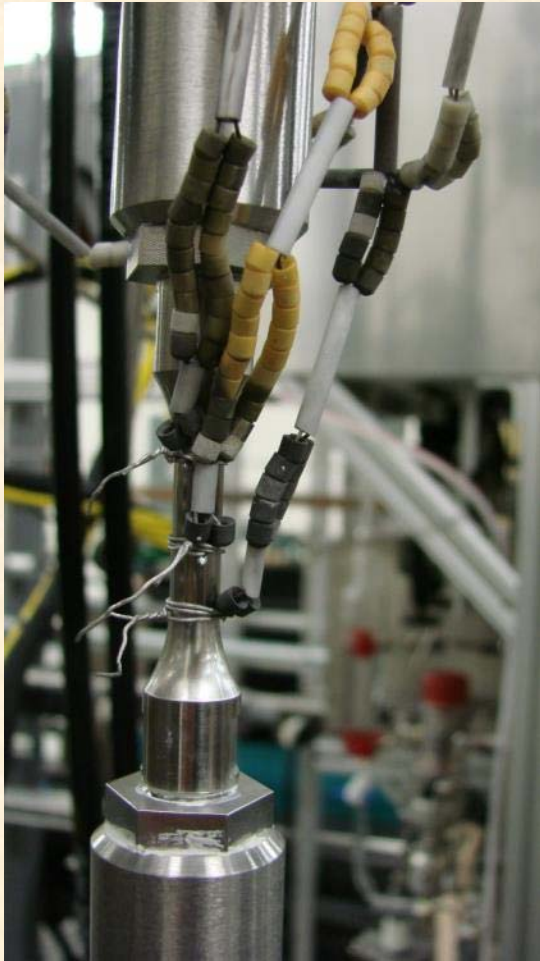
Specimen with three TCs
(before exposure)

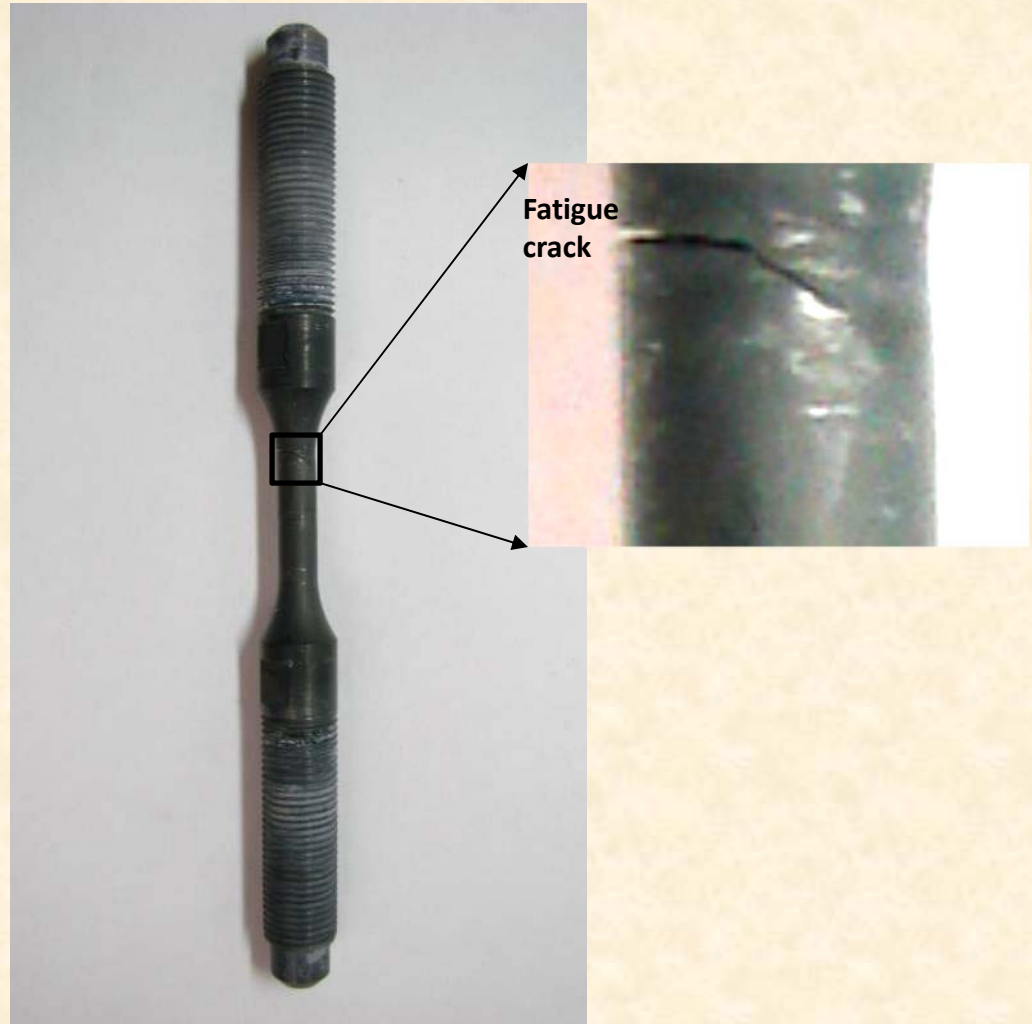
Failed specimen of wrought Haynes 282

$T \sim 850^{\circ}\text{C}$; 100% steam; $\nu = 10 \text{ Hz}$

$\sigma_{\text{max}} = 55 \text{ ksi}$; $R = -1$

(expected fatigue limit is $\sim 48 \text{ ksi}$ in air in this condition)

$N_f = 184,659 \text{ cycles}$

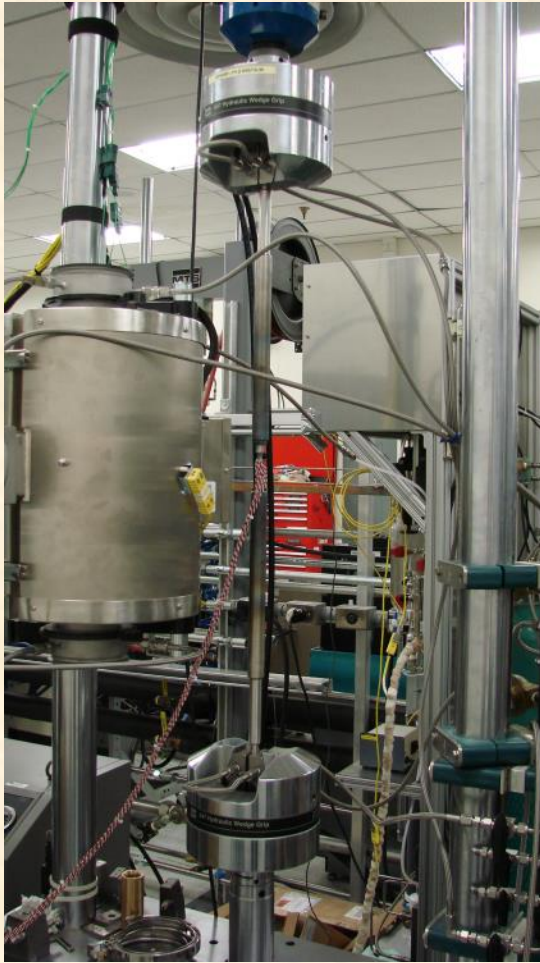
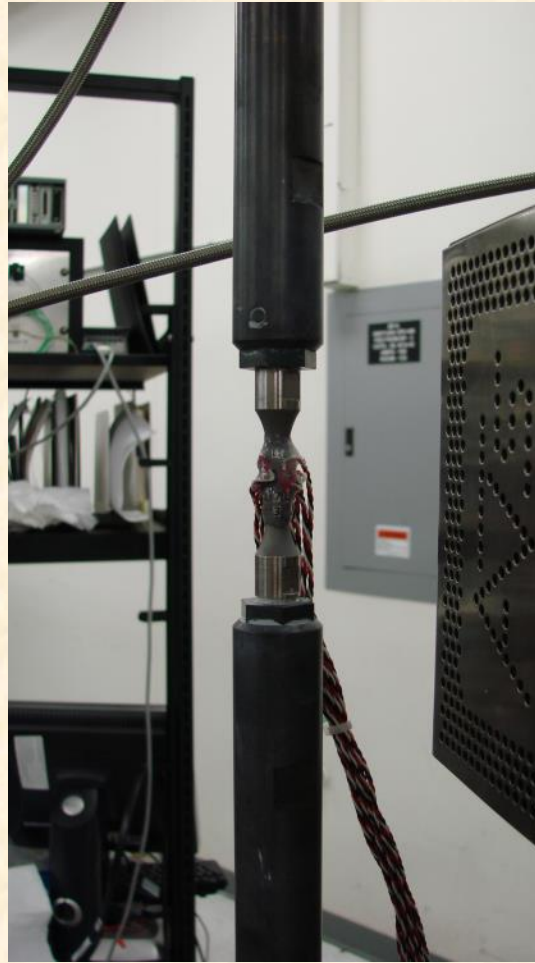
Machine alignment

Machine aligned by instrumented specimen (pictured)
Bending strain < 5% uniaxial strain as per ASTM standard

Several iterations required + problems solved

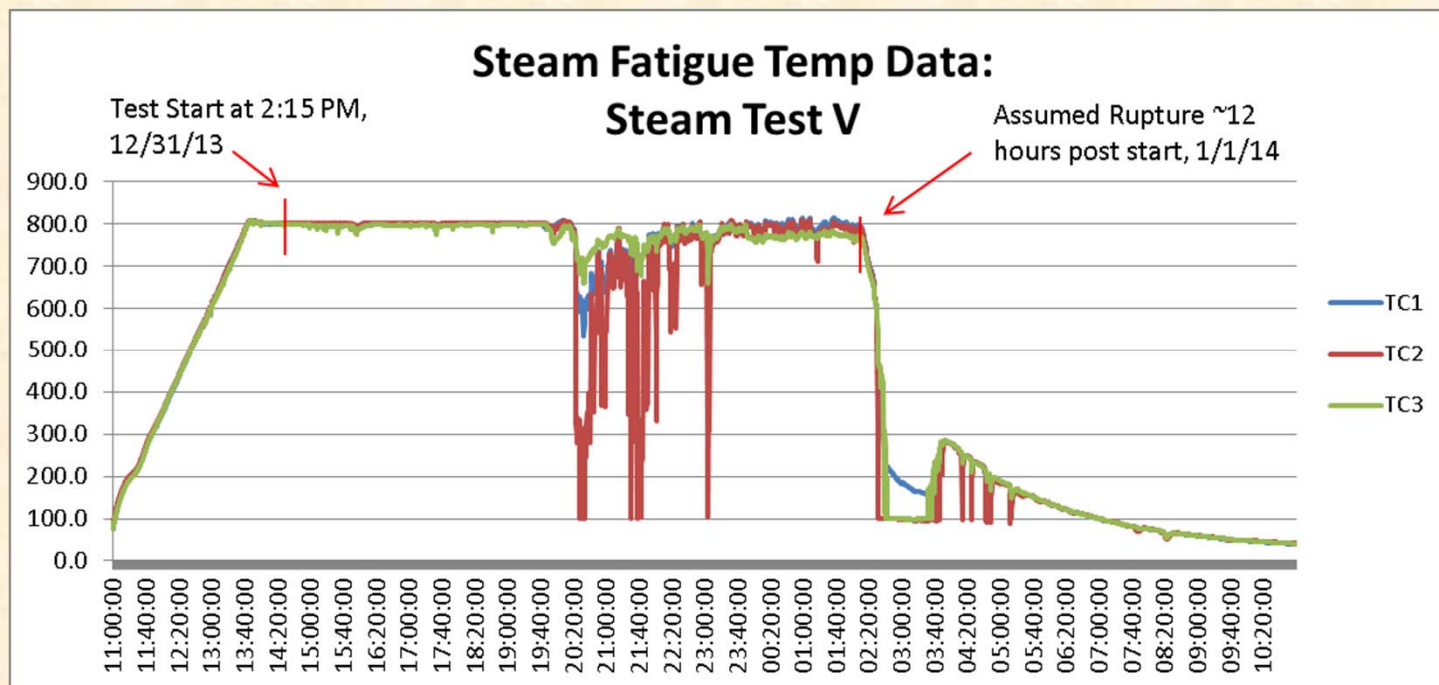
First good fatigue test in steam
