Characterization of Long-Term Serviced Coal Combustion Power Plant Extreme Environment Materials

S. Kung, A. Bridges, T. Lolla, J Siefert, J. Shingledecker

DOE-NETL 2020 FE R&D Project Review Meeting
September 29, 2020

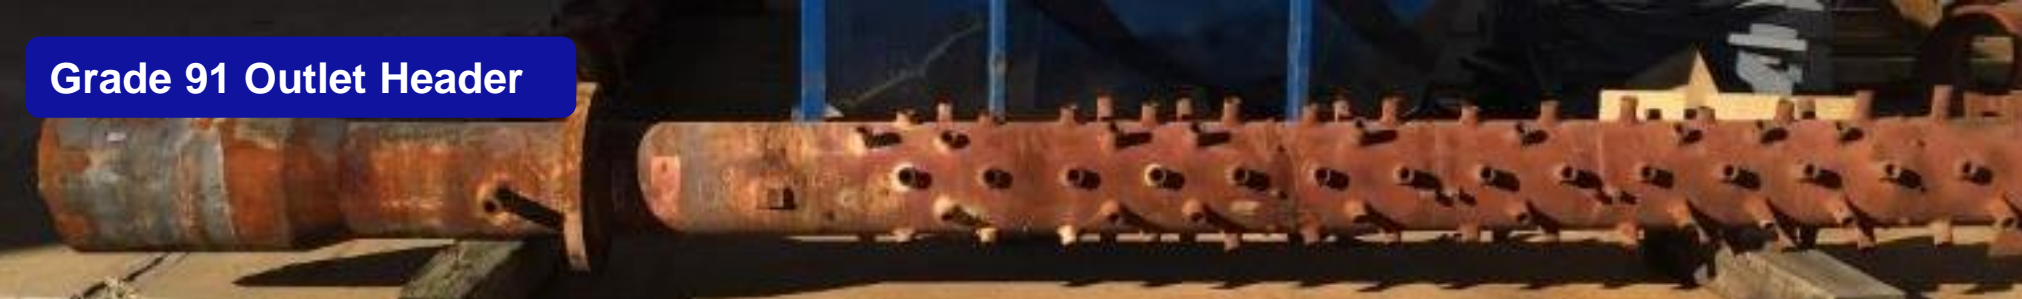
Grade 91 Outlet Header

An additional Grade 91 outlet header was identified and being acquired from UK after ~125,000 hours of service

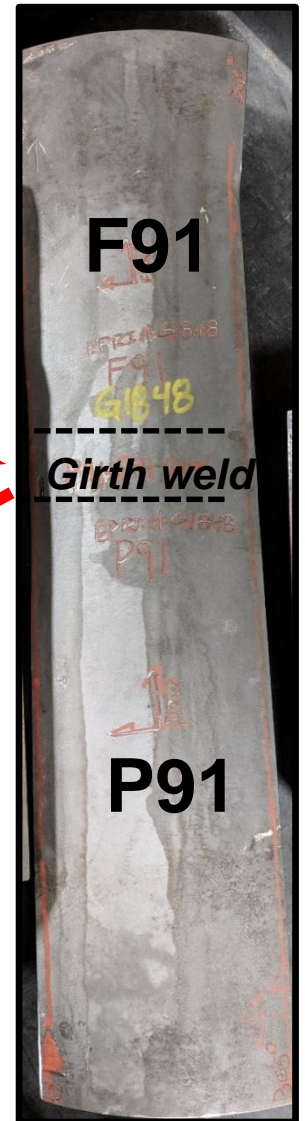
Example 1: Grade 91 Main Steam Outlet Header

- SH outlet header to HP turbine
- Pedigree:
 - 141,000 hours of service
 - 575°C (1,067°F) and 178 bar (2,590 psi)
 - ~3,300 starts
- Testing Performed:
 - Round-bar creep tests in base metal (F91 and P91)
 - Feature-type cross-weld creep tests (DMW)
 - Standard, time-independent tests (tensile, charpy, hardness, etc.)

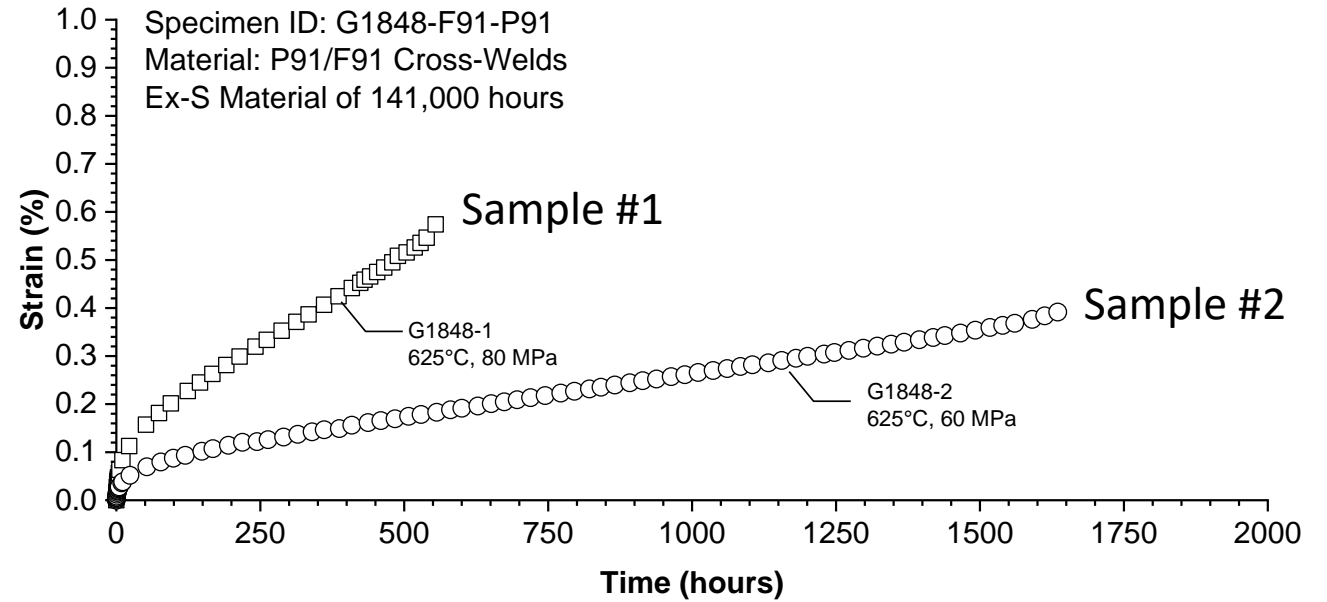
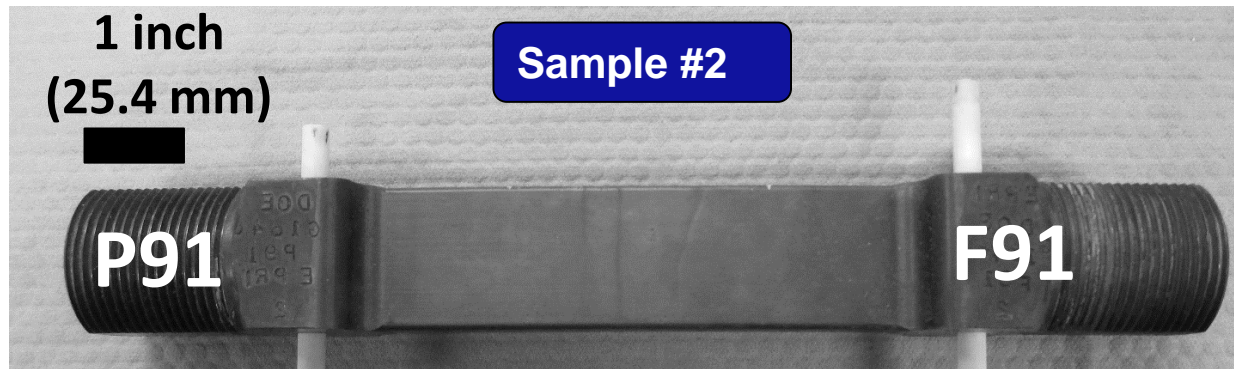
Example 1: Feature-Type Creep Tests for P91/F91 DMW

Sample #1: 625°C (1,157°F) and 80 MPa (11.5 ksi)

- Test ruptured after 556 hours

Sample #2: 625°C (1,157°F) and 60 MPa (8.7 ksi)

- Test interrupted after 1,637 hours
- Life fraction >98%
- See macro metallography (next slide)

Sample #2 test was interrupted immediately before failure (at >98% life fraction)

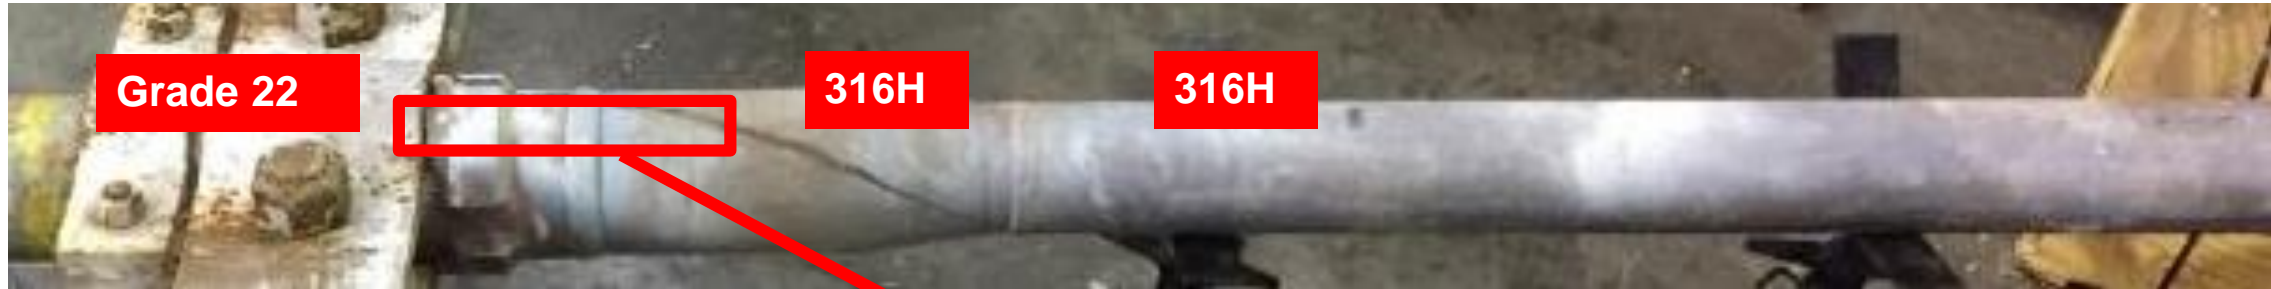
Example 2: Eddystone Unit 2 Main Steam Piping

316H/Gr. 22 DMW Piping

- Main steam piping to super pressure valve
- Early 1990s vintage
- Operating temperature: 1050°F (565°C)
- Operating pressure: 3750 psig

- 316H base-metal creep tests
- DMW cross-weld creep tests
