# Life Modelling of Critical Steam Cycle Components in Coal-Fueled Power Plants

DE-FE0031811

## **Southern Research - Engineering**

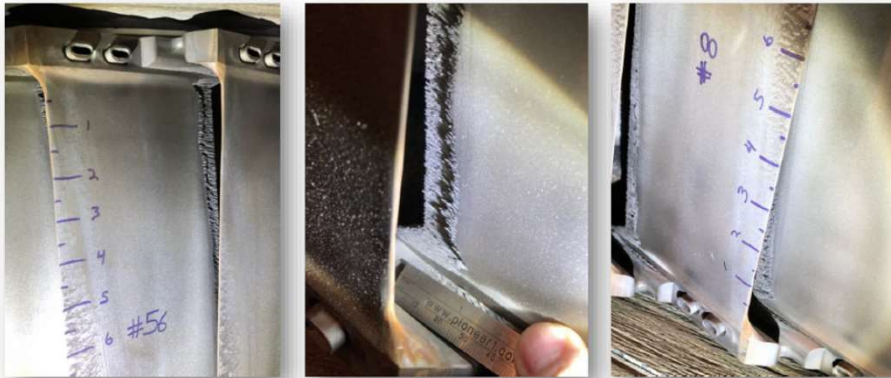
## Last Stage Bucket Leading Edge Erosion

- Recent inspection of GE D11 unit with 20 years of service revealed severe erosion.
- Similar findings on coal unit LSBs with 30+ years of service.

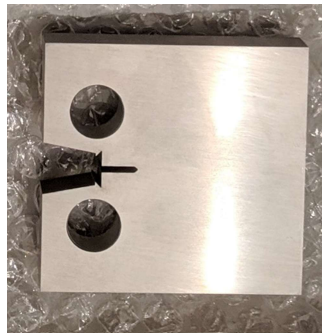
- Solid model of Last Stage Bucket (LSB or L0) created by use of 3-D scanning of Southern Company supplied blade
  - Local stress state quantified along length of LSB
- Analyzed operations and inspection data
  - Determined temperatures of interest
  - Characterized operational “cycles”
- Materials characterization testing ~80% complete
- Life modelling architecture (Kitagawa Diagram) initialized

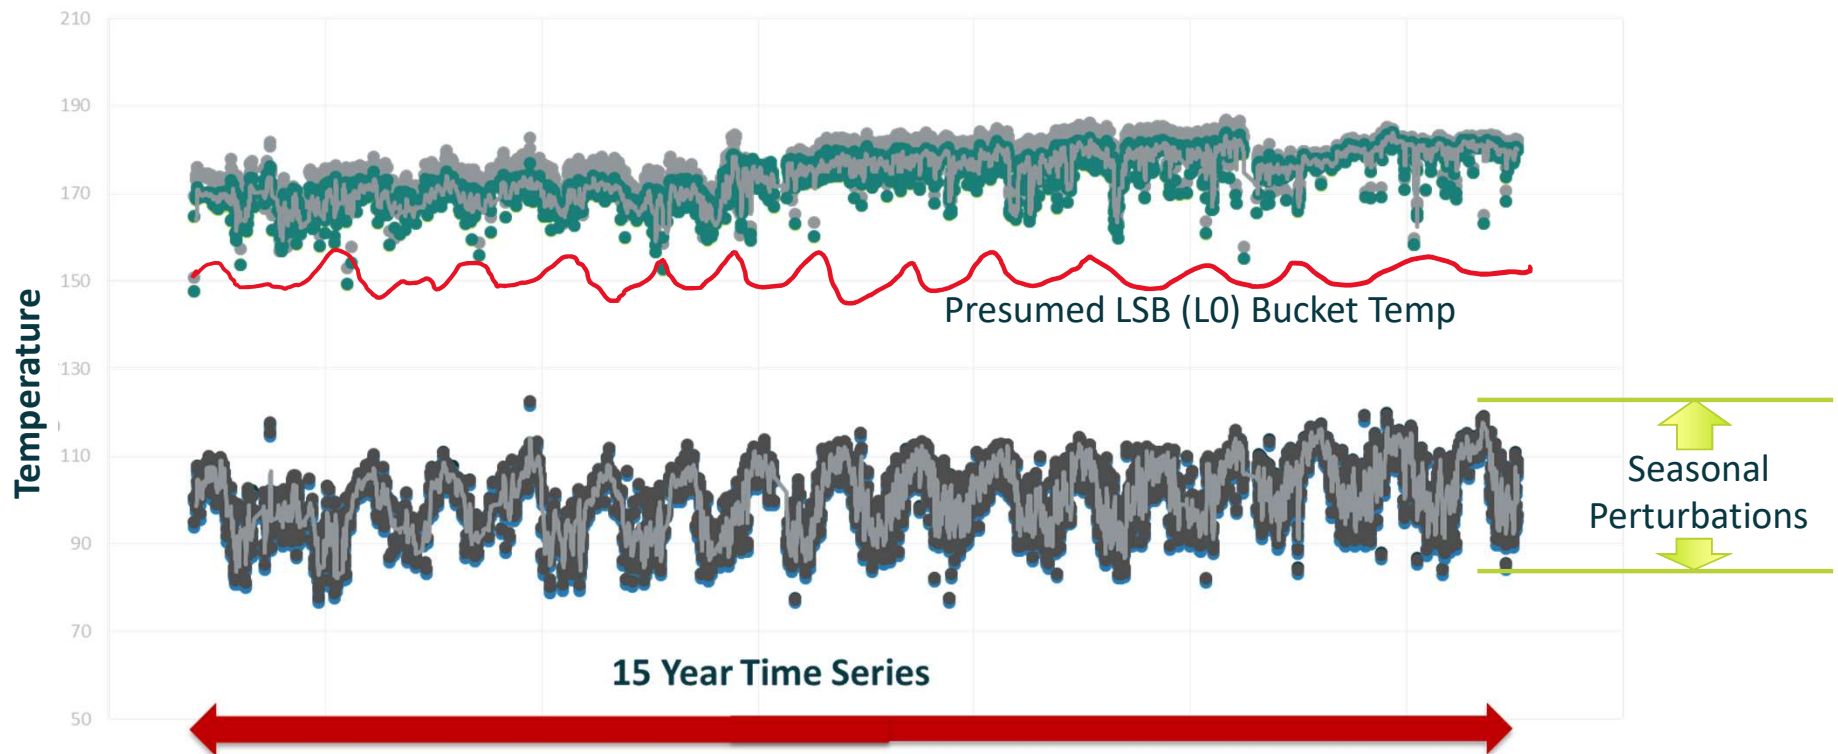
LSB operational temperature above 150°F

Characterization to be performed at 200°F

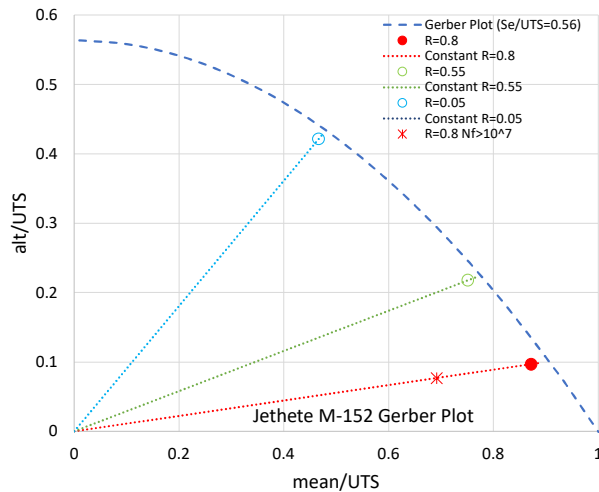
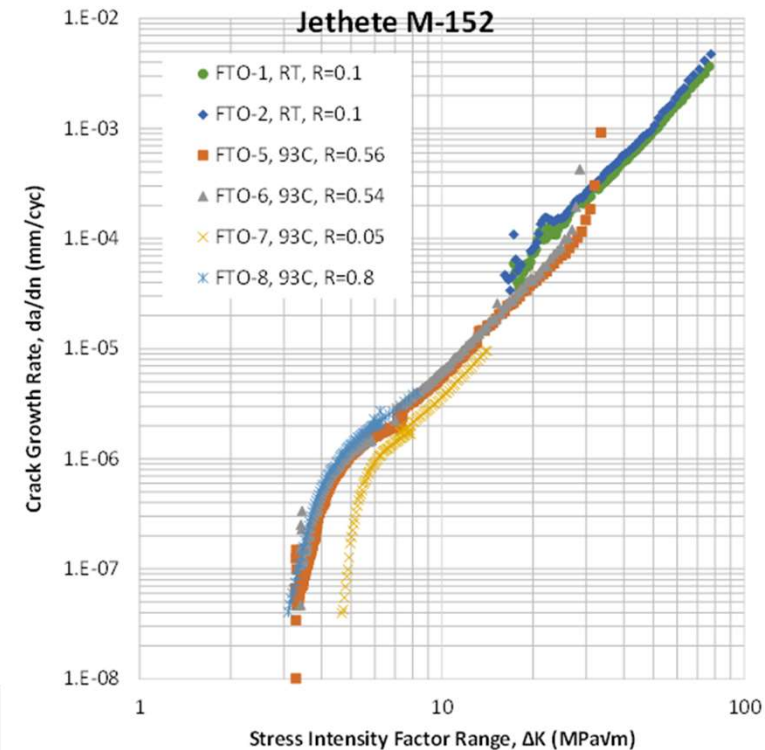
LSB FCG and FCG threshold testing complete

- FCGR and  $FCG_{th}$  insensitive to Temp between 27C and 100C
- FCGR insensitive to load ratio (R)
- $FCG_{th}$  exhibits R-sensitivity at low R
- Stress-Life testing (S-N) underway
- Data matches lit quite well

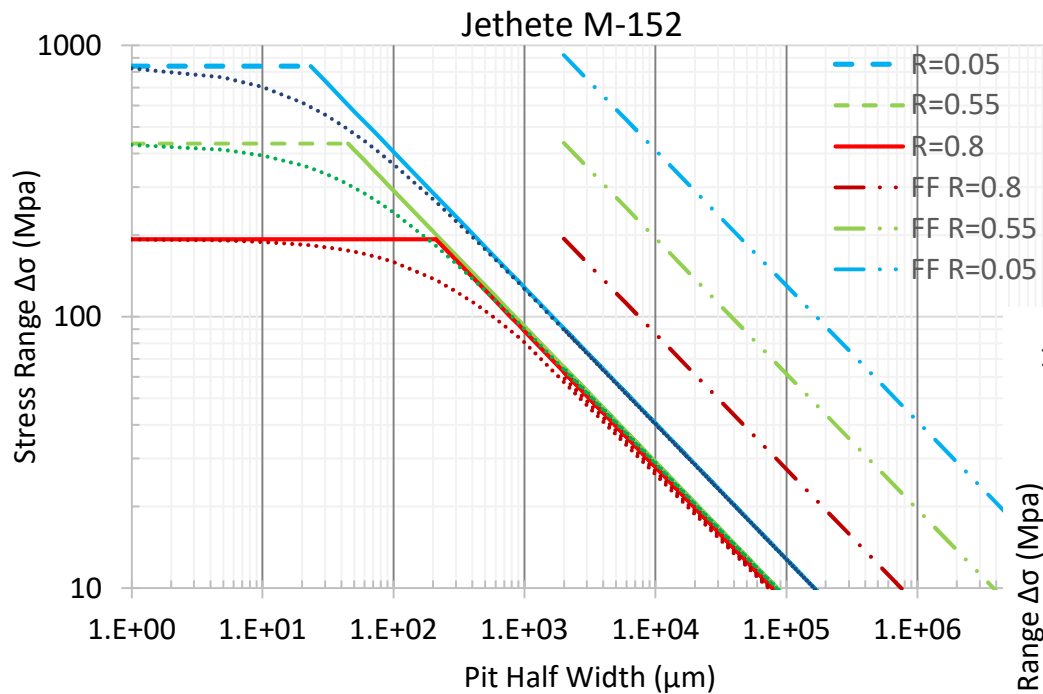
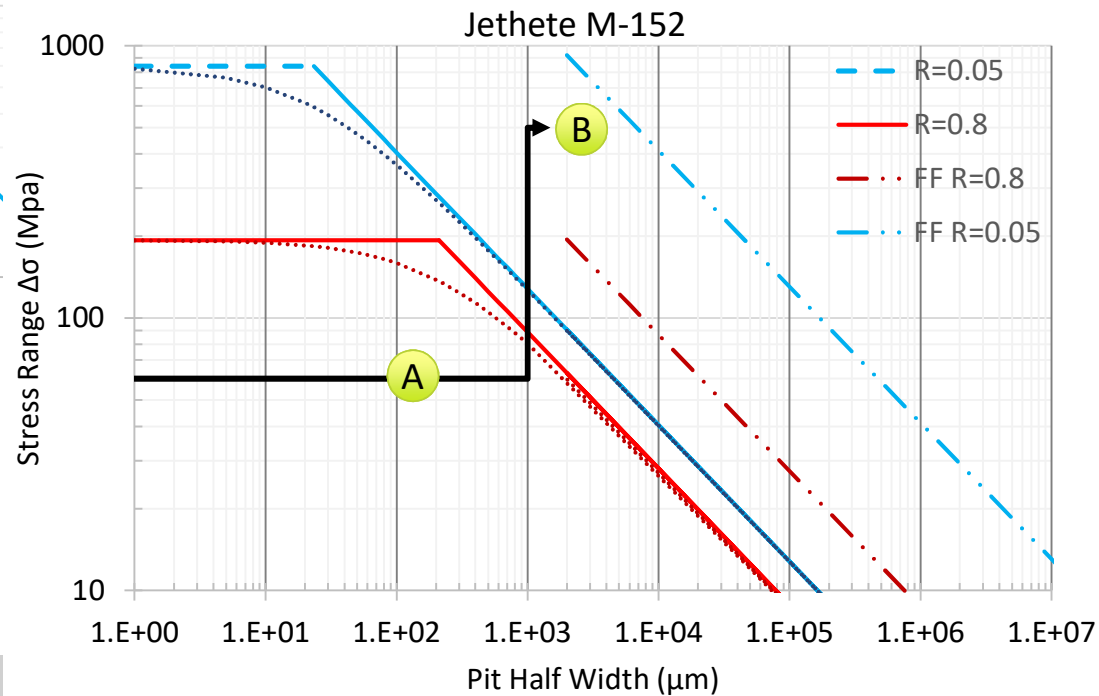
Kitagawa life diagrams preliminarily calibrated for Jethete blade material at 100C.

- LSB operates at  $R=0.8$  during steady state **A**
- LSB experiences  $R \sim 0.05$  during startup and shutdown **B**

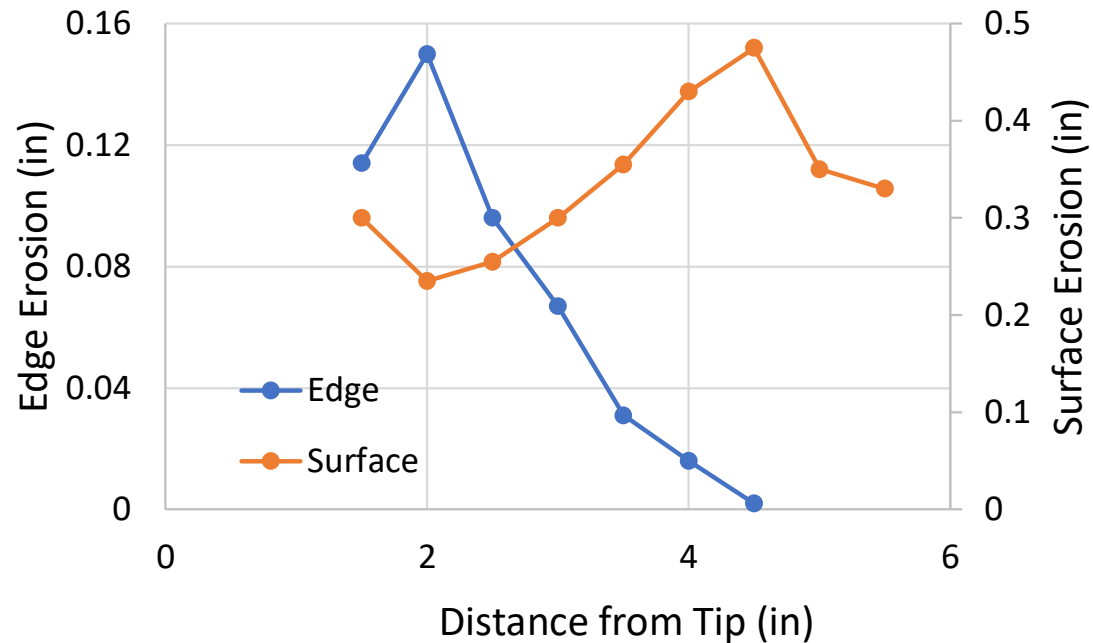
Field measurements taken during inspection performed by use of caliper

- Caliper measurements (“Edge” Data) of representative in-service blade shown in blue (note difference from 18-YR data)
- Surface erosion data (“Surface”) of representative in-service blade shown in orange

Neither measurement technique results in data that can be used to determine “crack” or “pit” size

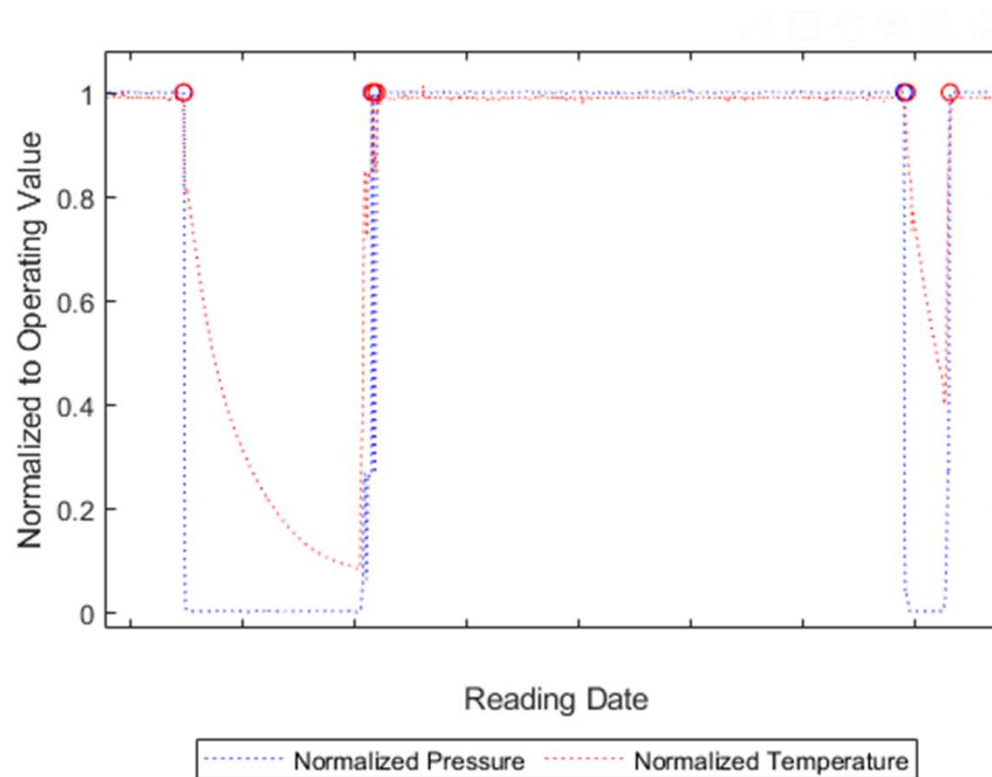
**Cycle starts when temp greater than 900F & pressure greater than 3400psig**

**Cycle ends when temp falls below 900F & pressure falls below 3400psig**

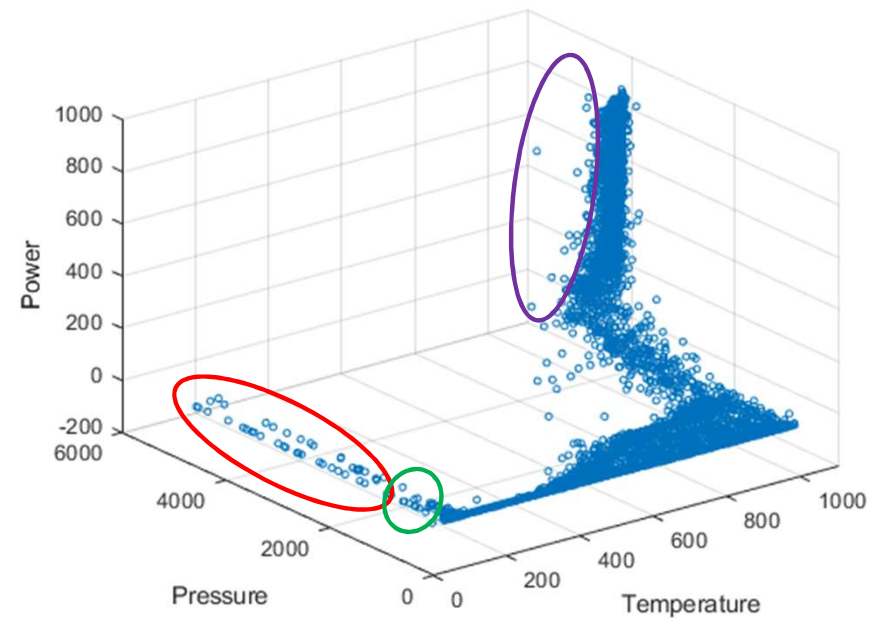
### Excursions in Operating Conditions

- **Prior Concerns**
  - Excursions on Both Temperature and Pressure
  - Many occur at low temp high pressure
- **Current understanding**
  - **Most events attributed to sensor errors and maintenance activities**
    - SoCo event logs, correlation to other sensor values, known pressure relief valve settings etc.
  - **Low temp moderate pressure (RT/2000psi) real**
    - Result of specific maintenance procedure “hydro”
    - 1 event/2 years
  - **High temp high pressure (Operating Temp/3900psi)**
    - Typically result in “trip” and shutdown
    - 1 event/year

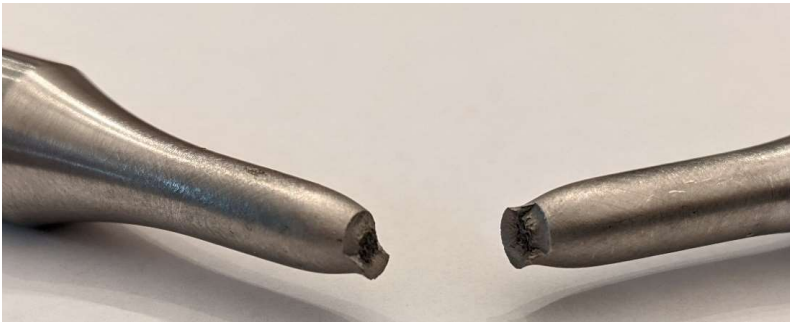
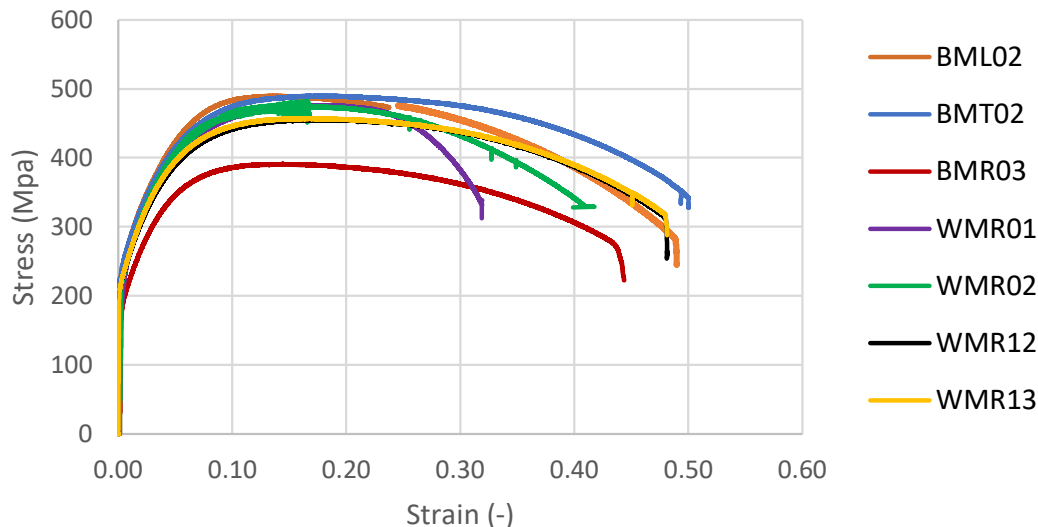
- RT monotonic testing complete
- Base Material (BM) and Weld Material (WM) exceptionally ductile (material removed from service behaves as annealed).
- BM is exhibiting transversely isotropic monotonic response (Radial orientation weaker).
- WM exhibiting considerable scatter in elongation to failure.
