Integrated Boiler Management Through Advanced Condition Monitoring and Component Assessment

DE-FE0031683

Crosscutting Research and Advanced Energy Systems Project
Review Meeting – Transformative Power Generation
May 12, 2021

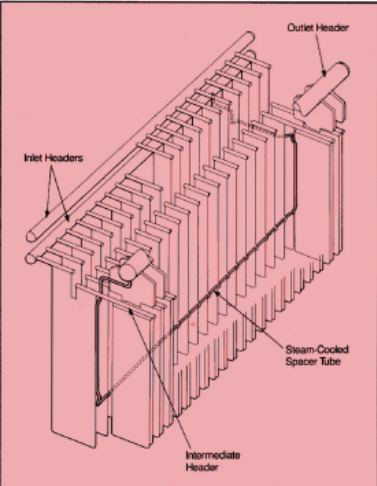
Figure 1 Pendant superheater with steam-cooled spacer tube.

Purpose
To advise owners and operators of B&W drum and once-through coal-fired design boilers, equipped with secondary superheater steam-cooled spacer tubes, to inspect the secondary superheater outlet header internal surfaces for cracks in the vicinity of the steam-cooled spacer tube entries. The steam-cooled spacer tube design (see Figure 1) is used on many units to maintain superheater section side spacing.

Problem
Internal, longitudinal cracks may develop on the inside of the outlet header in the vicinity of the steam-cooled spacer tube entries. These cracks are caused by thermal quenching from water that clears the spacer tube during startup and impinges on the higher temperature outlet header internal surface. Longitudinal-type cracking may also develop in the spacer tube bore holes because of this thermal quenching.
