Low-leakage seals for utility-scale sCO₂ turbines

DE-FE24007

GE Research

Overview of Utility-scale sCO₂ Seals Program

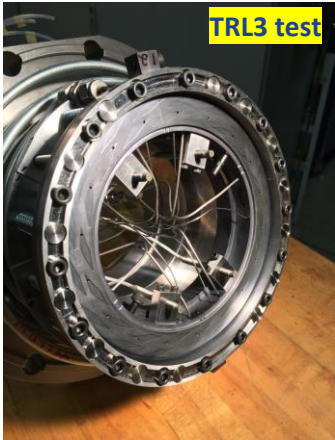
Radial Seal demo in air

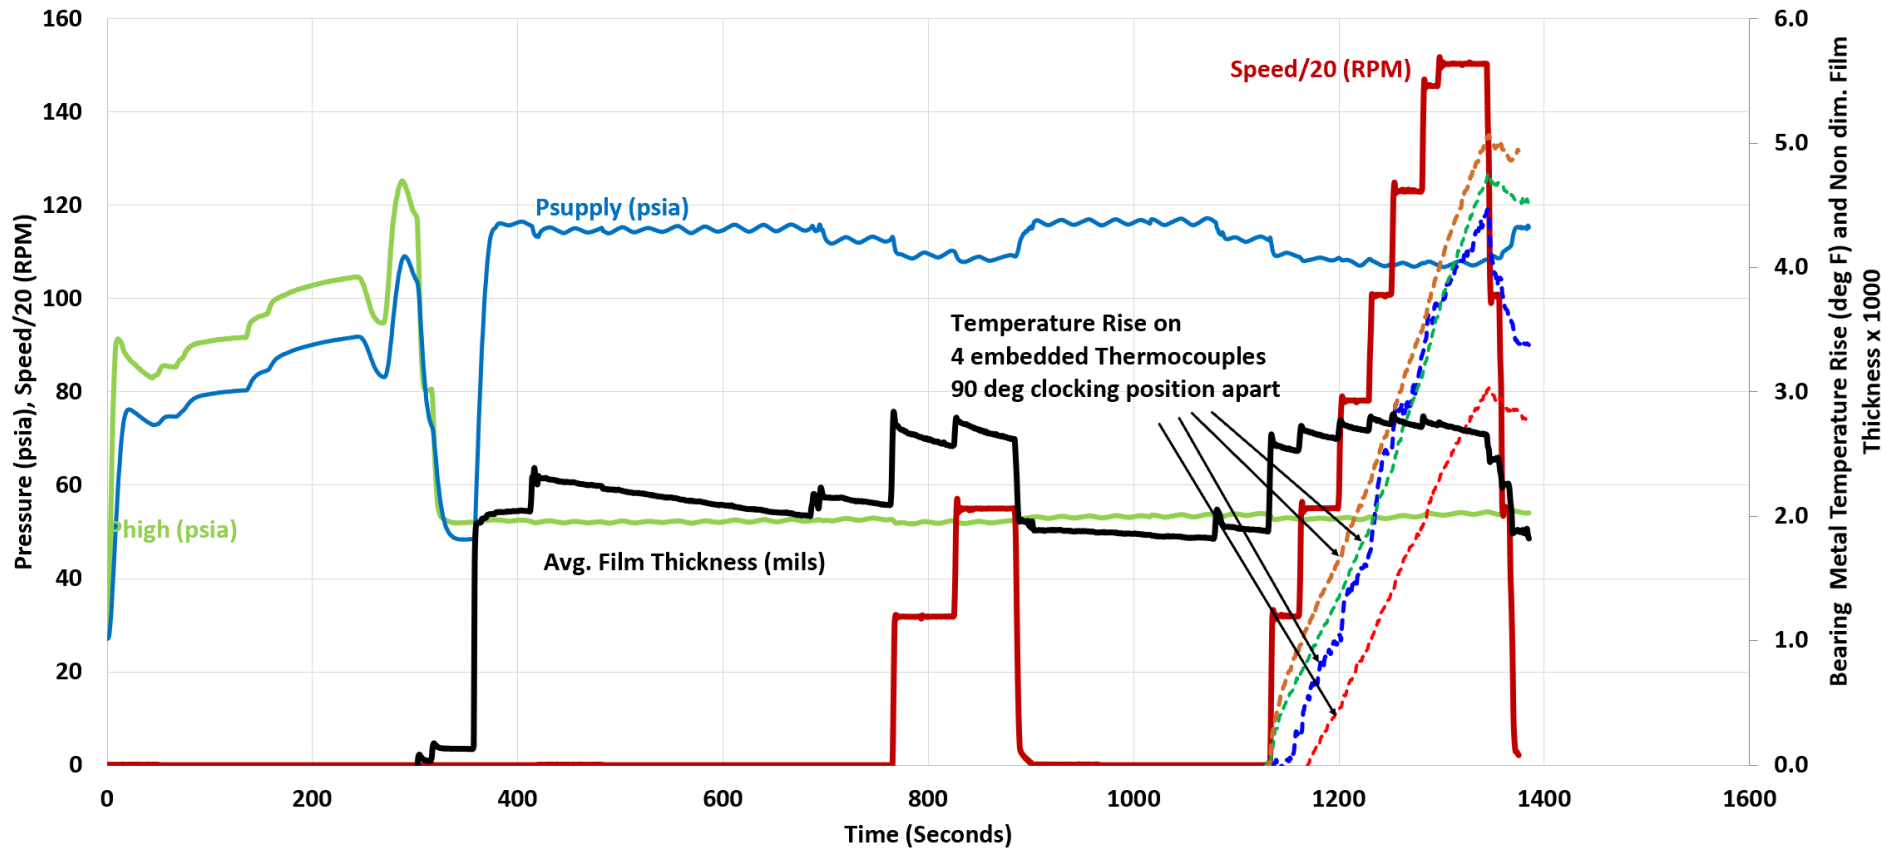
March 31st test 2022

- Rotating tests show $2-3 \times 10^{-3}$ non-dimensional film thickness
- Speeds tested up to 5200 rpm, 350 F inlet air
- Windage temperature rise ~ 5 degrees for this test
- Overall successful test for split-face technology with small operating gaps, on its way to TRL4/5

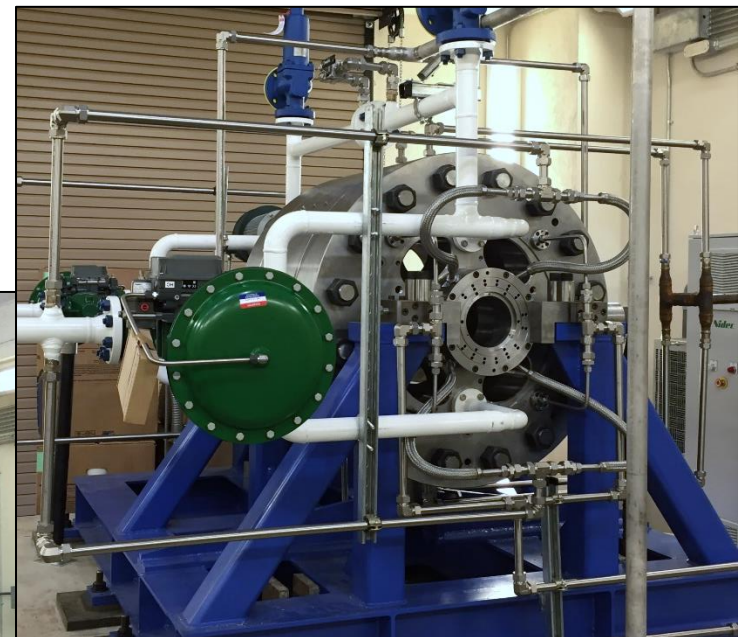
Air side
exhaust
stack

Heater
HX

Burner

From
pump

To rig

Open-
loop
vent

Stainless piping: upstream of rig / from heater
Painted CS piping: downstream of rig

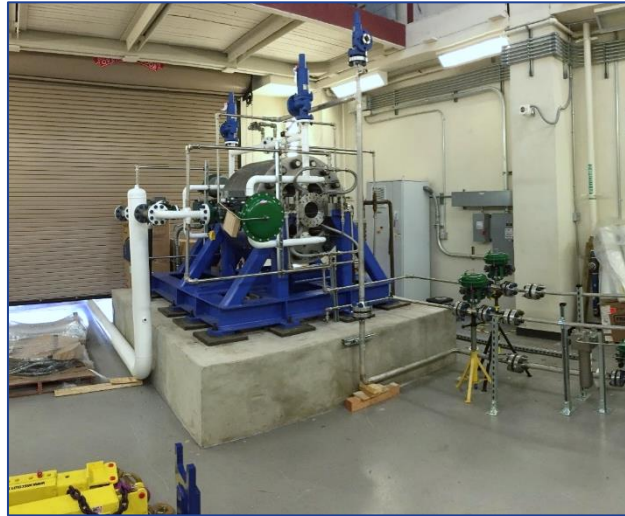
Cryostar Fill Pump Infrastructure 2020-2021

- Rig commissioned – end of year 2020
- Needed a larger Fill Pump
 - Repurpose a prior DOE pump, 2 tanks & new construction near Bldg. 278
 - 2020 – construction
 - 2021 – electrical VFD/sensor issues resolved with MW generator rental
 - 2021 – Dry Gas Seal on Pump failed (weather exposure). Issue resolved Dec 2021

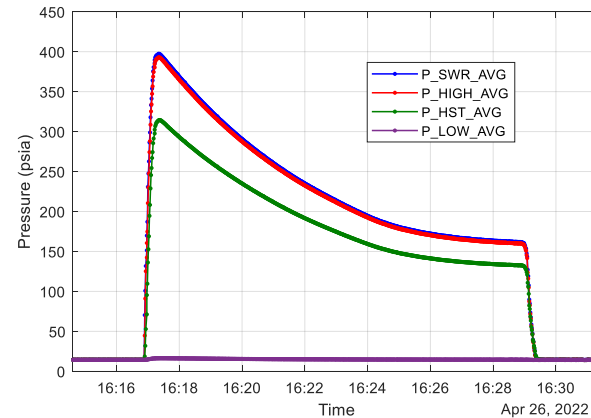
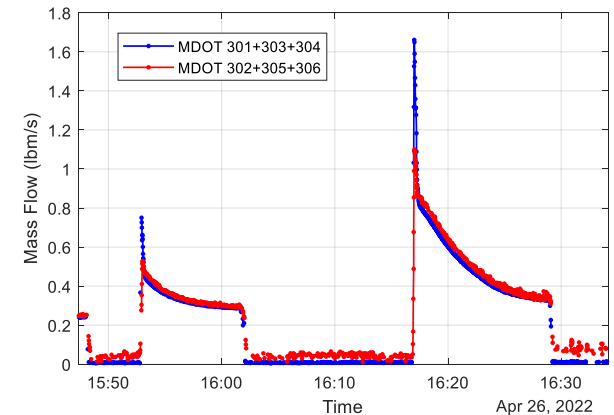
Low-medium pressure blow-down tests (Dec 2021- Apr 2022)

- Blow down tests from ~250 psi and ~450 psi
- Pressure drop over time due to flow leaking through seals
- Flow measurements are consistent: mass conservation
- Exercised flow through upstream cavity and hydrostatic supply

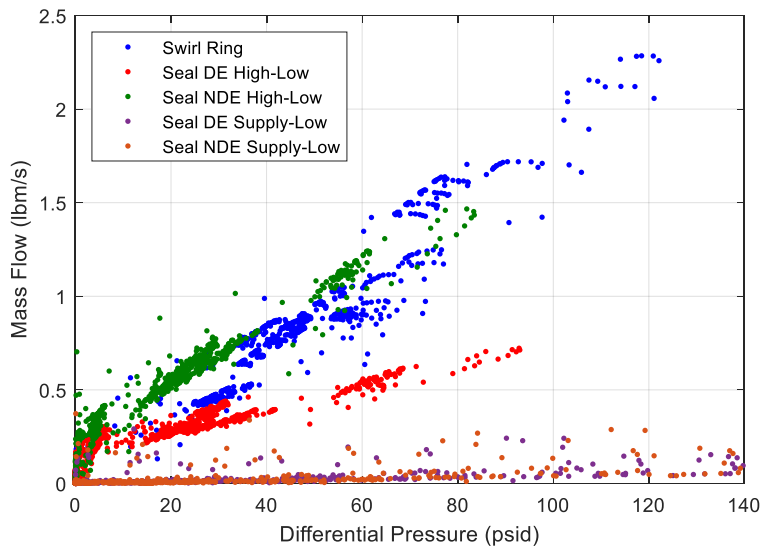
3/1/22: Original

New piston ring seals leak less than original

- Piston ring swapped Apr 8th to 10th
- Testing Apr 26th shows order of magnitude leakage improvement
- Metallic piston ring did not work well
- Apr 26th data is an enabler for longer duration tests, rotating tests
