2023 FECM / NETL Spring R&D Project Review Meeting

A Data-driven Multiscale Phytotechnology Framework for Identification and Remediation of Leached-Metals-Contaminated Soil Near Coal Ash Impoundments

Principal Investigator:

Bahareh Nojabaei

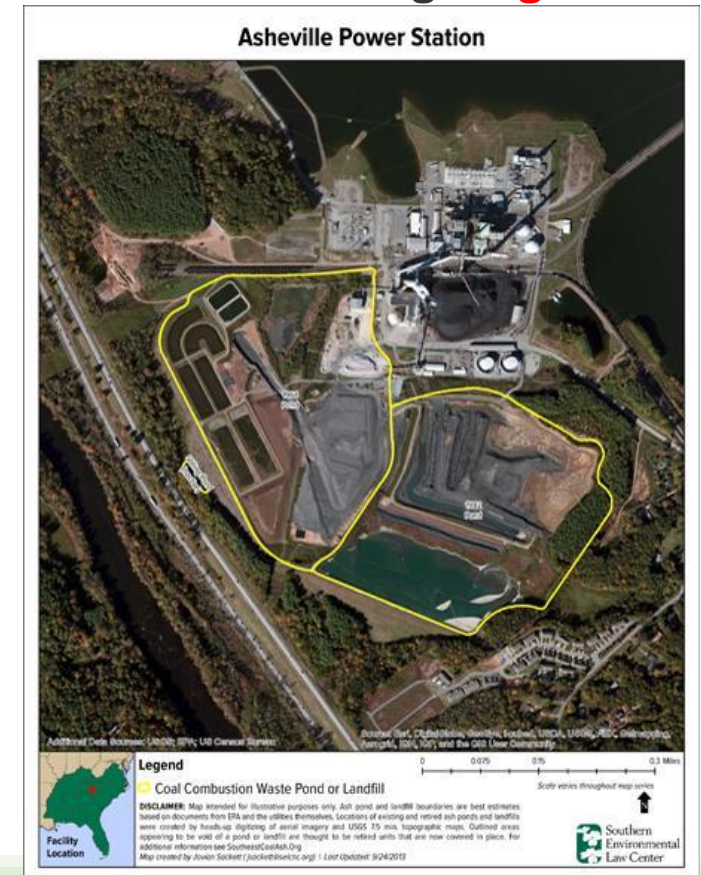
Unlined Impoundment	
Impoundment Name	1964 Ash Pond
Hazard Rating	High
Capacity	72,664,773 gallons
Ash	2,535,600 tons
Wastewater	9,776,000 gallons
Dam Height	100
Active	Yes

Unlined Impoundment	
Impoundment Name	1982 Ash Pond
Hazard Rating	High
Capacity	290,007,390 gallons
Ash	686,000 tons
Dam Height	95
Active	Yes

Unlined Impoundment	
Impoundment Name	Stilling Pond
Hazard Rating	Not Rated
Active	Yes

Asheville Power Station

Hazard Rating: High

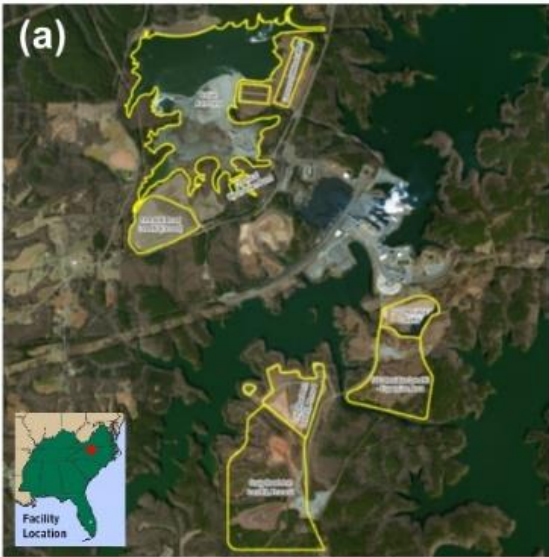
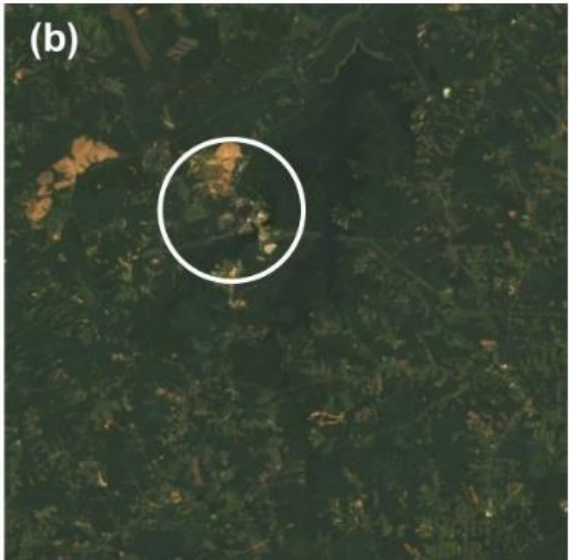
Belews Creek Stream Station in Walnut Cove, NC that has a “high hazard” rating

Satellite view with natural color

Satellite view with false color (combination of bands 4, 5, and 6)

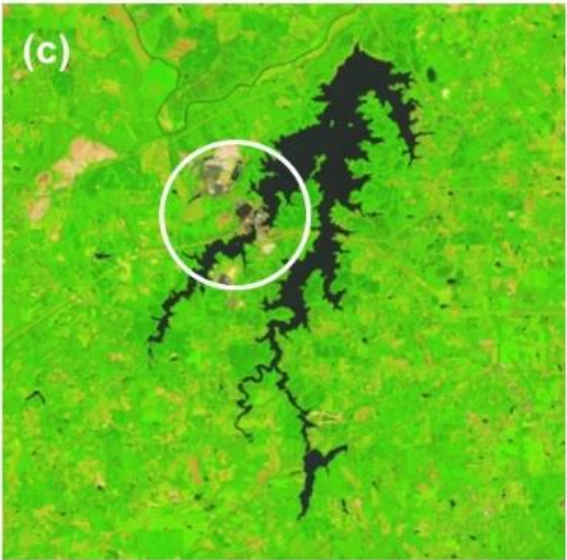
Satellite view with color infrared (combination of bands 3, 4, and 5)

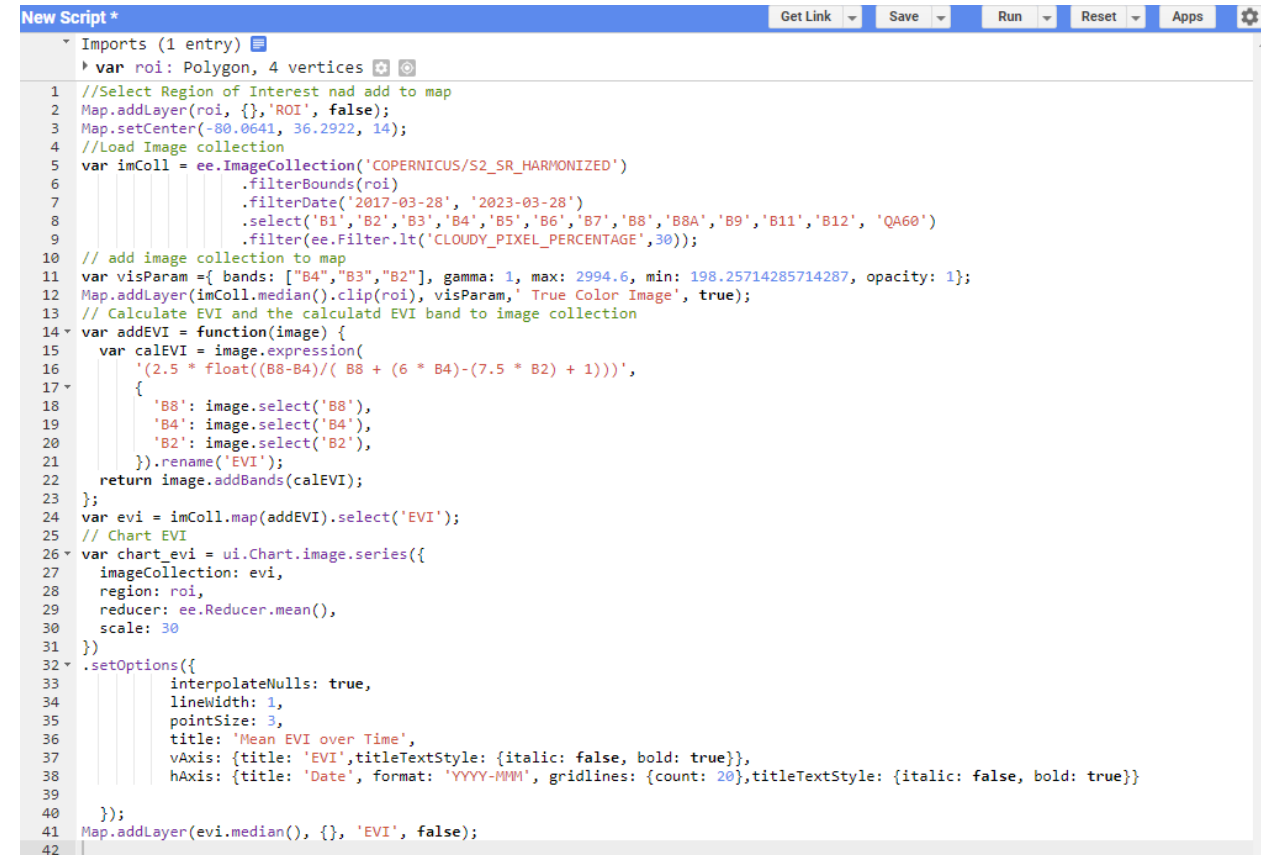
Workflow used for vegetation indices calculation

- Open google earth engine code editor.
- Select region of interest and set map center.
- Load Landsat or Sentinel satellite image collection from google cloud.
- Filter image collection with bands, datetime, cloud cover and region of interest.
- Add visualization parameters to visualize better.
- Add image collection to map.
- Define functions to calculate vegetation indices.
- Add calculated VI to image collection and add to map.
- Chart VI.

A simple code snippet is added here.

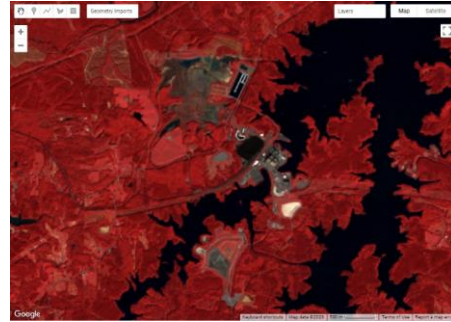
FALSE COLOR

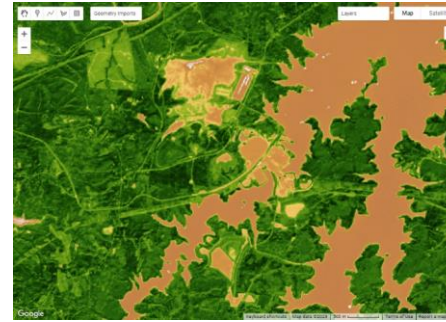
EVI

$$EVI = 2.5 * \frac{(NIR - Red)}{(NIR + 6 * Red - 7.5 * Blue + 1)}$$

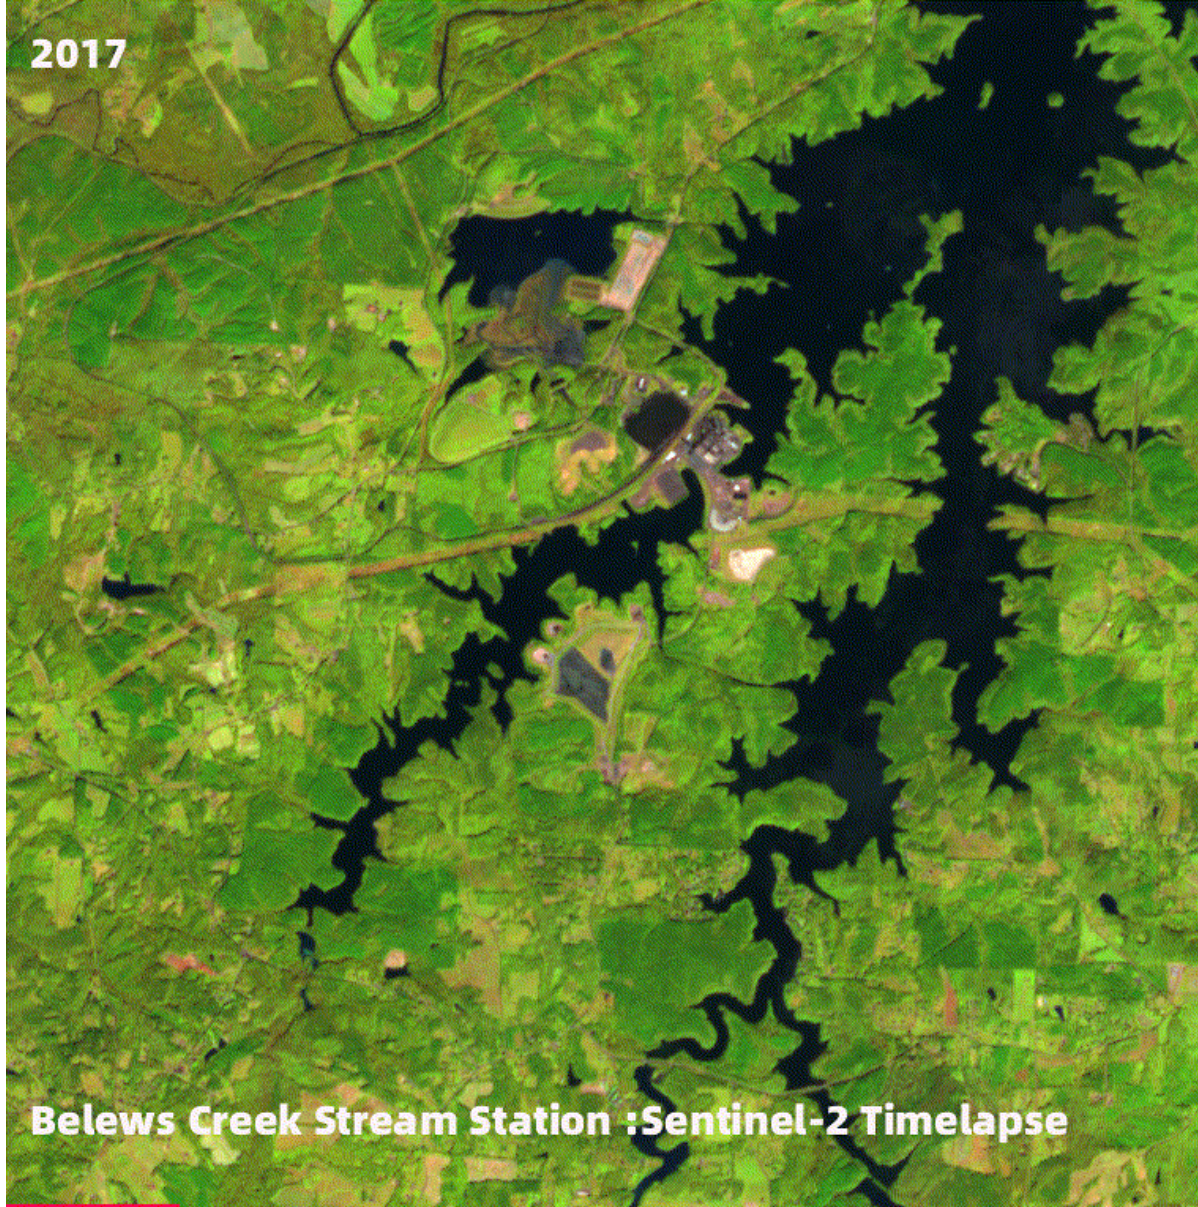
Time lapse from sentinel 2 (NDVI)
