Pipeline Materials Technologies for Mitigating Corrosion, Methane Emissions, and Hydrogen Embrittlement

FWP 1022424 Task 3

2024 Resource Sustainability Project Review Meeting

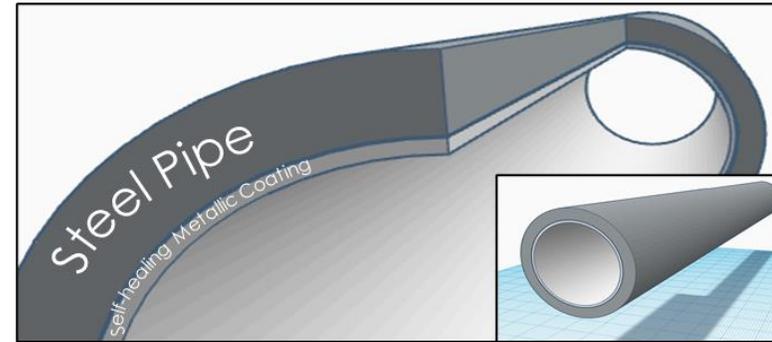
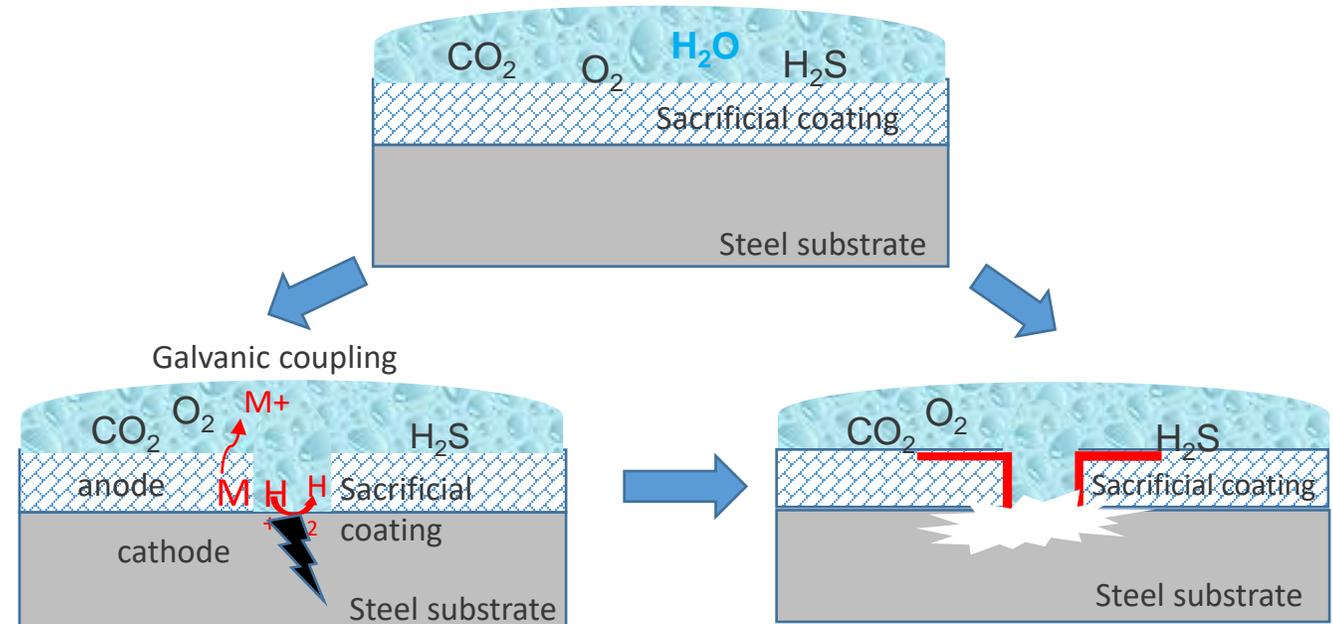
- Sacrificial coatings are used for corrosion protection.
- Zinc is a common sacrificial coating.
- However, Zn corrodes too fast in NG pipeline conditions.
- Can we slow Zn corrosion inside NG pipelines?
- Can we form *micro galvanic cells* to control Zn corrosion?

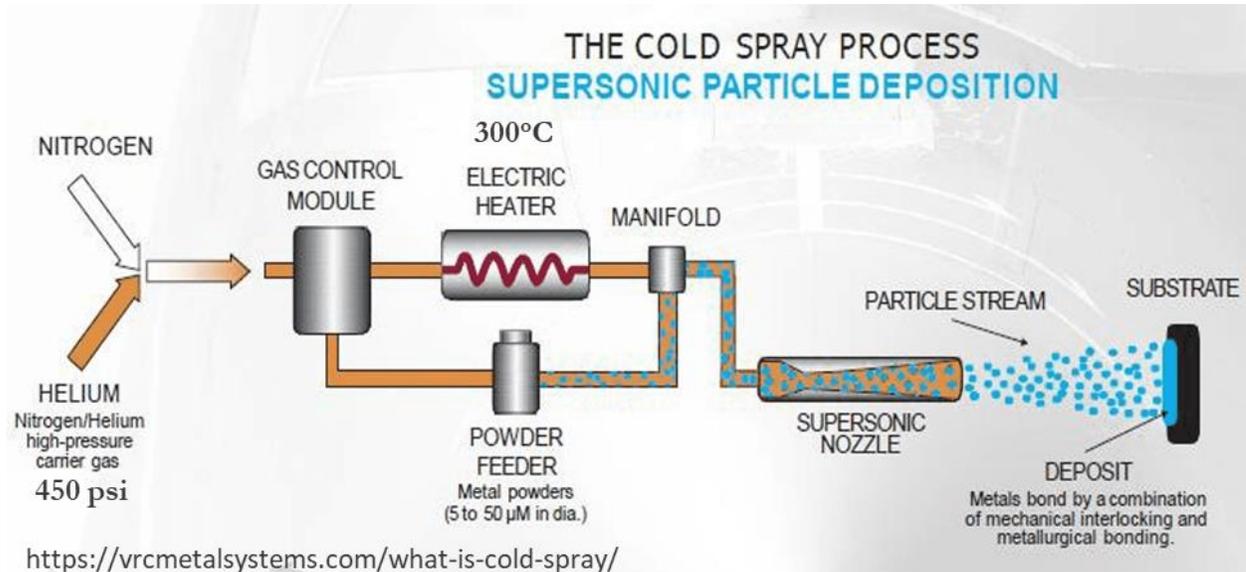
Cold Spray Coating Technology

Coatings	Thickness (μm)	Porosity (%)
ZnNb	428 ± 5.1	$\approx 0.32 \pm 0.13$
ZnCr	304 ± 7.0	$\approx 0.5 \pm 0.28$

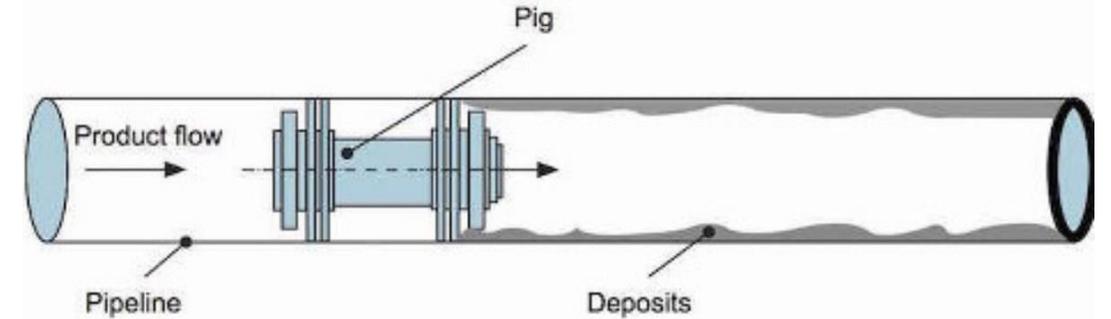
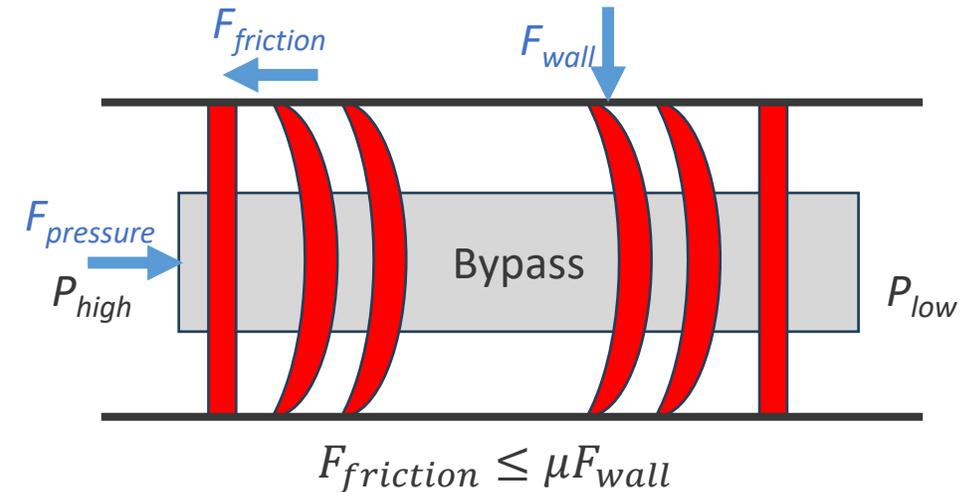
Forces imparted by pigging on cold-sprayed self-healing coatings

- Most forces on coatings during the pigging process will be:
 - Wall (compressive)
 - Friction (shear)
- Testing for **shear adhesion** and **wear properties** will determine the viability of these coatings to mechanical pigging.

$$\tau = \frac{P_{max}}{A} \text{ [MPa] (PSI)}$$

$$\text{wear} = \frac{CW_x}{\rho S_x} \text{ [mm}^3\text{/Nm]}$$

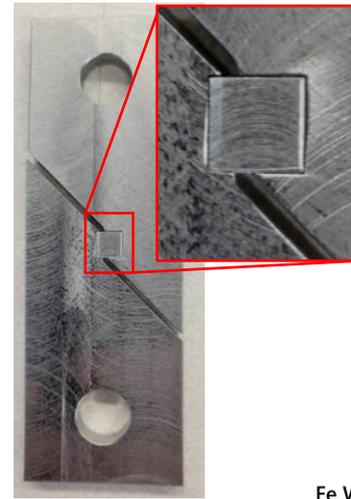
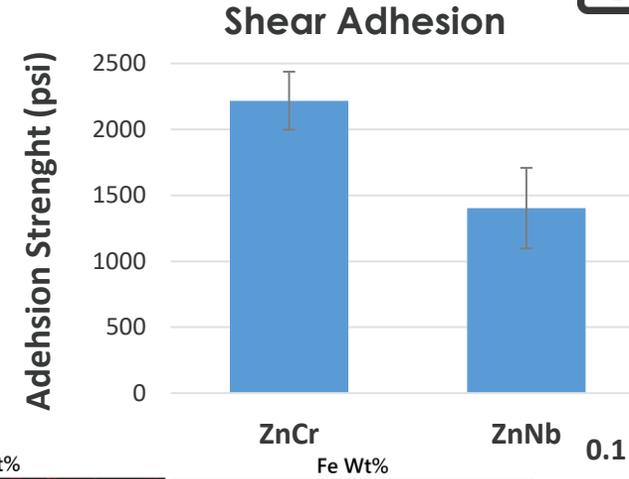
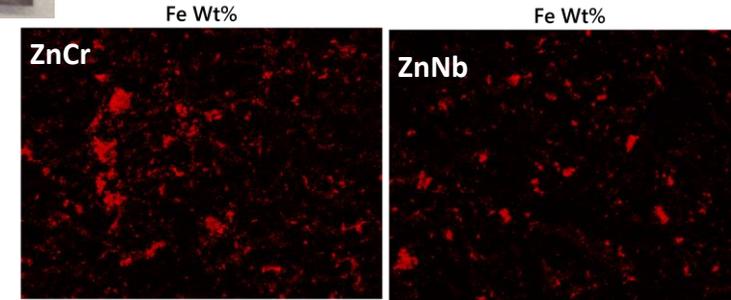
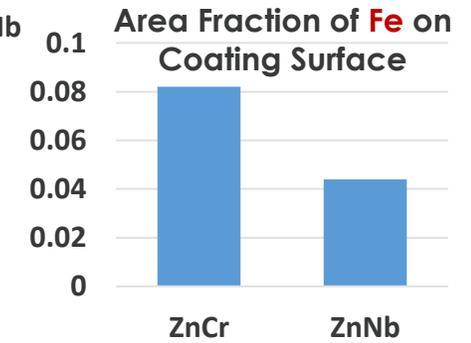
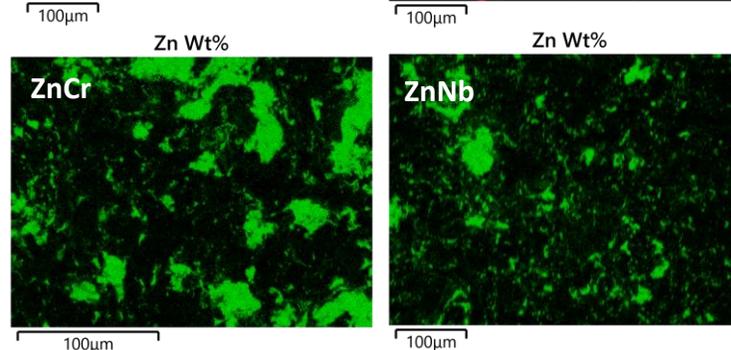
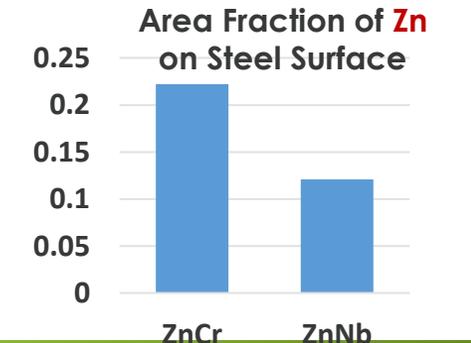
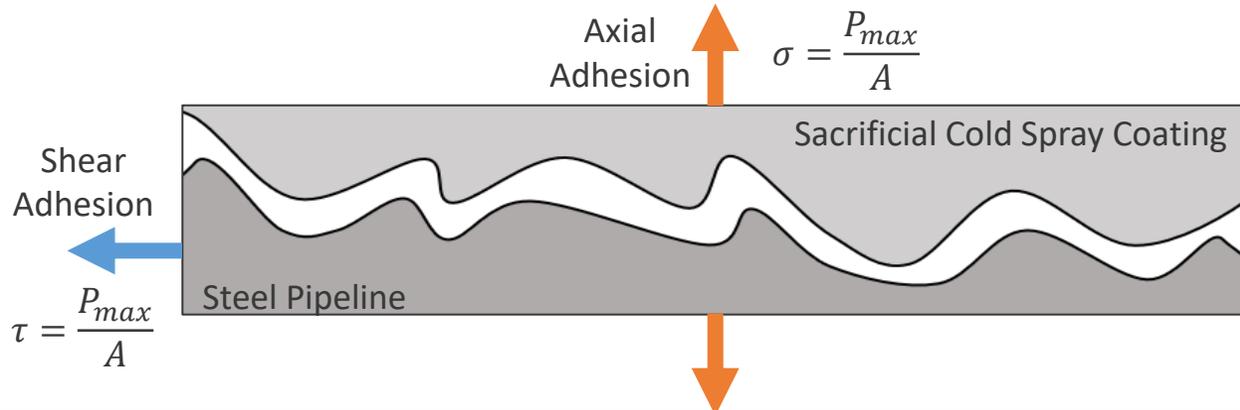
Shear Adhesion Testing

- Most forces on coatings during the pigging process will be friction (shear).
- Shear testing clevises were fabricated, and results were tabulated for both maximum shear strength (modified ASTM B 831).
- Fracture surfaces were imaged for elemental composition on both fracture surfaces.
- Shear adhesion appears to correlate with area fraction of elements left on opposing surfaces.
- Shear adhesion and axial adhesion measurements were not correlated.

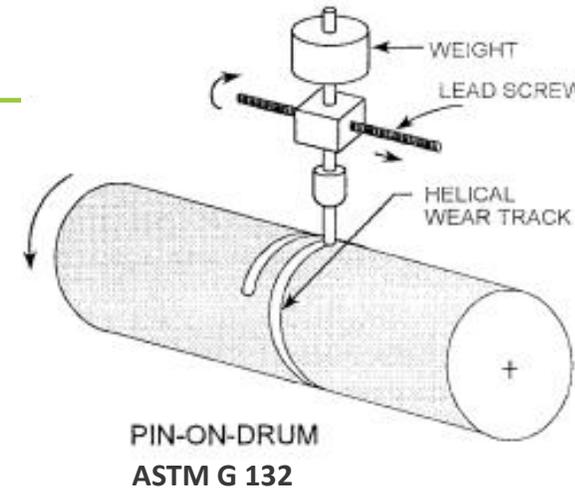
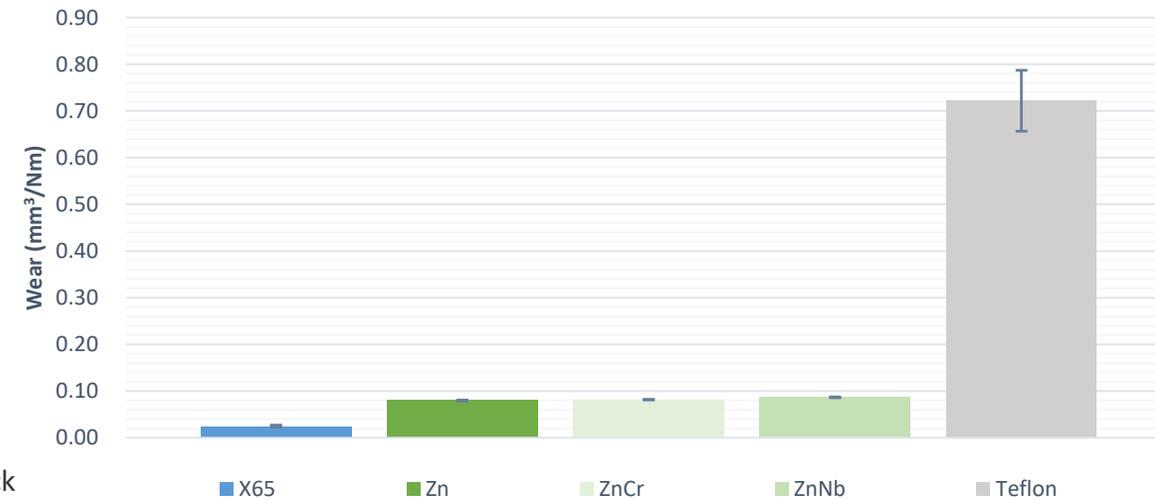
Pin-on-Drum Wear Test

- Wear properties of the zinc cold spray coatings is similar though slightly higher than pure zinc.
- The wear rate of zinc and the zinc cold spray coatings is approximately three times that of the underlying X65 pipeline material.

$$\text{wear} = \frac{CW_x}{\rho S_x} \left[\text{mm}^3 / \text{Nm} \right]$$

Abrasive	Force, N	distance, m
150 grit SiC	65.47	3.2

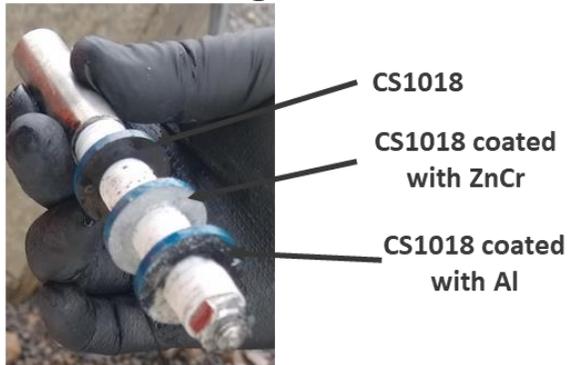
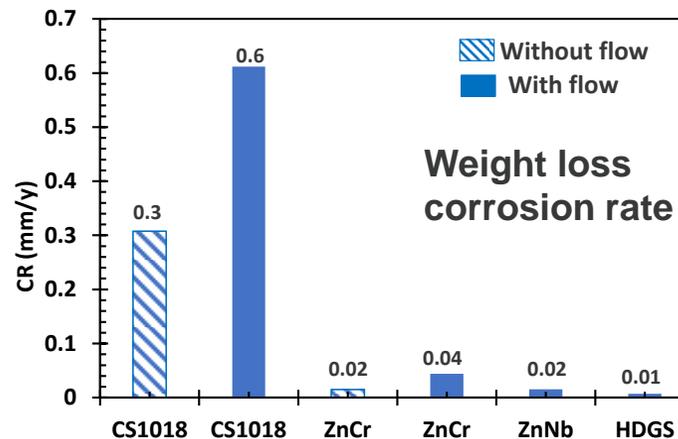
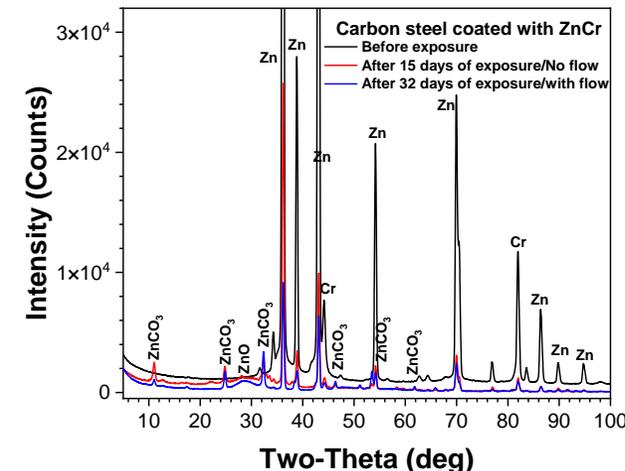
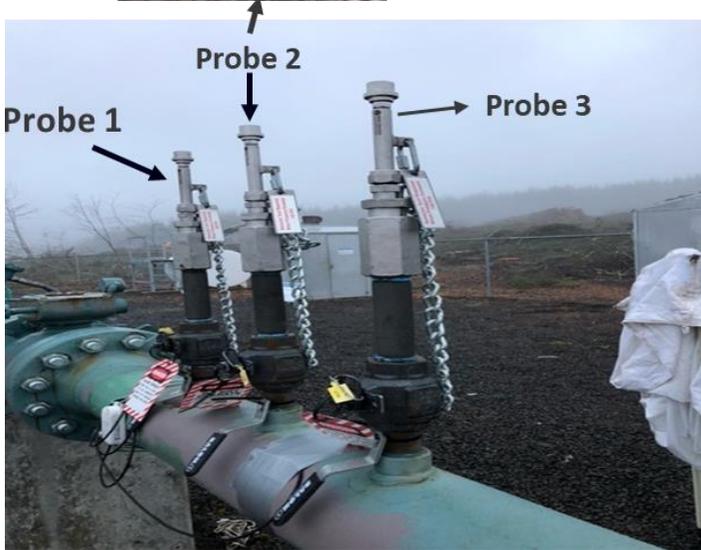
Field Test at NW Natural Gas Storage Facility - TRL 5

Probes removed after 32 days of exposure to natural gas under flow

Coating	SEM Image	EDS Image	C Ka1,2	Zn La1,2	Cr Ka1	O Ka1	S Ka1
CS1018 coated with ZnCr after 32 days of exposure with flow	SEM showing ZnCr coating and corrosion product	EDS showing ZnCr coating and corrosion product	25µm	25µm	25µm	25µm	25µm
CS1018 coated with ZnNb after 32 days of exposure with flow	SEM showing ZnNb coating and corrosion product	EDS showing ZnNb coating and corrosion product	25µm	25µm	25µm	25µm	25µm
Galvanized steel after 32 days of exposure with flow	SEM showing Zn coating and corrosion product	EDS showing Zn coating and corrosion product	50µm	50µm	50µm	50µm	50µm

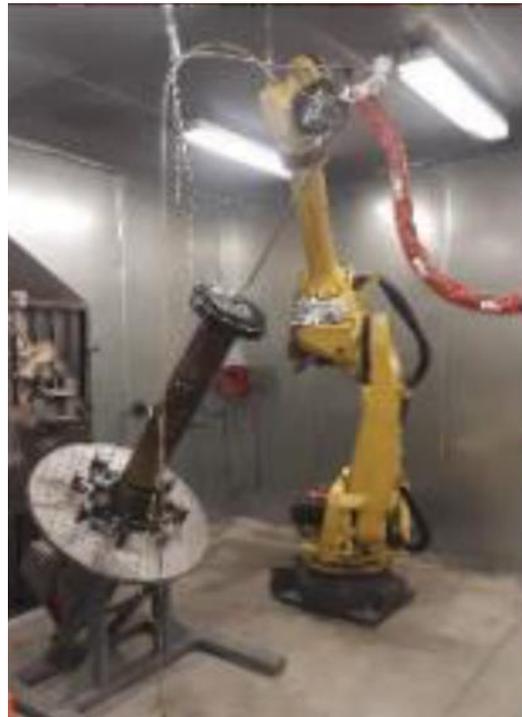
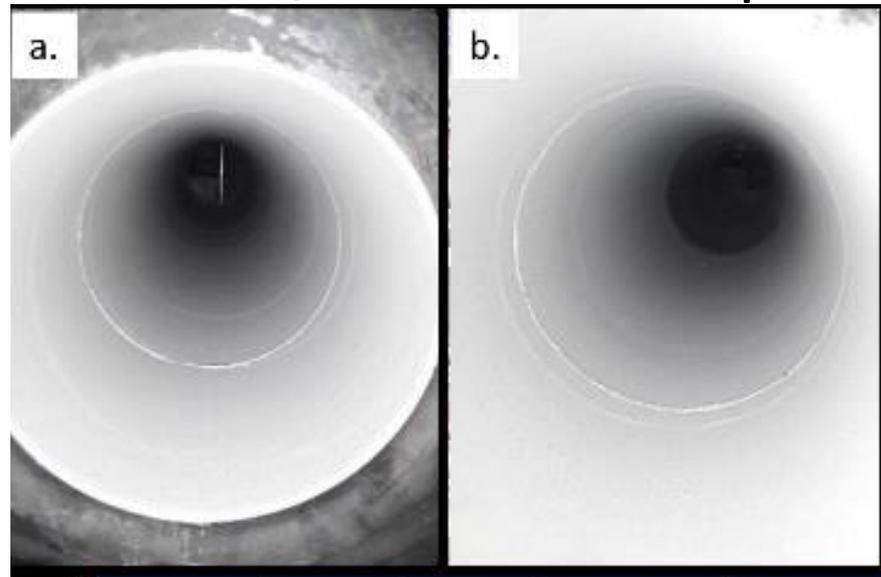
Cold spray setup at VRC Metal Systems

Pipe inner surface with Zn-Cr top-coat

Pipe inner surface with Zn-Nb top-coat

c.	Initial Diameter (In.)	Final Diameter (In.)	Deposition/ Layer (In.)	Total Deposition (In.)	Target Deposition (In.)
	6.048	5.998	0.0017	0.025	0.012-0.016
	6.048	6.02	0.0016	0.014	0.012-0.016

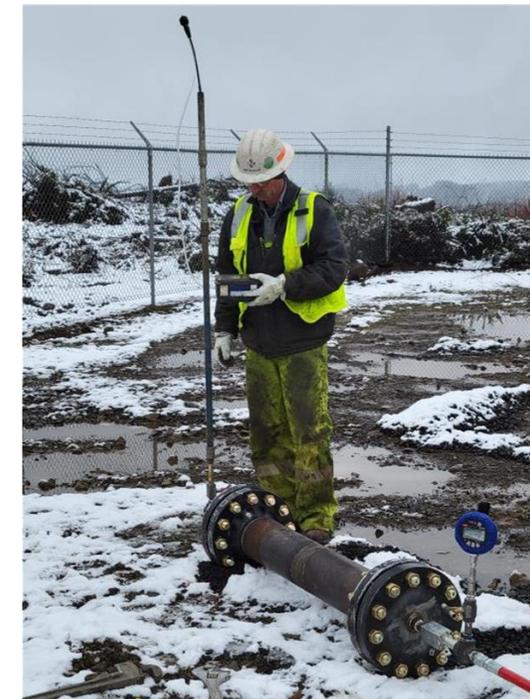
Field Test at NW Natural Gas Company:
 Gas Being Injected Into Test Sample Pipe (right of pipe - Red Hose) to Purge of Air. Verification of 100% Gas on Vertical Vent Pipe with Gas Detector (left of pipe), Indicating Air Purged.

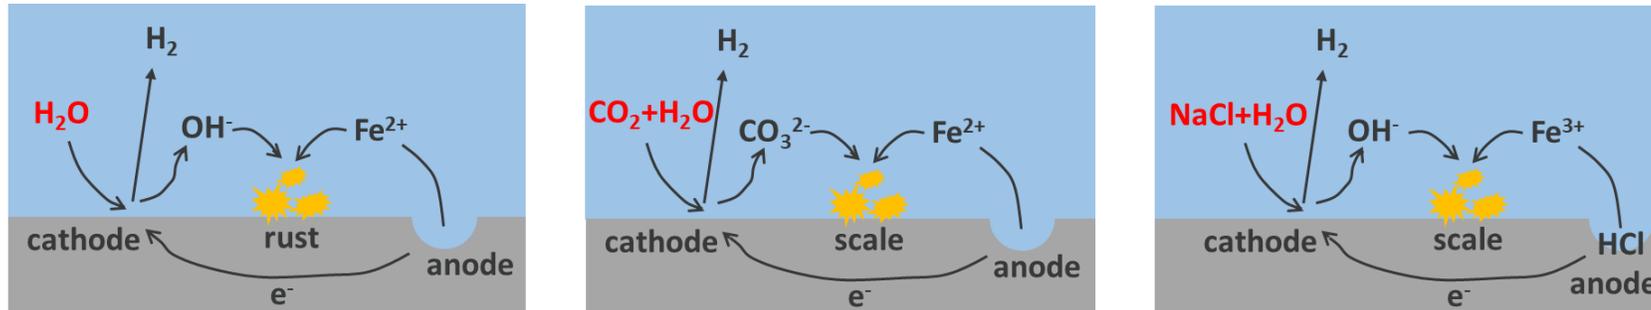
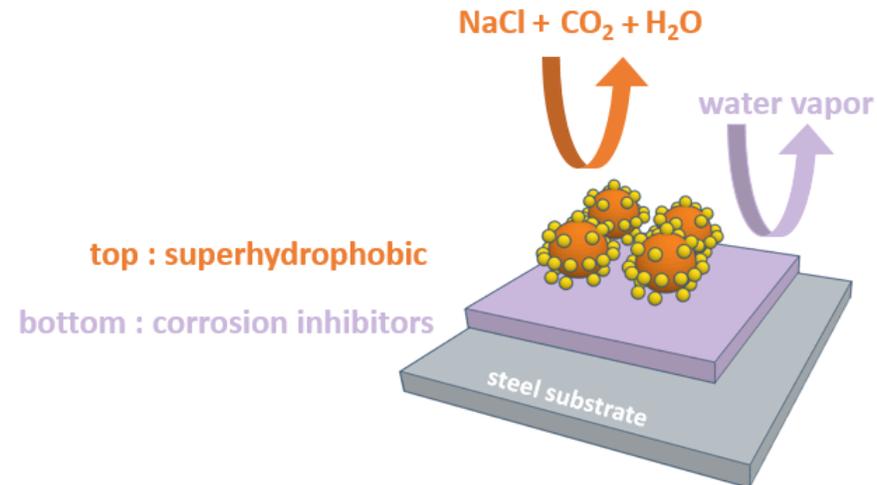
Three major corrosive species: H_2O , CO_2 , and $NaCl$

To the best of our knowledge, no existing material can handle all three corrosive species at once. A multilayer coating was developed, with each layer tackling a specific set of corrosive species.

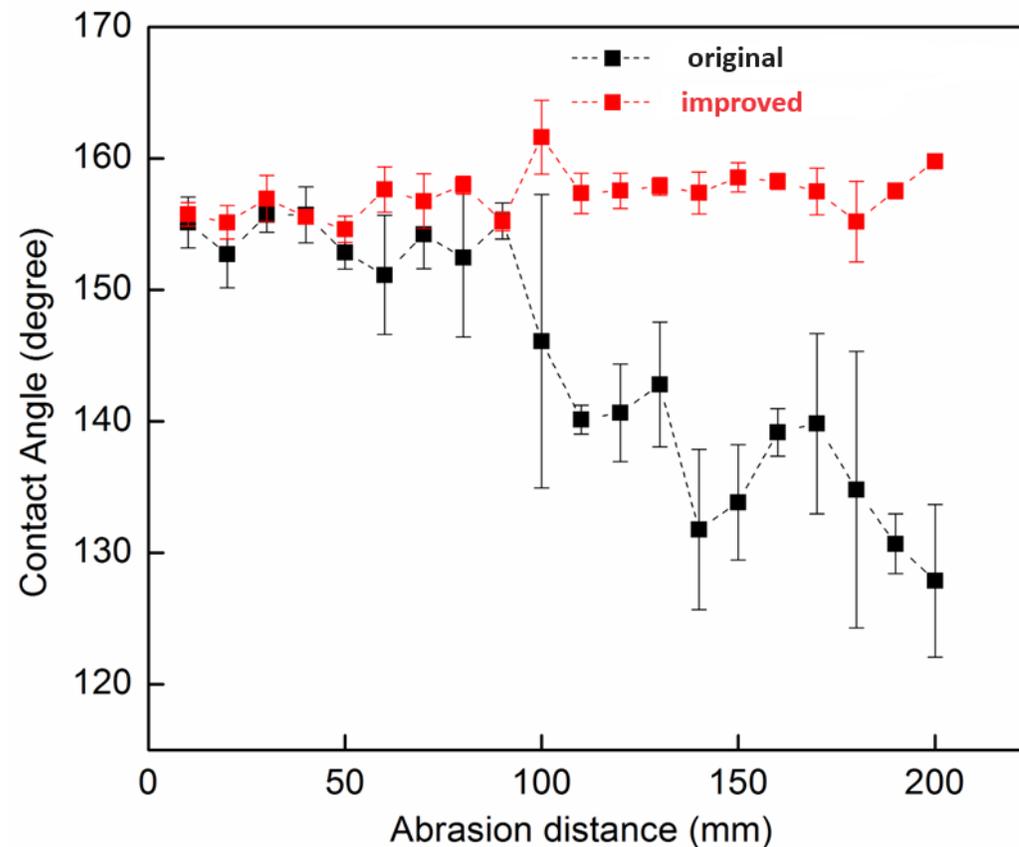
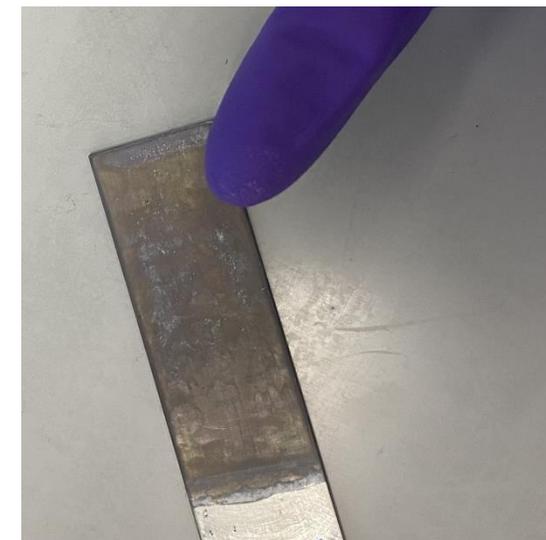
Improving mechanical property without lowering hydrophobicity (contact angle), which can be critical for surviving the field test.

dragged across a 600 grit sand paper over different distance

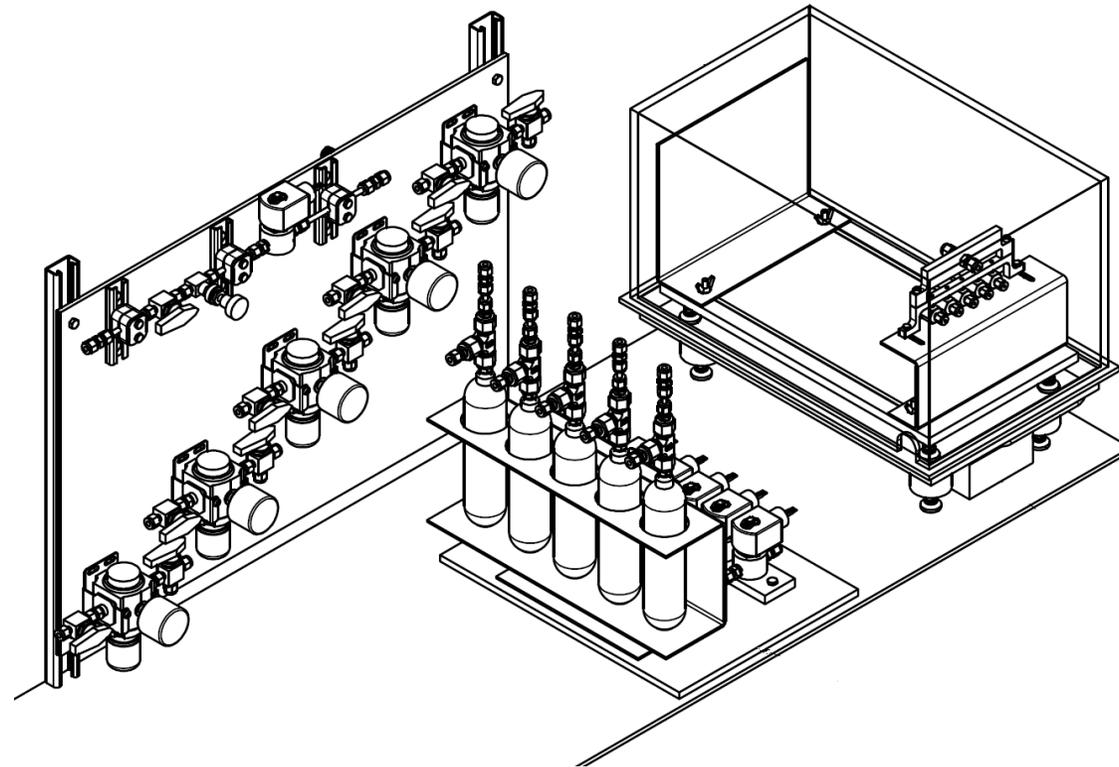
A multi-head spraying system was commissioned to automate the fabrication process and improve reproducibility.

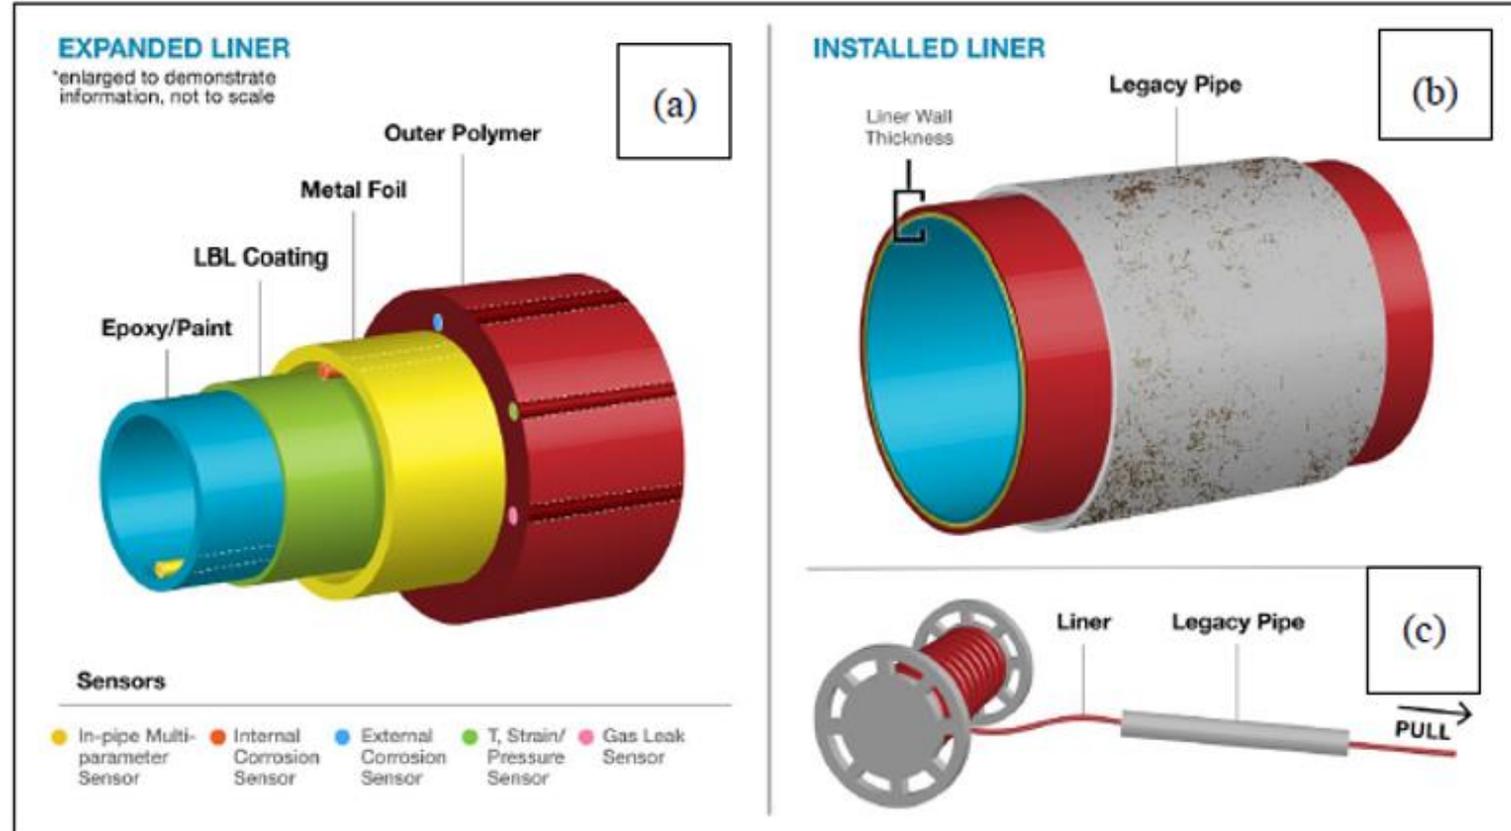
An illustration of sensor-embedded composite liner.

(a) Expanded view showing the individual layers of the liner.

(b) The liner is shown in the existing pipe after installation. (c) Installation process.

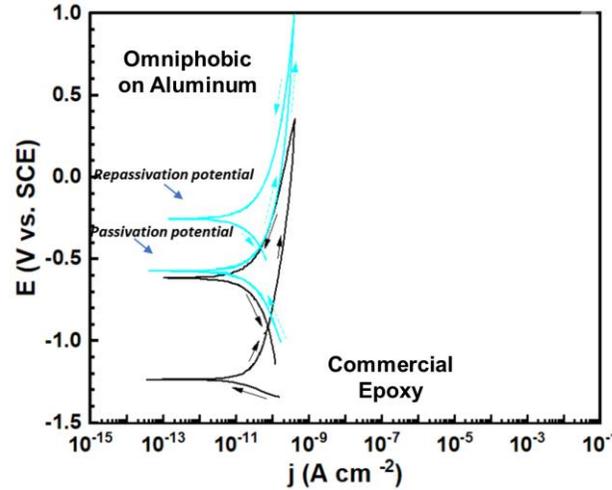
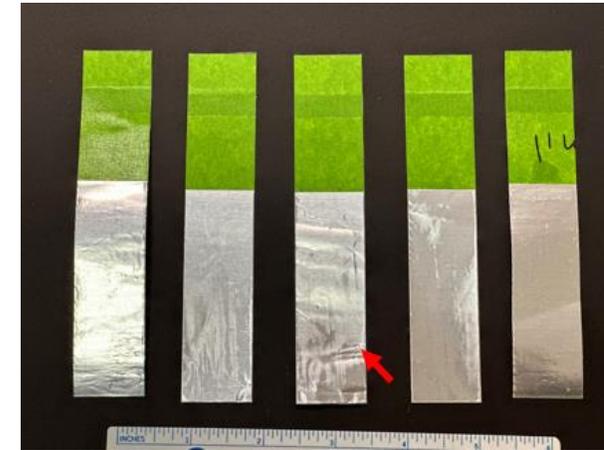
Minimal delamination observed on Oceanit A coating after peel test

- Collaborating with Oceanit to develop inner polymer layer for corrosion resistance
- Polyurethane-based “Oceanit A” coating outperformed alternative coatings
 - Lower corrosion rate
 - Higher bonding strength
- Oceanit A coating of 16 – 20 μm thickness selected as inner layer material

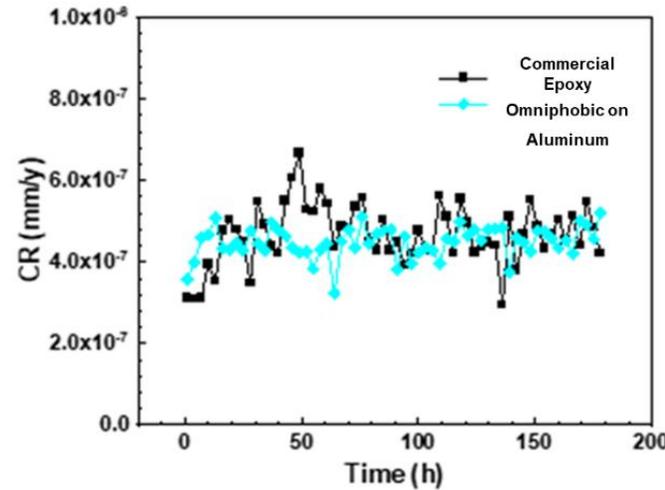
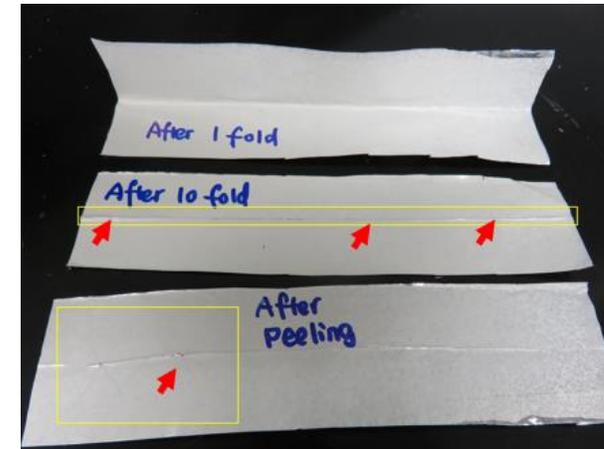
Significant delamination observed on BarRust 236 commercial epoxy coating after peel test

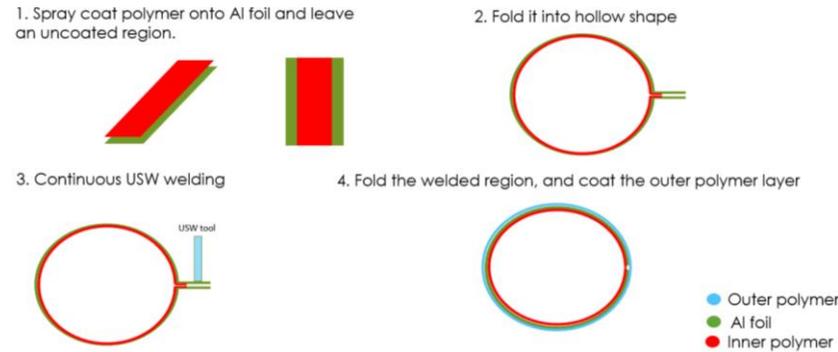
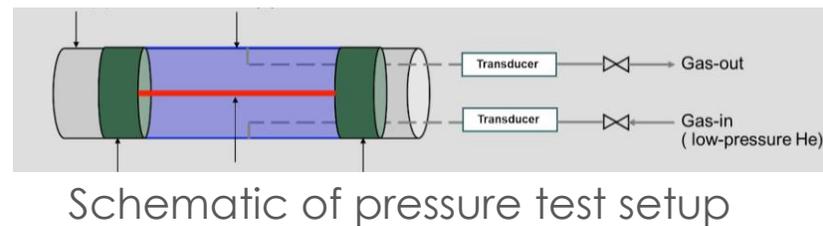
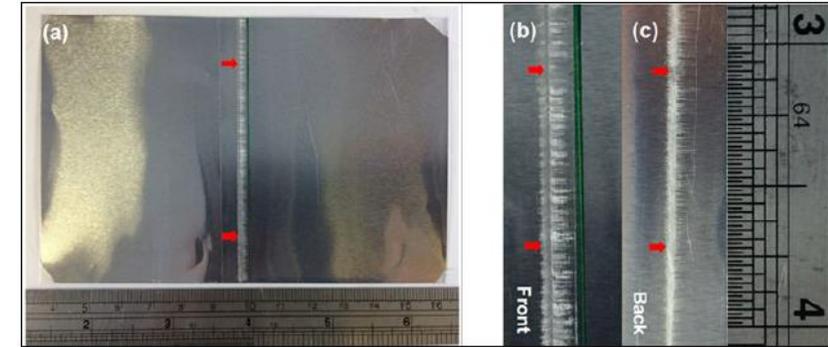
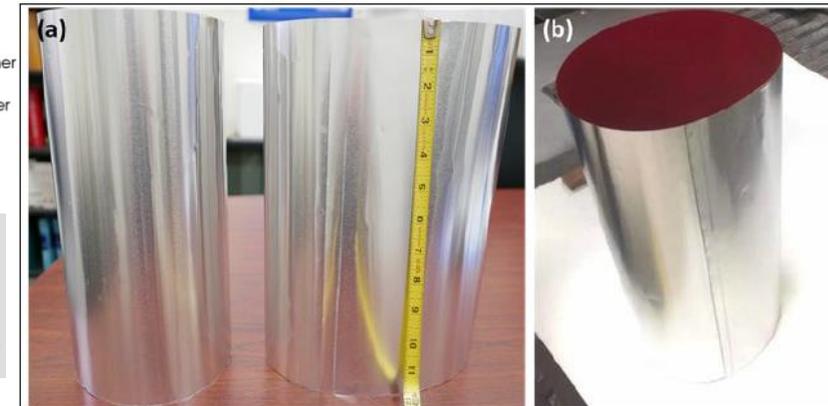
- Collaboration with ORNL
 - Improve scalability of Al foil ultrasonic welding to form liner with pipe geometry
 - Pressure testing of liner prototype
- Welding tests ongoing to improve flexibility of joined Al layer using thinner/softer foil
- Experimental rig suitable for pressure testing liner prototype ETA Q3 2024

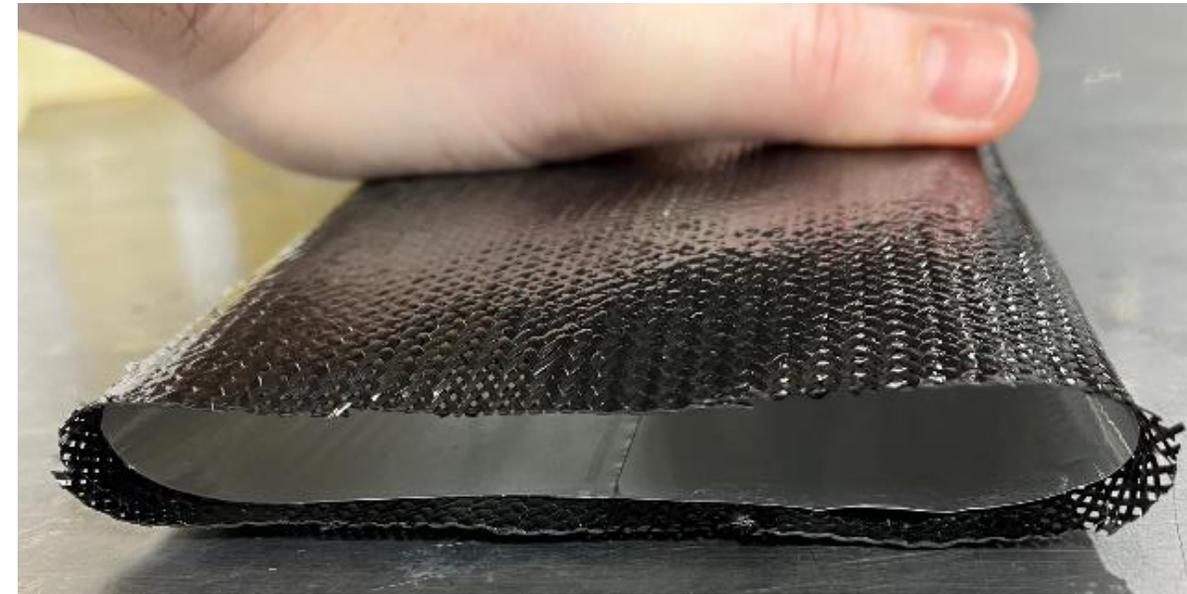
Resin-infused biaxial carbon fiber composite layer

- Collaborating with DBTech to develop outer polymer layer for mechanical strength
- Evaluating feasibility of two elastomeric resin-infused carbon fiber composite layer designs
 - Pre-cured (cured at plant)
 - Prepreg (cured in field via steam treatment)
- Demonstrated resin adherence to Al foil layer prevents creasing when folded

Adherence of resin to middle Al foil layer imparts minimum bending radius, preventing creasing when folded

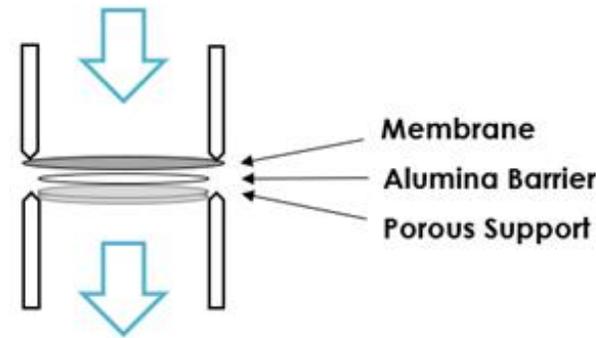
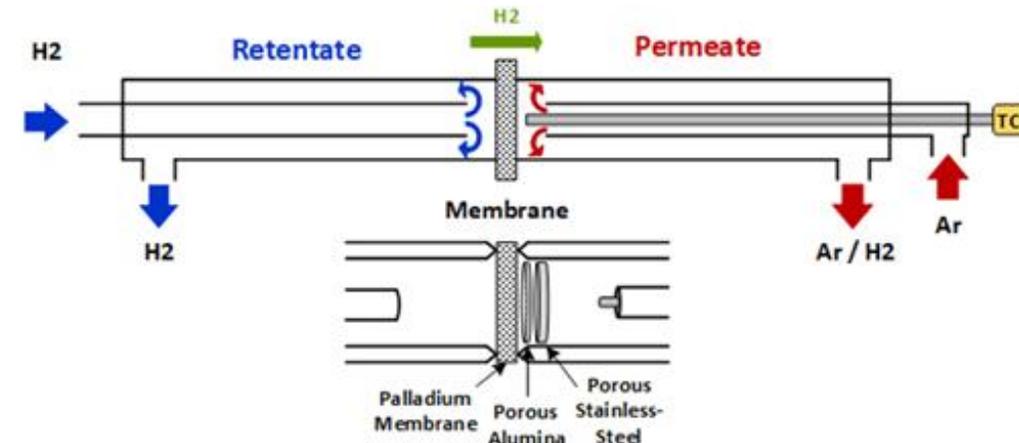
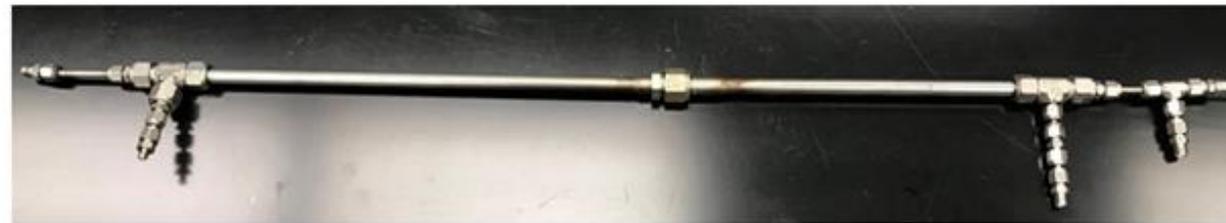
- No hydrogen permeation through welded foil detected at pressures up to 145 PSIG
- Seamless and welded foils had comparable rates of pressure increase
- Future efforts will focus on permeation testing of welded foils and foils with omniphobic coating at higher pressures (1000 psig)

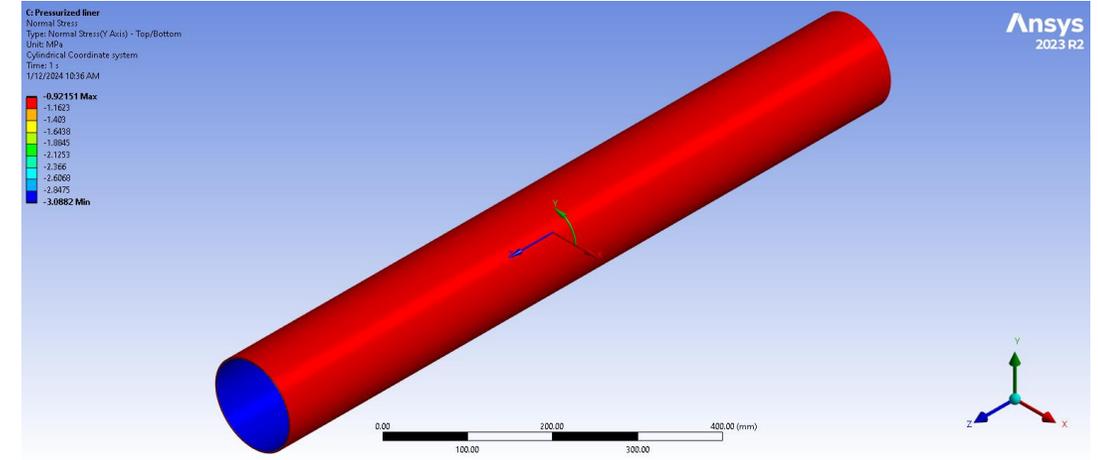
Axial stress in 3D

- Preliminary Ansys simulation results predict stress/strain of pressurized liner
- Future efforts will characterize performance of liner under different operating conditions and stresses associated with storage, installation, etc.
