DOE Contract DE-FE0012829

Pilot Test of a Nanoporous, Super-hydrophobic Membrane Contactor Process for Post-combustion CO₂ Capture

U.S. Department of Energy
National Energy Technology Laboratory
Carbon Management and Natural Gas & Oil Research Project Review Meeting
Virtual Meetings, August 12, 2021

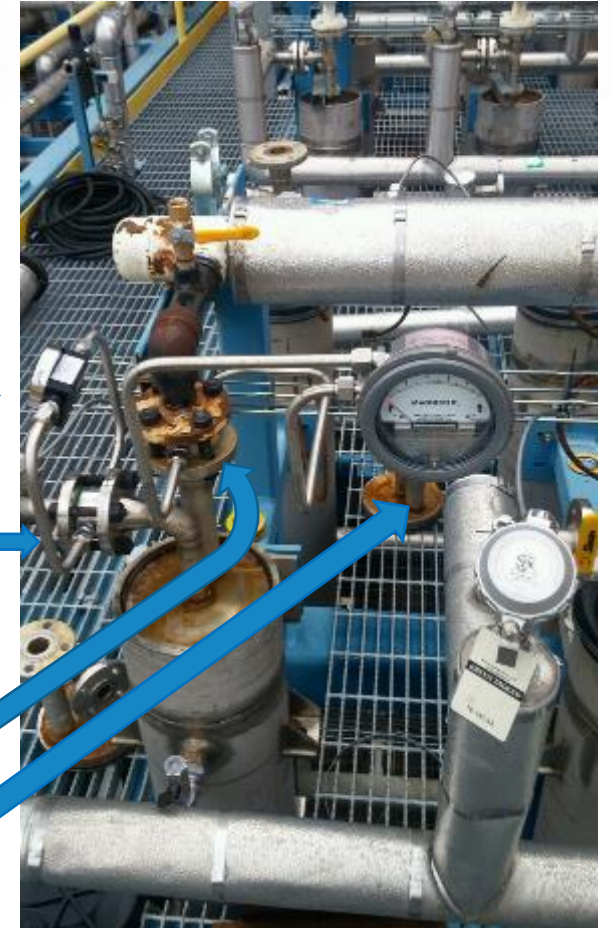
Additional flue gas filters and pre-membrane mesh pads installed to protect the membrane; orifice plates installed to monitor if there is a flow maldistribution issue

Liquid side
Pressure
gauge →
Liquid side
orifice plate →
Gas side
orifice plate ↗
Gas side
Pressure gauge ↗

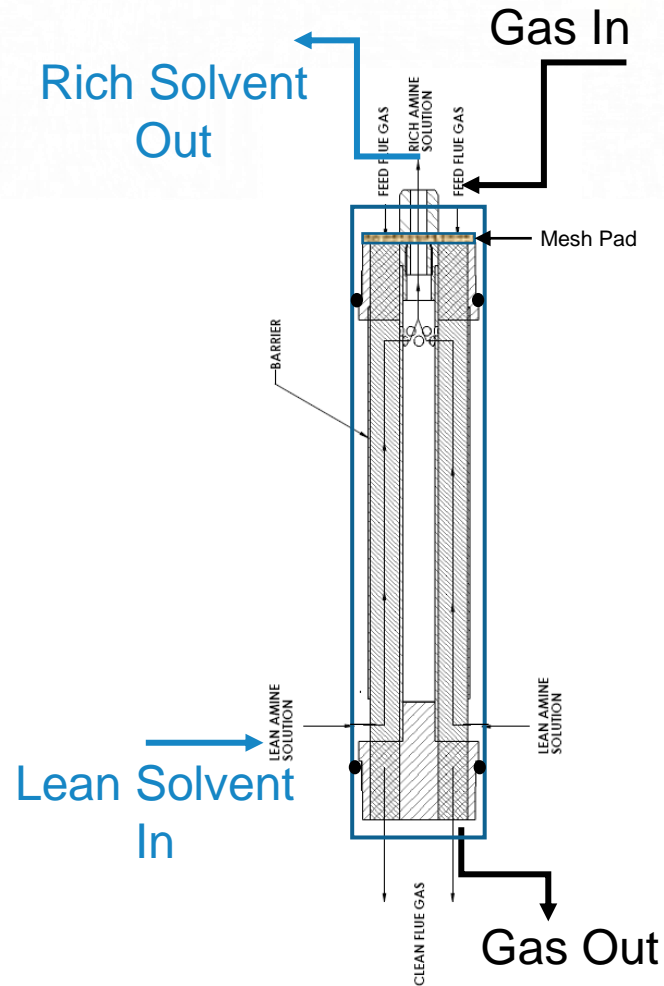
Approaches to recover membrane performance

Performance can be recovered, but stability was not improved

- **Approach 1**: Water wash followed by air dry
 1. Drain liquid from membrane shell side
 2. Remove inlet mesh pad
 3. Connect demineralized water to gas inlet, allow water to flow down to gas outlet
 4. Connect instrument air to the gas inlet, purge fibers with air
 5. Replace gas inlet mesh pad, bring membrane back online
- **Approach 2**: Air dry
 1. Drain liquid from membrane shell side
 2. Remove inlet mesh pad
 3. Connect instrument air to the gas inlet, purge fibers with air
 4. Replace gas inlet mesh pad, bring membrane back online
