# REPORT

## Internal Repair of Pipelines Final Technical Report

Reporting Period:  
September 30, 2002 through December 31, 2005

Submitted By:  
Edison Welding Institute  
1250 Arthur E. Adams Drive  
Columbus, OH 43221

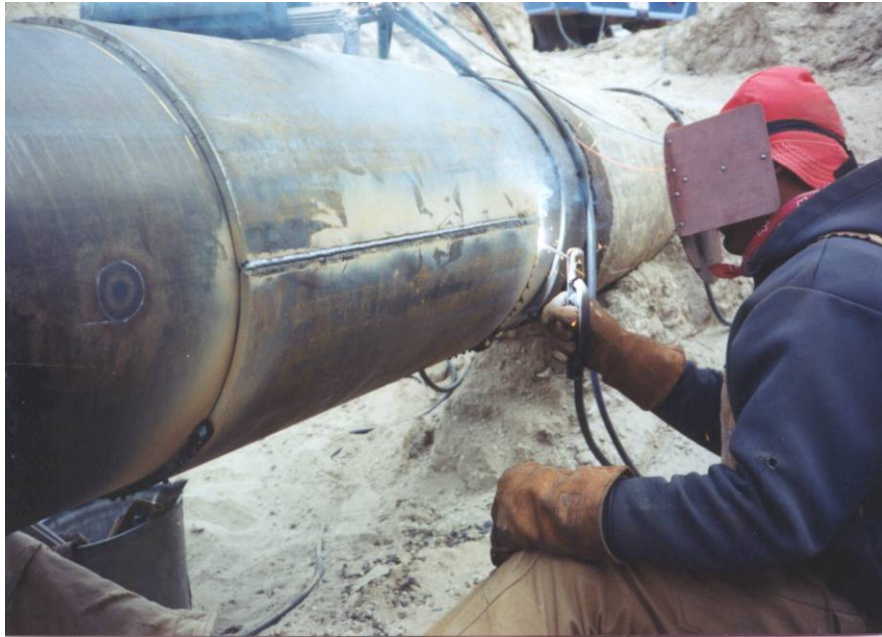
To prevent a corrosion defect from causing a pipeline to rupture, the area containing the defect must be reinforced to prevent the pipeline from bulging. The most predominant method of reinforcing corrosion defects in transmission pipelines is to install a welded full-encirclement repair sleeve (Figure 1). Full-encirclement sleeves resist hoop stress and can also resist axial stresses if the ends of the sleeves are welded.

**Figure 1 - Installation of a Full-Encirclement Repair Sleeve**

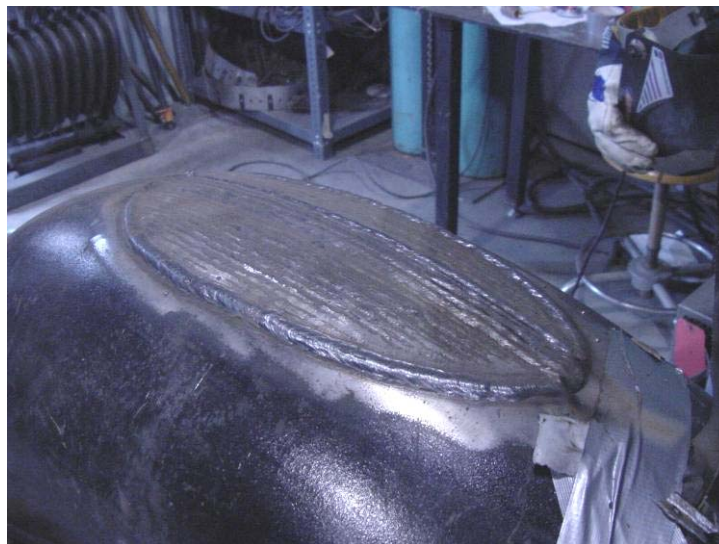
Gas transmission pipeline repair by direct deposition of weld metal, or weld deposition repair, is also a proven technology that can be applied directly to the area of wall loss, e.g., external repair of external wall loss, or to the side opposite to the wall loss, e.g., external repair of internal wall loss (Figure 2).

**Figure 2 - External Weld Deposition Repair of Internal Wall Loss in 90° Elbow**

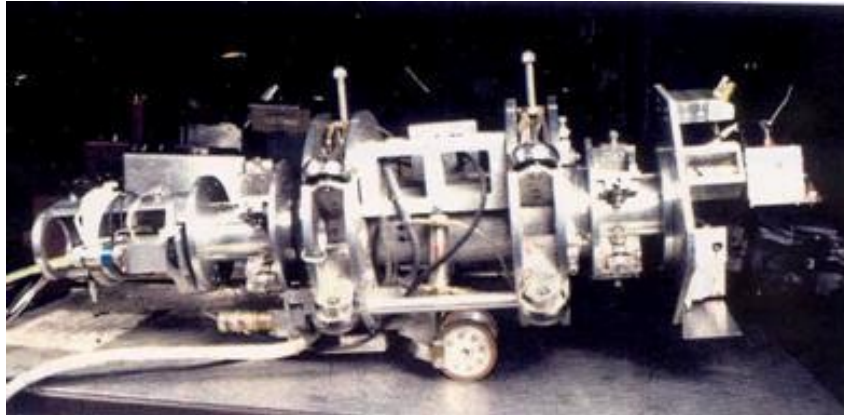
Deposited weld metal repairs are also used to repair circumferentially oriented planar defects (e.g., intergranular stress corrosion cracks adjacent to girth welds) in the nuclear power industry. Although remote welding was developed primarily for the nuclear power industry, working devices have been built for other applications, including repair of gas transmission pipelines. For example, Osaka Gas has developed remote robotic equipment for repair of flaws in the root area of welds of gas transmission lines (Figure 3).

**Figure 3 - Osaka Gas System Robotic Welding System**

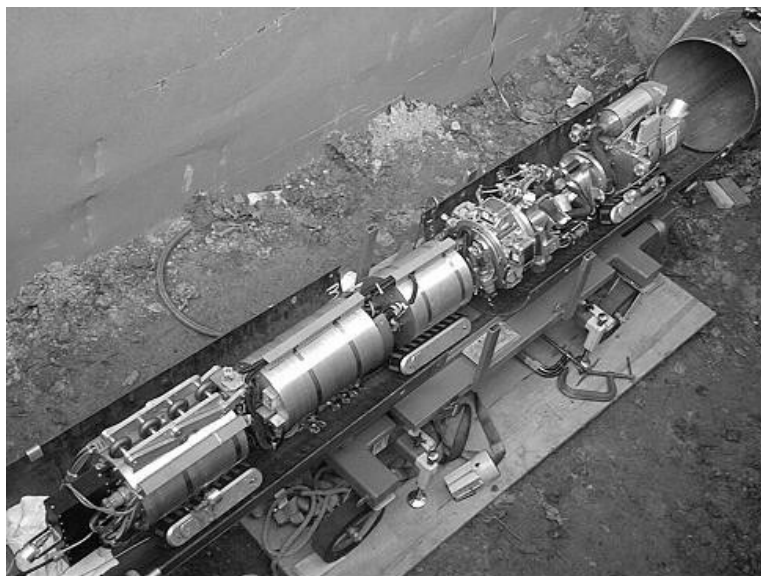
Pacific Gas and Electric Company (PG&E) has developed the Internal Pipeline NDE System (IPNS) for internal inspection of gas pipelines (Figure 4). The system incorporates a variety of inspection technologies to characterize girth weld and long seam flaws, corrosion, and dents and gouges.

**Figure 4 - Internal Pipeline NDE System (IPNS)**

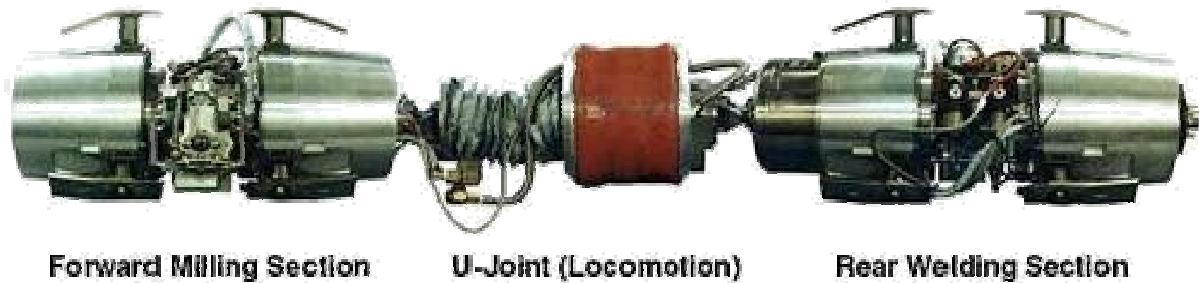
Honeybee Robotics and Consolidated Edison have developed the Welding and Inspection Steam Operations Robot (WISOR) system for inspection and repair of flanges in steam piping (Figure 5).

**Figure 5 - Welding and Inspection Steam Operations Robot (WISOR)**

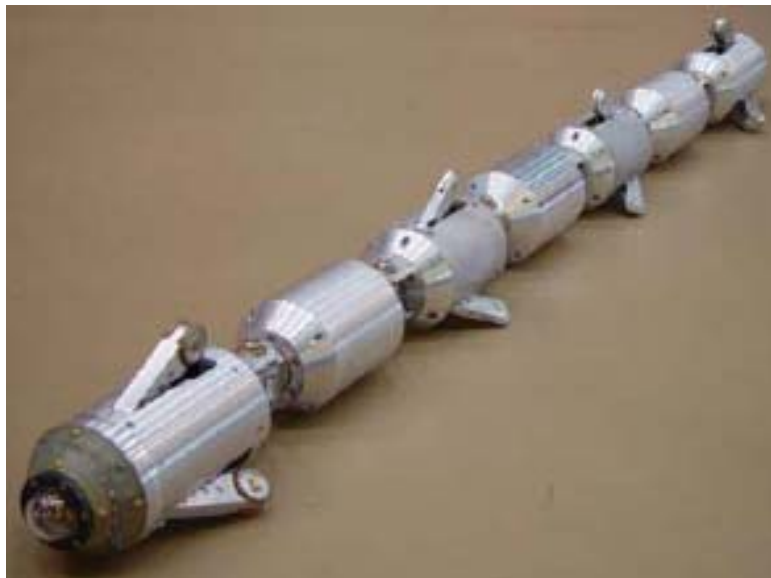
A successfully developed internal repair method could be coupled to an autonomous inspection robot such as the Explorer II (Figure 6) to provide continuous inspection and repair capability for the natural gas infrastructure.

**Figure 6 - Explorer II**

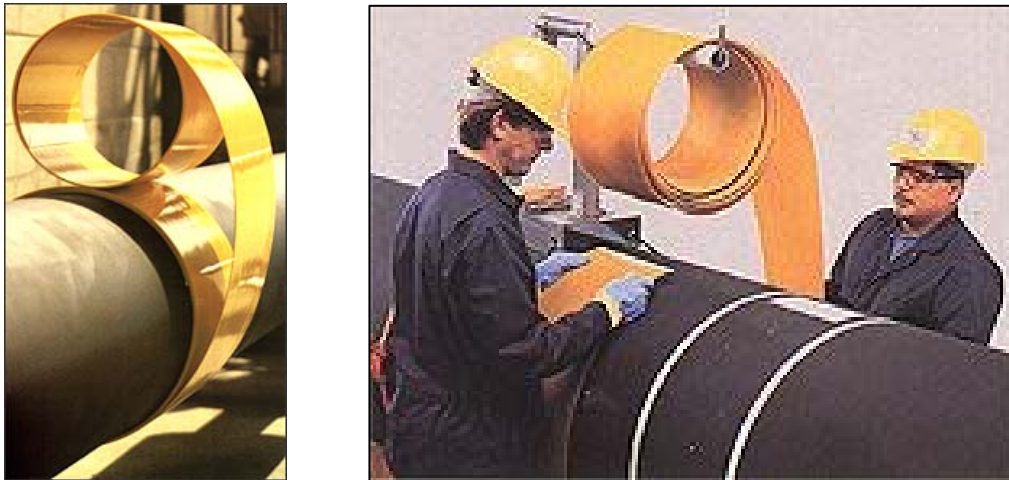
**Figure 7 - Clock Spring® Fiber-Reinforced Composite Device for Pipeline Repair**

Glass-fiber based composite systems, such as Clock Spring® (Figure 7), consists of a coil of continuous uniaxial e-glass fibers in a polyester matrix material that is bonded to the pipe using an adhesive. As is the case with welded full-encirclement repair sleeves, adhesive filler is applied to the defect prior to Clock Spring® installation to allow load transfer to the composite material.

The average tensile strength and elastic modulus of the Clock Spring® composite in the hoop direction are 70,000 psi and  $5.5 \times 10^6$  psi, respectively. The elastic modulus of steel is approximately  $30 \times 10^6$  psi. When a pipe with a corrosion defect that has been repaired using Clock Spring® is pressurized, both the steel and the Clock Spring® begin to carry the hoop stress that is generated by the pressure. The Clock Spring®, because it has a lower elastic modulus than steel, begins to carry the load at a reduced proportion compared to the steel. The reason for this is that a material with a lower elastic modulus must experience a greater amount of strain (elongation) to carry an equal amount of load compared to a material with a higher elastic modulus. Once the steel in the vicinity of the defect exceeds its elastic limit, (i.e., begins to yield), the Clock Spring® begins to carry a larger portion of the load while at the same time preventing the defect from bulging. Because yielding is required in order for the Clock Spring® to carry a larger portion of the load, the use of Clock Spring® is not recommended for low toughness pipe or for sharp defects.

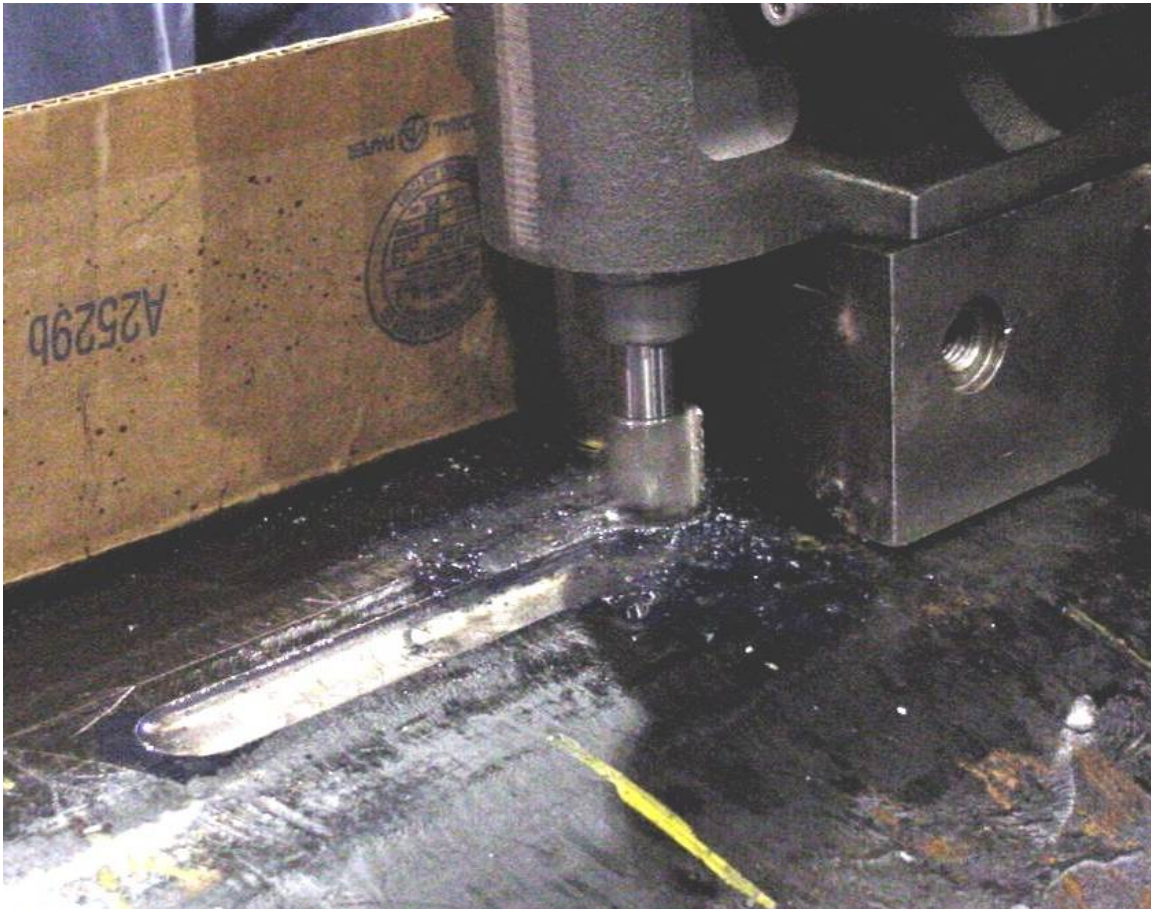
Given the fact that corrosion was the most significant contributor to natural gas pipelines failures during 2002 and 2003, the two most common types of corrosion, general corrosion and a deep/isolated corrosion pit (with approximately 30% reduction in burst pressure) were selected initially for repair process evaluation. For a specific pipe material and wall thickness combination, RSTRENG® software<sup>(2)</sup> was used to calculate the dimensions of the desired defect. As shown in Figure 11, a milling machine was used to introduce simulated damage into pipe specimens.

**Figure 11 - Milling Machine Set-Up Used to Simulate Corrosion Damage on Pipe Sections**

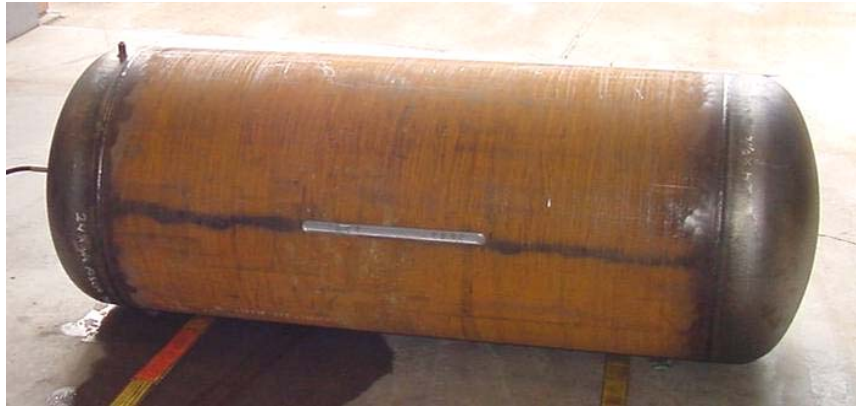
After simulated corrosion damage was introduced in to pipe sections, they were repaired with the appropriate repair technology. End caps were then welded to pipe sections as shown in Figure 12. Following the installation of end caps, pipe sections were hydrostatically pressurized to failure (i.e., burst pressure) using the set-up shown in Figure 13.

**Figure 12 - End Caps Welded on Pipe Section in Preparation for Hydrostatic Testing**

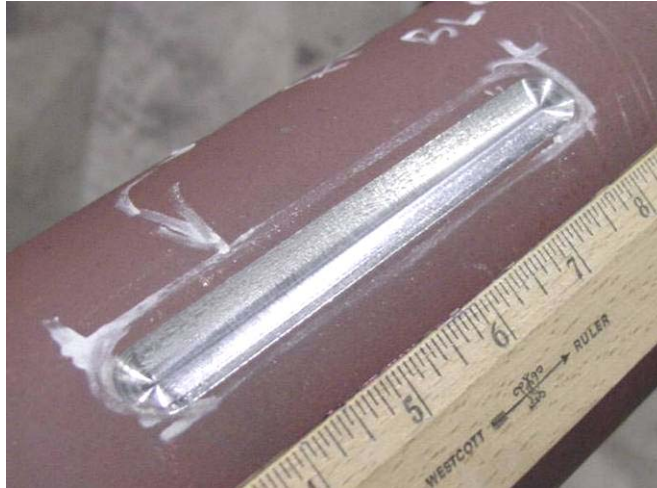
RSTRENG was used to determine that a long/shallow corrosion defect that represents a 30% reduction in burst strength needs to be 127 mm (5 in.) long by 2.54 mm (0.100 in.) deep for the 114.3 mm (4.5 in.) diameter API-5L, Grade B pipe. An end mill was used to machine a simple slot in the outside diameter (OD) of the pipe sections (Figure 14).

**Figure 14 - Long/Shallow Simulated Corrosion Damage for 114.3 mm (4.5 in.) Pipe**

For Test 02, a 114.3 mm (4.5 in.) diameter API 5L Grade B pipe with a long/shallow corrosion defect (Figure 14) was used. For Test 03, a 114.3 mm (4.5 in.) diameter API 5L Grade B pipe

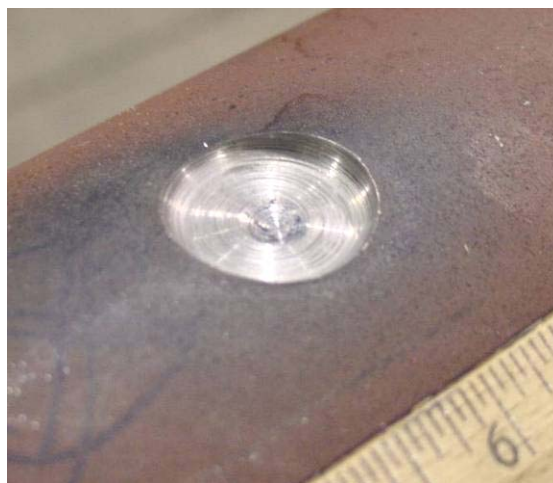
RSTRENG was also used to determine that a short/deep corrosion pit with 30% reduction in burst pressure needs to be 25.4 mm (1 in.) long by 4.01 mm (0.160 in.) deep for the 114.3 mm (4.5 in.) diameter API 5L Grade B pipe. An end mill with rounded corners was used to machine this simulated corrosion pit in the OD of pipe sections (Figure 15).

**Figure 15 - Short/Deep Simulated Corrosion Damage for 114.3 mm (4.5 in.) Pipe**

with a short/deep corrosion pit defect (Figure 15) was used. Both Test 02 and Test 03 were repaired with the RolaTube GF liner.

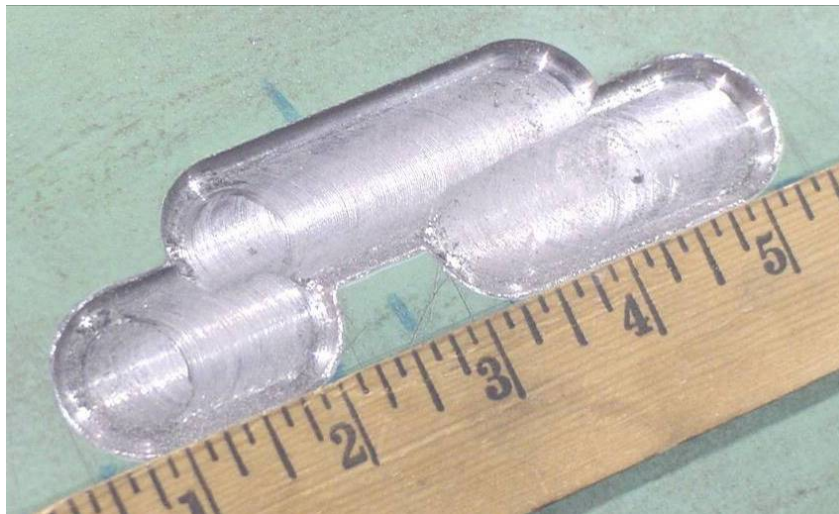
508 mm (20 in.) diameter API 5L X52 pipe. An end mill was used to machine a more stylized slot (i.e., more representative of actual corrosion damage) in the OD of pipe sections as shown in Figure 16. End caps were similarly welded to pipe sections in preparation for burst testing.

**Figure 16 - Short/Deep Simulated Corrosion Damage for 508 mm (20 in.) Pipe**

A stylized short/extra deep defect that represents a 50% reduction in burst strength was calculated to be 127 mm (5 in.) long by 4.75 mm (0.187 in.) deep for the 508 mm (20 in.) diameter API-5L X52 pipe (picture not shown but similar to Figure 16). An end mill was used to machine the defect in the OD of the pipe section. End caps were welded to the pipe section in preparation for burst testing.

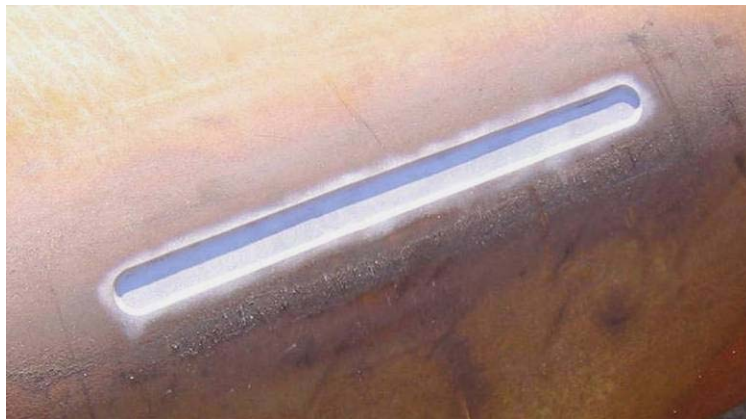
A long/shallow corrosion defect that represents a 25% reduction in burst strength was calculated to be 381 mm (15 in.) long by 2.74 mm (0.108 in.) deep for the 508 mm (20 in.) diameter API-5L X52 pipe. An end mill was used to machine a simple slot in the OD of the pipe section as shown in Figure 17. End caps were welded to the pipe section in preparation for burst testing.

**Figure 17 - Long/Shallow Simulated Corrosion Damage for 508 mm (20 in.) Pipe**

For Test 07, a 508 mm (20 in.) diameter X52 pipe with a long/shallow corrosion defect (Figure 17) was used on a pipe section similar to that shown in Figure 35. The Test 06 patch was the same thickness as the Test 07 patch, which consisted of all 0, 90 construction and was fabricated/installed with the same materials and procedures developed for the Test 04 patch. As shown in Figure 49, the Test 07 patch was 711.2 mm (28 in.) long by 254 mm (10 in.) wide by 7.62 mm (0.3 in.) thick and consisted of 18 layers (layers 1 and 18 were glass woven roving). This test was included to evaluate the performance of a CF patch on a defect that exceeds the length beyond which the hoop stress in the pipe can no longer distribute itself around the end of the defect.

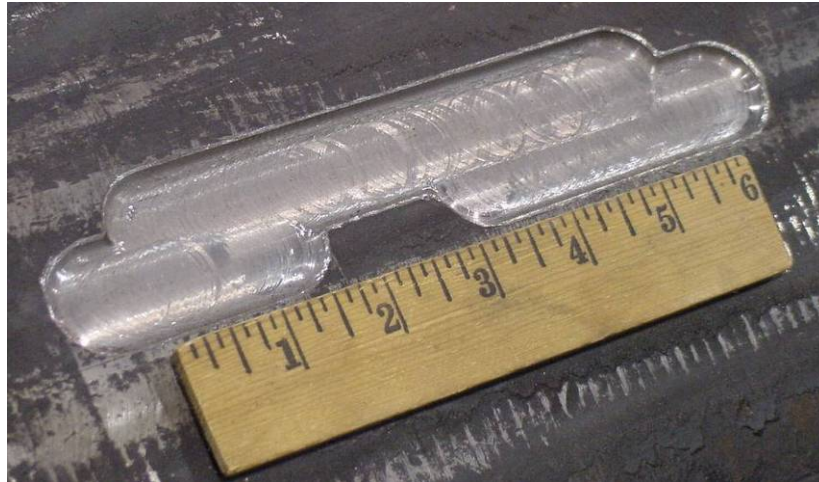
A short/deep corrosion defect that represents a 25% reduction in burst strength was calculated to be 190.5 mm (7.5 in.) long by 3.96 mm (0.156 in.) deep for the 558.8 mm (22 in.) diameter API-5L, Grade B pipe. An end mill was used to machine a simple slot in the OD of pipe sections as shown in Figure 18. End caps were welded to pipe sections in preparation for burst testing.

**Figure 18 - Short/Deep Simulated Corrosion Damage for 558.8 mm (22 in.) Pipe**

The Magnatech Pipeliner II was used to make the weld deposition repair of a short/deep, stylized corrosion defect (Figure 18) evaluated in Test 01. Test 01 welding was done with a shielding gas mixture of 95% Argon (Ar) and 5% Carbon Dioxide (CO<sub>2</sub>). Filler metal was a GMAW 0.89 mm (0.035 in.) diameter AWS ER70S-6 electrode. Welding parameters are shown in Table 3 and Table 4.

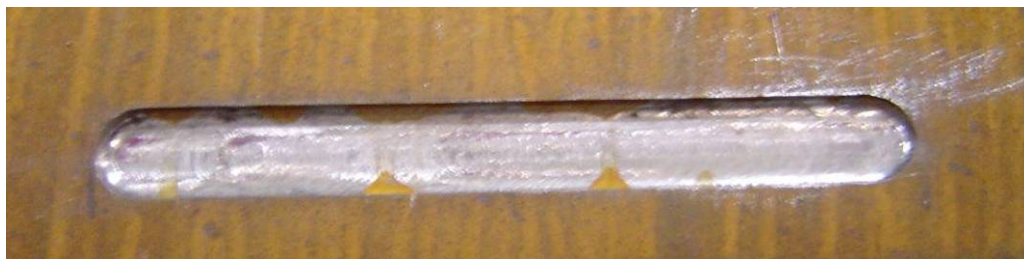
A short/extra deep corrosion defect that represents a 60% reduction in burst strength was calculated to be 228.6 mm (9 in.) long by 5.94 mm (0.234 in.) deep for the 609.6 mm (24 in.) diameter API-5L X65 pipe. An end mill was used to machine the simple slot in the OD of pipe sections as shown in Figure 19. End caps were welded to pipe sections in preparation for burst testing.

**Figure 19 - Short, Extra Deep Simulated Corrosion Damage for 609.6 mm (24 in.) Pipe**

Test 12 used a 609.6 mm (24 in.) diameter by 7.9 mm (0.312 in.) wall, API 5L X65 pipe with the short/extra deep slot shown in Figure 19. Three layers of helically wound steel strip were installed in the Test 12 pipe using the same methodology developed for Test 09. The 987.95 MPa (143.25 ksi) UTS steel strip was used with a normal quantity of the old adhesive (3M DP460). After the adhesive cured, end caps were welded on the pipe section and the assembly was pressure tested to failure.

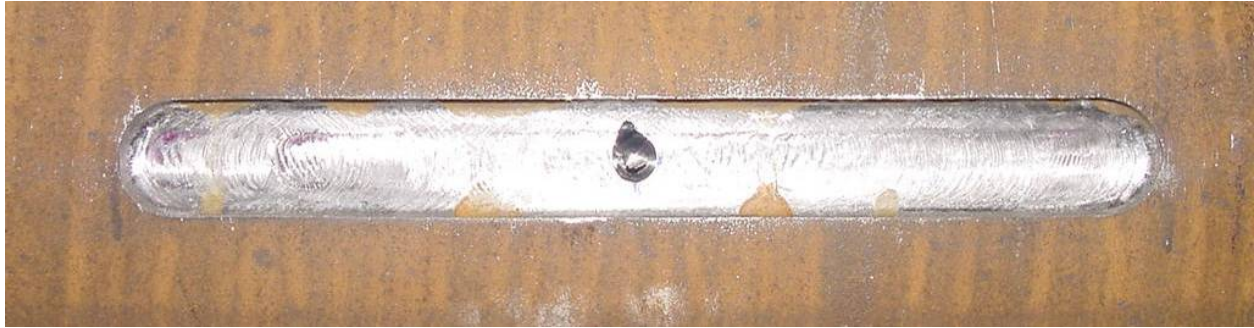
For the 609.6 mm (24 in.) diameter API-5L X65 pipe, a thru-wall pit was also incorporated into a short/extra deep corrosion defect representing a 60% reduction in burst strength (228.6 mm (9 in.) long by 5.94 mm (0.234 in.) deep). Figure 21 is a close up view of the through hole in the 609.6 mm (24 in.) pipe section. An end mill was used to machine the slot and the through-wall pit in the OD of the pipe section as shown in Figure 20. End caps were welded to pipe sections in preparation for burst testing.

**Figure 20 - Short, Extra Deep Damage with Through Hole for 609.6 mm (24 in.) Pipe**

Test 13 used a 609.6 mm (24 in.) diameter by 7.9 mm (0.312 in.) wall, API 5L X65 pipe featuring a short/extra deep slot with a through hole as shown in Figure 20 and Figure 21. Three layers of helically wound steel strip were installed in the Test 13 pipe using the same methodology developed for Test 09. The 987.95 MPa (143.25 ksi) UTS steel strip was used with a normal quantity of the old adhesive (3M DP460). After the adhesive cured, end caps were welded on the pipe section and the assembly was pressure tested to failure.

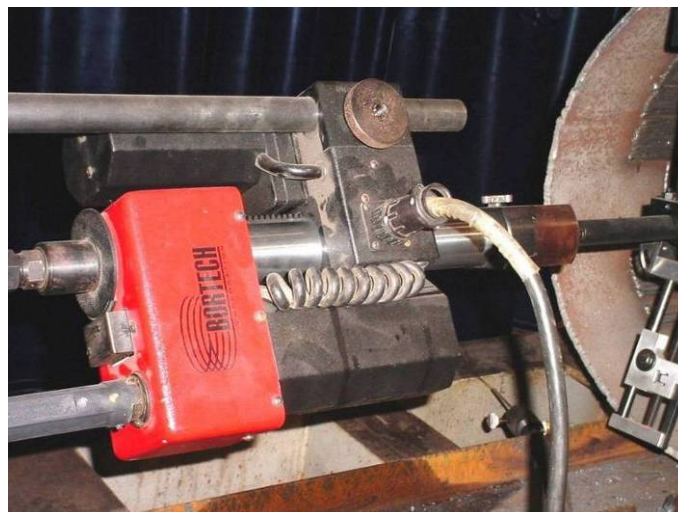
The internal bore cladding system manufactured by Bortech (Figure 23) was designed for spiral cladding the inside of pipe that is preferably in the vertical position.

**Figure 23 - Bortech Motion Mechanism for Continuous Spiral Deposition**

Each system had motion control limitations and individually would not be appropriate candidates for an internal repair welding system. The internal bore cladding system manufactured by Bortech (Figure 23 and Figure 86) was designed for spiral cladding the inside of a pipe that is preferably in the vertical position.

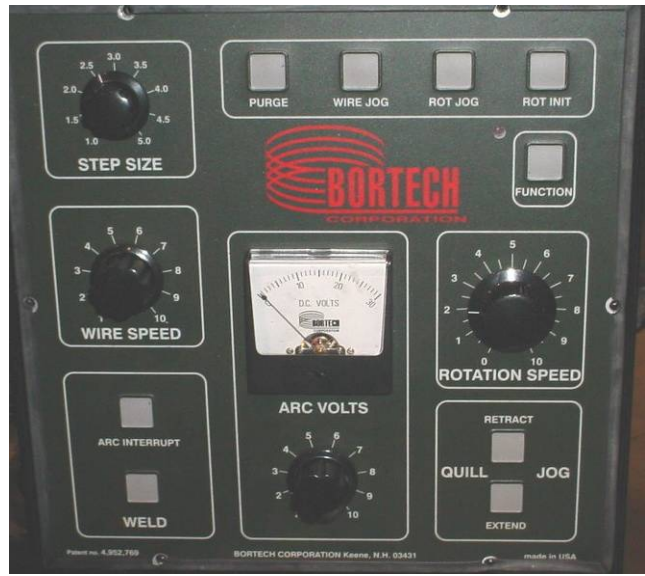
Figure 24 - Bortech Controller

The Bortech system has simple controls for operating constant voltage (CV) power supplies (Figure 24). This includes the ability to set wire feed speed, voltage, step size (for the spiral motion), and rotation speed (i.e., travel speed). The system is very affordable as it uses simple motors for motion. When positioned inside a horizontal pipe, the rotation drive suffered from significant backlash. Conversations with the supplier led to the purchase and installation of a counterbalance weight that was used to balance the weight of the opposing torch.

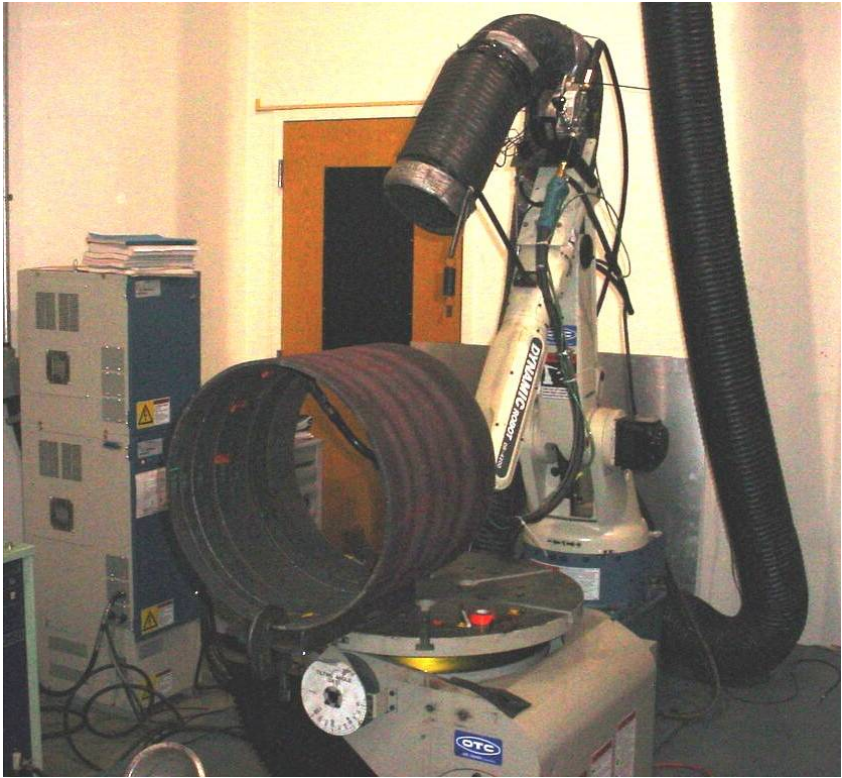
Figure 25 - OTC Robot Set-Up for Internal Welding

Based on the results experienced with the Bortech system, the team decided to develop preliminary welding procedures using a robotic GMAW system. A 6-axis coordinated motion robot (Figure 25) permitted the application of weave beads for spiral cladding or stringer beads in either

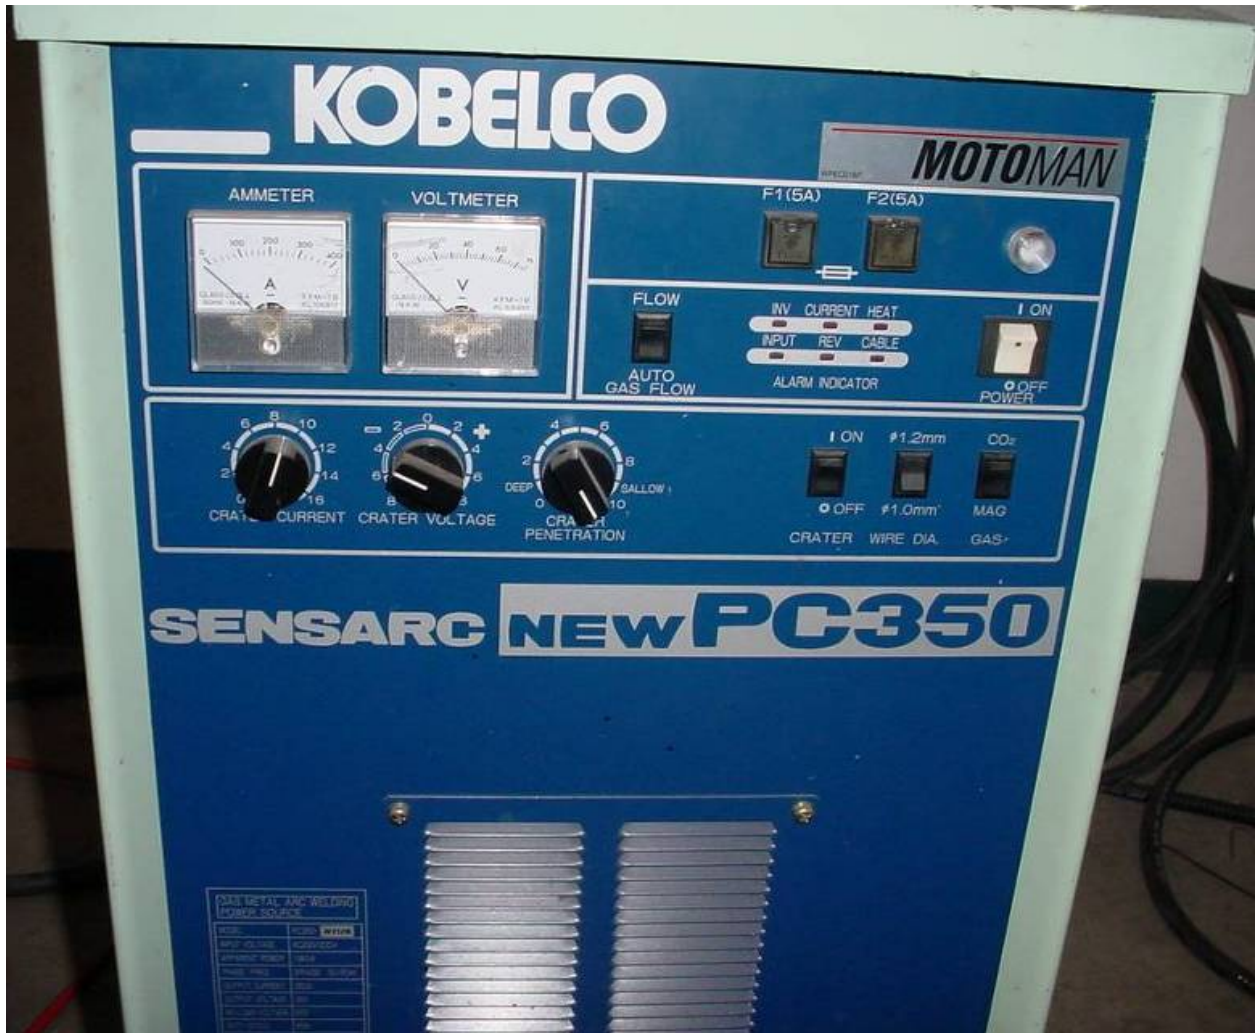
The OTC Daihen robot was interfaced to an advanced short-circuit welding power supply, the Kobelco PC-350 shown in Figure 26.

Figure 26 - Kobelco PC-350 Variable Polarity Fuzzy Logic Power Supply

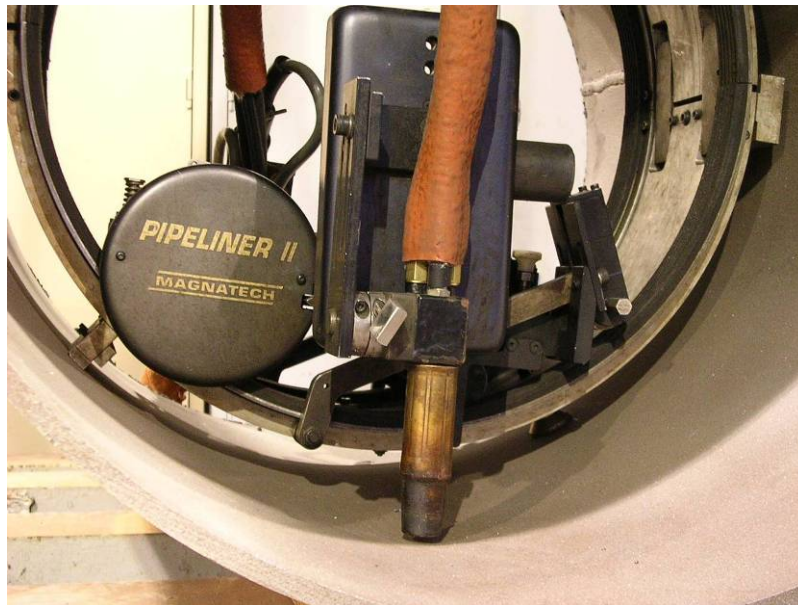
The Magnatech Pipeliner II welding tractor was designed to weld the inside diameter of 508 mm (22 in.) pipe. Figure 28 shows the Magnatech control pendant.

Figure 27 - Magnatech Pipeliner II Welding Tractor

Several years ago, PG&E purchased a welding tractor (Figure 27) from Magnatech for internal weld repair procedure development. This system was loaned to EWI so it could be used for pipeline repair evaluations, as this equipment is portable where the robot welding system is not.

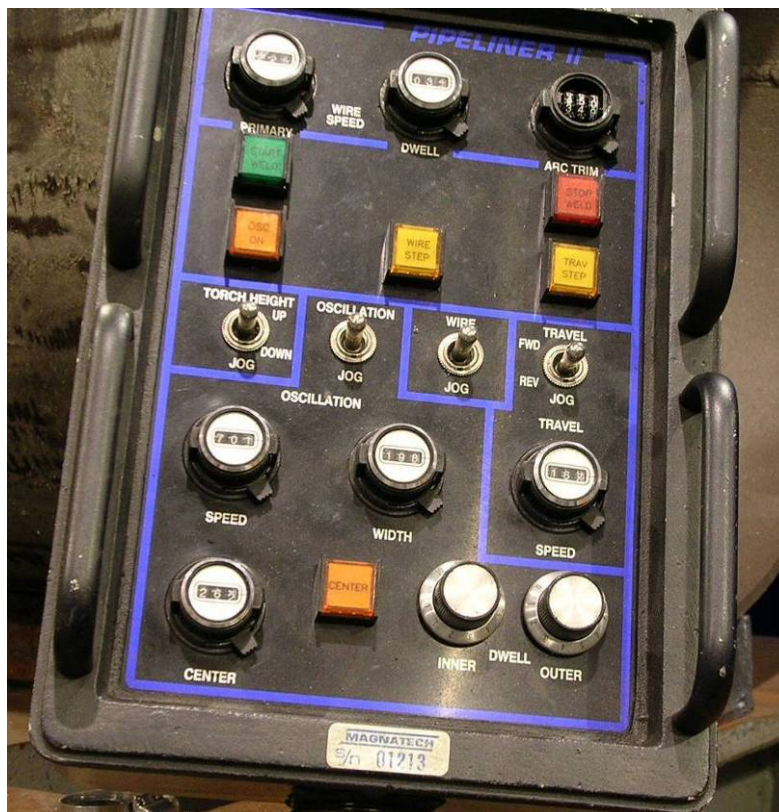
Figure 28 - Magnatech Control Pendant

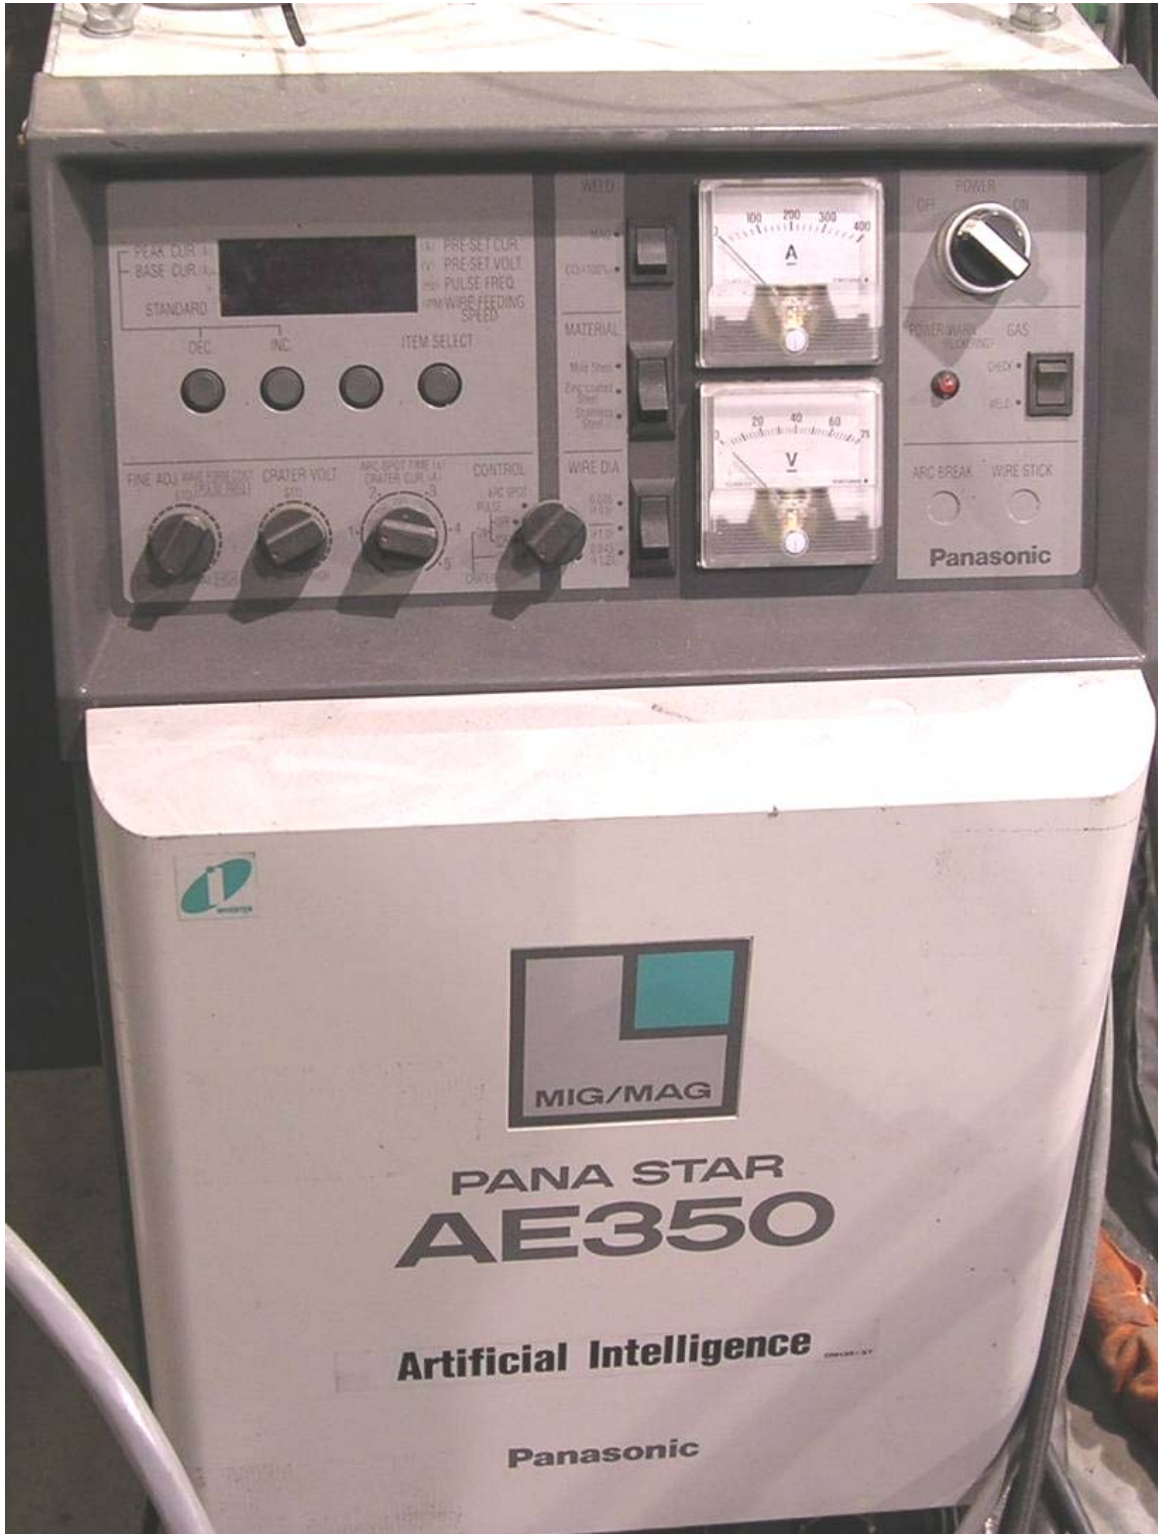
The Magnatech tractor was interfaced to a Panasonic AE 350 power supply, which is shown in Figure 29.

Figure 29 - Panasonic AE 350 Power Supply

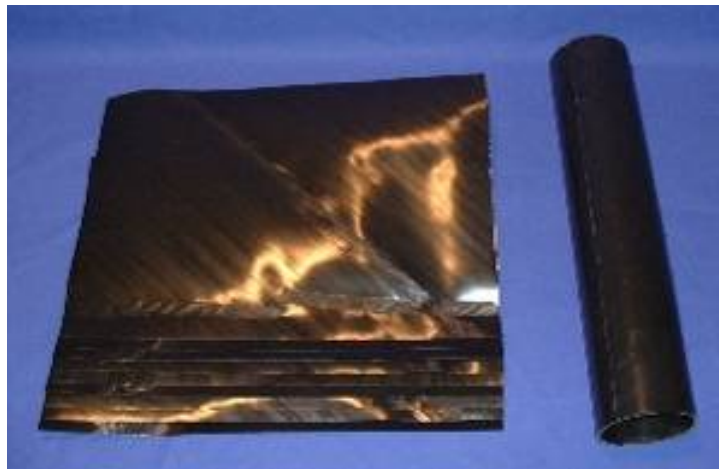
For Test 02 and Test 03, RolaTube developed a modified version of their bi-stable reeled glass fiber (GF) composite product, which uses nine plies of a glass-polypropylene material in the form of overlapping, pre-pregnated tapes of unidirectional glass and polymer. Glass-high density polyethylene (HDPE) material was also considered. The glass-polypropylene material was selected after problems were encountered bonding the glass-HDPE material to steel. Heat and pressure were used to consolidate the glass-polypropylene material into a liner (Figure 30). The resulting wall thickness of the liner is 2.85 mm (0.11 in.).

**Figure 30 - Lay-Up and Forming of GF-Reinforced Composite Liner**

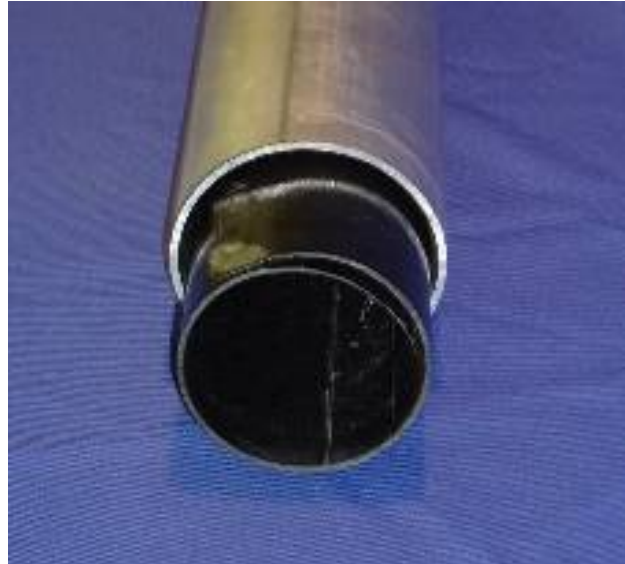
**Figure 31 - Insertion of GF Liner into 114.3 mm (4.5 in.) Diameter Pipe**

The inside surface of each 1.2 m (4 ft.) long section of 114.3 mm (4.5 in.) diameter API 5L Grade B pipe was degreased prior to installing the GF liners (Figure 31).

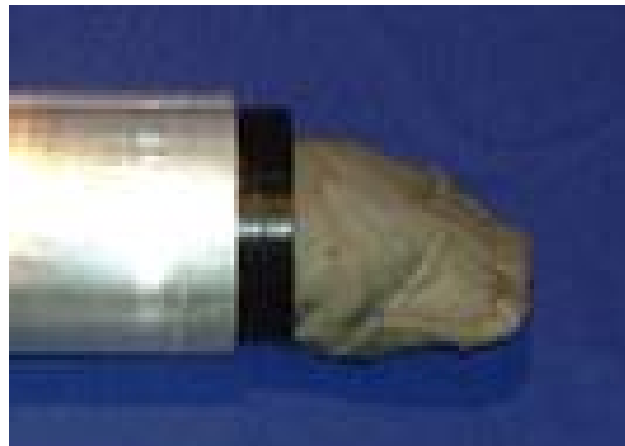
**Figure 32 - Silicon Rubber Bag Inserted into GF Liner**

The installation process consisted of locating the GF liner inside the pipe and inserting a silicon rubber bag inside the liner (Figure 32). The silicon bag was then inflated to press the liner against the inside diameter (ID) of the pipe wall.

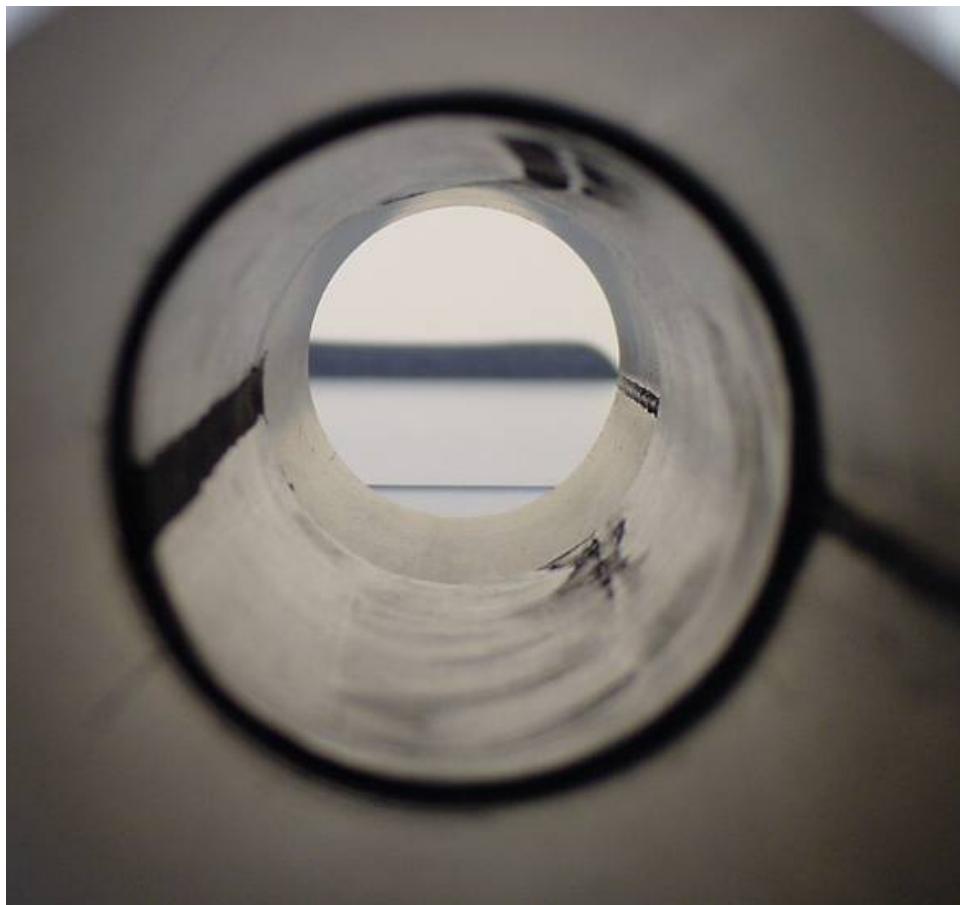
**Figure 34 - GF Liner Installed in 114.3 mm (4.5 in.) Diameter Pipe**

An installed liner is shown in Figure 34.

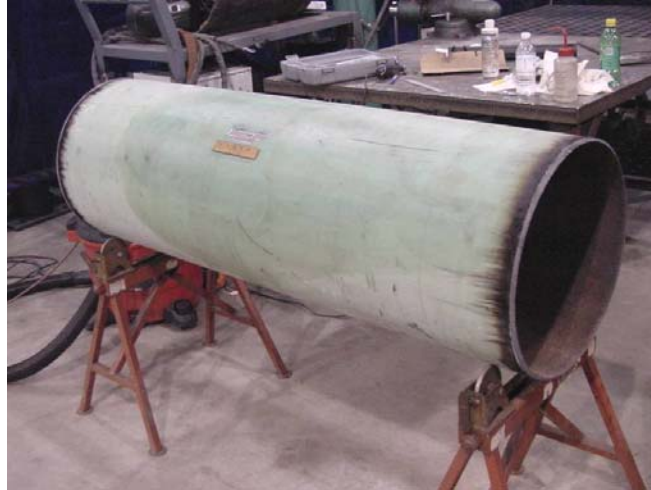
**Figure 35 - Pipe Section Used for Carbon Fiber Patch Test 04**

For Test 04, a 508 mm (20 in.) diameter X52 pipe with a short/deep, stylized corrosion defect (Figure 16) was used on the pipe section shown in Figure 35.

For Test 05, a 508 mm (20 in.) diameter X52 pipe with a short/deep, stylized corrosion defect (Figure 16) was used on a pipe section similar to that shown in Figure 35. The Test 05 patch was fabricated/installed with the same materials and procedures developed for the Test 04 patch. As shown in Figure 47, the Test 05 patch resembles a "pressure bandage" wherein there is a solid 254 mm (10 in.) long by 254 mm (10 in.) wide by 11.43 mm (0.45 in.) thick solid thickness of composite in the middle with wings of composite material that neck down toward the outside of both ends. This gives the "pressure bandage" patch a total overall length of 711.2 mm (28 in.). All 0, 90 construction was used with 27 layers (layers 1 and 27 were glass woven roving). Calculated fiber volume was 50% - 55%. The "pressure bandage" patch was allowed to cure for approximately two weeks after fabrication. After the patch was installed in the pipe section, it was allowed to cure for another week before hydrostatic testing to failure.

For Test 06, a 508 mm (20 in.) diameter X52 pipe with a short/deep, stylized corrosion defect (Figure 16) was used on a pipe section similar to that shown in Figure 35. As compared to the Test 05 patch, the Test 06 patch was thinner. Test 06 patch consisted of all 0, 90 construction fabricated/installed with the same materials and procedures developed for the Test 04 patch.

For Test 08, a 508 mm (20 in.) diameter by 6.35 mm (0.25 in.) wall, API 5L-X52 pipe with a short/deep, stylized corrosion defect (as shown in Figure 16) was used on a pipe section similar to that shown in Figure 35. The Test 08 patch was steel. The steel patch and the pipe section it was installed in were both taken from the same longer pipe section.

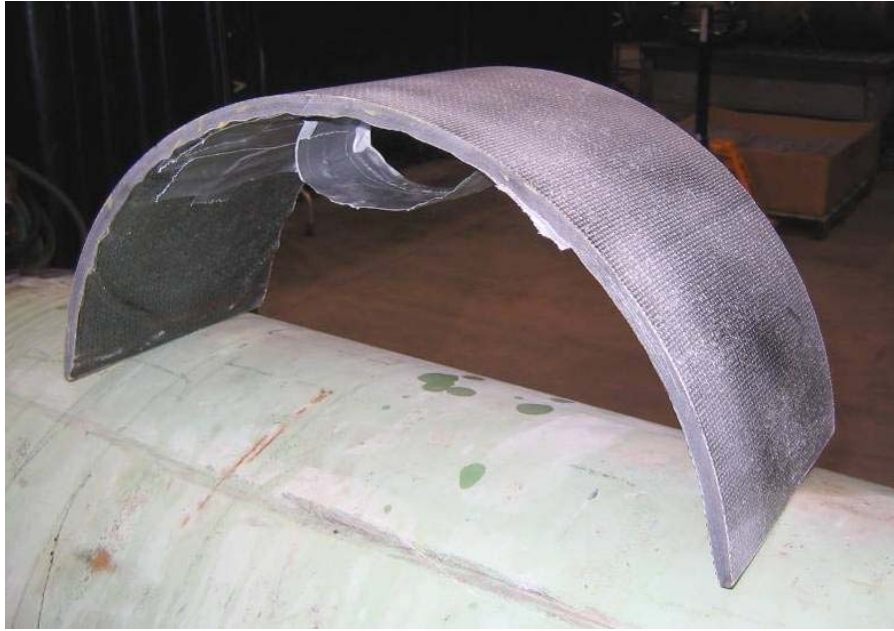
**Figure 41 - Completed Test 04 CF Patch with Grit-Blasted OD**

To facilitate Test 04 patch installation, the outer surface of the patch was grit-blasted using 50 - 80 grit Alumina to remove surface resin (Figure 41). Similarly, the installation area inside the pipe was grit-blasted to a near-white blast with 50 - 80 grit Alumina (Figure 42). After cleaning, a liberal coating of 3M DP460 epoxy adhesive was applied to the internal faying surface and a thin coating was applied to the patch faying surface (Figure 43).

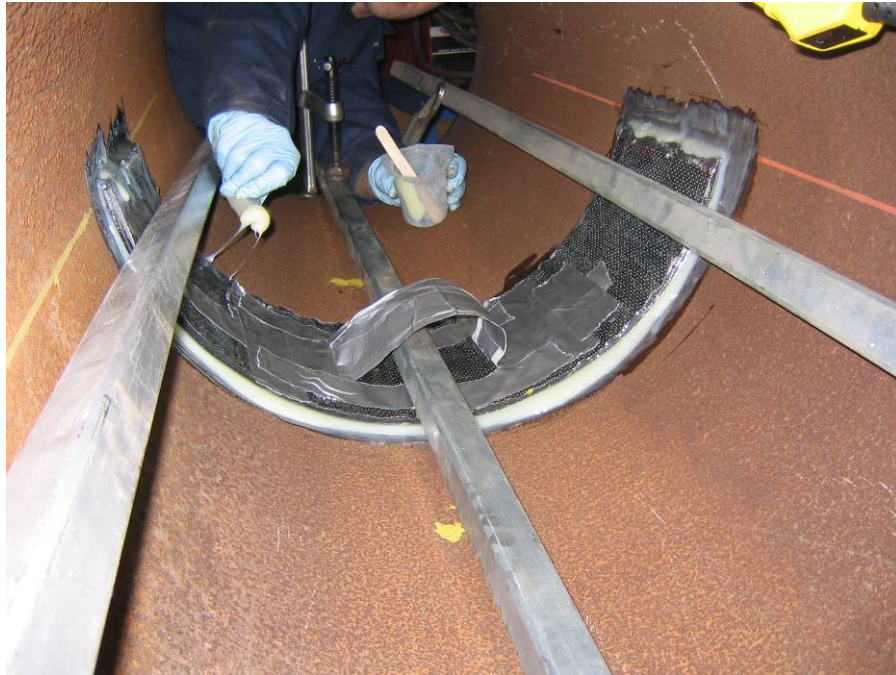
**Figure 45 - Clamping Bars Used to Hold Test 04 CF Patch in Place**

Bar clamps were used along the axis of the pipe to hold the patch in place for cure. Figure 45 shows the adhesive squeeze-out being removed prior to forming a fillet as shown in Figure 46.

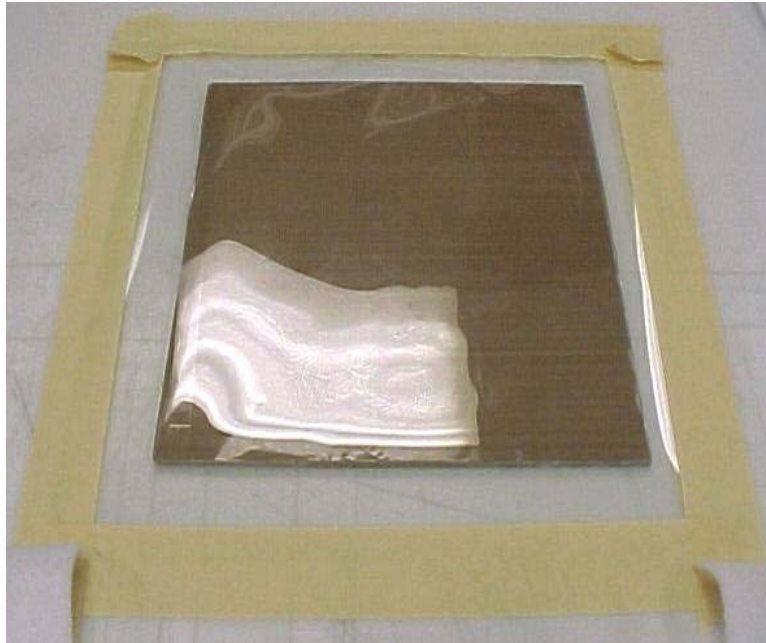
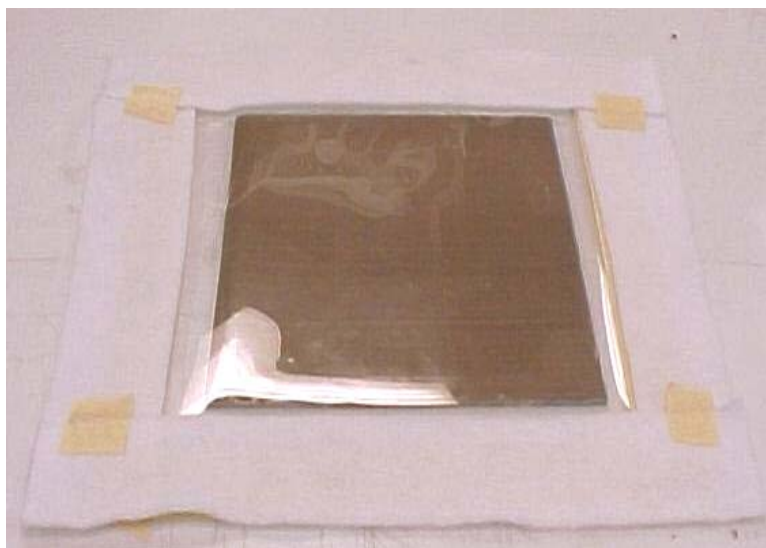
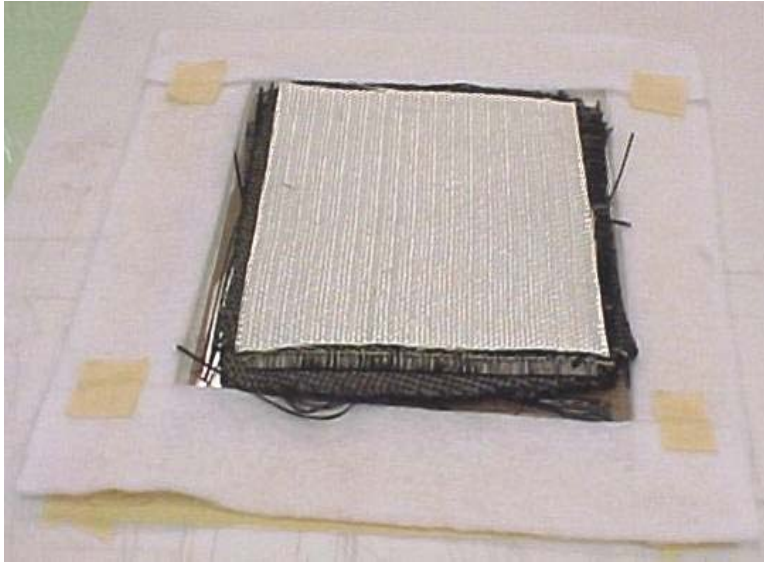
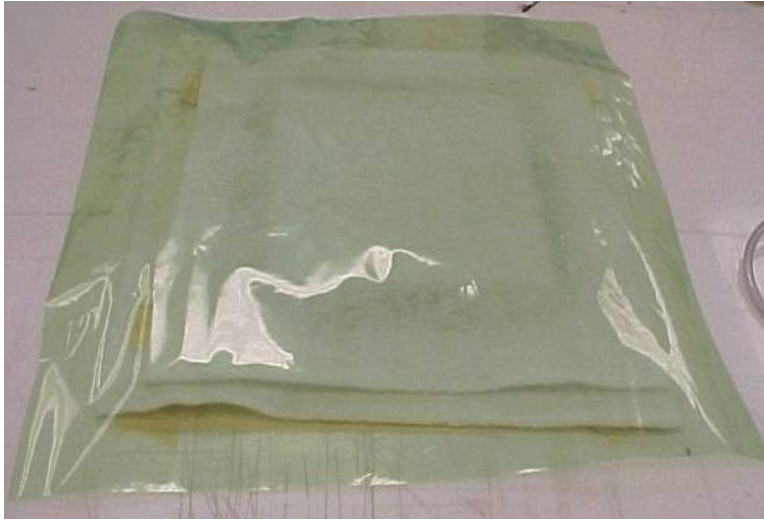
All panels were produced using a combined hand lay-up vacuum bagging technique and were cured at least one month under ambient conditions before testing or were post cured at 70°C (158°F) for 2 hours. Figure 50 through Figure 55 show the panel fabrication process.
