# REPORT

## Internal Repair of Pipelines Final Technical Report

Reporting Period:  
September 30, 2002 through December 31, 2005

Submitted By:  
Edison Welding Institute  
1250 Arthur E. Adams Drive  
Columbus, OH 43221

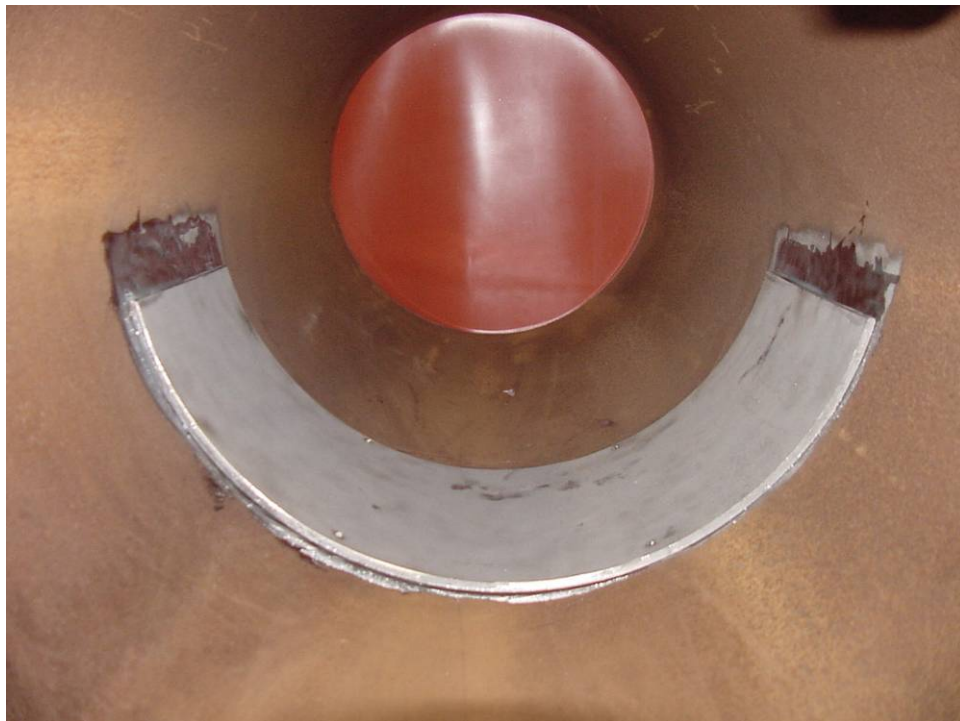
**Figure 57 - Test 08 Steel Patch Prior to Epoxy Curing**

The patch and ID of the pipe were sandblasted and cleaned prior to assembly. The steel patch was installed in the pipe section using the same epoxy adhesive (3M DP460) that was used for CF liner Tests 04 - 07. The epoxy was applied to both the patch and the ID of the pipe. Figure 57 through Figure 59 show various views of the steel patch inside the pipe section before the epoxy was cured.

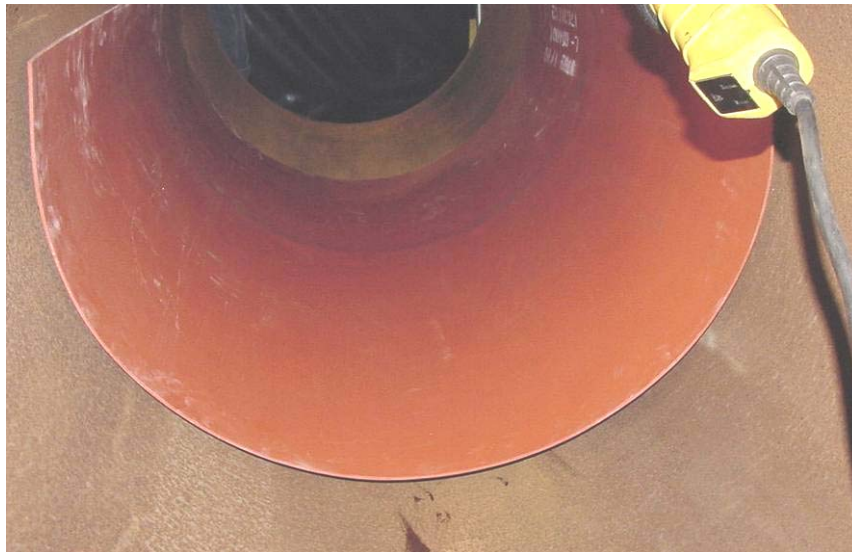
**Figure 60 - Rubber Sheet Protecting Inflatable Bladder From Epoxy for Test 08**

For this and subsequent tests, an inflatable bladder was used to facilitate the installation process. Figure 60 shows the rubber sheet that was placed over the steel patch to protect the inflatable bladder from epoxy that leaked from around the patch.

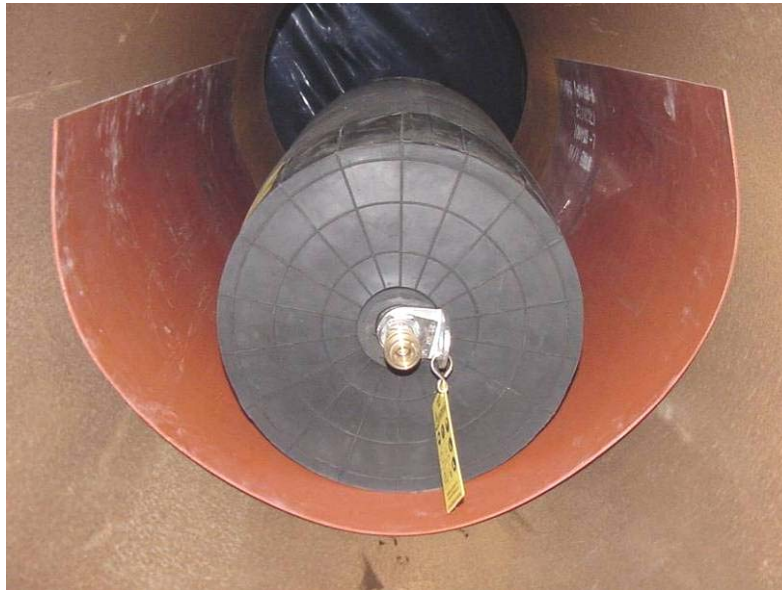
**Figure 61 - Bladder Prior to Pressurization for Test 08**

The inflatable bladder was then inserted into the pipe, pressurized to 206 kPa (30 psi), and held overnight to assure a sound bond between the steel patch and the ID of the pipe (Figure 61).

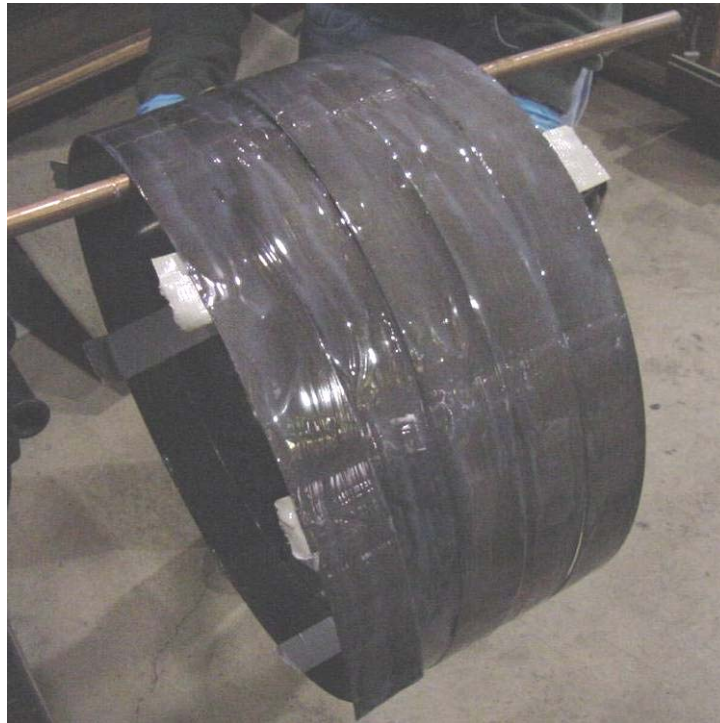
**Figure 64 - Test 09 Helically Wound Steel Strip with 3M DP460 Epoxy Applied**

The OD of the strip and the ID of the pipe were sandblasted using the same procedures used for Tests 04 - 08. The same epoxy (3M DP460) used for Tests 04 - 08 was also applied to the OD of the strip and to the ID of the pipe (in a similar manner to that shown in Figure 64 and Figure 65).

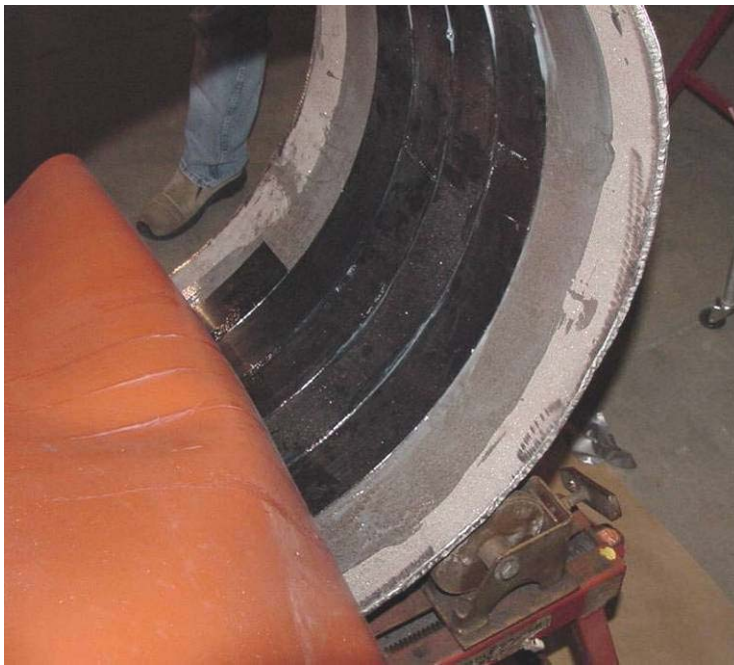
**Figure 67 - Helically Wound Steel Strip Expanded to Fit Pipe ID (similar to Test 09)**

Once the steel strip was inserted into the pipe, the tape was removed and the steel strip was allowed to spring outward against the ID of the pipe (Figure 67). A rubber sheet was placed over the helically wound steel strip to protect the inflatable bladder from epoxy that leaked from around/between the coils.

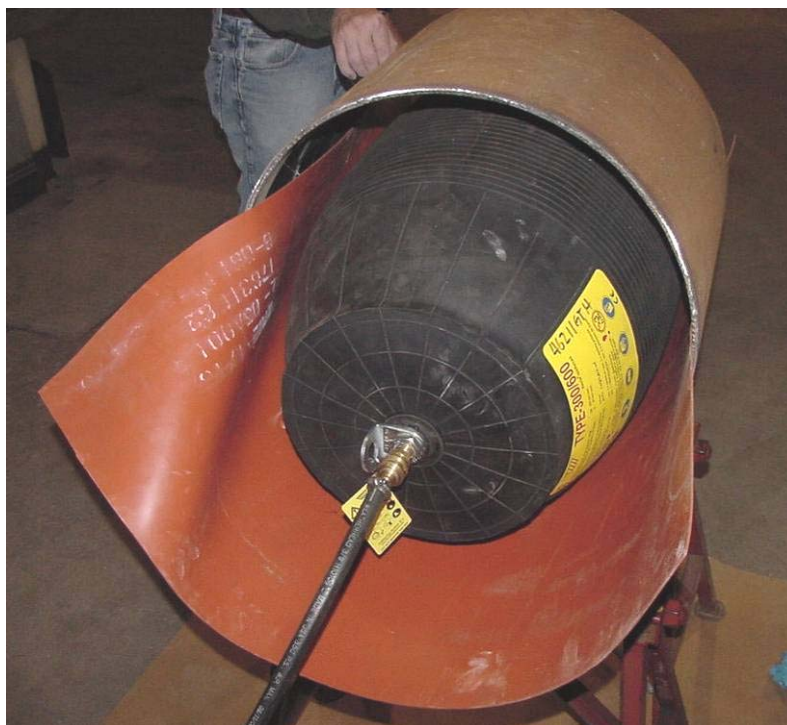
**Figure 68 - Inflatable Bladder Inserted in Pipe (similar to Test 09)**

An inflatable bladder was then inserted into the ID of the pipe and pressurized to 206 kPa (30 psi) and held overnight to assure sound bonding between the helically wound steel strip and ID of the pipe (Figure 68 and Figure 69).

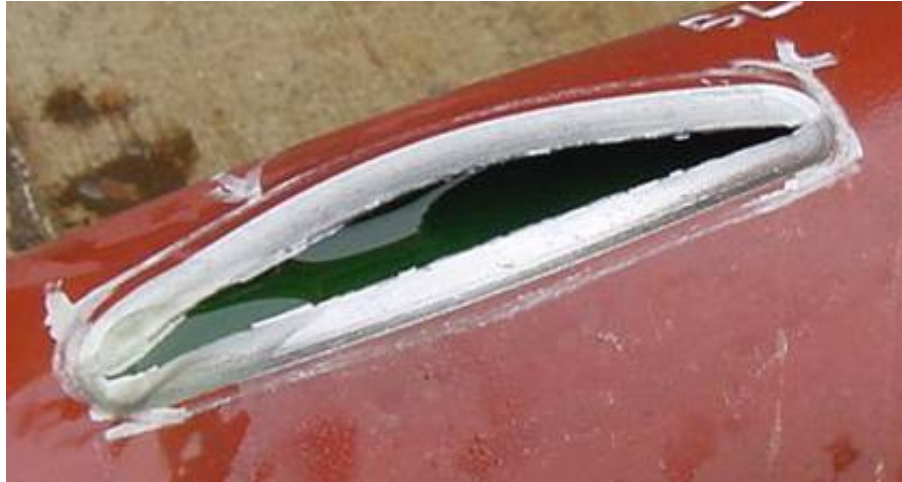
Figure 92 through Figure 97 show the results of the baseline burst tests for the majority of the pipe materials used in the investigation. Figure 92 shows the 114.3 mm (4.5 in.) diameter specimen with un-repaired long/shallow simulated corrosion damage after burst testing. Calculated with RSTRENG® to represent a 30% reduction in burst strength, defect dimensions were 127 mm (5 in.) long by 2.54 mm (0.100 in.) deep.

**Figure 92 - 114.3 mm (4.5 in.) Pipe with Un-Repaired Long/Shallow Damage after Burst Test**

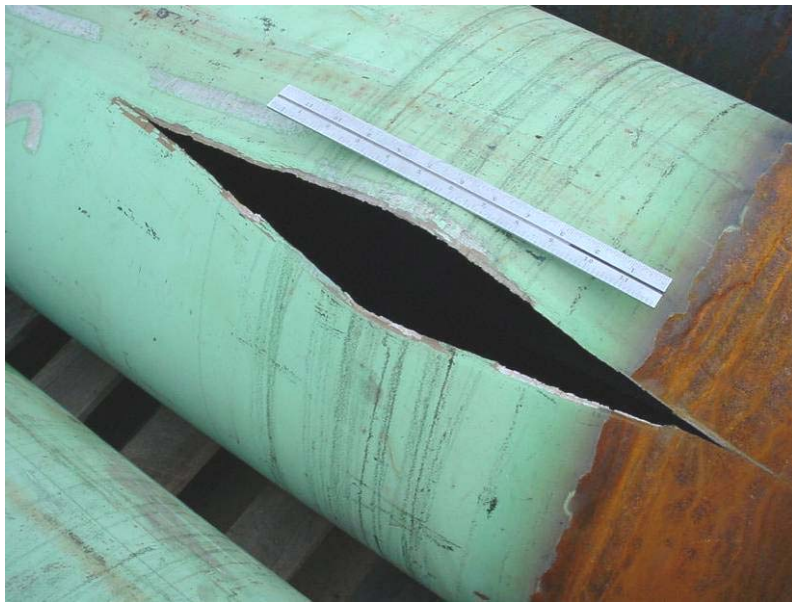
Figure 94 is the 508.0 mm (20 in.) diameter specimen in the virgin condition after burst testing.

**Figure 94 - 508.0 mm (20 in.) Virgin Pipe After Burst Testing**

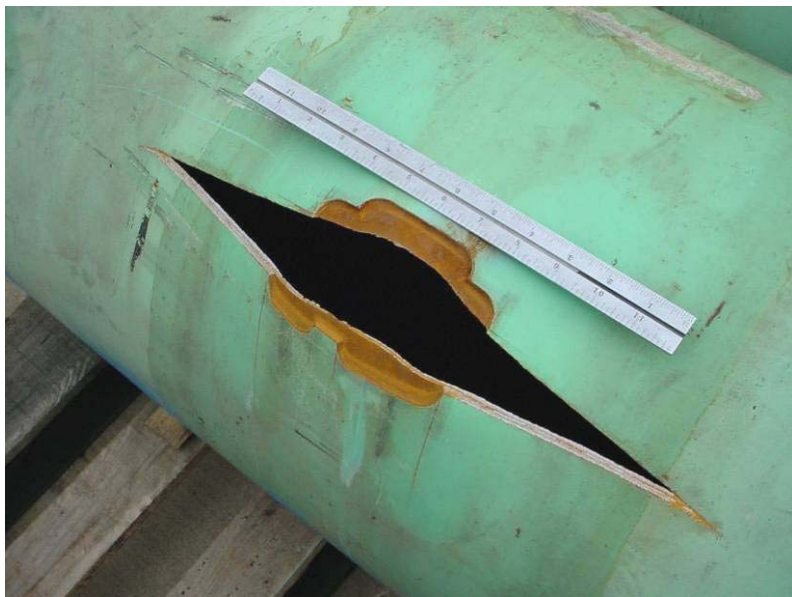
Figure 95 is the 508.0 mm (20 in.) diameter specimen with a long/shallow, stylized corrosion defect after burst testing. Calculated with RSTRENG® to represent a 25% reduction in burst strength, defect dimensions were 381 mm (15 in.) long by 2.74 mm (0.108 in.) deep.

**Figure 95 - 508.0 mm (20 in.) Pipe with Un-Repaired Damage After Burst Testing**

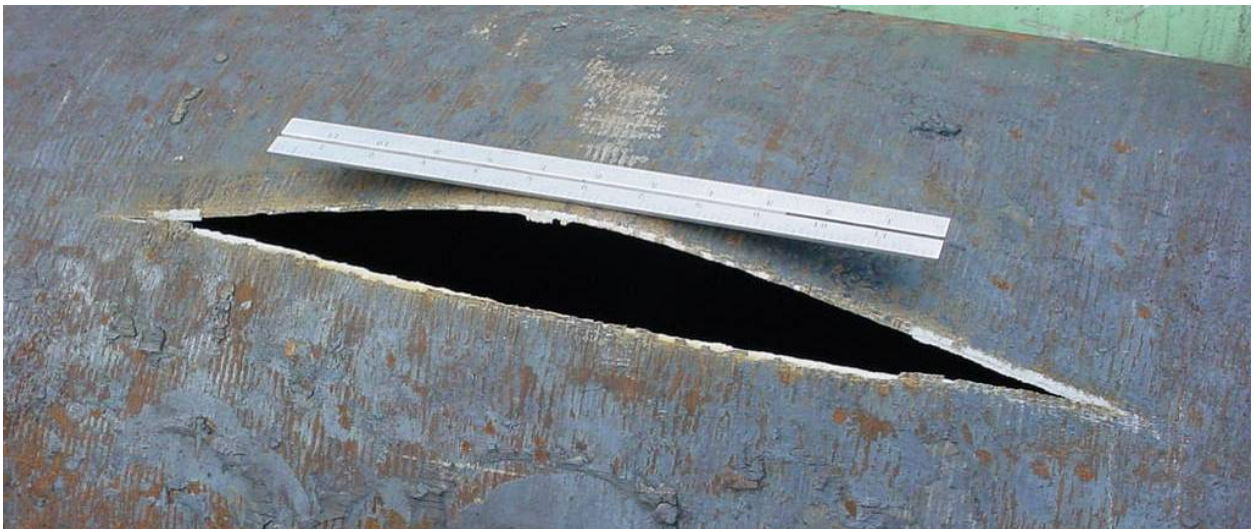
Figure 96 is the 558.8 mm (22 in.) diameter specimen in the virgin condition after burst testing.

**Figure 96 - 558.8 mm (22 in.) Virgin Pipe After Burst Testing**

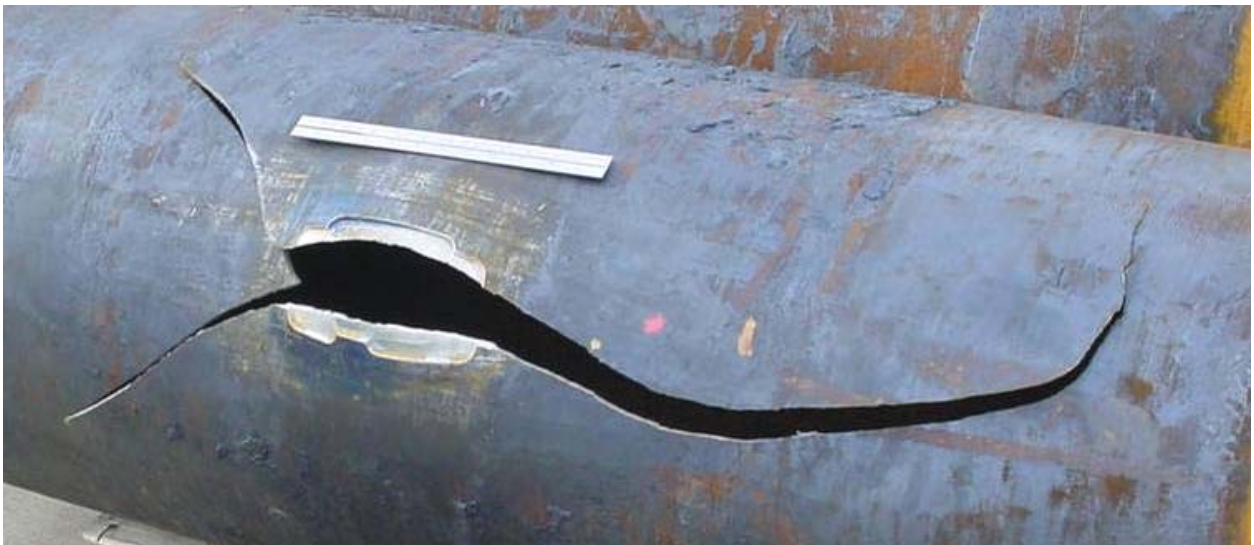
Figure 97 is the 558.8 mm (22 in.) diameter specimen with stylized, short/deep corrosion defect. Calculated with RSTRENG® to represent a 25% reduction in burst strength, defect dimensions were 190.5 mm (7.5 in.) long by 3.96 mm (0.156 in.) deep.

**Figure 97 - 558.8 mm (22 in.) Pipe with Un-Repaired Damage After Burst Testing**

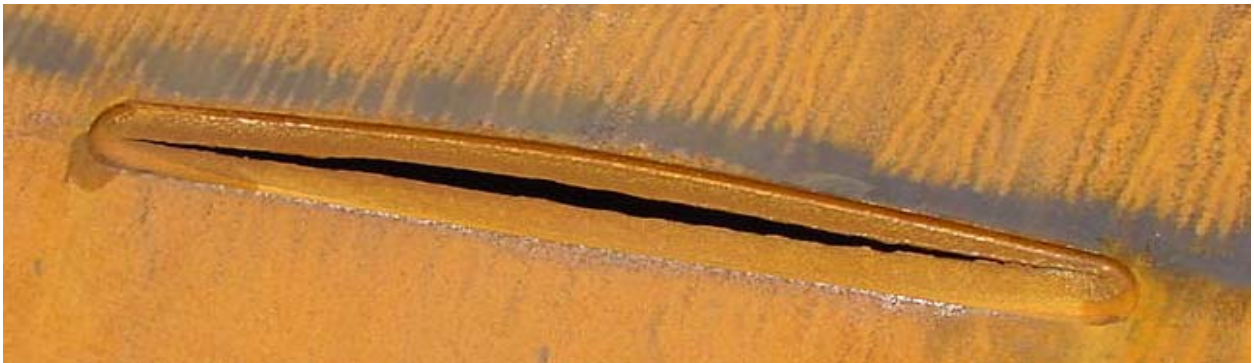
Figure 98 is the 609.6 mm (24 in.) diameter specimen with an extra long/shallow corrosion defect. Calculated with RSTRENG® to represent a 60% reduction in burst strength, defect dimensions were 381 mm (15 in.) long by 5.66 mm (0.223 in.) deep.

**Figure 98 - 609.6 mm (24 in.) Pipe with Un-Repaired Extra Long/Shallow Damage After Burst Testing**

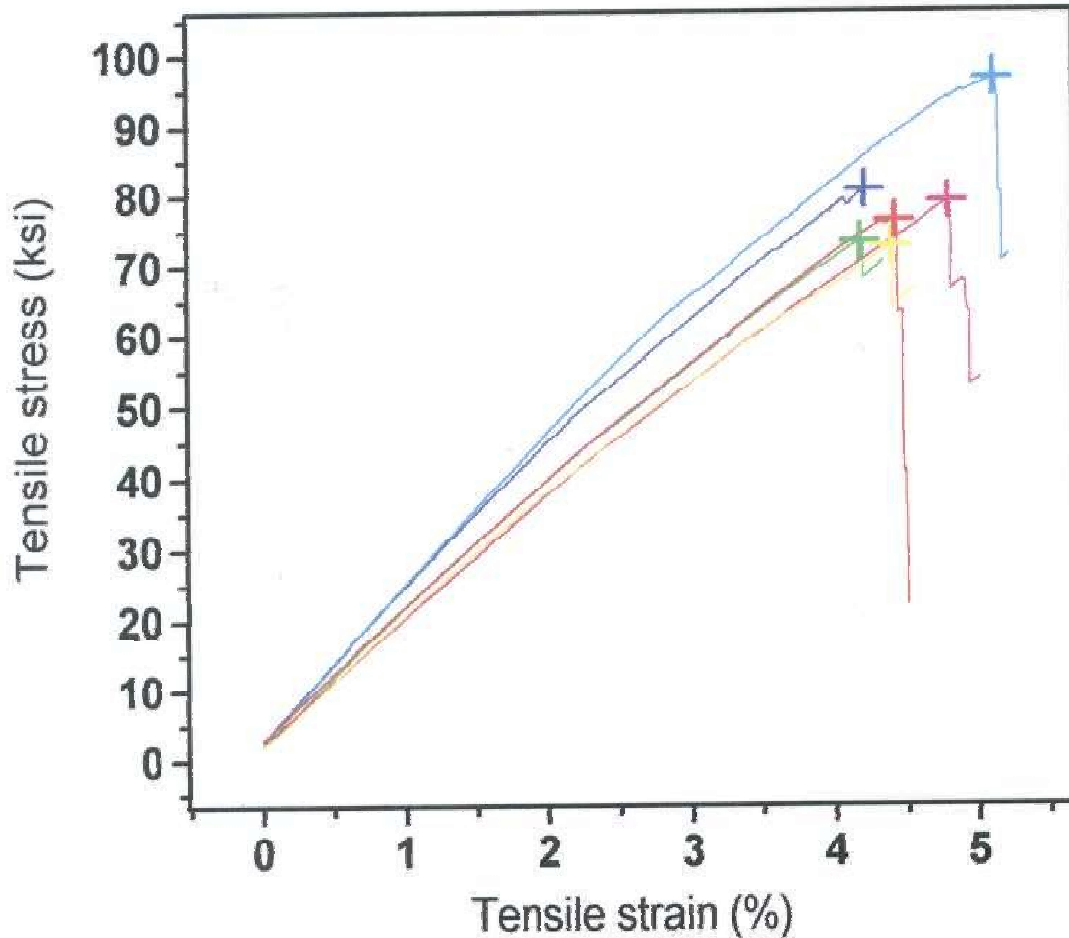
Tensile testing was carried out to determine the modulus of elasticity for the glass/polypropylene liner material that was used for Tests 1 and 2 (Table 14 and Figure 101). The mean value for the modulus of elasticity for the liner material was measured to be approximately 15.2 GPa (2.2 x 10<sup>6</sup> psi).

**Figure 101 - Tensile Test Results for GF Polypropylene Liner Material**

Analysis of the results indicates that the difference in modulus of elasticity between the steel and the liner material prevents the liner from carrying its share of the load. The modulus of elasticity for steel is approximately 206.8 GPa (30 x 10<sup>6</sup> psi). Tensile testing was carried out to determine the modulus of elasticity for the glass/polypropylene liner material that was used (Table 14 and Figure 101). The mean value for the modulus of elasticity for the liner material was measured to be approximately 15.2 GPa (2.2 x 10<sup>6</sup> psi). Because the GF liner material has a significantly lower modulus of elasticity than the steel pipe, as pressure in the lined pipe increases, the stiffness of the steel prevents the composite liner material from experiencing enough strain to share any significant portion of the load.

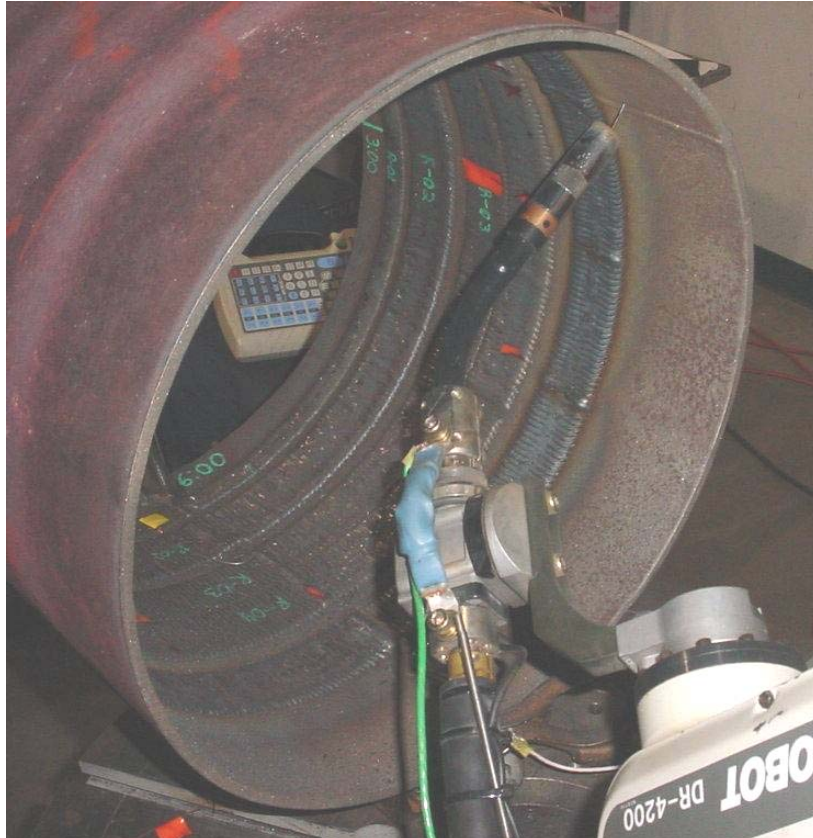
The standard robot welding torch (Figure 108) could only be used for half a revolution, then it had to be unwound to complete the remainder of each deposit ring. This limitation was acceptable for parameter development since the focus was the welding parameters not high duty cycle welding. The robot was interfaced to an advanced short-circuit power supply, the Kobelco PC-350.

**Figure 108 - OTC Robot Arm and Torch**

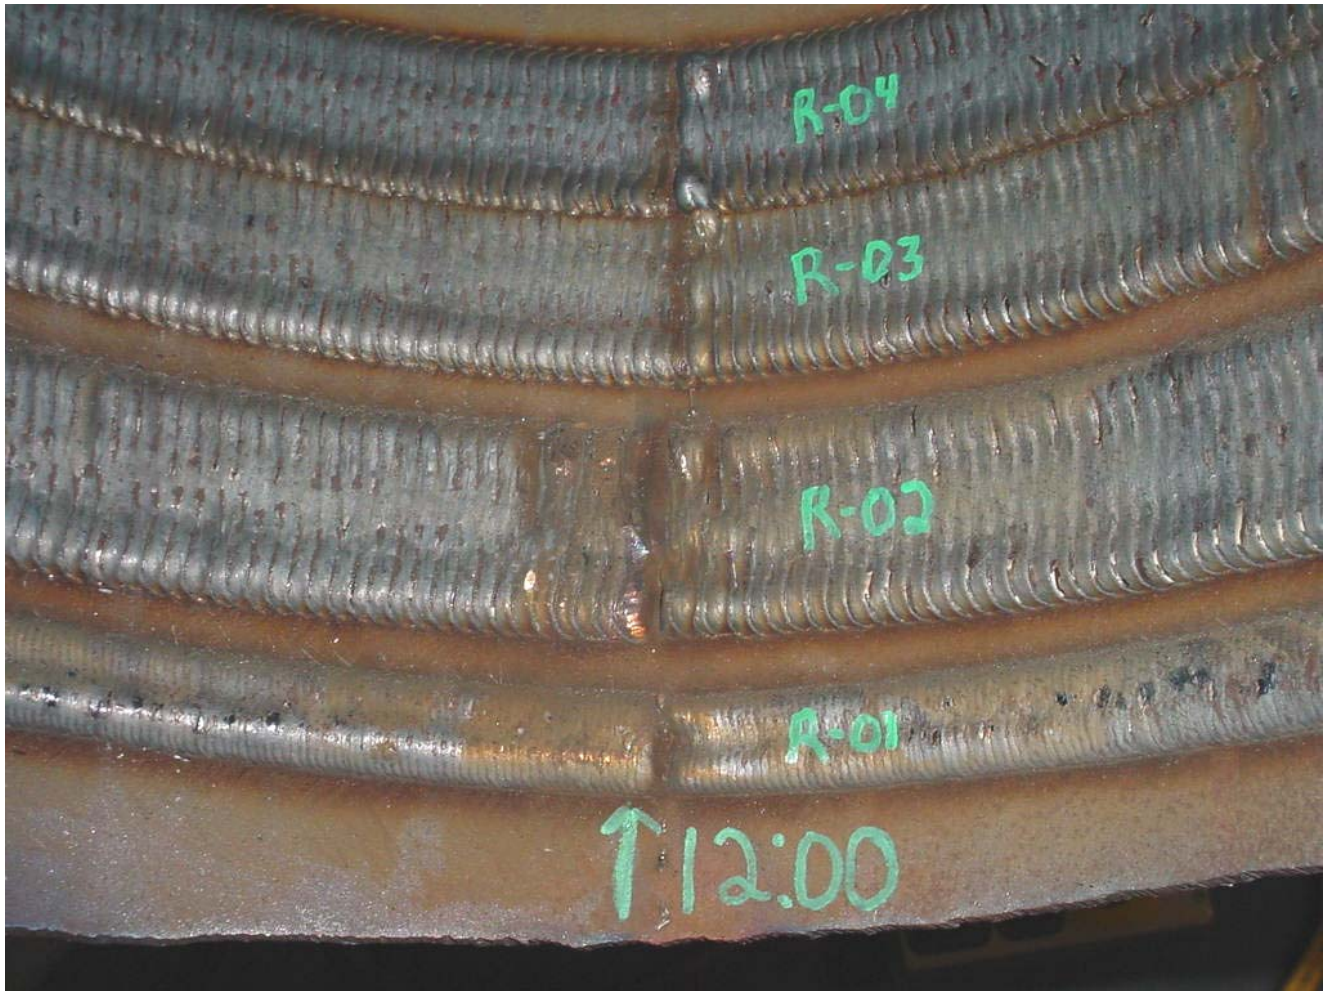
Using the robot welding system, ring welding procedures using weaving were developed for several bead widths (Figure 110). This figure shows the location where the first half of the ring was stopped and the second half was started in the overhead position. This was not an ideal stop-start location but was required with the robot to manage the welding cables. If start-stops were required to complete a repair, it would be preferred to have them positioned at a different location around the circumference, ideally in the flat position. Tie-in parameters will need to be optimized for each possible starting position once preferred bead shape weaving parameters are selected. A true orbital bore welding machine, like the Bortech, would have a current and shielding gas commutation system to provide infinite rotations without cable problems thereby minimizing stop-starts.

Figure 110 - Tests R-01 - R-04 at 12:00 (Note the Poor Tie-Ins for R-01 through R-03)

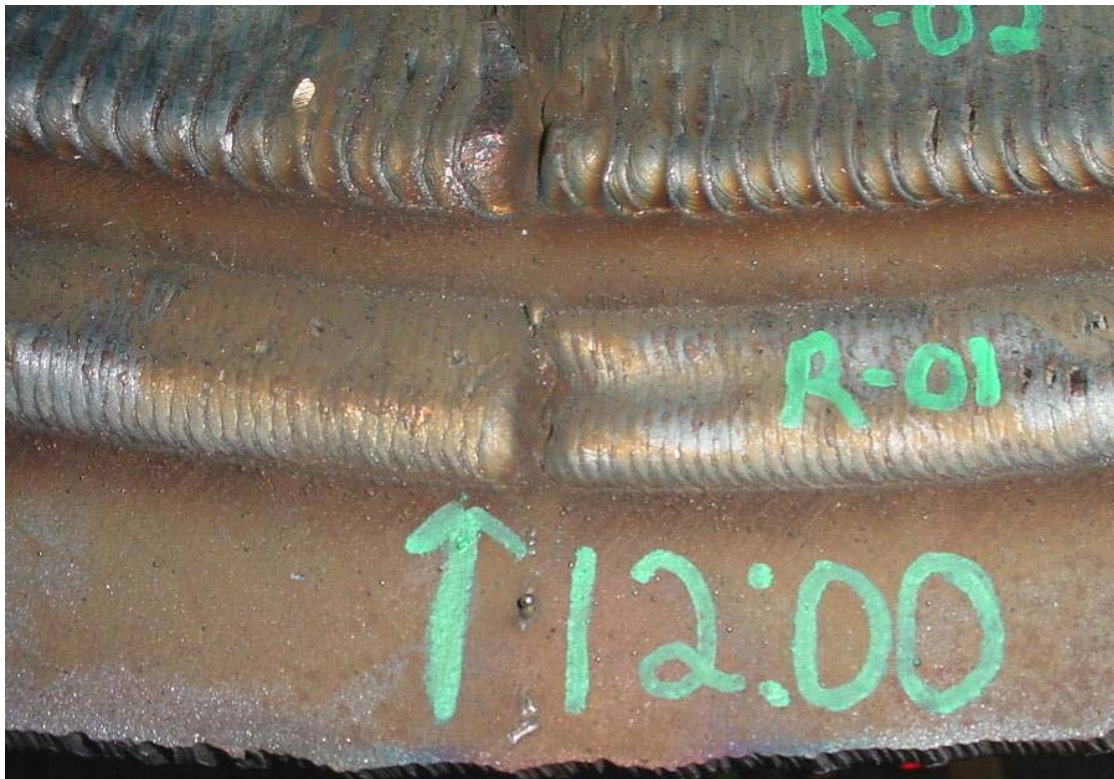
When welding was initiated, the pipe was near room temperature. The weld bead profile at the start (Figure 111 and Figure 112) slowly changed as a steady-state temperatures are built in the material based on the heat input of each welding procedure. In general, most weld starts appeared more convex based on the low starting material temperature. Note that test R-04 was overlapped on test R-03 to provide a larger deposit layer in Figure 112.

Figure 111 - Test R-01 at 12:00 Show Poor Stop-Start Tie-In

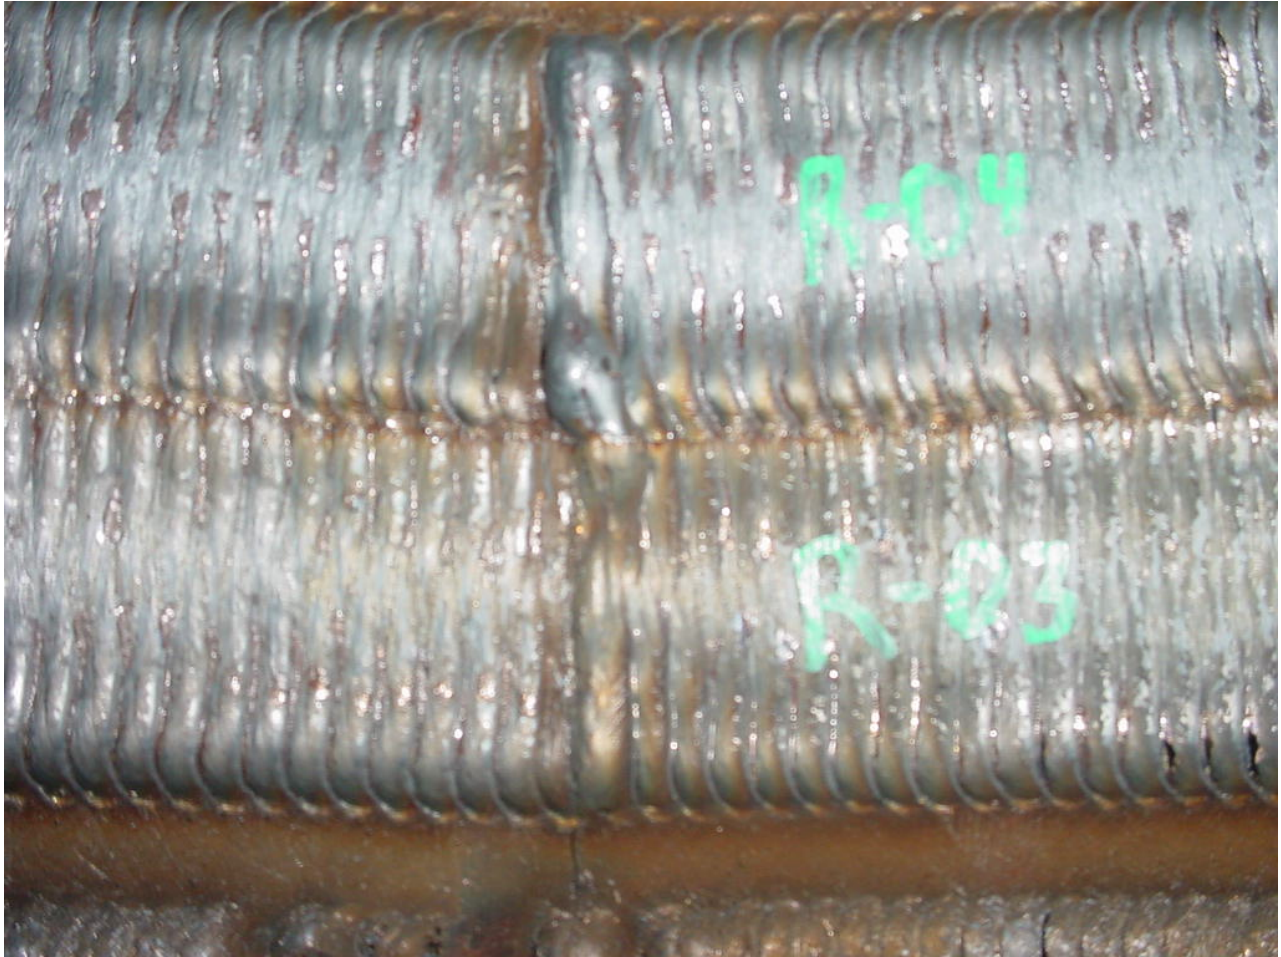
Figure 112 - Tests R-03 and R-04 at 12:00 Show Better Stop-Start Overlap

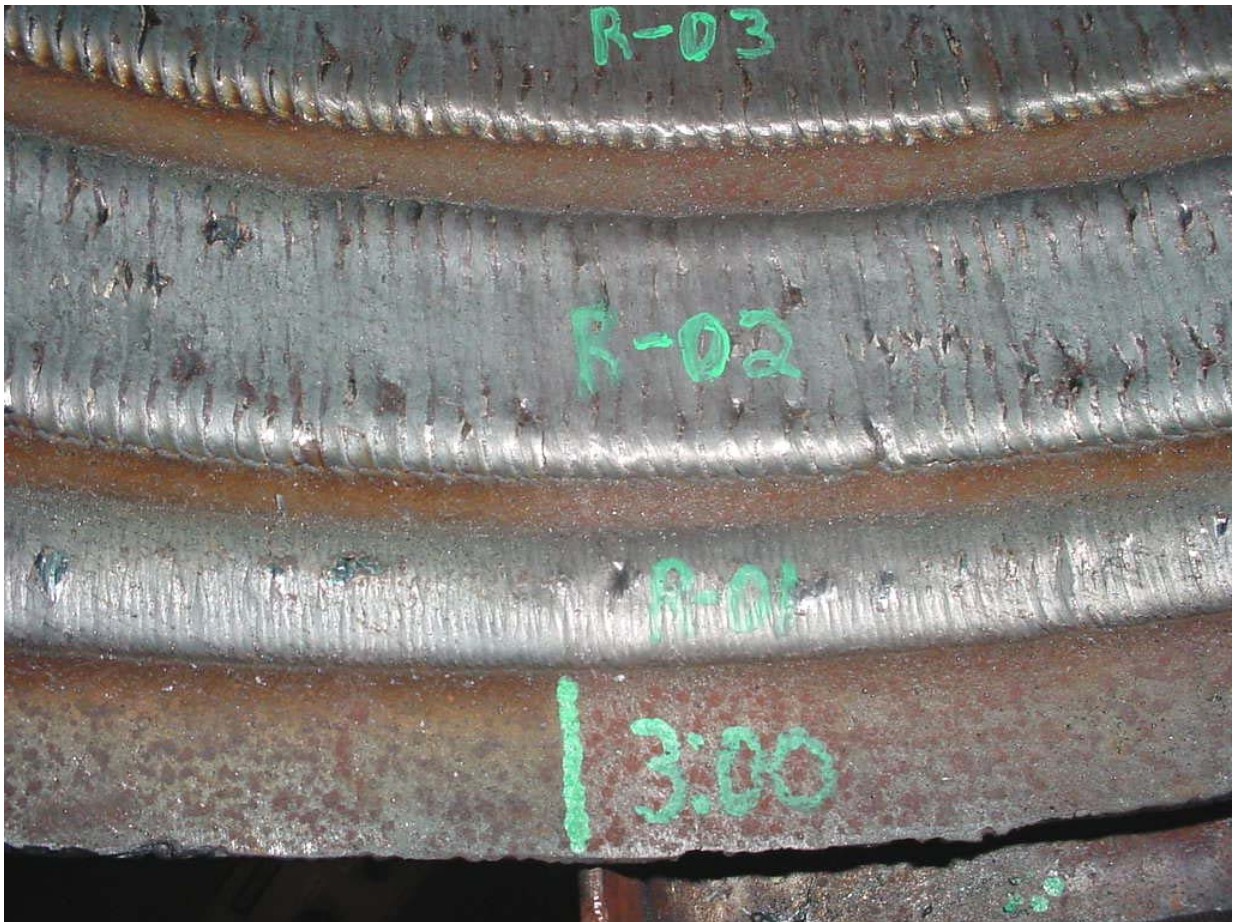
The preferred welding parameters were based on optimizing the bead shape in the steady state (Figure 113). For internal repair of pipelines, a programmable weld controller could be used to use higher welding heat input at the weld start. This would provide better weld bead start quality. Once welding the start parameters could be ramped in the steady-state parameters to provide uniform bead shape.

Figure 113 - Tests R-01 and R-02 at 3:00 Showing Steady-State Bead Shape

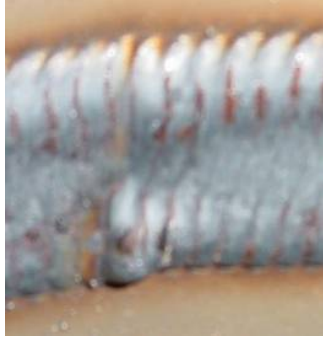
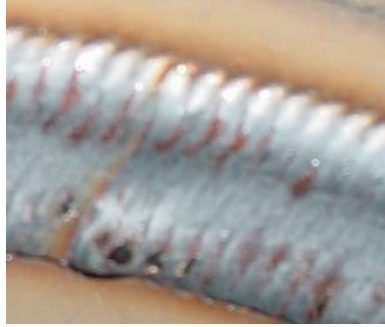
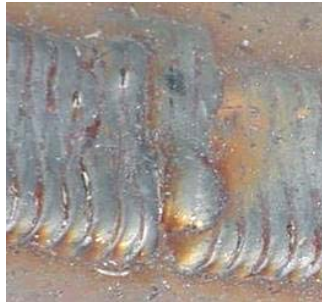
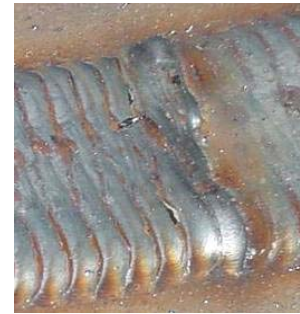
To further improve starting bead shape, some additional tests were performed using 7.62 mpm (300 ipm) wire feed speed (Figure 114). These tests were used by the technician to study the precise location for starting on a "stop" and to evaluate gravity effects. As shown by these tests, start bead shape can be improved through the use of higher wire feed speeds (which produce higher heat input). No additional procedures were developed with the 6-axis robot.

12:00 – Too Much Overlap

1:00 – Too Much Overlap

7:00 – Bad Appearance Due  
Robot Program Error

8:00 – Good

**Figure 114 - Tie-In Tests Using Parameters R-05 Every 30° Around One Ring Deposit**

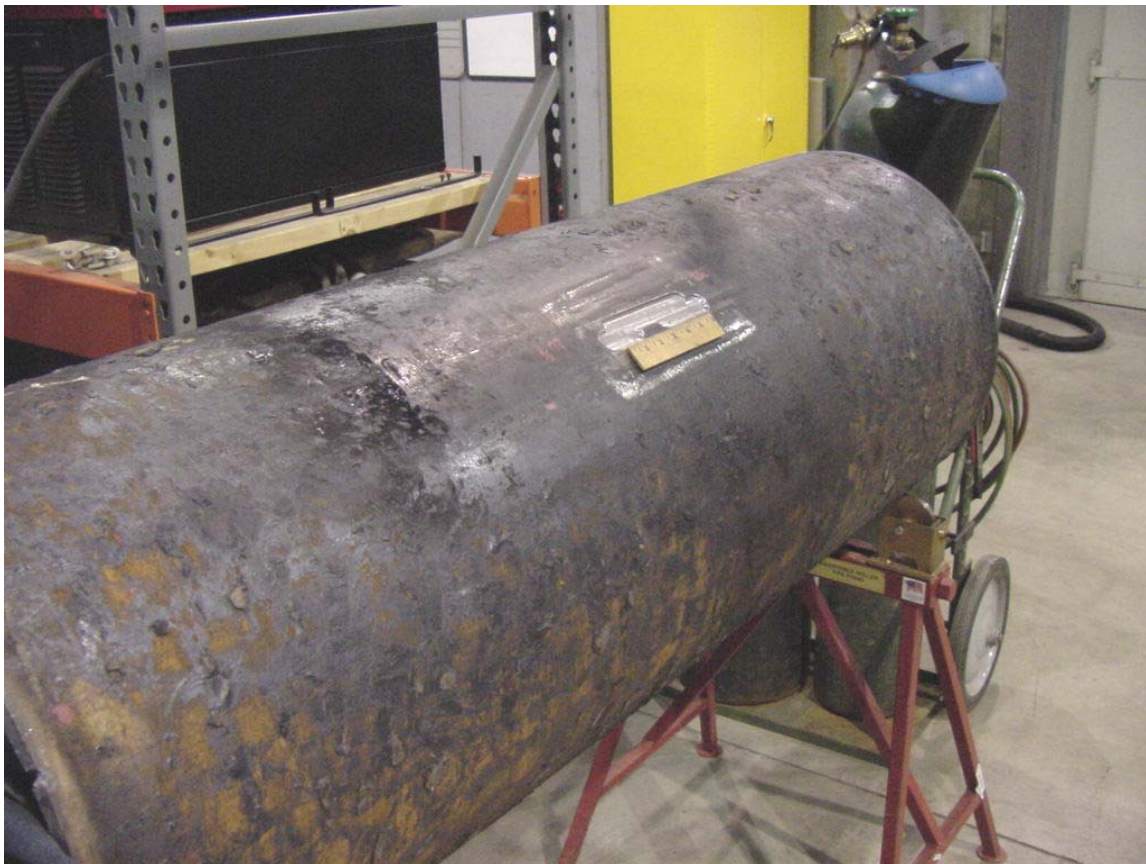
The Magnatech Pipeliner II was used to make a weld deposition repair on a 558.8 mm (22 in.) diameter API 5L, Grade B pipe section. Test 01 incorporated a short/deep, stylized corrosion defect representing a 25% reduction in burst strength. Defect dimensions were 190.5 mm (7.5 in.) long by 3.96 mm (0.156 in.) deep (pictured in Figure 18). This defect was introduced into the pipe section shown in Figure 115.

**Figure 115 - Short/Deep Simulated Corrosion on 558.80 mm (22 in.) Pipe for Test 01**

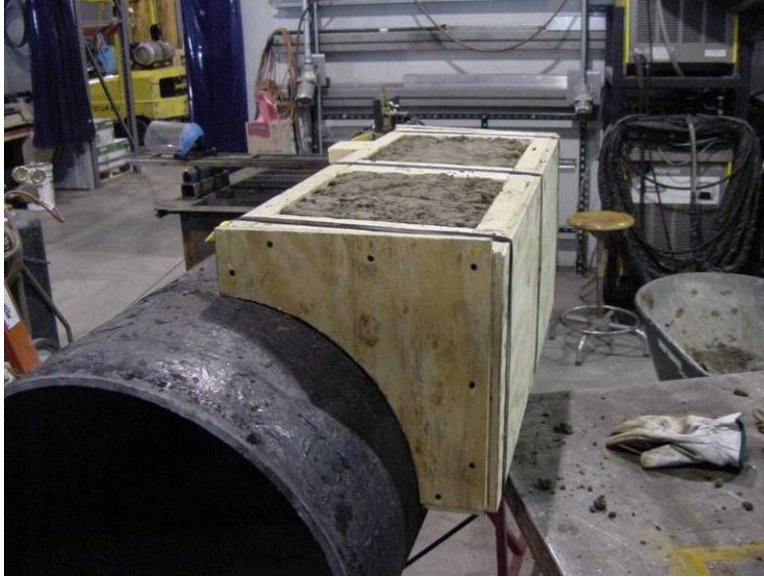
Test 01 welding was done with a shielding gas mixture of 95% Ar + 5% CO<sub>2</sub>. Filler metal was a GMAW 0.89 mm (0.035 in.) diameter AWS ER70S-6 electrode. Welding parameters are found in Table 3 and Table 4. The soil box in Figure 116 was used to simulate in-service welding conditions and soil related cooling rates during weld deposition repair.

**Figure 116 - Soil Box for Weld Deposition Repair Test 01**

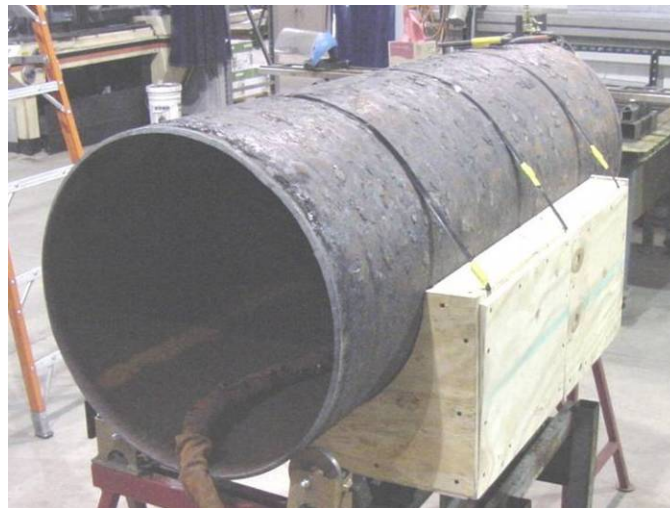
The pipe section with the soil box was rotated 180° (as shown in Figure 117) to facilitate welding on the ID of the pipe from the 6:00 position (where the weld passes were initiated) to the 9:00 position (where the weld passes were terminated).

**Figure 117 - Orientation of Pipe Section with Dirt Box for Weld Deposition Repair Test 01**

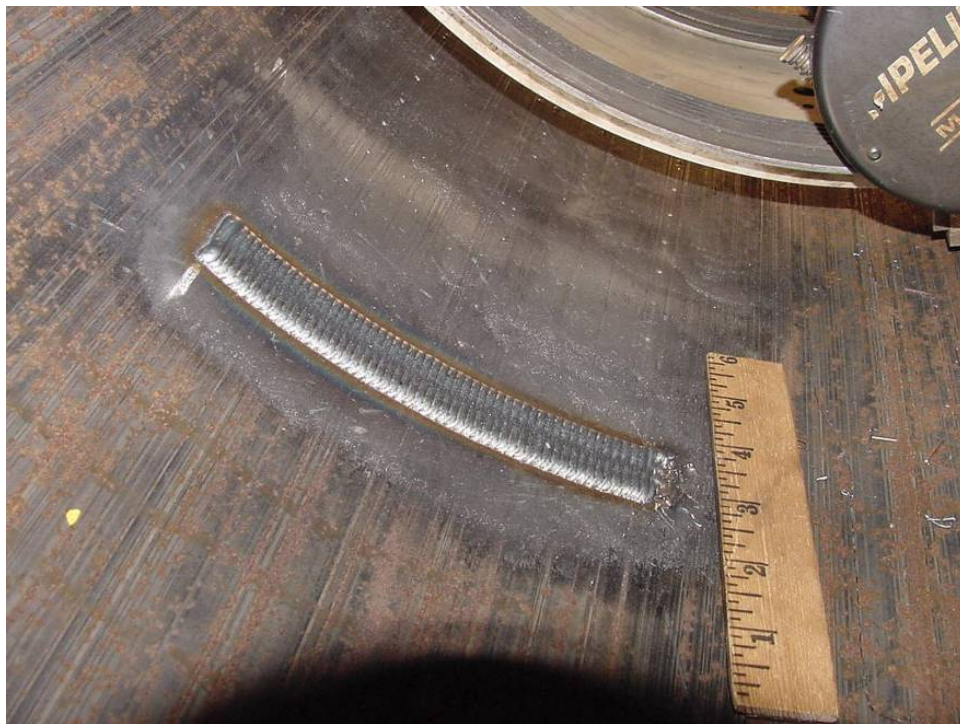
The weld deposition repair consisted of two layers of welds. The first pass of weld Layer 1 is shown in Figure 119.

**Figure 119 - First Pass of Weld Layer 1 for Test 01**

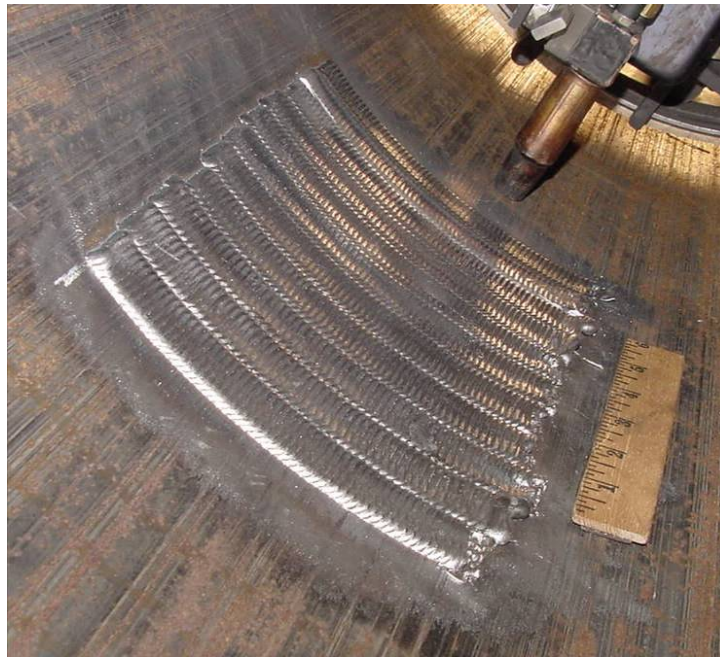
**Figure 122 - Completed Weld Layer 1 for Test 01**

The completed weld Layer 1 is shown in Figure 122. The axial length of Layer 1 exceeded the simulated corrosion by more than 25.4 mm (1.0 in.), which is three times the pipe wall thickness. The rule of thumb for pipeline welding repair is to deposit weld metal such that it exceeds the corrosion area by at least one wall thickness.

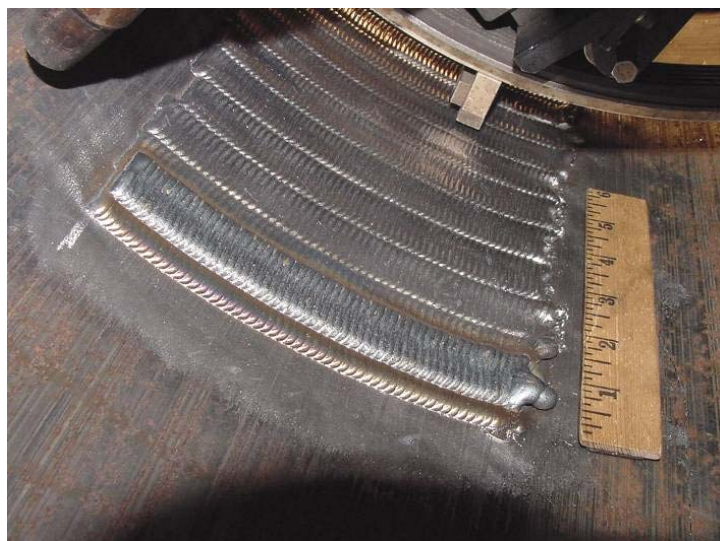
**Figure 123 - First Pass of Weld Layer 2 for Test 01**

First pass of weld Layer 2 is shown in Figure 123. Layer 2 passes were centered over the weld toes of the previous layer.

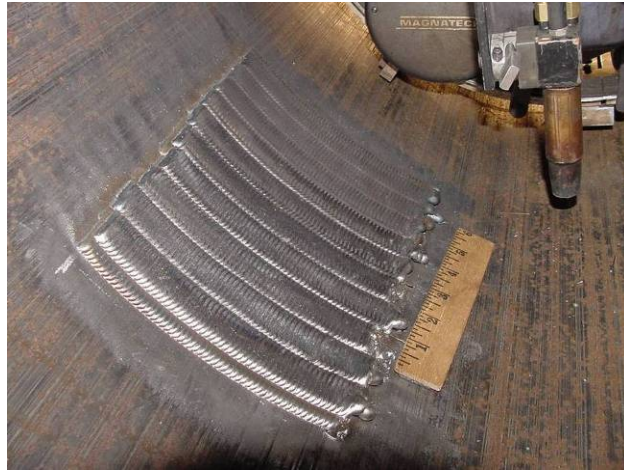
**Figure 124 - Finished Weld Layer 2 of Test 01**

Completed second layer is shown in Figure 124.

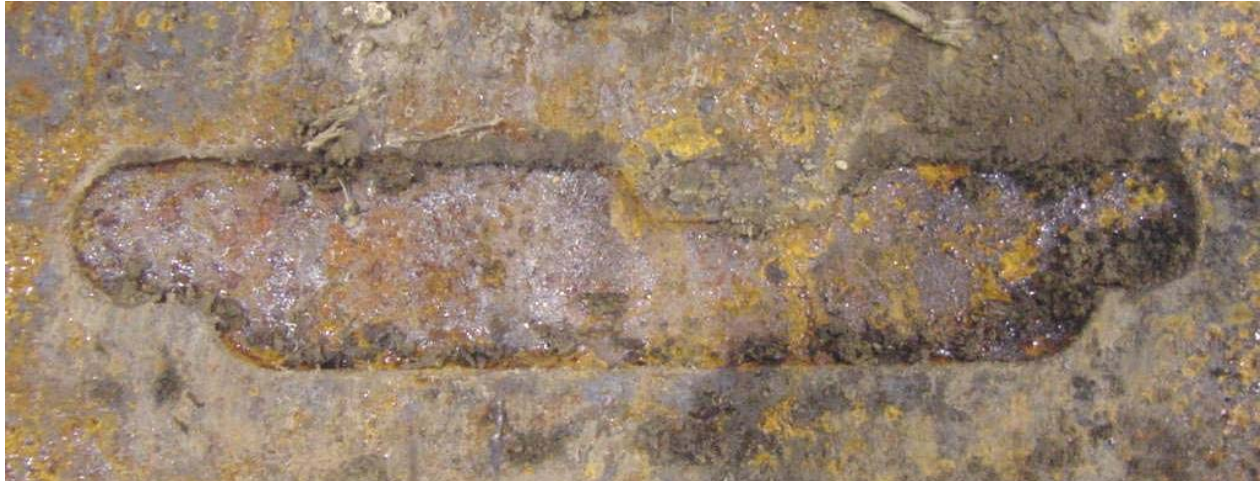
**Figure 126 - Simulated Corrosion on Outside of Pipe After Weld Repair Test 01**

The area of simulated corrosion on the outside pipe surface is shown after internal weld deposition repair in Figure 126.

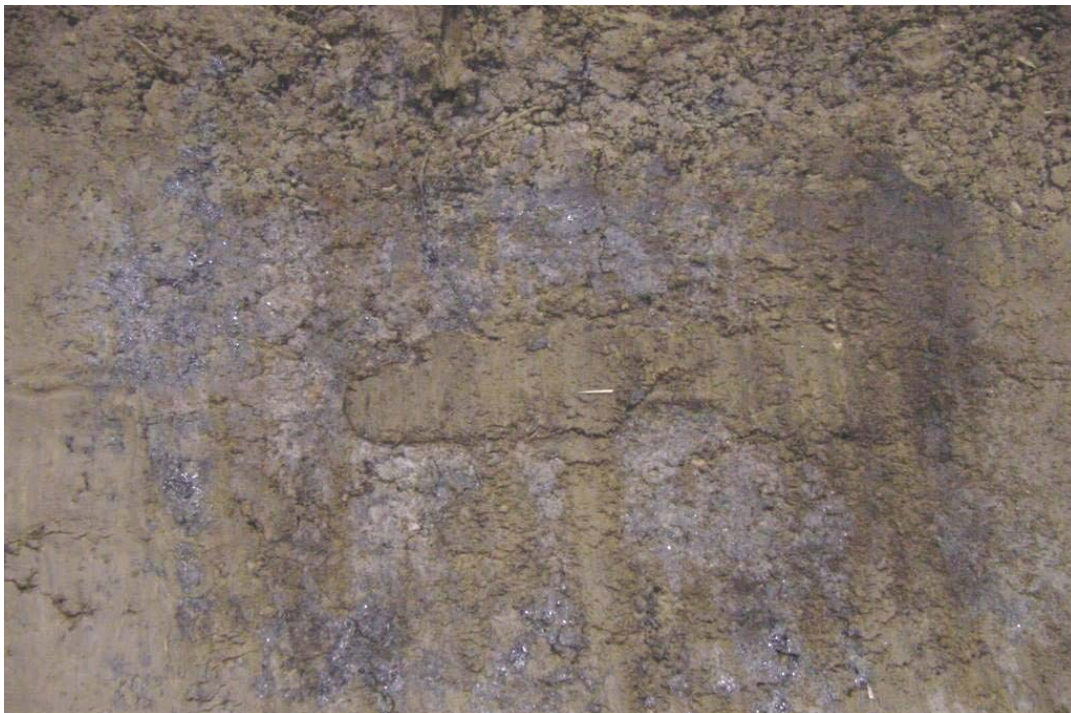
**Figure 127 - Soil in Contact With Pipe During Weld Repair Test 01**

After the box with soil was removed from the weld repaired pipe section, an impression of the corrosion damage was left in the soil as shown in Figure 127. The outline of the weld deposition is also clearly visible where the asphalt coating melted and transferred to the surrounding soil during the welding process.

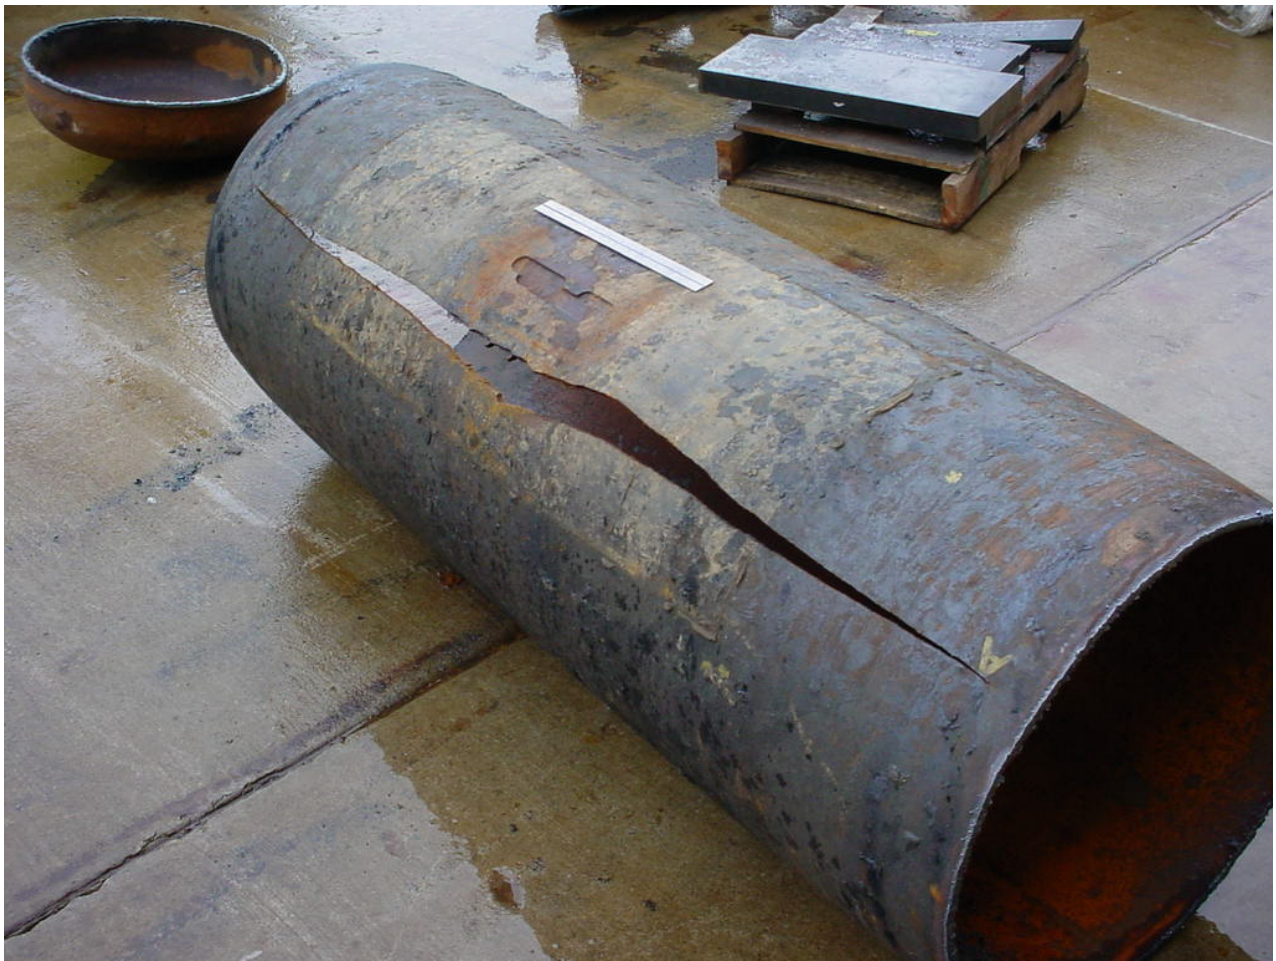
**Figure 130 - Test 01 Pipe Section After Hydrostatic Burst Test**

Figure 130 is a photo of Test 01 after burst testing. The failure occurred at the toe of the weld repair Layer 1. This weld toe area apparently acted as a stress concentration from which the failure initiated. The failure was also influenced by secondary stresses that were produced as the result of the re-rounding of the "dent".
