# REPORT

## Internal Repair of Pipelines Final Technical Report

Reporting Period:  
September 30, 2002 through December 31, 2005

Submitted By:  
Edison Welding Institute  
1250 Arthur E. Adams Drive  
Columbus, OH 43221

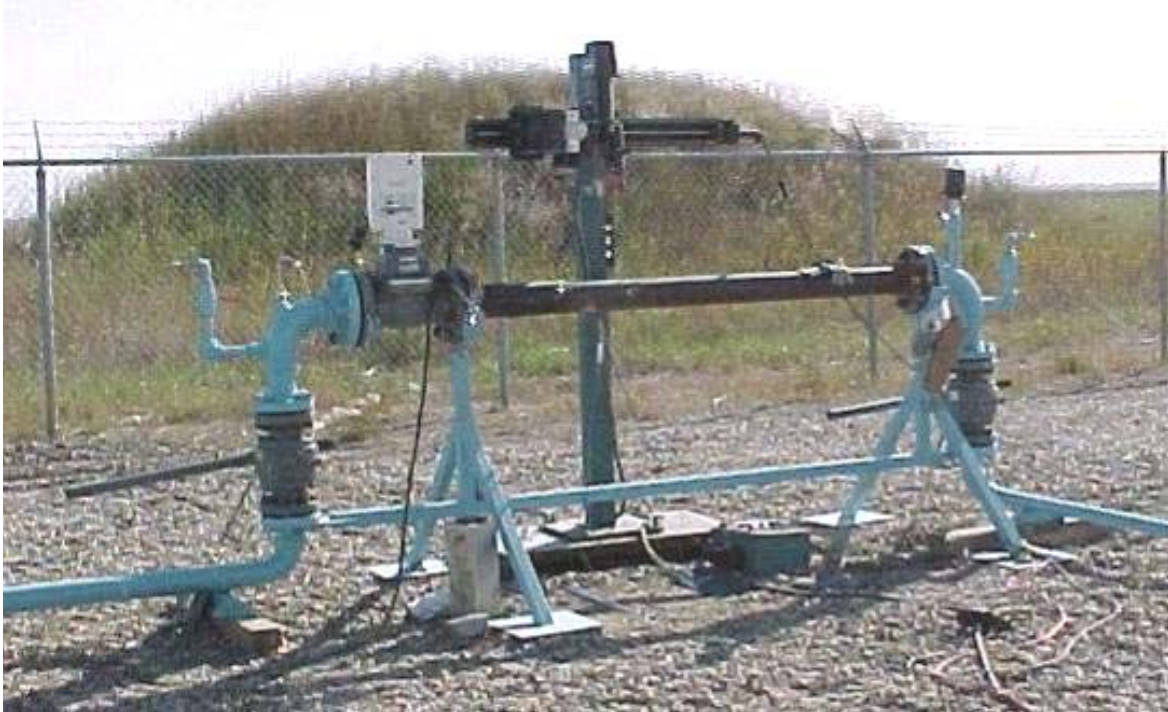
**Figure 131 - Set-Up for Welding Thin Wall Pipe with Pressurized Methane Gas**

During any arc welding operation, the material being welded is exposed to temperatures that range from ambient to well above the melting temperature 1,536°C (2,736°F). When steel at high temperature is exposed to a hydrocarbon gas (such as methane), carburization can occur. When steel at temperatures above 1,130°C (2,066°F) is exposed to methane, eutectic iron can form as the result of diffusion of carbon from the methane into the steel. In previous work at EWI,<sup>(7)</sup> welds were made on the outside of a thin-wall (3.2 mm (0.125 in.)) pipe containing methane gas pressurized to 4.5 MPa (650 psi) with a flow rate of 6.1 m/sec (19.9 ft./sec). Figure 131 shows the equipment set-up used to perform these welding trials.

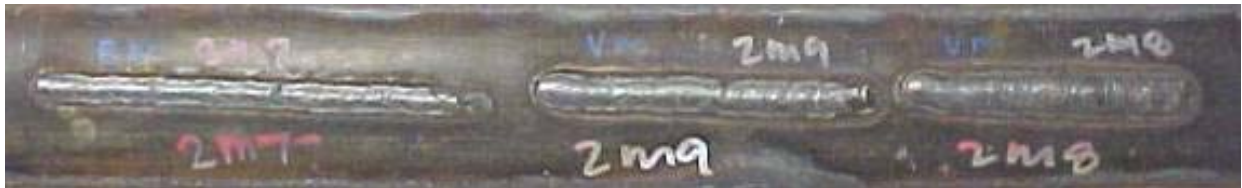
**Figure 132 - Welds Made in Pressurized Methane - Appearance from OD**

Figure 132 shows the external appearance of welds 2M7, 2M9, and 2M8 made on the outside of the thin-wall pipe under these conditions. Figure 133 shows the appearance of these welds from the inside.

Figure 134 is a metallographic cross section thru Weld 2M9 (from Figure 132 and Figure 133).

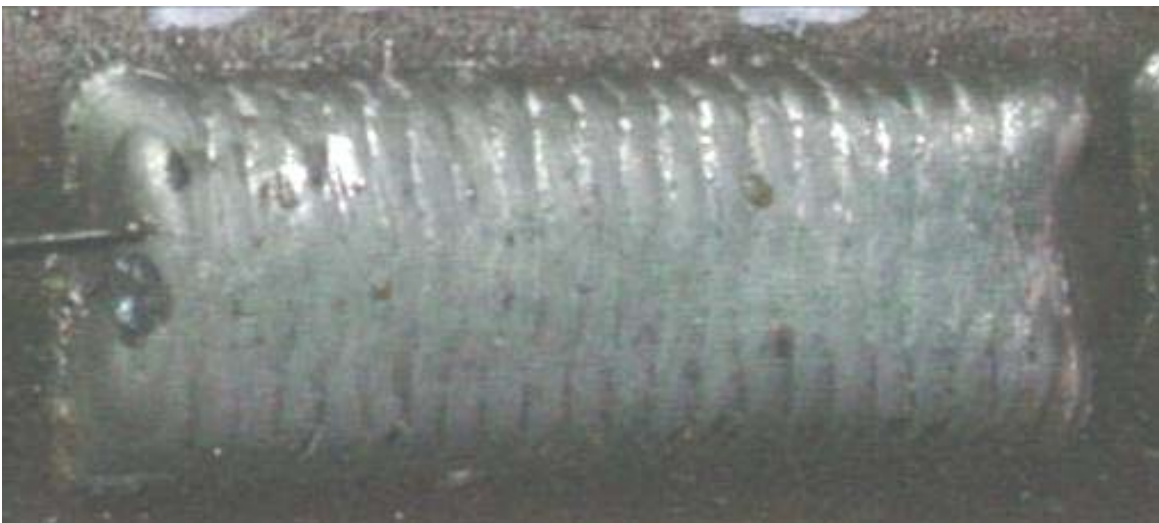
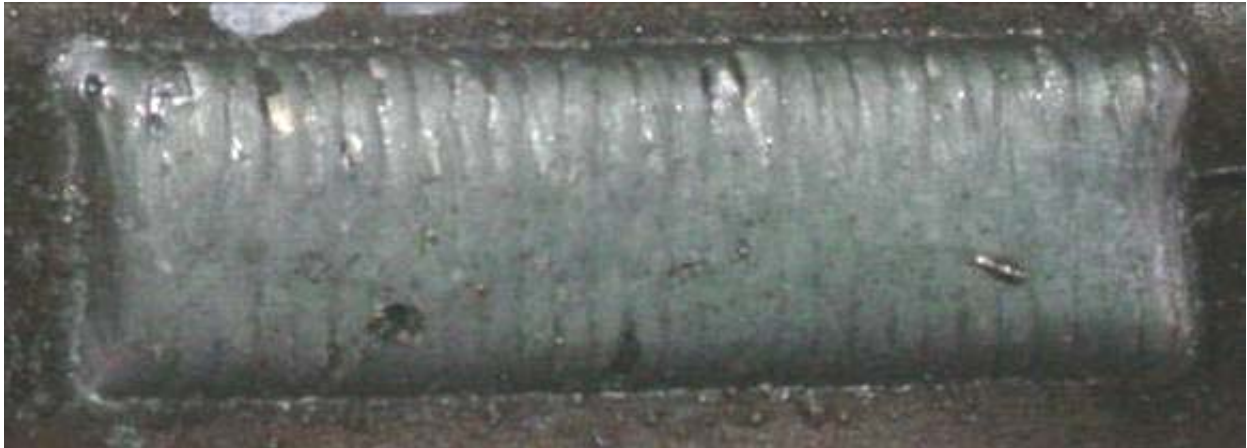
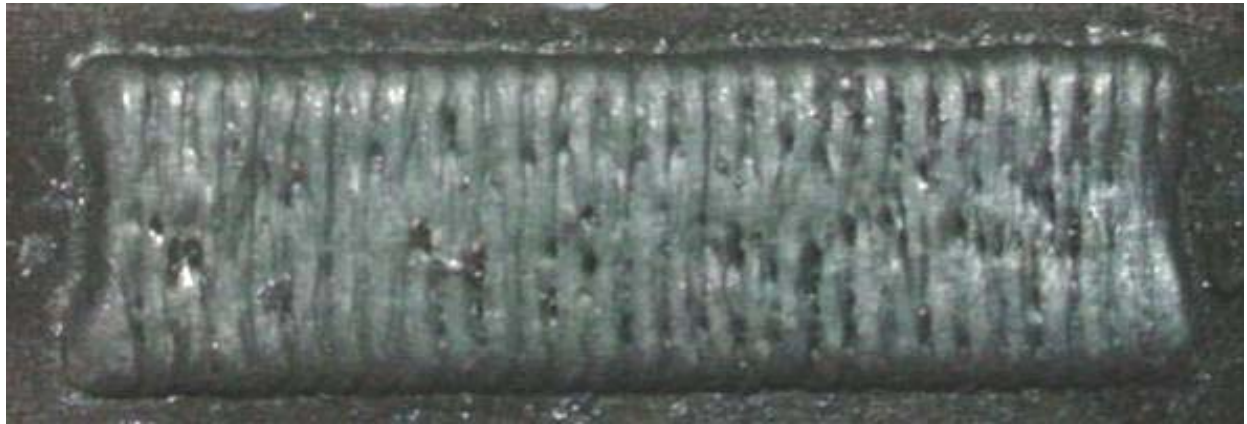
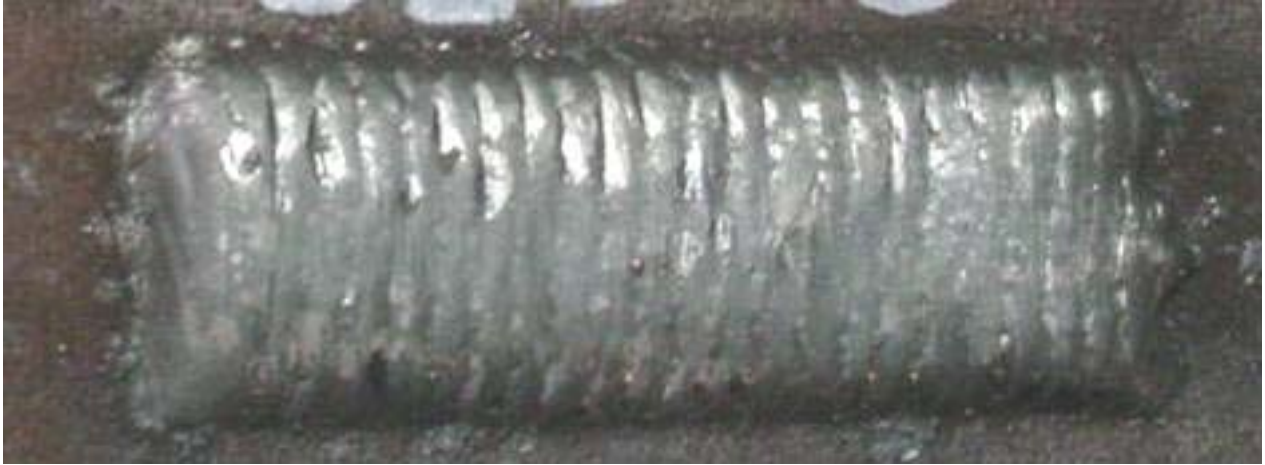
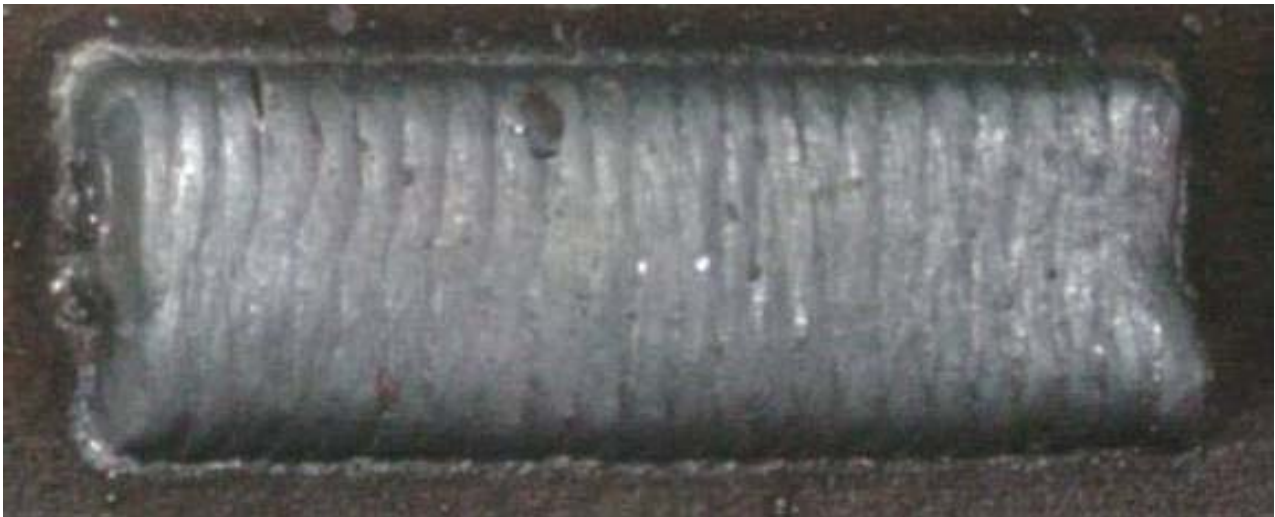
Photos of welds that were made during this portion of the investigation are shown in Figure 138 through Figure 144. A visual examination of the samples revealed that a volume of 3% methane in the shielding gas caused porosity in weld specimens 325-4 (Figure 140), 325-5 (Figure 141), and 325-9 (Figure 144).

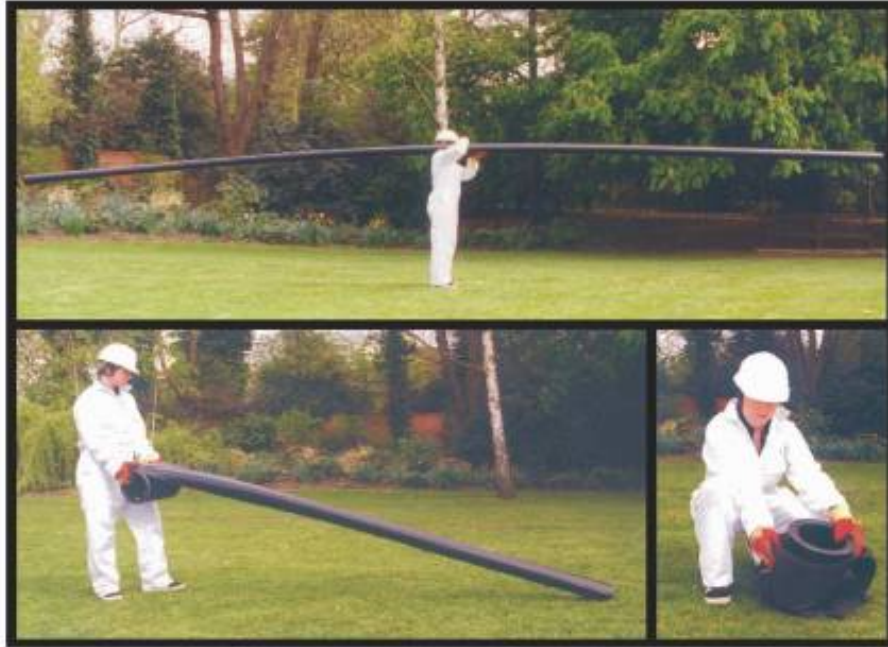
**Figure 145 - RolaTube Bi-Stable Reeled Composite Material**

The investigation of glass fiber (GF) reinforced liner repairs resulted in the discovery of several potentially useful commercial fiber-reinforced composite liner products that are directly applicable to internal repair. The GF test program focused on a modified Wellstream-Haliburton/RolaTube product, which was a bi-stable reeled composite material used to make strong, lightweight, composite pipes and pipe linings (Figure 145). When unreeled, this product changes shape from a flat strip to an overlapping circular pipe liner that is pulled into position. One example of this product is 100 mm (4 in.) diameter by 2.5 mm (0.10 in.) thick that has a 5.9 MPa (870 psi) short-term burst pressure.

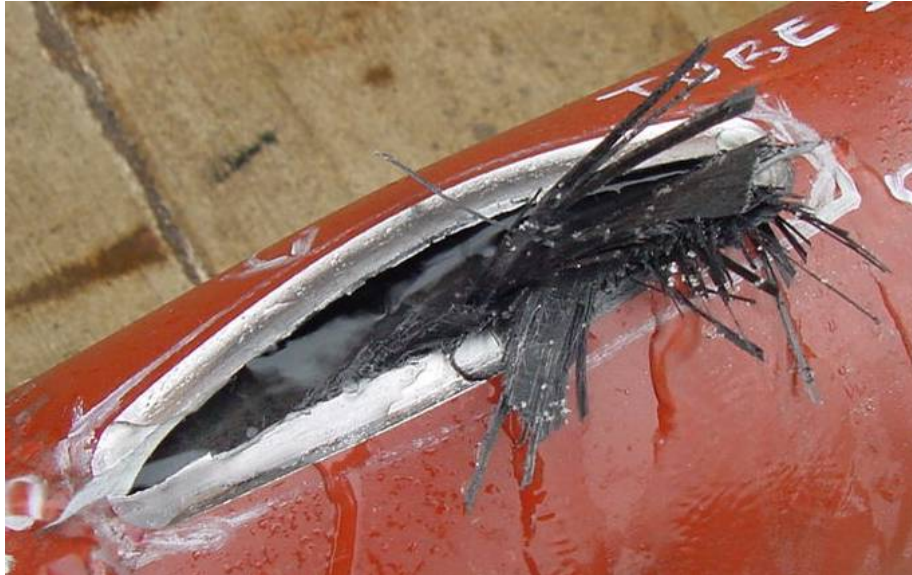
**Figure 146 - Test 02 Pipe with GF Liner Repair of Long/Shallow Damage After Burst Test**

After end caps were welded on the ends of the pipe section (Figure 12), the Test 02 pipe was hydrostatically pressurized to failure. The specimen ruptured in the area of simulated corrosion damage as shown in Figure 146.

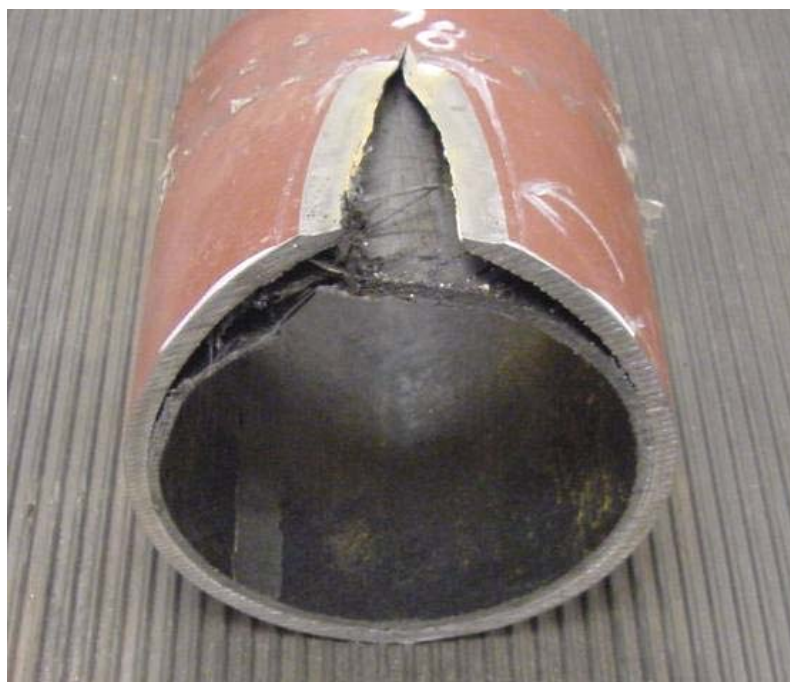
**Figure 147 - Cross Section of Test 02 Burst Test Specimen**

A postmortem analysis was conducted on the Test 02 burst test specimen. So as not to damage the liner, water jet cutting was used to section the specimen. Results indicate that the liner did rupture (Figure 147 and Figure 148), thus disbonding was not an issue.

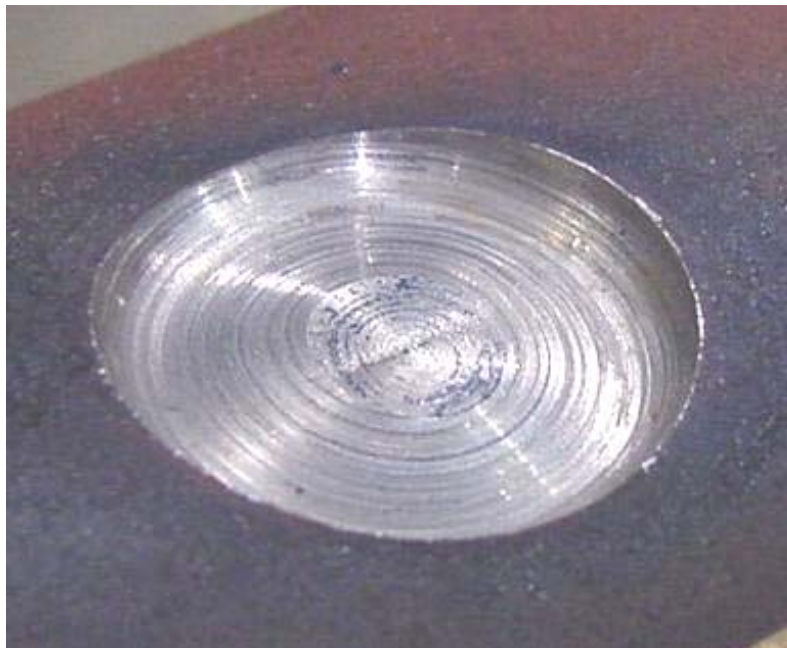
**Figure 149 - Test 03 Pipe with GF Liner Repair of Short/Deep Damage after Burst Test**

After end caps were welded on the ends of the pipe section (Figure 12), the Test 03 pipe was hydrostatically pressurized to failure. The specimen developed a leak in the center of the simulated corrosion damage as shown in Figure 149.

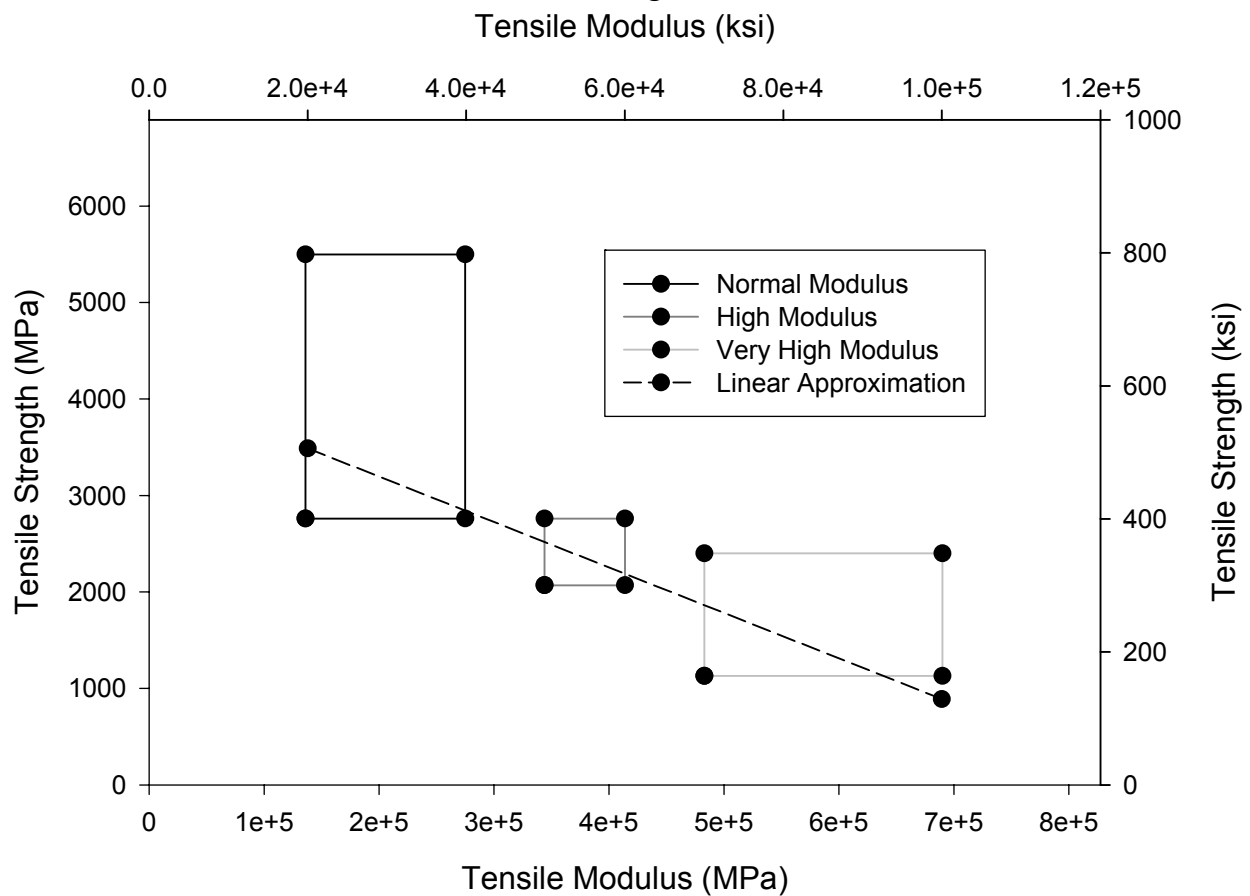
**Figure 150 - Relationship Between Modulus and Strength for Carbon Fibers**

Figure 150 shows some estimates of the ranges of tensile strength and modulus for carbon fibers. The strength goes down as the modulus increases, a relationship that can be approximated by a linear relationship between the fiber modulus  $E_f$  and the tensile strength of the fiber  $\sigma_{fu}$

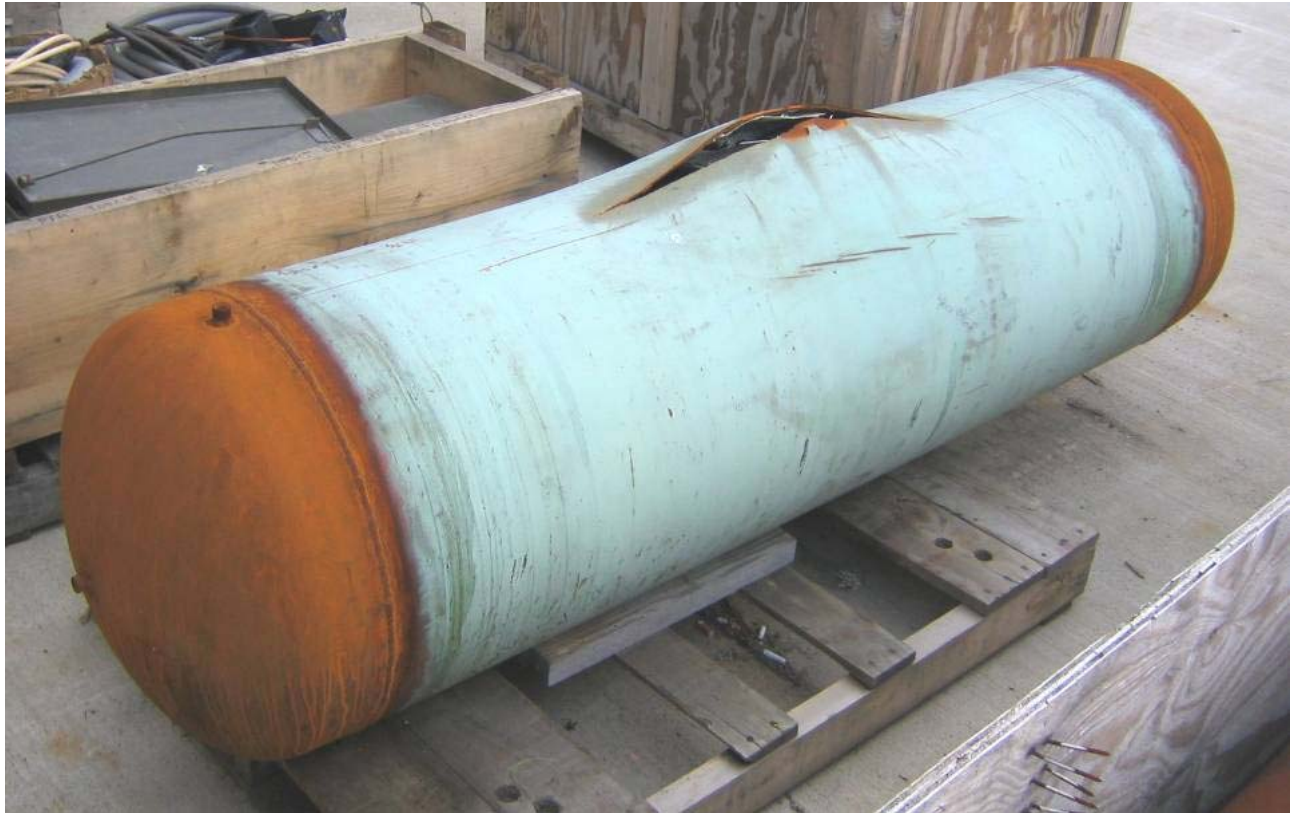
**Figure 152 - Test 04 Pipe With CF Patch Repair After Burst Test**

After two weeks of adhesive cure time, end caps were welded on the pipe section and the specimen was hydrostatically tested to failure (Figure 152). Rupture occurred in the area of reduced thickness.

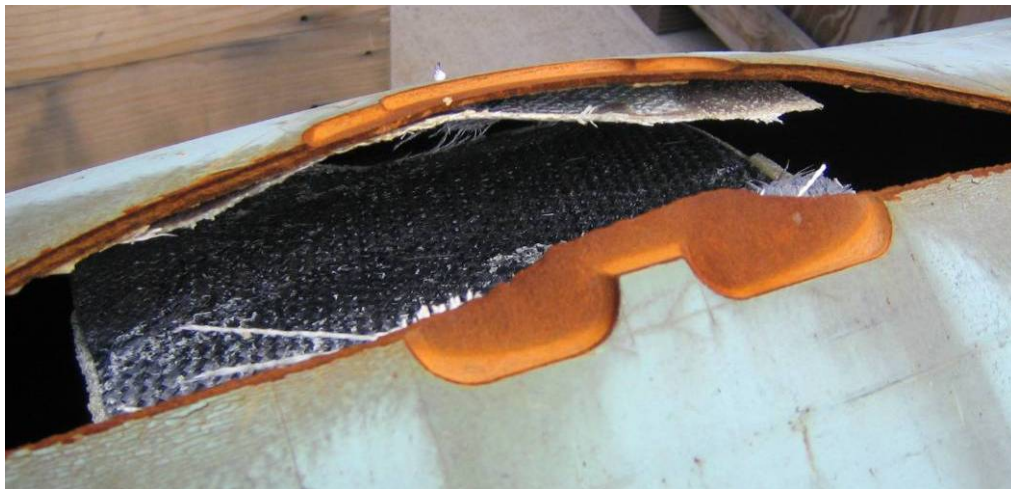
**Figure 153 - Test 04 Failure Initiation Site**

Figure 153 is a closer view of the failure initiation site. Figure 154 clearly shows that the failure was caused by interlaminar shear mostly between the anti-corrosion glass layer and the carbon layer (1 → 2 layer interfacial failure is common in composites). There was no evidence of disbonding between the pipe and the composite liner.

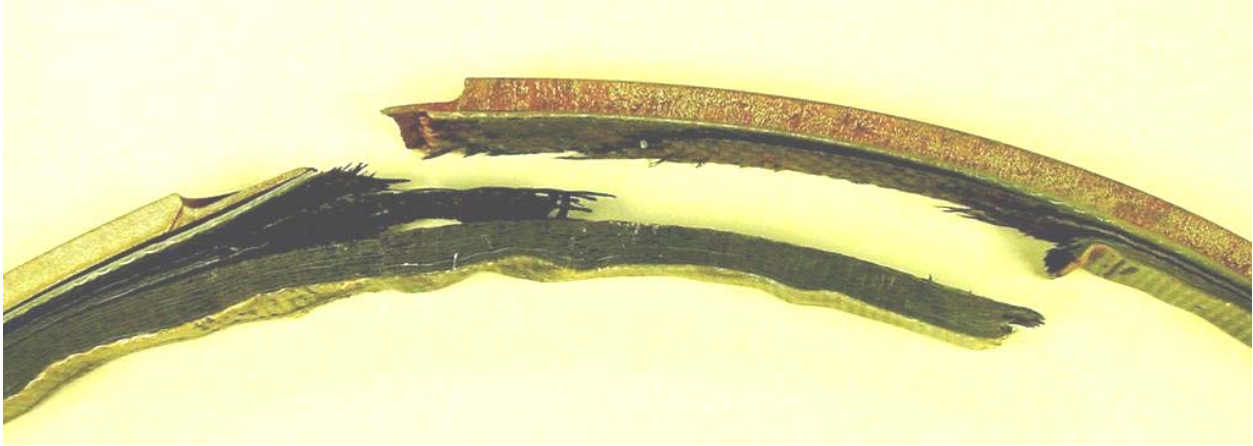
**Figure 156 - Failure of Test 05 Pipe and Composite Repair**

The pipe section with Test 05 patch was then sectioned in the circumferential direction. Figure 156 and Figure 157 show cross sections taken from locations in the area of the simulated corrosion damage. Figure 156 shows a full failure of the pipe and composite repair. Figure 157 shows a failure of the pipe and the disbondment between the ID of the pipe and the composite repair. This failure was caused by interlaminar shear, which appears to have occurred after the steel reached the plastic range (i.e., after the yield point of the steel was exceeded).

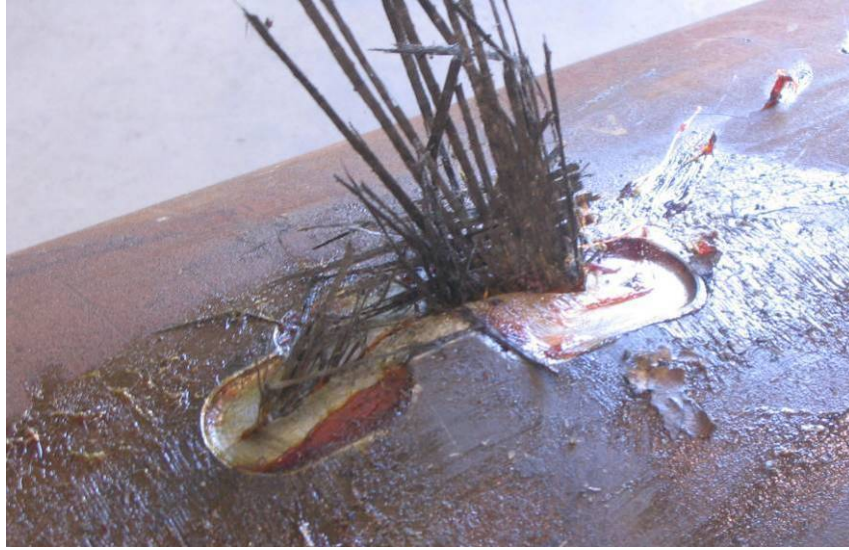
**Figure 158 - Test 06 Damage after Burst Testing**

Figure 158 shows the failure of the Test 06 patch from the OD of the pipe section.

Postmortem analysis indicate that the Test 06 patch failed due to interlaminar shear, which appears to have occurred after the steel reached the plastic range (i.e., after the steel's yield point was exceeded). This failure mode was very similar to that of the Test 05 patch.

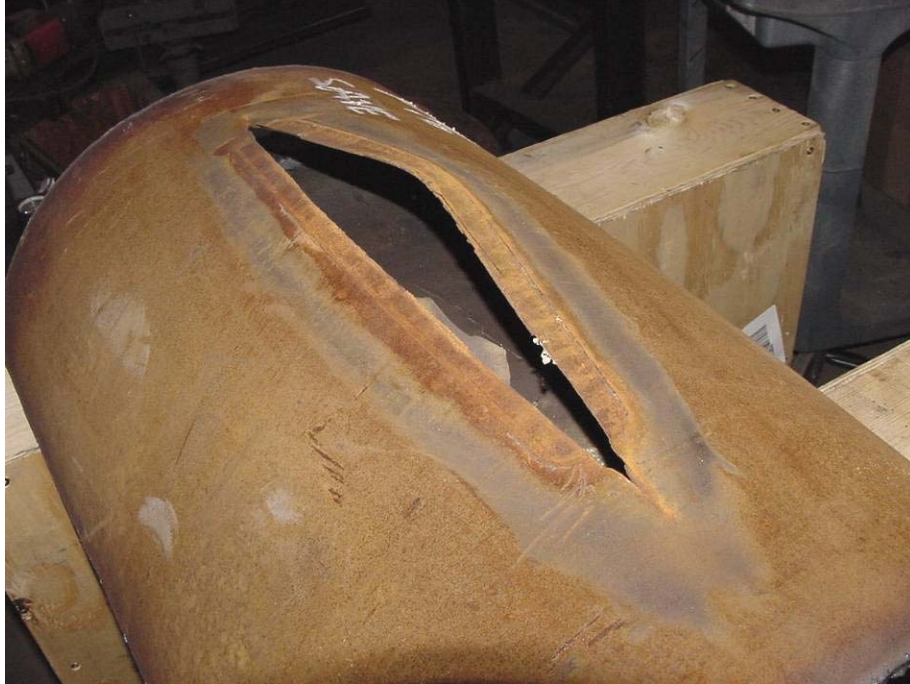
**Figure 159 - Test 07 Damage After Burst Test**

Figure 159 shows the OD of the Test 07 pipe section with long/shallow simulated damage after burst testing.

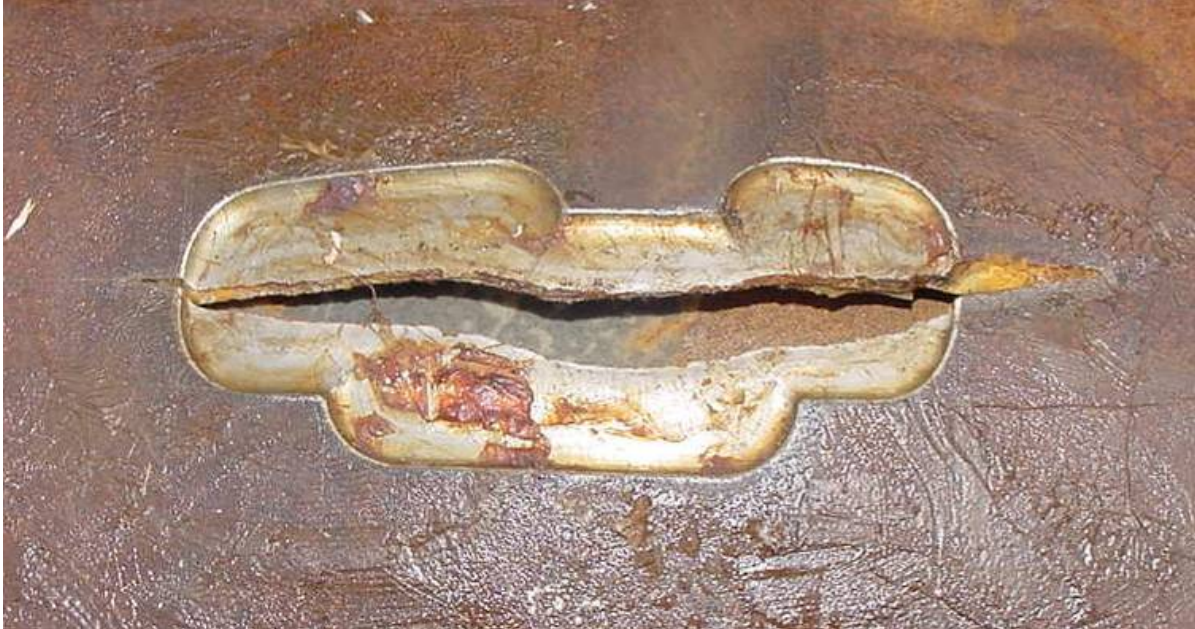
**Figure 163 - Test 08 Damage after Burst Test**

Figure 163 and Figure 164 show the OD and ID, respectively, of the Test 08 pipe section with steel patch repair after burst testing.

Postmortem analysis indicates that, as in Test 07, the adhesive between the outside of the patch and the inside of the pipe failed in shear when the pipe material began to globally yield.

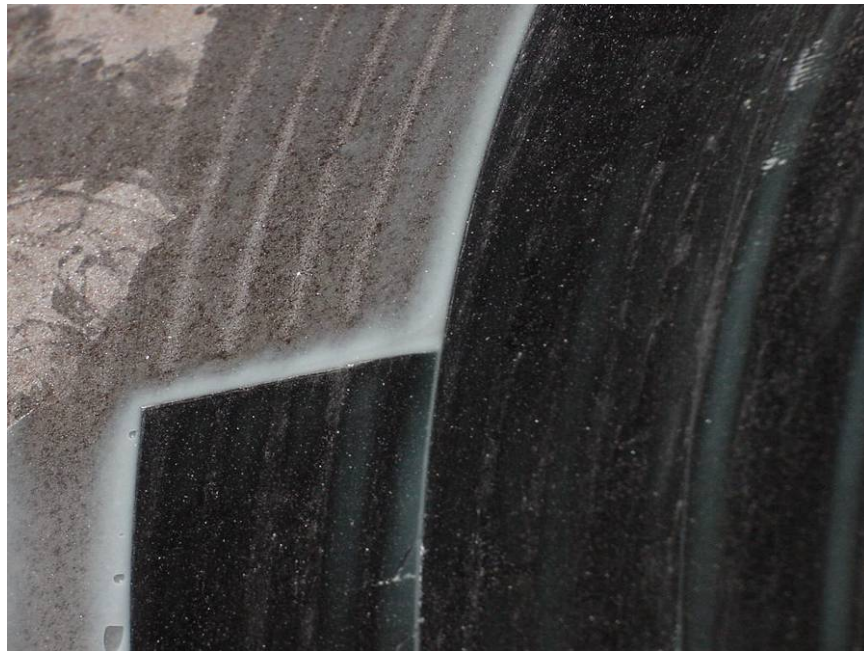
**Figure 166 - Close Up of Completed Helically Wound Steel Strip Repair**

Figure 166 is a close up of the same installation which shows good intimate contact between the adjacent windings of the steel strip and between the OD of the helically wound steel strip and the ID of the pipe.

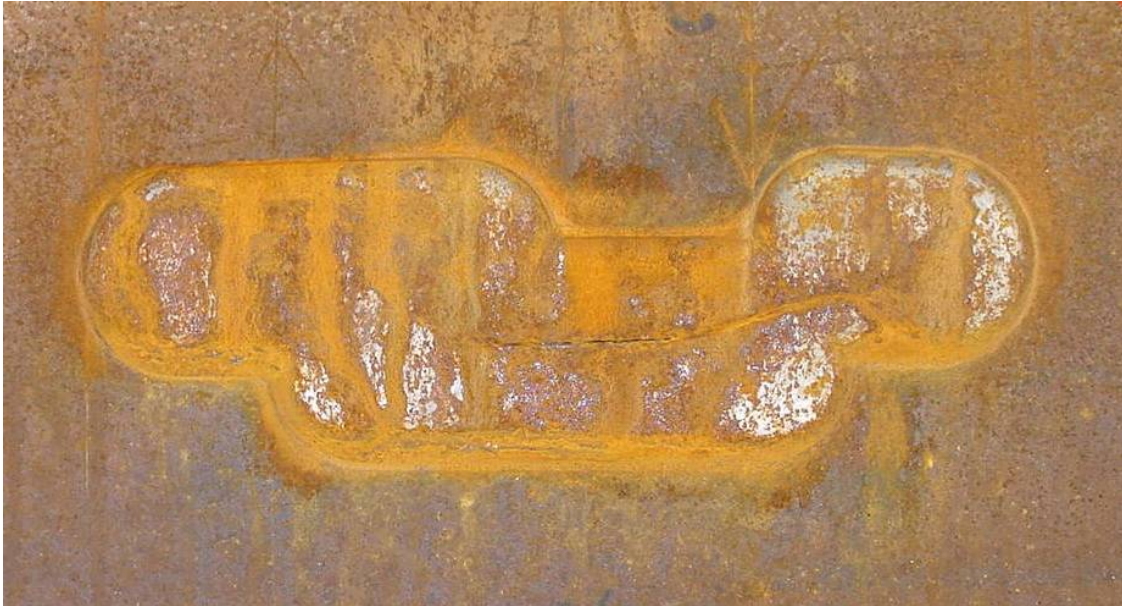
**Figure 167 - Test 09 Damage after Burst Test**

Figure 167 shows the defect on the OD of the Test 09 pipe section with helically wound steel strip repair after burst testing.

Postmortem analysis indicates that Test 09 also failed when the pipe material began to globally yield. Upon doing so, the adhesive failed in either tension or shear, which allowed a leak path through the layers of helically wound steel strip to develop. This in turn allowed pressure to act upon the defect, after which it failed. It is interesting to note that the failure was a leak (as shown in Figure 161) as opposed to a rupture.

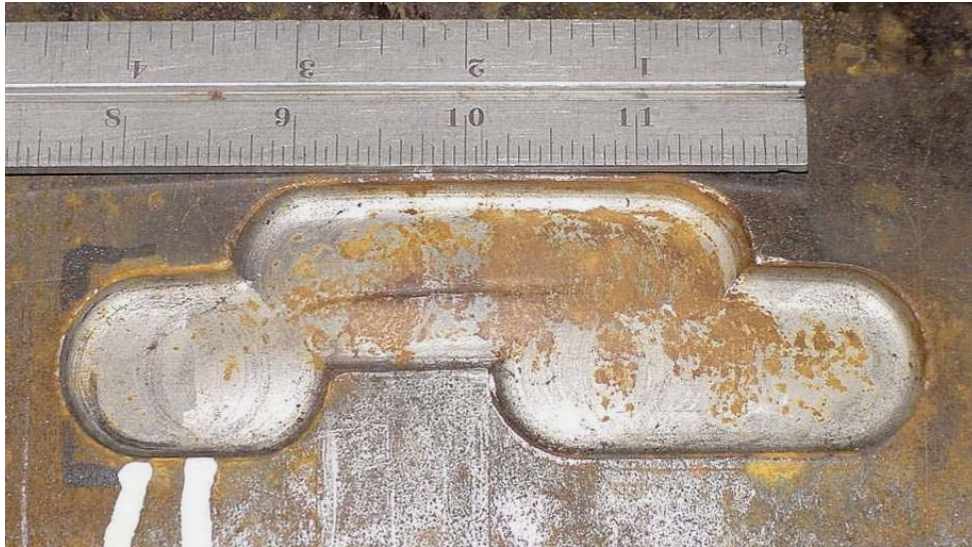
**Figure 168 - Test 10 Damage after Burst Test**

Figure 168 shows the defect on the OD of the Test 10 pipe section with helically wound steel strip repair with Lord 7542 A/D adhesive after burst testing.

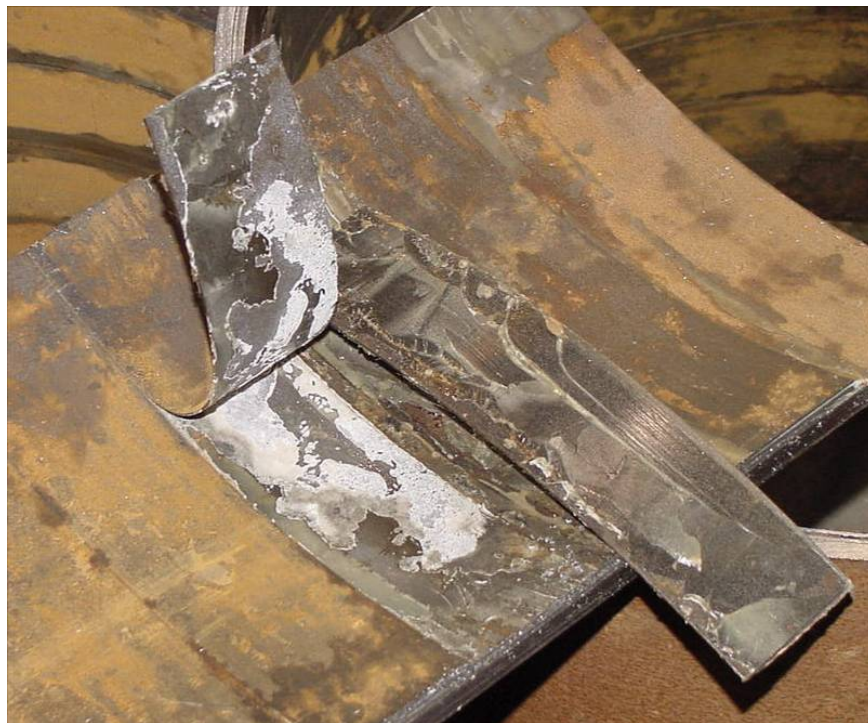
**Figure 169 - Large Number of Voids in Urethane Adhesive from Test 10**

Post mortem analysis of the Test 10 specimen revealed a large number of voids in the adhesive layer between the steel strip and the pipe ID (Figure 169). It was not clear whether this was the result of the shorter cure time associated with the urethane adhesive as compared to the epoxy adhesive or the result of having used a smaller quantity of adhesive.

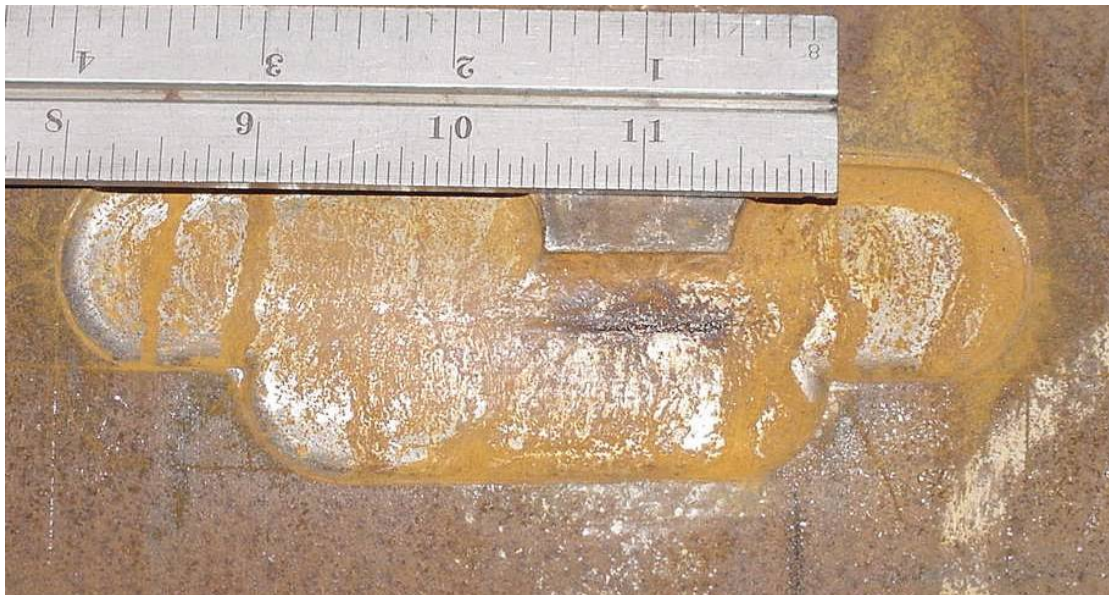
**Figure 170 - Test 11 Damage after Burst Test**

Figure 170 shows the defect on the OD of the Test 11 pipe section with the low strength helically wound steel strip repair after burst testing.

As with Test 10, postmortem analysis of the Test 11 specimen revealed a large number of voids in the adhesive layer between the steel strip and the pipe ID. It is not clear whether the performance of this repair was adversely affected by these voids, which were apparently the result of having used a smaller quantity of adhesive, or by the lower strength steel strip material.

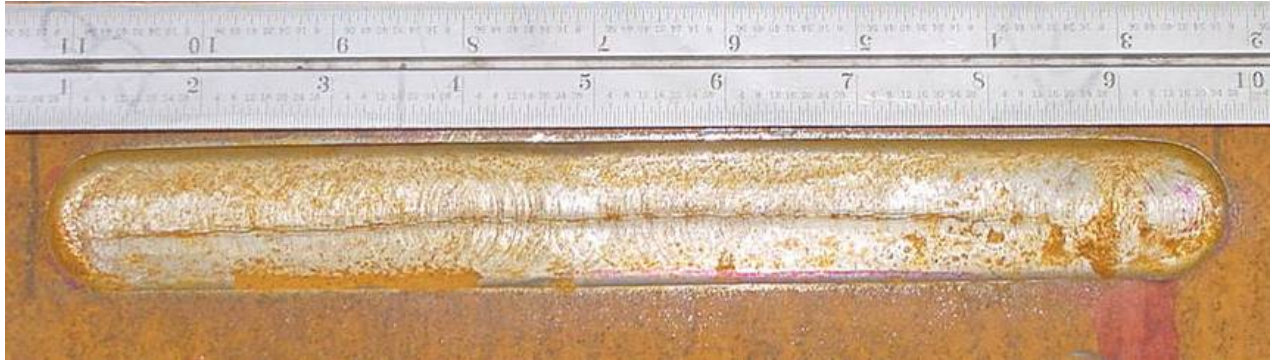
**Figure 171 - Test 12 Damage after Burst Test**

Figure 171 shows the defect on the OD of the Test 12 pipe section with helically wound steel strip repair after burst testing.

Post mortem analysis indicates that Test 12 developed a leak along the length of the simulated corrosion damage after the pipe steel experienced a significant amount of global yielding (i.e., well beyond the point where the yield strength was exceeded). Figure 172 contains the pressure vs. time plot for Test 12.

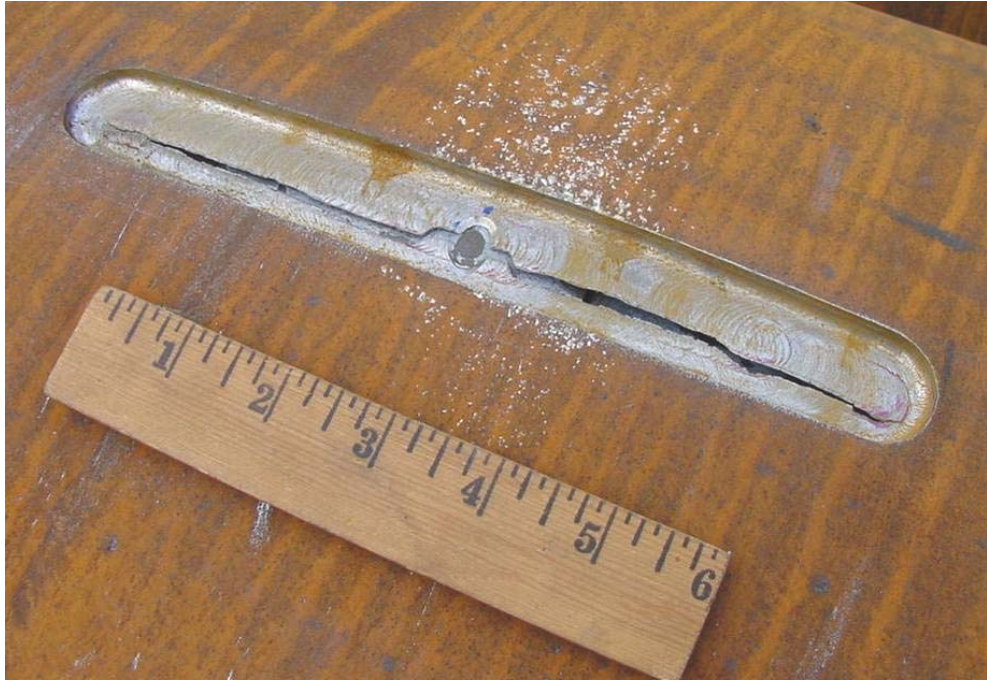
**Figure 173 - Test 13 Damage after Burst Test**

Figure 173 and Figure 174 show the defect on the OD of the Test 13 pipe section with helically wound steel strip repair after burst testing.

Post mortem analysis indicates that Test 13 developed a leak along the length of the simulated corrosion damage after the pipe steel experienced a significant amount of global yielding (i.e., well beyond the point where the yield strength was exceeded). Figure 175 contains the pressure vs. time plot for Test 13.

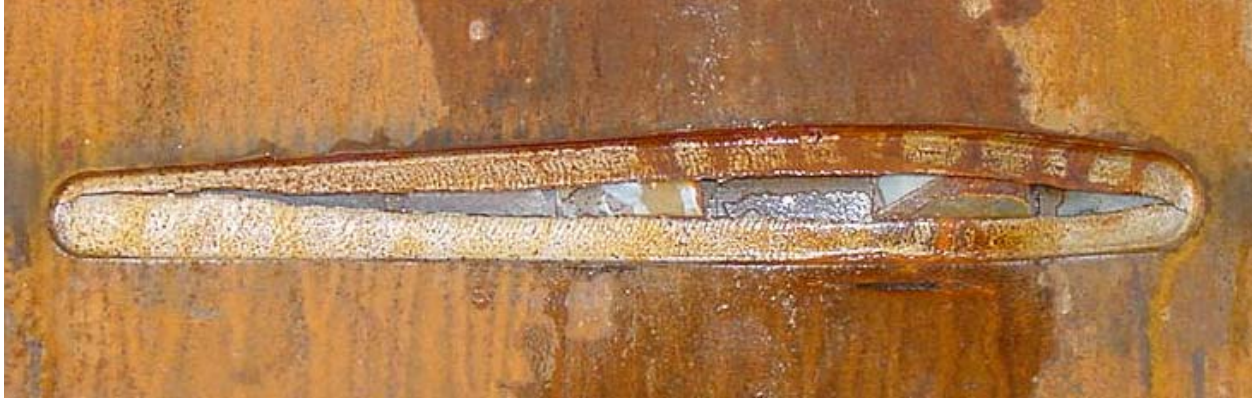
**Figure 176 - Test 14 Damage after Burst Test**

Figure 176 and Figure 177 show the defect on the OD of the Test 14 pipe section with helically wound steel strip repair after burst testing.

Post mortem analysis indicates that Test 14 developed a leak along the length of the simulated corrosion damage after the pipe steel experienced a noticeable amount of global yielding (i.e., beyond the point where the yield strength was exceeded). Figure 178 contains the pressure vs. time plot for Test 14.
