The Development of a Permanent, Mechanical Repair Sleeve for Plastic Pipe

Contract No. 03-NT41880.000

Technology Assessment Review

Bart Hill
Gas Technology Institute
Des Plaines, IL 60018

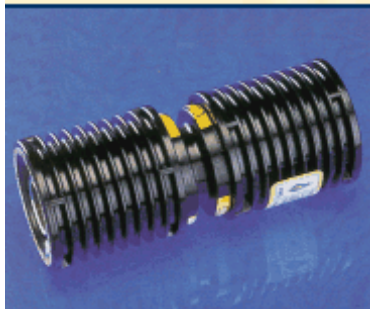
There are several different methods that are utilized for connecting the replacement PE piping to the existing infrastructure including mechanical fittings (see Figure 1 below, R.W. Lyall's LYCOFIT® double ended fitting²), heat fusion joining, and / or electrofusion fittings. Nevertheless, the replacement of the damaged pipe portion does require the main to be completely shut down. This process is even more cumbersome when flow is required to keep customers downstream of the damaged area to be kept "live". This would then require a bypass to be installed and subsequently impacting both costs and labor.

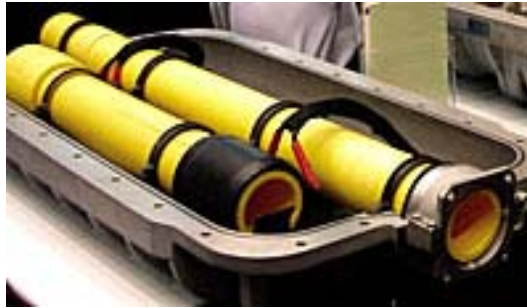
Figure 4

Mueller and Co. offers the Magic Box (Figure 4) as an additional tool for repairing scraped or gouged plastic main without having the need to shutdown the flow of gas. The Magic Box is bolted over the damaged section of pipe that is to be cut out and replaced using the Box's technology. Under live conditions, the Magic Box cuts out the damaged section of pipe and moves a new replacement piece inline with the existing main. The replacement pipe is then electrofused into place making the repair complete. The Magic Box can repair two, three and four inch plastic pipe, as

well as fuse in the respective size valve. The installation of the Magic Box is not suitable for third-party damaged ruptures under a blowing gas condition.

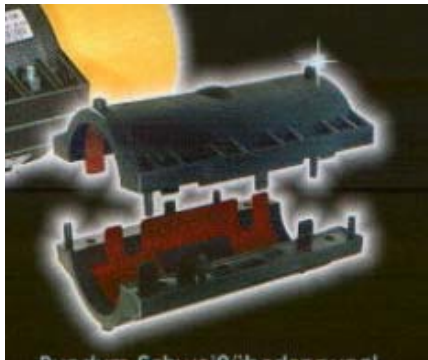
Figure 5

In Europe, DA Export offers an electrofusion repair fitting (Figure 5) for PE pipe. This repair fitting can be installed on a pressurized pipe that has been gouged or on a non-pressurized gas main that has been breached. However, the product is only available in European pipe sizes and must be modified to accommodate the U.S. market.
