Internal Repair of Pipelines – Project Review Meeting

NETL Project No. NT 41633

May 12, 2005 – Morgantown, WV

Bill Bruce and Nancy Porter
Edison Welding Institute

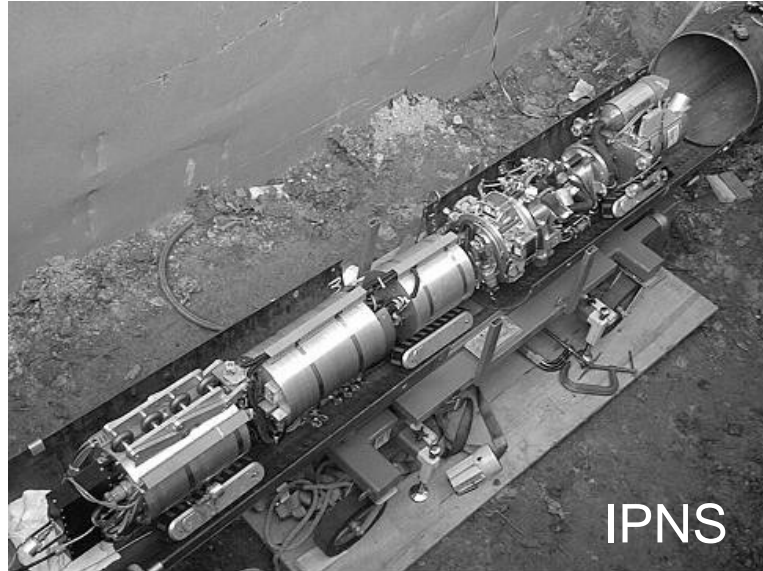
IPNS

- Developed primarily by needs in the nuclear power industry
- Working devices have been built for other applications
 - Osaka Gas
 - Remote robotic equipment for repair of flaws in the root area of girth welds in gas transmission lines
 - PG&E Internal Pipeline NDE System (IPNS)
 - Uses several inspection technologies to characterize girth weld and long seam flaws, corrosion, and dents and gouges
 - Grinder is incorporated for preparation of areas of interest

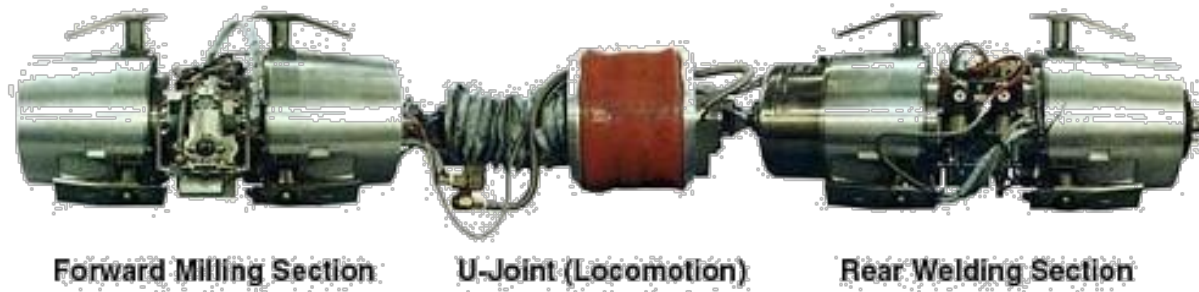
WISOR

Forward Milling Section

U-Joint (Locomotion)

Rear Welding Section

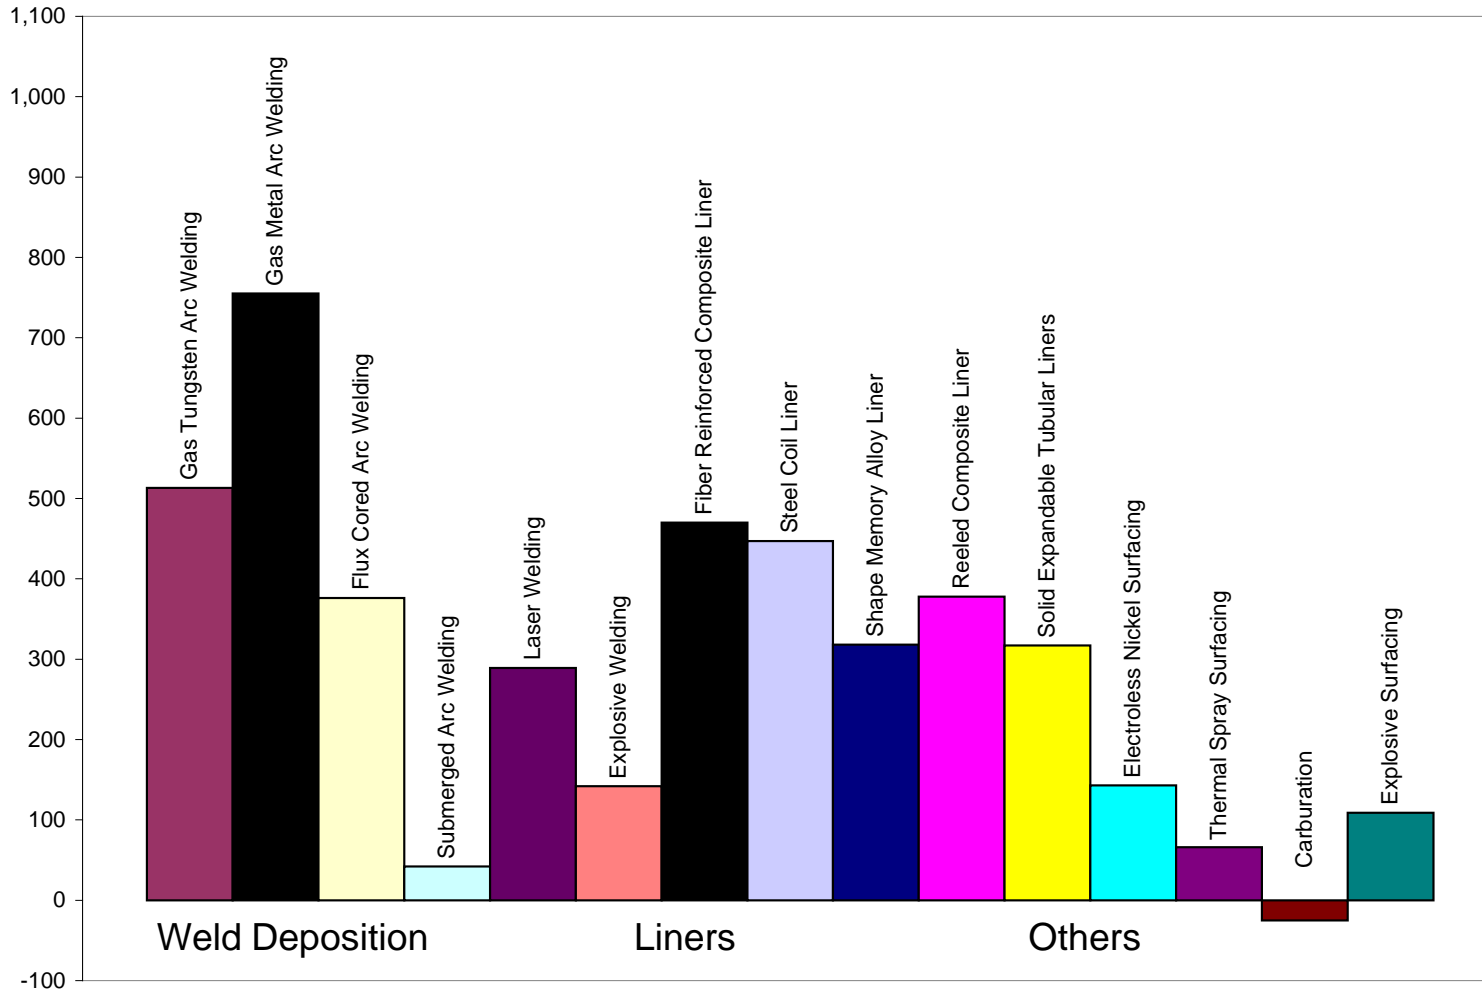
Composite Score for Potential Repair Methods

- Evaluation exercise was carried out to determine which specific repair options should be emphasized in the experimental portion of this project
- Five major feasibility categories were included
 - Technical feasibility
 - Inspectability of completed repairs
 - Technical feasibility of the process while the pipeline is in service
 - Repair cost
 - Industry experience with the repair method

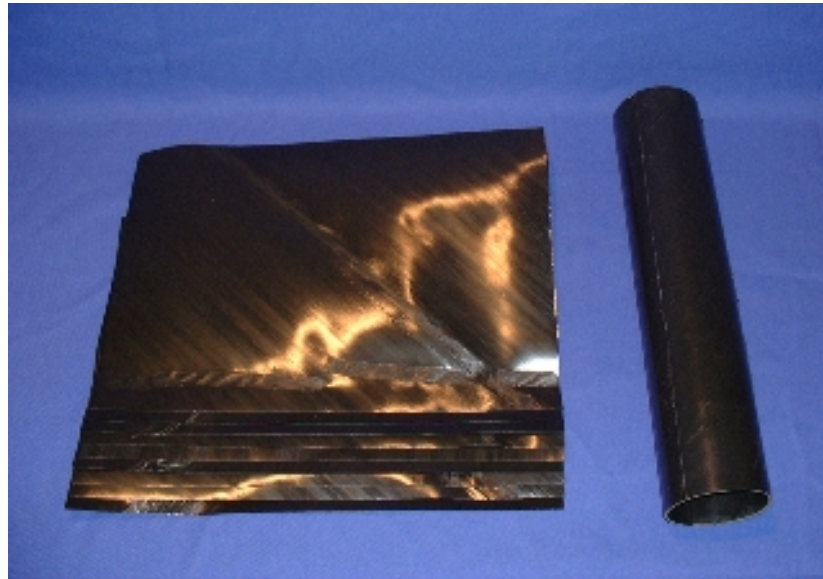
Liner Material Lay-up and Forming

- Lay-up
 - 9 plies of glass-polypropylene precursor (Plytron)
 - “Pre-preg” tapes of unidirectional glass and polymer
 - +/- 45° orientation
 - Tapered overlapping seam
- Forming
 - Plies consolidated into liner with heat and pressure
 - Wall thickness of liner is 0.11 in.

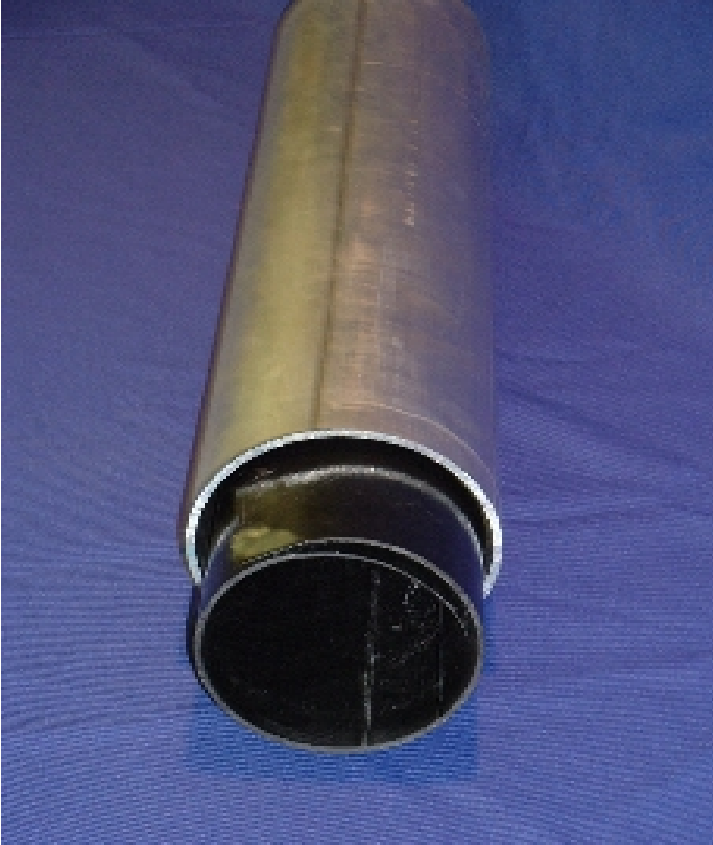
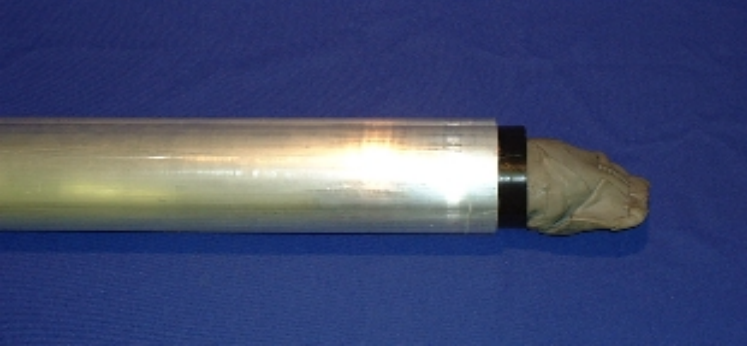
Pipe Lining Process

- API 5L Grade B – 4.5 in. diameter by 0.156 in. wall thickness
- Procedure
 - De-grease and prepare inner surface
 - Insert silicon rubber bag into liner and locate inside pipe
 - Inflate bag to press liner against pipe wall
 - Heat to ~400° F in oven to fuse liner to pipe wall
- Test set up required external heating of pipe
 - In field, possible choices include:
 - IR heaters on an expansion pig
 - Inflatable bag using hot air

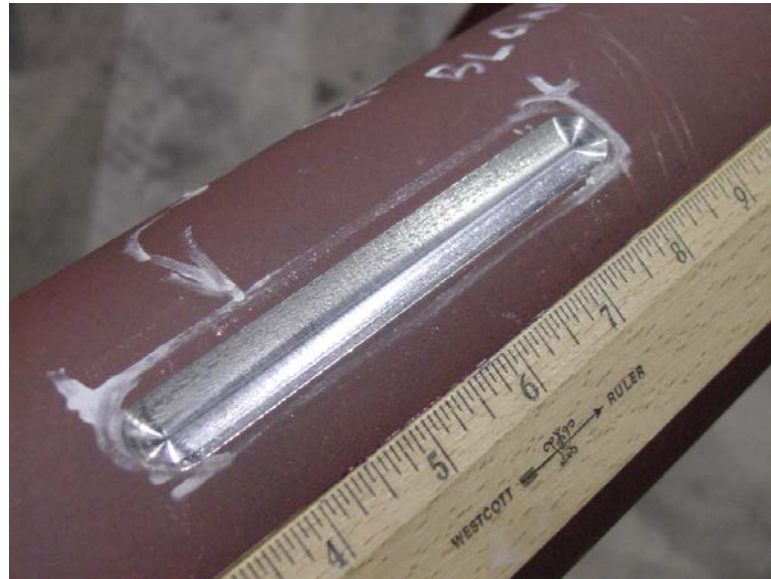
Simulated Corrosion Damage

- Simulated corrosion damage was introduced into four pipe sections
 - Two without lining and two with lining
- Long, shallow damage representative of general corrosion
- Short, deep damage representative of a deep isolated corrosion pit
 - ~30% reduction in burst pressure

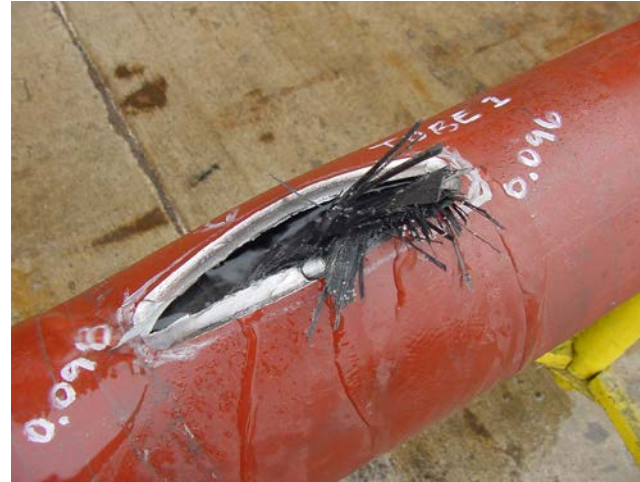
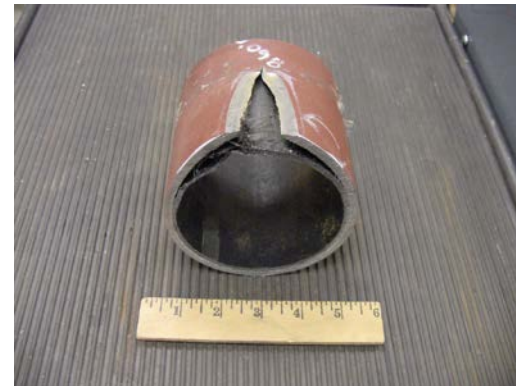
Hydrostatic Pressure Testing

- Failure pressures for pipes with liners were only marginally greater than pipes without liners
- Analysis of results
 - Difference in modulus of elasticity between the steel and the liner material prevents the liner from carrying its share of the load
- Disbonding was not an issue

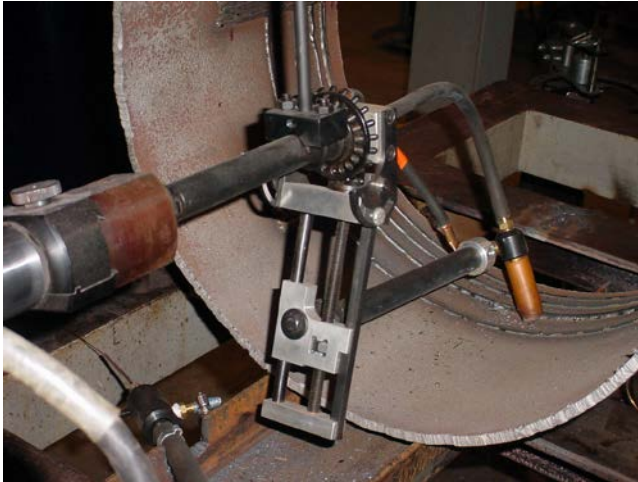
Bortech

- Three welding systems were evaluated for use in the development of welding parameters
 - Internal bore cladding system (Bortech)
 - Six-axis robot capable of complex motion control (OTC Daihen)
 - Orbital welding tractor configured for inside welding (Magnatech Pipeliner)
- OTC robot welding system was used to develop baseline repair welding parameters
 - Transfer parameters to a more-suitable system for pipeline repair demonstrations
- API 5LX-52 – 22 in. diameter by 0.312 in. wall thickness

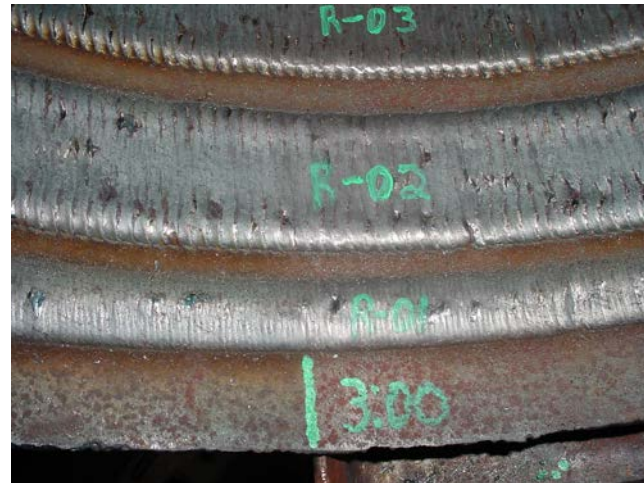
Ideal Weld Bead Shape

- Uniform thickness across weld section except near weld toes which should taper smoothly into the base material
 - Smooth toes promote good tie-ins with subsequent weld beads
- The fusion boundary should be uniform and free from defects
- Preliminary tests were also performed to evaluate bead overlap and tie-in parameters that would be required to make high quality repairs

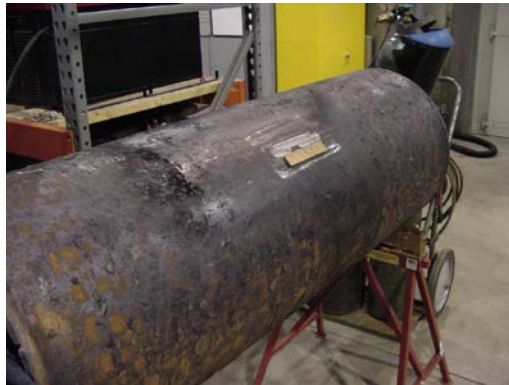
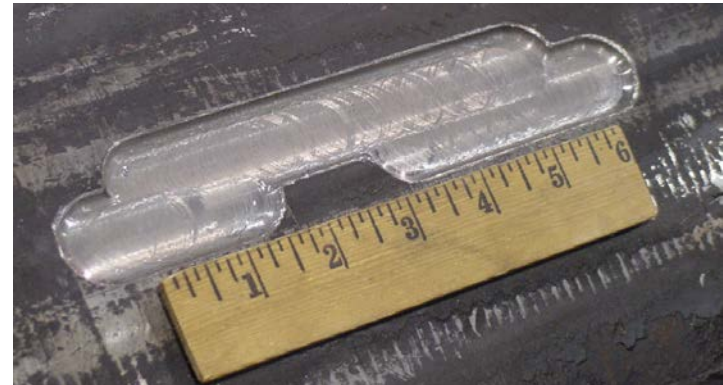
Weld Repair Experiment

- Pipe material
 - 22 in. diameter by 0.312 in. wall thickness API 5L-Grade B (1930's vintage)
- Simulated corrosion damage
 - 7.5 in long by 0.156 in. deep
 - 25% reduction in predicted burst pressure

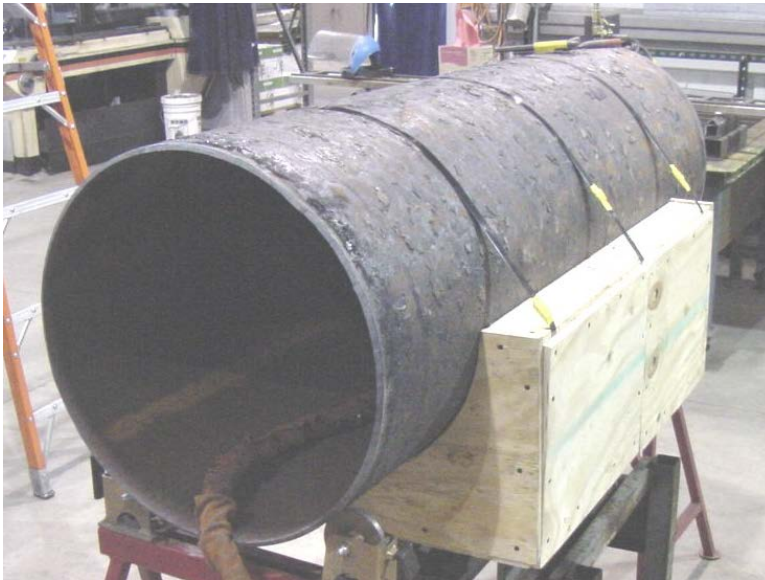
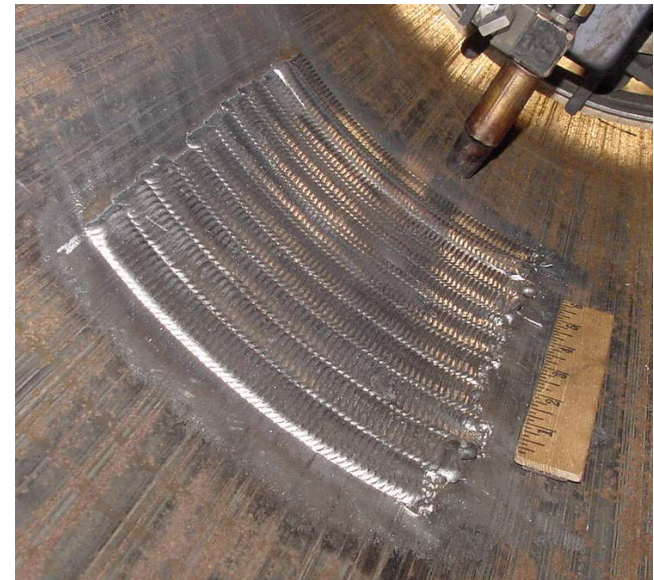
Deposition of Repair

- Soil box to simulate heat transfer to the surrounding soil
- Two layers of weld metal
 - After-repair minimum wall thickness > nominal wall thickness

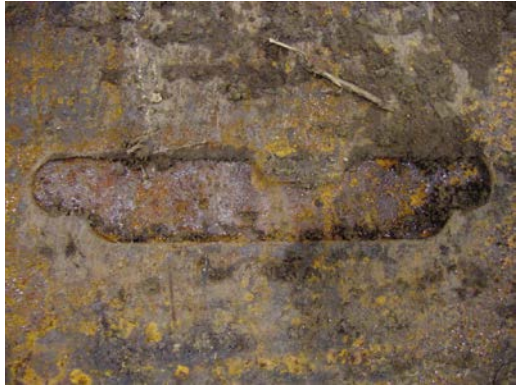
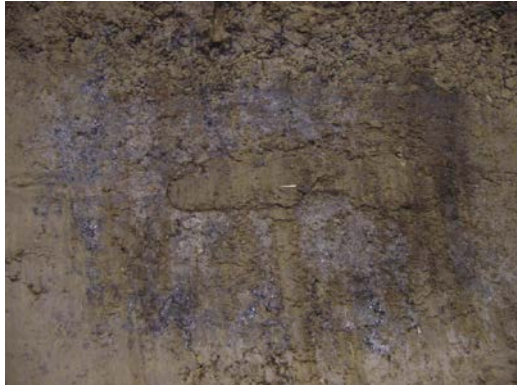
Coating Transfer and Welding Distortion

- Ultrasonic wall thickness measurements
 - Several areas of lack-of-fusion defects were detected between the weld toes of the first layer and the inside diameter of the pipe
 - Considered inconsequential given their size and circumferential orientation
- Visual examination
 - Asphalt coating melted and transferred to the surrounding soil during the welding process
 - Significant welding distortion from weld heating and cooling cycles resulted in out-of-roundness

- When applied to the outside of an exposed pipeline, dents or concavity that result from welding residual stresses can be overcome by simply applying more weld metal until the outside diameter of the pipe is restored

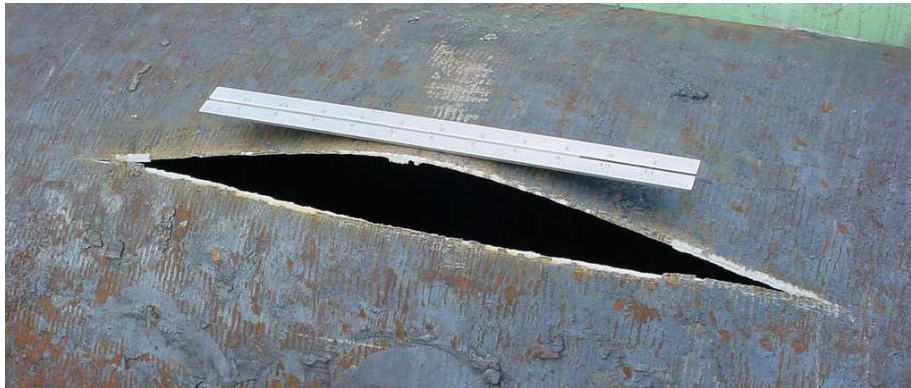
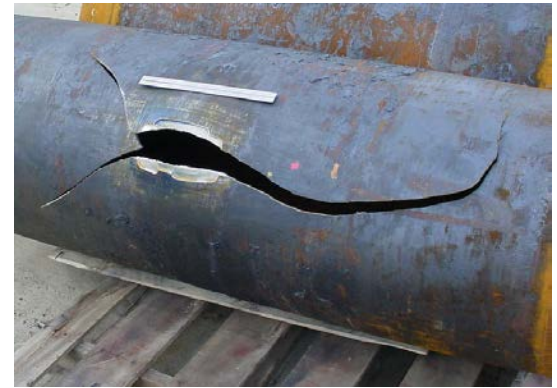
Hydrostatic Pressure Testing

- Burst test for pipe w/out damage
- Burst test for pipe w/un-repaired damage
- Burst test for pipe w/repair

- Pressure at 100% SMYS – 992 psi
- Burst pressure for pipe w/out damage – 1,841 psi
- Burst pressure for pipe w/un-repaired damage – 1,563 psi
 - 15% reduction from pipe w/out damage
- Burst pressure for pipe w/repair – 1,404 psi
 - 10% reduction from pipe w/un-repaired damage
 - 42% improvement from pressure at 100% SMYS
 - 23% reduction from pipe w/out damage

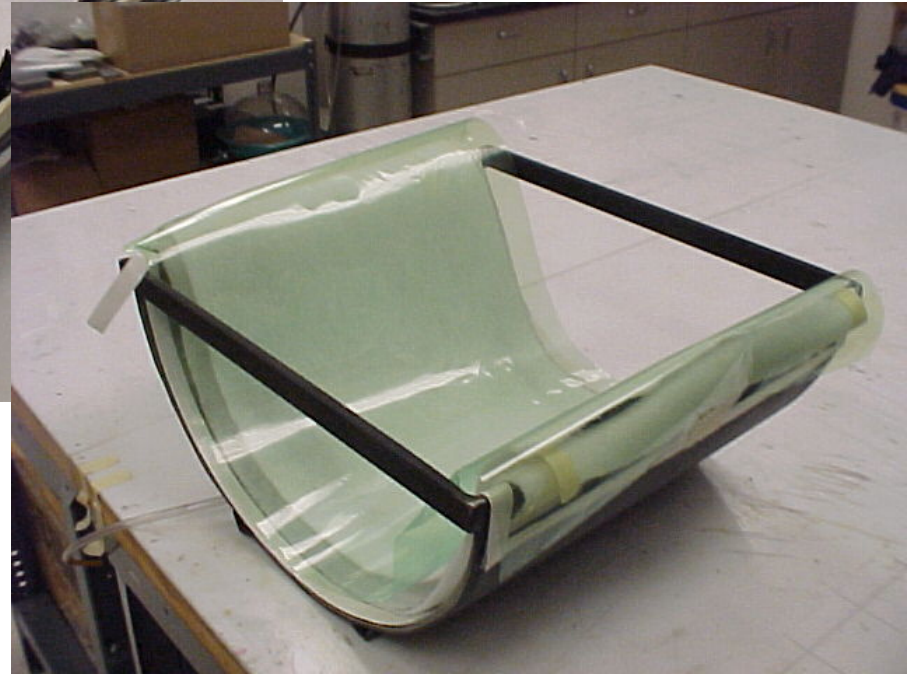
Wet Lay-up Followed by Vacuum Bagging

- Fabricated using a wet lay-up process followed by vacuum bagging
- The half-round composite patch had an outside diameter that matched the inside diameter of the pipe section
 - 10 in. in length, 28 in. wide, 0.45 in. thick
 - 27 layers; layers 1 and 27 were glass woven roving
 - Remaining layers consisted of alternating layers of +/- 45 degree and 0 - 90 degree (fiber orientation) carbon fiber fabric
- Calculated fiber volume was 40% - 45%.

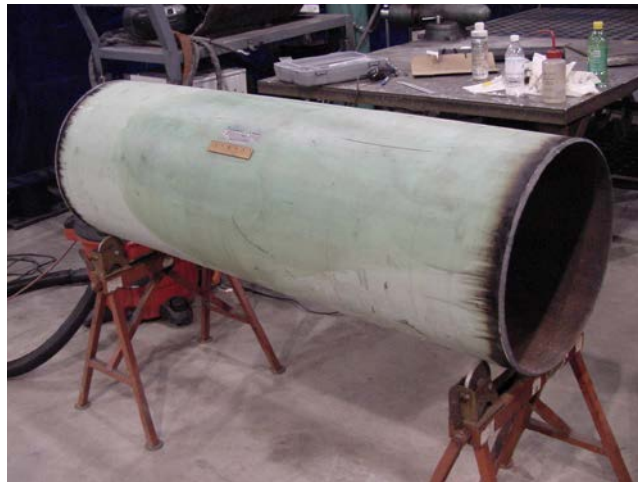
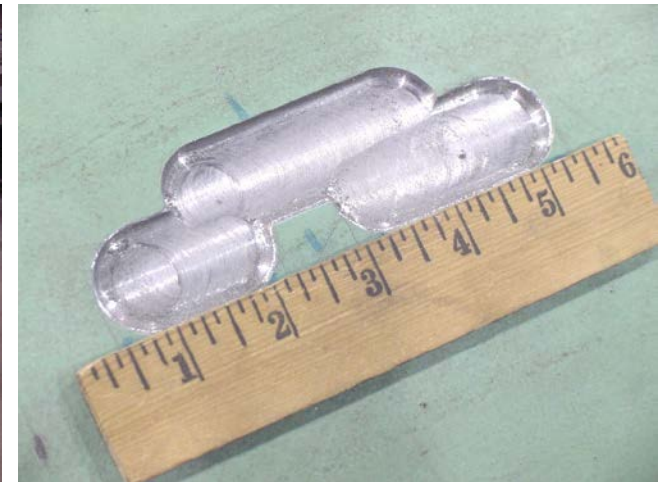
Composite Patch Experiment – Design No. 1

- Pipe material
 - 20 in. diameter by 0.250 in. wall thickness API 5L-52
- Simulated corrosion damage
 - 5.0 in long by 0.136 in. deep
 - 25% reduction in predicted burst pressure

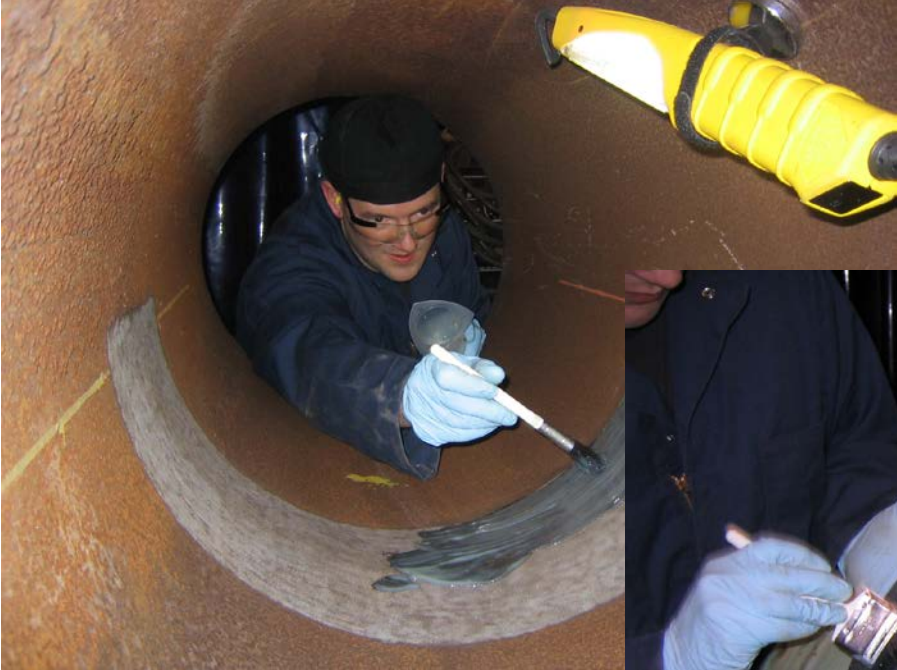
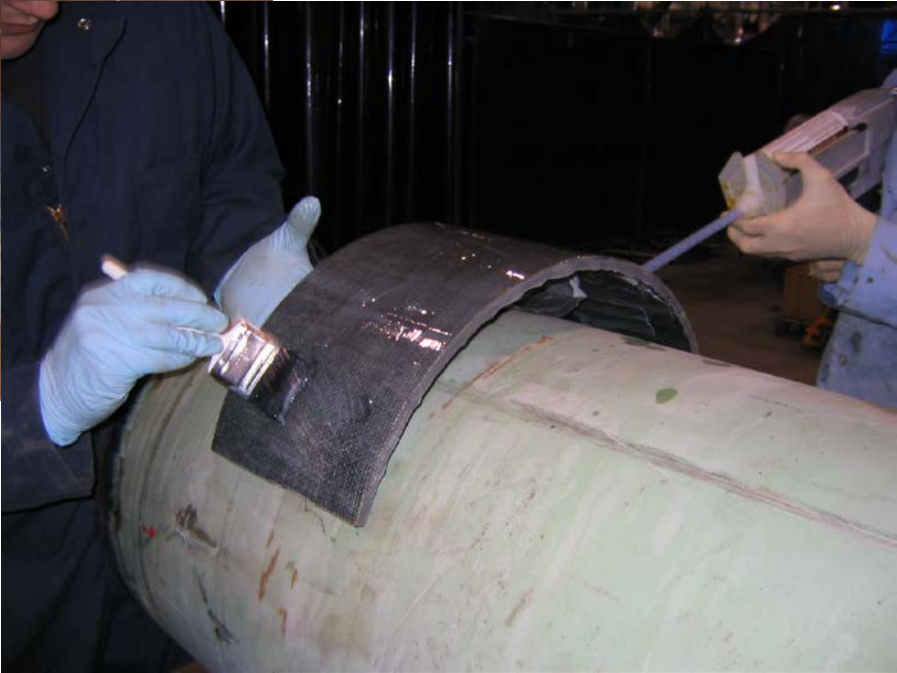
Installation of Patch

- Grit-blasting using 50 - 80 grit Alumina
 - Inside surface of pipe
 - Outside of Patch to remove surface resin
- Liberal coating of 3M DP460 epoxy adhesive was applied to the internal faying surface and a thin coating was applied to the patch faying surface
- Patch was positioned and held in place using bar clamps

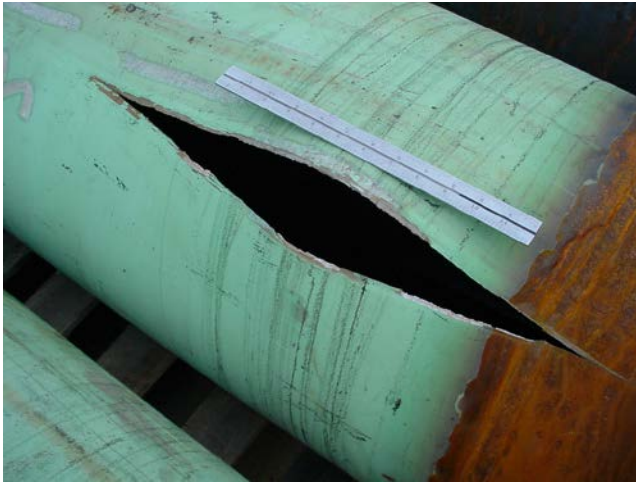
Pipe w/out damage

- Protocol
 - Burst test for pipe w/out damage (virgin pipe)
 - Burst test for pipe w/un-repaired damage
 - Burst test for pipe w/repair

- Pressure at 100% SMYS – 1,300 psi
- Burst pressure for pipe w/out damage – 2,325 psi
- Burst pressure for pipe w/un-repaired damage – 2,112 psi
 - 9% reduction from pipe w/out damage
- Burst pressure for pipe w/repair – 2,194 psi
 - 4% improvement from pipe w/un-repaired damage
 - 69% improvement from pressure at 100% SMYS
 - 6% reduction from pipe w/out damage

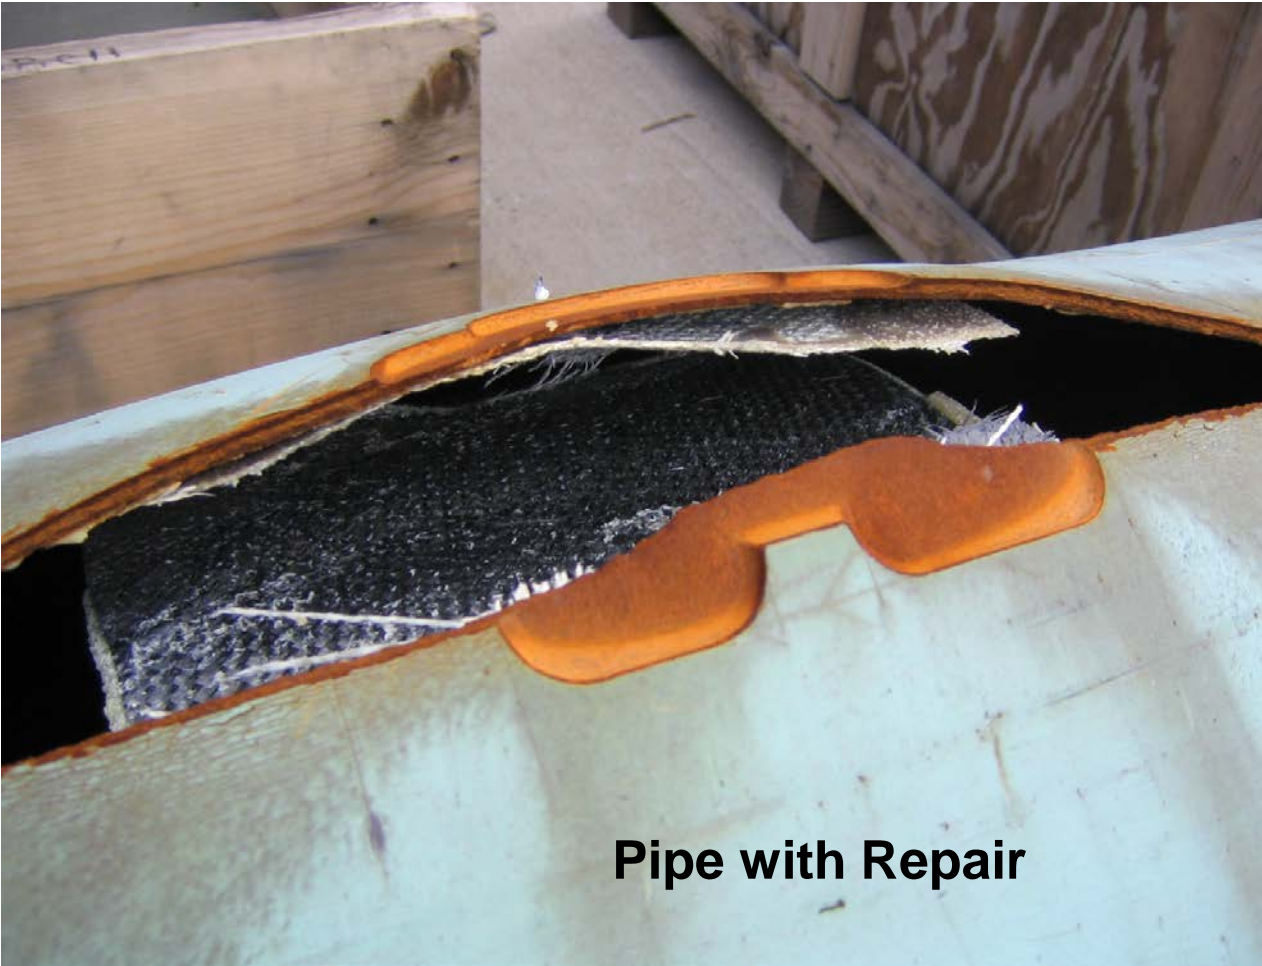
Pipe with Repair

Burst Test For Pipe w/Repair

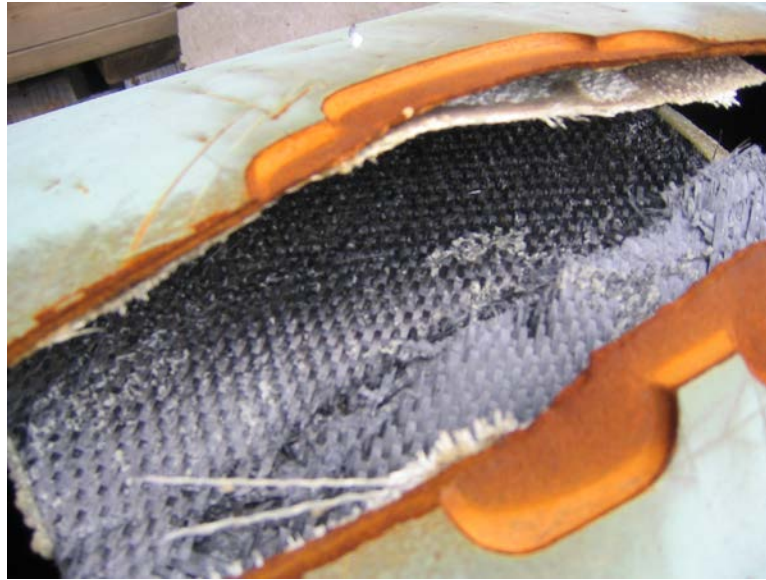
Post Mortem Analysis

- Failure was caused by interlaminar shear mostly between the anti-corrosion glass layer and the carbon layer
 - 1 → 2 layer interfacial failure is common in composites
- No evidence of disbonding between the pipe and the composite liner.

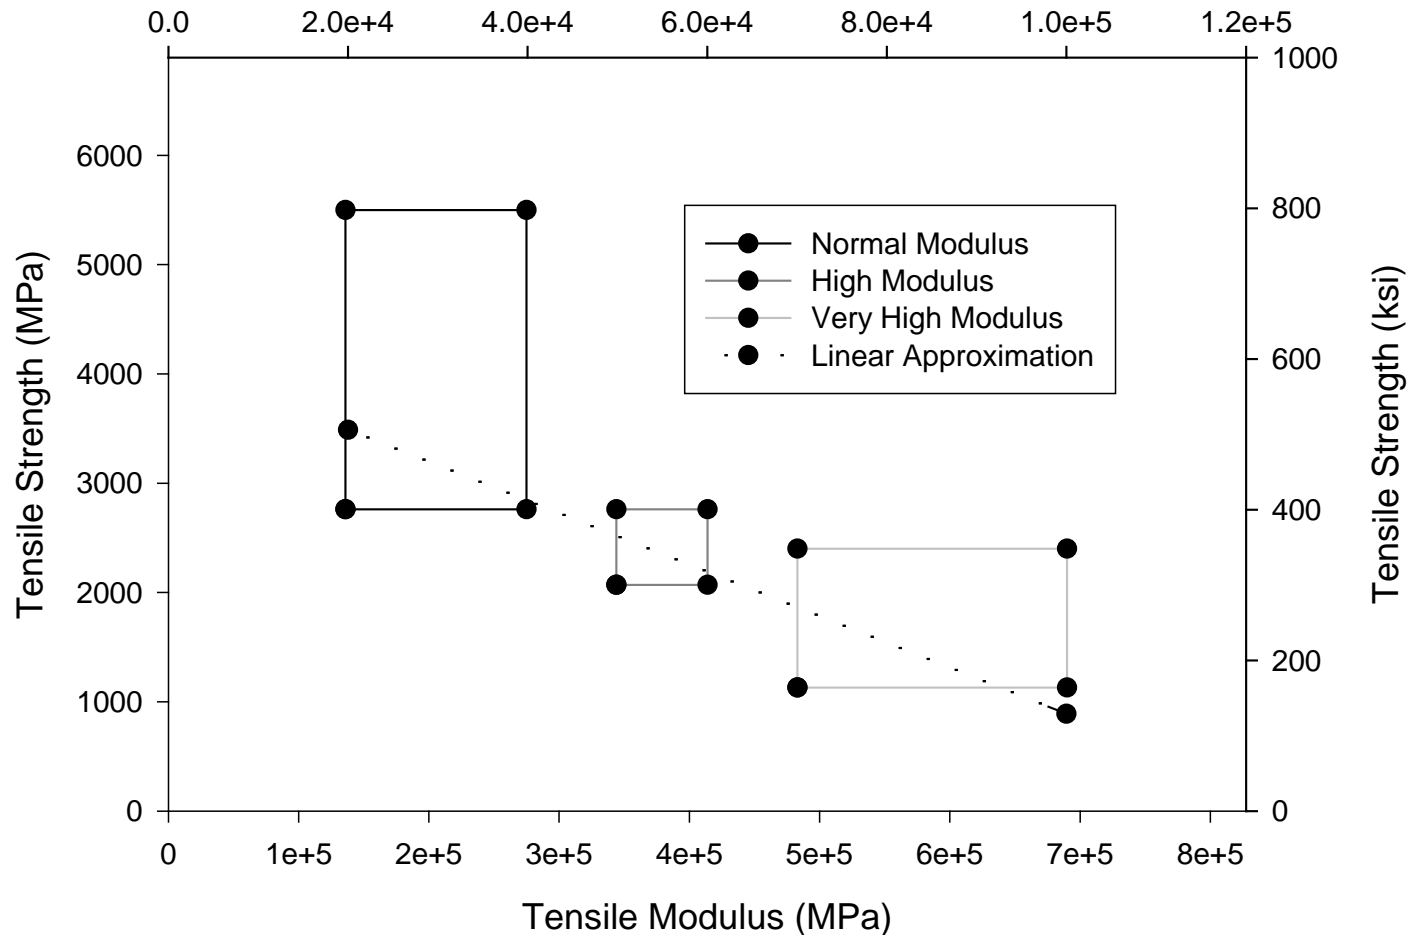
Carbon Fiber Strength and Modulus
Tensile Modulus (ksi)

Optimization of Patch Design – Performance Field

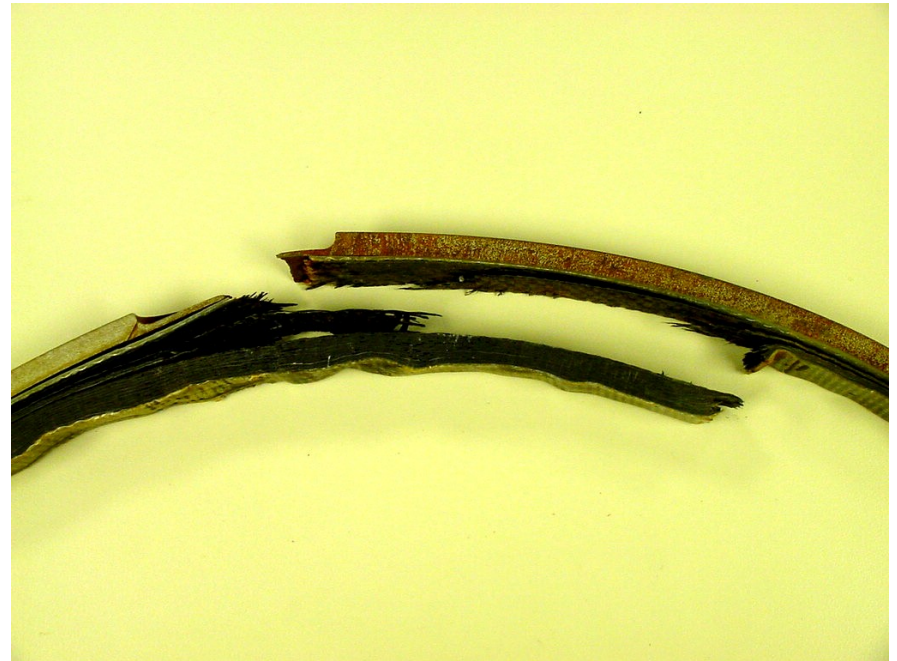
Post Mortem Analysis

- Repair was sectioned in the circumferential direction
- Ultimate failure of the patch was the result of interlaminar shear
- Failure appears to have occurred after the steel reached the plastic range (i.e., after the yield point of the steel was exceeded)

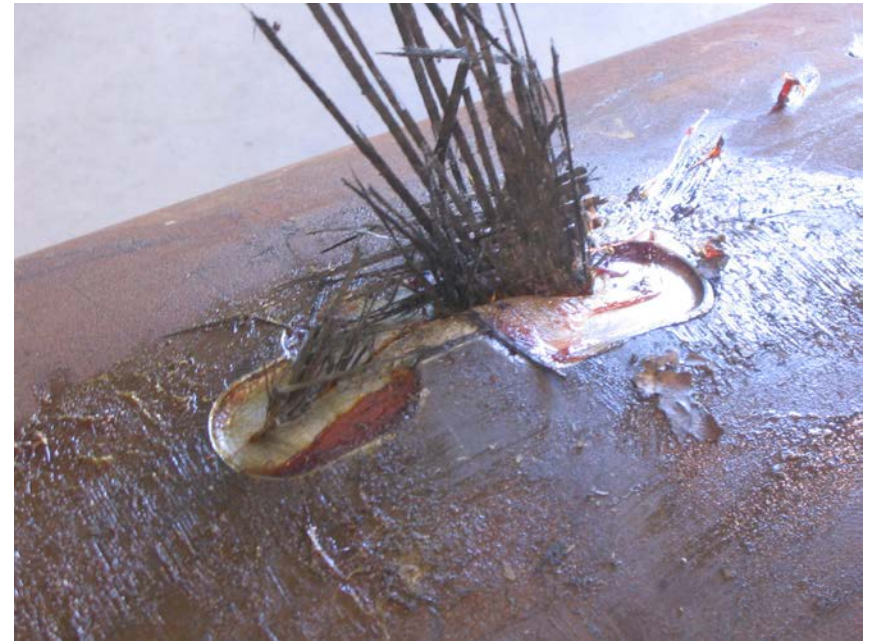
Higher Modulus Composite Patch – Design No. 3 (thin)

- Results similar to those for thicker patch
- Postmortem analysis underway

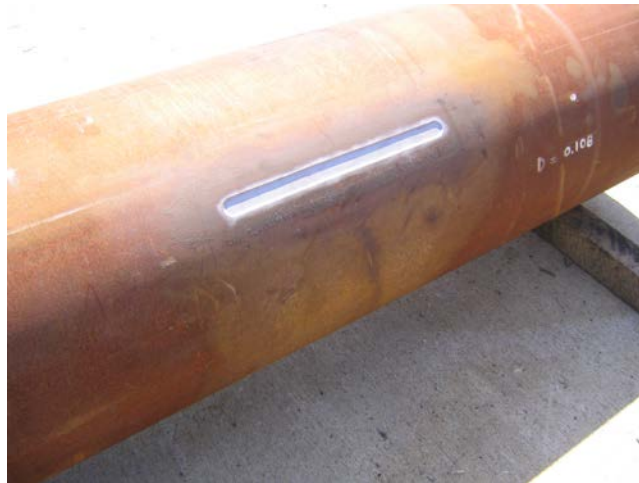
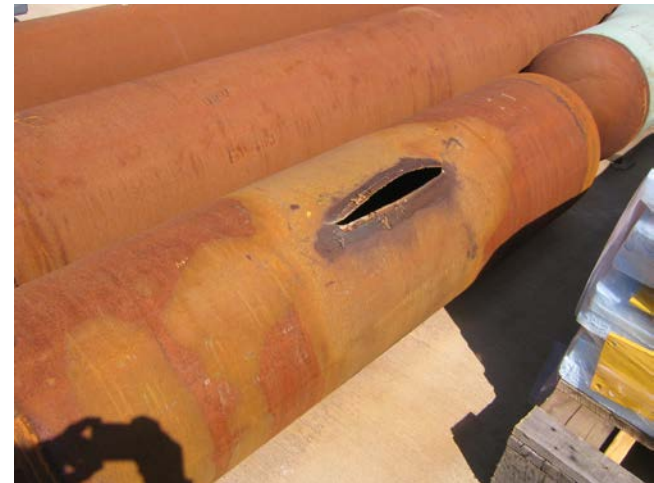
Higher Modulus Composite Patch Experiments – Design No. 3 – Long-Shallow

- Pipe material
 - 20 in. diameter by 0.250 in. wall thickness API 5L-52
- Simulated corrosion damage
 - 15 in long by 0.100 in. deep
 - 25% reduction in predicted burst pressure

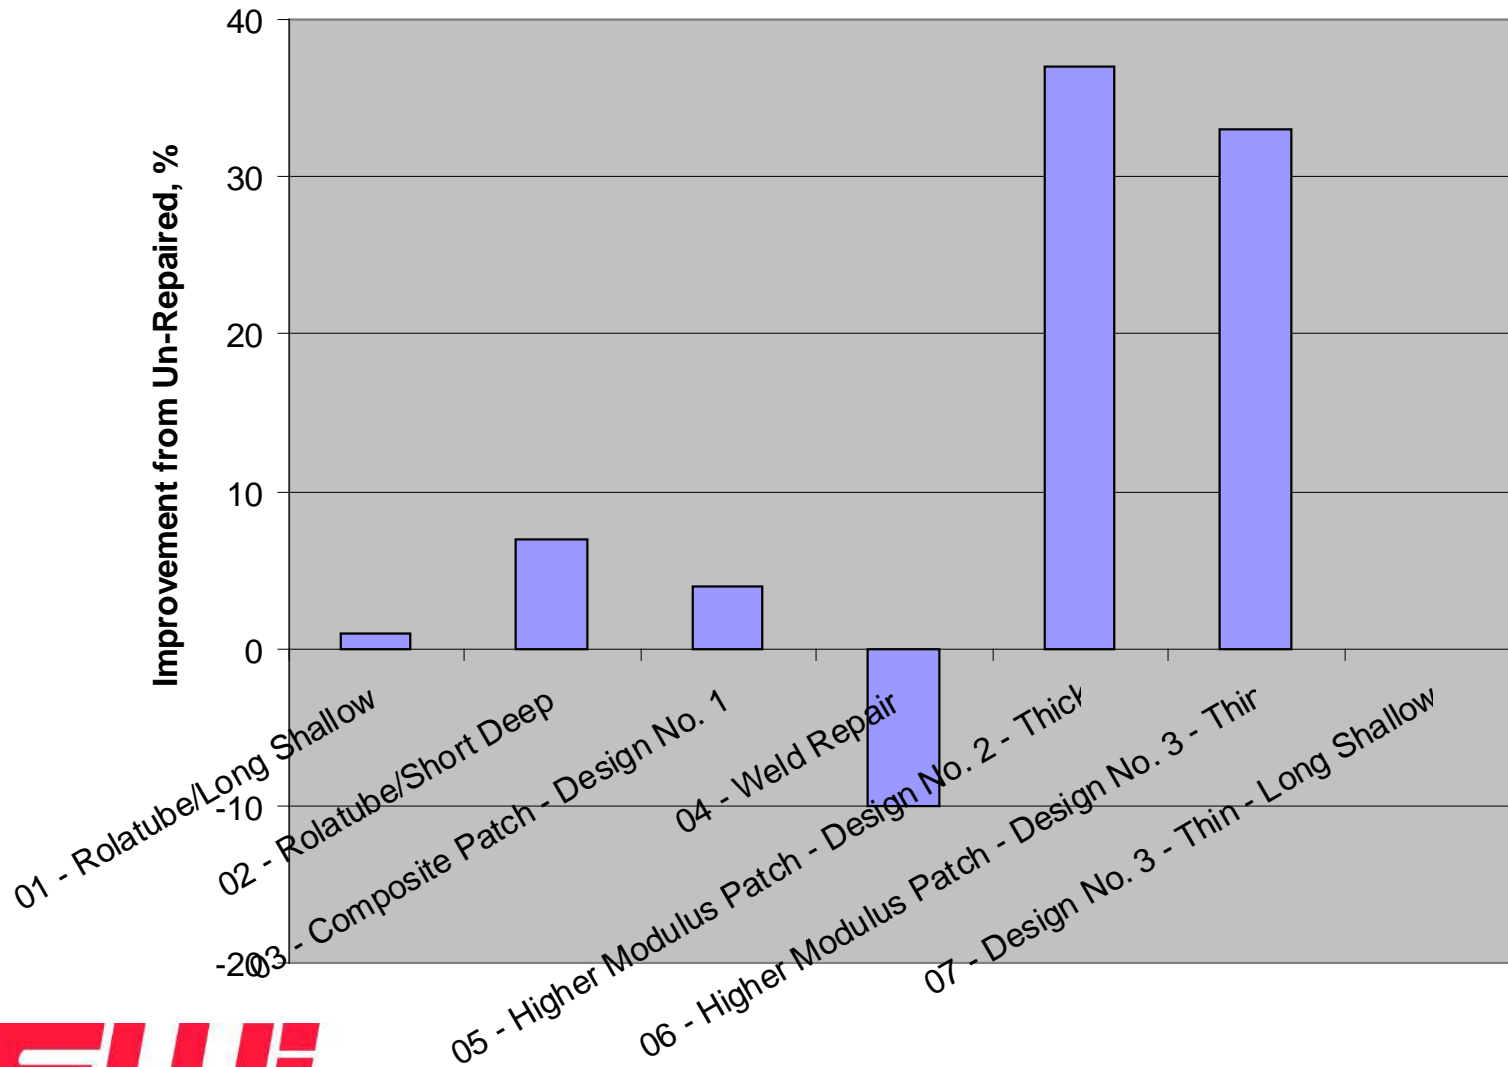
Summary of Burst Test Results

- 01 – Rolatube - Long Shallow
- 02 – Rolatube - Short Deep
- 03 – Composite Patch – Design No. 1
- 04 – Weld Repair
- 05 – Higher Modulus Composite Patch – Design No. 2
- 06 – Higher Modulus Composite Patch – Design No. 3
- 07 – Higher Modulus Composite Patch – Design No. 3 –
Long Shallow Damage

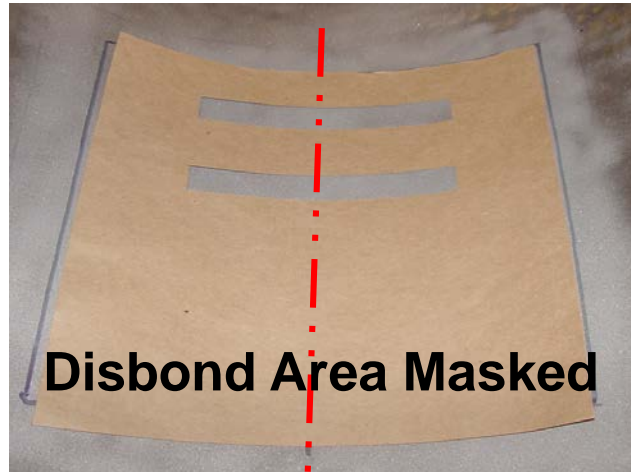
Disbond Area Preparation

Silicone Oil applied to Pipe to simulate Disbond between Pipe and the Adhesive

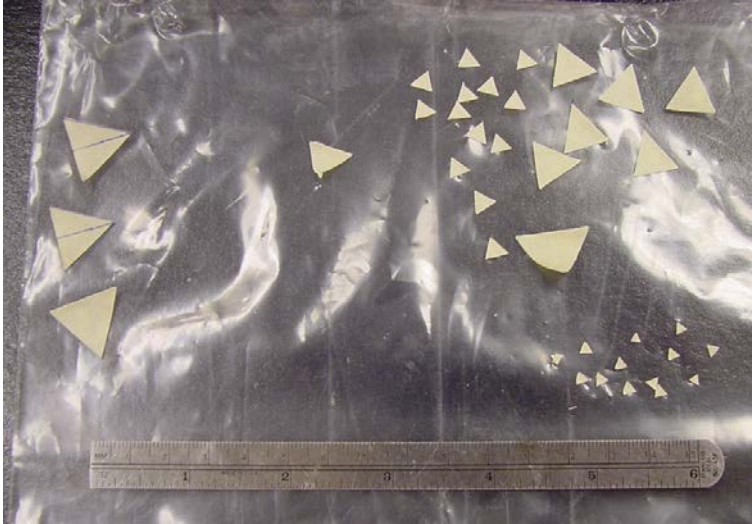
Defect Preparation

- Defects made from masking tape
- Defects affixed to Patch to simulate defects between Patch and the Adhesive
