Probabilistic Life Assessment and Aged Materials Testing for Service Feedback of Gas Turbine Components

Patxi Fernandez-Zelaia¹, Michael Kirka¹, Sebastien Dryepondt¹, Yousub Lee¹, Anand Kulkarni², Kyle Stoodt², Jason Weissman², Andreas Rucki², Santosh Narasimhachary²

¹ Oak Ridge National Laboratory
 ² Siemens Corporation Corporate Technology

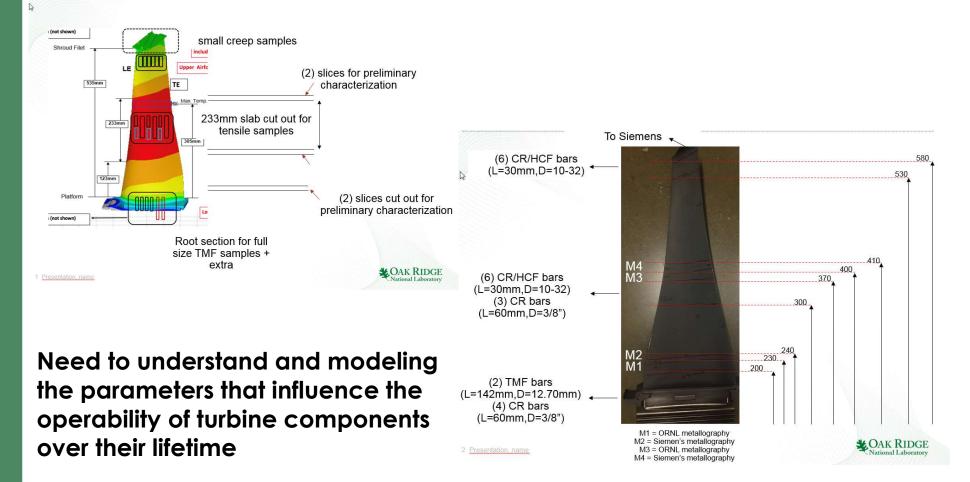
Proposed Blade Sectioning plan

Data Generation to establish Process-Structure-Property Correlations

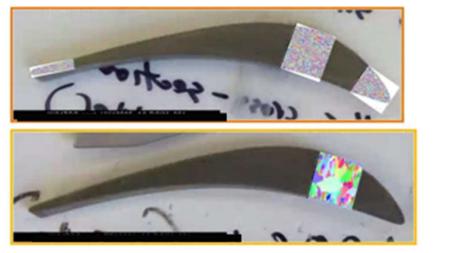
Microstructure Characterization

- Characterization work also ongoing at Munich Siemens facility
- Confirm fine recrystallized structure in one blade
- Characterization of root section

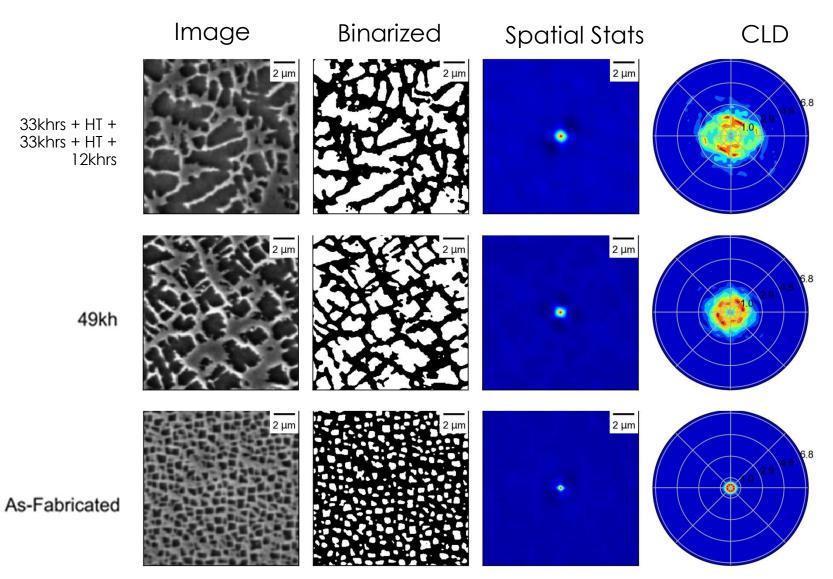
Microstructure Characterization – blades

- Microscopy performed on three blades
 - As-fabricated
 - 78khrs cumulative service hours (3 intervals)
 - 33khrs + repair + 33khrs + repair + 12khrs, sent to ORNL
 - 49khrs cumulative service hours
 - pulled, over-aged, dimensionally out of tolerance sent to ORNL
 - Recrystallized microstructure due to HT or service (?)
 - over-aged to make metal easier to repair (lower strength), standard HT to return to service (solution, primary, secondary)

33khrs + HT + 33khrs + HT + 12khrs

100-500µmgrainsmaster to edit

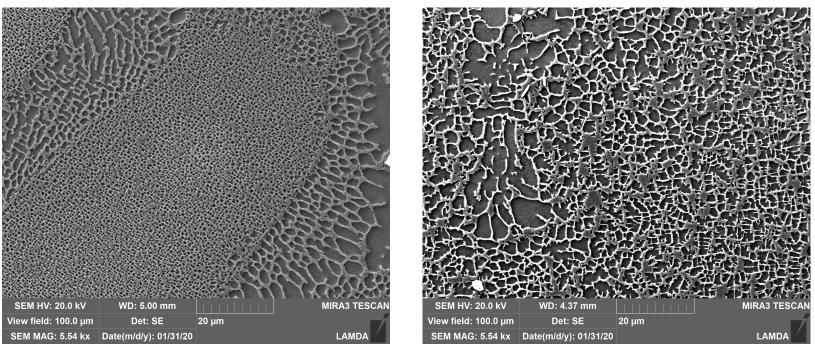
Microstructure Characterization – blades

As-fab

49khr

- Moderate coarsening of gamma-prime
 - Initial 325nm
 - 49khrs + HT 2.35µm
 - 33khrs + HT + 33khrs + 12khrs 2.64µm

Fine scale precipitate tends to coarsen

Eutectic unaffected

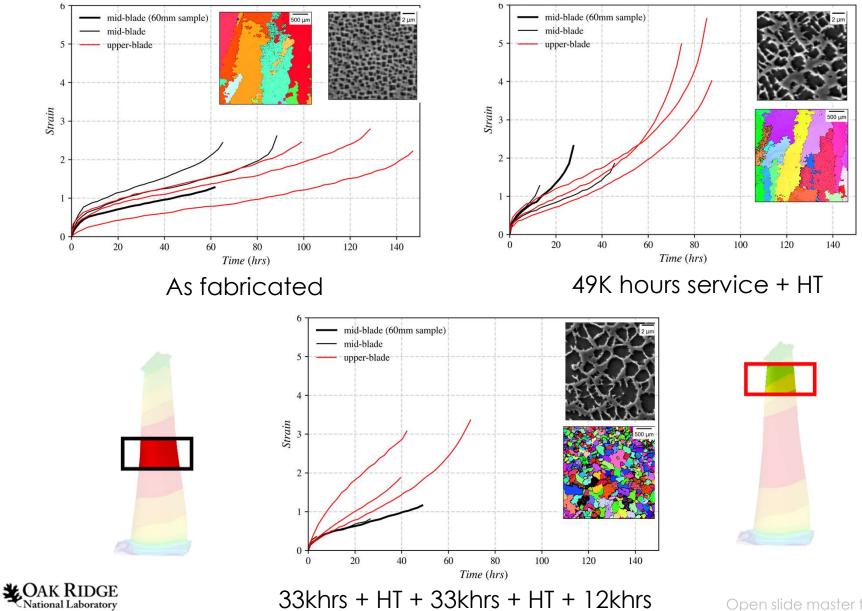
Preliminary Creep results (760C 690MPa)

- Exposure drives an increase in gamma prime size which drives down remaining life
- Repairs occasionally performed impose additional HT cycle
 - Recrystallization either due to service or these repairs
- Smaller grain size results in debit on creep life
- Consistently upper blade exhibits longer life
 - Need to characterize returned samples, perhaps lower temperatures inhibit coarsening...?
