# **Reduction of Methane Leaks through Corrosion Mitigation Pre-treatments for Pipelines with Field Applied Coatings (FE0031874)**

U.S. Department of Energy  
National Energy Technology Laboratory  
Resource Sustainability Project Review Meeting  
October 25 - 27, 2022

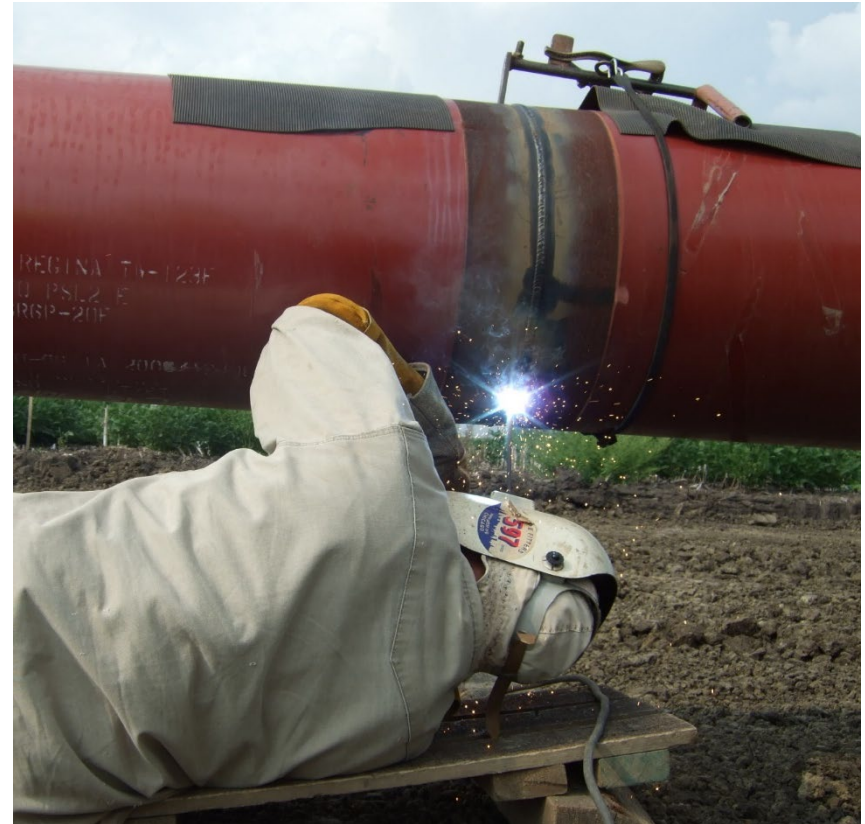
## ■ Pipe material: Steel

- Microalloyed, up to 80ksi min. yield strength
- 12-42" diameter, ¼"-1" wall, manufactured in 40'-80' length segments

## ■ External pipeline coating

- **Factory coating:** Fusion bonded epoxy (FBE) except for pipe ends, left bare for field welding
- **Field FBE coating:** Applied over welds and pipe ends, often in adverse weather conditions (wind, rain, cold, etc.), and is usually lower quality and has higher failure rate

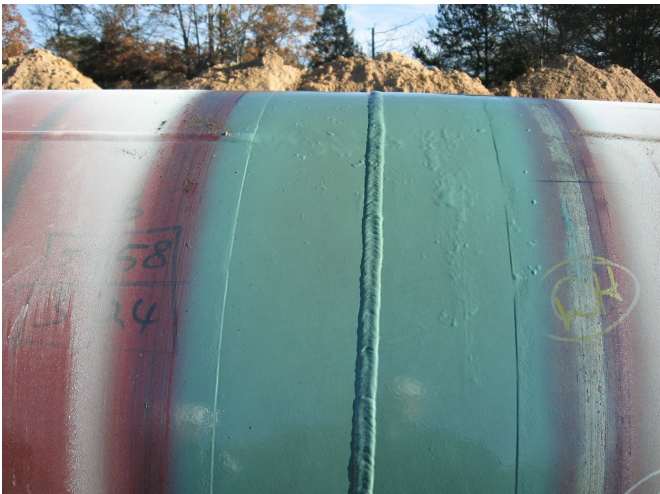
Field coating applied over dirt/debris

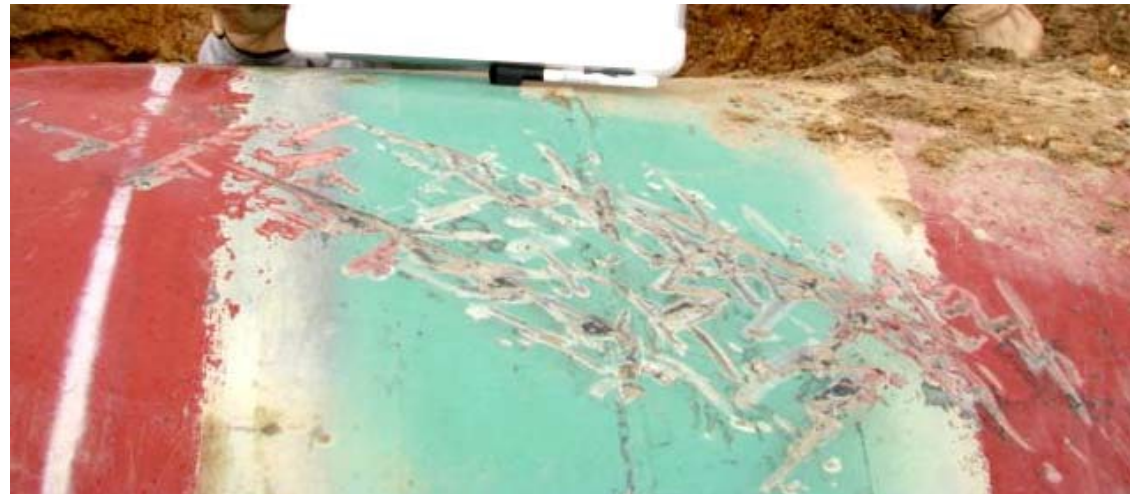
Construction damage of girth weld coating found by DCVG Survey during pipeline operation

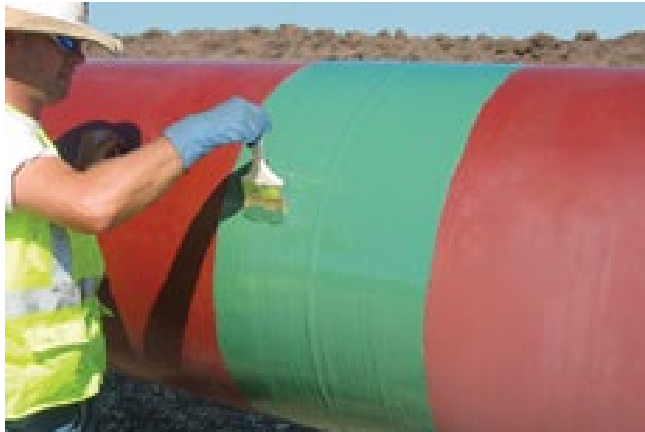
Field-applied pipeline coating over pipe ends and field girth weld is:

- Usually **lower quality** than factory-applied pipe coating
- Results in more frequent **coating failures**

Axial cross-section of buried steel pipeline

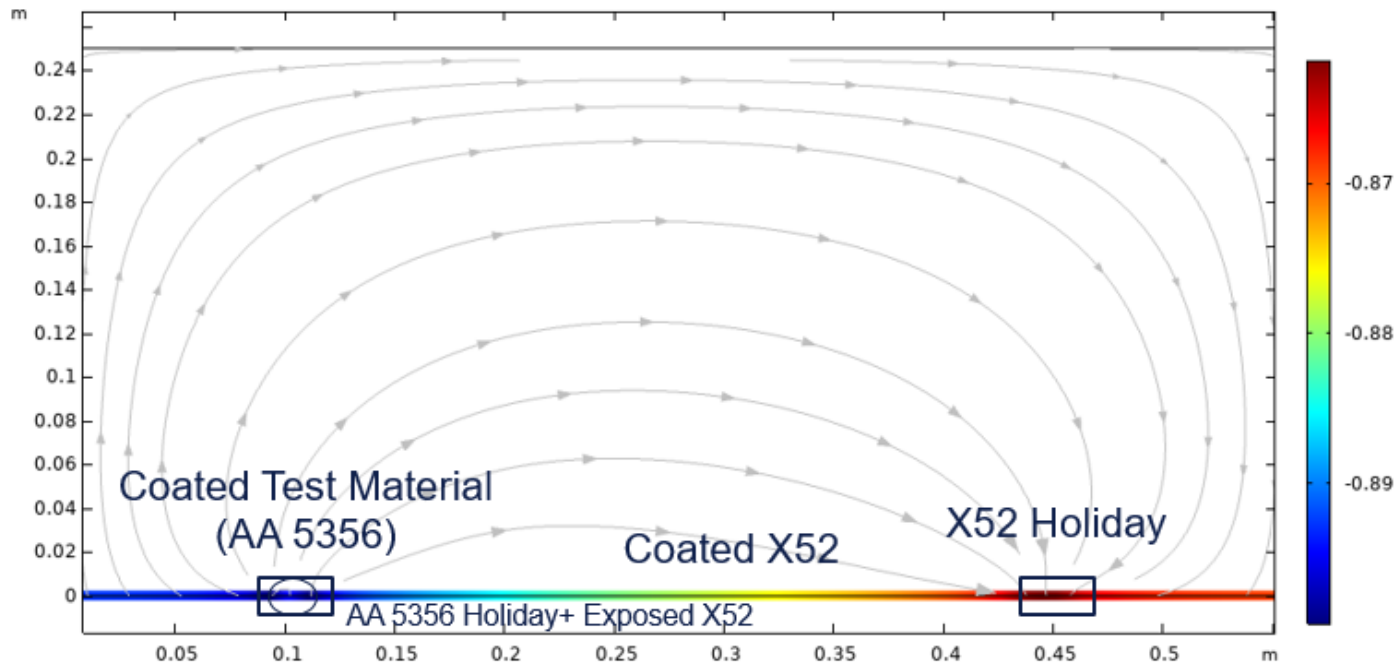
# Example COMSOL Simulation #2: Without CP and Sacrificial Coating

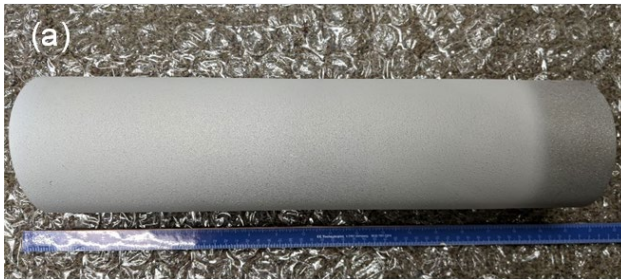
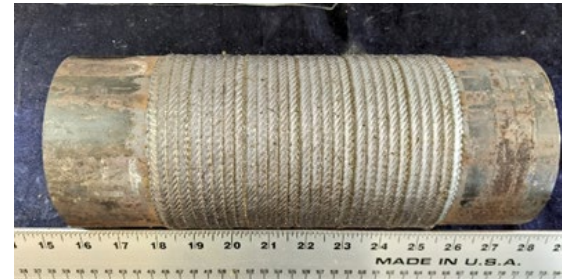
- Sacrificial Alloy: Aluminum 5356
  - Flame sprayed to avoid brittle intermetallics
- Corrosion Resistant Alloy: Steel B9
  - Gas metal arc welded on 4.5” dia. X42 pipe
