# Considerations for Offshore Pipelines / Pipelines That Cross Navigable Waterways and Water Bodies

Workshop - Roadmap for CO2 Transport Fundamental Research

# Overview

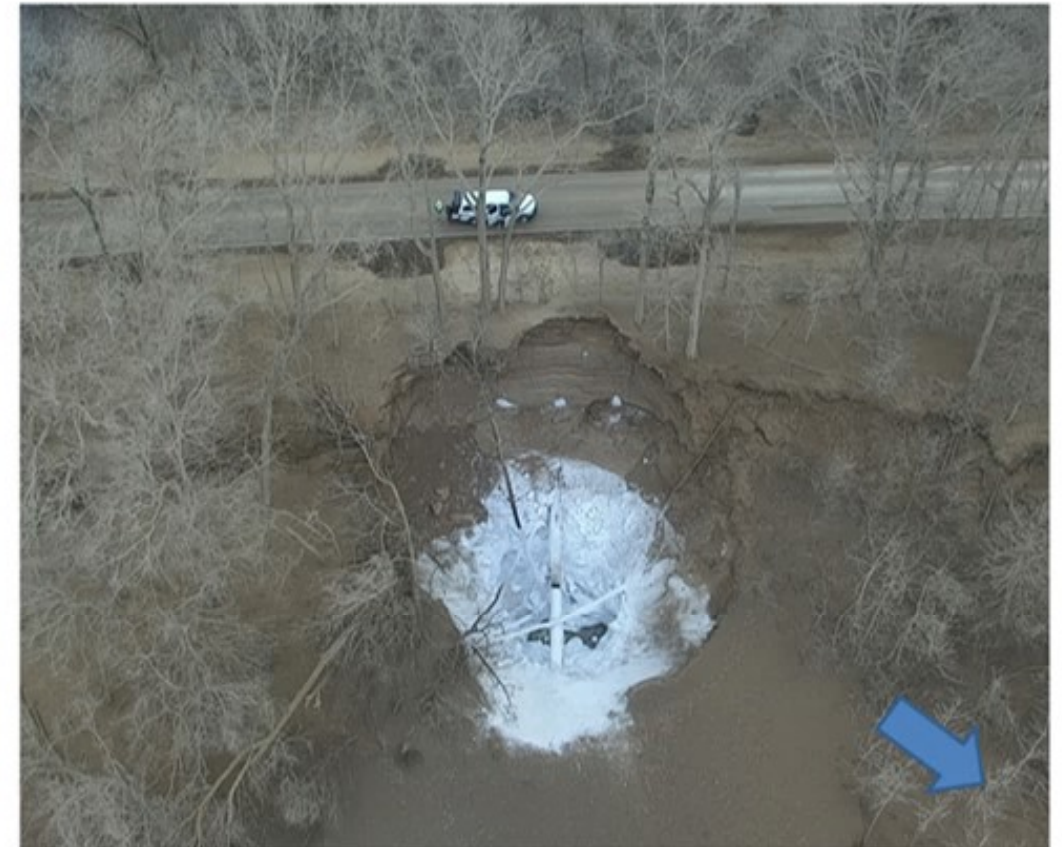
Figure 2: Vehicle is Parked on HWY 433 - The White is Ice Generated by the Release of CO<sub>2</sub> - The Blue Arrow Points North  
(Aerial Drone Photograph Courtesy of the Mississippi Emergency Management Agency)

- ❑ On February 22, 2020, a CO2 pipeline operated by Denbury ruptured in proximity to the community of Satartia, Mississippi.
- ❑ The rupture followed heavy rains that resulted in a landslide, creating excessive axial strain on a pipeline weld.
- ❑ Pipeline was installed in 2009.

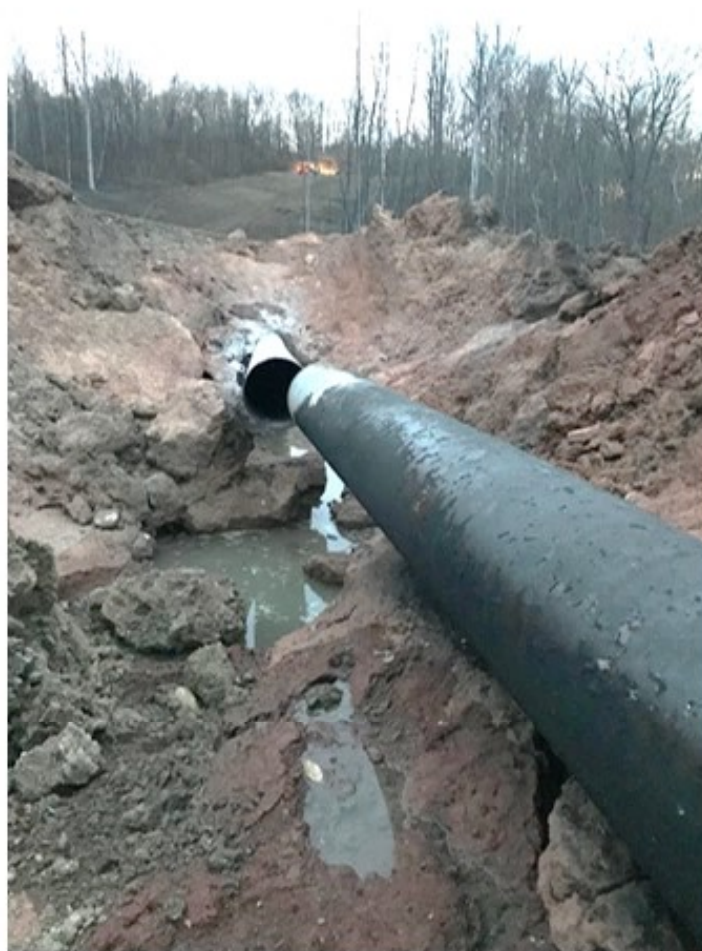
Incident No.	OD (inch)	Grade	Nature of Incident	Approximate Elapsed Time for Start of Service
1	20"	X70 PSL2	In-Service Rupture	1 Year
2	30"+	X80/X70	In-Service Rupture	6 years
3	12.75"	X52	In-Service Leak	14 years
4	30"	X70M	Hydrostatic Leak	N/A
5	30"	X70	Hydrostatic Leak	N/A
6	42"	X70 PSL2	In-Service Rupture	3 years
7	12.75"	X52/X65	In-Service Rupture	4-5 years
8	24"	X70	In-Service Rupture	3.5 years
9	36"	X70	Hydrostatic Leak	N/A
10	Information can't be released	X70	In-Service Rupture	Less than 1 year

- ❑ Recent systematic investigation started ~2015
- ❑ Incidents
  - ❖ occurred in-service and during hydrostatic testing
  - ❖ 30+ incidents.
    - ▶ US
    - ▶ Asia
    - ▶ South America
  - ❖ Grade: X52 to X80
  - ❖ Manual or semi-automatic welds
- ❑ Some incidents before 2015 may have similar contributing factors.

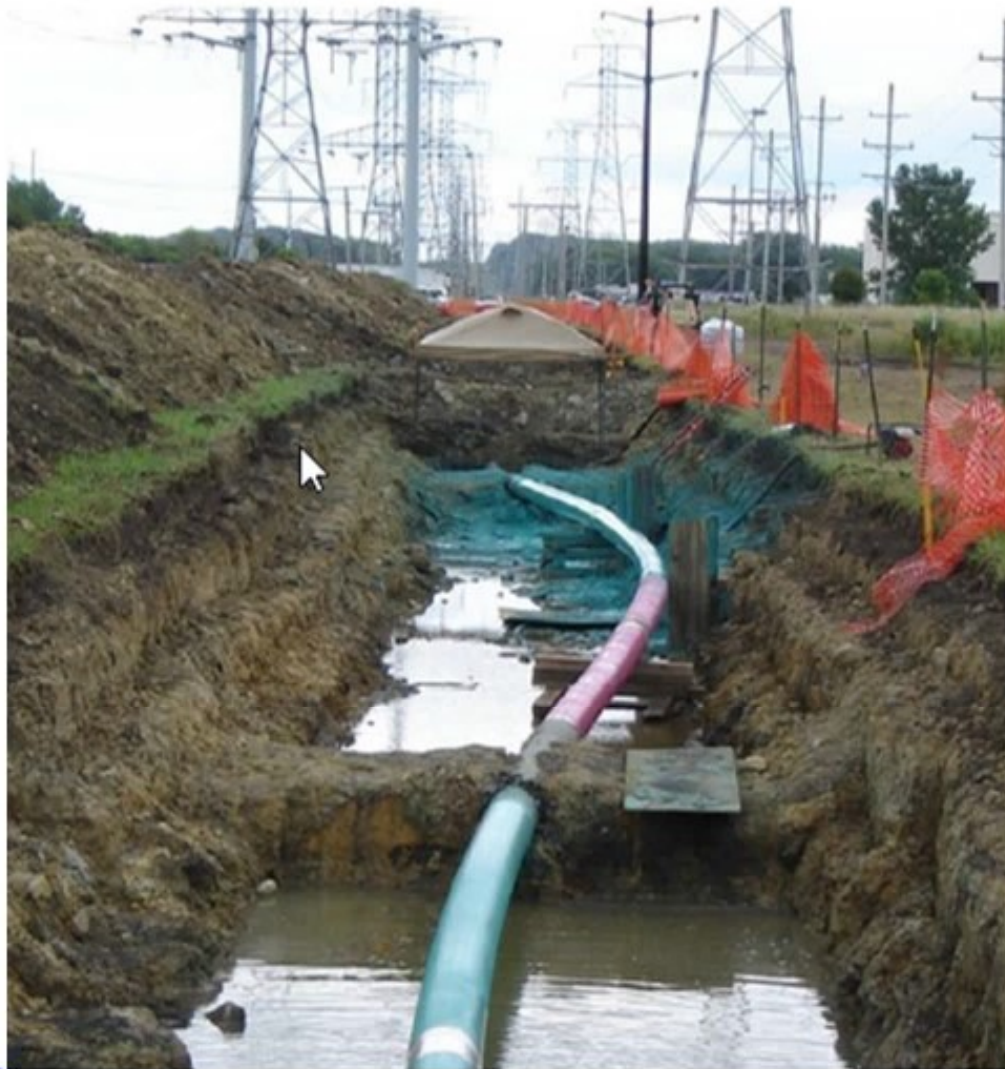
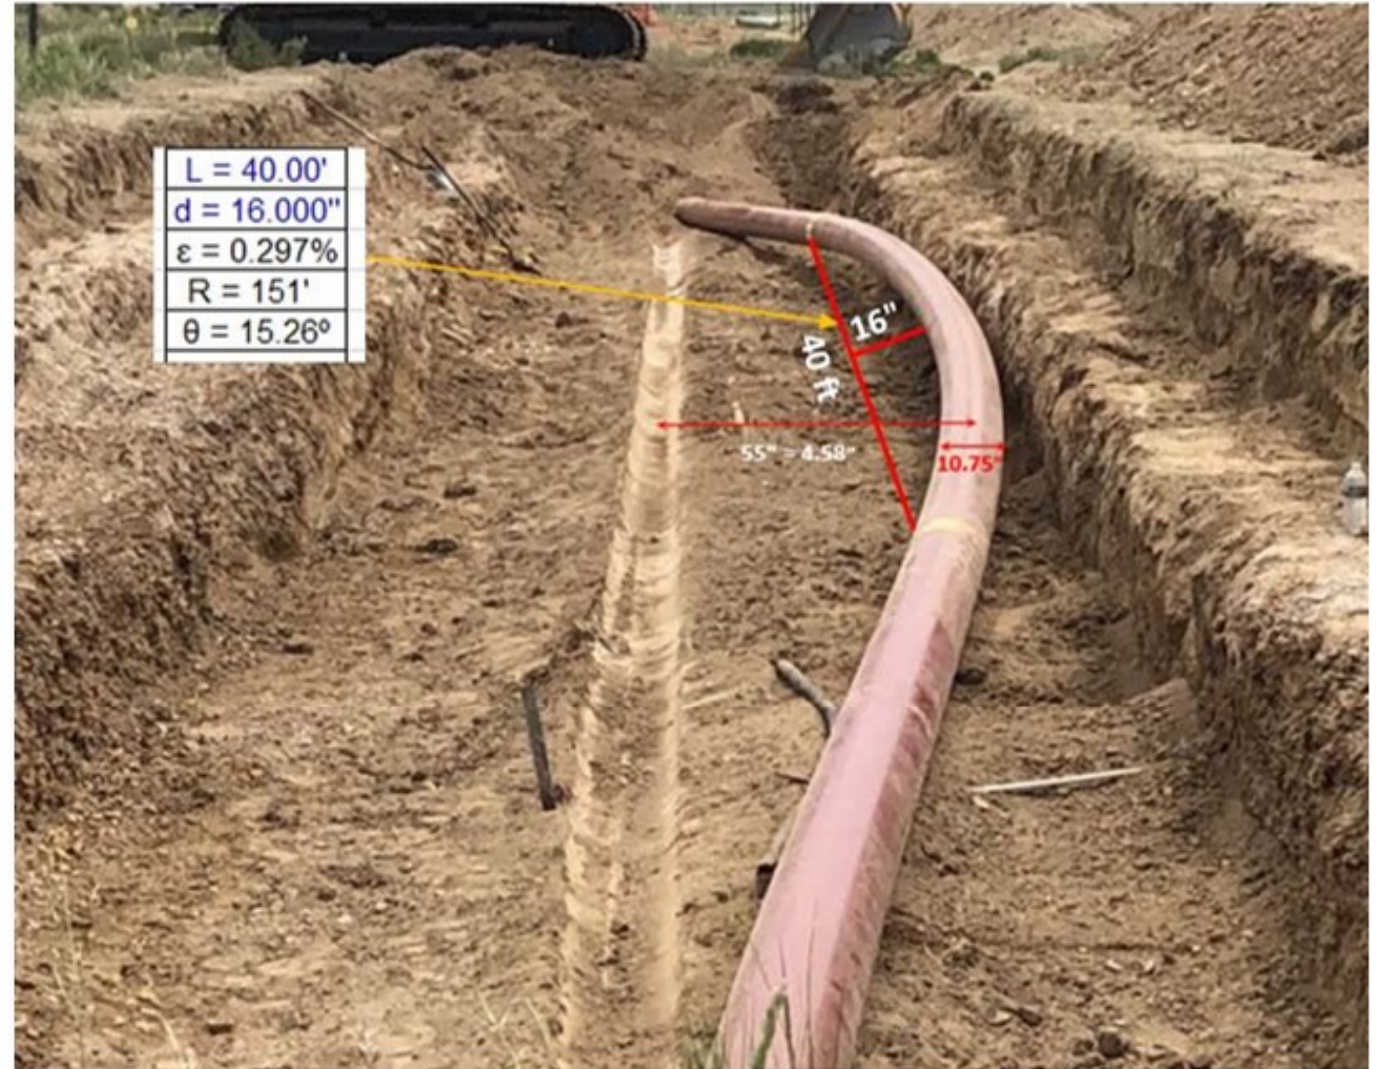
- Pressure vessels: level of longitudinal stress is lower than that of hoop stress.

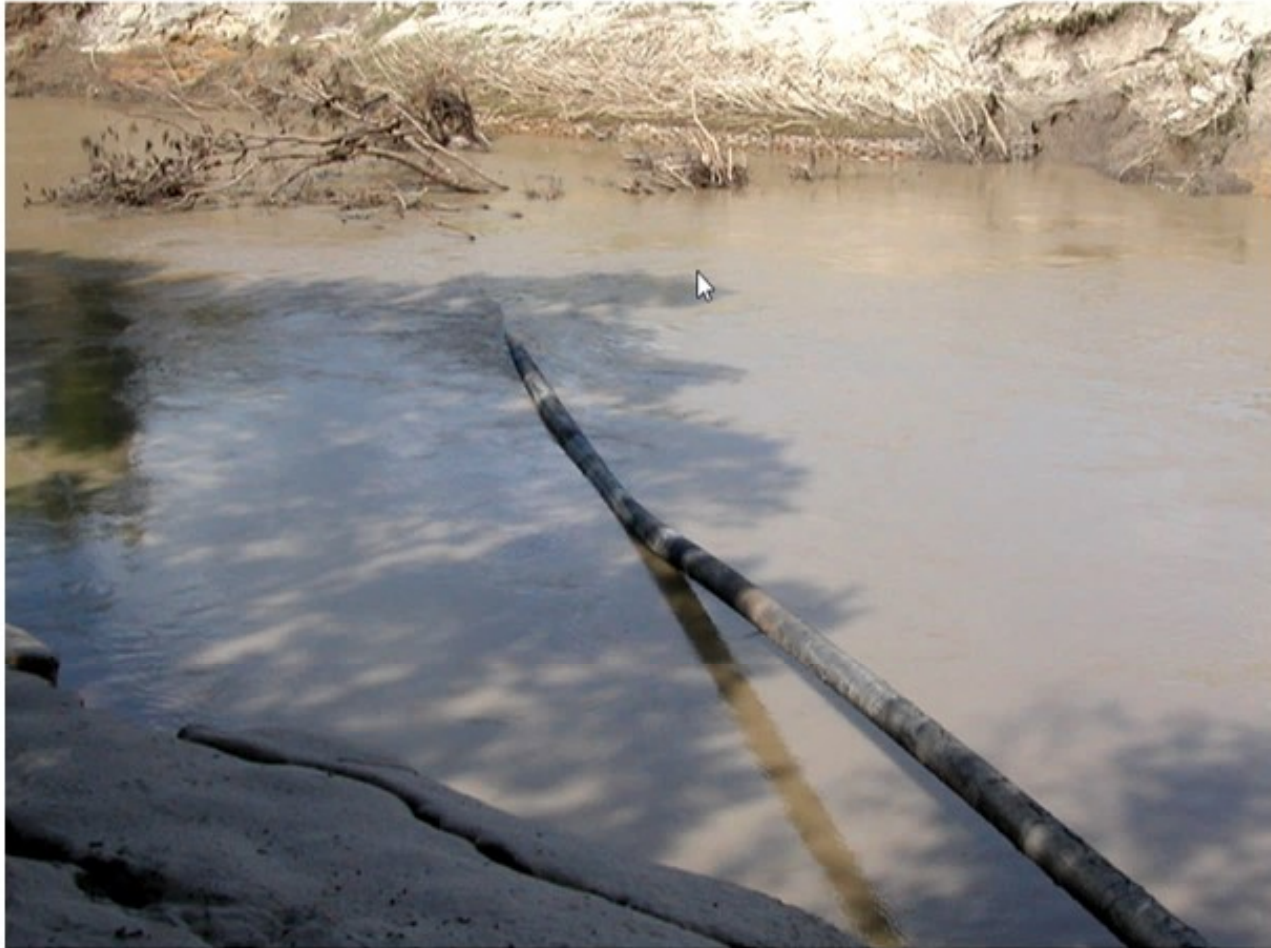
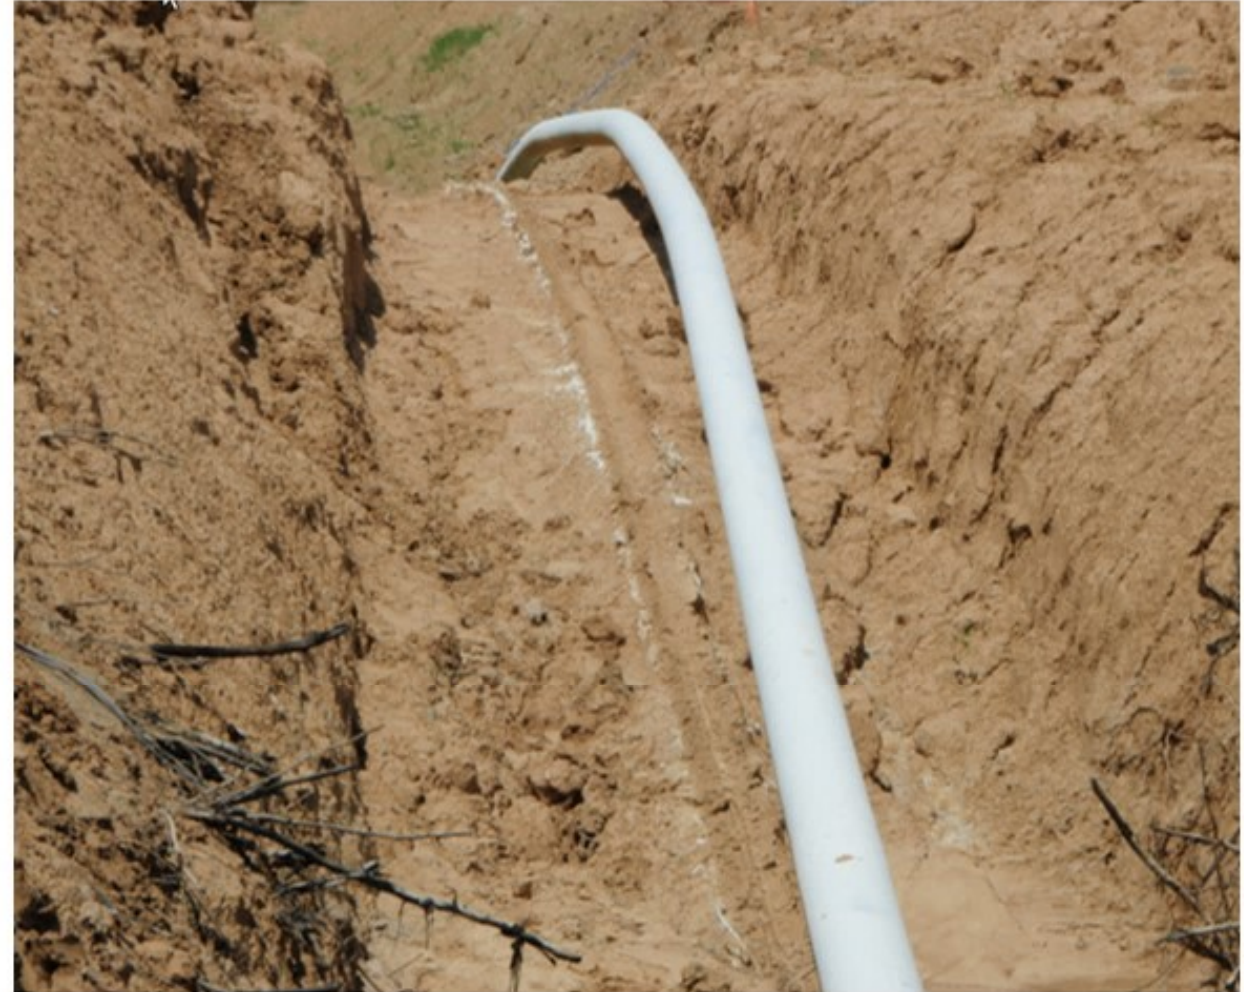
- Longitudinal stresses in pipelines can exceed yield strength, higher than hoop stress.

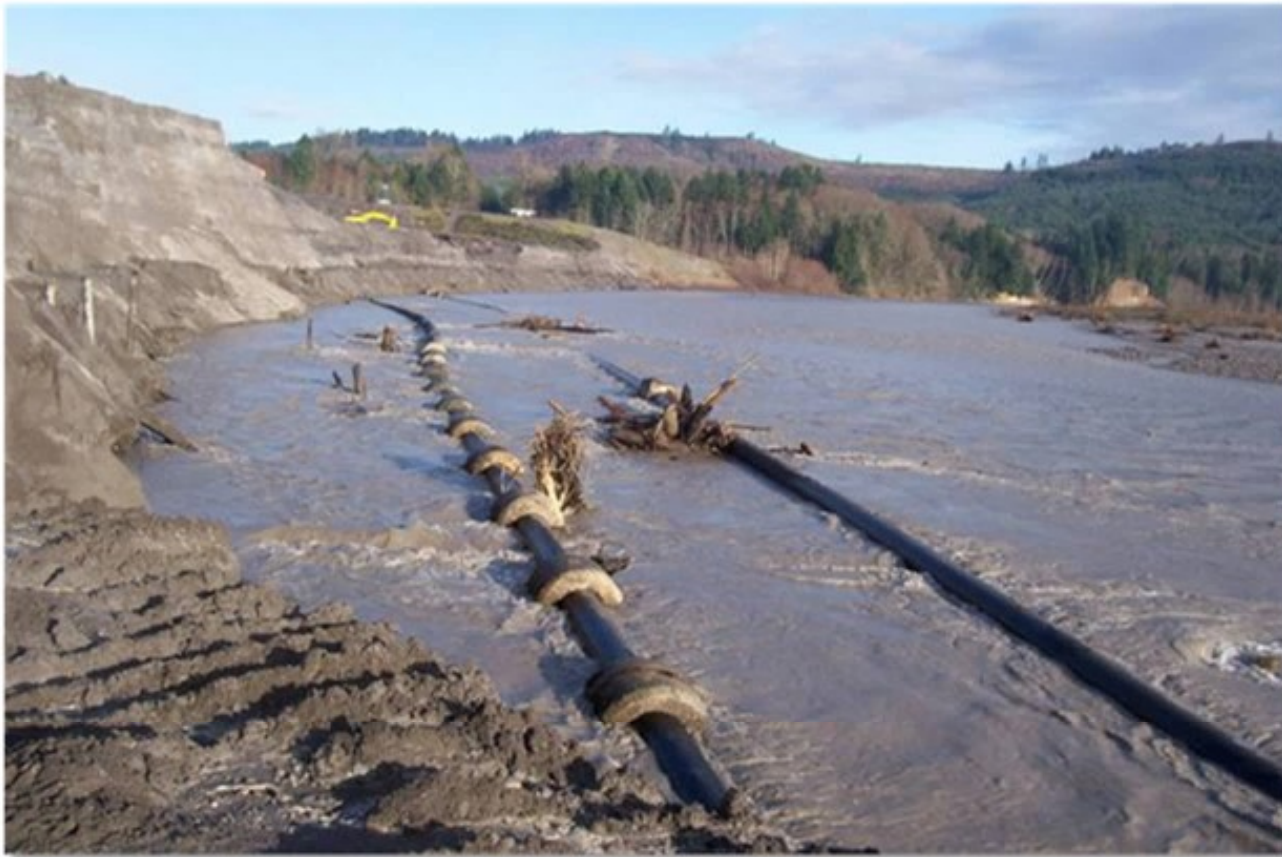
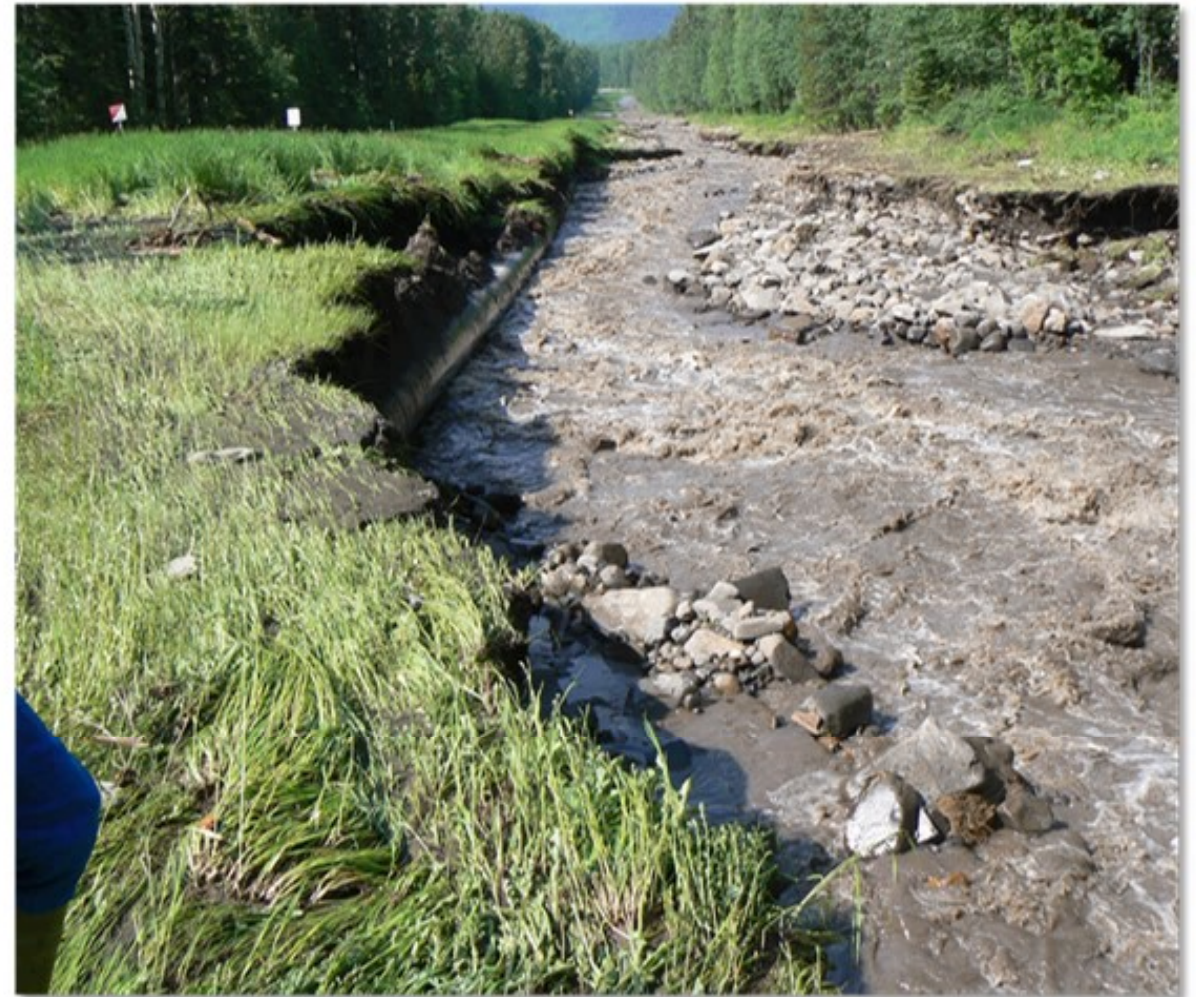
- Longitudinal stresses in pipelines can exceed yield strength, higher than hoop stress.

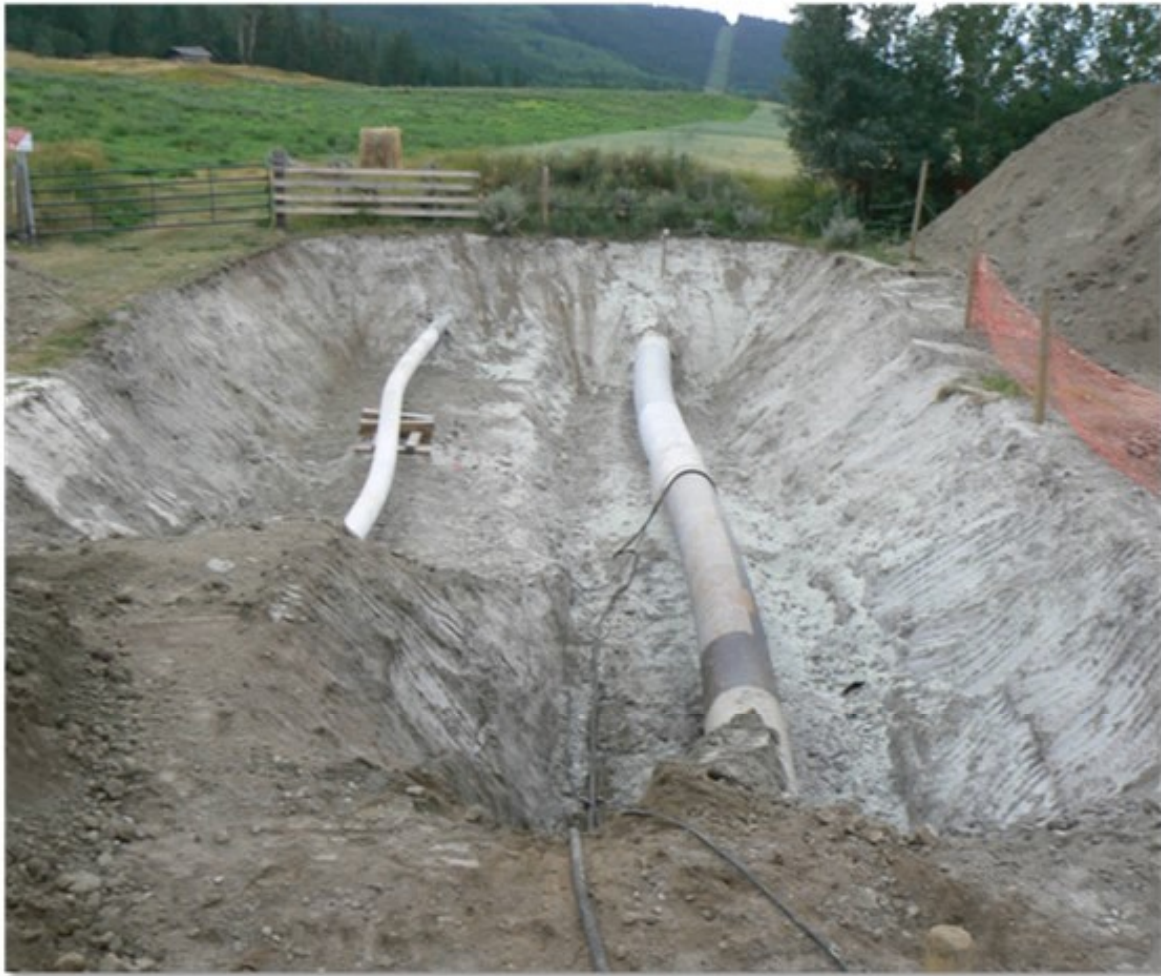
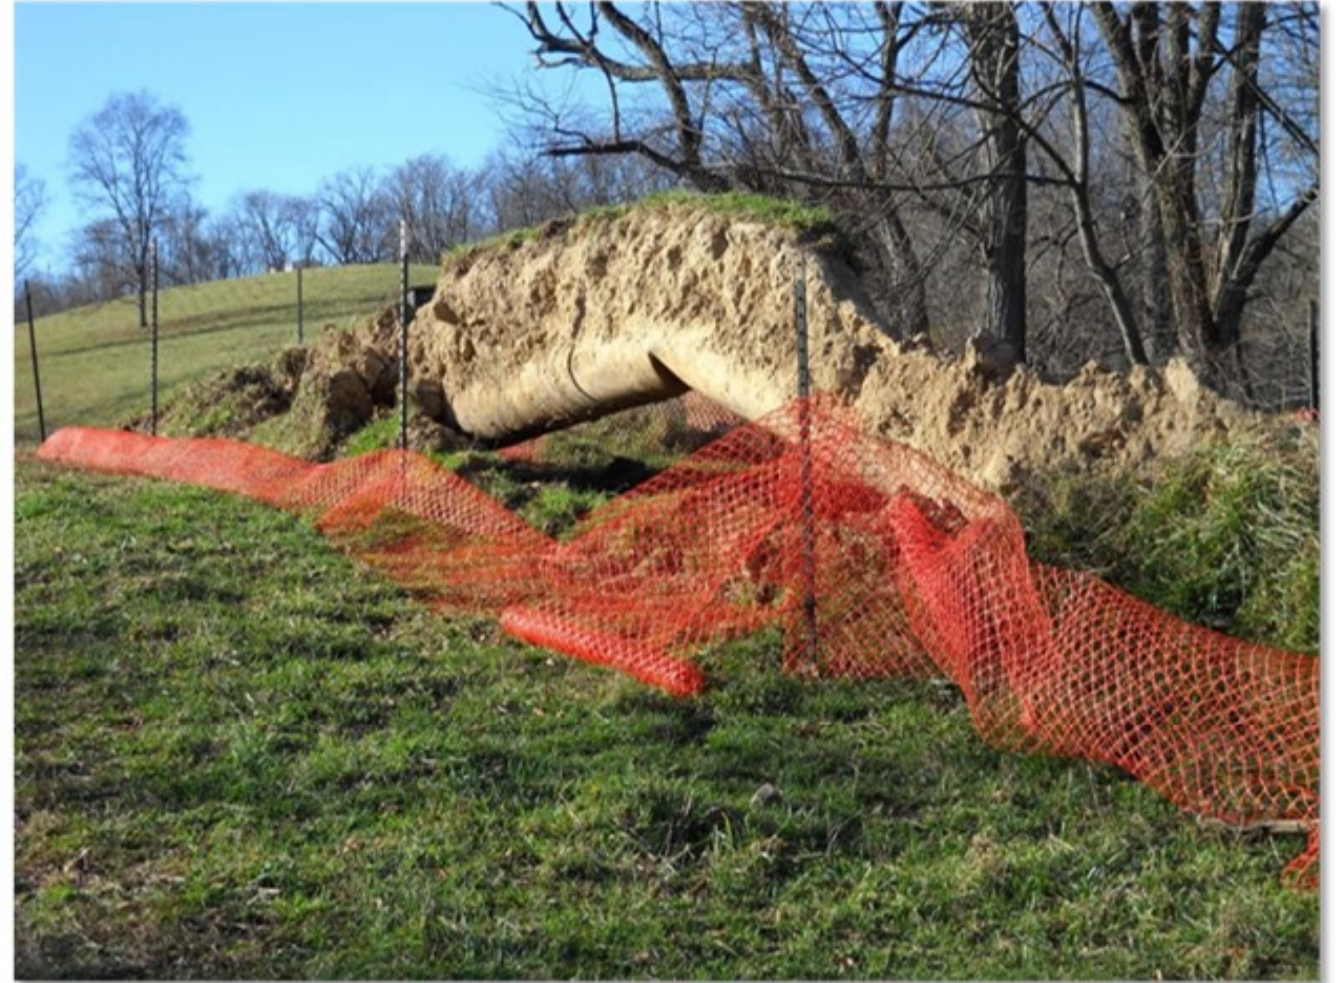
- Longitudinal stresses in pipelines can exceed yield strength, higher than hoop stress.
