# Reduction of Methane Leaks through Corrosion Mitigation Pre-treatments for Pipelines with Field Applied Coatings

DE\_FE0031874

Kenneth Lee, DNV GL USA

U.S. Department of Energy  
National Energy Technology Laboratory  
Resource Sustainability Project Review Meeting

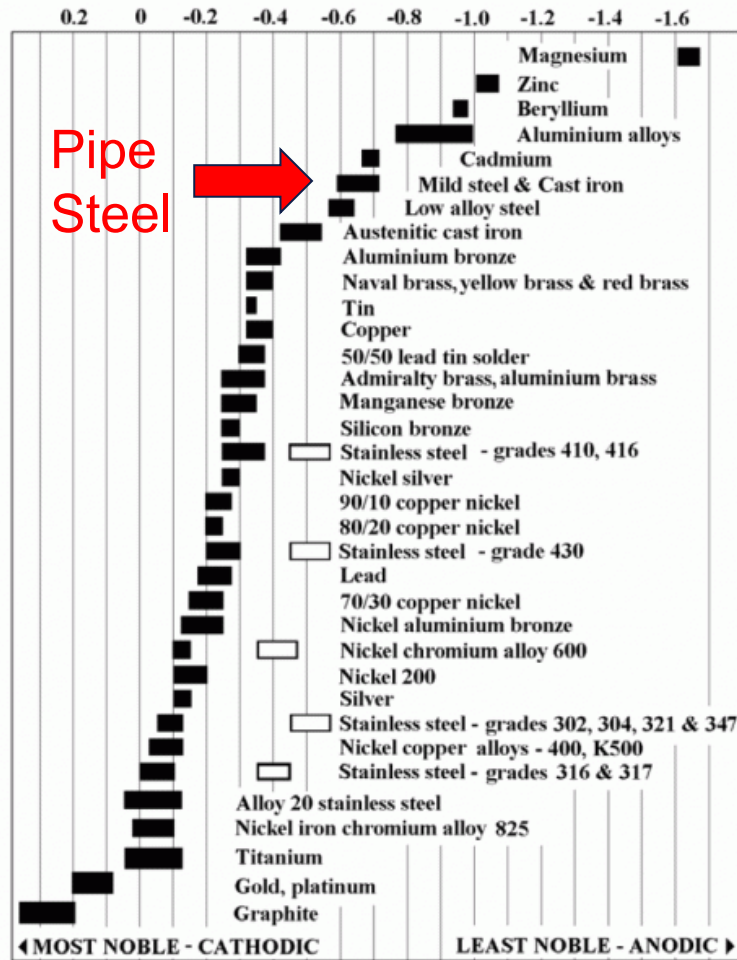
Galvanic series of metals

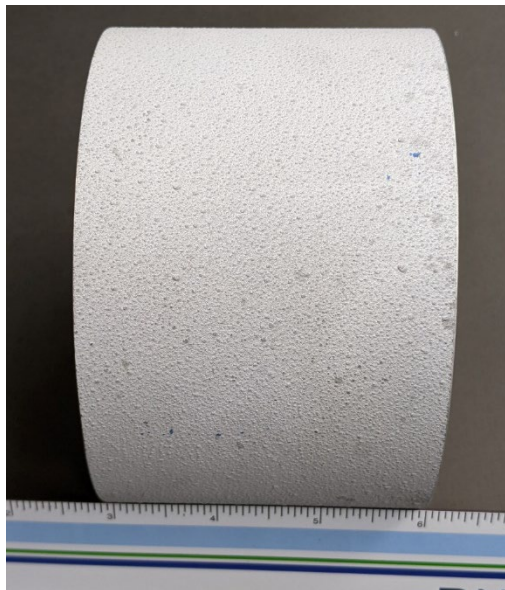
- 4.5" diameter X42 steel pipe coupons were coated by:
  - Flame sprayed aluminum 5356 (~450  $\mu\text{m}$ )
  - GMAW steel B9 & machined smooth (4 mm)

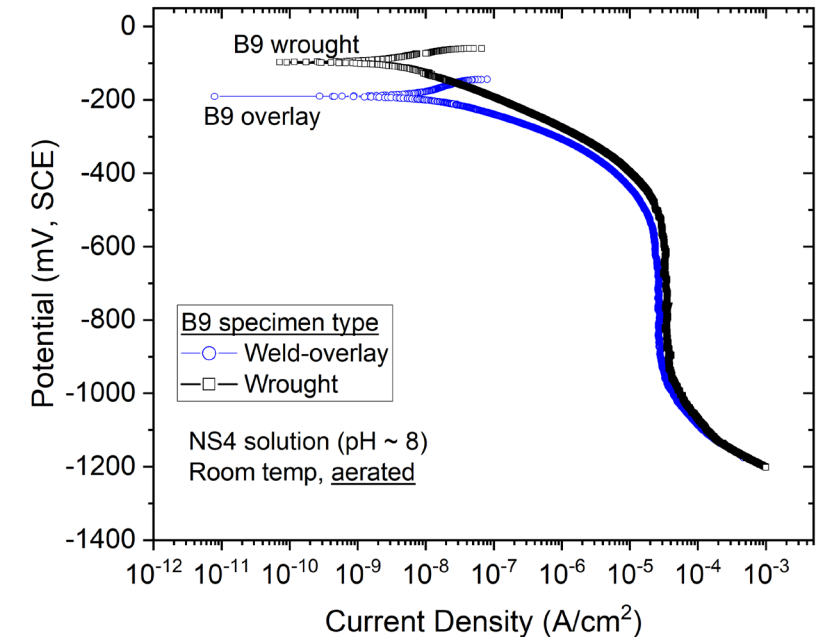
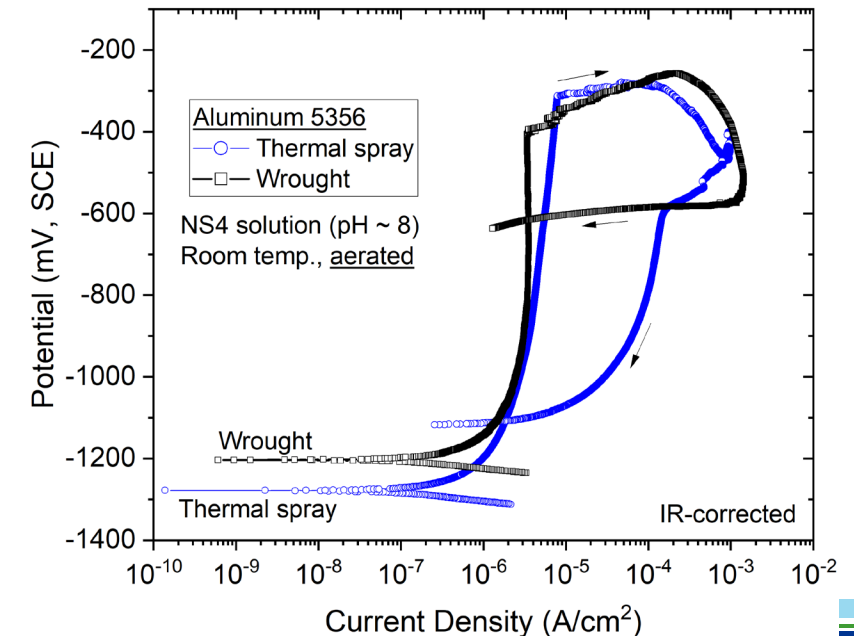
- Test results of aluminum 5356 and steel B9 samples were very similar to previous tests of the original wrought alloys
- Both coatings provided protection over a range of simulated soil conditions
  - Aluminum 5356 exhibited low corrosion rates in simulated soil conditions from pH 5 to pH 11, with breakdown of semi-protective film observed at pH 12.
  - Steel B9 coating exhibited low corrosion rates in aerated conditions as well as soil environments ranging from pH 5 to pH 8.

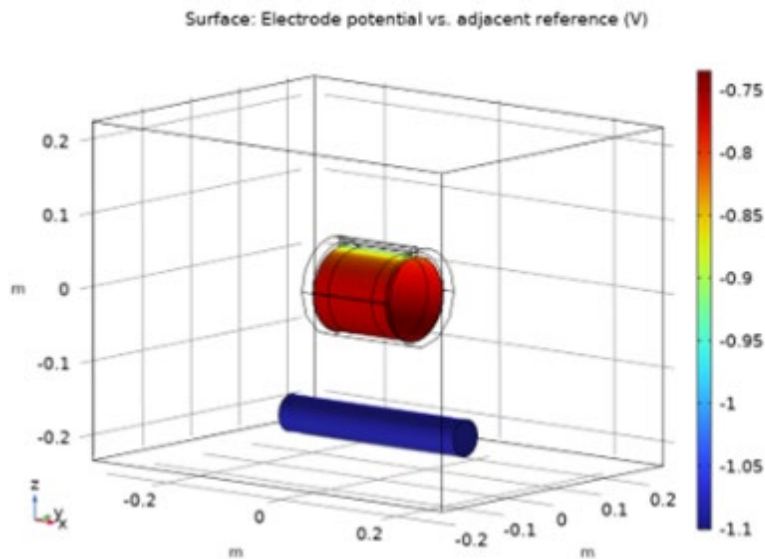
- Primary objectives are to test design of coupon assembly (sealing, sleeve function, electrochemical response, etc.) and optimize procedures for field tests
- Measured corrosion rates, galvanic corrosion, and effects of CP on coupon behavior

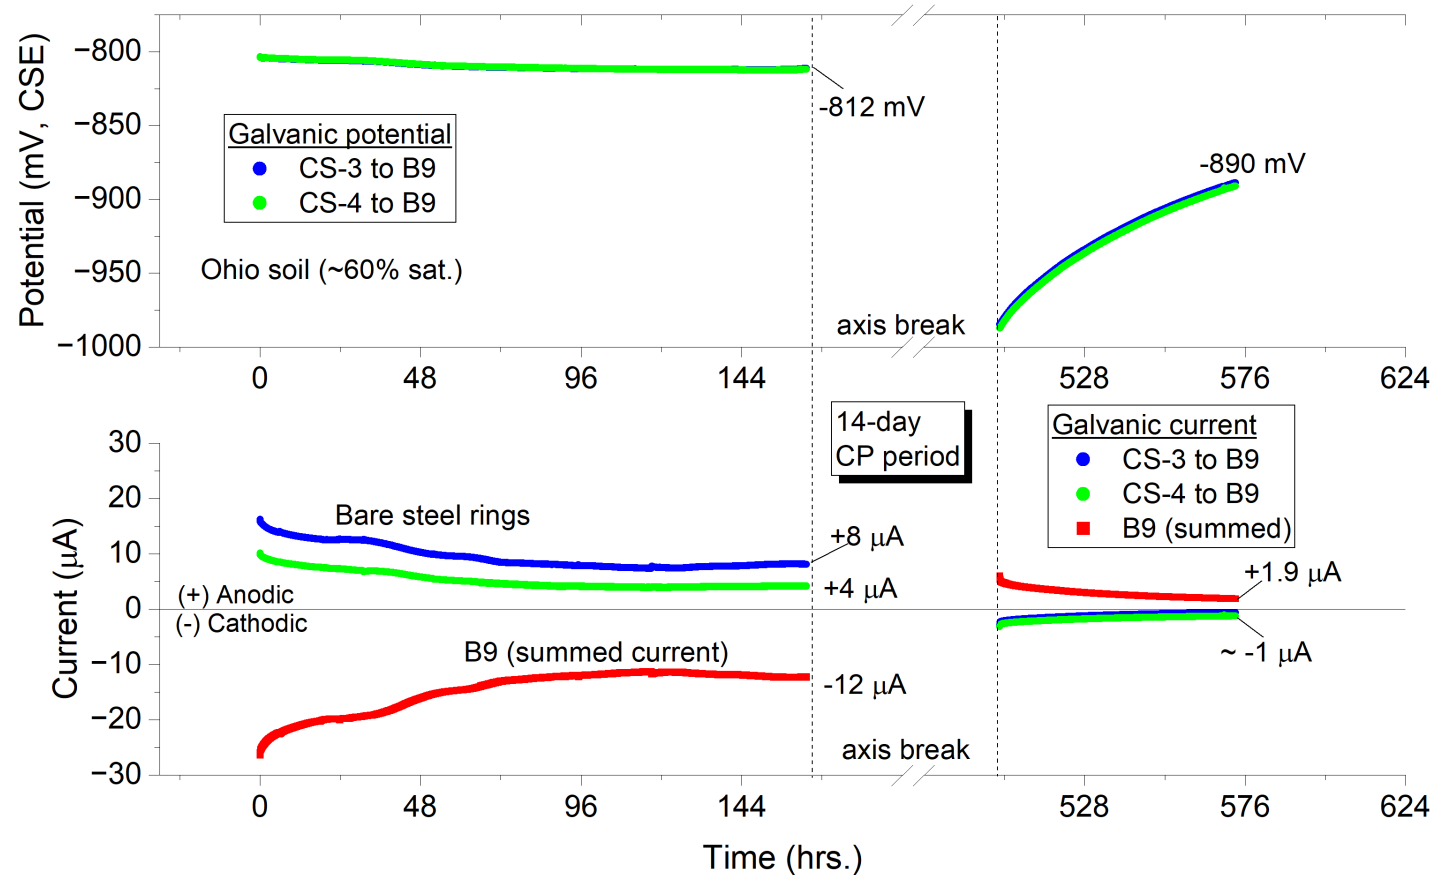
- Test coupon design was successful in capturing the complex conditions created by a disbonded coating
- Provided useful results to validate the fitness of the coupon design for field testing
- Demonstrated functionality and correlation with prior lab tests
- Cathodic protection (CP) did not worsen galvanic interactions in 14-day CP period

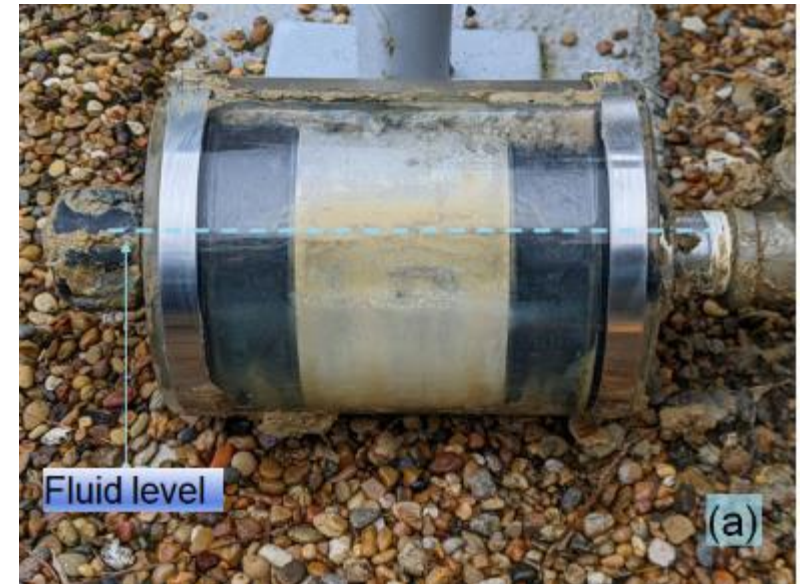
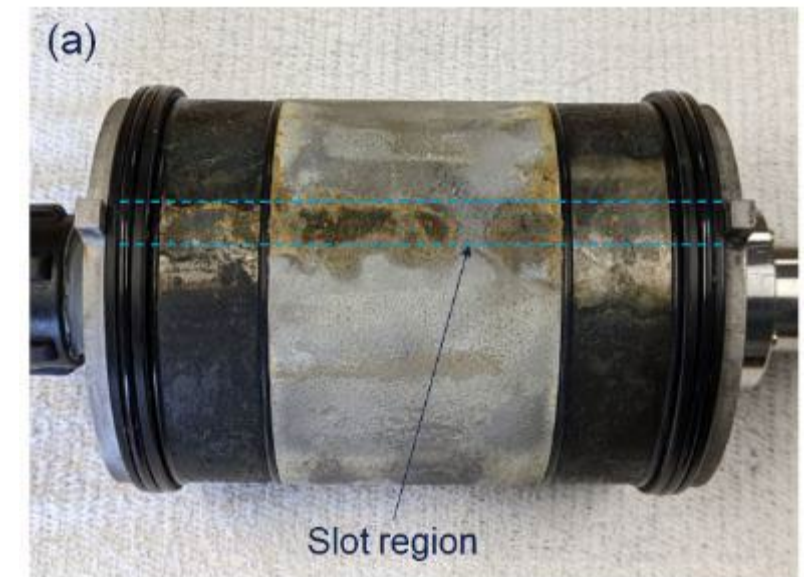
- Overall results correlated with previous lab tests. Field variability in weather, soil, and CP conditions introduced additional factors to consider in the interpretation of the results.
- OCP data and initial galvanic current measurements were consistent with lab results obtained in Enbridge supplied soil.
- Heavy rains filling the coupon disbondment cavity and high CP levels may have raised the local pH around the coupons, which is being reviewed.

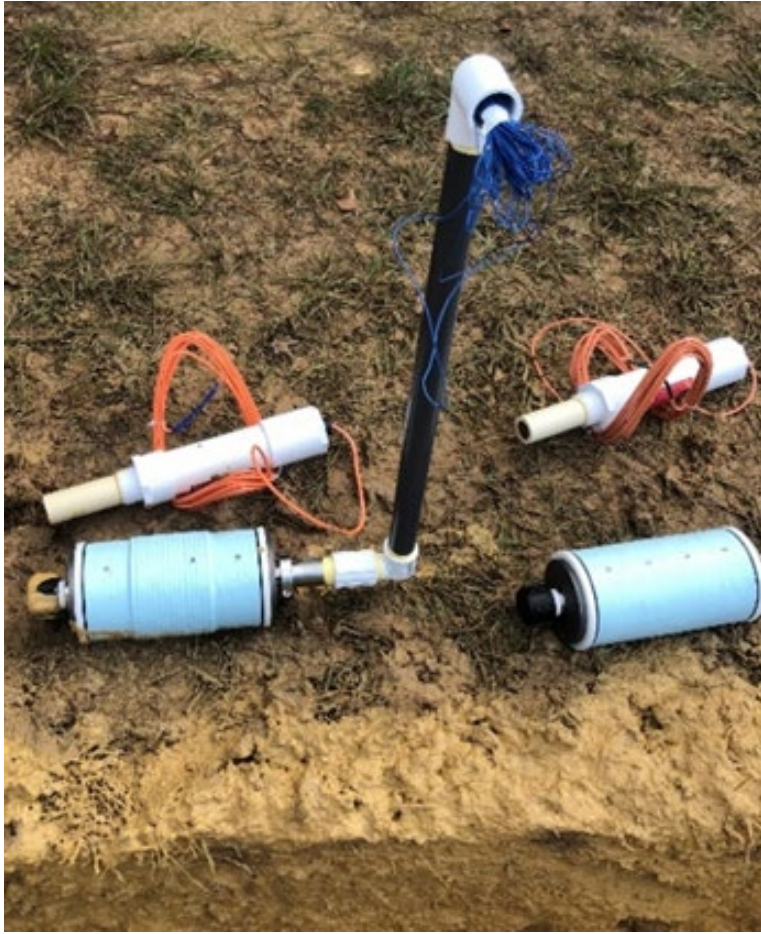
TX

# 6-Month Test Installation at Pipeline Field Sites
