Development of a Remote External Repair Tool for Damaged or Defective Polyethylene Pipe

Final Report

February 2007

Contract/Grant No. DE-FC26-03NT41879

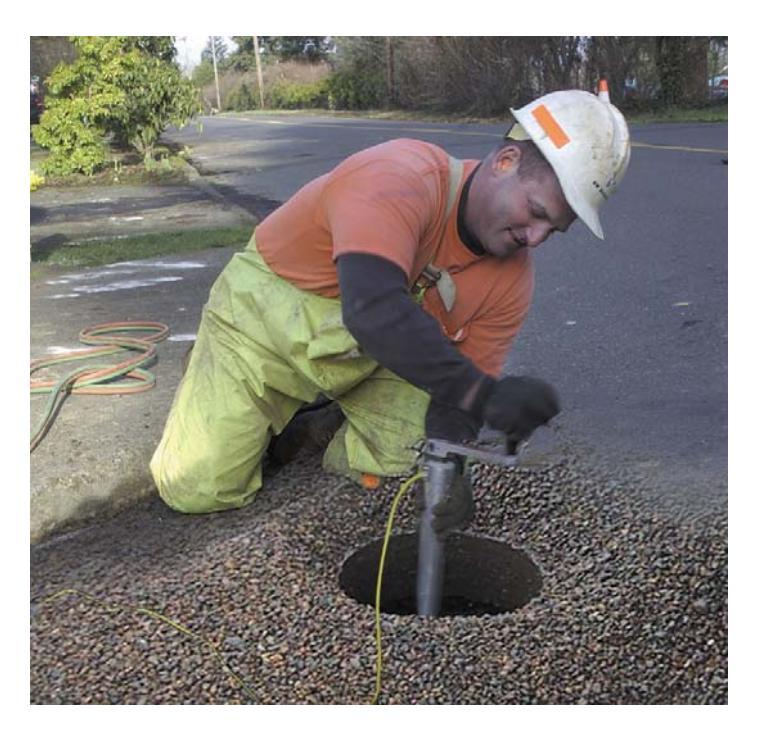
Figure 1: Keyhole Excavation

repair operation and a single excavation. It operates in difficult and keyhole access situations (Figure 1) without the need for pipe squeeze-off.

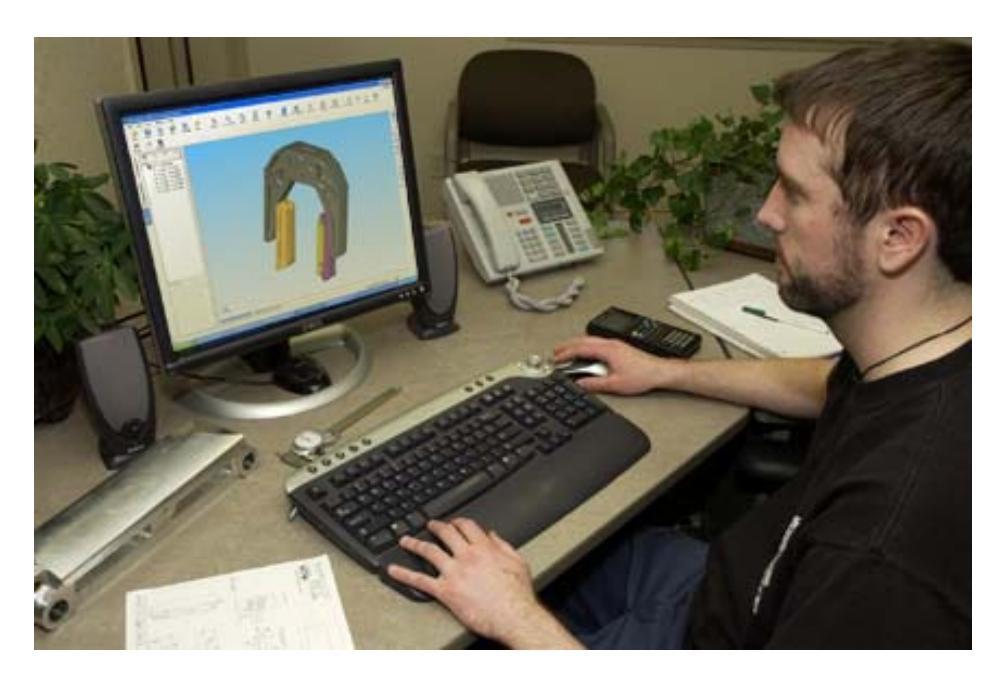
Figure 2: SolidWorks® 3D modeling of the mechanical tool design

Three mechanical tool configurations were designed. The optimum design was developed using SolidWorks® 3D modeling (Figure 2) to ensure remote operation, keyhole application, and compliance with natural gas industry operating practices.⁶

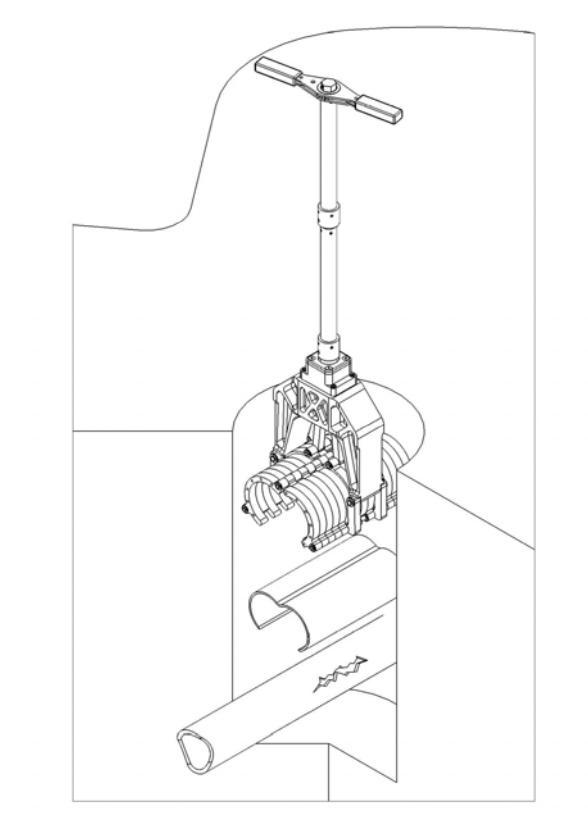
Figure 3: Final Test Tool Design

The optimum design concept (Figure 3) was chosen and a test tool was developed and tested in the laboratory to determine functionality, safety and reliability.

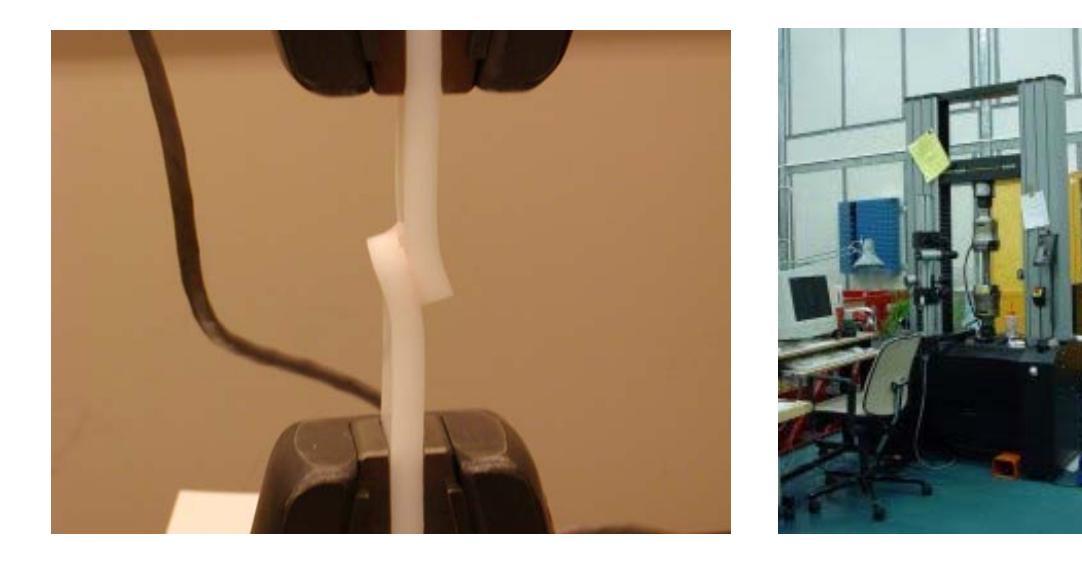
Figure 4: Overlap Shear Test using an Instron Machine

2. PE adhesives: This method utilized structural plastic glues to join the surfaces of the PE patch and the damaged PE pipe. This phase of the research focused on finding an adhesive to bond PE to PE natural gas pipe, which would withstand at least 500 psi (as with the gel concept above). Although many different adhesives were considered, the investigation focused on three structural plastic glues (3M DP8005, 3M DP8010 and Loctite 3030). Glue strength was tested on all three glues with an overlap shear test using an Instron machine (Figure 4).

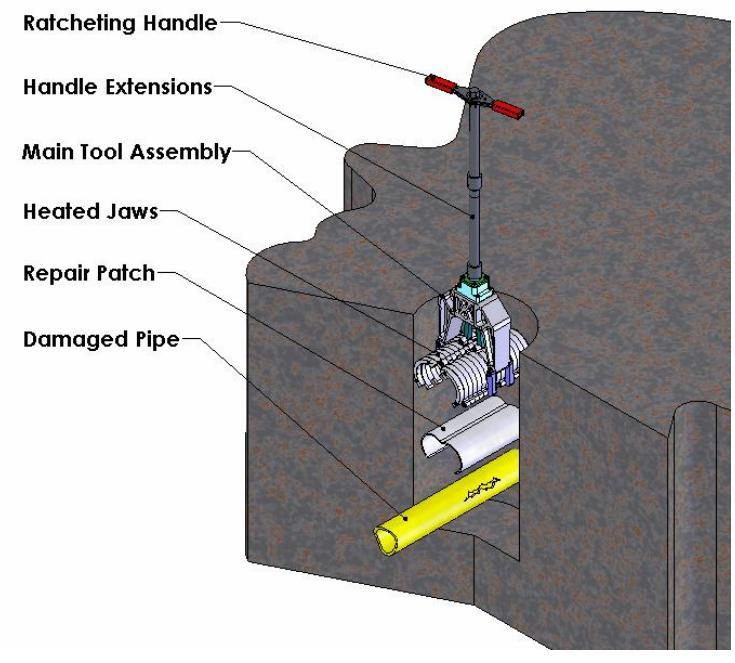
Figure 5: Final design of the engineered prototype for PE pipe repair

Information from Phase 1 was used to guide the final design of the engineered prototype and the repair patch (Figure 5).

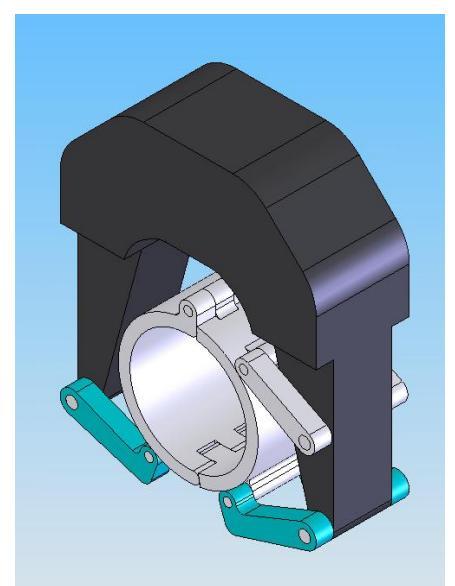
<u>CAD Concept 1 (Figure 8)</u>: Solid jaws were incorporated and manipulated by three linkage points. Solid jaws were beneficial in applying constant controlled pressure, but were not favorable for work on more than one pipe size. In order for the tool to apply pressure to the repair patch, a constant downward force and/or the use of loaded springs or cylinders was required. This concept had an asymmetrical closure on the pipe, which could present problems when used in keyhole excavations.

Figure 8: Repair Tool Design Concept 1

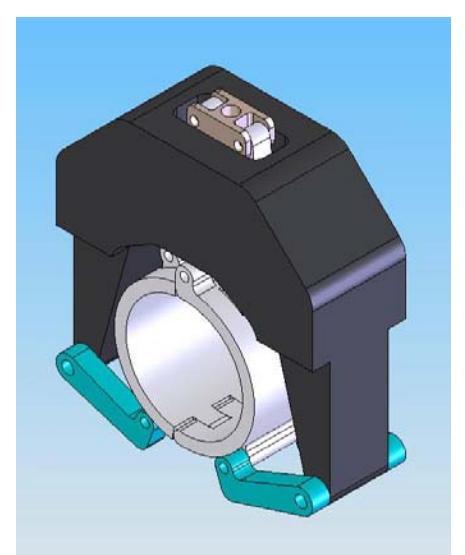
<u>CAD Concept 2 (Figure 9)</u>: Solid jaws were incorporated with four linkage points to open and close the jaws. Closure was controlled mechanically by turning a drive thread. This concept provided symmetrical closure on the pipe making it more advantageous than Concept 1, especially for use in keyhole excavations.

Figure 9: Repair Tool Design Concept 2

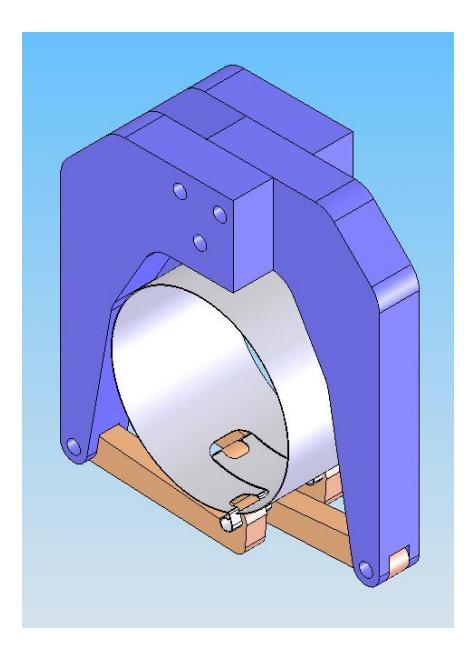
<u>CAD Concept 3 (Figure 10):</u> This concept differed from the other two CAD concepts by utilizing a flexible jaw made from either spring steel or a band heater. Three linkage points wrapped the jaw around the pipe, and with downward force and/or loaded springs applied pressure to the patch. However, the jaw closure did not exhibit as much control as CAD Concept 1 or 2.

Figure 10: Repair Tool Design Concept 3

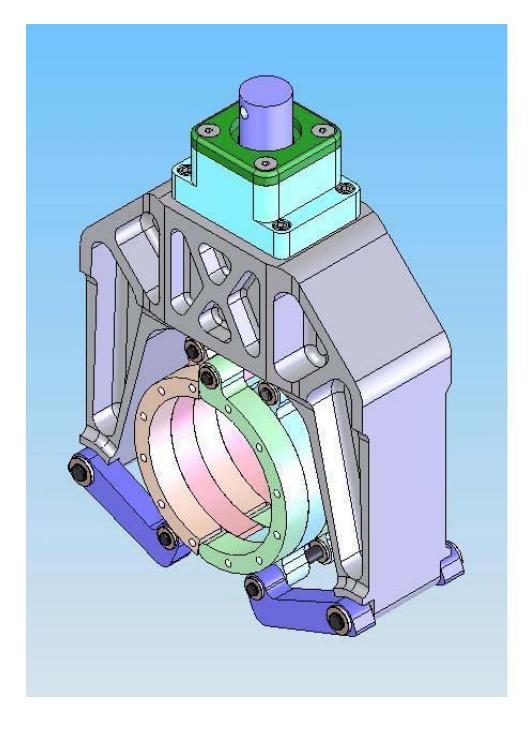
- The dynamics of the tool were reviewed and verified.
- Mechanical stops were added to insure the reliability of the tool.
- The weight of the tool was minimized while ensuring structural integrity.
- The design was reviewed to ensure suitability for manufacturing.
- The jaws were redesigned as layered components and cut using the water jet method to simplify the production process.
- The jaw design was improved to accommodate cartridge heaters and a thermocouple.

Figure 11: Final Test Tool Design

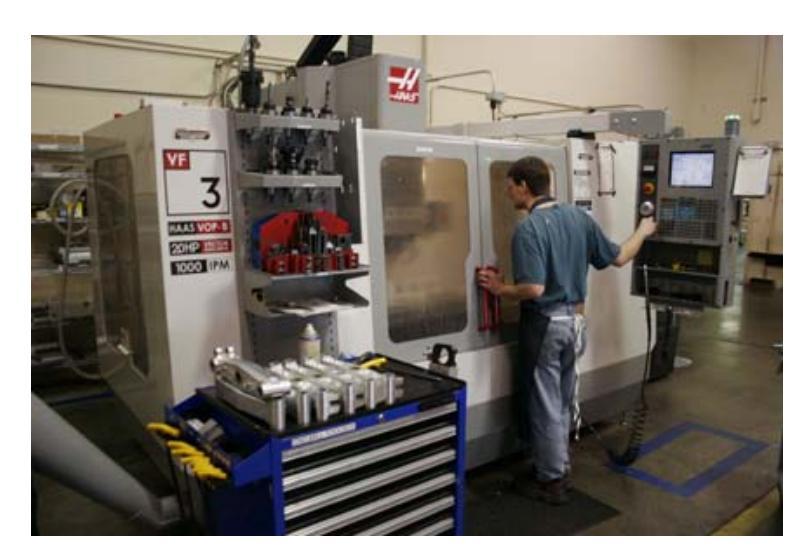
Figure 12: Computer Numerically Controlled (CNC) Machining Center

The preferred design was transferred from SolidWorks® to Computer Aided Machining (CAM) software for virtual machining of each part. The CAM software output a program to manufacture each tool component using Computer Numerically Controlled (CNC) machining centers (Figure 12). The test tool was assembled (Figure 13) based on the mechanical drawings presented in Subtask 3.3. A majority of the mechanical components were fabricated from 6061-T6 aluminum. In-house testing was performed to determine safe and effective operation of the test tool.

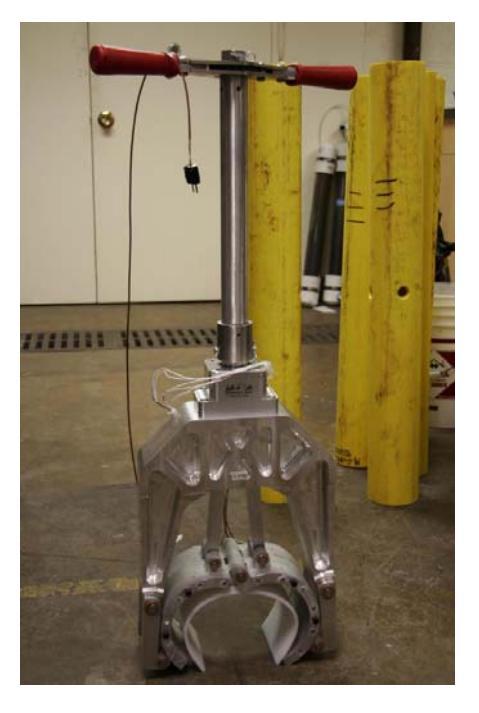
Figure 13: Final Test Tool with Repair Patch

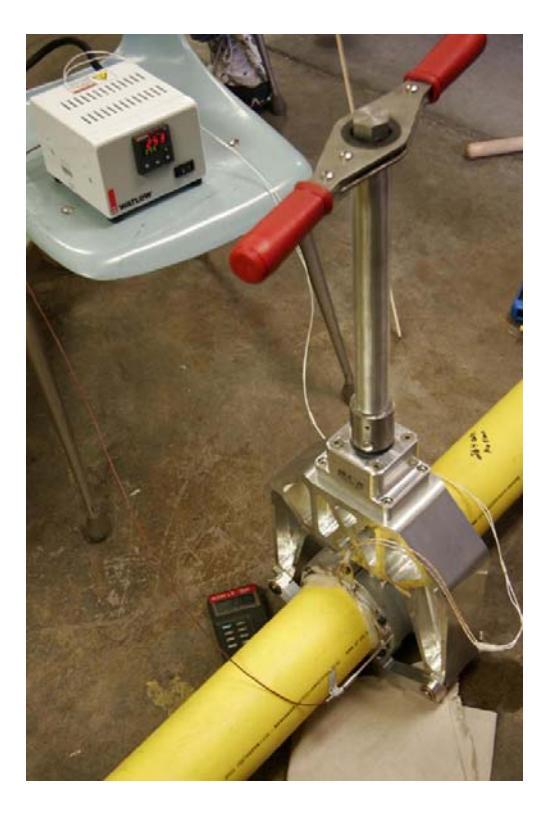
The mechanical design proved successful (Figure 14) during initial functionality testing. A 1-inch hole was drilled into the pipe wall of a 3 ft section of 4-inch IPS SDR 11.5 MDPE pipe to simulate damage produced by a large gouge. This pipe section was used to test the ability of the test tool to successfully apply a thermochemical patch over the simulated damage. Little effort was required to fully wrap the PE gel film patch around the damaged area of the pipe. The tool applied adequate constant pressure to the patch. The internally heated (cartridge heaters) jaws heated rapidly and held the temperature at ~257°F/125°C. The repair process was completed in 90 minutes. The initial repaired pipe sample was able to withstand > 450 psig of hydraulic pressure during a quick burst test.

Figure 14: Test tool successful in bonding the repair patch to 4-inch PE pipe

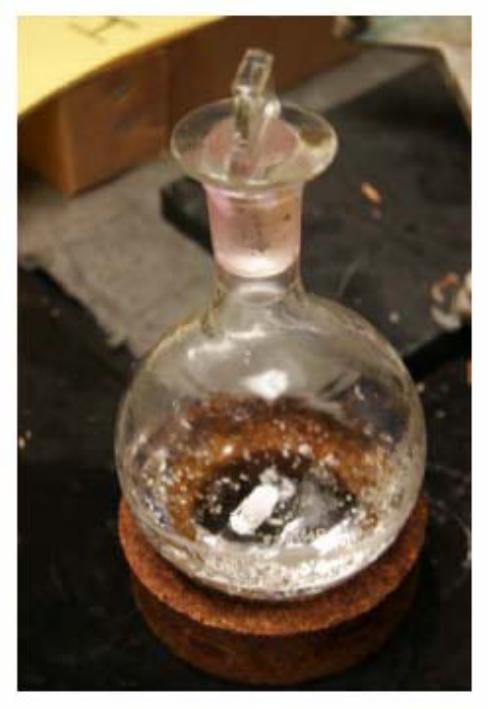
Figure 15: UHMWPE powder dissolved in heated solvent

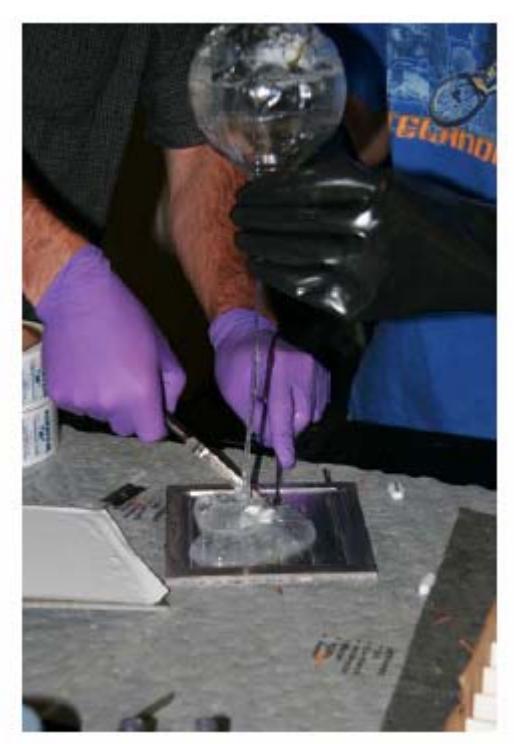
Figure 16: Dissolved UHMWPE pressed into a sheet

was pressed into a sheet (Figure 16) that consisted of approximately 3-8% of PE (93-98% solvent). This pressed sheet was then dried (Figure 17) to an approximate solvent concentration of 10-20%.

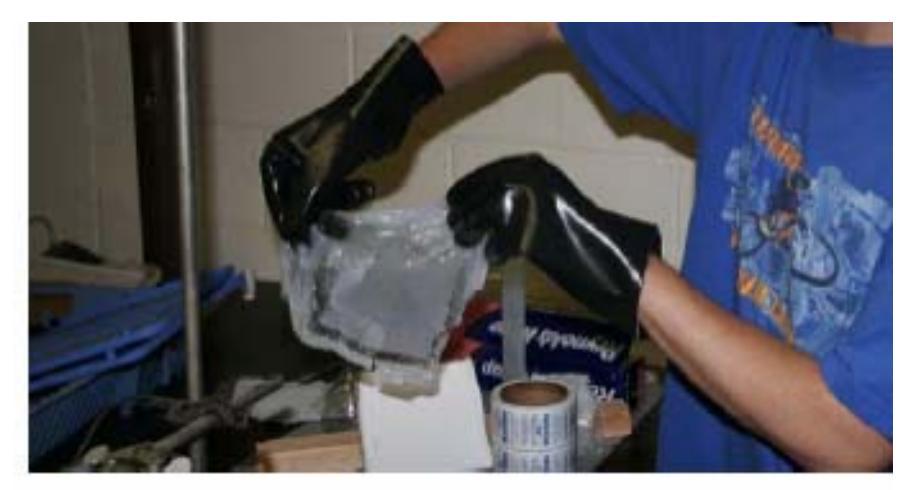
Figure 17: Pressed Gel Sheet

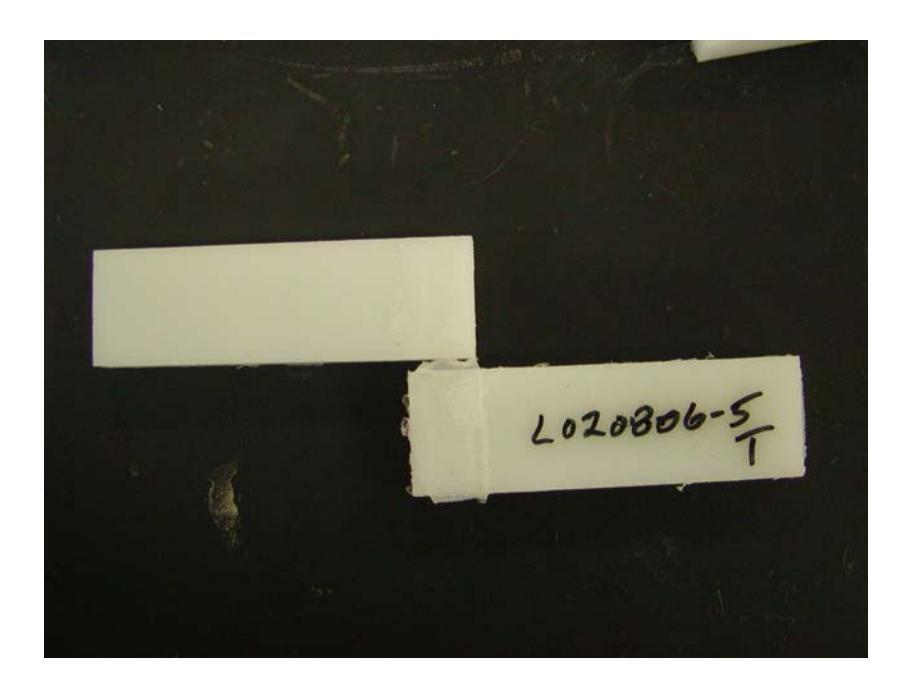
Subsequently, the UHMWPE gel sheet was cut into strips and sandwiched between two pieces of HDPE substrate (Figure 18). The HDPE substrates were bonded using the PE gel in a Carver press (Figure 19) equipped with heated platens. Various scenarios of the lap shear tests were performed varying the test sample thicknesses, pressure of application, and temperature of the platens. All the samples were prepared using a modified version of the ASTM standards D3163, D3165, and D5868.

Figure 18: UHMWPE gel sheet prior to being sandwiched between HDPE substrates

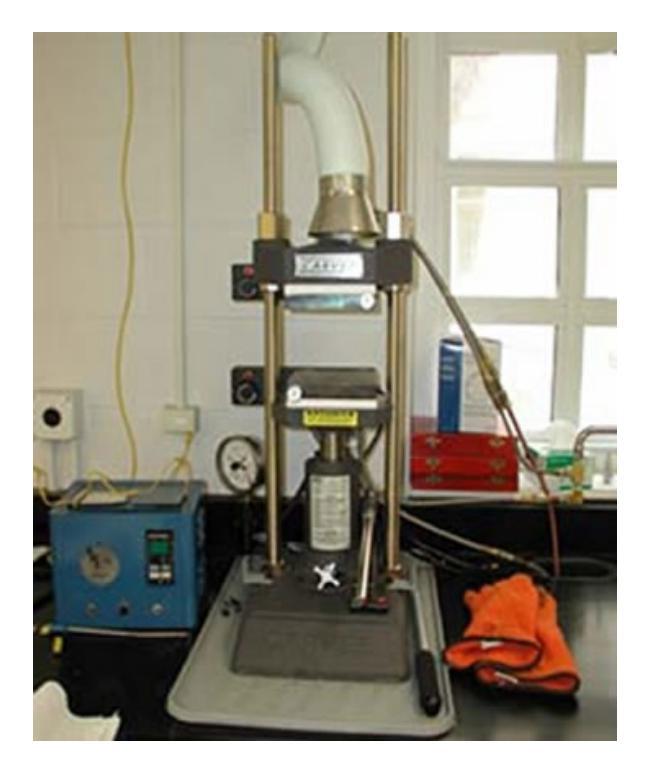
Figure 19: Carver press equipped with heated platens

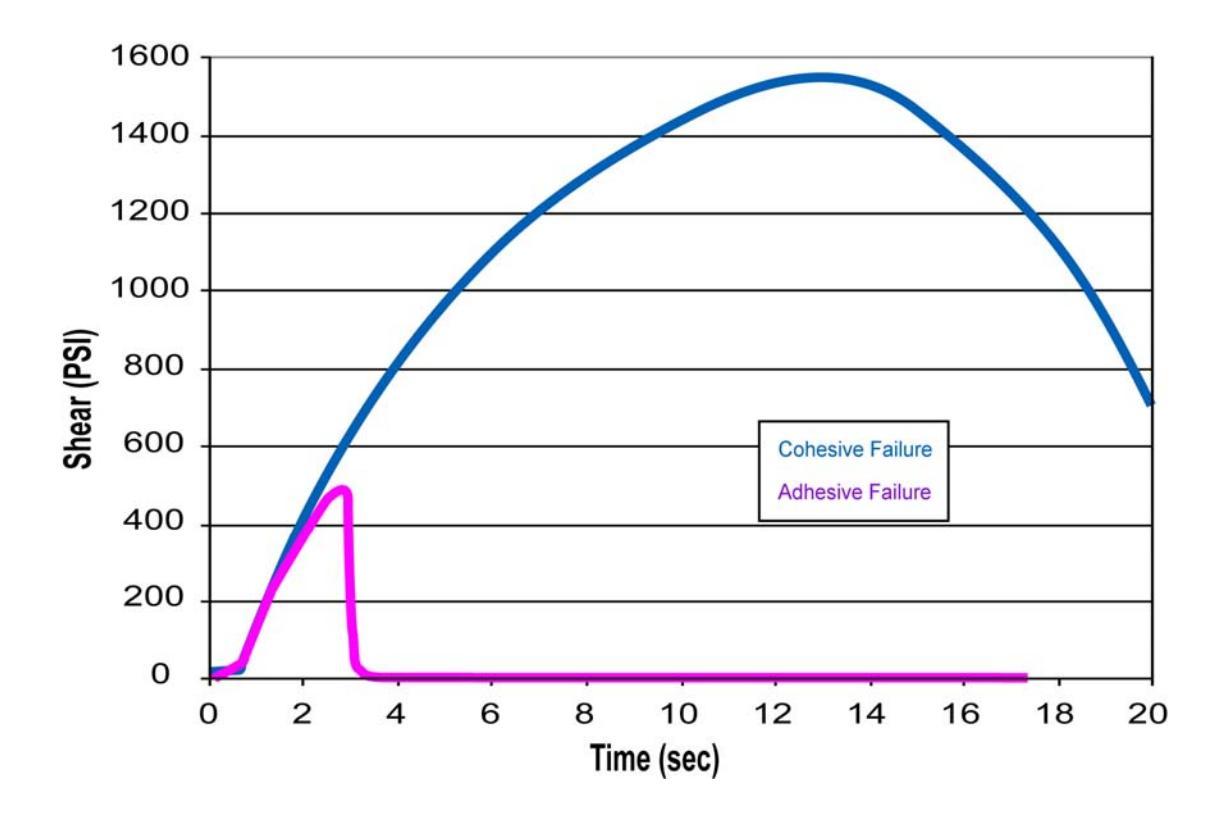
When these PE gel lap shears were tested in an Instron, they exhibited cohesive failures (i.e., the substrate (PE) failed) as opposed to the adhesive failures seen with the DP8010 bonds. A graph showing adhesive vs. cohesive failures during a lap shear test is shown in Figure 20.

Figure 20: Graph of cohesive vs. adhesive failures during lap shear tests

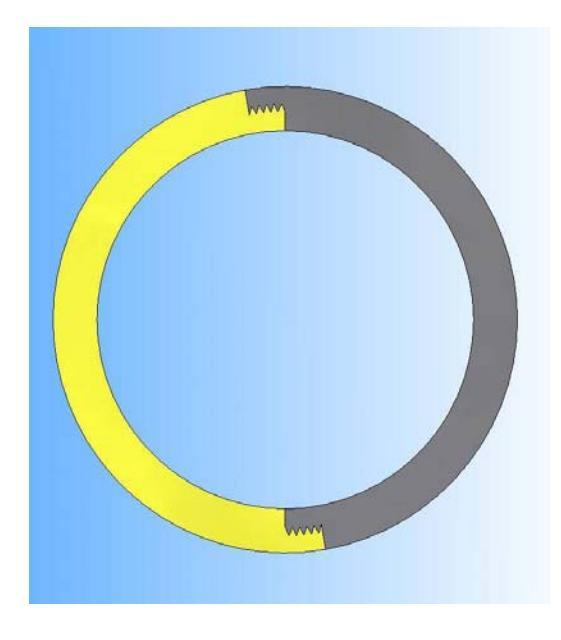
Figure 21: Overlapping half-wrap patch design concept

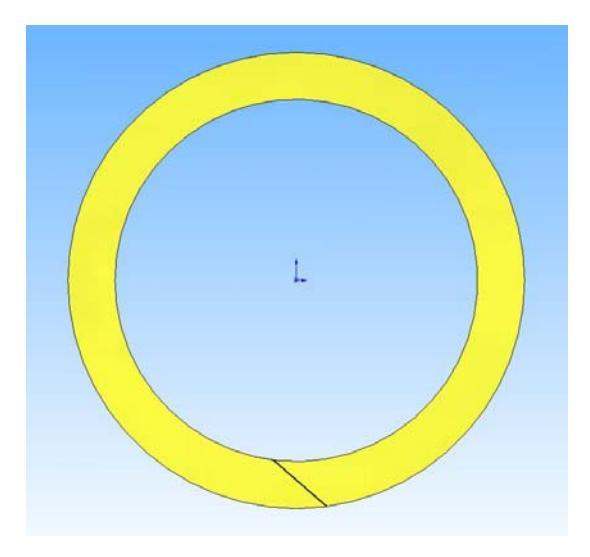
ends (Figure 22). A full-wrap patch substrate was pre-formed to fit inside the open jaws of the repair tool (see Figure 23). Once the tool was placed over the pipe, the patch assembly was molded to tightly wrap around the pipe and overlap at the tapered joint.

Figure 22: Overlapping full-wrap patch design concept

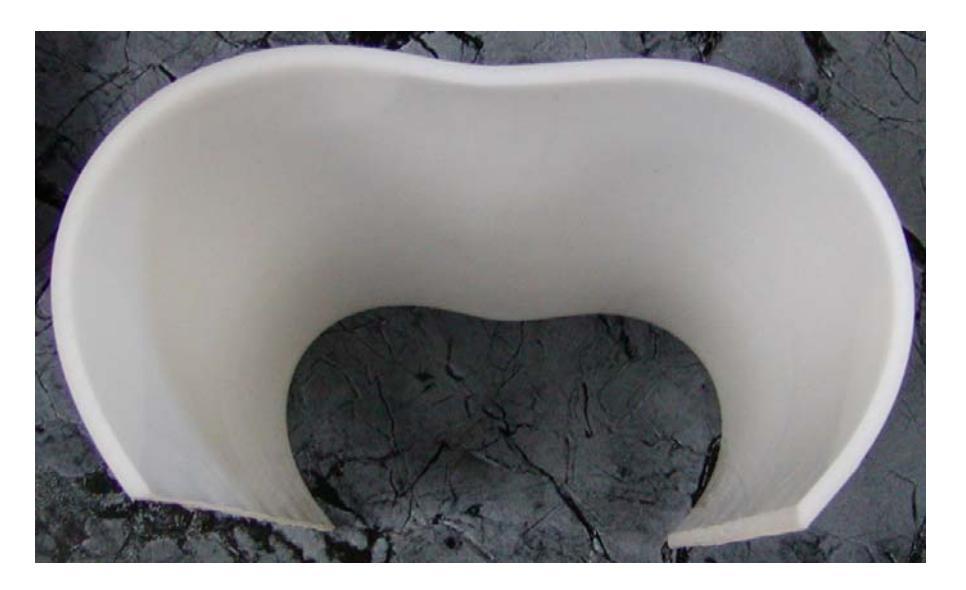
Figure 23: Preformed overlapping full-wrap patch

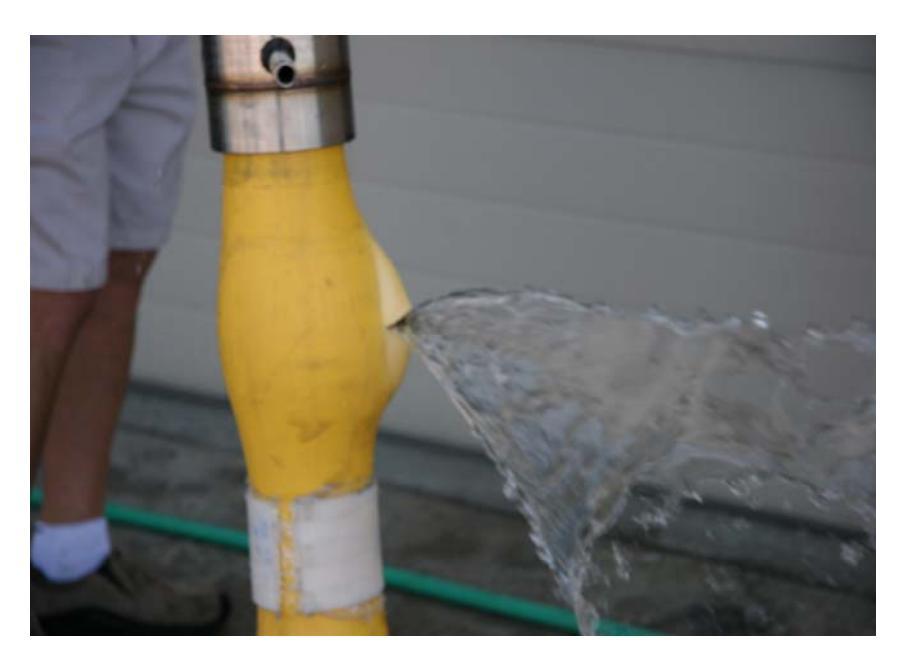
Pressure tests were performed on repaired 4-inch MDPE pipe samples obtained during the test tool performance tests in Task 4.4 to determine how well the PE adhesive, PE gel and PE gel film patches adhered to the pipe surface. The initial pressure tests conducted were quick burst tests performed by raising the hydrostatic pressure in the patched pipe to 600 psi over a short time period (1-5 min) and held until the repaired pipe failed (Figure 24).

Figure 24: Successful bond of PE gel patch to 4" MDPE pipe at 600 psi during quick burst testing

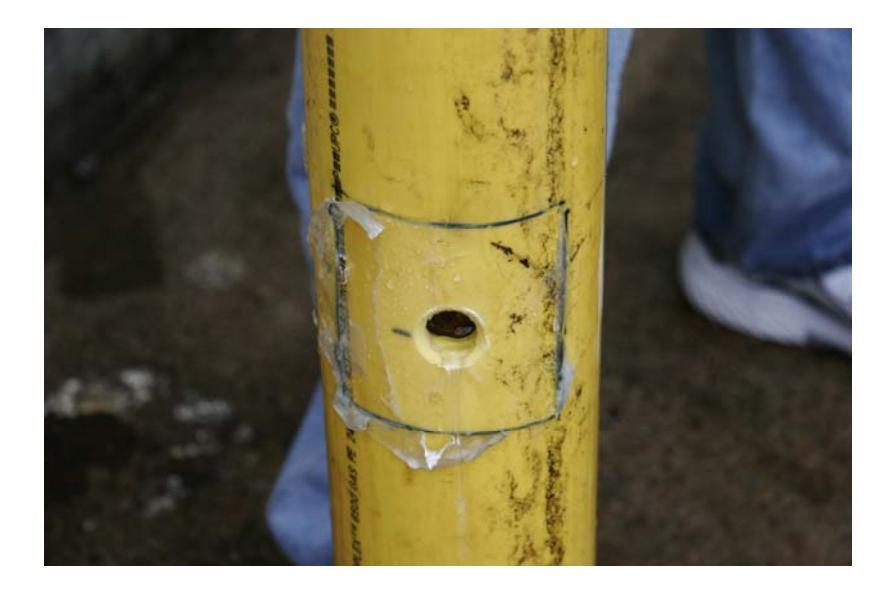
Figure 25: Failure of adhesive patch during quick burst testing at 450 psi

All the quick burst tests performed on the repaired PE pipe samples using DP8010 commercial adhesive patches resulted in patch bond failures between 250 psi and 450 psi (Figure 25). The PE gel and PE gel film patches, however, resulted in many successful quick burst tests where the pipe failed at locations away from the patch (Figure 26).

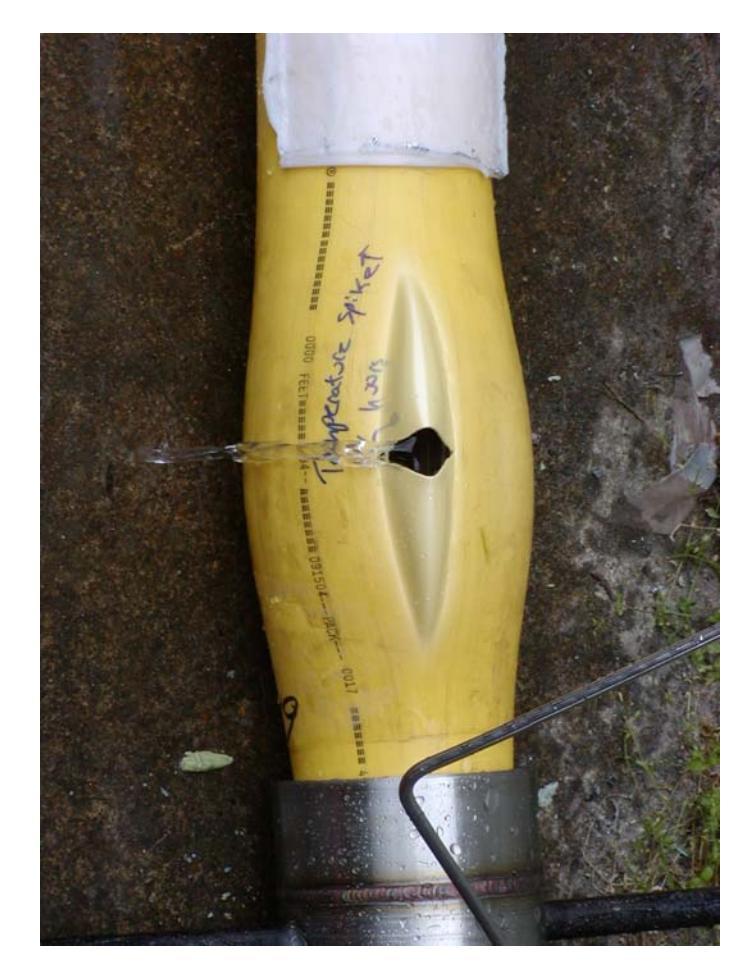
Figure 26: Quick burst test shows pipe failure below PE gel film patch – Indicative of successful bonding

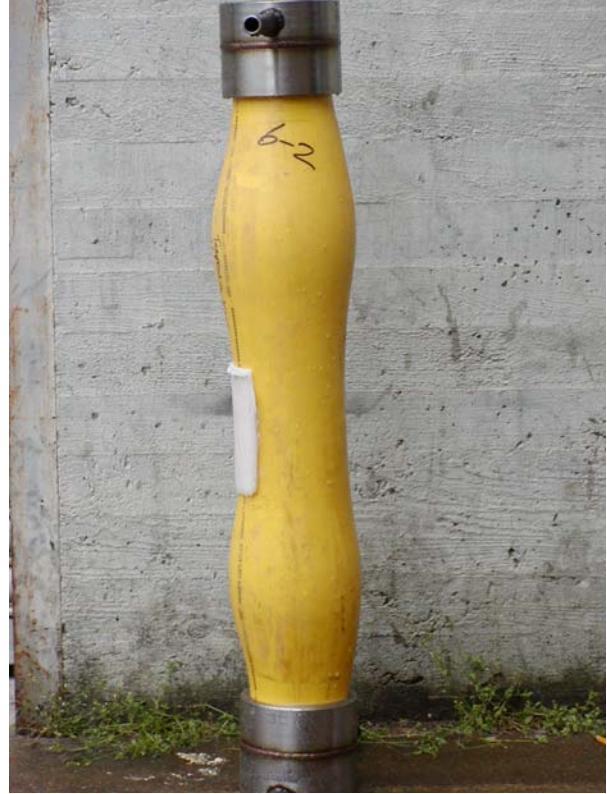
During initial quick burst tests, it was observed that the pipe seemed to be reinforced for hoop stress in the vicinity of the patch, even if only a half patch was applied (Figure 27).

Figure 27: Pipe sample repaired with half patch showing hoop stress reinforcement

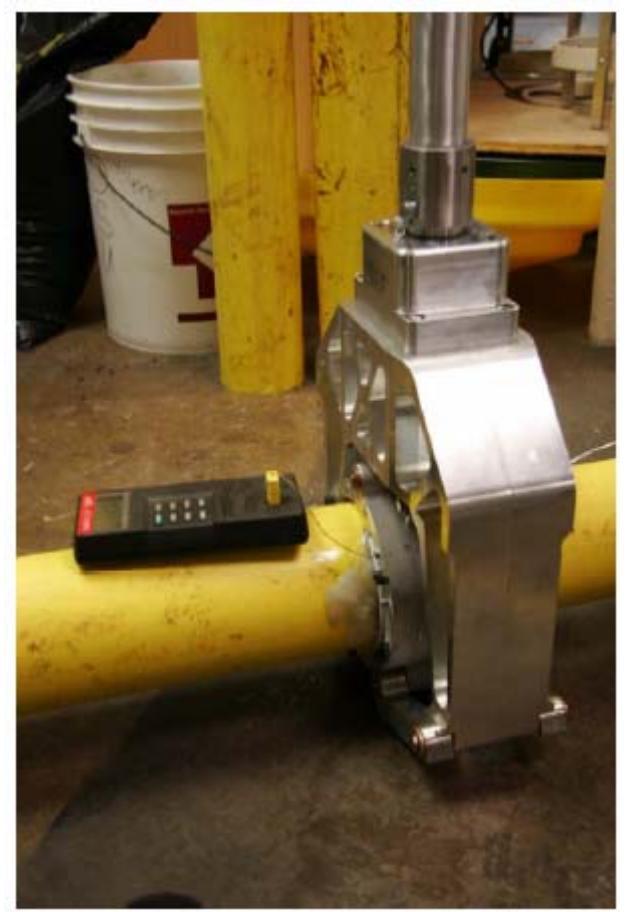
Figure 28: Overlapping full-wrap patch applied to 4-inch MDPE pipe during demonstration for Northwest Natural

At demonstrations performed for Northwest Natural Gas field crews in Portland, Oregon on February 25, 2005 (Figures 28 & 29), a thermo-chemical PE gel film repair patch (developed in Task 4.1) was applied over a 1-inch diameter hole drilled into the wall of one 4 ft section of 4-inch IPS (SDR 11.5) MDPE pipe pressurized to 45 psig. The repair patch was applied using the test tool developed during Phase 1. The repair patch successfully bonded to the pipe under pressure. Subsequently, the repaired pipe sample was sent to OSU for quick burst testing as reported in Subtask 5.1. The test tool was also successfully demonstrated to DOE/NETL project managers at Timberline Tool facilities in Kalispell, Montana on July 13-14, 2005 (Figures 30 & 31).

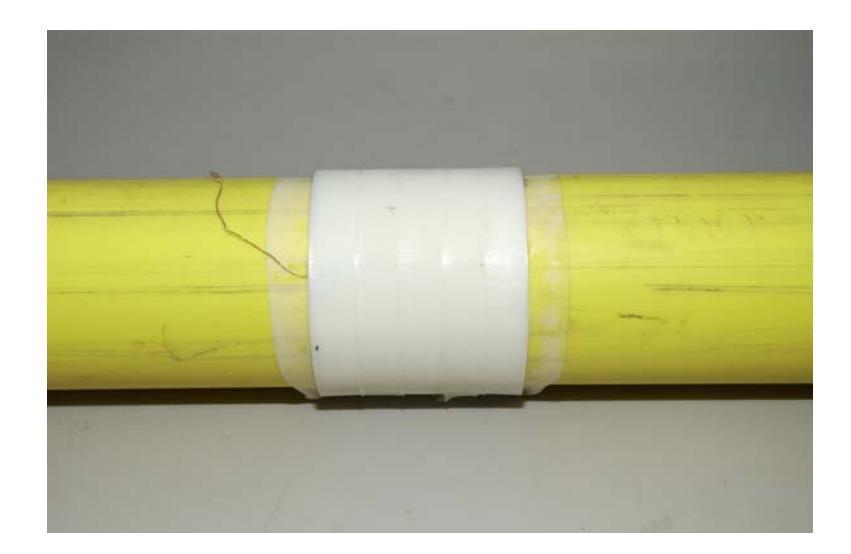
Figure 29: Completed bonding of overlapping full-wrap patch on 4- inch MDPE pipe

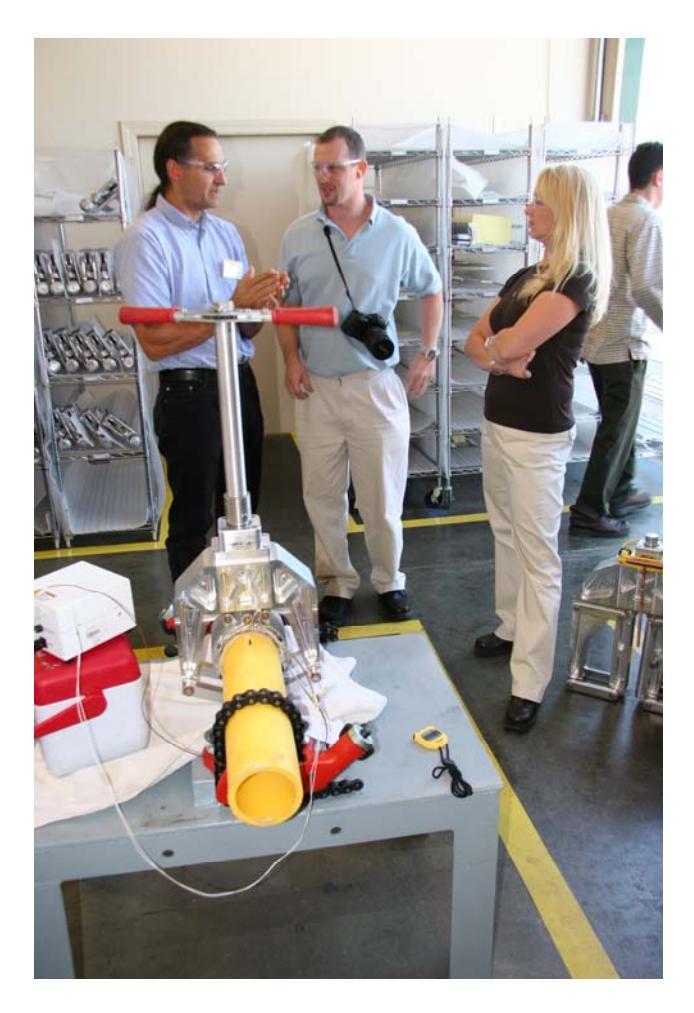
Figure 30: Test tool and PE gel film patch repair process successfully demonstrated to DOE/NETL project managers at Timberline Tool facilities

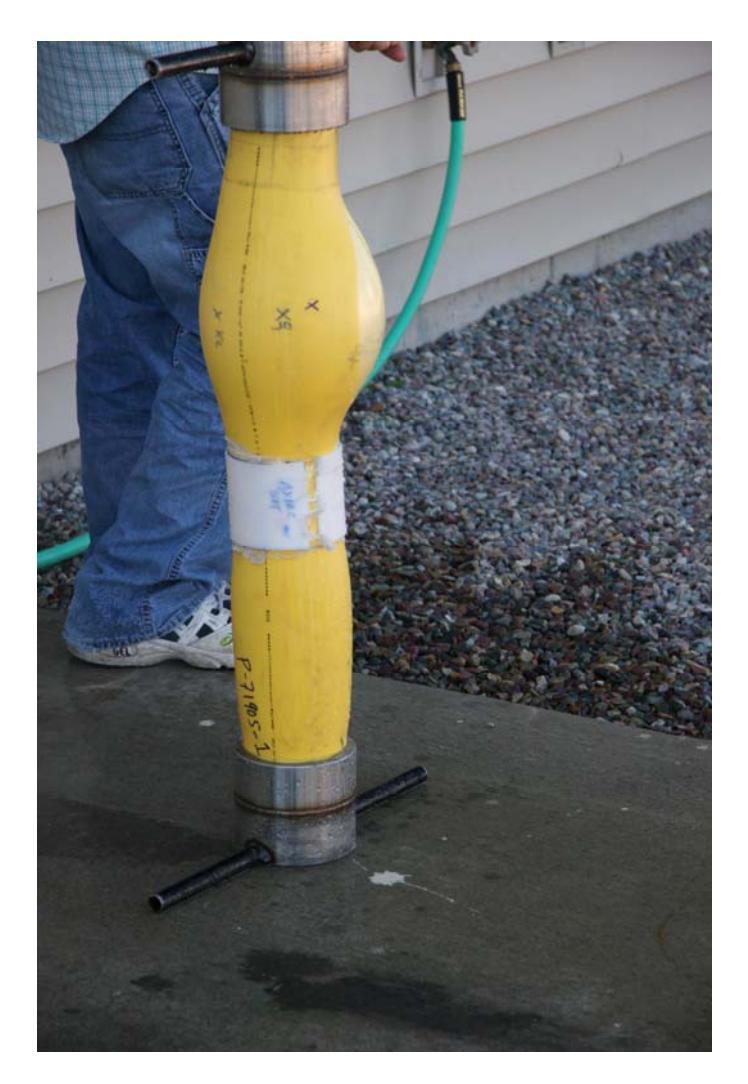
Figure 31: Quick burst test for DOE/NETL demonstrates successful bonding of PE gel film patch on 4-inch MDPE pipe

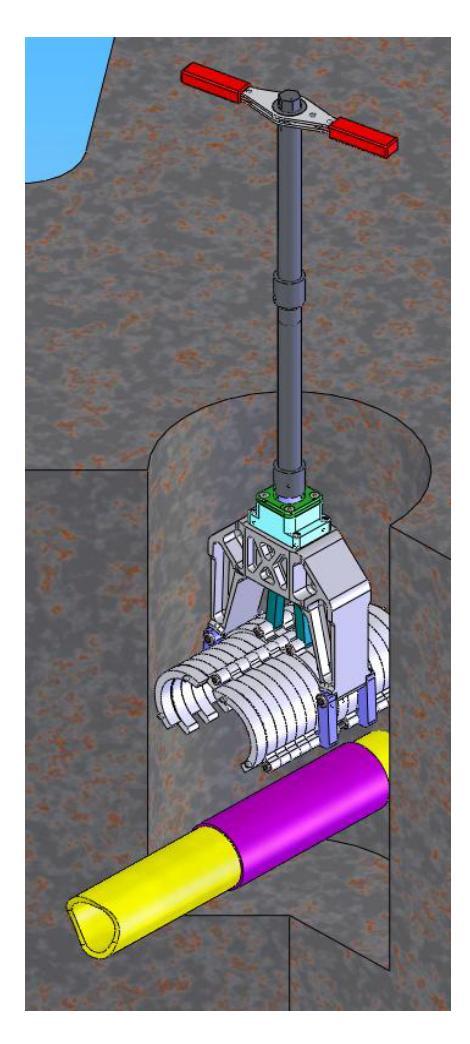
- The jaw components were redesigned to cover a section of pipe 12 inches long in order to repair the majority of damaged pipe (small nicks as well as large gouges), (Figure 32).
- The internal cartridge heaters were redesigned to accommodate the extension of the jaws.

Figure 32: Engineered prototype design shown with 12-inch jaws

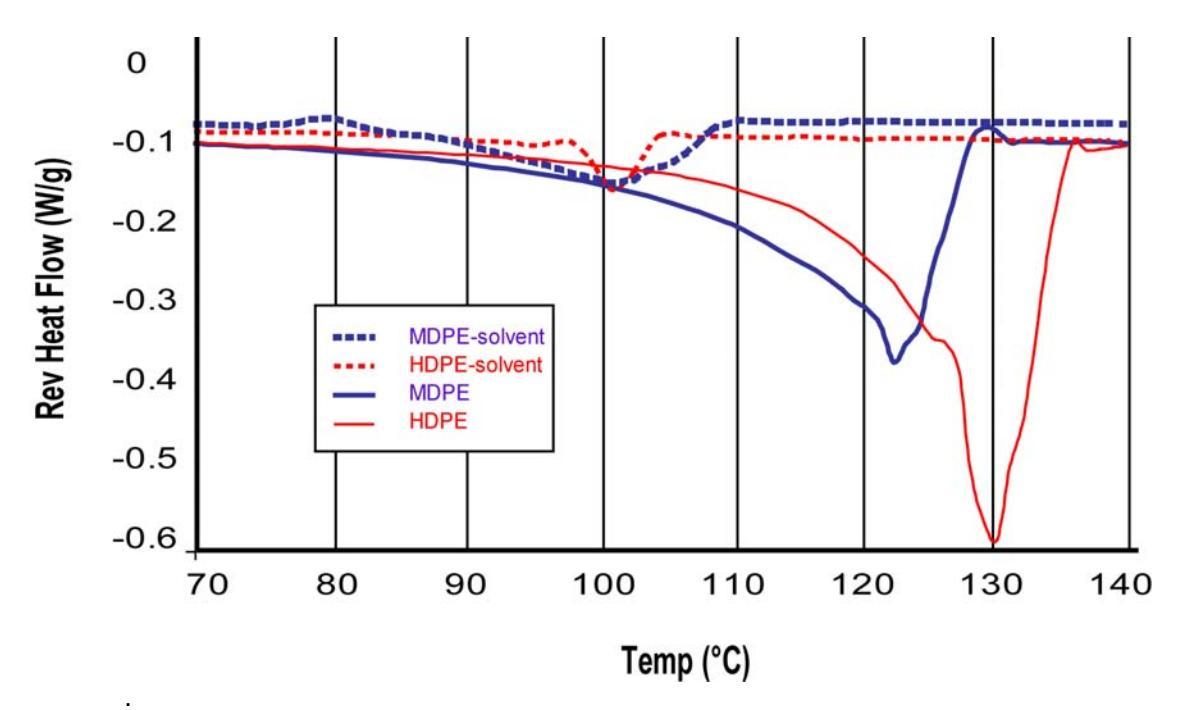
Differential Scanning Calorimetry (DSC) of PE, in the presence of the solvent, showed an effective lowering of the melting point of both MDPE and HDPE (Figure 33). Lowering the melting point allowed for fusion welding to take place at the substrate-film-substrate interface without significantly diminishing the overall strength of the bulk of the substrate polymers during the bonding process. PE gel films reached their peak strength with a cure temperature of 230°-248°F/110°-120°C. It was vital, however, to have enough solvent in the PE gel film (or PE gel) to allow the solvent to affect both substrate surfaces during the cure process.

Figure 33: Differential scanning calorimetry curves of virgin PE vs. PE with solvent shows the effect of solvent on lowering the melting point of PE

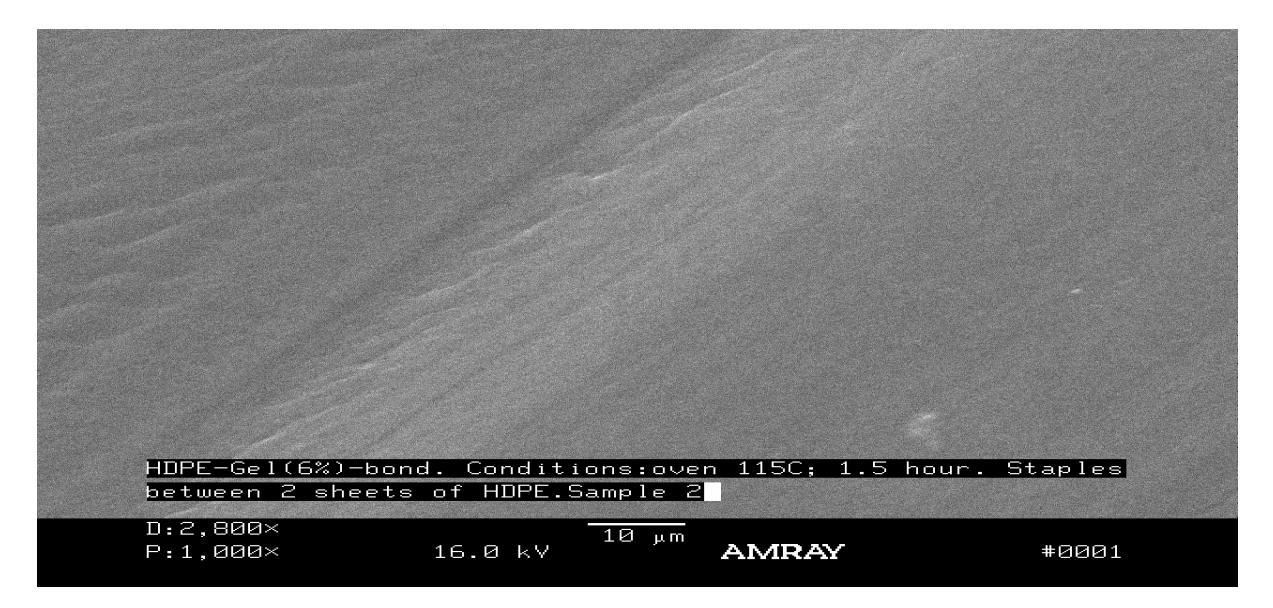
Another indication that the bonding mechanism was successful is shown by a scanning electron microscopy (SEM) micrograph of the bonded area (Figure 34). From this SEM micrograph, a uniform area was seen with no defined layers. This uniform bond area indicated a seamless fusion of the two substrates.

Figure 34: SEM micrograph showing uniform PE bond interface

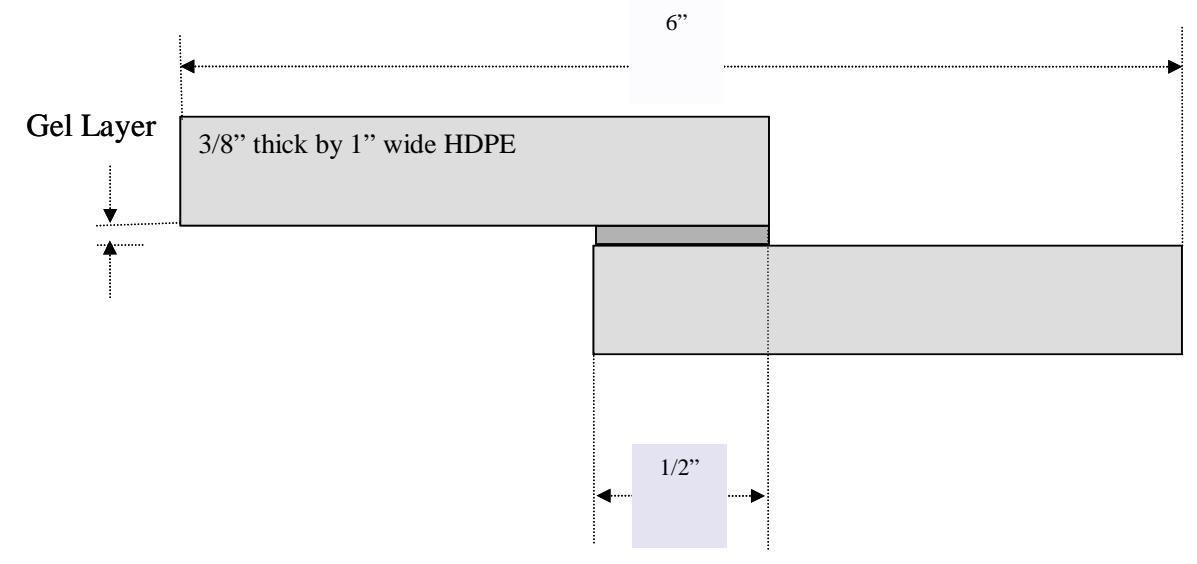
Lap shear samples were designed to test the bond strength of the PE gel or PE gel film bonds (Figure 35). The lap shear samples were then pulled at a rate of 1-inch per minute to test the strength of the bonds (early work samples were pulled at 1/2-inch per minute). The major variables affecting bond strength were time, temperature, and pressure. For these tests, the platen pressure was maintained at 20 psi. The polymer fusion process required just enough pressure to keep the substrate-film-substrate in firm contact since lower pressures resulted in air gaps, and higher pressures squeezed out the gel layer, both of which resulted in inferior bonds.

Figure 35: Diagram of lap shear sample design

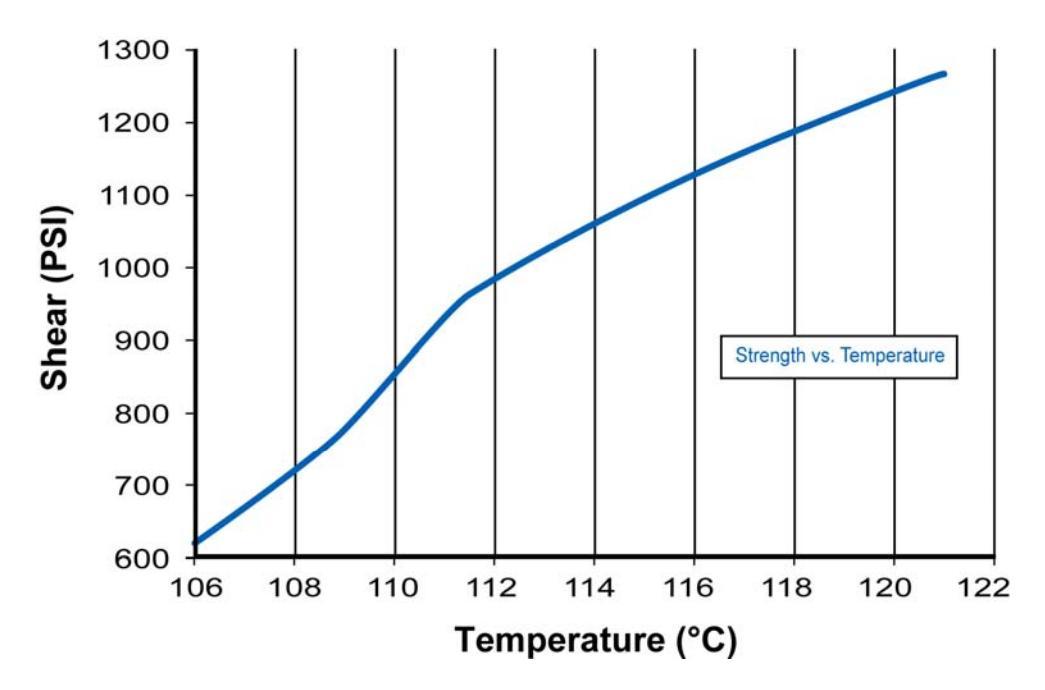
Temperature experiments were performed with a total cure time of 90 min. For these tests, the lap shear samples were produced at a temperature range of 223°-248°F/106°-120°C. The curve of these points is shown in Figure 36. As expected, in this temperature range, the strength of the bond increased almost linearly as the temperature increased.

Figure 36: Graph of bond strength as a function of bonding temperature

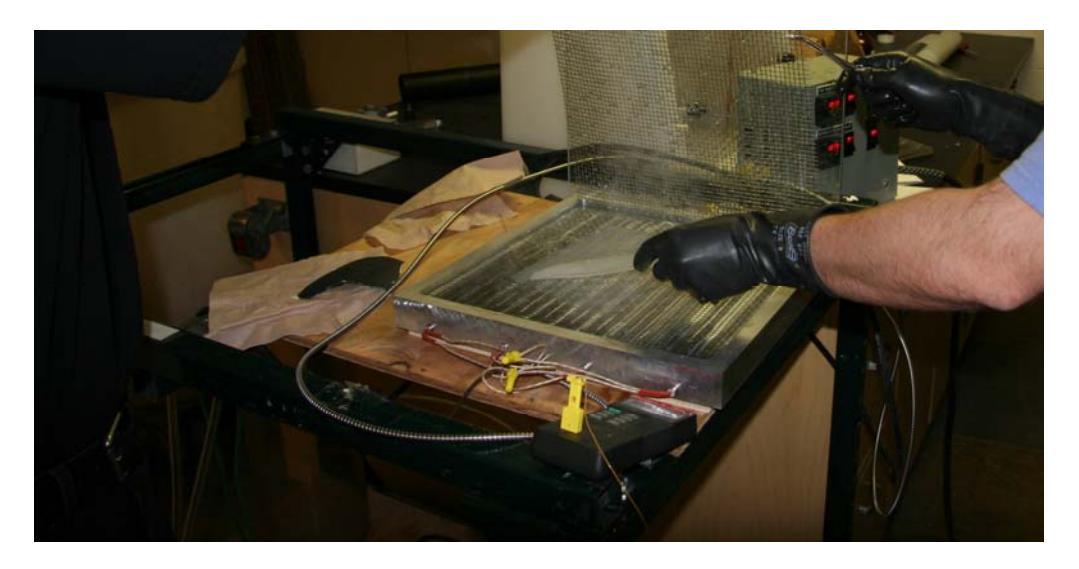
The large PE gel film patches were made by swelling (Figure 37) 8" X 8" UHMWPE films in solvent until they were larger (Figure 38) than a 14" X 14" swollen film. This PE gel film was then placed between a pre-formed sheet of HDPE substrate (the patch) and a very thin sheet of HDPE (0.001"-0.003") (the packaging material) in a sandwich-like configuration (Figure 39).

Figure 37: Swelling process used to fabricate a large PE gel film patch

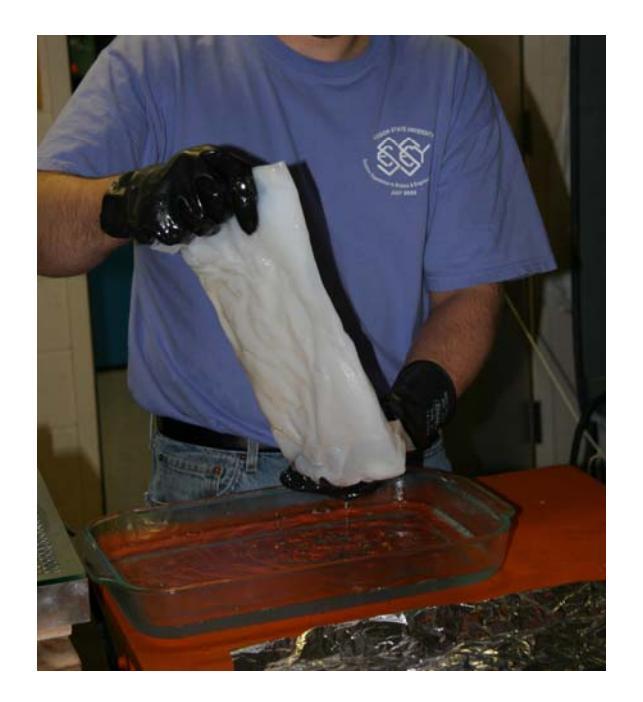
Figure 38: Photo of the final large PE gel film patch after the swelling process
