Development of a Remote External Repair Tool for Damaged or Defective Polyethylene Pipe

Final Report

February 2007

Contract/Grant No. DE-FC26-03NT41879

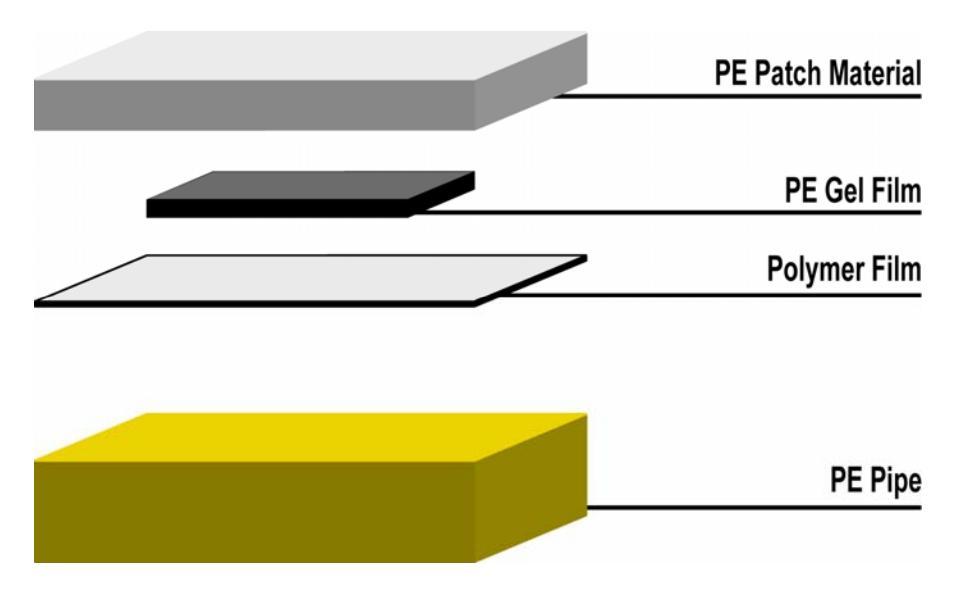
Figure 39: Diagram of PE gel film patch design

The large PE gel film patches were made by swelling (Figure 37) 8" X 8" UHMWPE films in solvent until they were larger (Figure 38) than a 14" X 14" swollen film. This PE gel film was then placed between a pre-formed sheet of HDPE substrate (the patch) and a very thin sheet of HDPE (0.001"-0.003") (the packaging material) in a sandwich-like configuration (Figure 39).

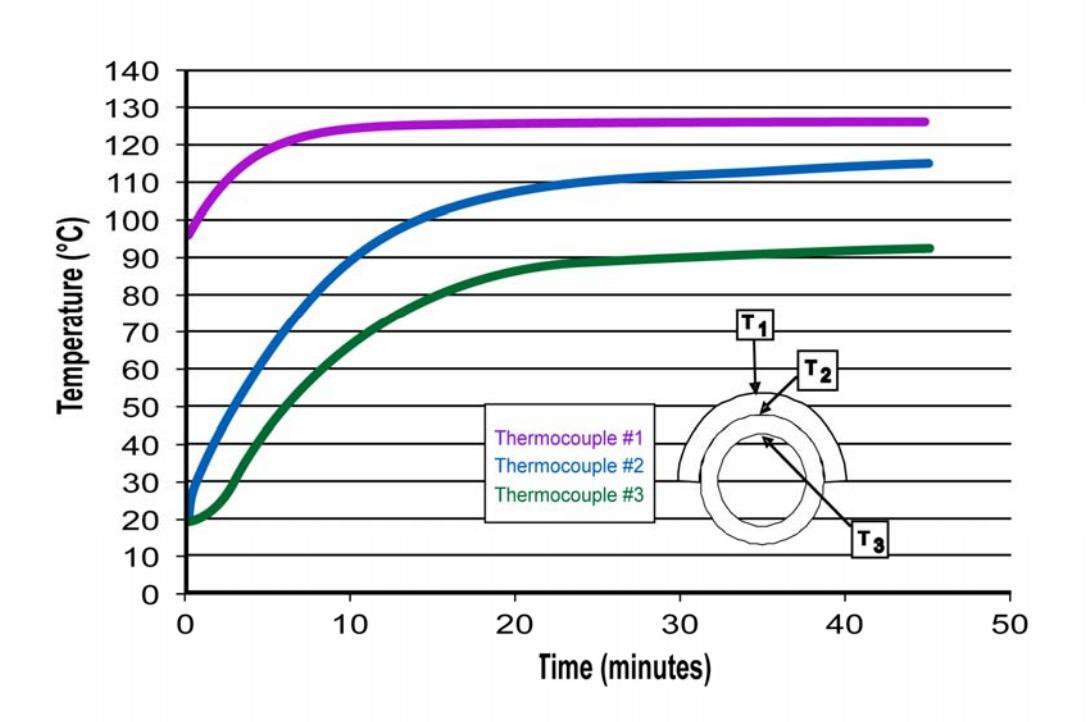
temperature on an actual pipe sample was significantly different due to the onesided heating and the additional heat losses. For this reason, heating profiles were developed for the engineered prototype tool (Figure 40). These profiles showed that, starting at a temperature of 86°F/30°C, approximately 20 minutes was required for the interface temperature to reach the desired temperature. It also illustrated that the pipe being patched remained well below its natural melting point. As with the lap shears, the pipe patch interface required a minimum of 30-60 minutes at the desired temperature to achieve good bond strength. Therefore, a total cure time of 90 minutes was used when patching pipes with the engineered prototype repair tool. This allowed the bond interface polymers enough time to fuse.

Figure 40: Temperature vs. heating time for 257°F/125°C platen temperature

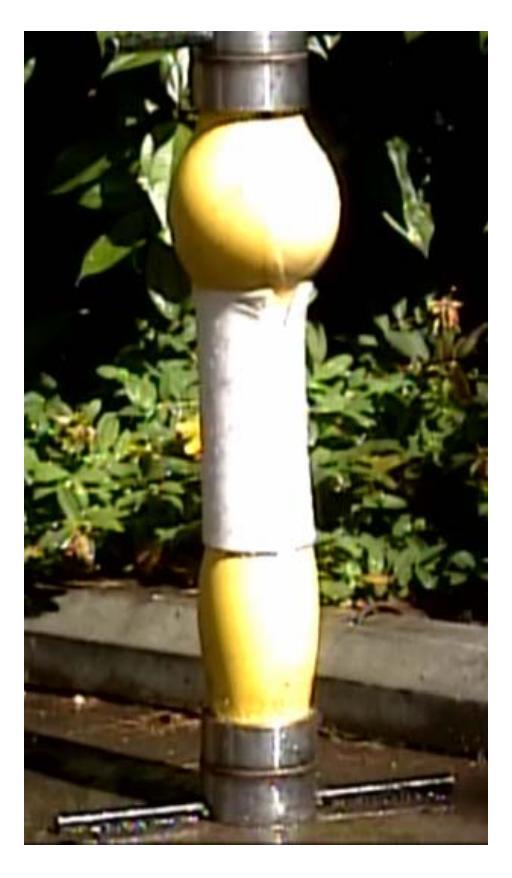
Figure 41: Quick burst test with overlapping full-wrap gel film patch shows successful bond at 500 psi

The technical objective of this subtask was to determine the overall performance of the HDPE repair patch (full wrap-overlapping PE gel film) using quick-burst testing to 600 psi, sustained pressure testing to 200 psi and stress-rupture regression on PE pipe samples repaired by the engineered prototype in Phase 2. Tests were conducted to determine the overall performance of the repair patch (including bonding) with ASTM D1599 quick-burst tests (Figures 41 & 42) at 73°F/23°C and 176°F/80°C; ASTM D1598 sustained pressure tests at 73°F/23°C and 176°F/80°C; and 73°F/23°C stress-rupture regression per ASTM D2837. Results of these tests showed successful bonding of a full wrap patch. Furthermore, a closed system full wrap-overlapping PE gel film patched pipe was held at room temperature and 200 psi for greater than 5 months without any loss in pressure (Figure 43).

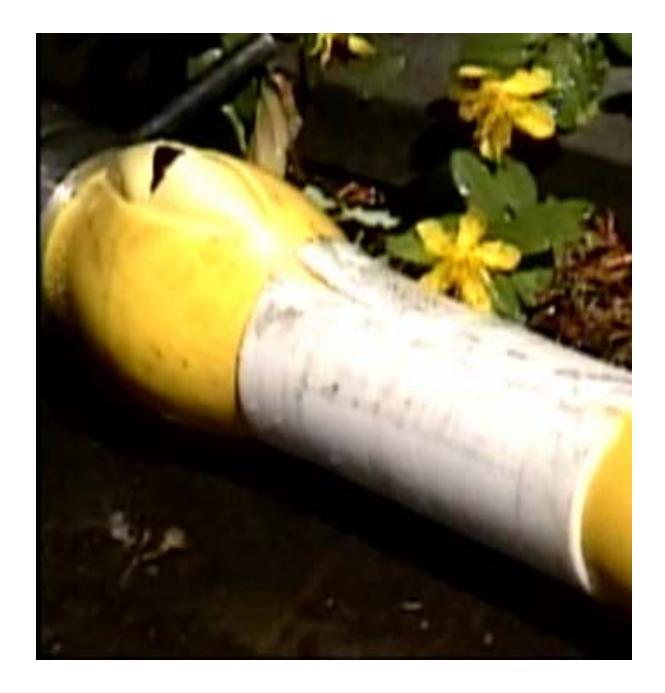
Figure 42: Quick burst test with overlapping full-wrap gel film patch shows successful bond & pipe failure below the patch at 600 psi

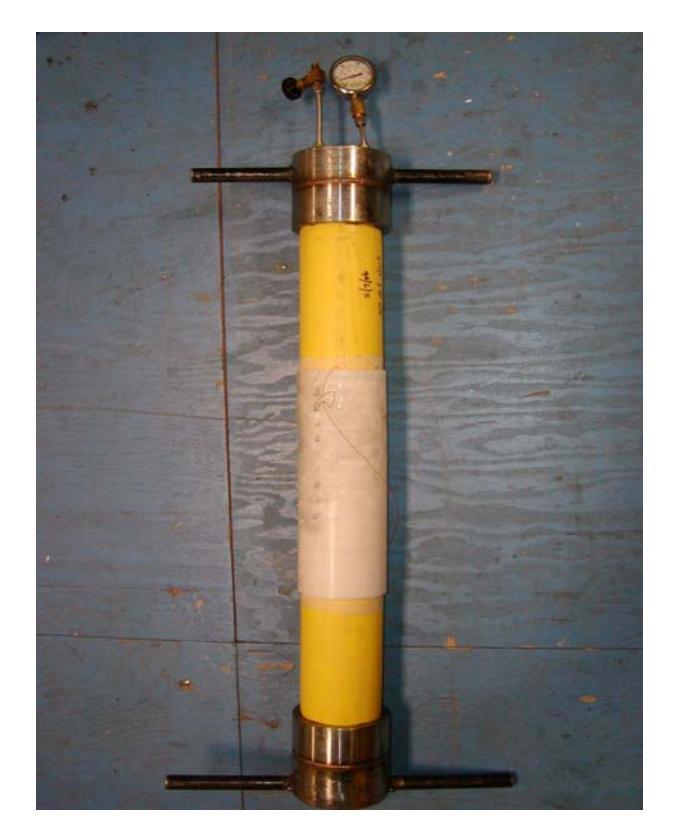
Figure 43: Closed system overlapping full-wrap gel film patch held at room temperature & 200 psi for > 5 months without any loss in pressure

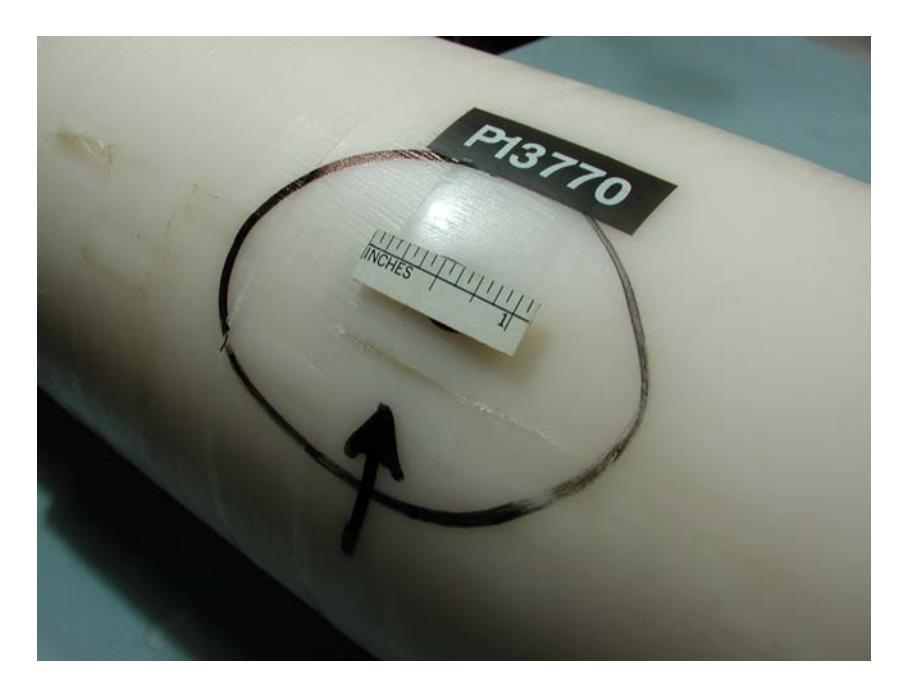
Figure 44: Photo of HDPE patch material failure at the 25-year mark during accelerated age testing

This HDPE repair patch substrate failure was of a brittle nature that was not seen in the room temperature lap shear tests in Task 8.2. In order to find the mechanism associated with these failures, lap shear samples were thermally "aged" in days and then pulled to find what effect thermal aging had on the bonds and substrates. These tests showed that the adhesive bond interfaces retained the majority of their strength, while the HDPE substrates themselves became embrittled and weakened. Figure 45 shows this weakening trend for HDPE as a function of time in 176°F/80°C water. The HDPE lost more than half of its strength within 5-6 days at these conditions.

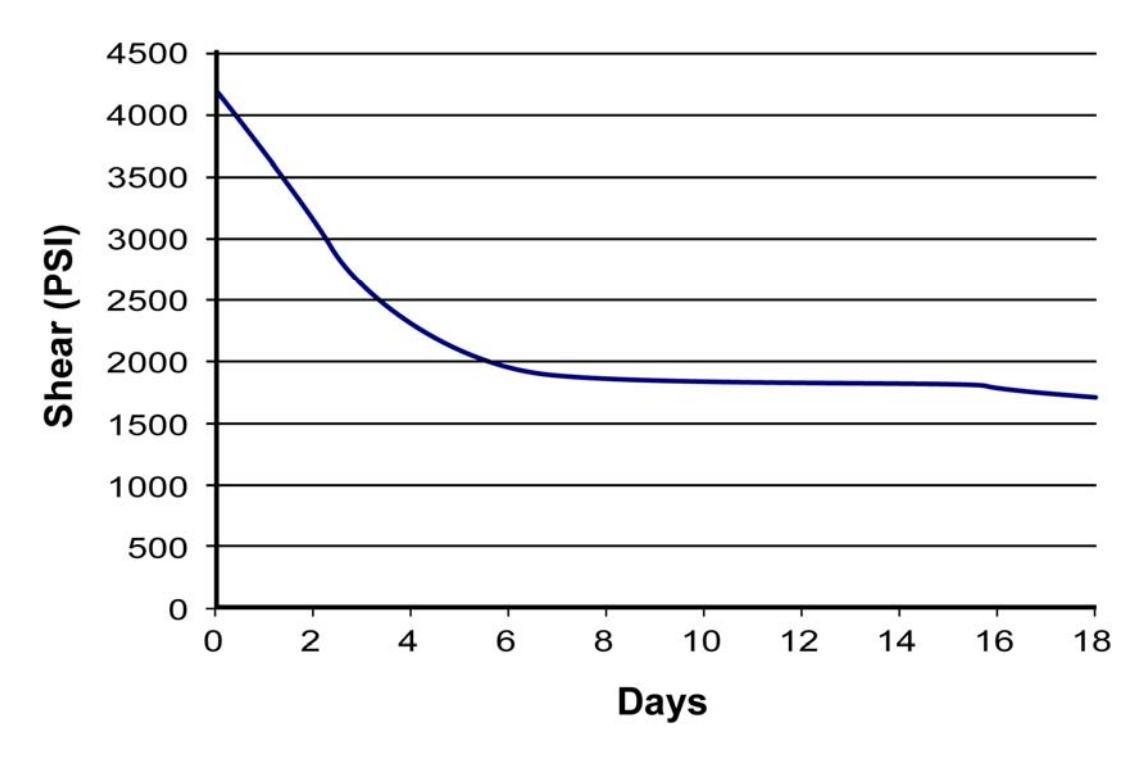
Figure 45: Graph of HDPE patch material strength loss vs. time (days)

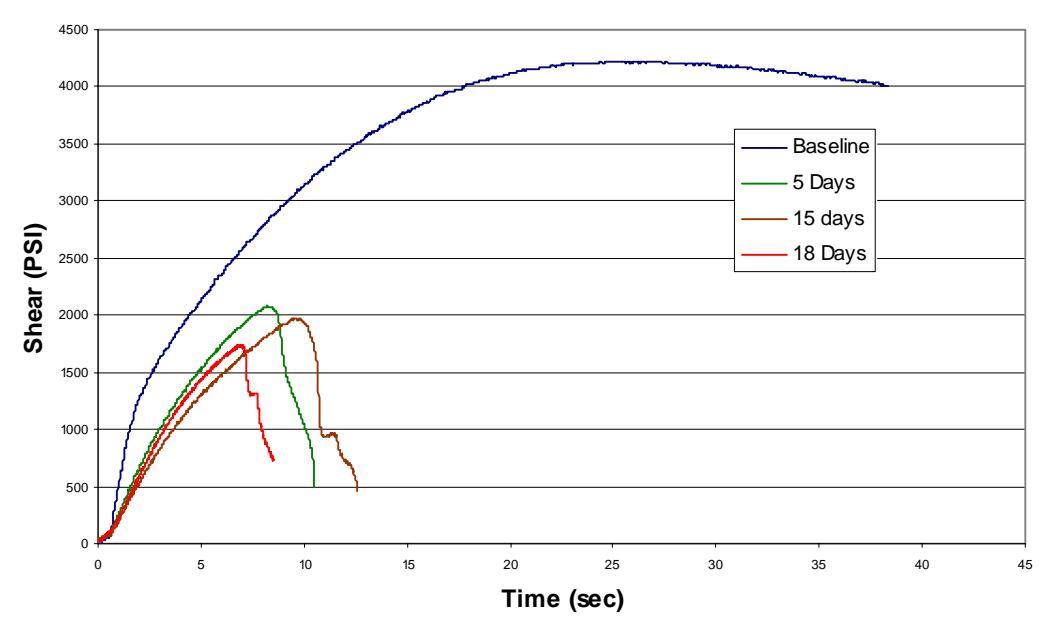
The same information is presented in Figure 46, where the average pull data (shear) was graphed for 5, 15, and 18 days, compared to non-aged samples (baseline).

Figure 46: Graph of HDPE patch material strength loss at 5, 15, and 18 days

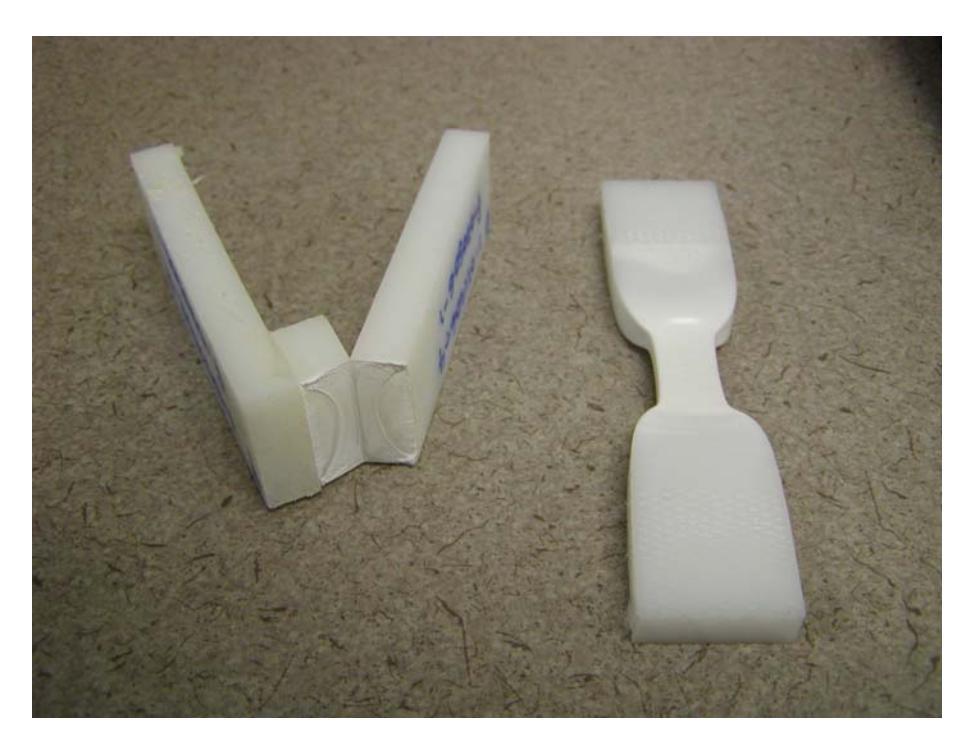
Figure 47: Broken embrittled HDPE material (left) compared to typical necking in HDPE control sample (right)

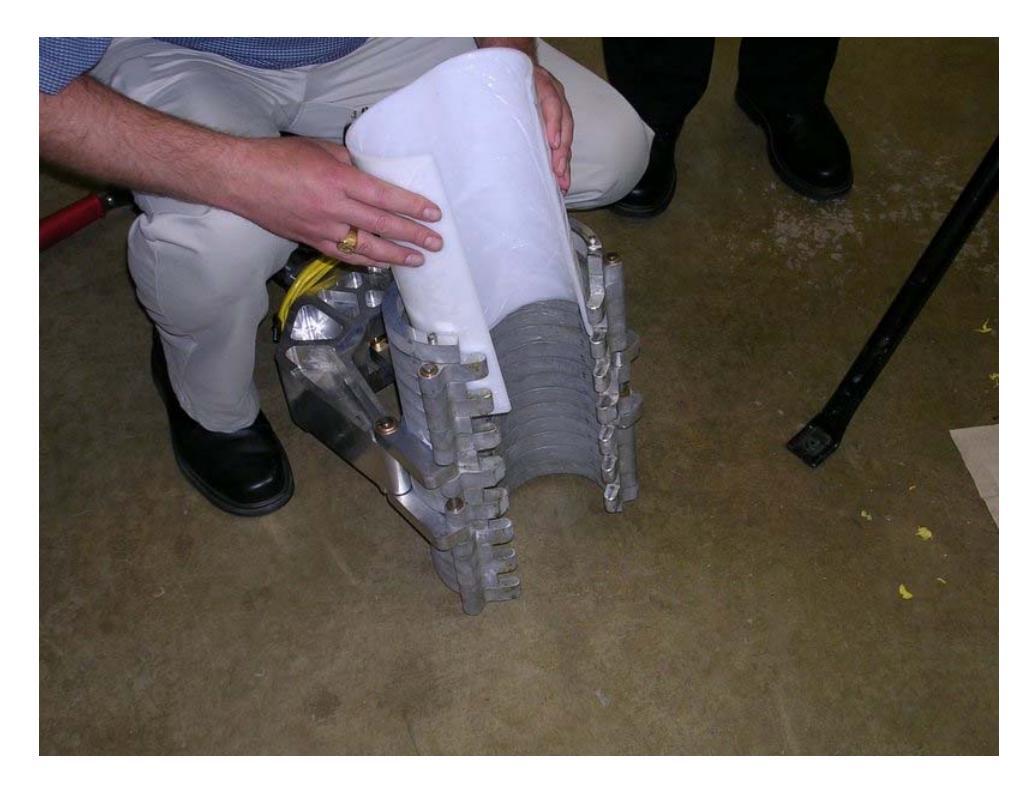
Figure 48: PE gel film repair patch being loaded into the engineered prototype for Nicor Gas demonstration in Naperville, IL

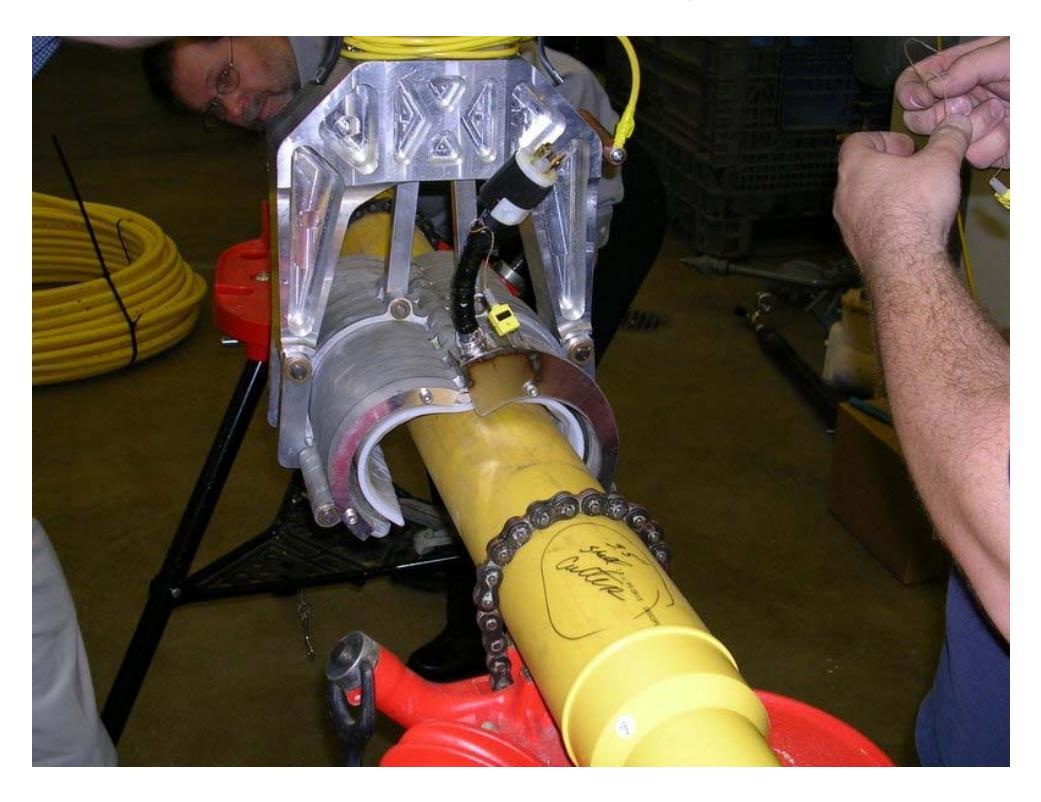
Figure 49: Engineered prototype with PE gel film repair patch being applied to damaged 4-inch MDPE pipe

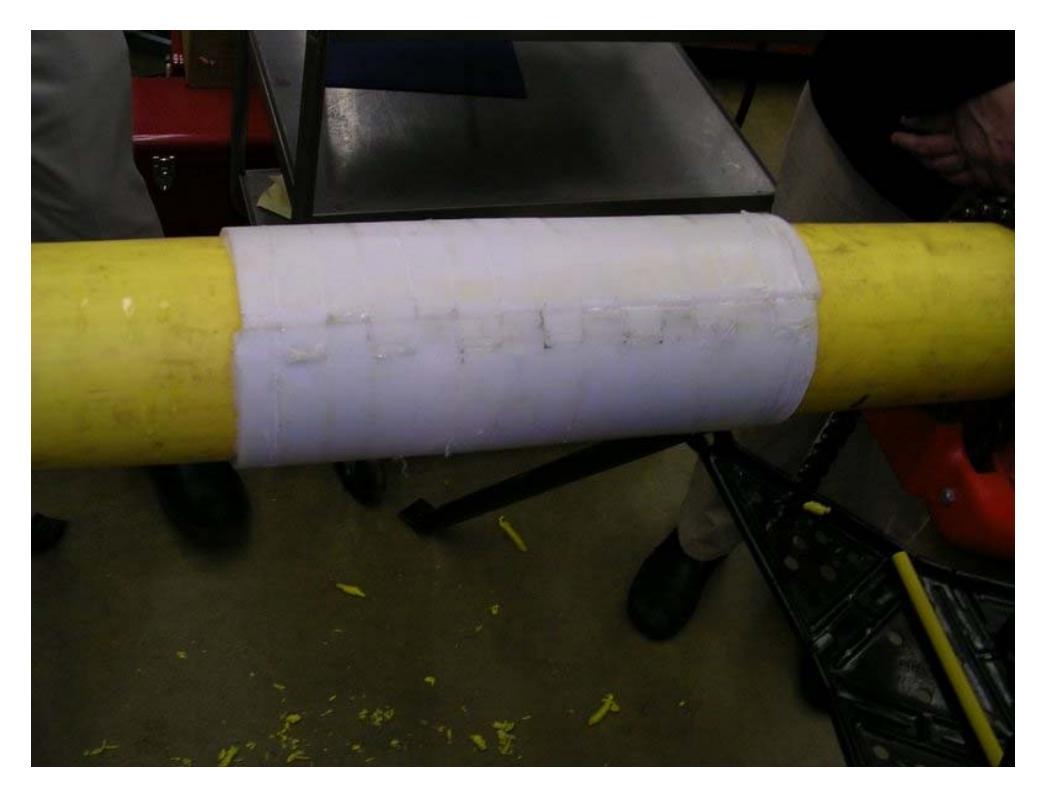
Figure 50: PE gel film patch successfully repaired a damaged 4-inch MDPE pipe

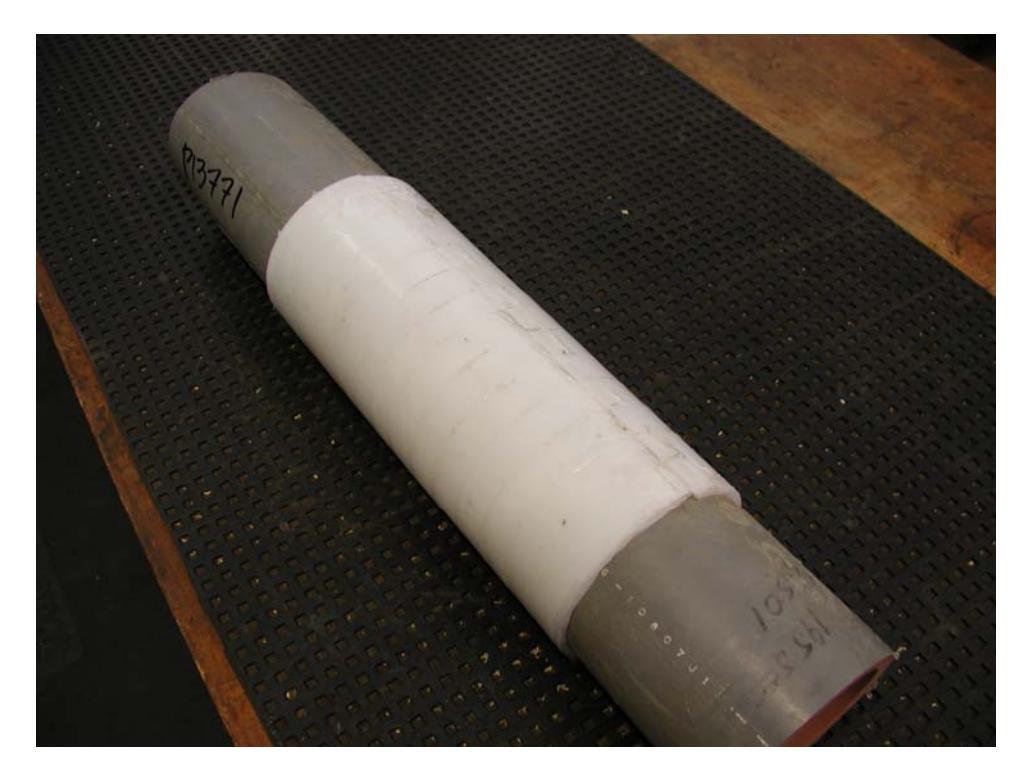
Figure 51: Overlapping full-wrap PE gel film patch successfully bonded to oxidized 4-inch IPS Aldyl-A pipe during demonstration for Sempra Energy

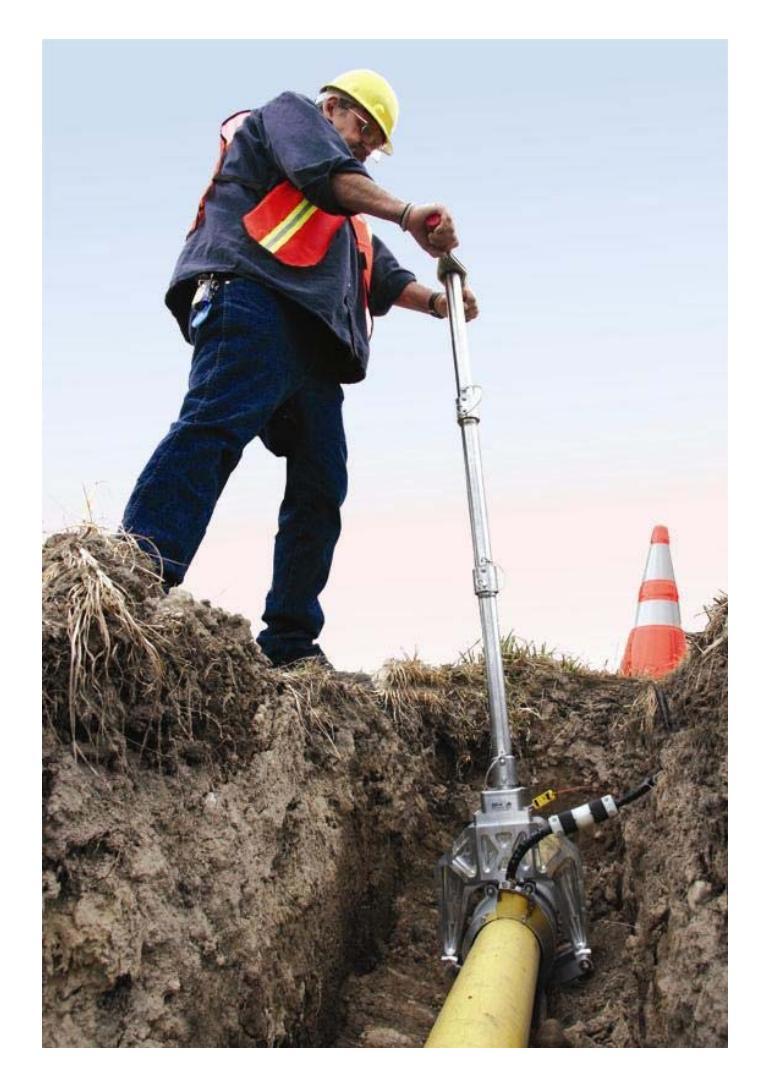
Figure 52: Final engineered prototype applying a PE gel film patch on 4-inch MDPE pipe
